# Fatigue Testing of Low-Cost Fiberglass Composite Wind Turbine Blade Materials

K. E. Hofer and L. C. Bennett  
IIT Research Institute

November 1981

Prepared for  
NATIONAL AERONAUTICS AND SPACE ADMINISTRATION  
Lewis Research Center  
Under Contract DEN 3-182

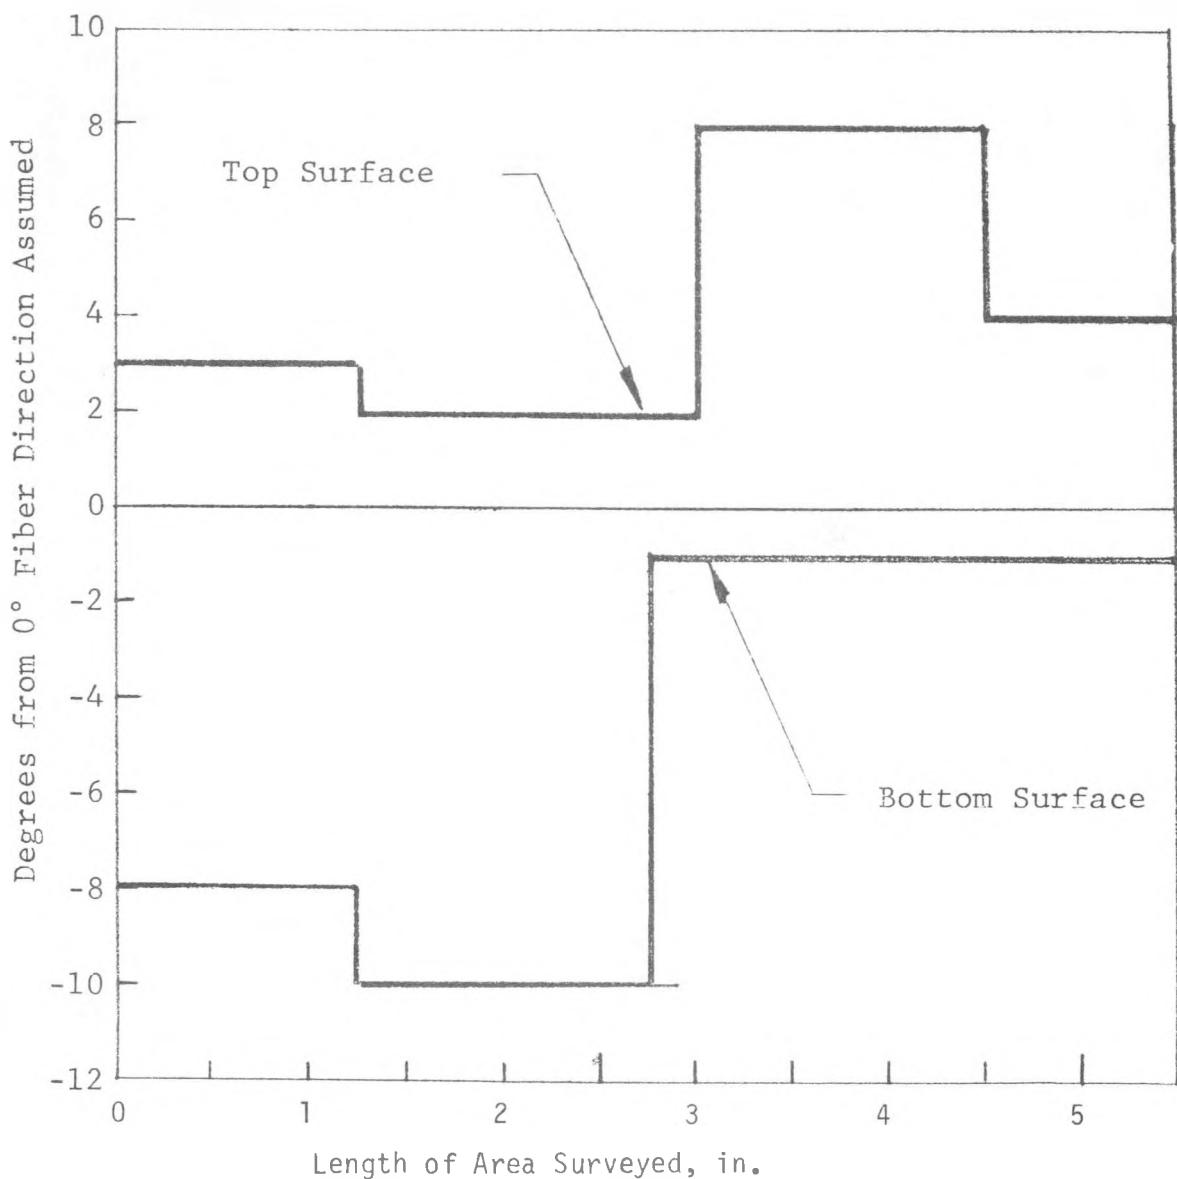
Figure 1. Direction of fibers relative to assumed  $0^\circ$  fiber direction.

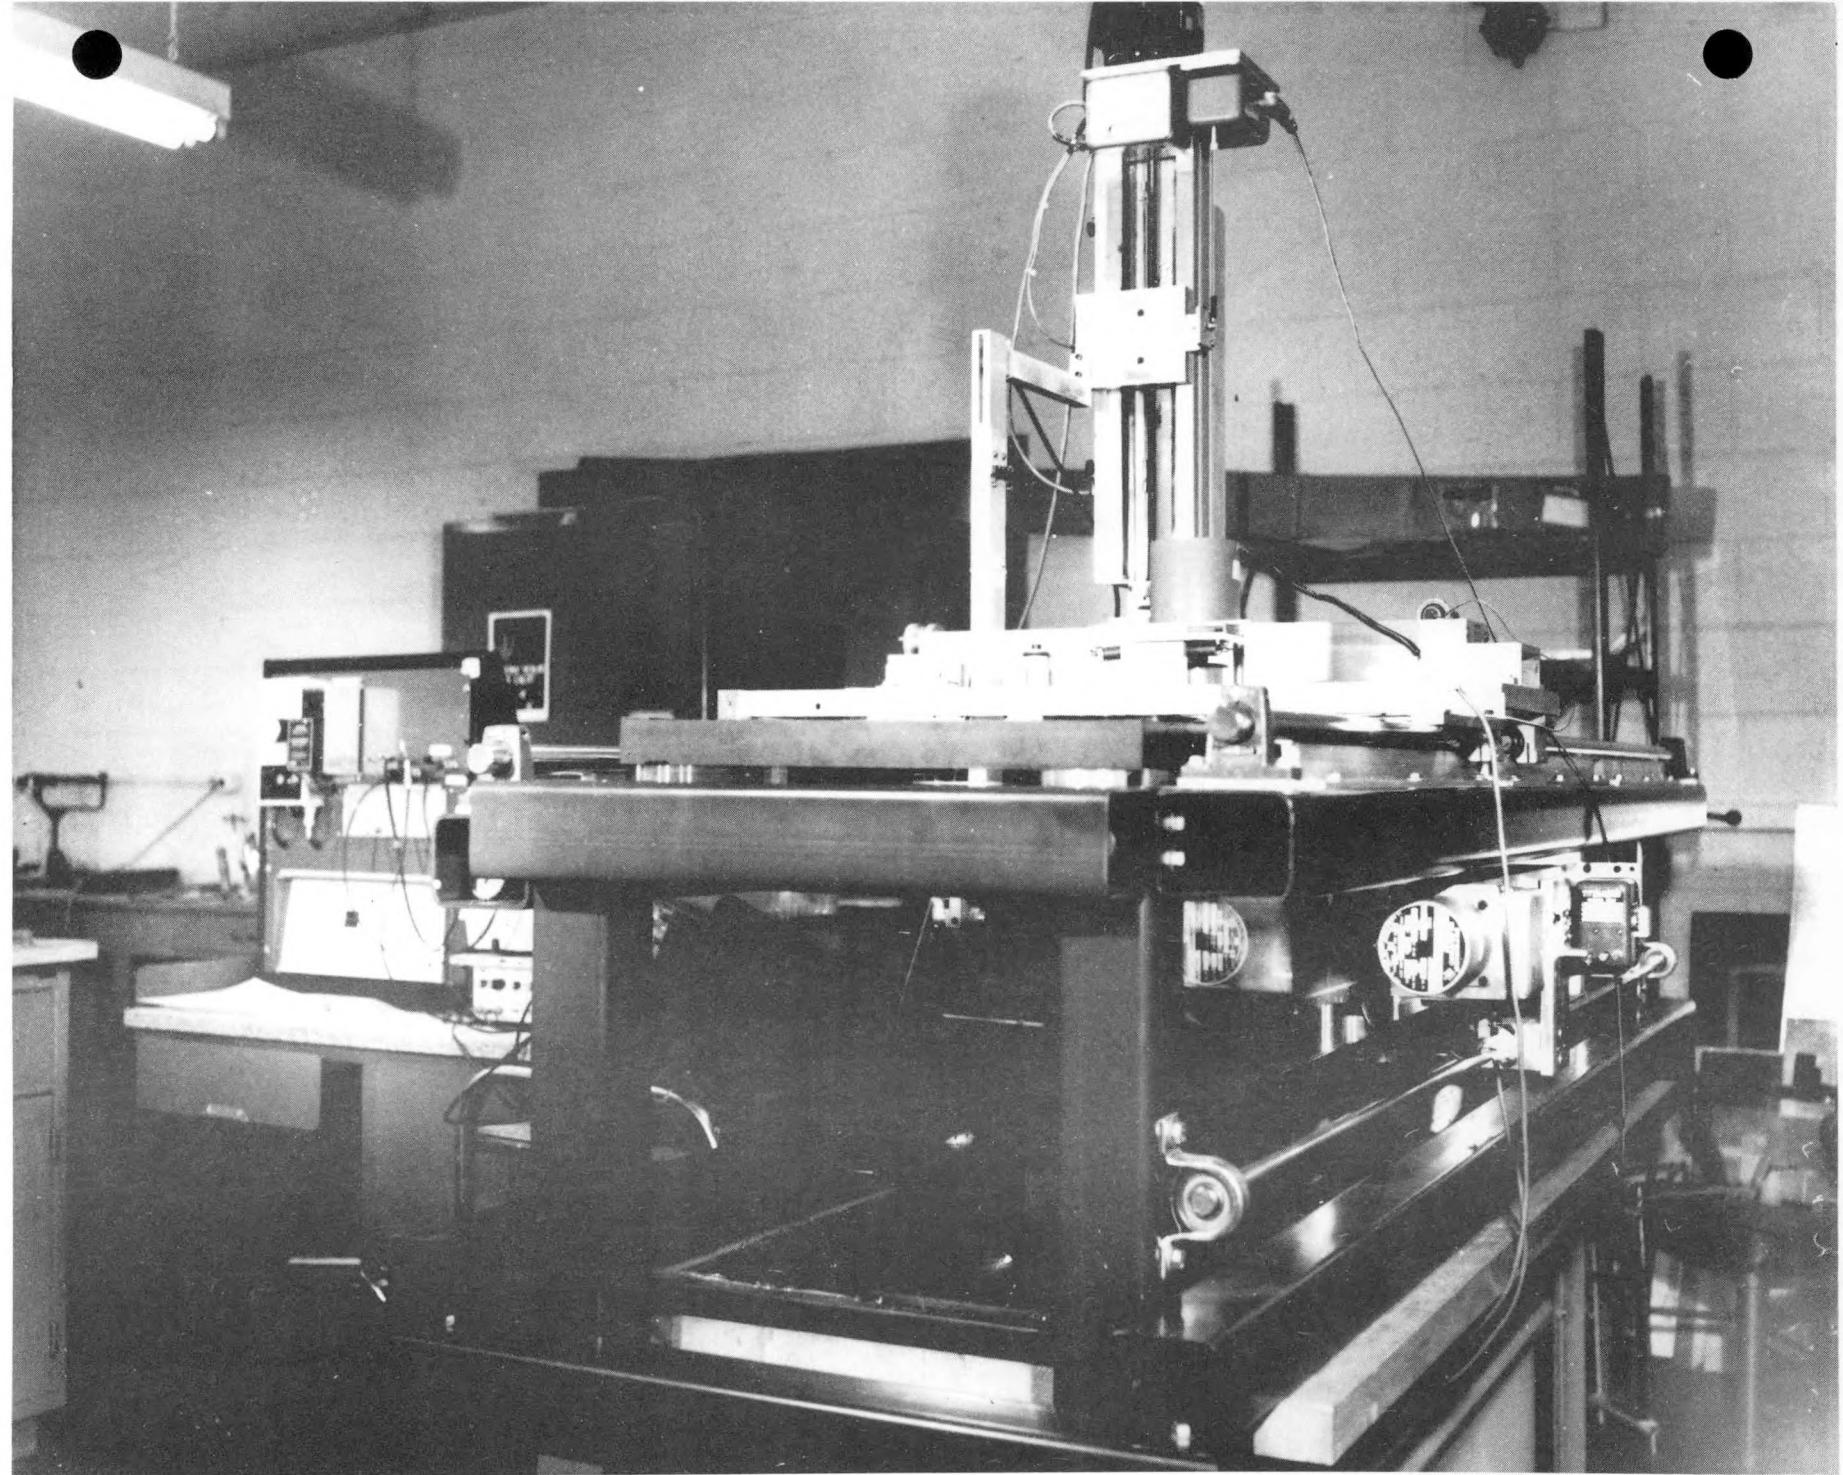
Figure 2. Nondestructive ultrasonic scanning system for inspecting wind turbine blade materials.

Although the panels of epoxy matrix composites had all been subjected to routine nondestructive inspection by ultrasonic C-scan by NASA prior to shipment to IITRI, the polyester panels had not. As a consequence, the polyester panels were subjected to C-scan by IITRI prior to specimen preparation. The apparatus shown in Fig. 2 was utilized for this purpose.

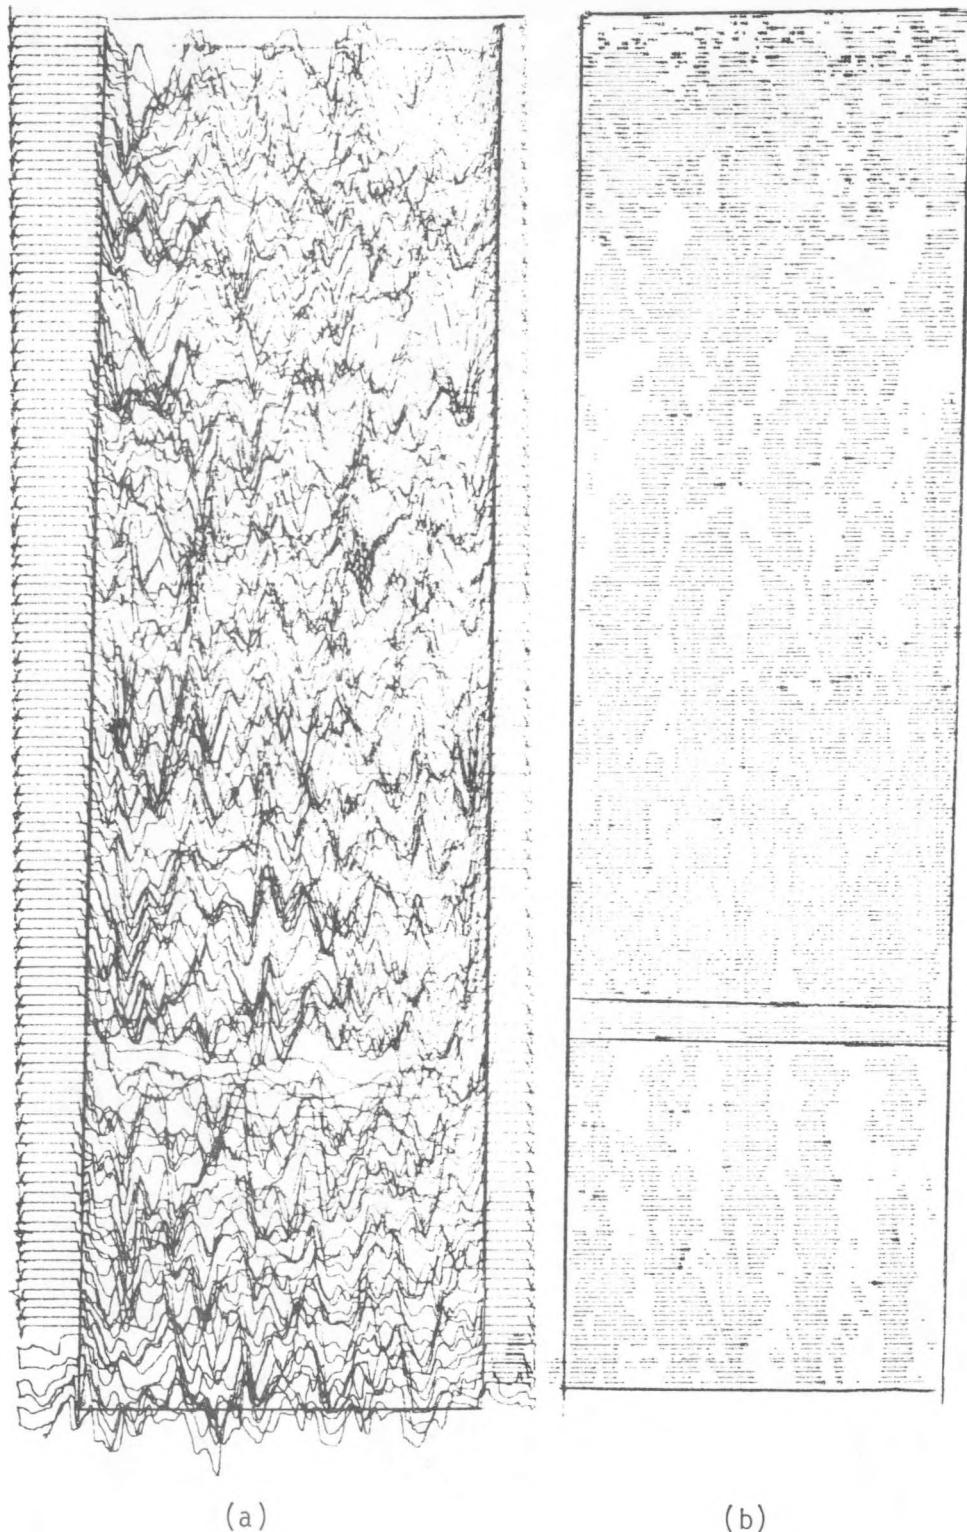
Figure 3. Specimen scanned at 1 Megahertz (pulse-echo mode).  
a) db attenuation versus position along various traversing paths in panel; b) gated scan with pen-paper contact only when attenuation is less than a fixed level.

Figures 3 and 4 show the attenuation versus position and C-scans for a trial sample at 1 and 5 MHz, respectively, in the pulse-echo mode. The 1 MHz pulse-echo scan was repeated after overnight immersion, to eliminate air

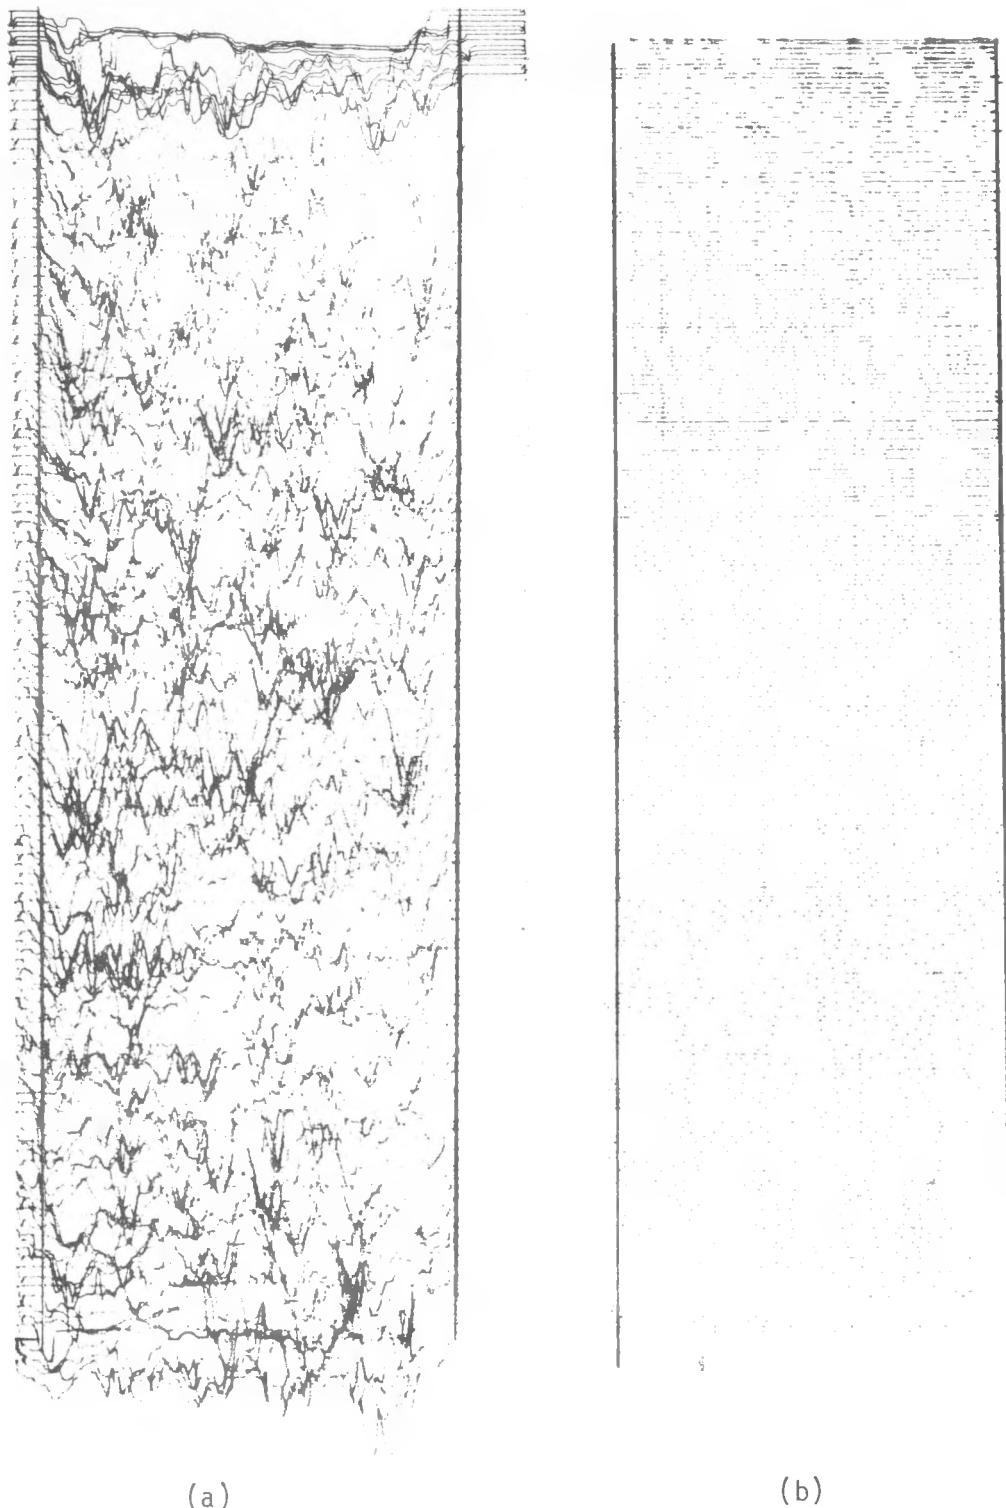
Figure 4. Specimen scanned at 5 Megahertz (pulse-echo mode).  
a) db attenuation versus position along various traversing paths in panel; b) gated scan with pen-paper contact only when attenuation is less than a fixed level.

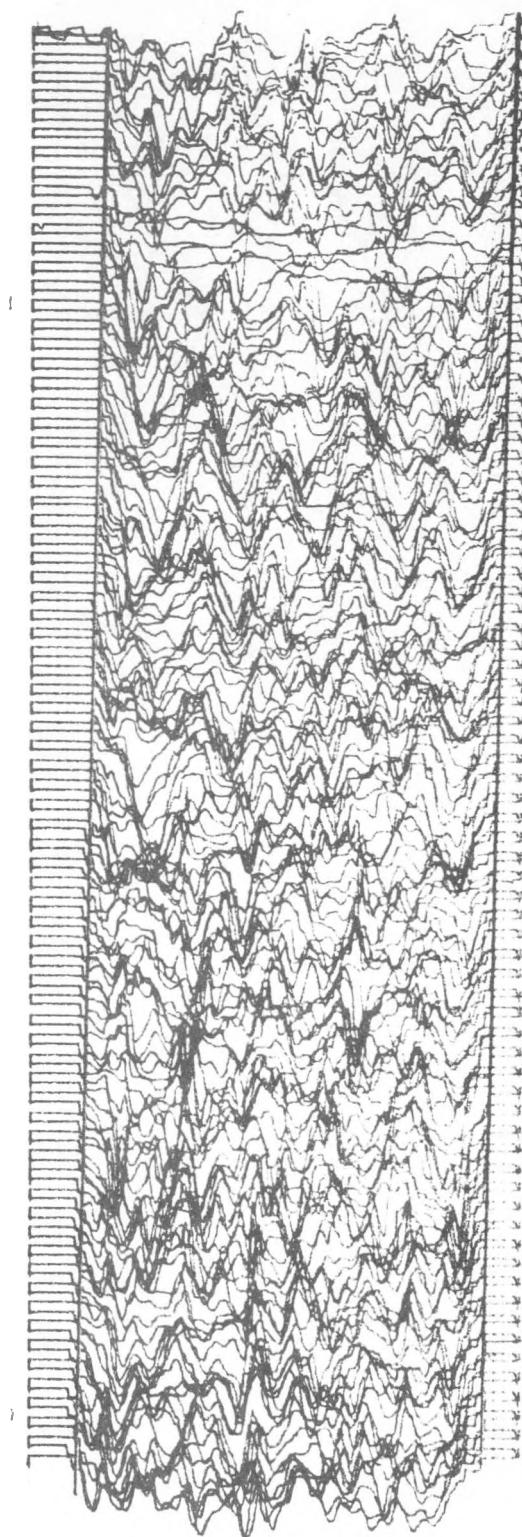
Figure 5. Same sample as shown in Figure 1 tested at 1 Megahertz pulse-echo mode after 24 hours immersion to eliminate air bubbles. a) db attenuation versus position along various traversing paths in panel; (b) same panel with a gated scan with pen-paper contact only when attenuation is less than some fixed level.

bubbles possibly attached to the surface. Figure 5 shows the results. No improvement over the scan shown in Figure 3 was evident. Finally, a through-transmission scan was performed for the same sample. Figure 6 shows those results.

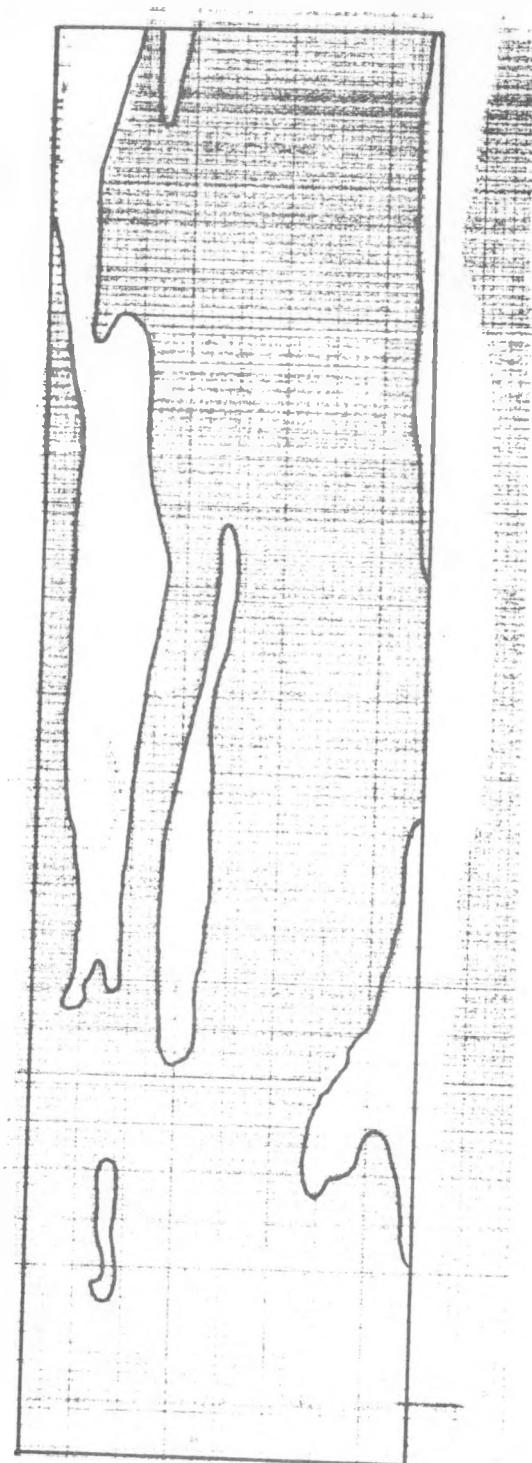
Figure 6. Through-transmission gated scan at 5 Megahertz - sample as used in Figures 1 to 3; regions of greatest attenuation shown outlined by ink.

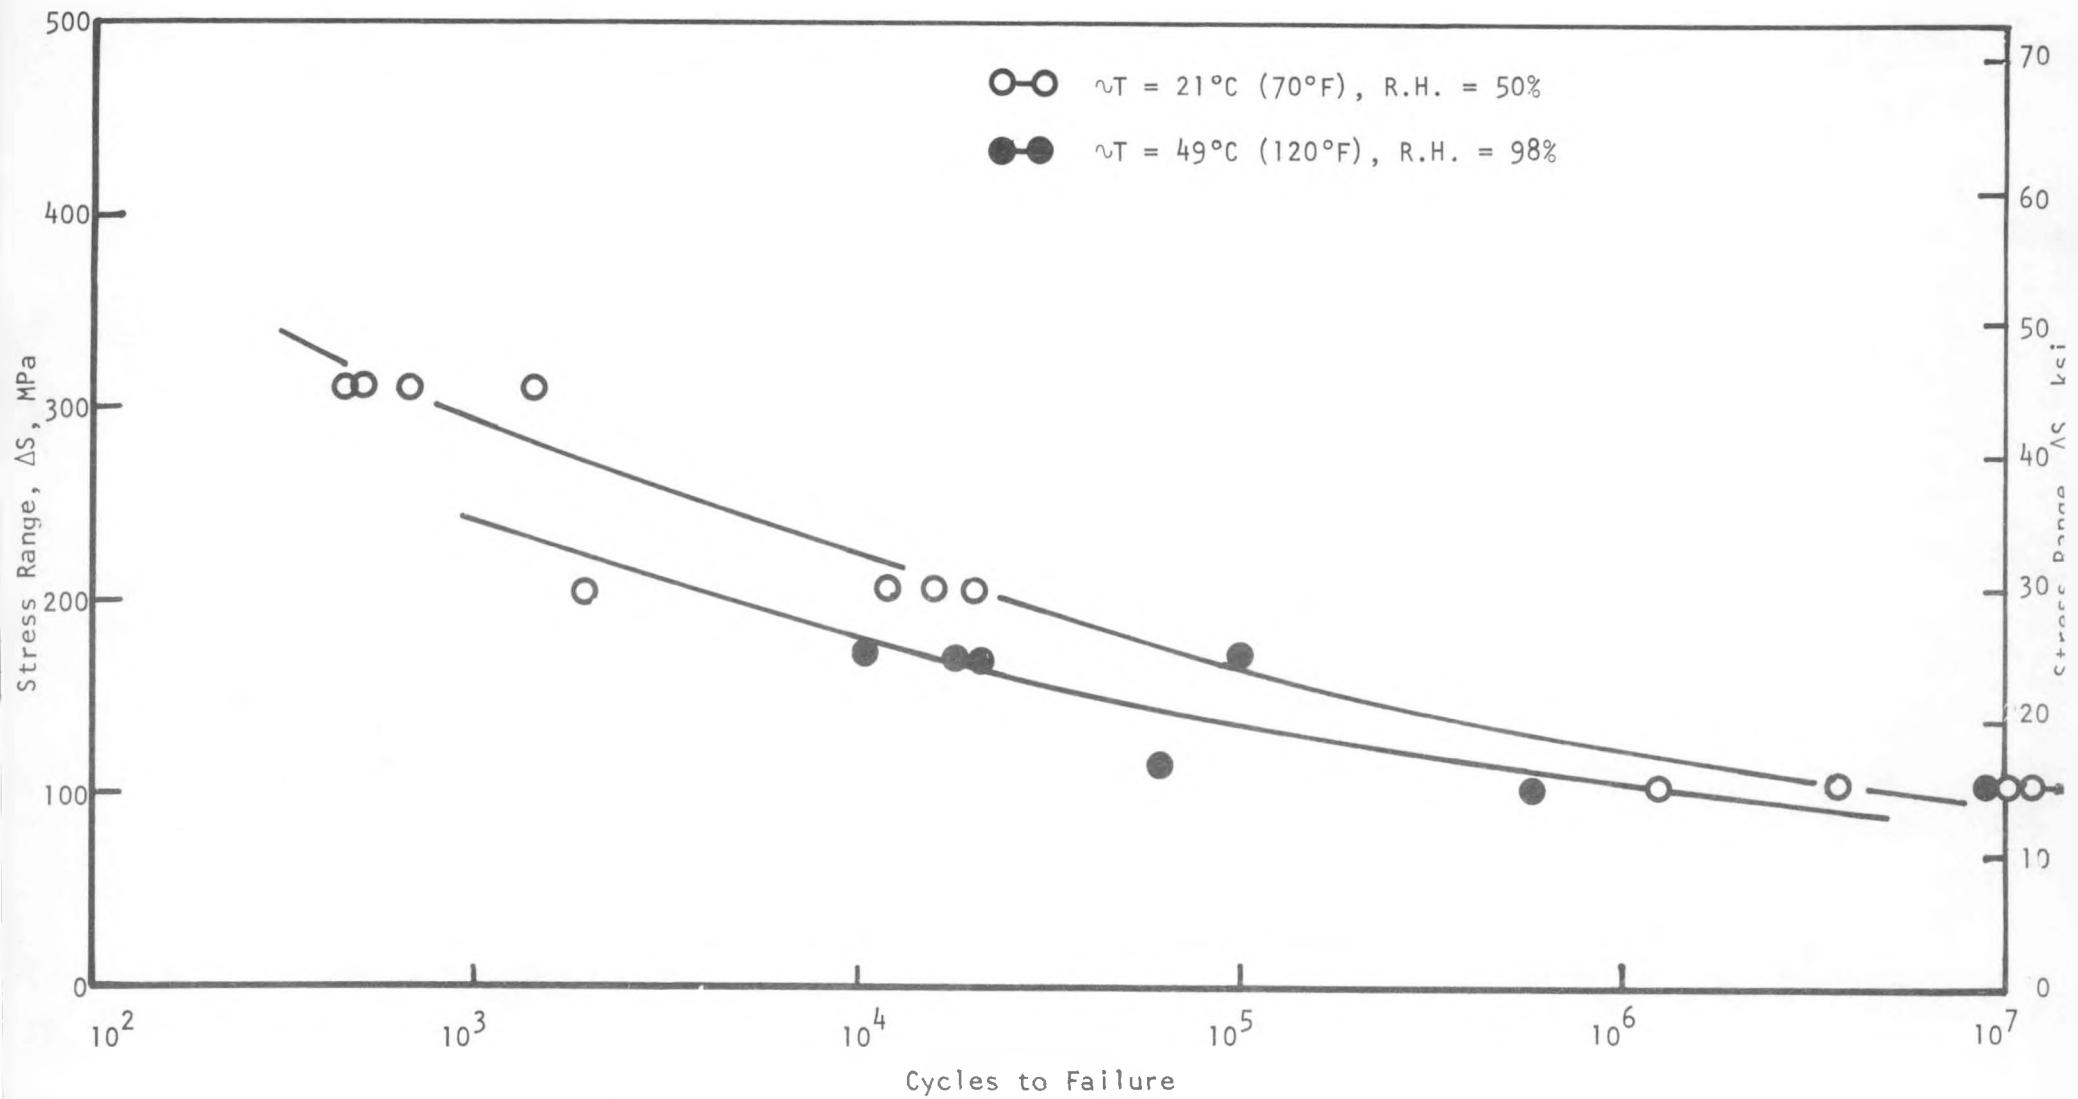
Figure 9. Baseline S-N fatigue life diagram for epoxy matrix composite with winding pattern 1, tested at  $R = 0$ ,  $\phi = 1$  to 30 Hertz and various environments as noted.

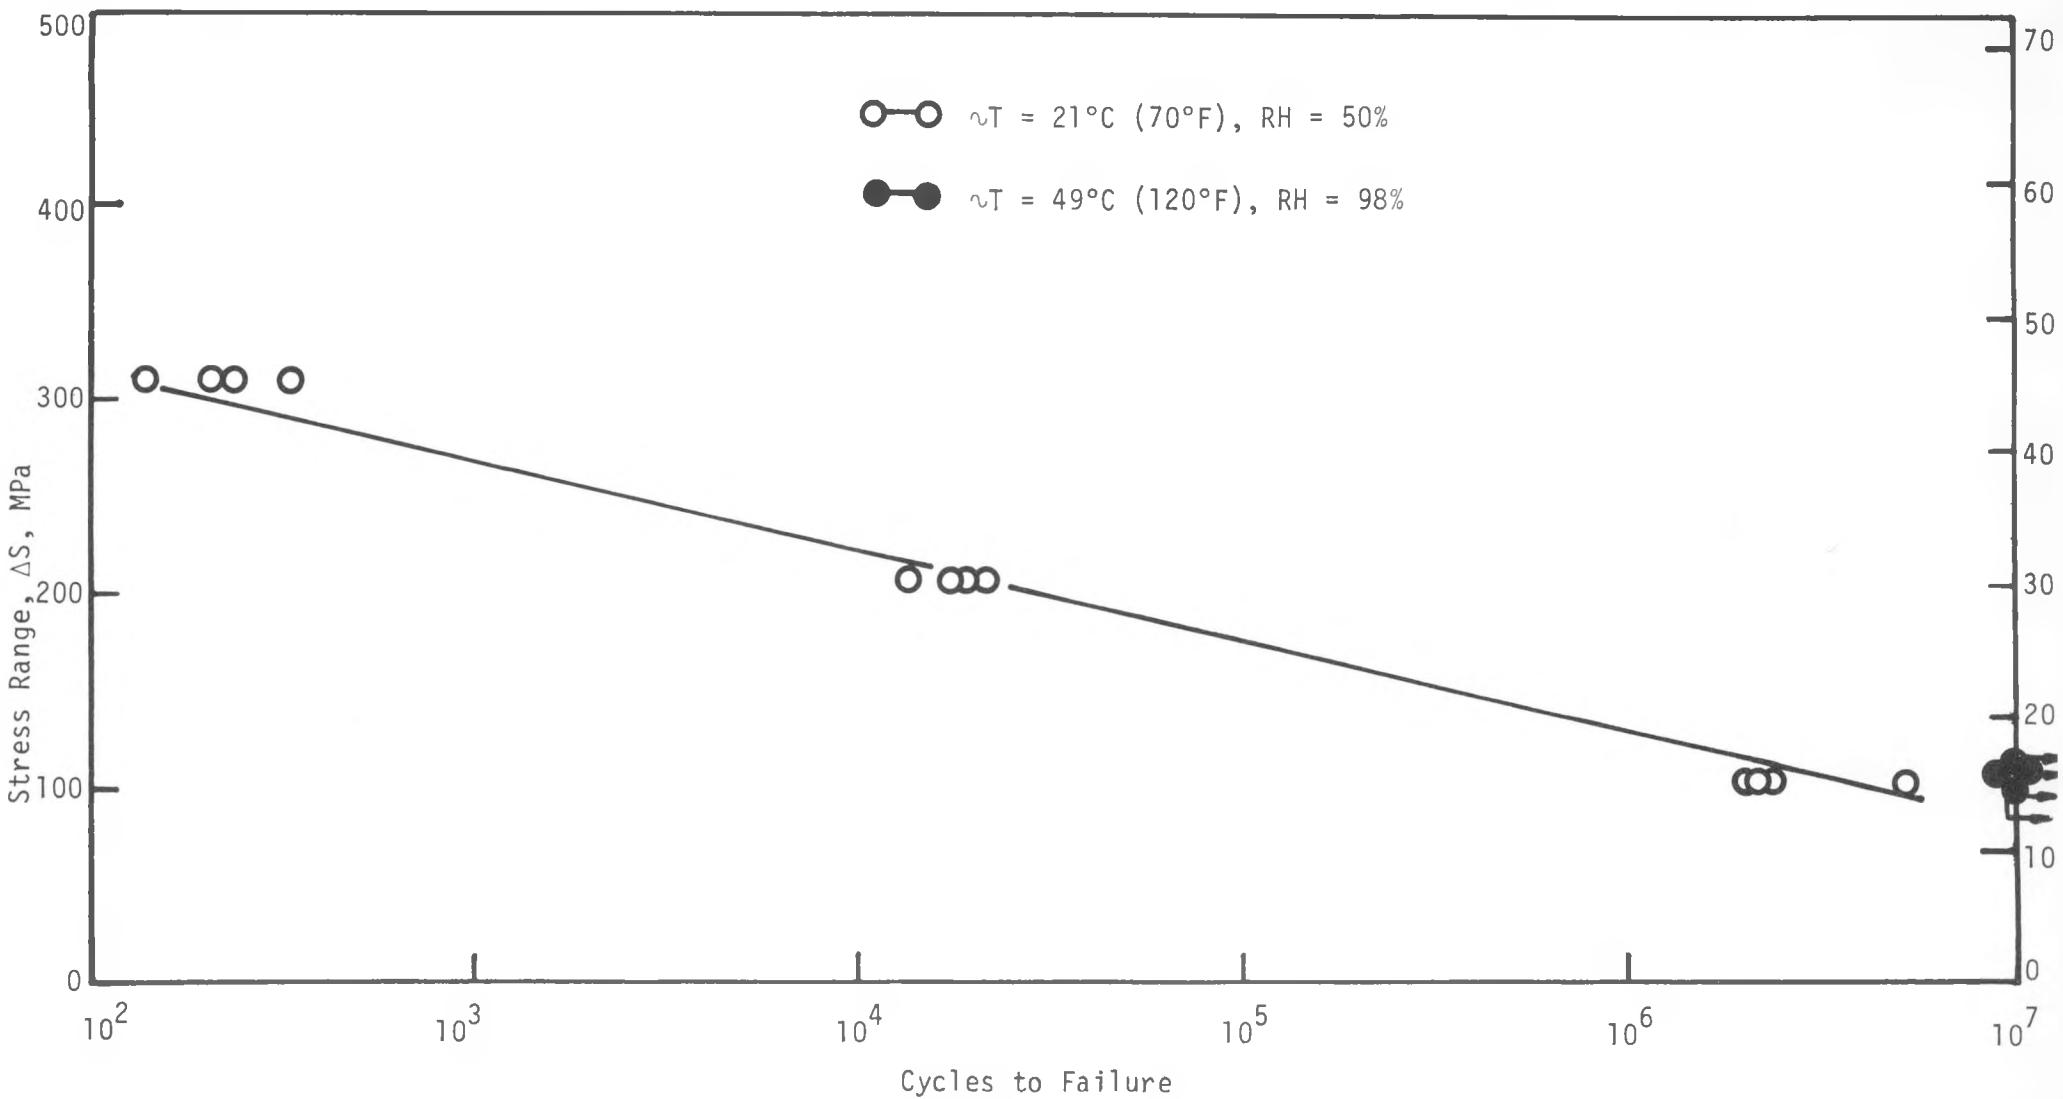
Figure 10. Baseline S-N fatigue life diagram for epoxy matrix composite with winding pattern 2, tested at  $R = 0$ ,  $\phi = 1$  to 30 Hertz and various environments as noted.

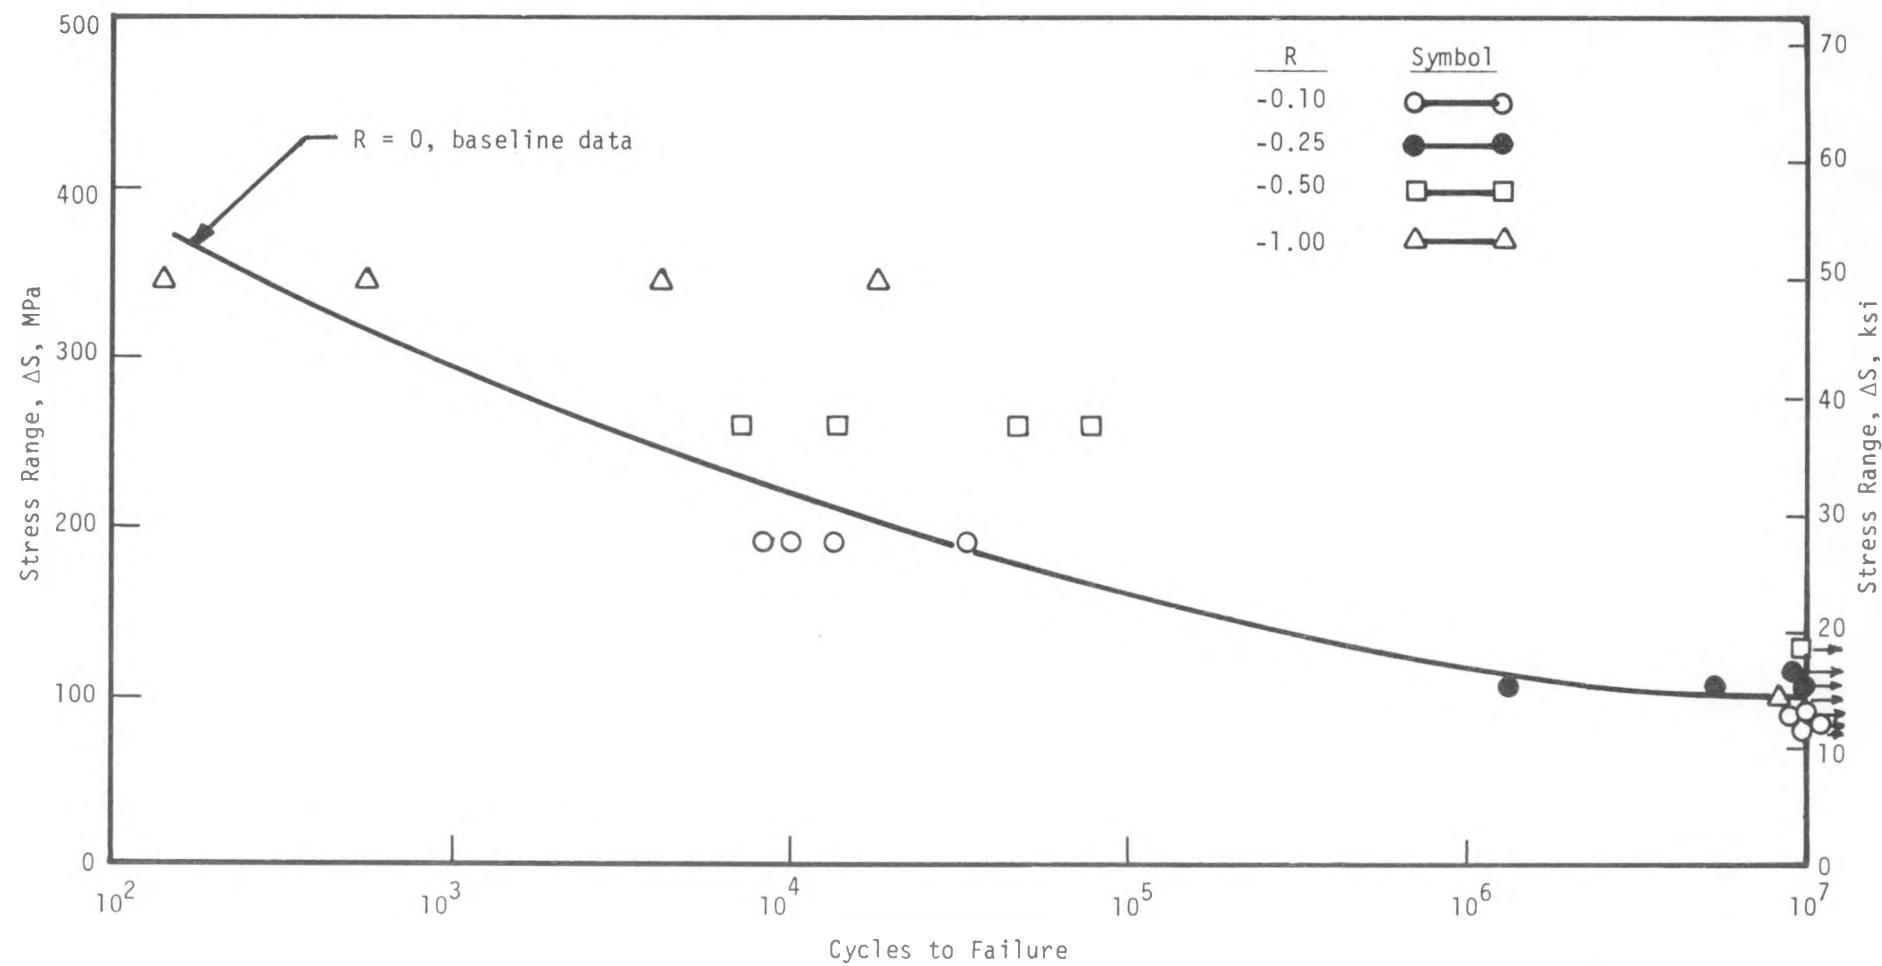
Figure 11. Effect of mean stress on the fatigue endurance for the epoxy matrix composite with winding pattern 1; all tests performed at ambient conditions,  $T = 21^\circ\text{C}$  ( $70^\circ\text{F}$ ), RH = 50%.

The fatigue lines are plotted in Fig. 11 for various values of the stress range, i.e.,  $|S_{max} - S_{min}|$ . The stress range can be calculated from Table 17 of Appendix C by multiplying the peak stress per cycle (stress level) by the value  $(1-R)$  where  $R$  is the  $R$  ratio. Thus for a peak stress of 82.8 MPa (12 ksi) at an  $R$  ratio of -0.25, we have the stress range =  $1.25 \times 82.8 = 103.5$  MPa. The alternating component of this stress range is  $0.5 \times 103.5 = 51.75$  MPa and the mean stress would be  $82.8 - 51.75 = 31.05$  MPa. Figure 12 is a modified Goodman Plot of constant life curves obtained from Fig. 11 and the values of the alternating component of the stress range.

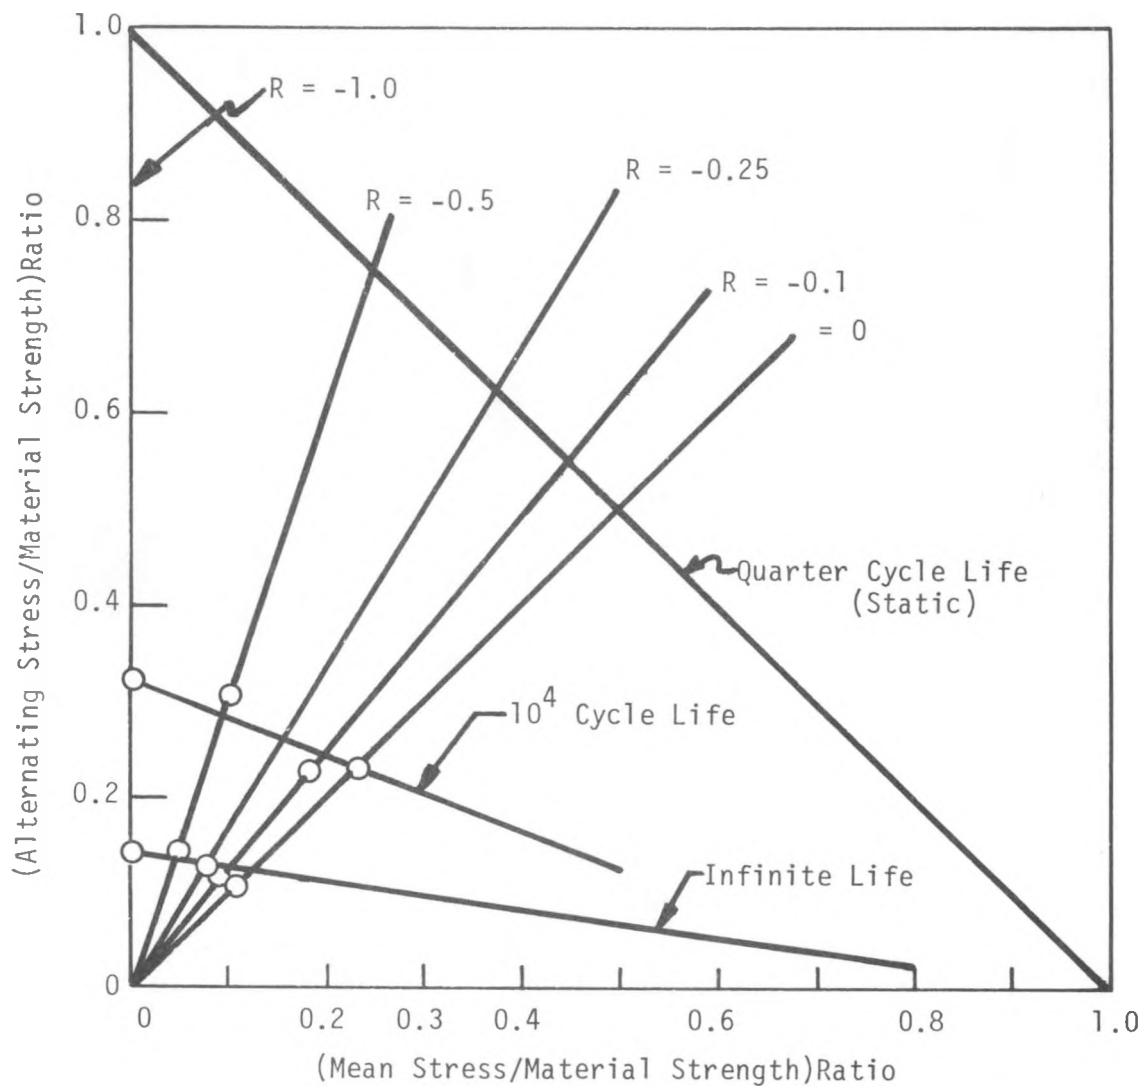
Figure 12. Modified Goodman diagram illustrating the effect of mean stress on the behavior of epoxy matrix composites with winding pattern No. 1 at  $T = 21^\circ\text{C}$  ( $70^\circ\text{F}$ ) and RH = 50%. [Material strength = 464 MPa (67.2 ksi).]

The curves portrayed in Fig. 12 are similar to those obtained for other common aerospace structural materials including metals, plastics, and composites. Thus, no particular problem would arise from the use of such curves in design with the TFT fiberglass/epoxy composites.

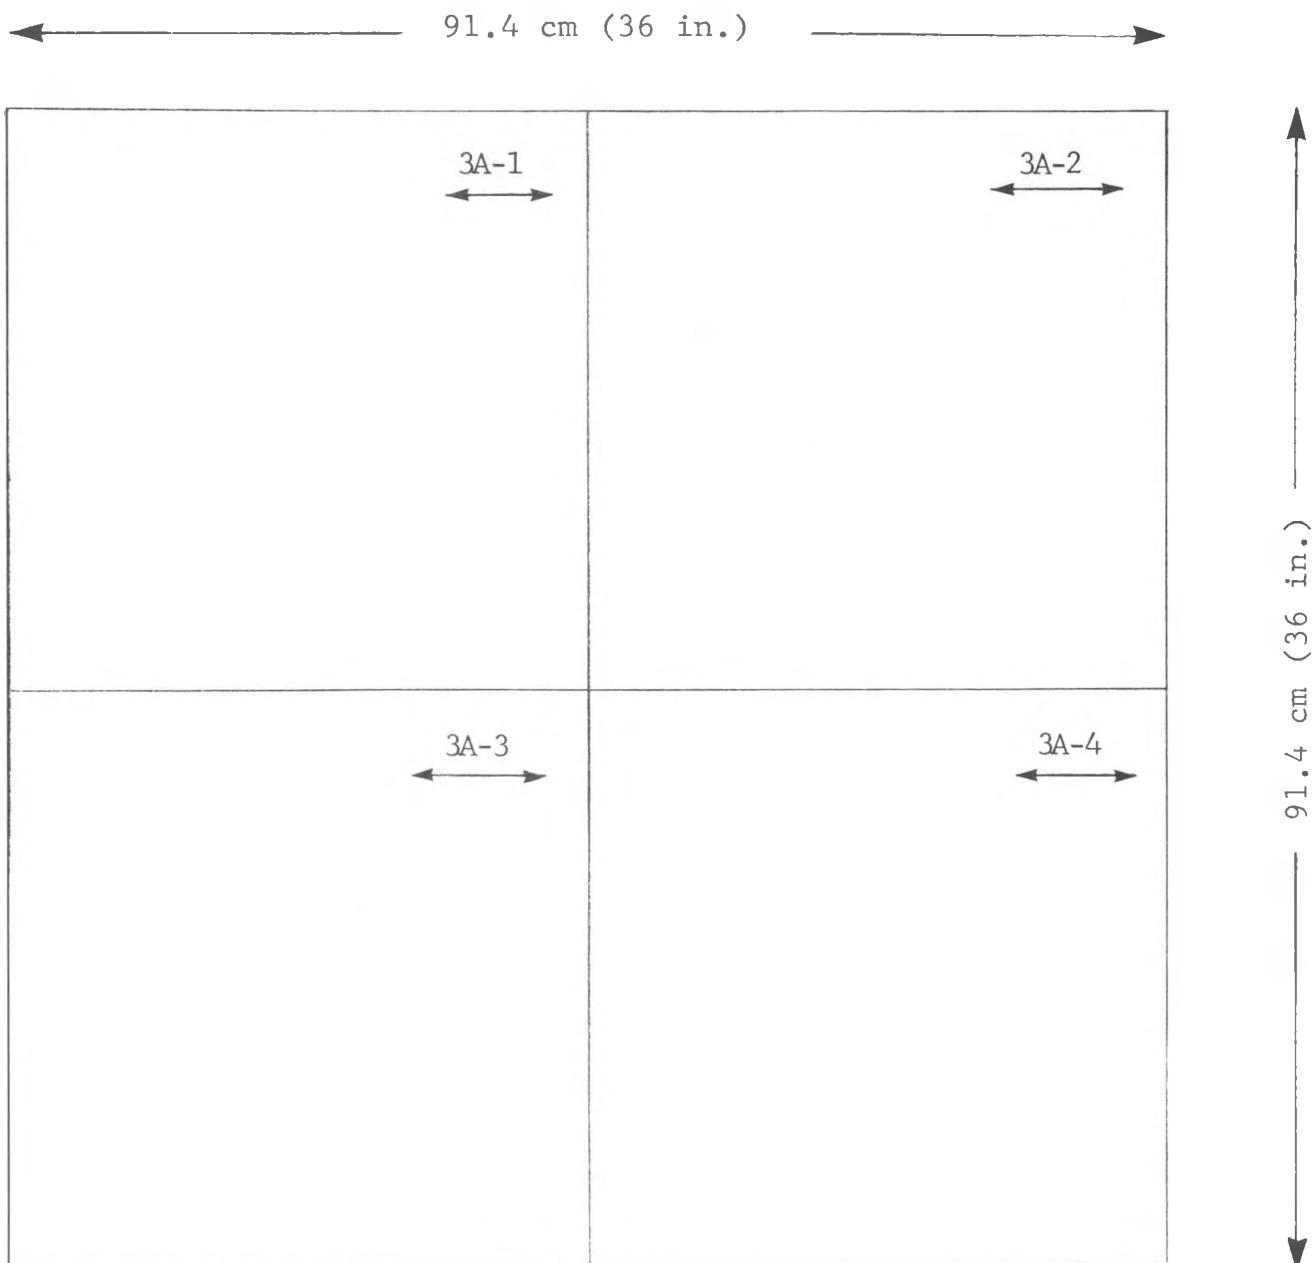
Figure 13. Typical example of panel partitioning prior to specimen blanking operations (panel No. 3A for epoxy matrix/TFT with winding pattern No. 1). The arrows beneath the subpanel numbers refer to the principal, or  $0^\circ$ , filament direction.

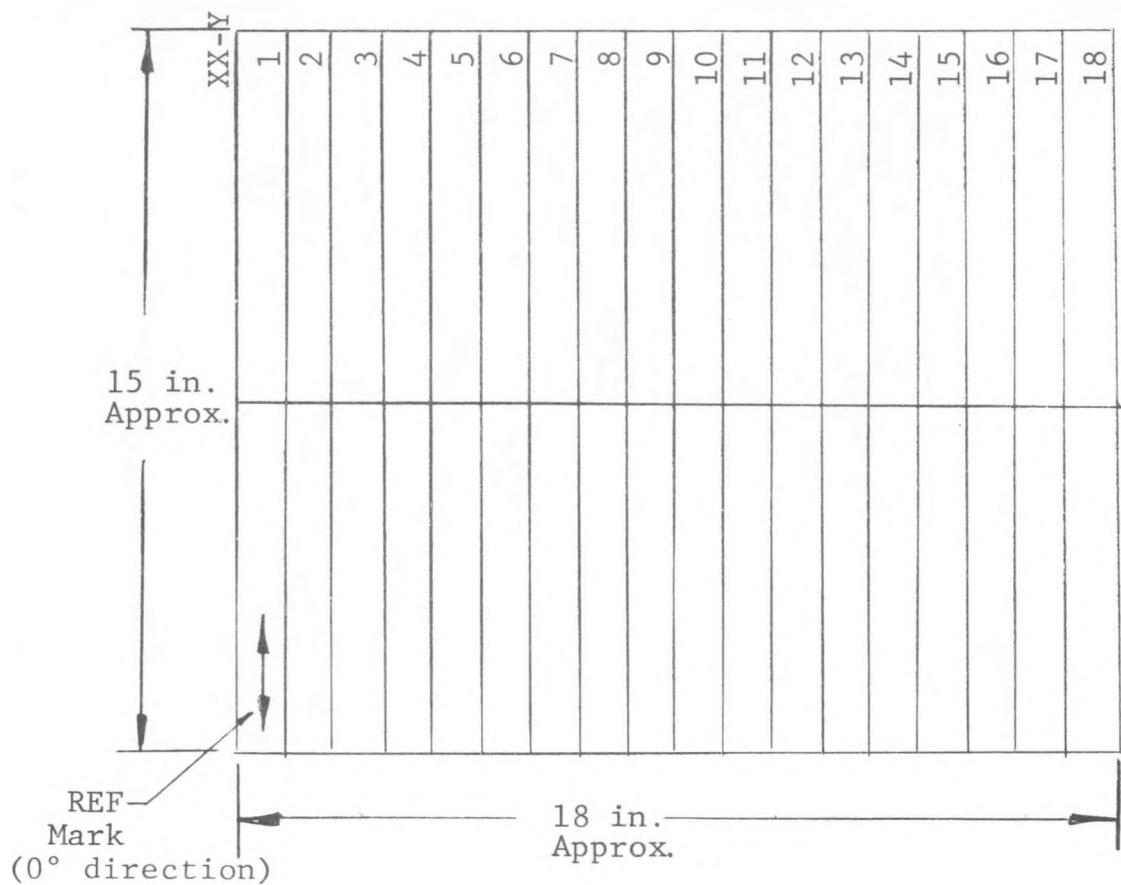
Figure 14. Sub-panel specimen blanking scheme. Each strip is 1 in. wide. All strips were cut parallel to reference mark (in 0° direction).

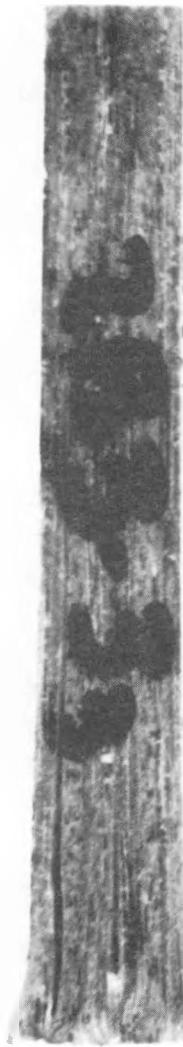
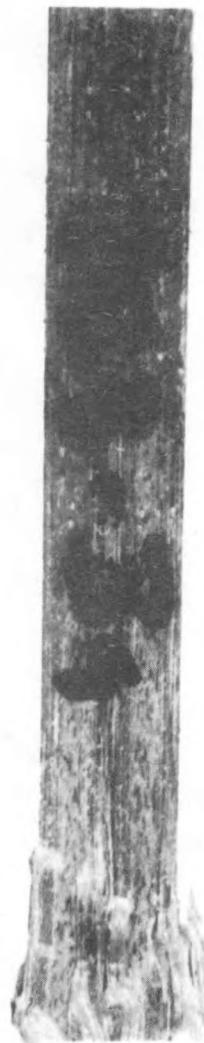
Figure 15. Fracture appearance of winding patterns 1 and 2 specimens subjected to static compression loading.

An examination of the static tension and compression failure modes was made as well. Figures 15 and 16 illustrate failures for both of the epoxy matrix composites (Winding Pattern Nos. 1 and 2). Figure 15 shows compression failures. Note that the failures for the two patterns are dissimilar. It would appear that the material from plates prepared by Winding Pattern No. 1 show shear failure, with the failure zone occurring away from the ends and in the center of the material. Similarly, it appears that material from plates prepared by Winding Pattern No. 2 shows an end brooming mode that is located at the end of the specimen. Delamination is also present in the failure of Winding Pattern No. 2. As seen from Fig. 16, there was no apparent difference in the tension failures for the two materials.

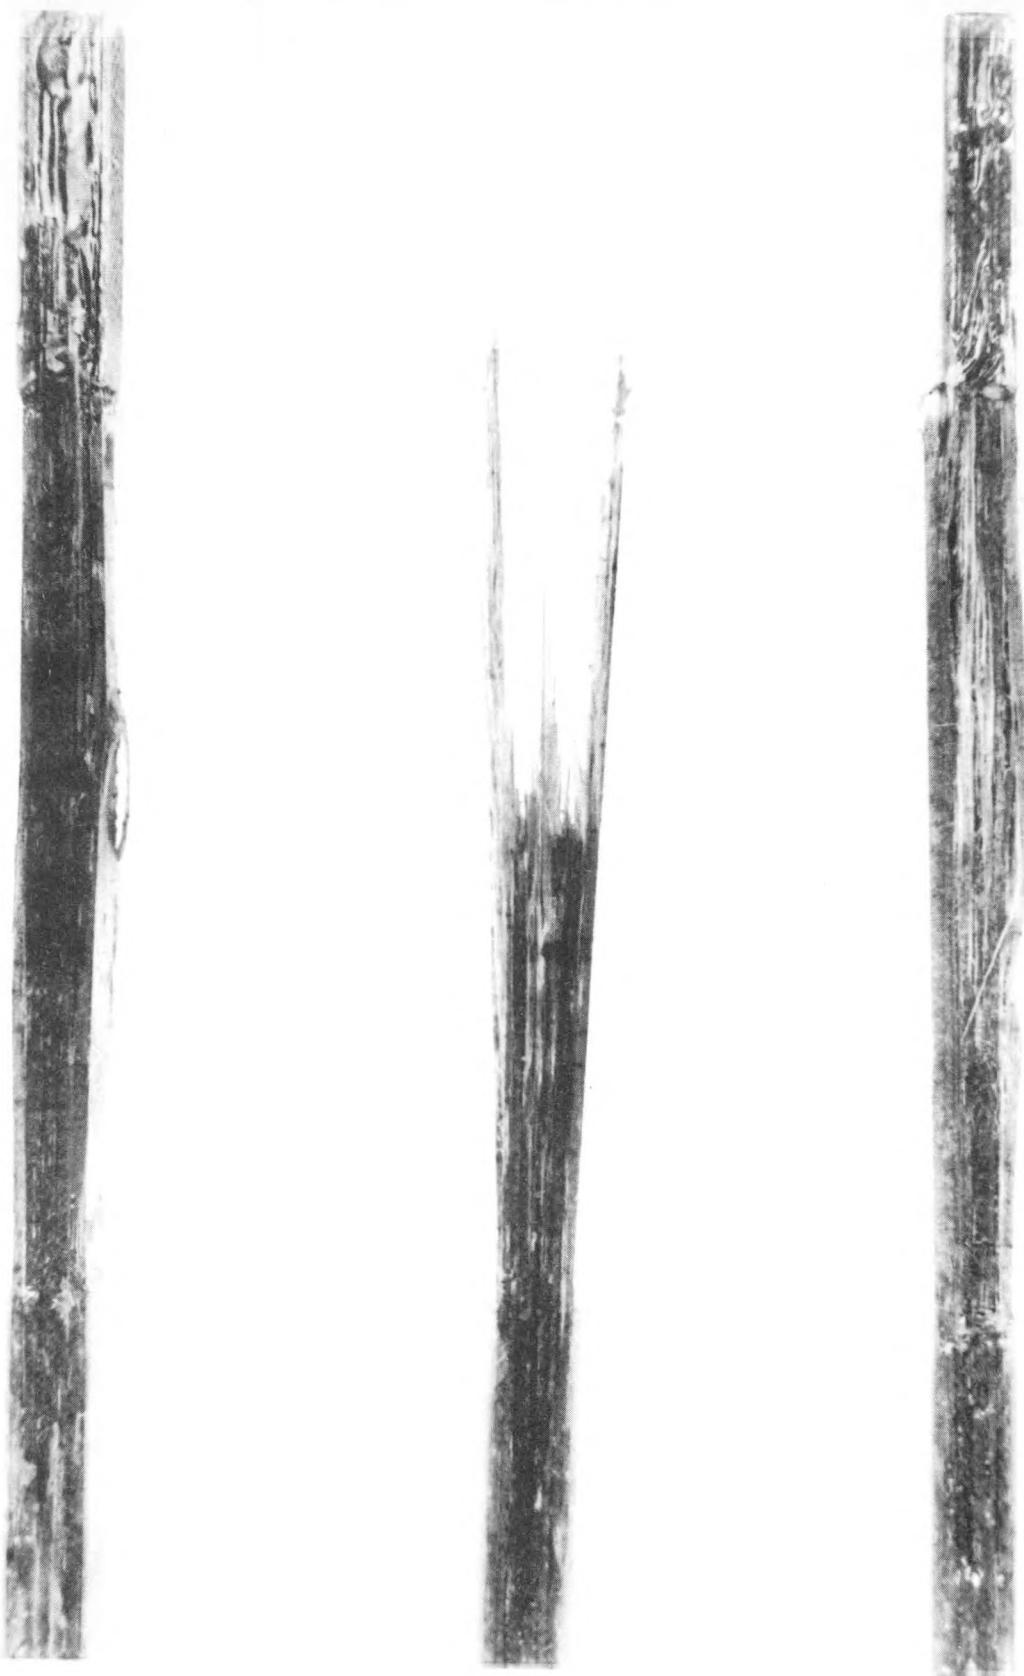
Figure 16. Typical fracture appearance of specimens subjected to static tension loading.
