# Fatigue Testing of Low-Cost Fiberglass Composite Wind Turbine Blade Materials

K. E. Hofer and L. C. Bennett  
IIT Research Institute

November 1981

Prepared for  
NATIONAL AERONAUTICS AND SPACE ADMINISTRATION  
Lewis Research Center  
Under Contract DEN 3-182

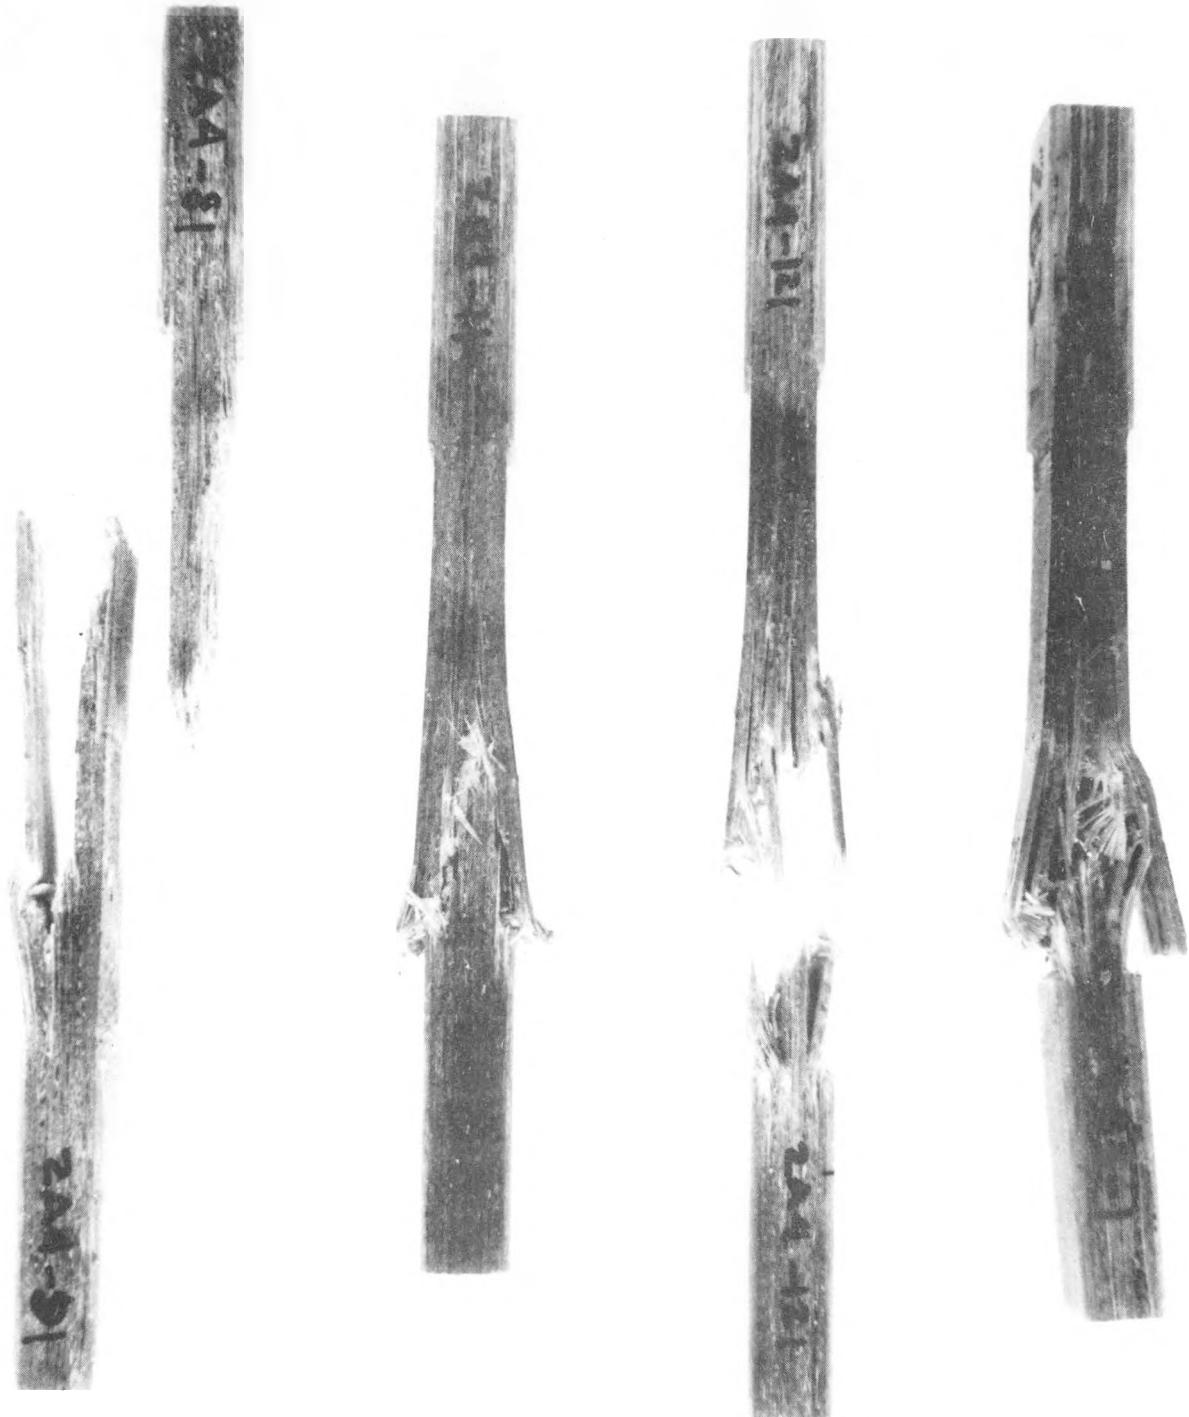
Figure 17. Fracture appearance of samples of winding pattern 2 subjected to fully-reversed loading.

Finally, preliminary compression fatigue tests were performed with two specimens at 0° to the principal fiber direction and two specimens at 2° to the principal fiber direction for the epoxy matrix composite with Winding Pattern No. 2, i.e., the 0°/90°/±45° composites. The samples were 1 in. wide x 11 in. long and were fully stabilized during repeated fully-reversed ( $R = -1$ ) loading. The results for a constant amplitude stress of 80% of the static compression strength are shown in Table 8. The test frequency was 1.0 Hertz. As a given specimen failed, it was replaced with a steel dummy sample and stroking was continued. Failed samples are shown in Fig. 17 of the epoxy matrix composites with Winding Pattern No. 2.

Both from failed specimen appearance and from the test results it appeared that there was no detectable difference in the results for the two fiber directions.

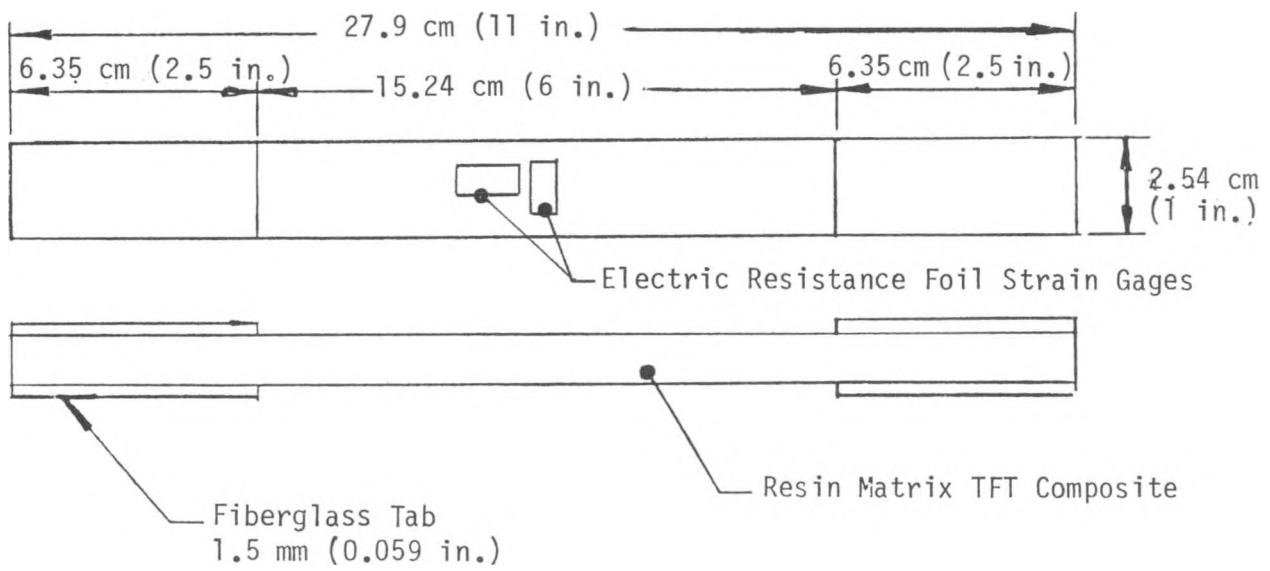
Figure 18. Static and fatigue coupon for both epoxy matrix and polyester matrix/TFT composites.

Specimens were conditioned, as will be described later, and were then instrumented with three electrical resistance foil strain gages located at the center of the 6 in. gage section shown in Fig. 18.

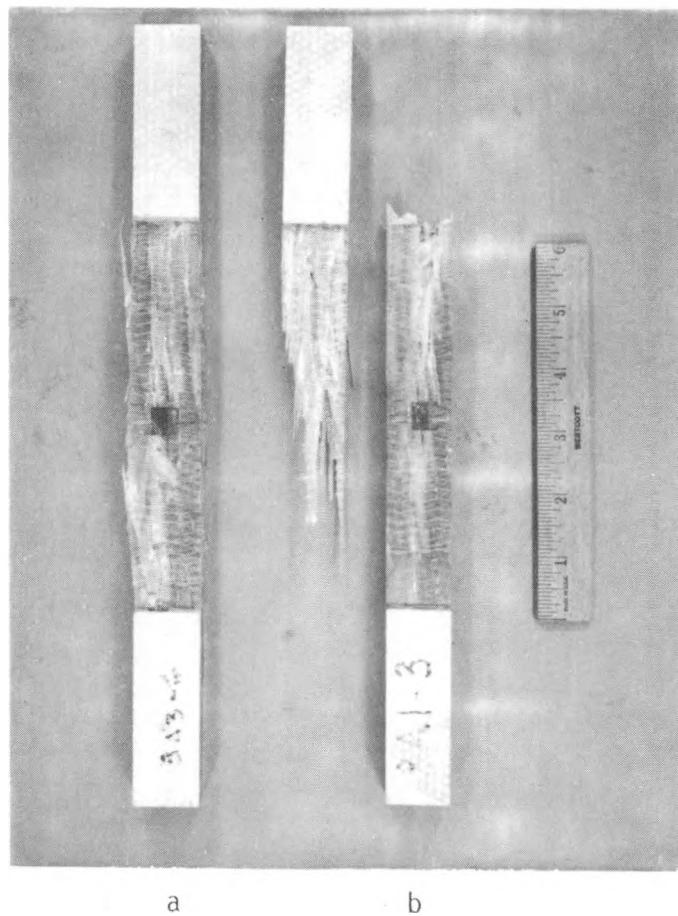
Figure 19. Top view of fractured TFT/epoxy matrix static tension specimens Winding Pattern No. 1. a) RTD; b) wet.

Typical failed room temperature dry and wet samples are shown in Figs. 19 and 20 for epoxy matrix/TFT fiberglass composites with Winding Pattern Nos. 1 and 2, respectively.

In tension, the epoxy matrix composites differed substantially based on structure of the reinforcement. Pattern No. 1 laminates showed practically no difference between the dry and wet fracture modes. Pattern No. 2 appears as brooming type failures (many long filament bundles with a large amount of individual fiber spraying) for the dry material. Wet, the failures appeared to be local failures of the fiber bundles with few individual fibers showing up. The polyester tension fracture modes were similar to those of epoxy matrix pattern No. 2. The dry tension failure mode exhibited multiple bundle fractures with longitudinal "intra-bundle" fractures as well as separation of bundles. The wet and supersaturated tension fracture modes appeared as multiple bundle fractures with separation.

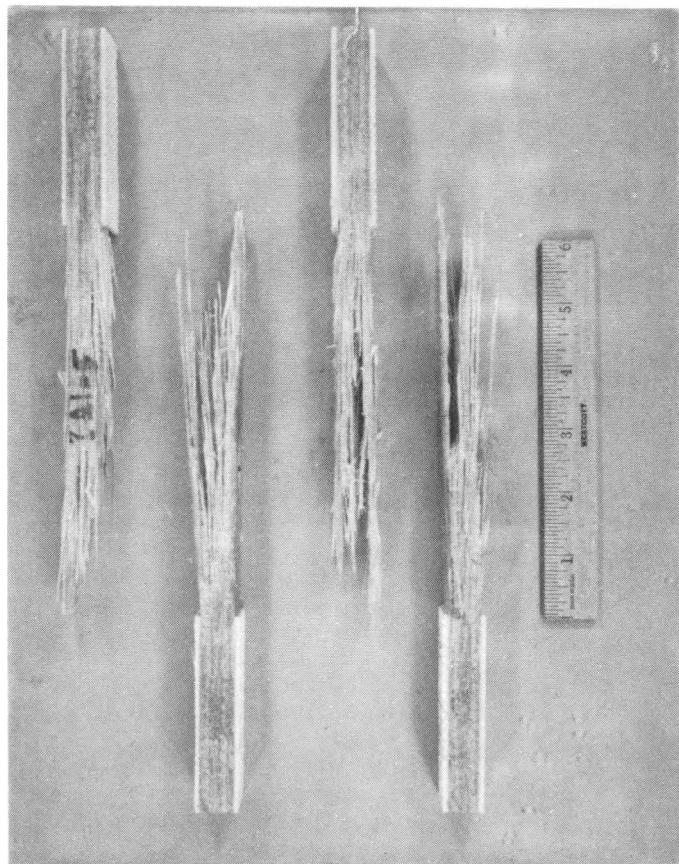
Figure 20. Side view of fractured TFT/epoxy matrix, static tension on specimens with Winding Pattern No. 2. a) RTD; b) wet.

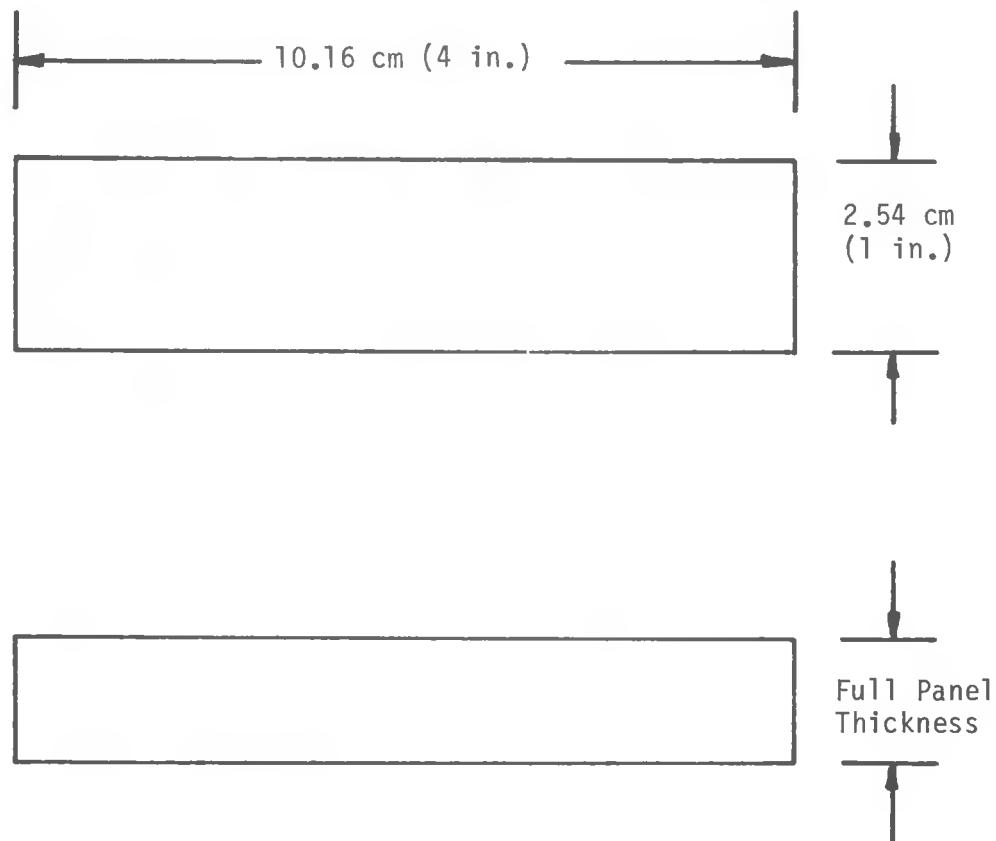
Figure 21. Static compression specimens.

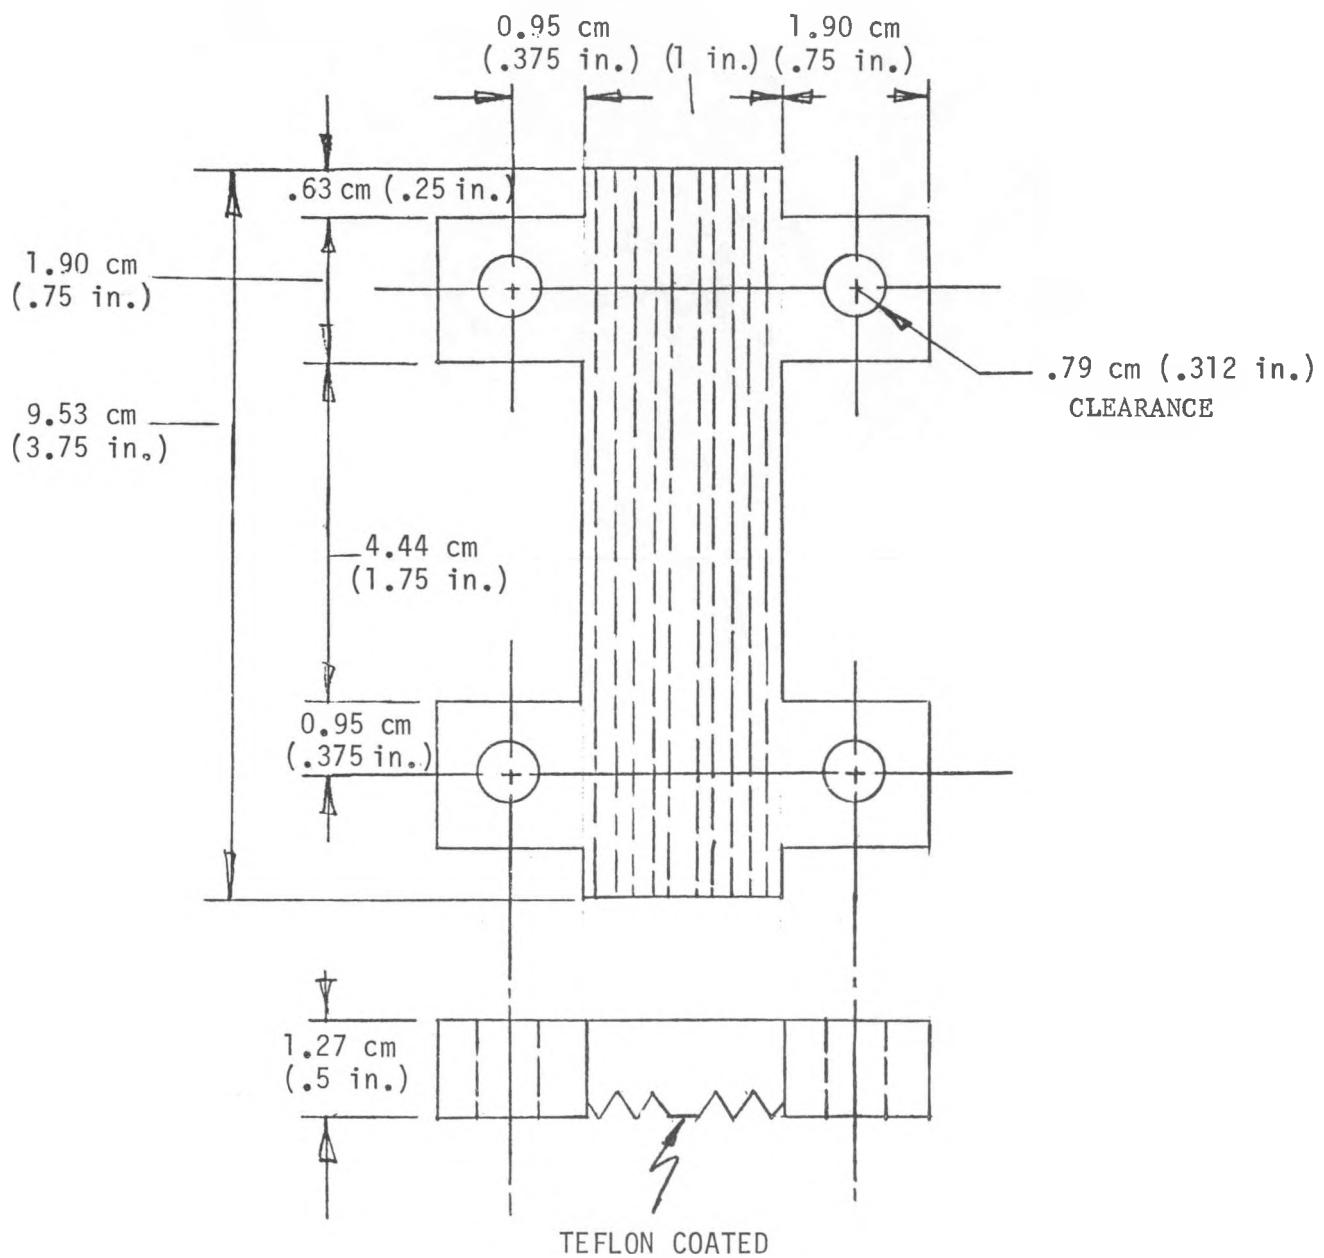
Figure 22. Stainless steel static compression fixture  
(two sides required).

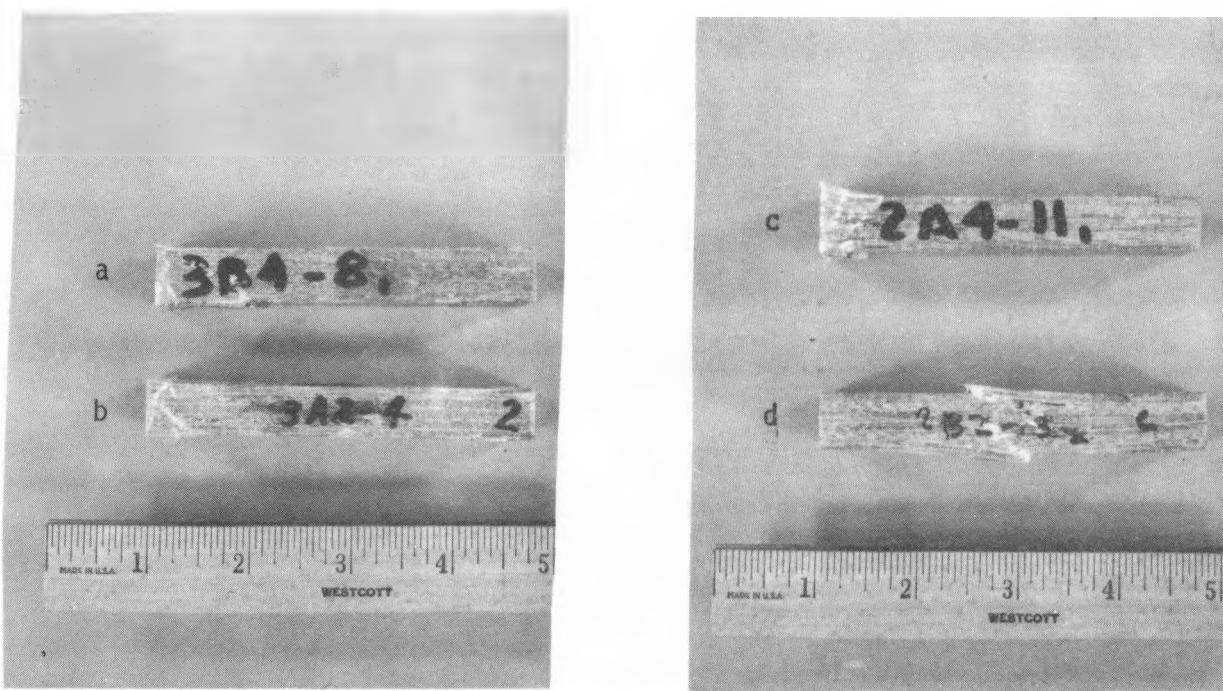
Figure 23. Typical failed compression samples for epoxy matrix/TFT fiberglass with Winding Pattern Nos. 1 and 2.  
a) Winding Pattern No. 1, tested RTD; b) Winding Pattern No. 1 tested wet; c) Winding Pattern No. 2, tested RTD;  
d) Winding Pattern No. 2, tested wet.

Typical static compression failure modes are shown in Fig. 23. All failures were a combination of transverse fracture and brooming.

The static compression failure modes for both epoxy matrix patterns 1 and 2 were by end brooming for both dry and wet states, with one specimen of pattern No. 2 failing the center of the gage section. The polyester static compression specimen exhibited different failure modes wet and dry. The dry failures were by brooming while the majority of the wet failures were in the center of the gage section by direct compression.

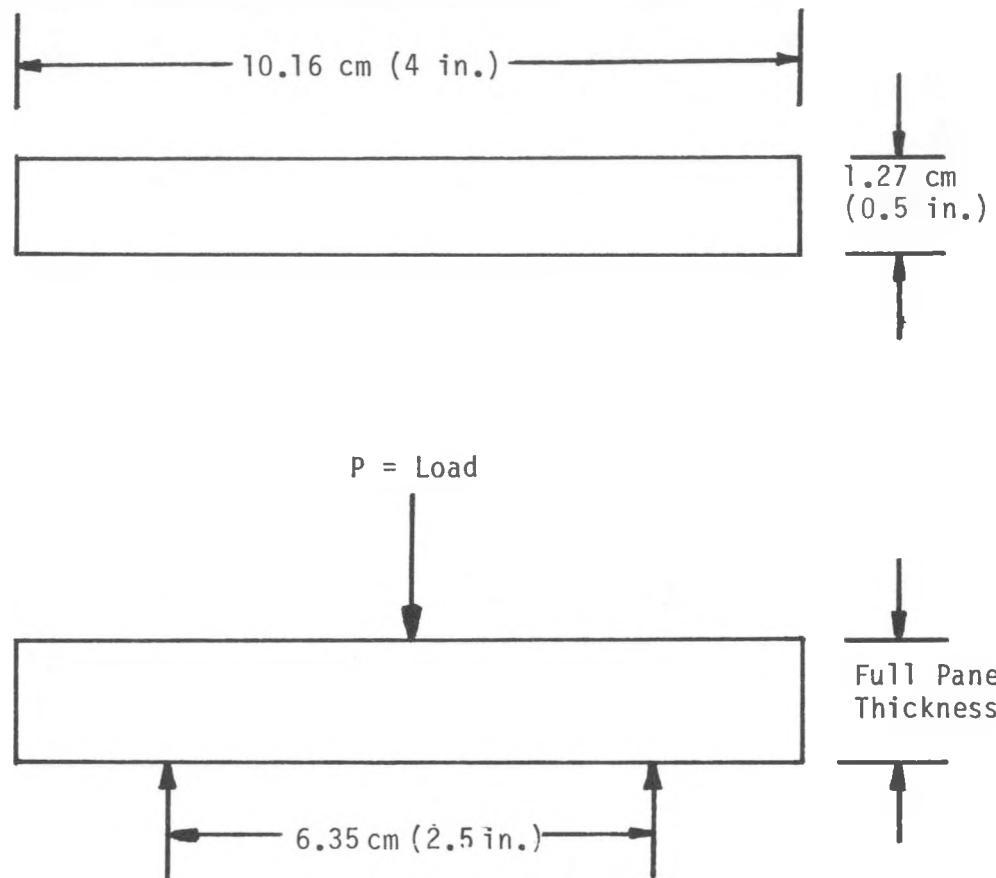
Figure 24. Schematic of the interlaminar shear specimen and loading procedures.

Interlaminar shear tests were conducted on samples with transverse filament tape (TFT) fiberglass reinforced epoxy and polyester matrix composites. The short beam shear specimen shape and test methods are shown schematically

in Fig. 24. Loads were increased steadily to failure. The interlaminar shear strength was calculated as follows:

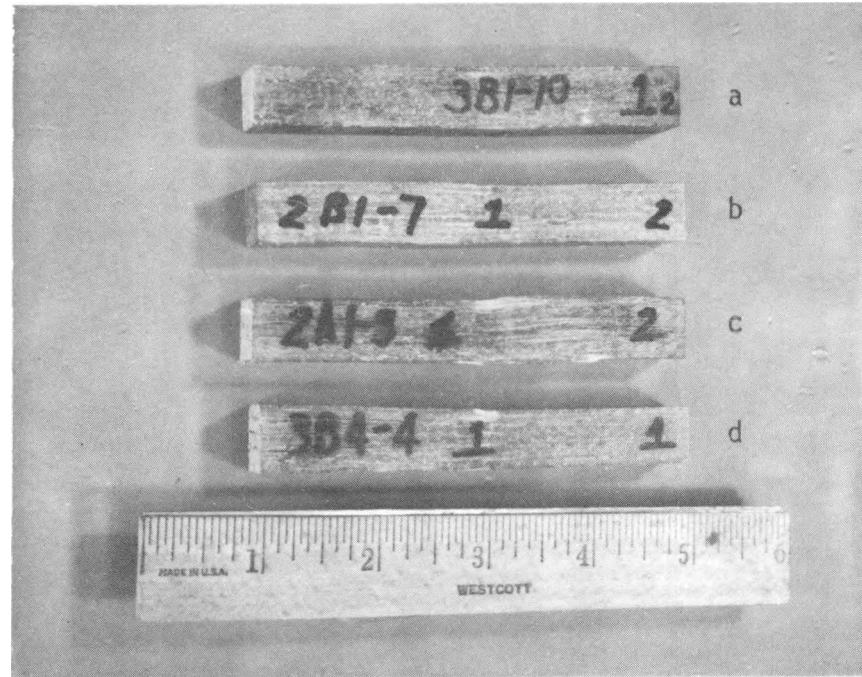
Figure 25. Typical side views of interlaminar shear failures of epoxy matrix/TFT composites with Winding Pattern Nos. 1 and 2. a) Winding Pattern No. 1 tested wet; b) Winding Pattern No. 2 tested wet; c) Winding Pattern No. 2 tested dry; d) Winding Pattern No. 1 tested dry.

Typical failed samples are shown in Fig. 25.

The static interlaminar shear failure modes for epoxy matrix pattern No. 1 appeared as multiple interlaminar separations with wide gaps dry and a single interlaminar fracture wet. Pattern No. 2 failures showed a substantial hinge like appearance viewed from the side for both wet and dry samples. The polyester material exhibited multiple interlaminar separations with a slight crushing directly under the central load (this was never a source of the terminal failure).

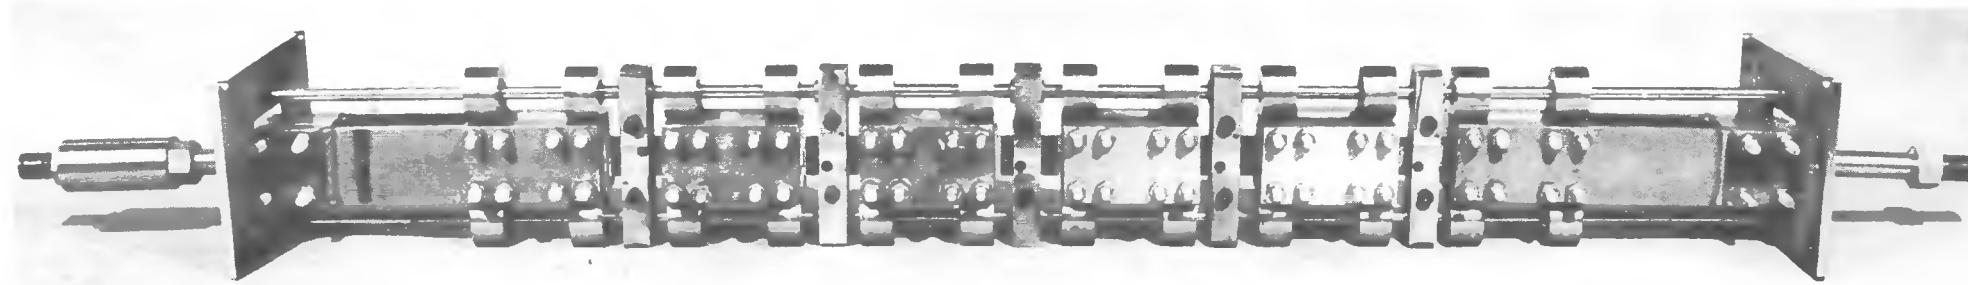
Figure 26. Multi-specimen loading chain for fatigue testing TFT fiberglass composite wind turbine blade material.

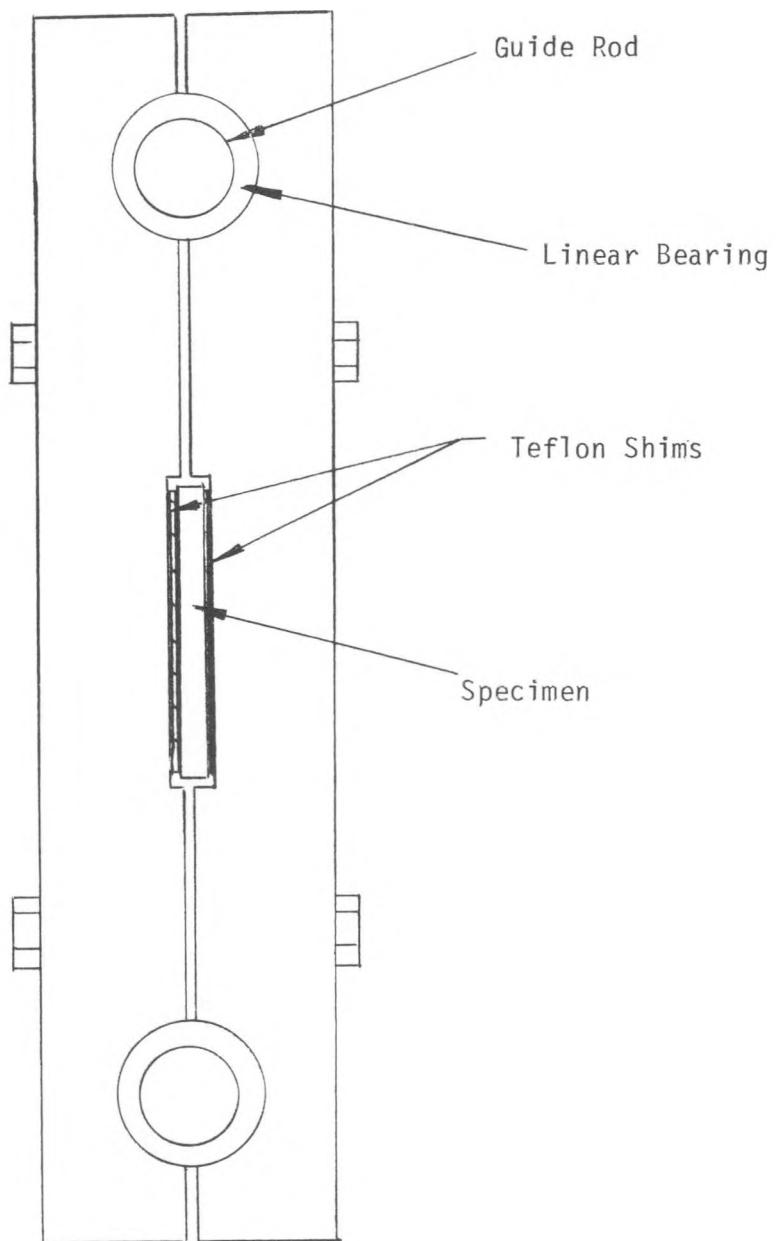
Figure 27. Schematic of compression fatigue anti-buckling stabilization bars.

The problem was solved by adding inserts to the conventional compression fatigue stabilizing fixture shown in Fig. 27. These inserts are shown in Fig. 28, and fit around the Thomson Ball Bushings. The stabilizing bars were fitted around the thick samples, were restrained to move parallel to the axis of compressive stroking, and were centered on the centerline of the actuator motion. In addition to these specimens anti-buckling measures, additional support for the two end yokes in the chain were required. This modification was necessary to prevent buckling of the overall chain. Figure 29 shows this modification. Figure 30 shows the test stand with five-specimen chain for fatigue loading.

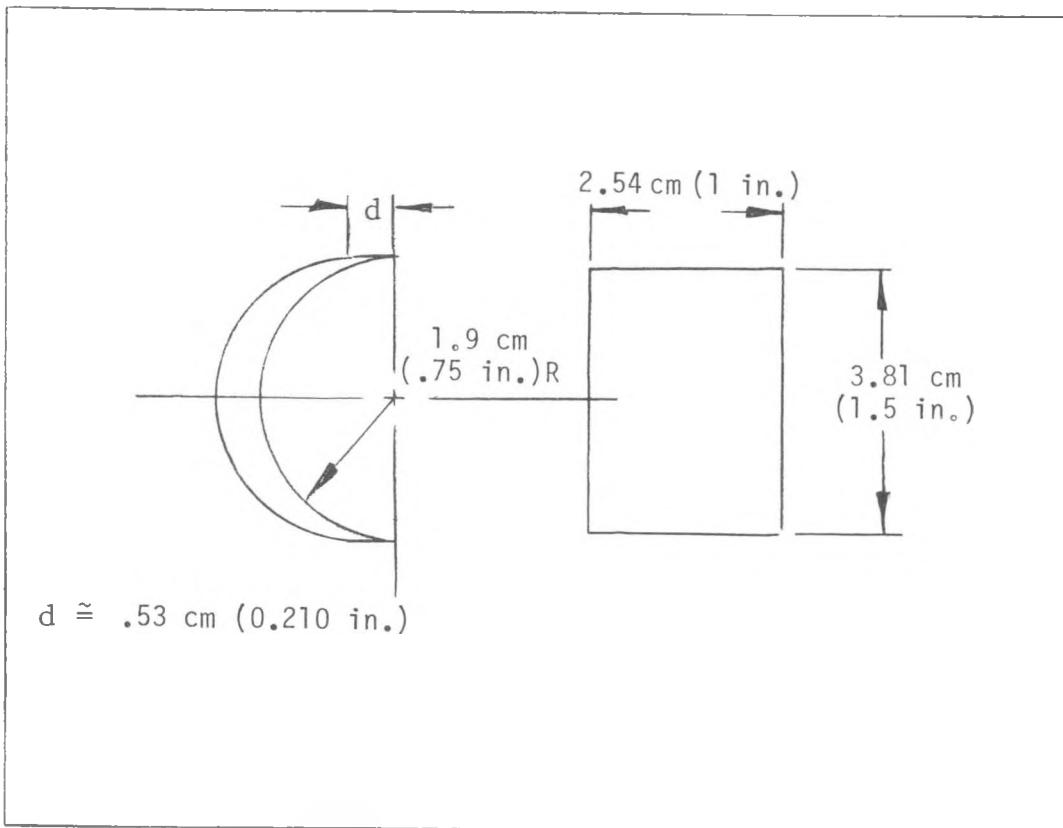
Figure 28. Spacer segments for compression fatigue stabilizing bars.

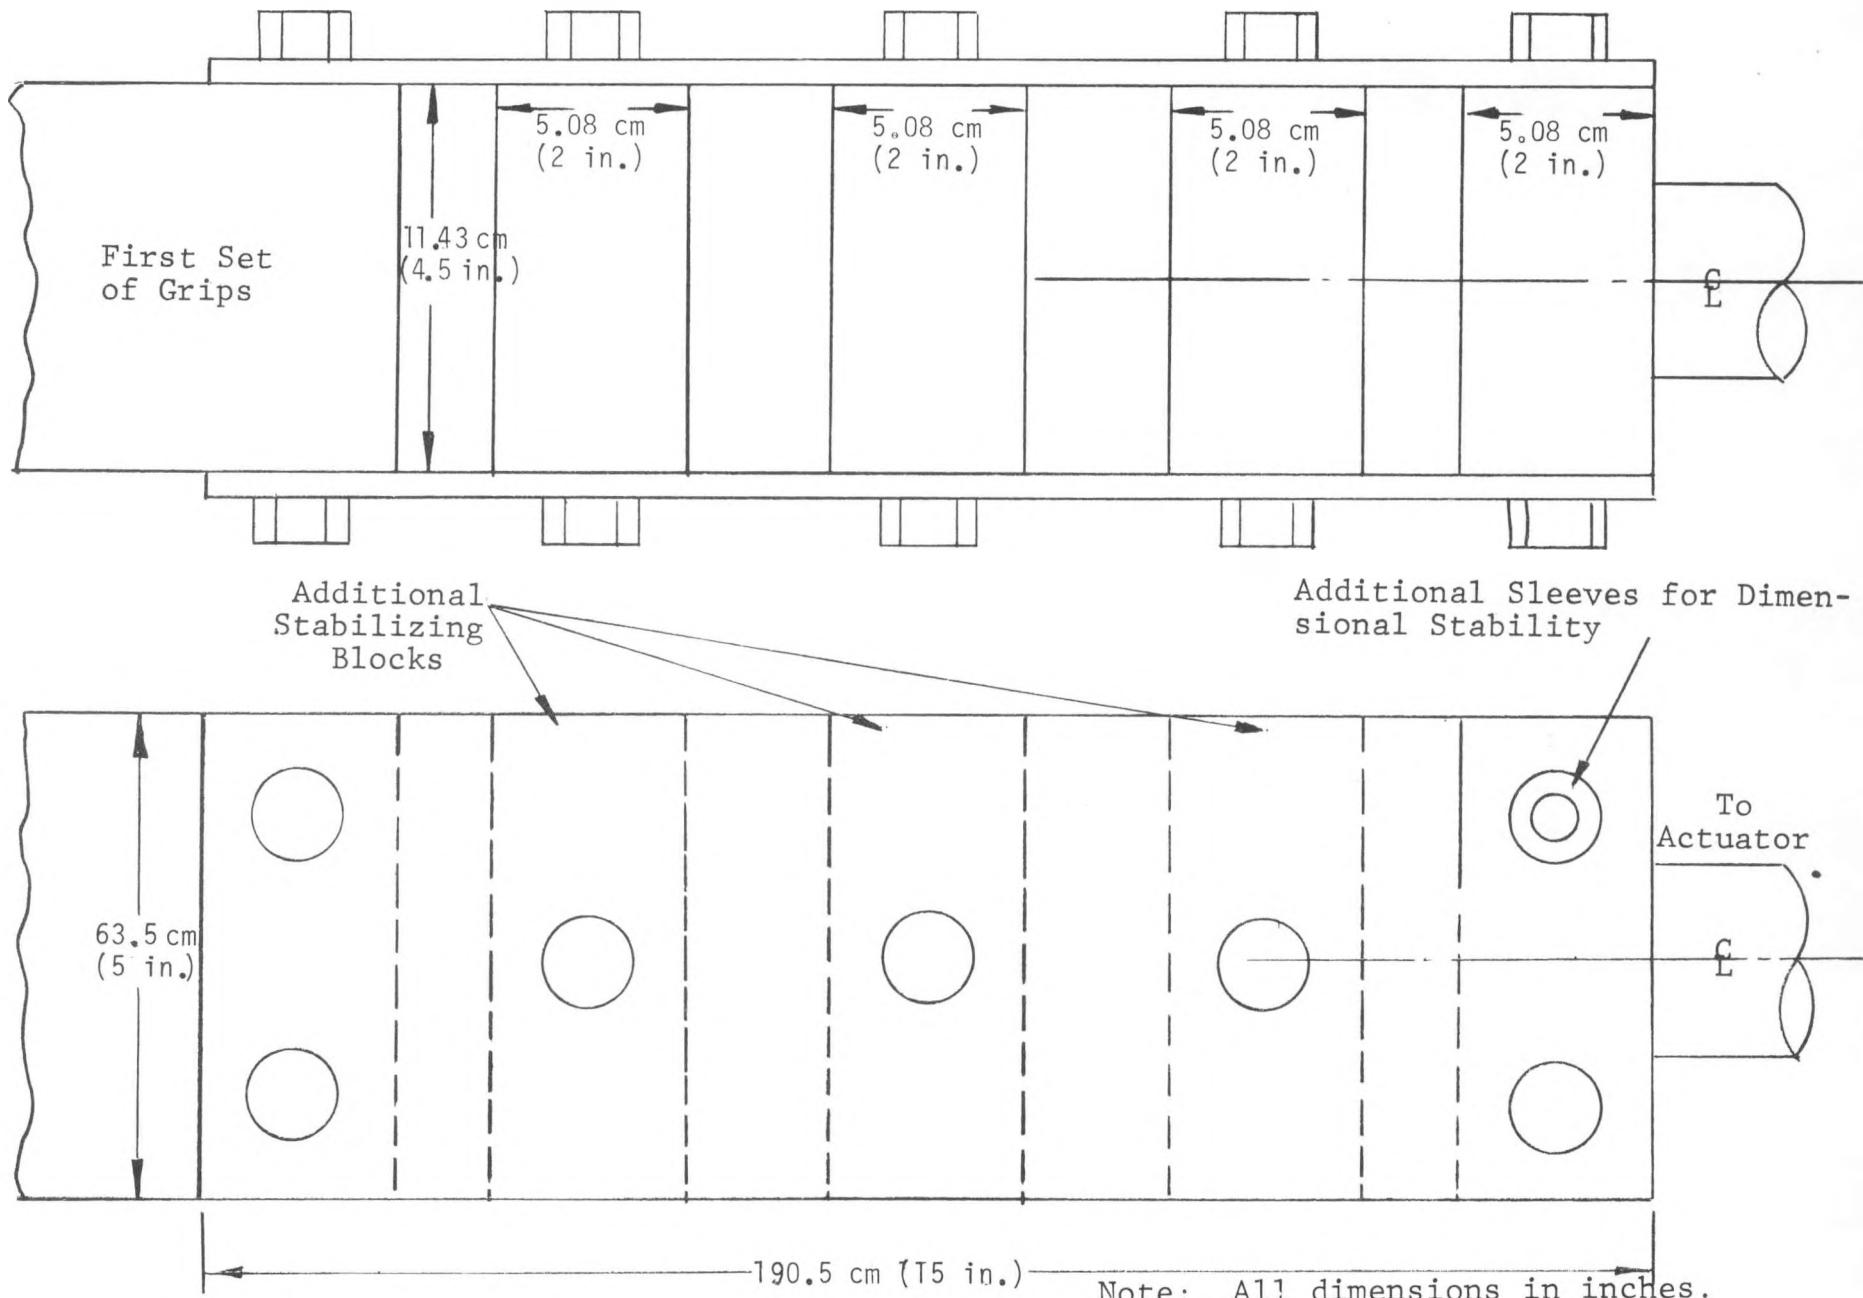
Figure 29. Schematic of modification of multi-specimen chain load transmitting yoke required to prevent buckling.

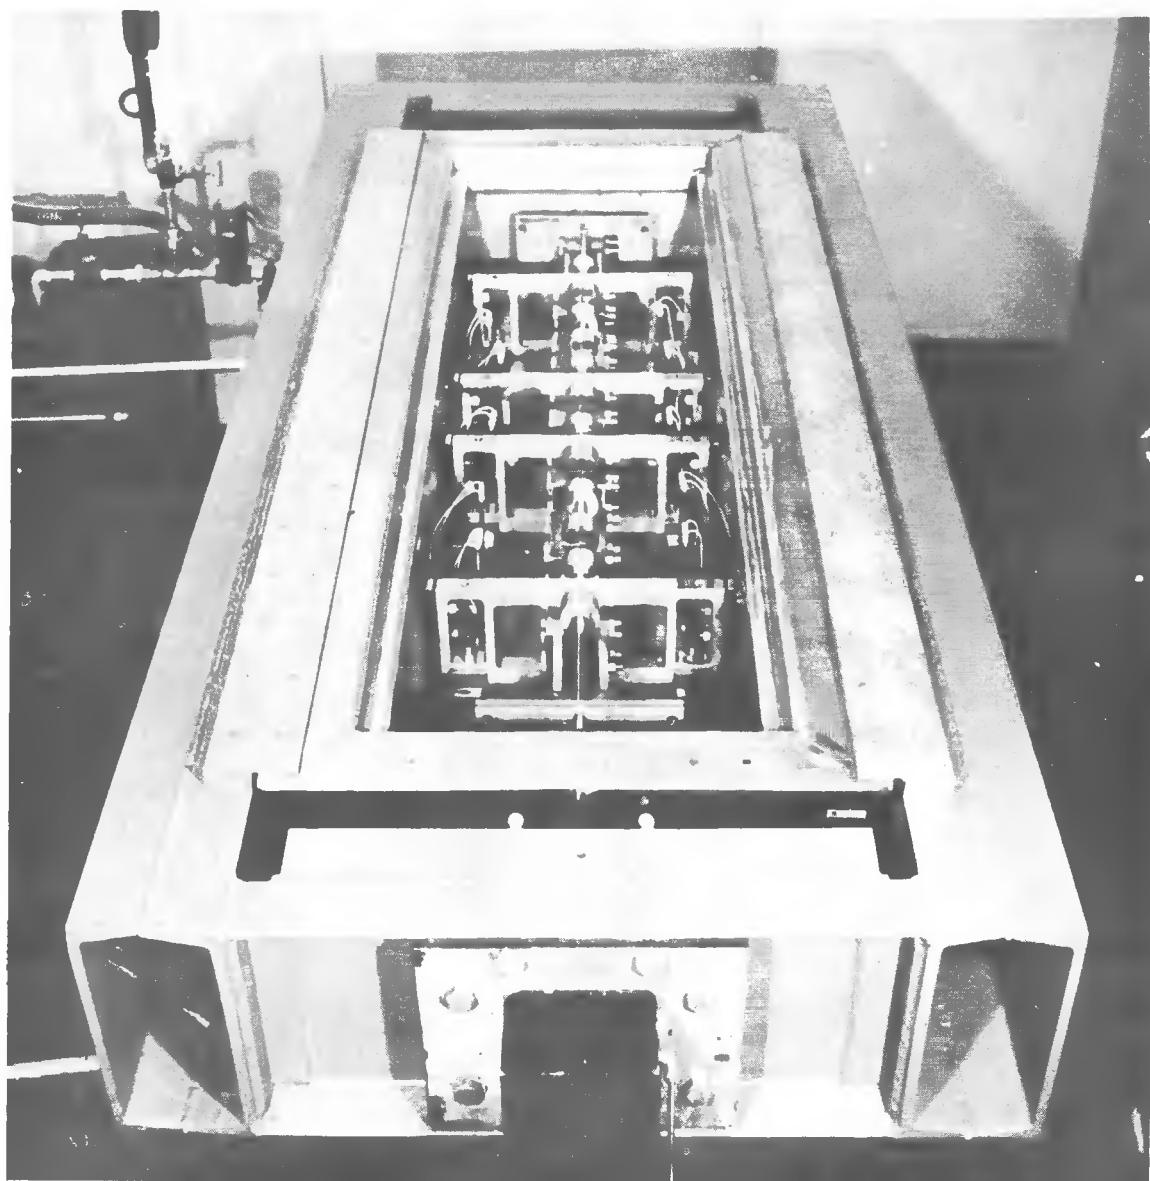
Figure 30. Test stand with five-specimen chain for spectrum fatigue loading

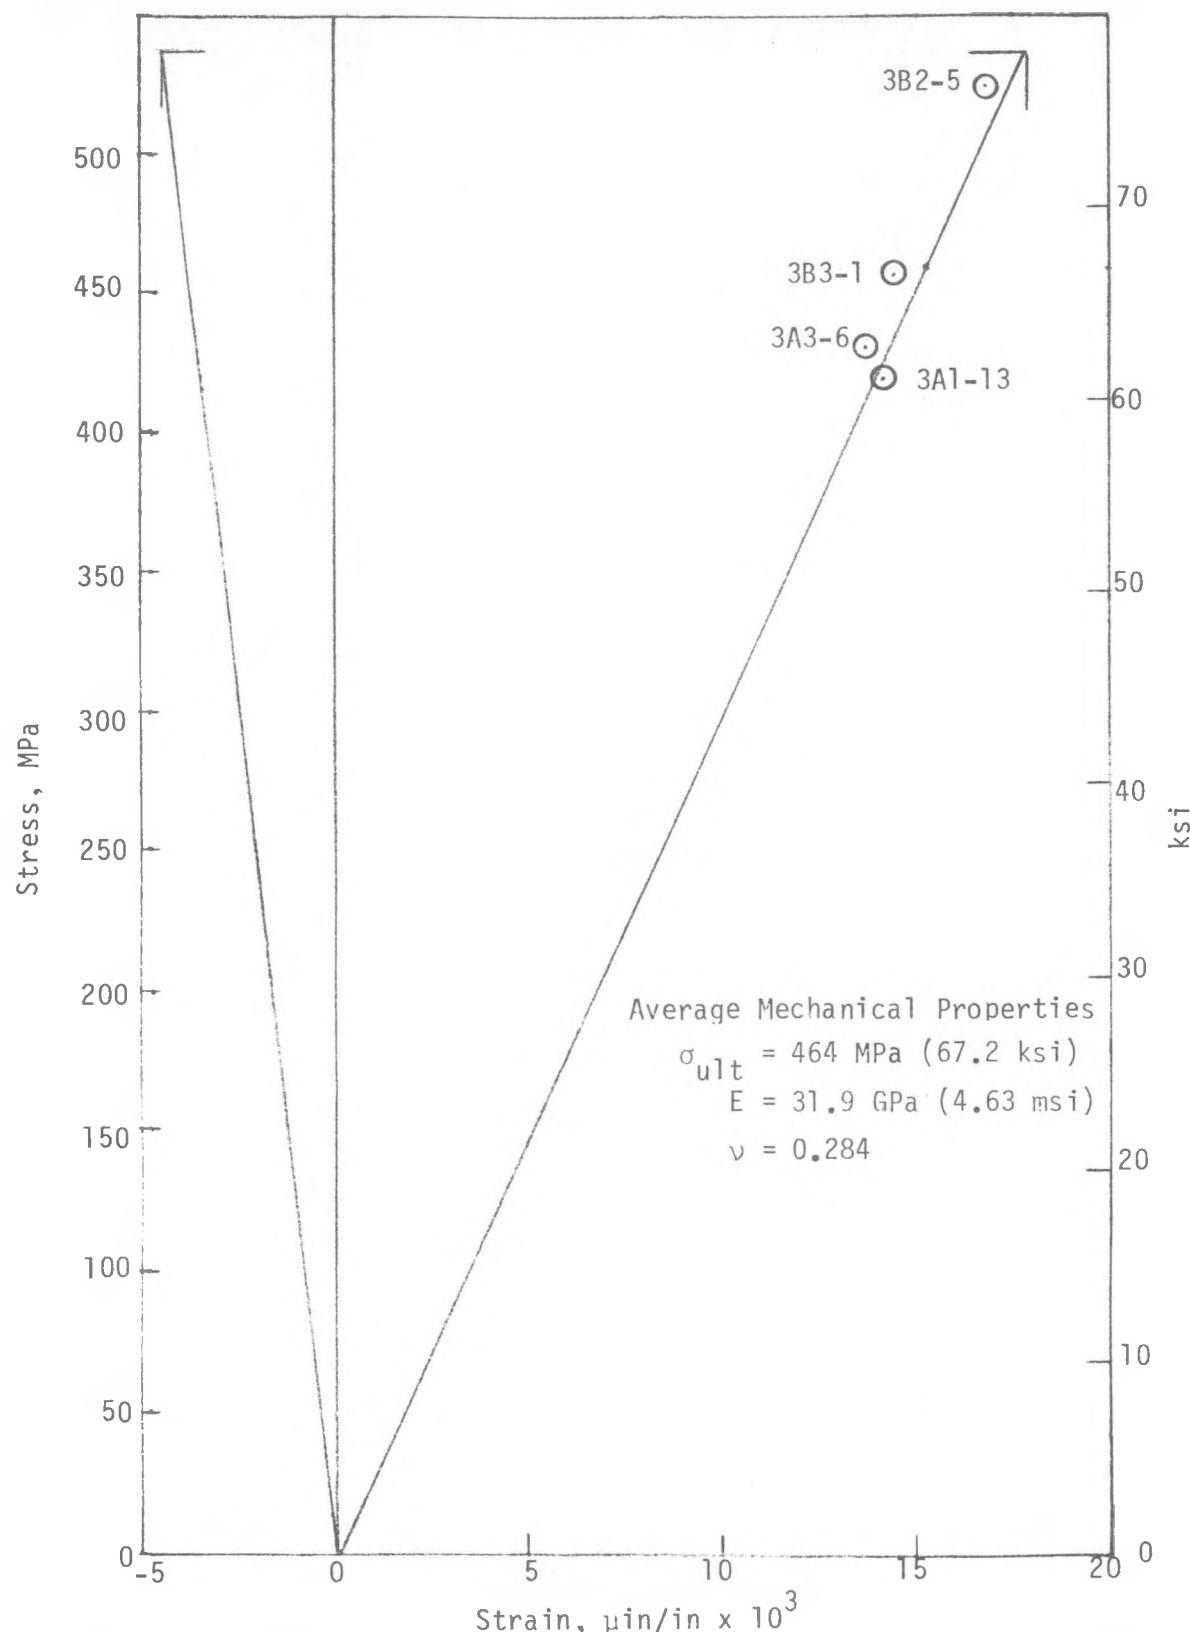
Figure 31. Tensile stress-strain curve for epoxy matrix composites with winding pattern No. 1 tested dry at room temperature. Curve shown for Specimen No. 3B4-7, endpoints of other tests shown by circles..

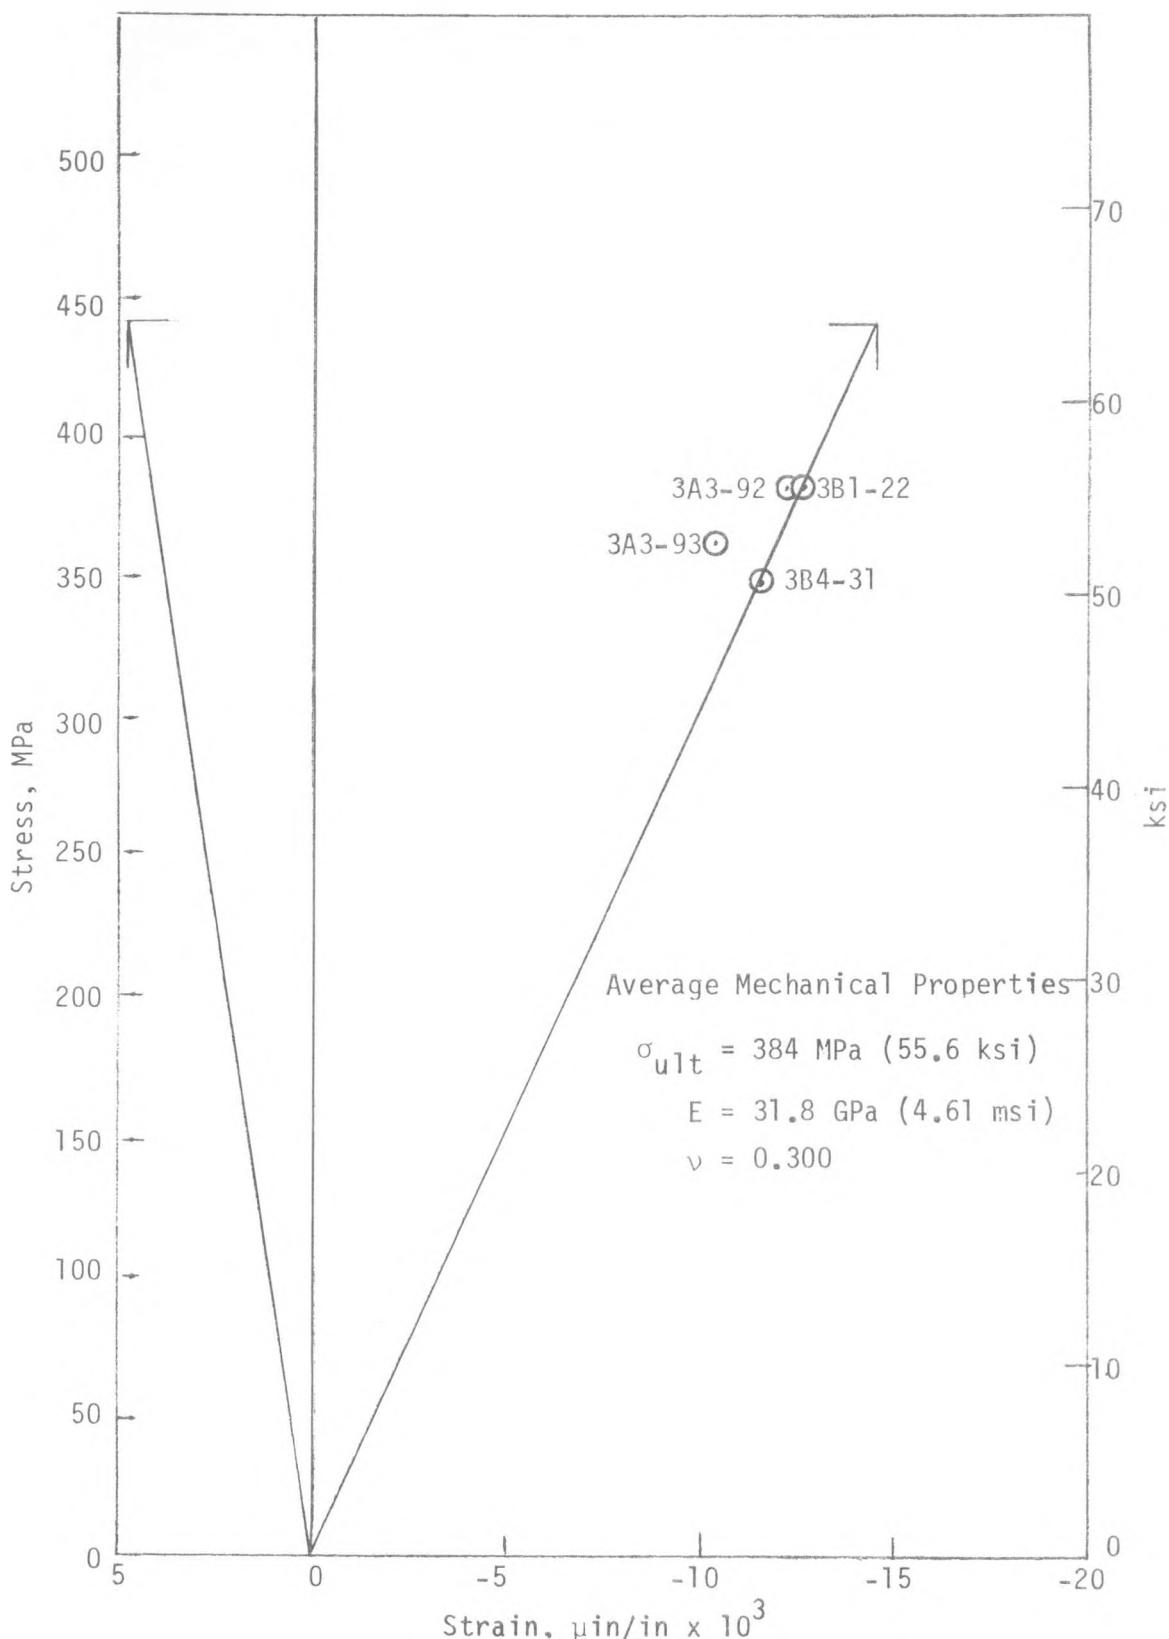
Figure 32. Compressive stress-strain curve for epoxy matrix composites with winding pattern No. 1 tested dry at room temperature. Curve shown for Specimen No. 3B1-23, endpoints of other tests shown by circles.

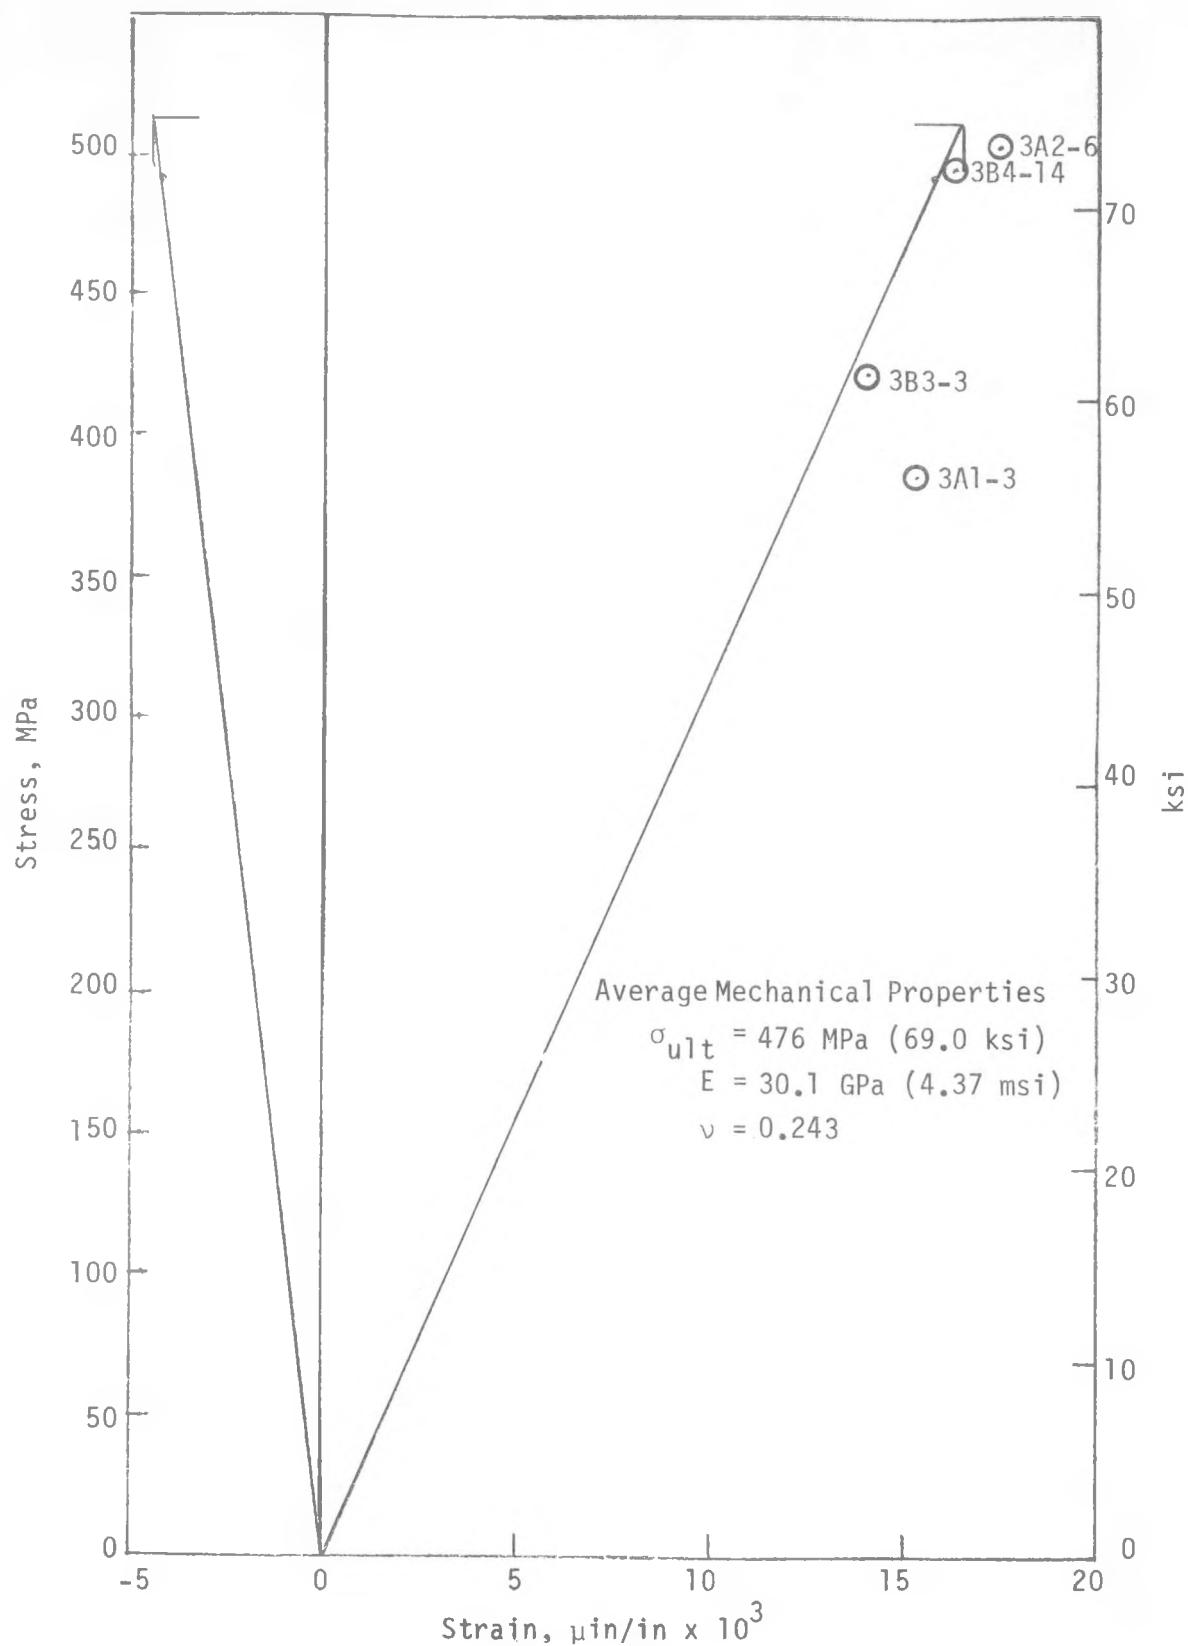
Figure 33. Tensile stress-strain curve for epoxy matrix composites with winding pattern No. 1 tested wet at 49°C (120°F). Curve shown for Specimen No. 3B2-12, endpoints of other tests shown by circles.
