# Fatigue Testing of Low-Cost Fiberglass Composite Wind Turbine Blade Materials

K. E. Hofer and L. C. Bennett  
IIT Research Institute

November 1981

Prepared for  
NATIONAL AERONAUTICS AND SPACE ADMINISTRATION  
Lewis Research Center  
Under Contract DEN 3-182

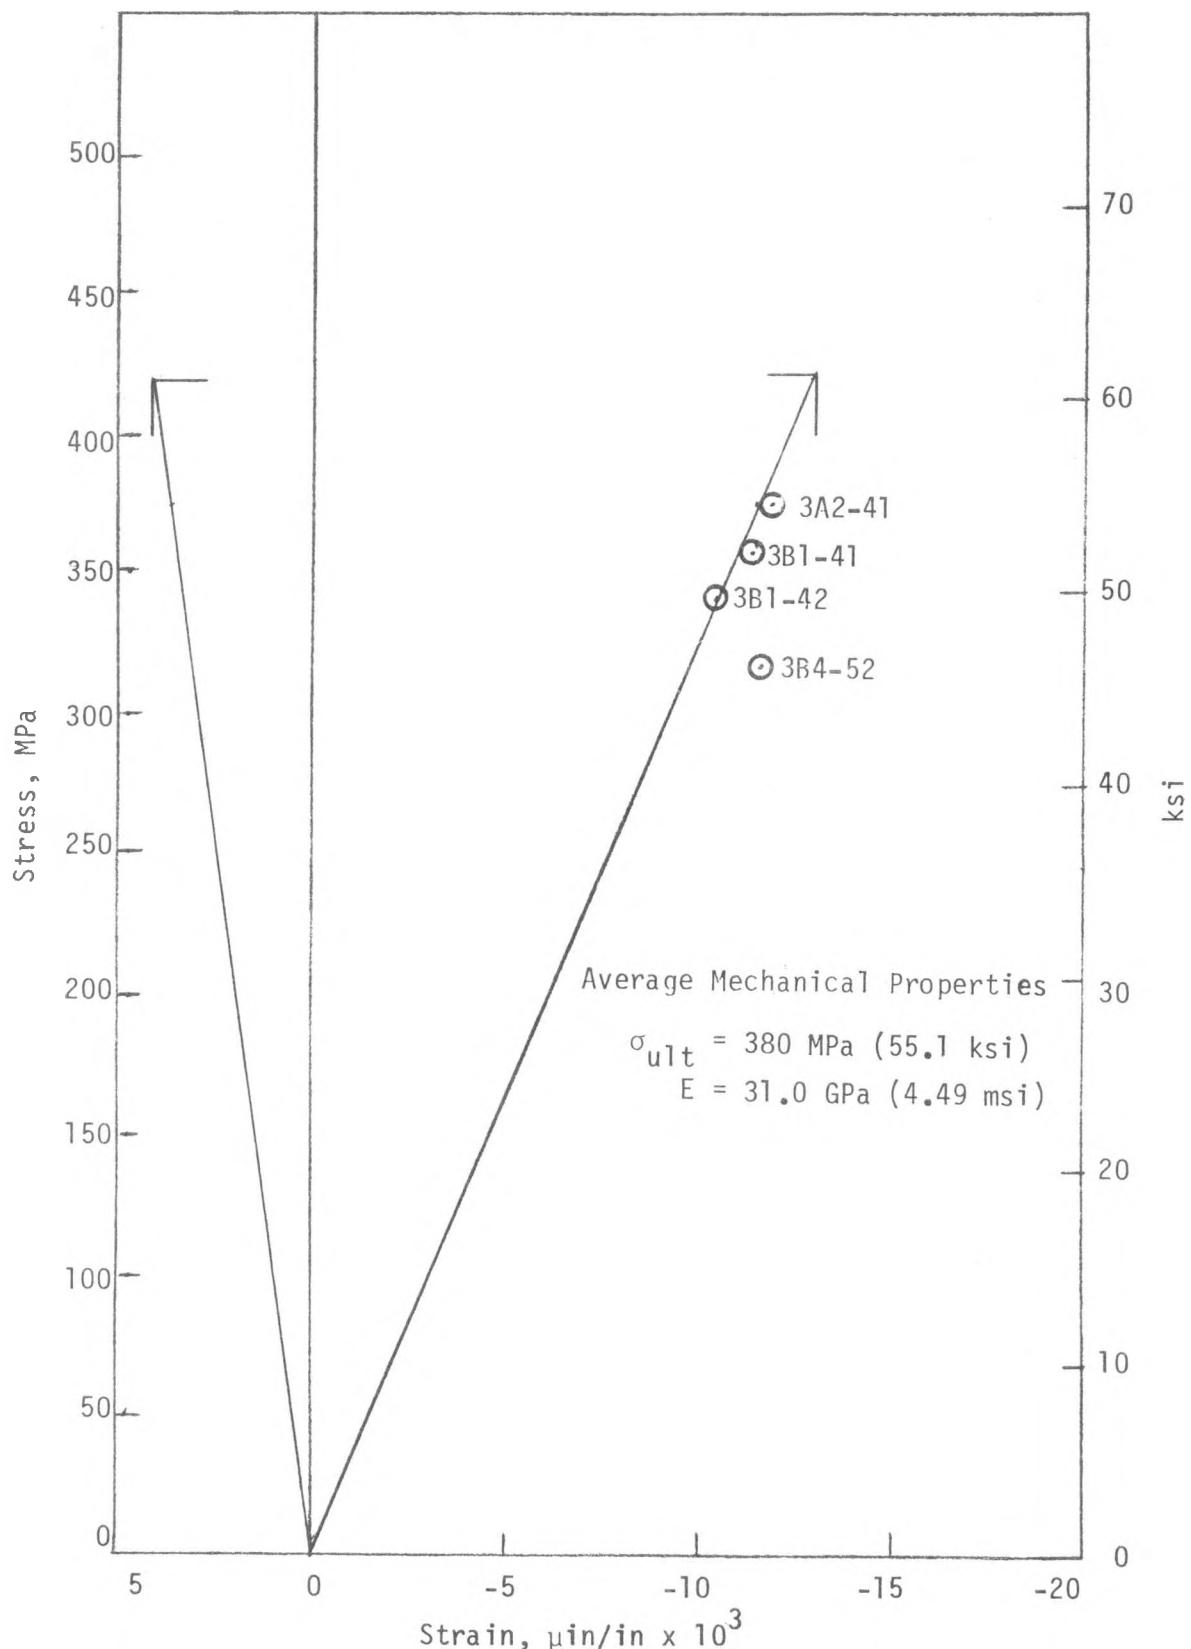
Figure 34. Compressive stress-strain curve for epoxy matrix composites with winding pattern No. 1 tested wet at 49°C (120°F). Curve shown for Specimen No. 3A2-42, endpoints of other tests shown by circles.

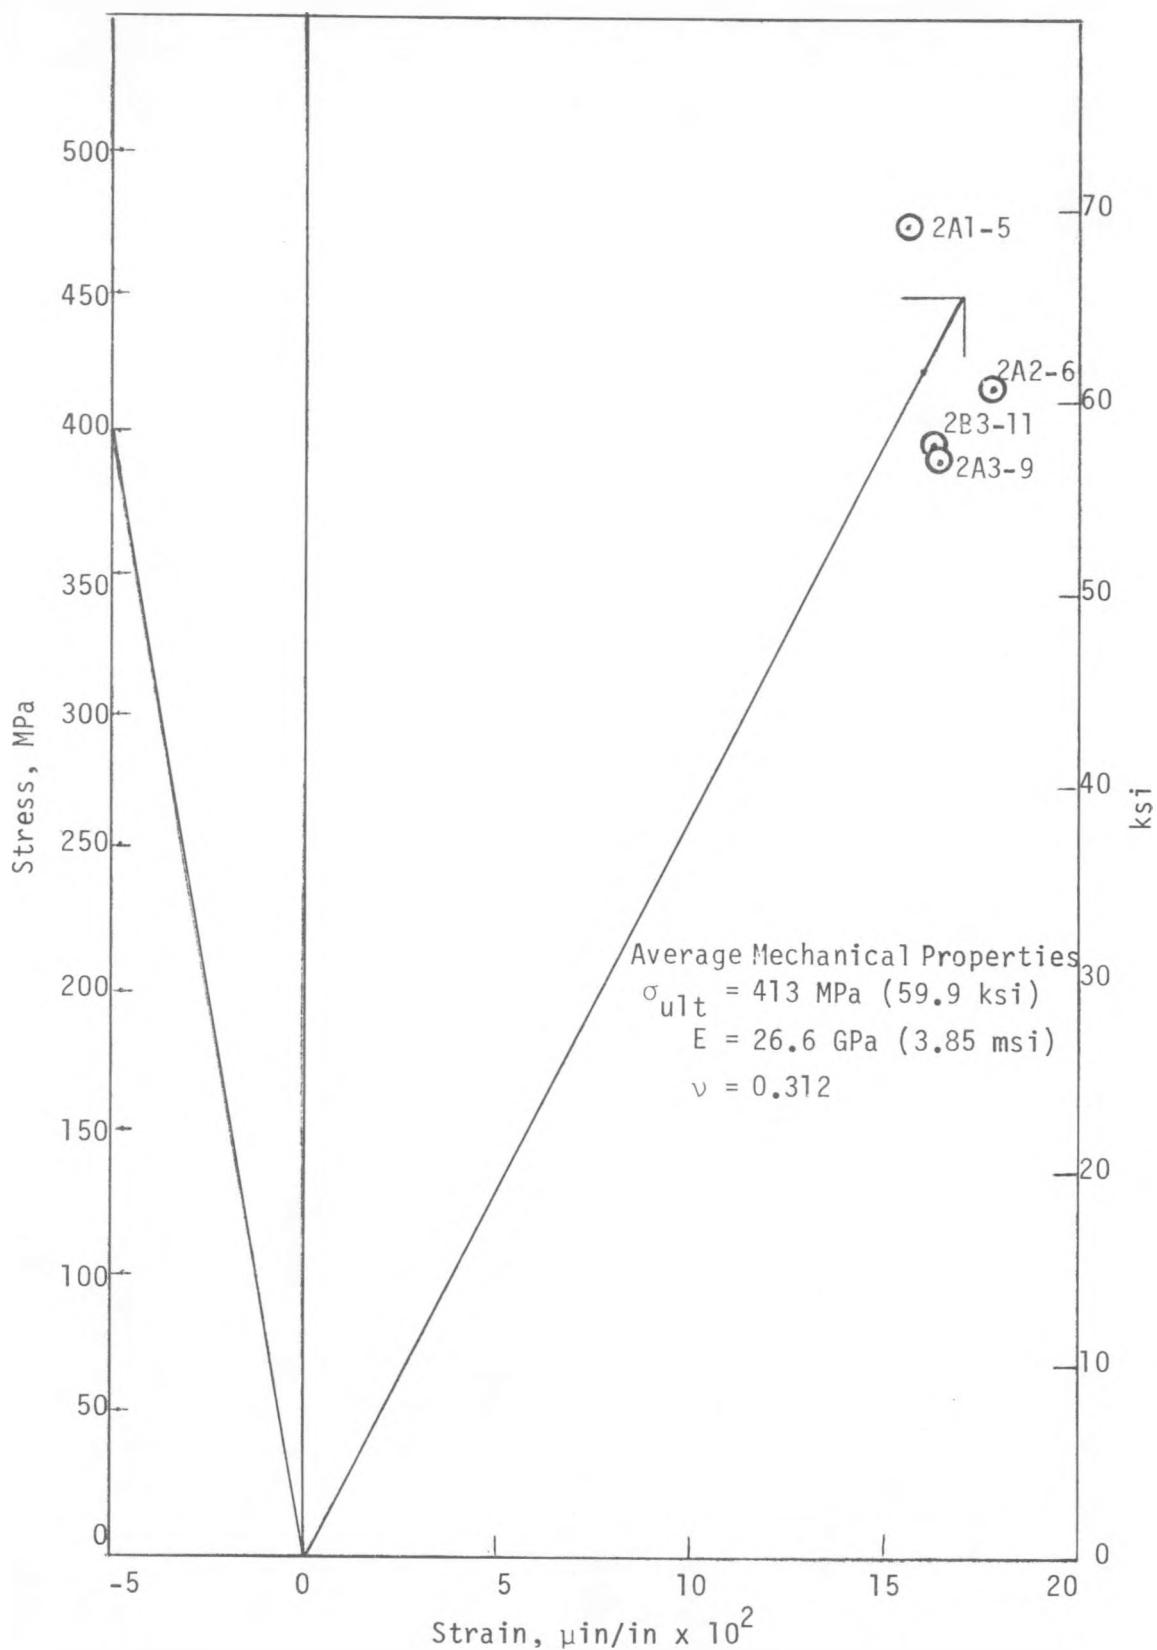
Figure 35. Tensile stress-strain curve for epoxy matrix composites with winding pattern No. 2 tested dry at room temperature. Curve shown for Specimen No. 2B2-2, endpoints of other tests shown by circles.

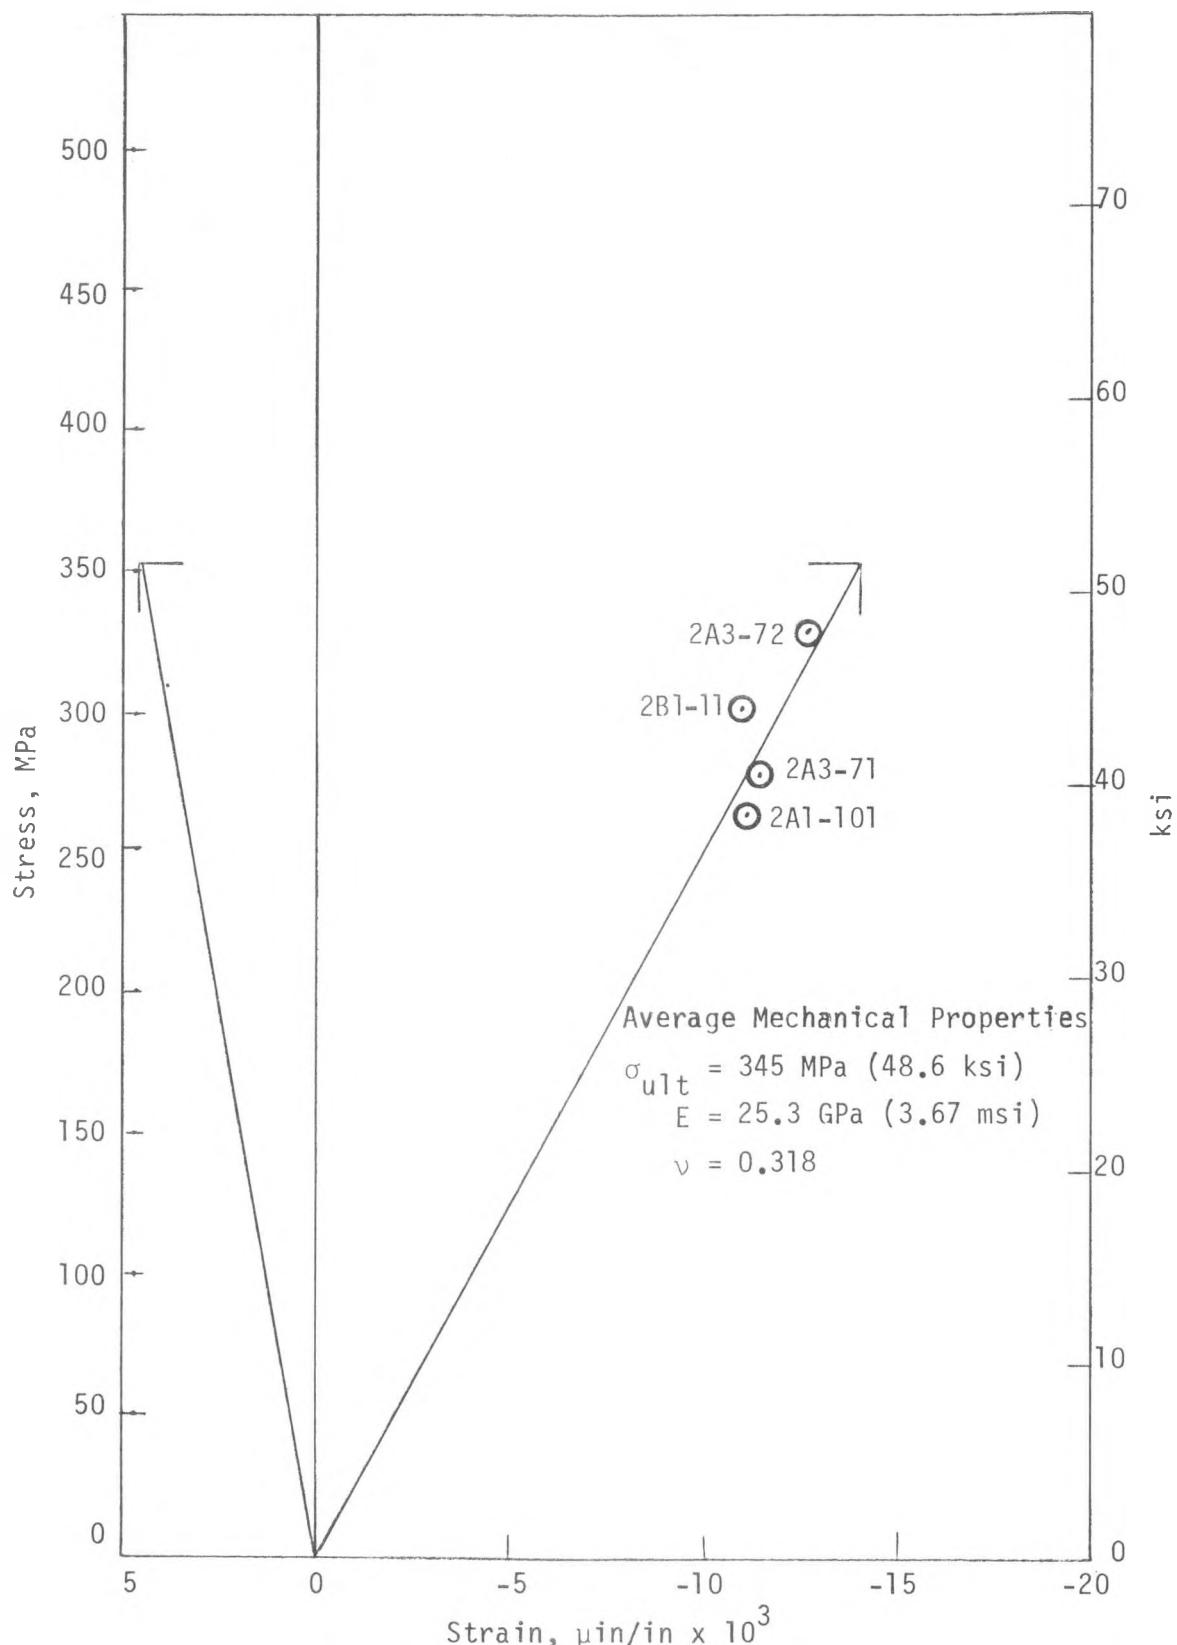
Figure 36. Compressive stress-strain curve for epoxy matrix composites with winding pattern No. 2 tested dry at room temperature. Curve shown for Specimen No. 2A1-102, endpoints of other tests shown by circles.

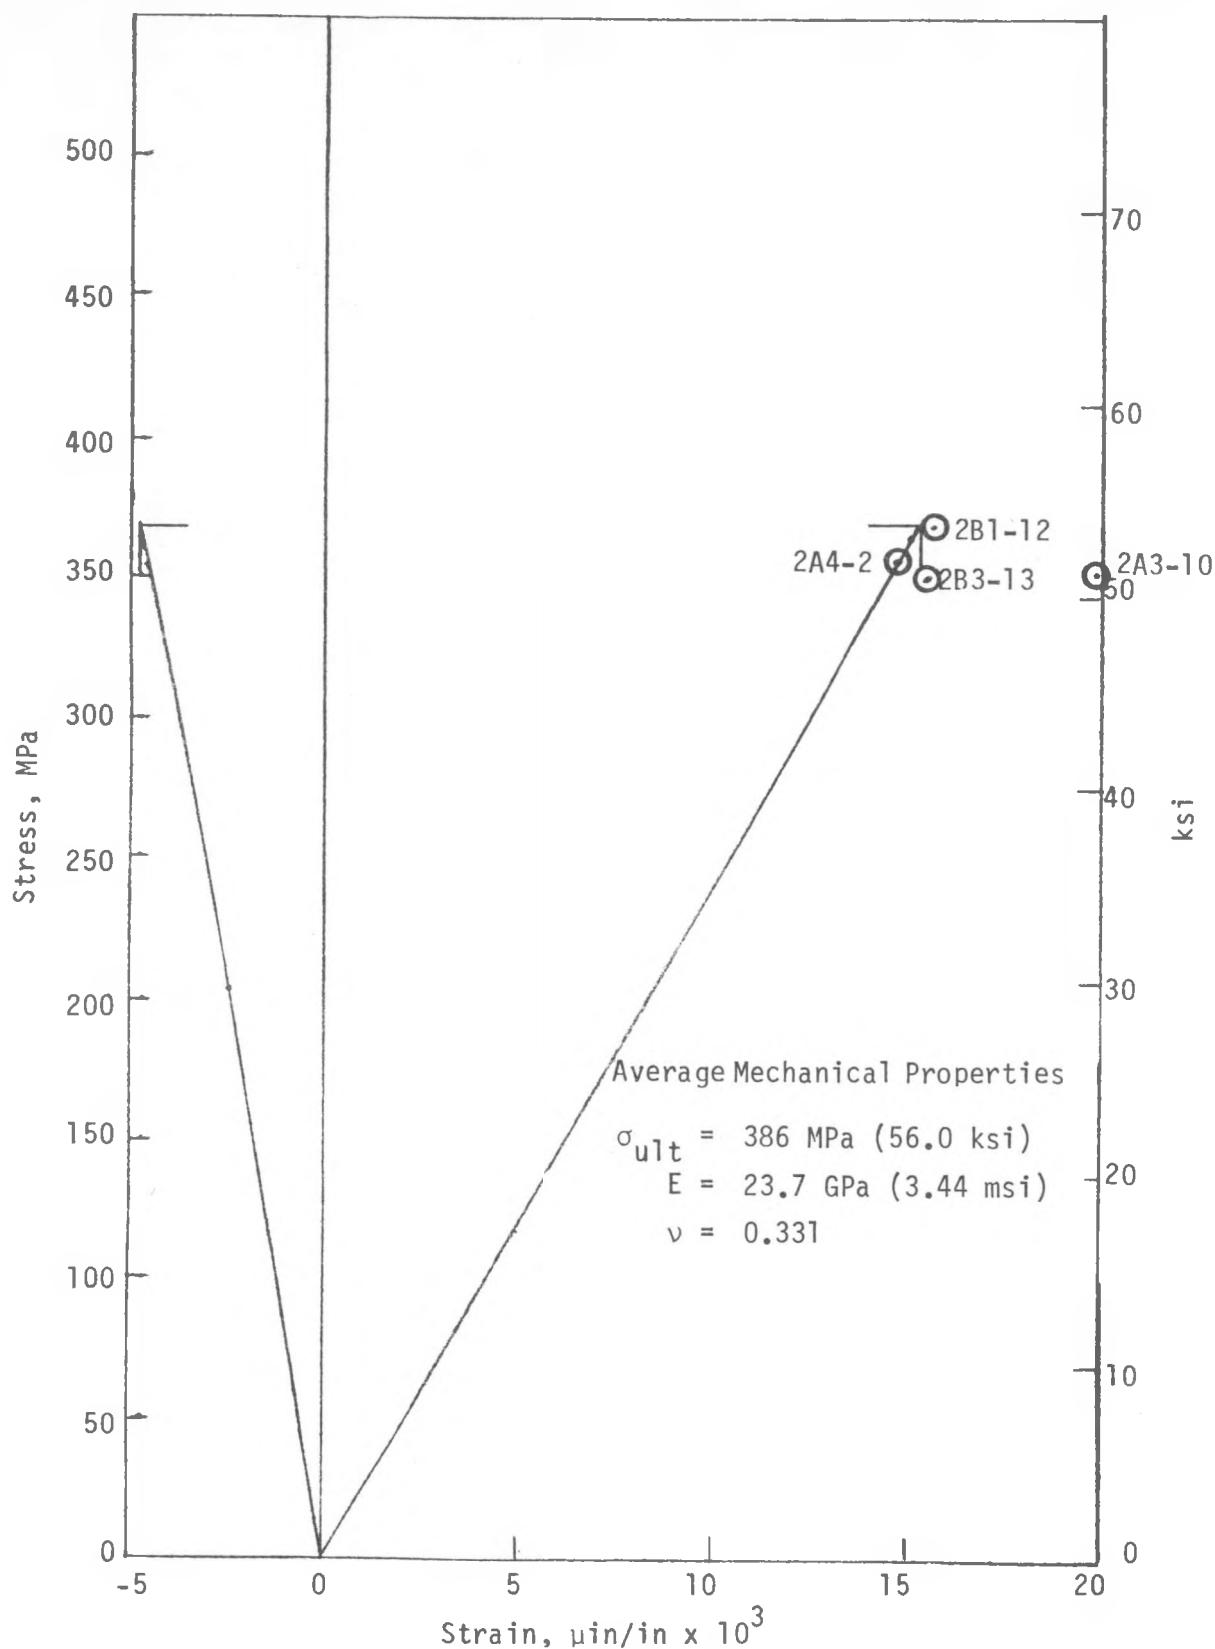
Figure 37. Tensile stress-strain curve for epoxy matrix composites with winding pattern No. 2 tested wet at 49°C (120°F). Curve shown for Specimen No. 2B3-5, endpoints of other tests shown by circles.

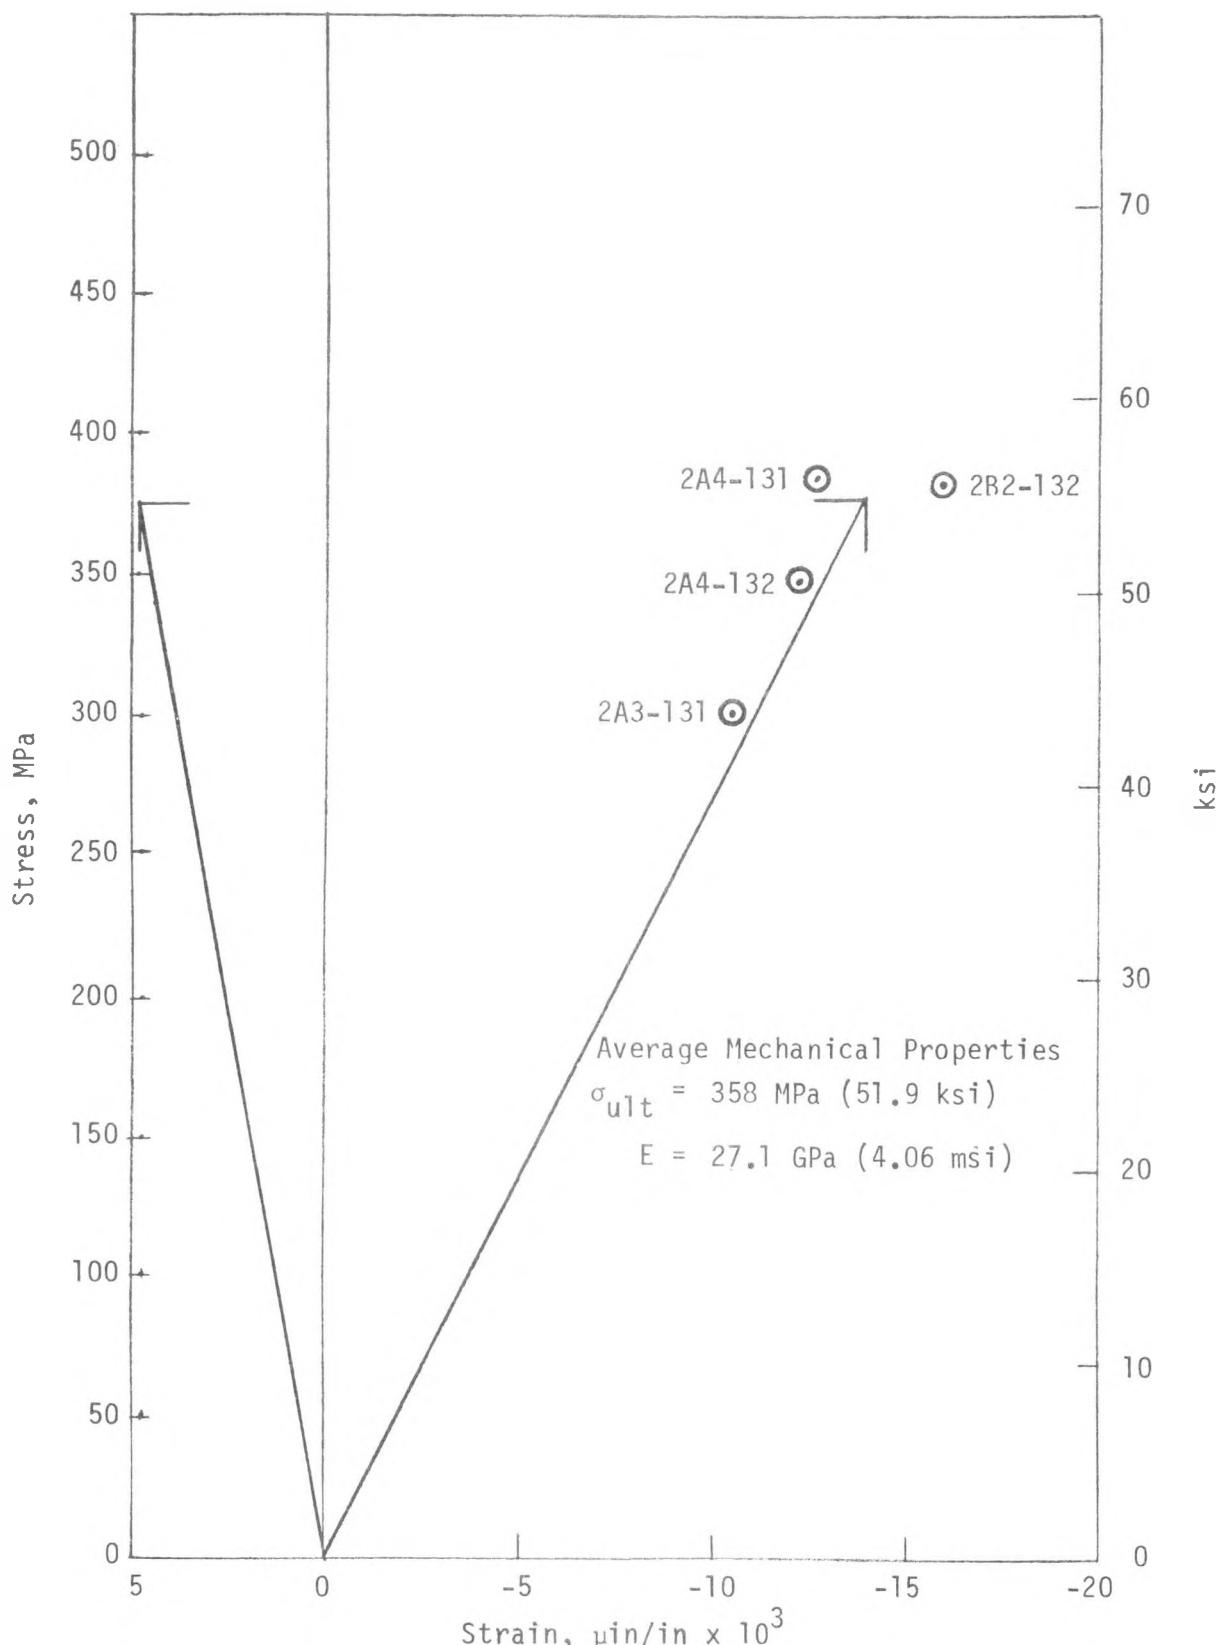
Figure 38. Compressive stress-strain curve for epoxy matrix composites with winding pattern No. 2 tested wet at 49°C (120°F). Curve shown for Specimen No. 2B2-131, endpoints of other tests shown by circles.

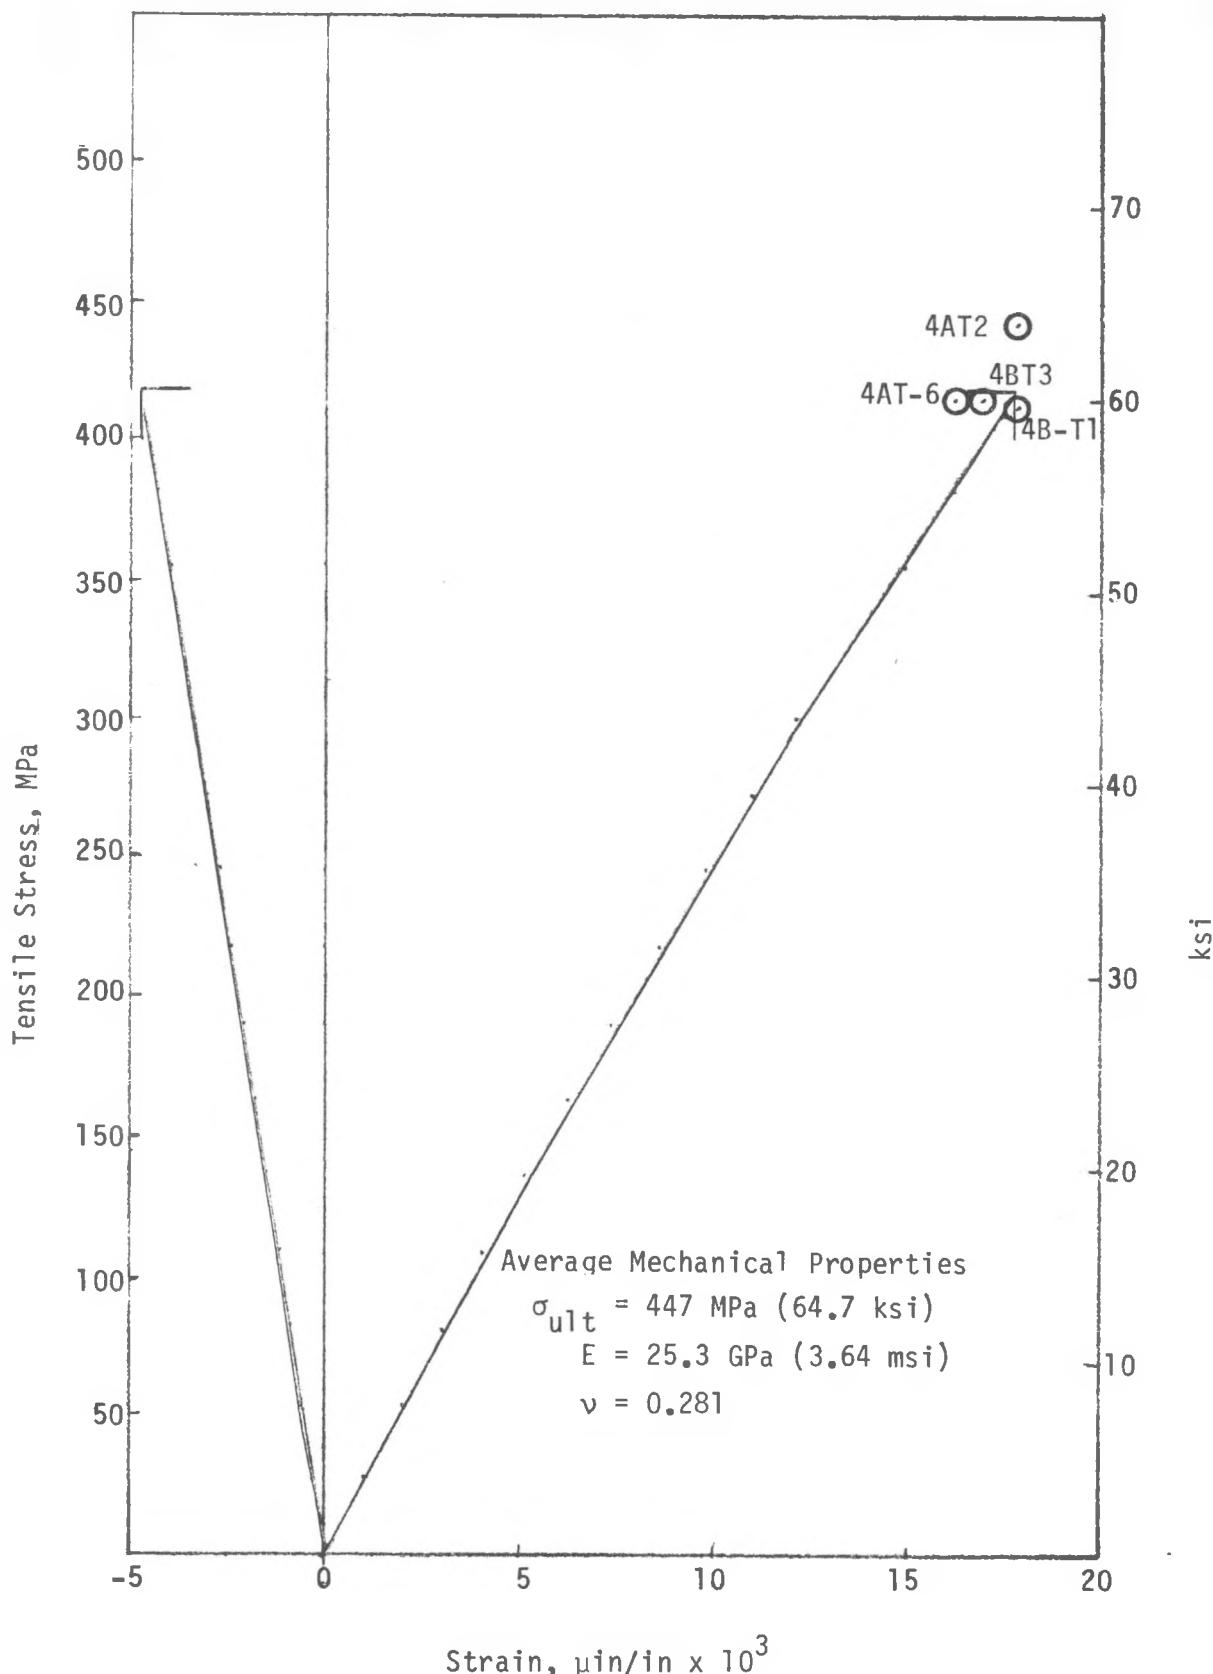
Figure 39. Tensile stress-strain curve for polyester matrix composites tested dry at room temperature. Curve shown for Specimen No. 4B-T5, endpoints of other tests shown by circles.

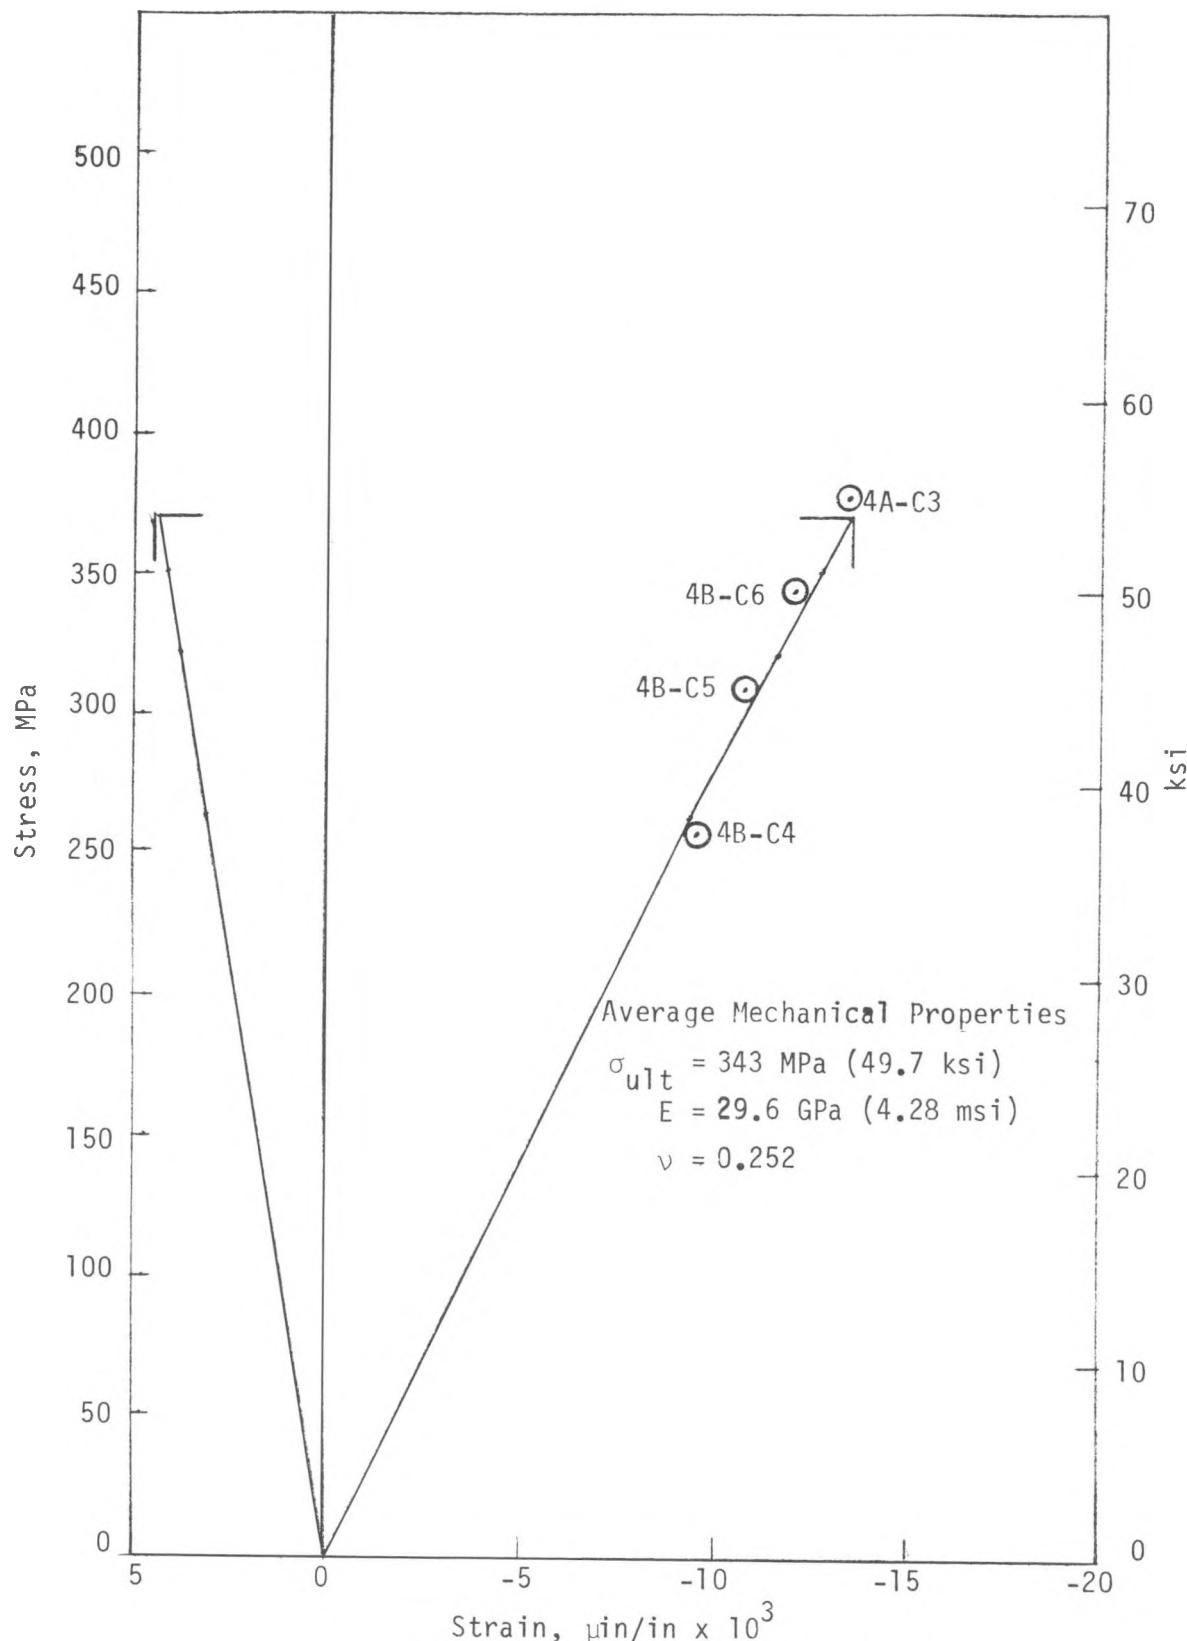
Figure 40. Compressive stress-strain curve for polyester matrix composites tested dry at room temperature. Curve shown for Specimen No. 4B-C2, endpoints of other tests shown by circles.

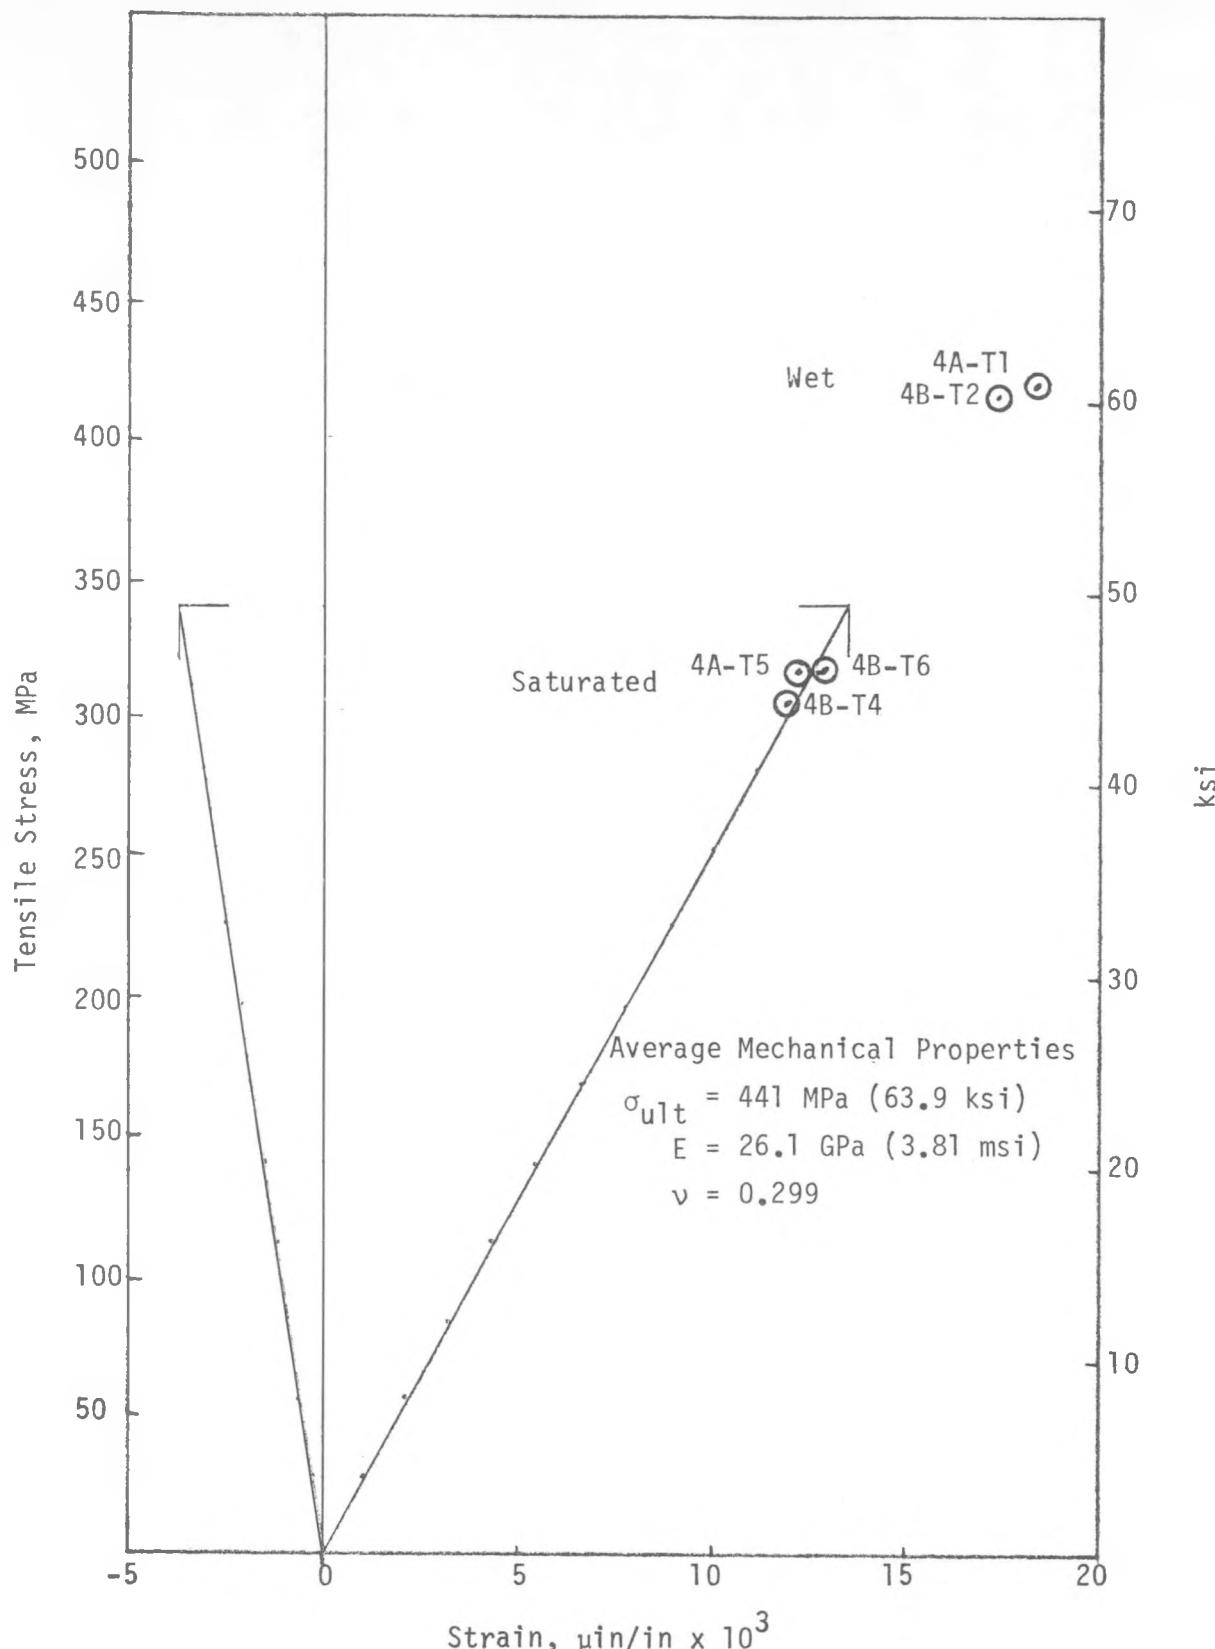
Figure 41. Tensile stress-strain curve for polyester matrix composites tested wet at 49°C (120°F). Curve shown for Specimen No. 4A-T3, endpoints of other tests shown by circles.

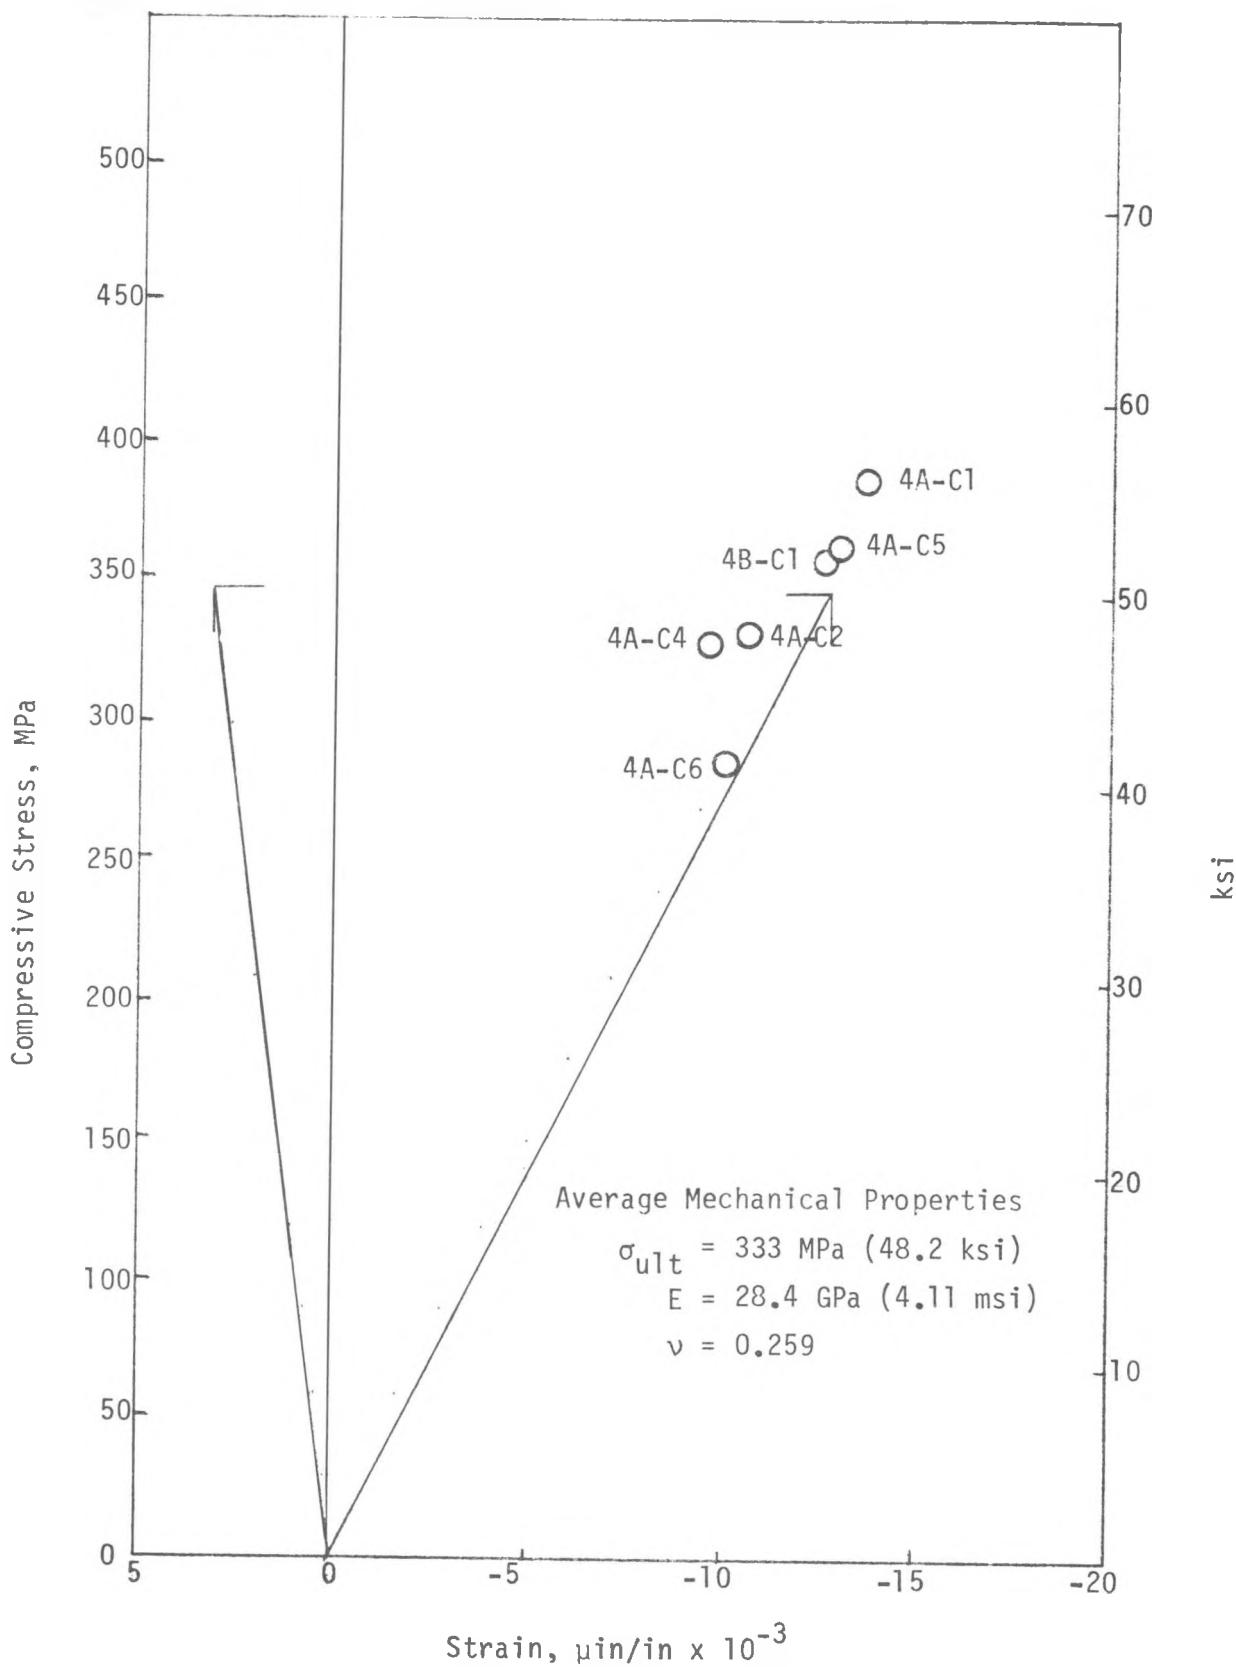
Figure 42. Compressive stress-strain curve for polyester matrix composites tested wet at 49°C (120°F). Curve shown for Specimen No. 4A-C6, endpoints of other tests shown by circles.
