Facility Decontamination Technology Workshop

November 27-29, 1979

Prepared for the
U.S. Department of Energy
Three Mile Island Operations Office
Under DOE Contract No. DE-AC07-76IDO1570

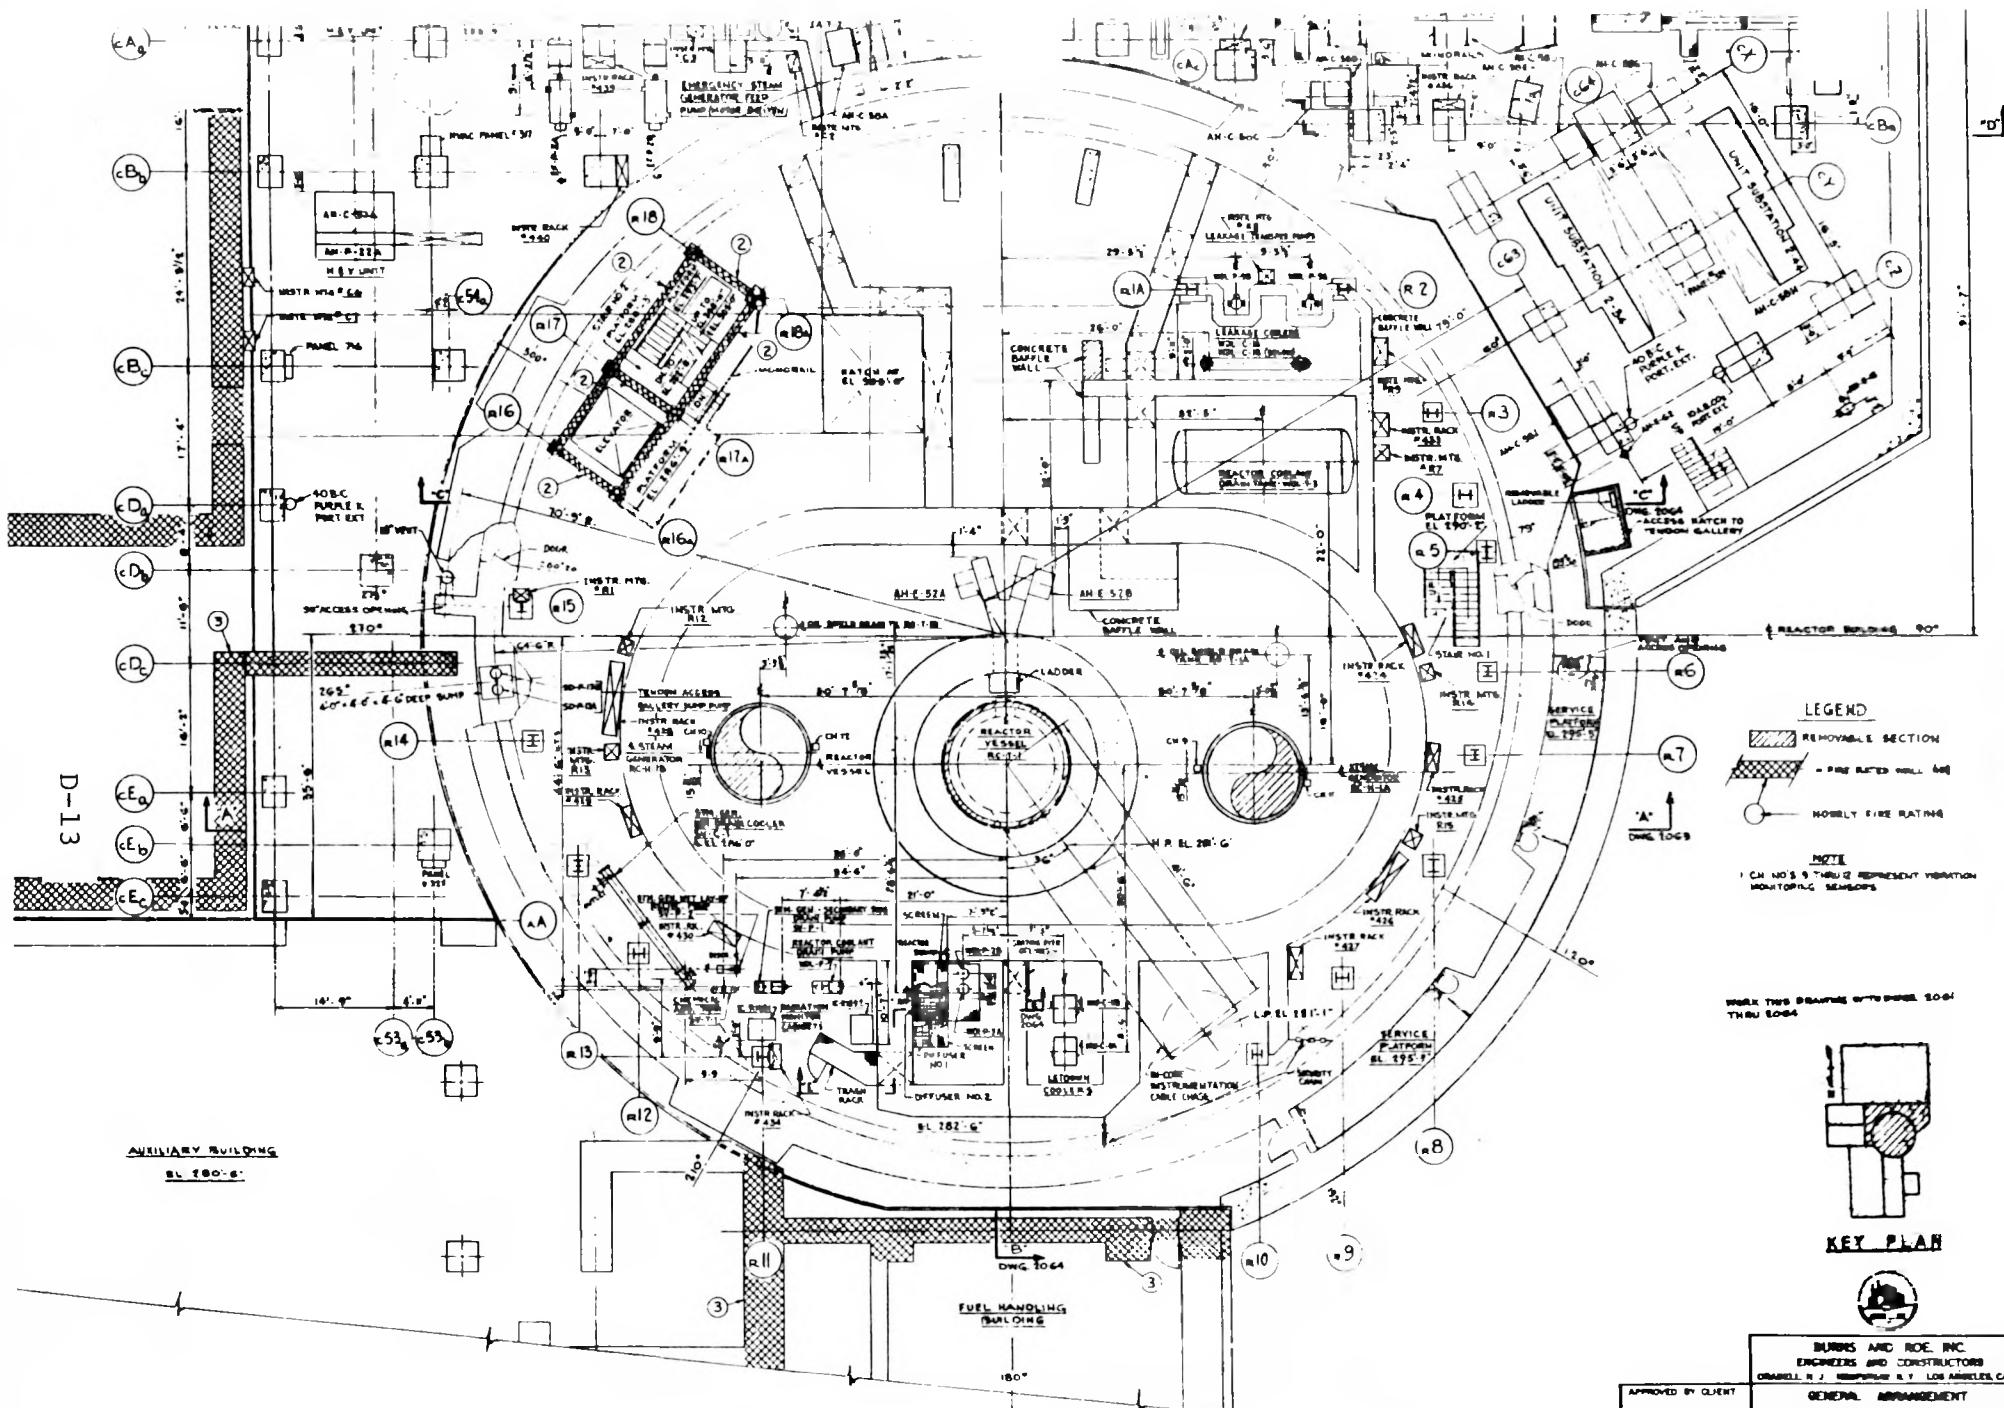
SLIDE 1

APPROVED BY CLIENT		ORBELL, R. J. HOSPITAL, R.Y. LOS ANGELES, CALIF.												
NOT REQUIRED		GENERAL ARRANGEMENT REACTOR & CONTROL BUILDING AREA 1 FLOOR PLAN EL 282'-6"												
		JERSEY CENTRAL POWER & LIGHT CO. THREE MILE ISLAND STATION - UNIT 2

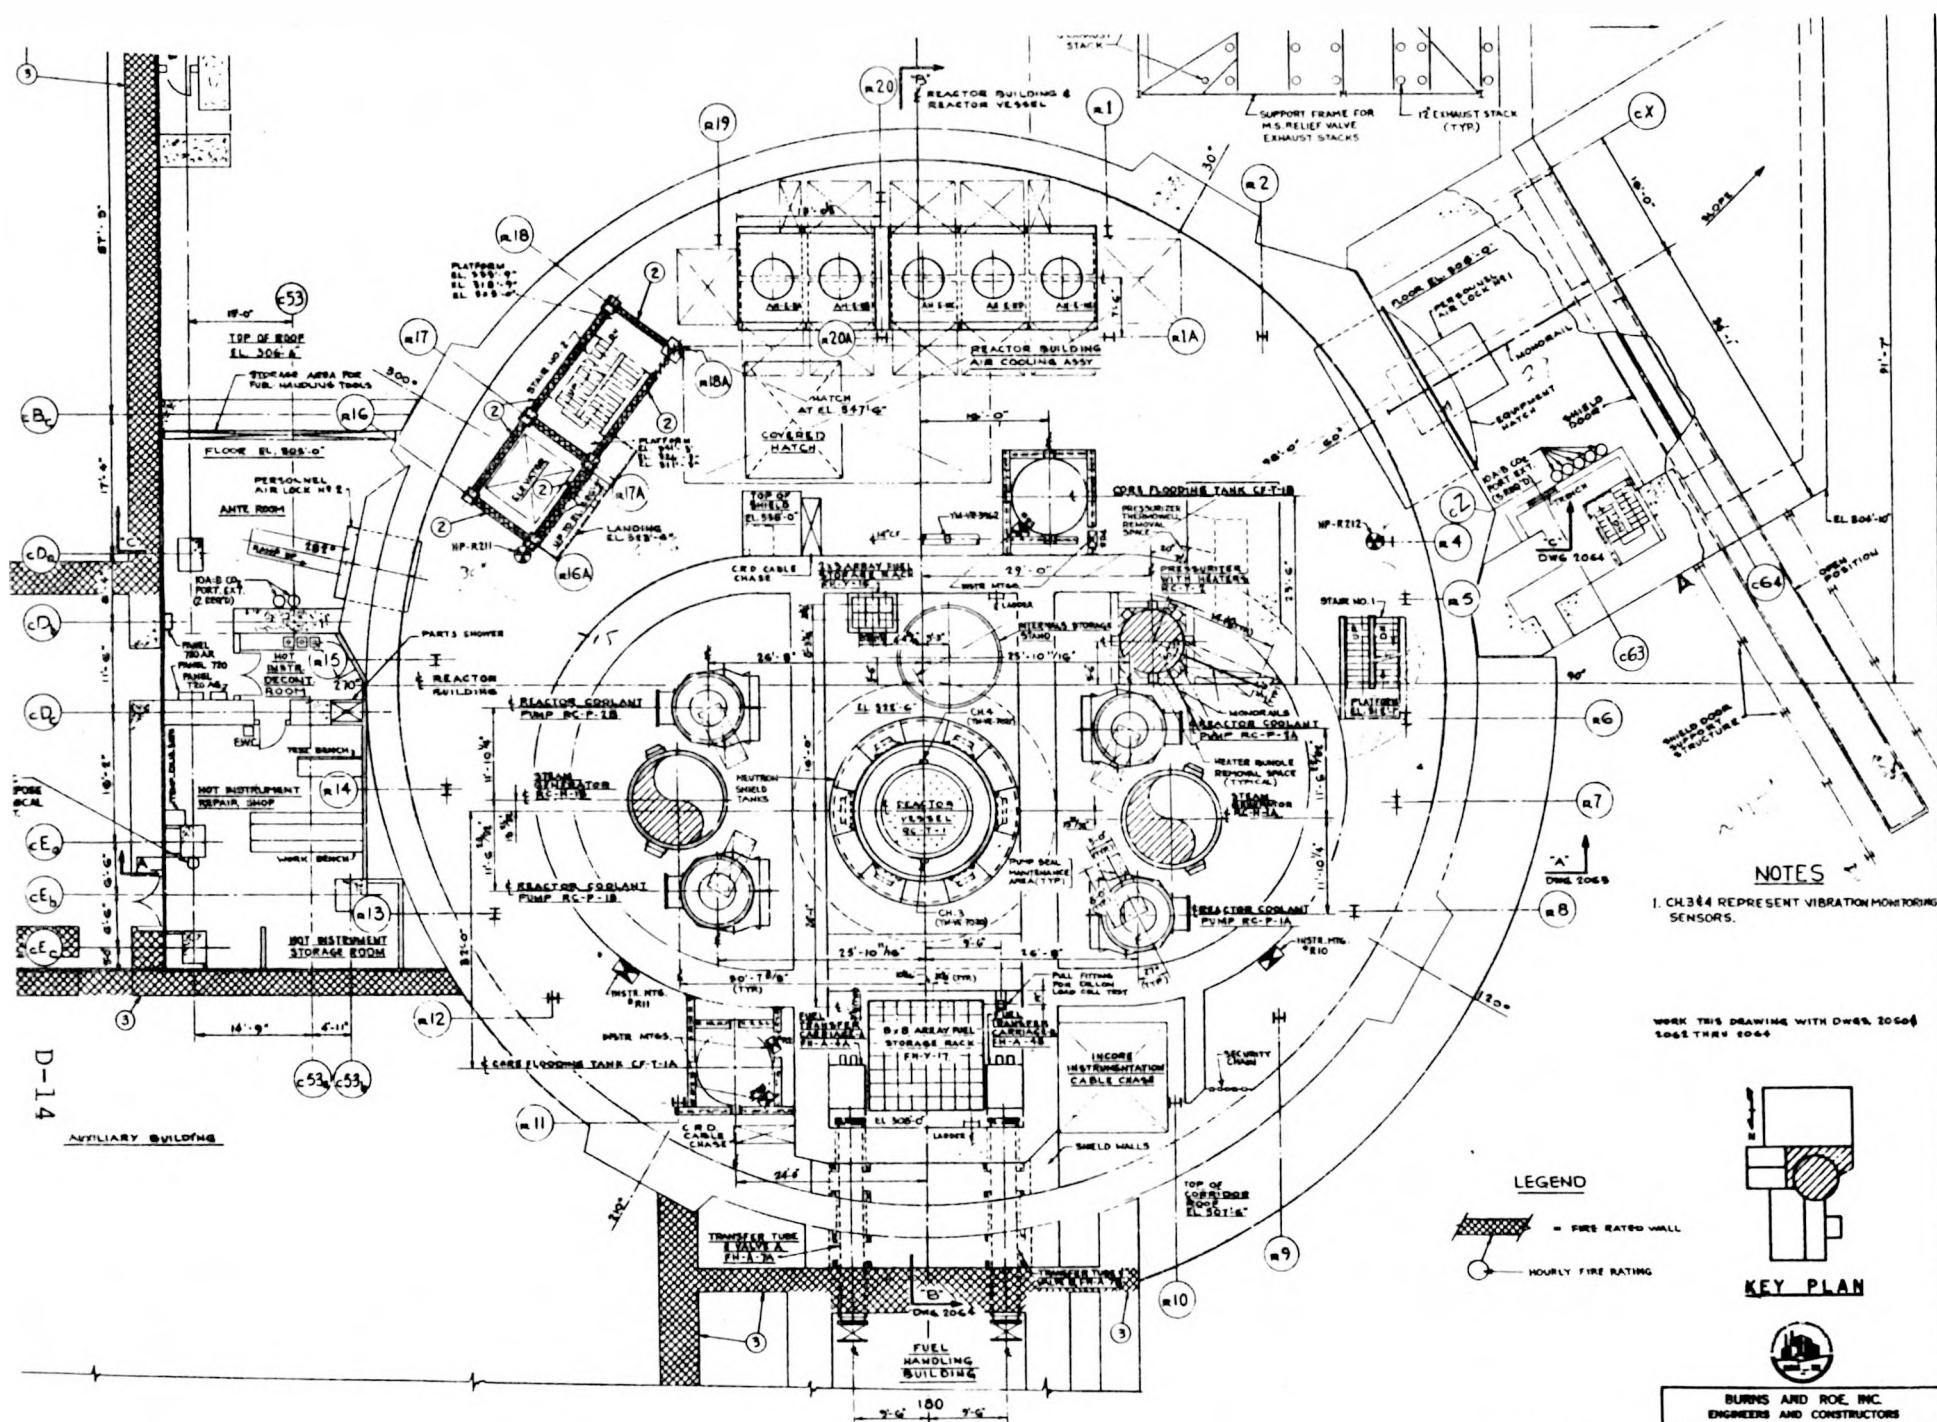
SLIDE 2

APPROVED BY CLIENT	GENERAL ARRANGEMENT REACTOR & CONTROL BUILDING AREA FLOOR PLAN EL 305'-0"		
NOT REQUIRED	JERSEY CENTRAL THREE MILE ISL. UNIT 2		
REVISION	REVISION	REVISION	REVISION
REVISION	REVISION	REVISION	REVISION

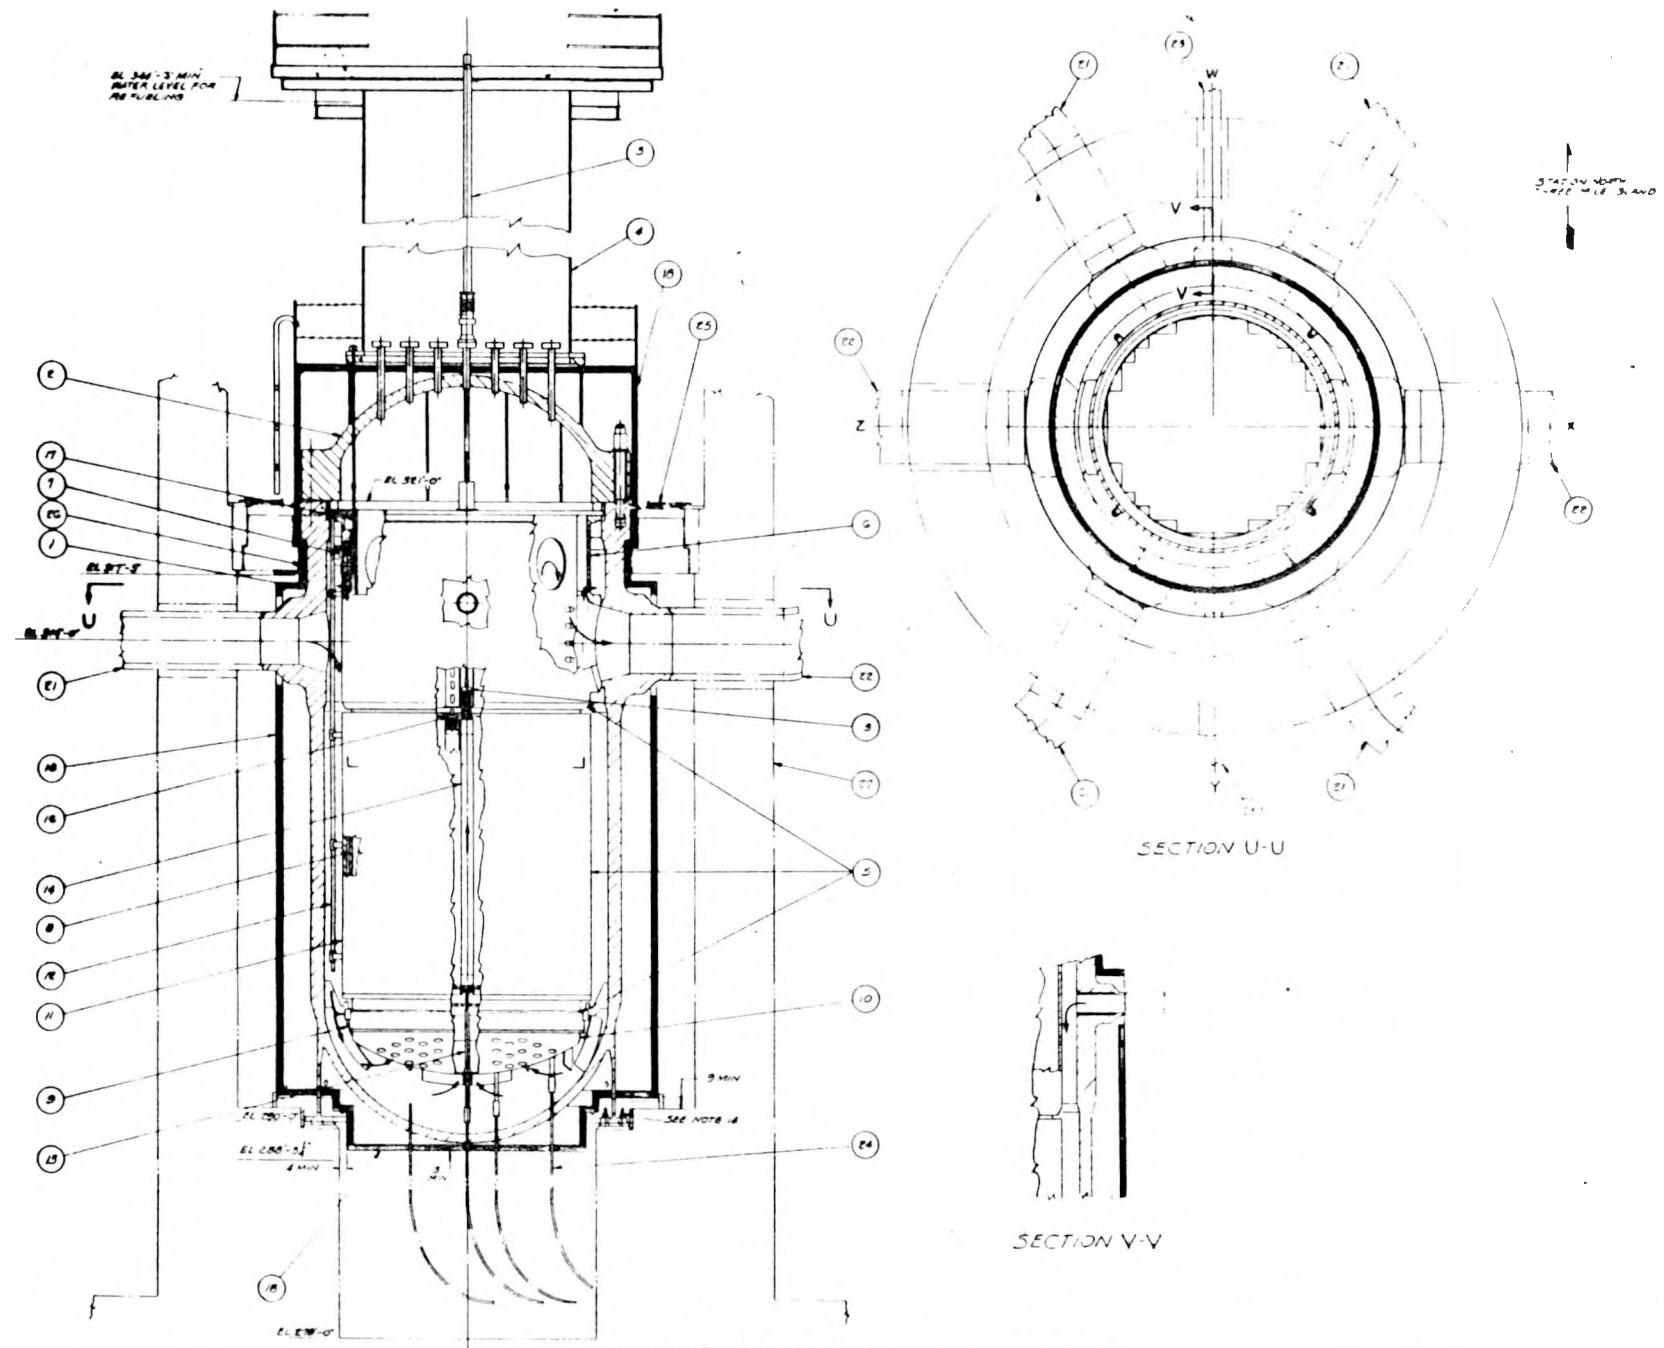
• FIGURE 7

REACTOR VESSEL ARRANGEMENT

The reactor vessel insulation shown in Figure 7 is a metal reflective type made up of very thin panels of stainless steel. There are approximately 20 thin layers in an assembly of about 4 inches thick. These are pre-assembled panels that are installed in the field. At TMI-2, there are stand-off's between the insulation and the reactor vessel so that you can get between the insulation system and the vessel for inservice inspection. The complete NSS loop and some of the smaller piping is covered with this insulation. Depending upon the degree of contamination of the insulation this may involve significant decontamination problems.

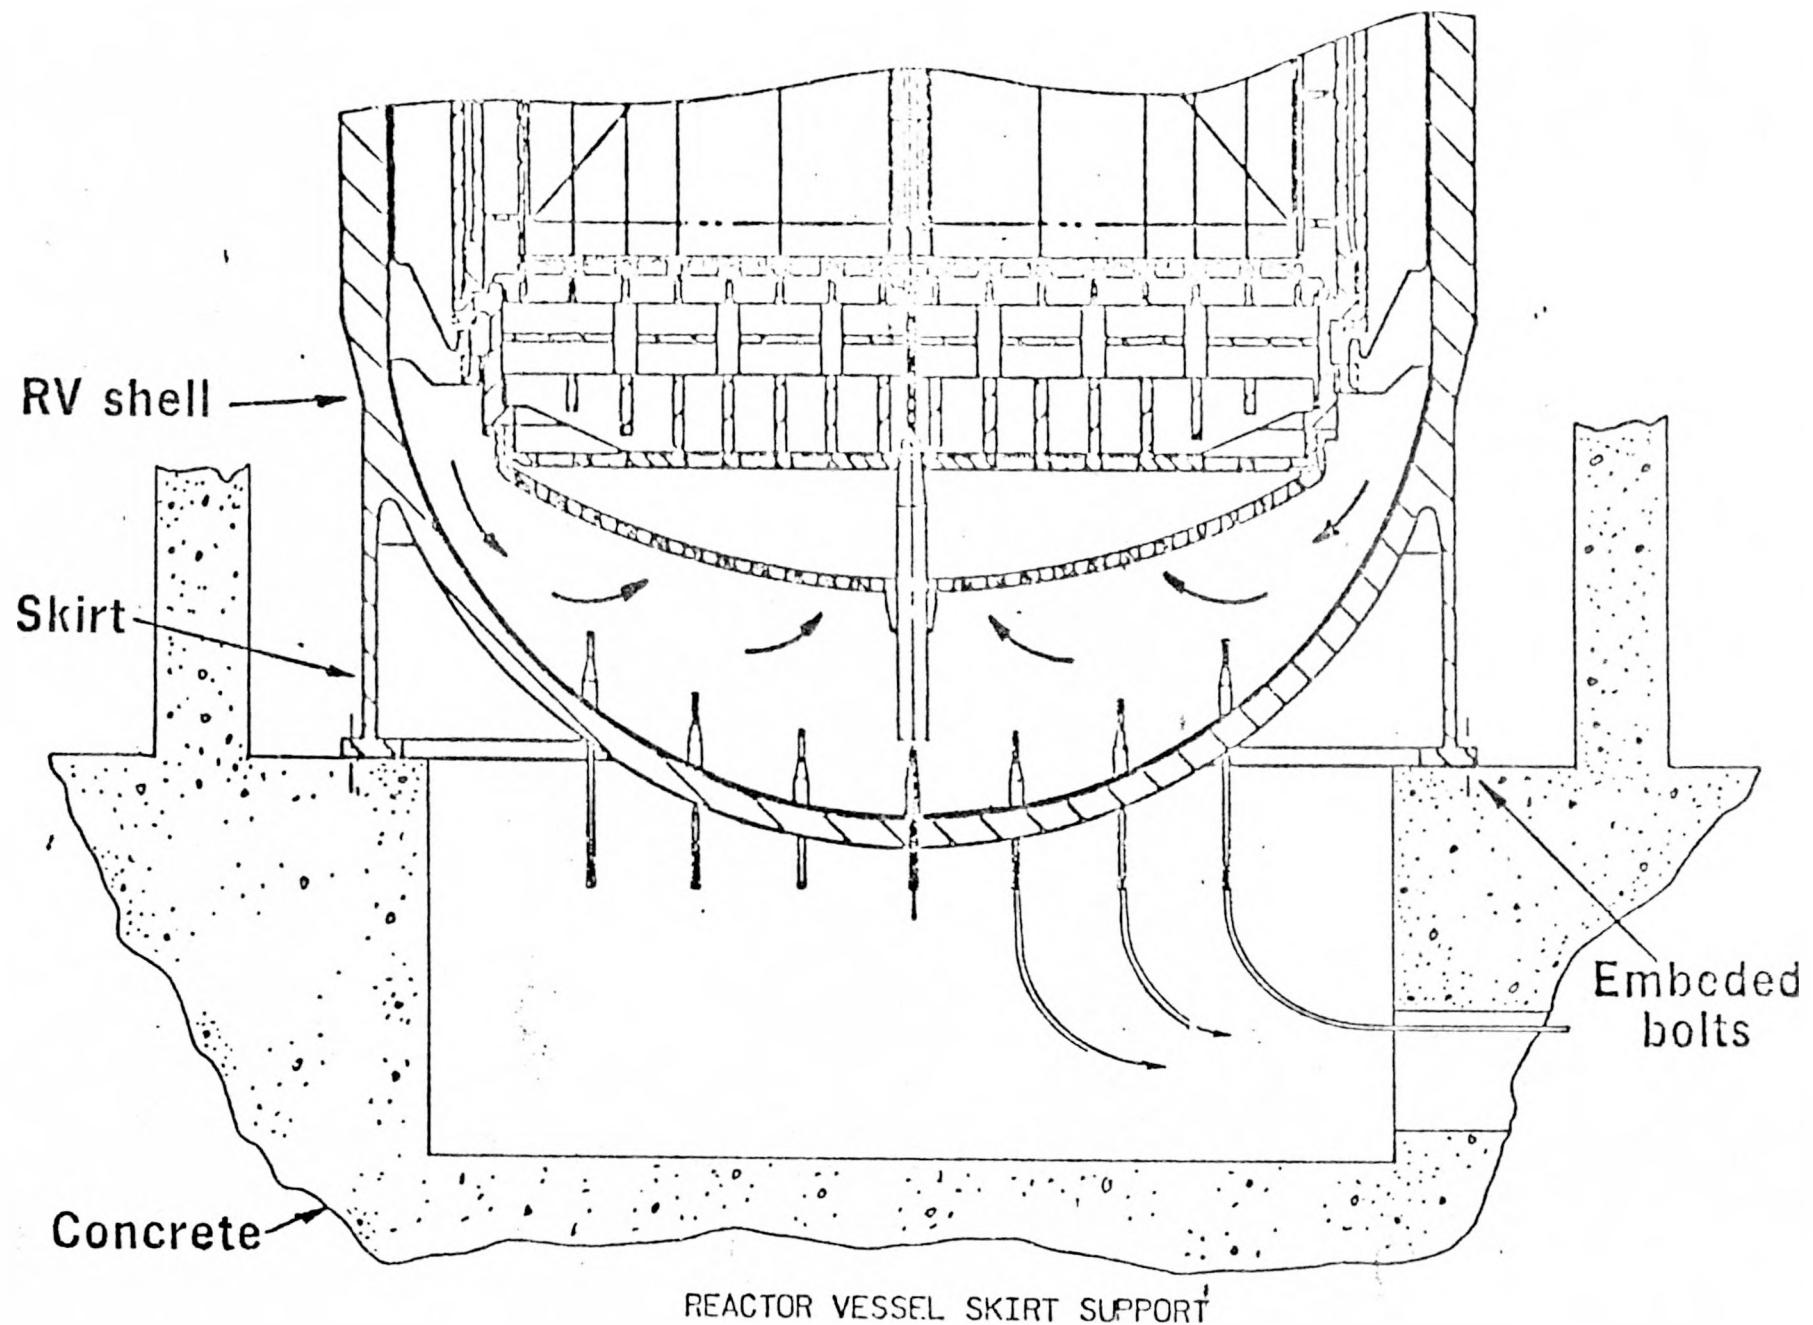
FIGURE 12

Reactor coolant system

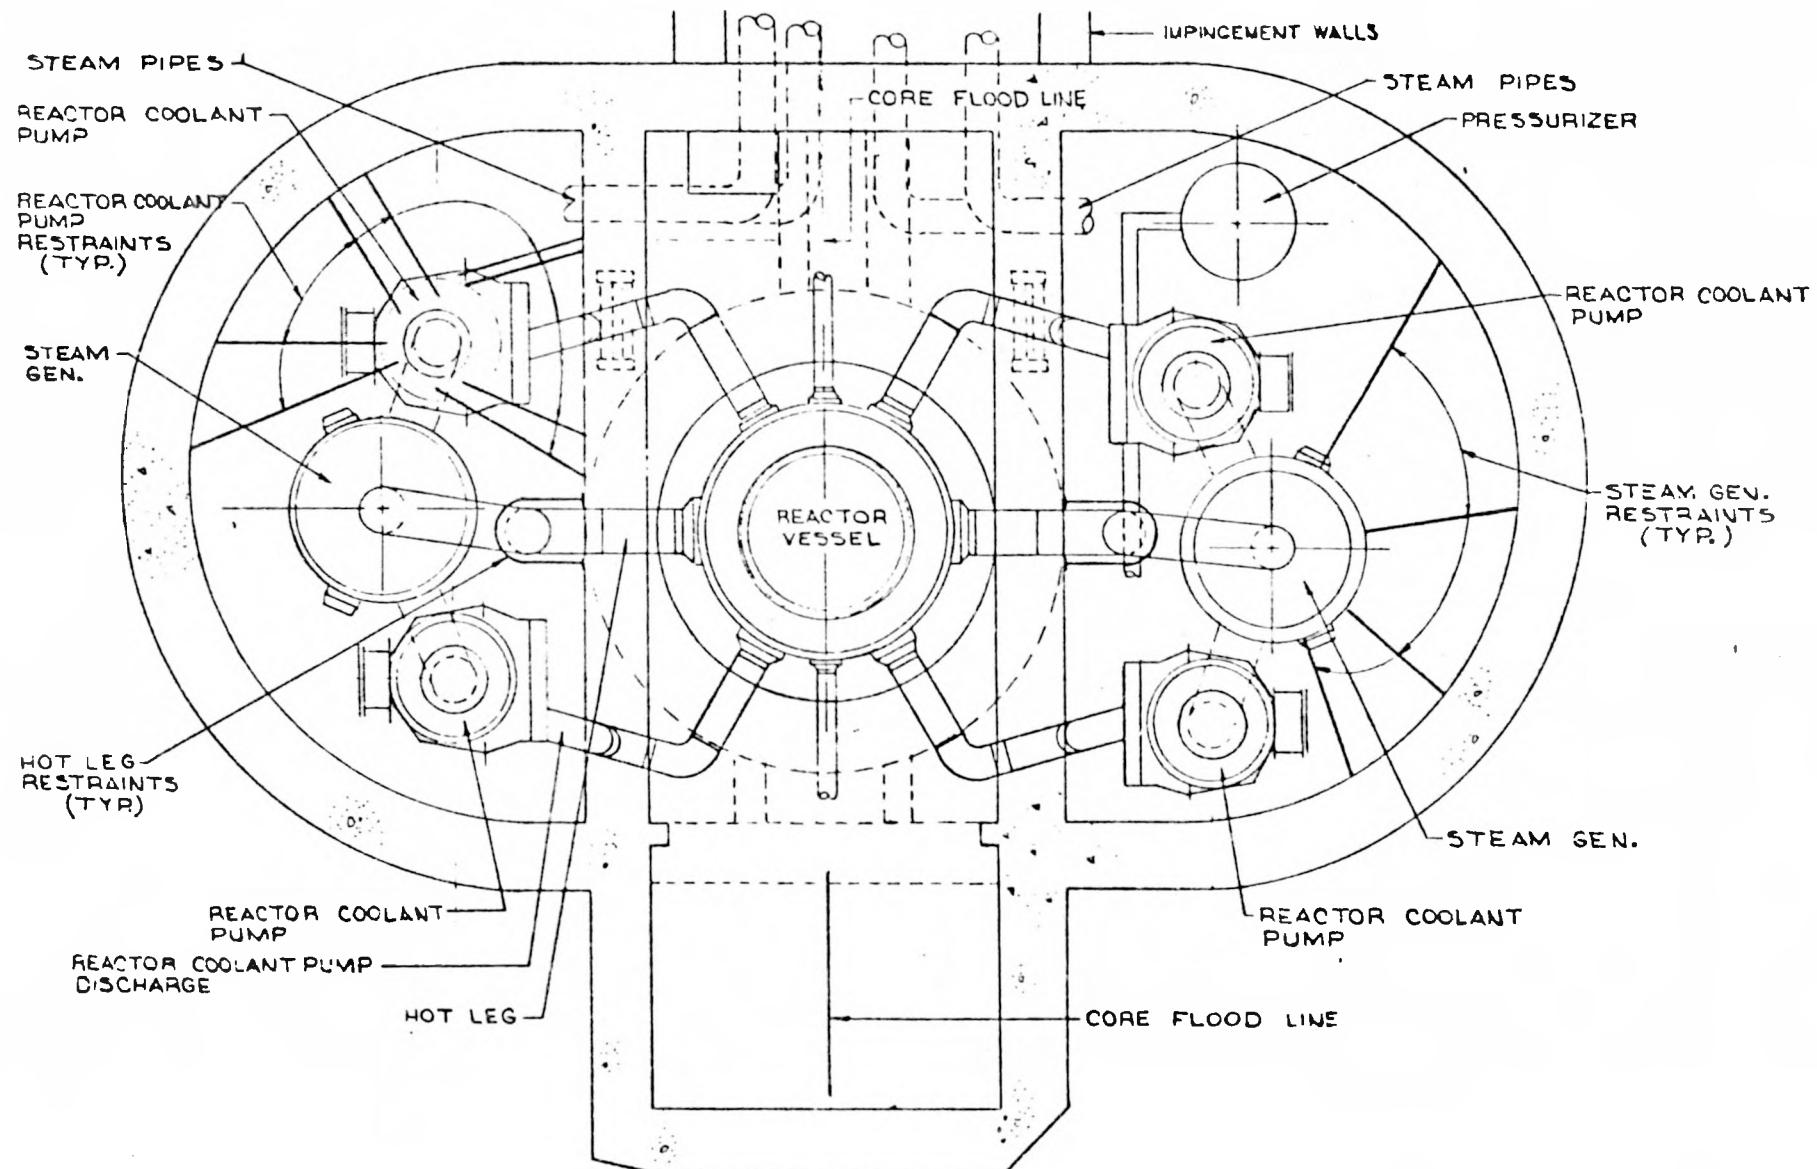
FIGURE 13

Pump supports

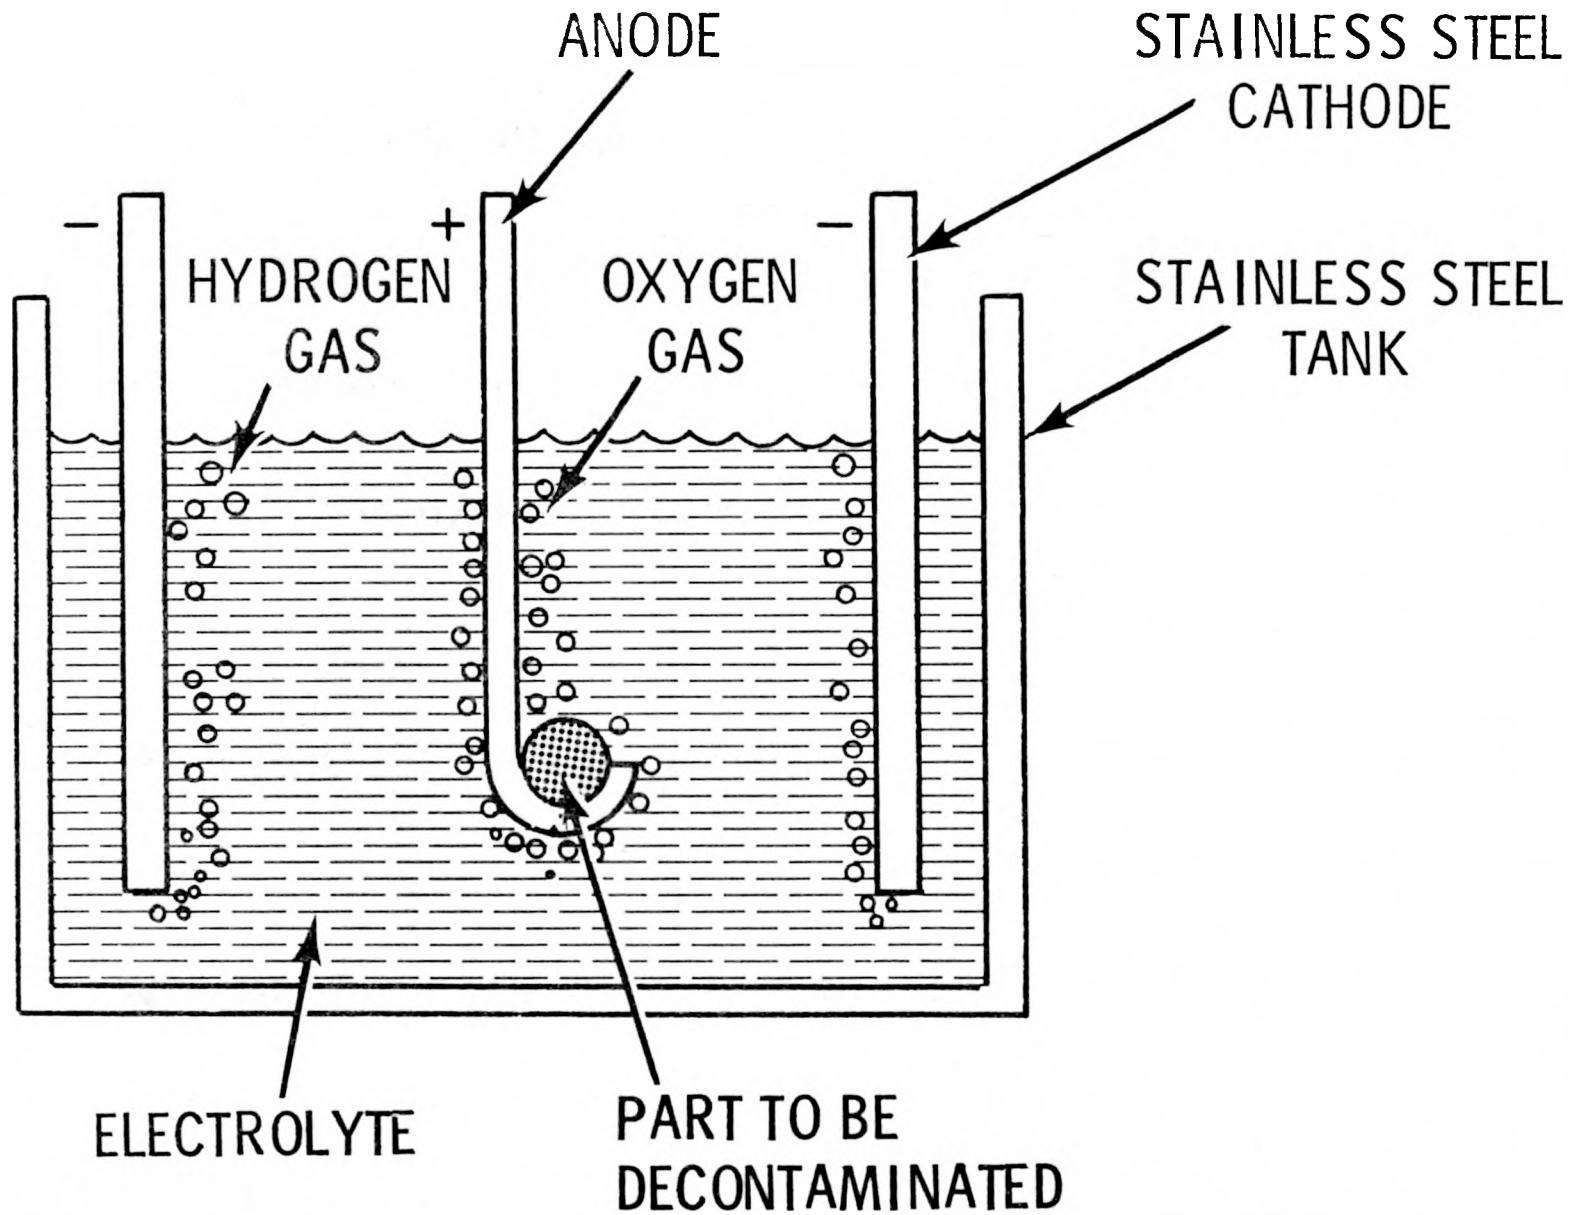
ELECTROPOOLISHING OF 304 L STAINLESS STEEL IN PHOSPHORIC ACID

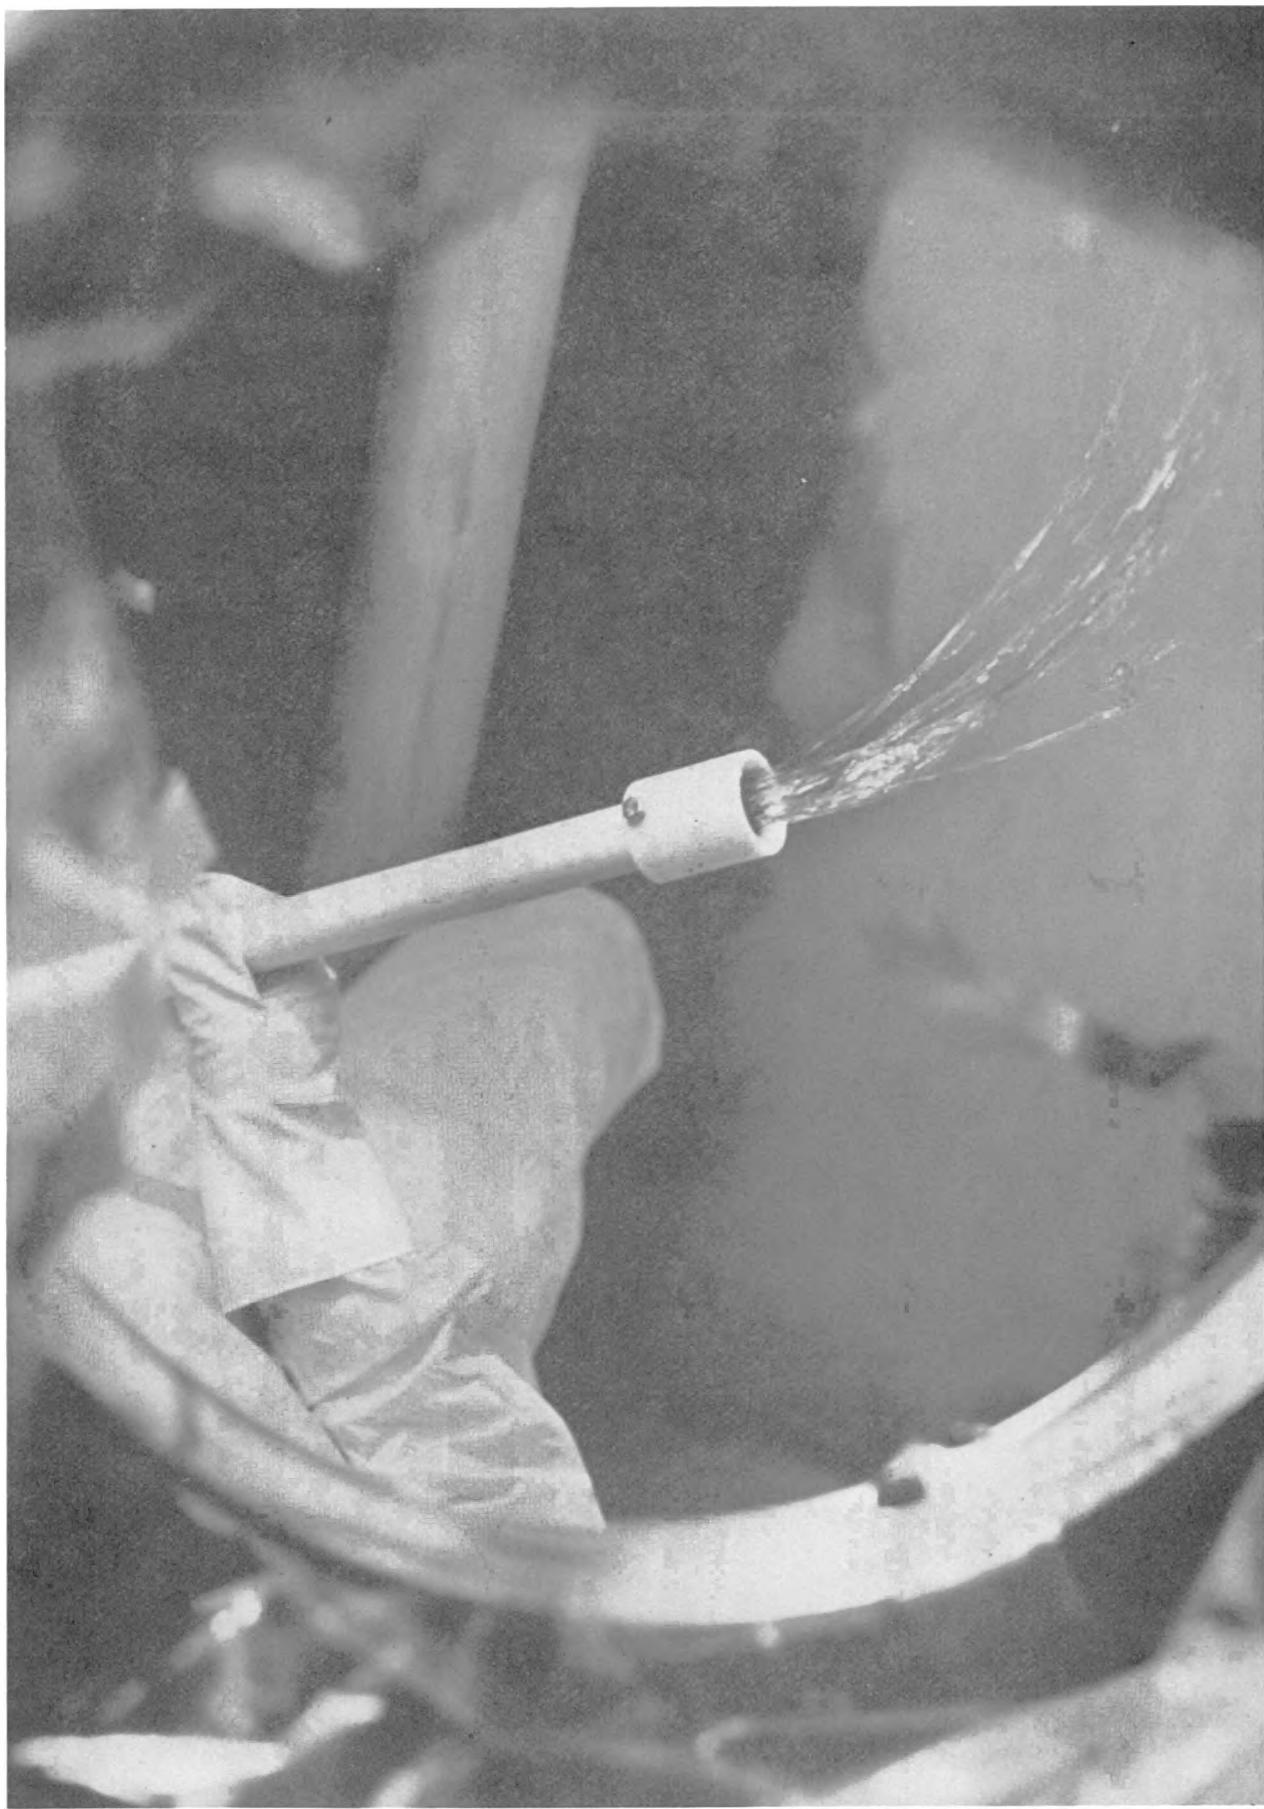
- DECONTAMINATE IRREGULAR SURFACES WITHOUT CONTACT
- PORTABLE SYSTEM IDEAL FOR FIELD APPLICATIONS
- SPOT DECONTAMINATION

CONTACT TECHNIQUE

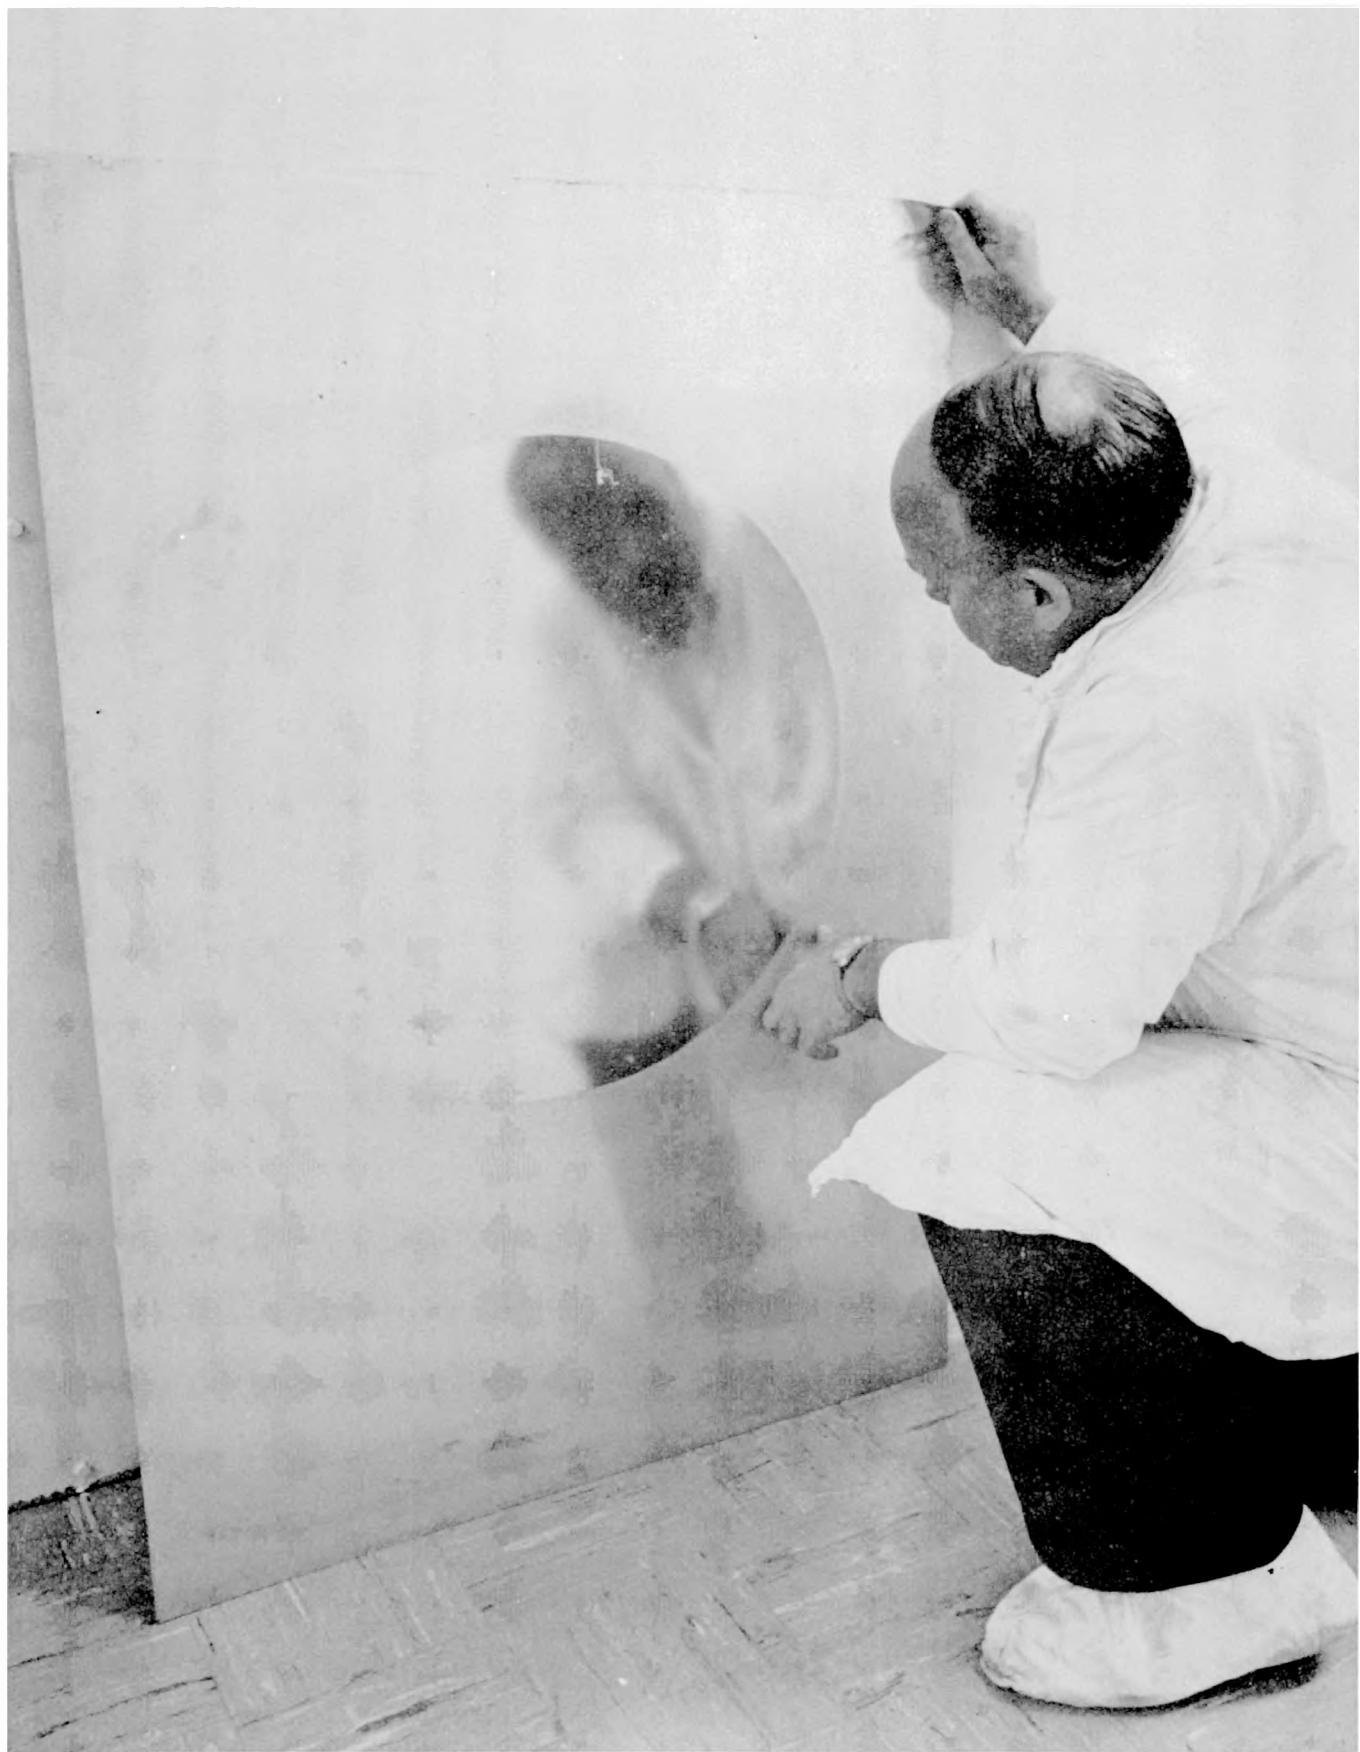
- DECONTAMINATE PLANAR SURFACES
- COMPLETE CONTAINMENT OF ELECTROLYTE
- USEFUL FOR LARGE AREAS

BRUSH TECHNIQUE

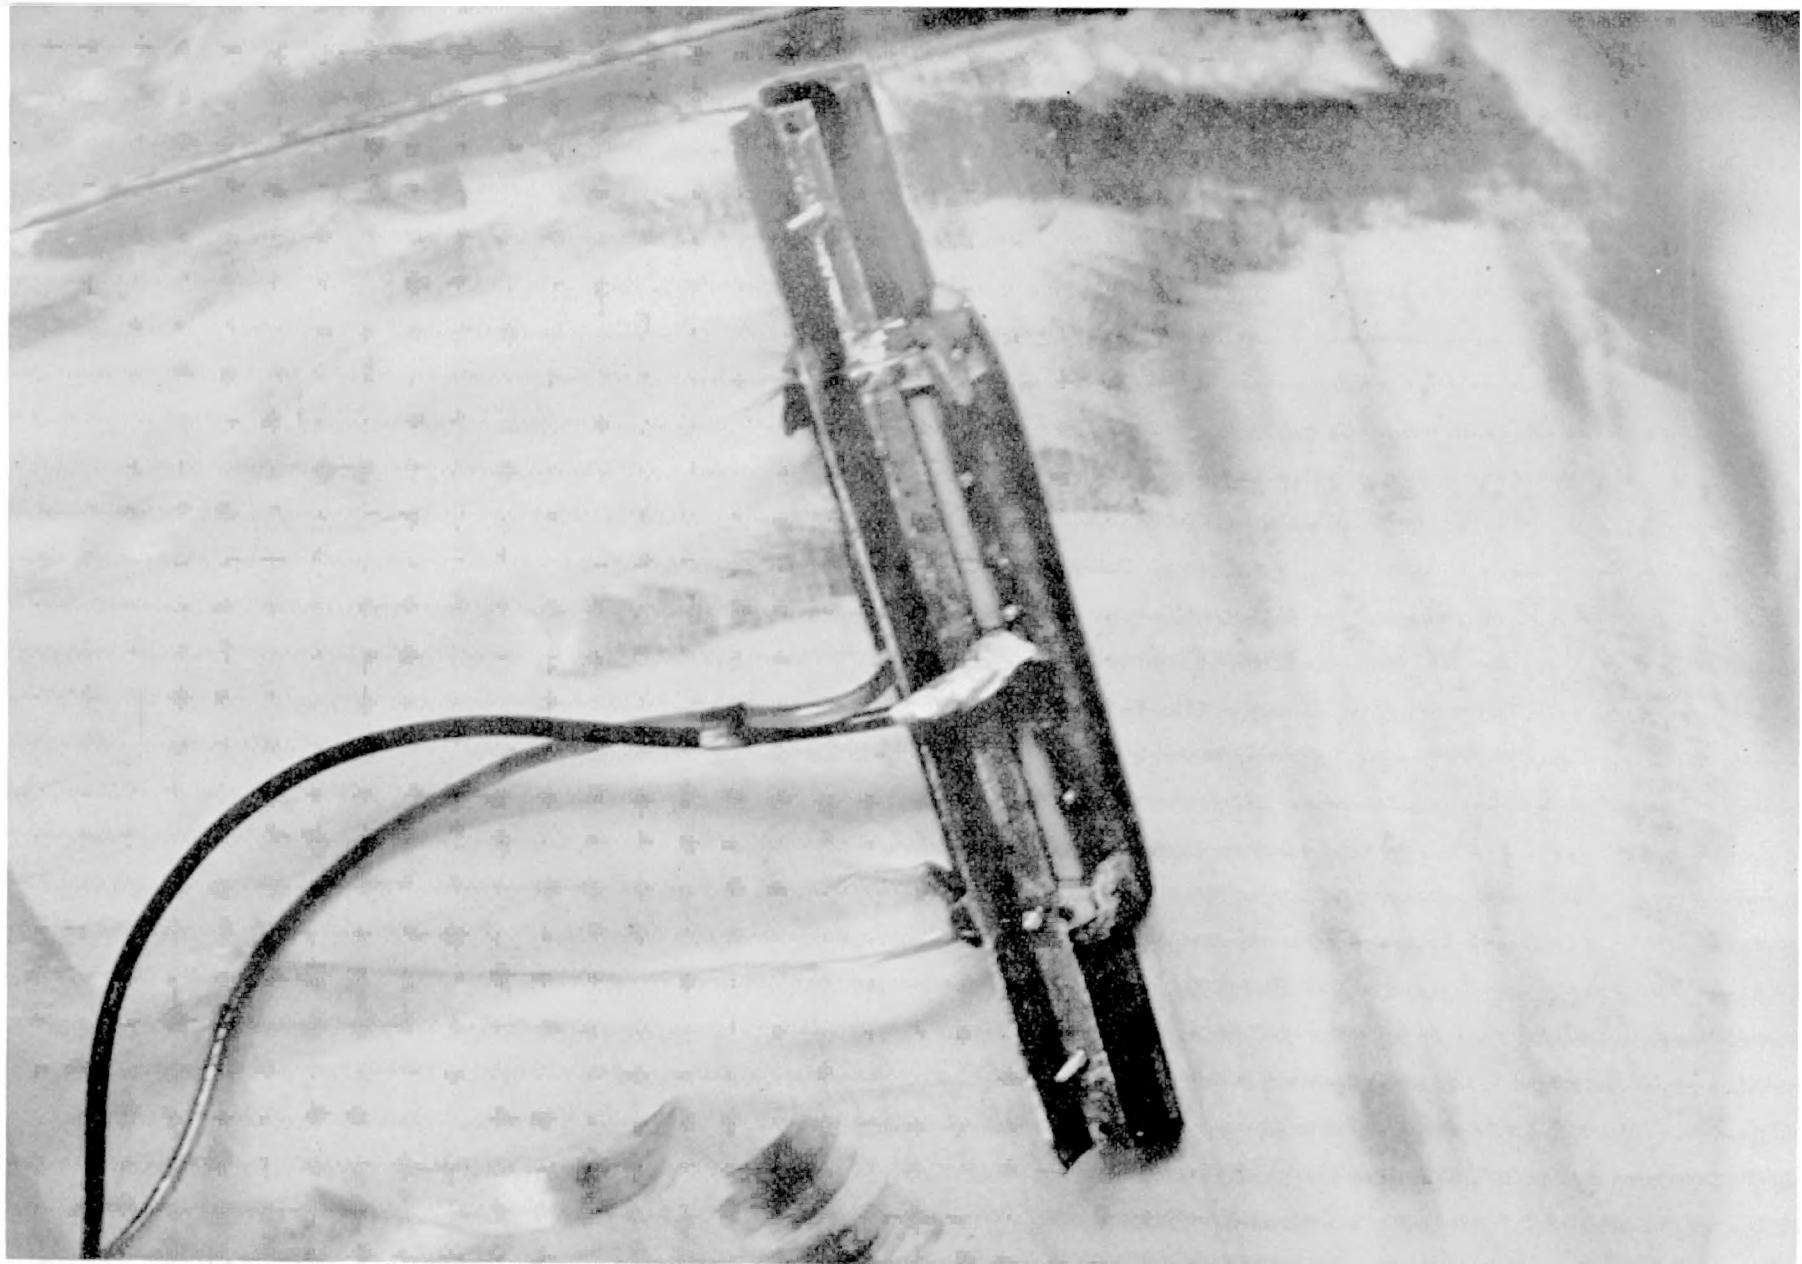
SLIDE 21

INTERNAL CATHODE TECHNIQUE

- DECONTAMINATE INTERNAL SURFACES OF PIPE
- DECONTAMINATE LONG LENGTHS
- DECONTAMINATE CURVED SECTIONS

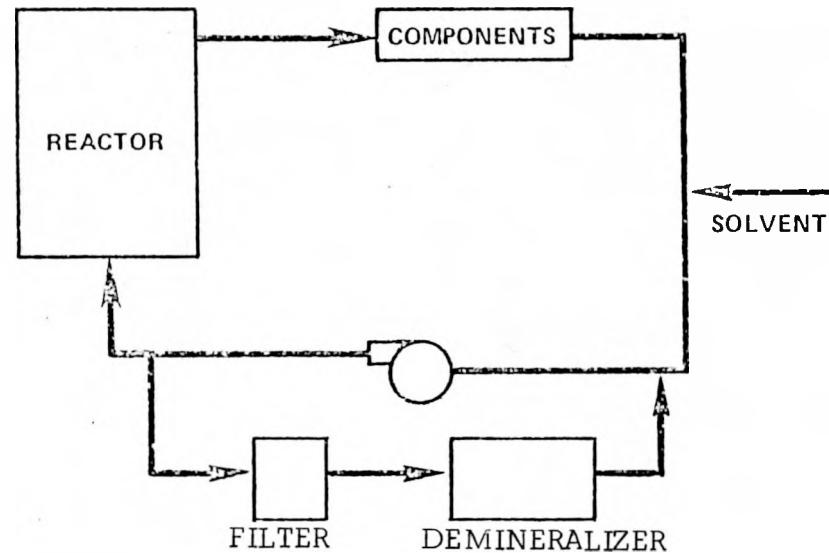
FIGURE 1

SIMPLIFIED FLOW DIAGRAM FOR
RAPID DECONTAMINATION PROCESS

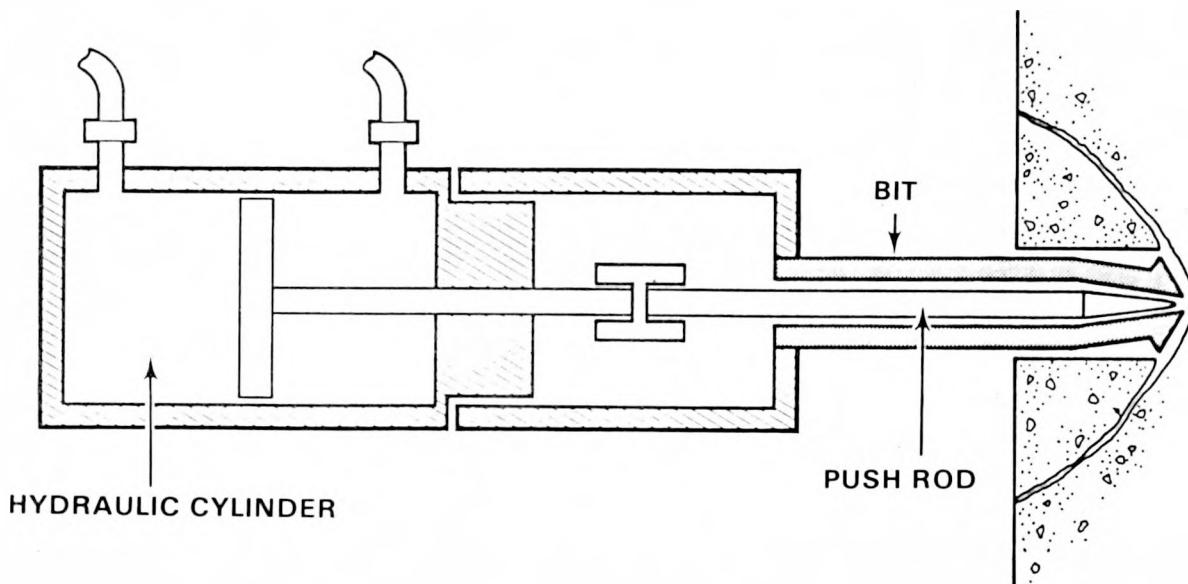
FIGURE 18. Concrete Spaller
