Facility Decontamination Technology Workshop

November 27-29, 1979

Prepared for the
U.S. Department of Energy
Three Mile Island Operations Office
Under DOE Contract No. DE-AC07-76IDO1570

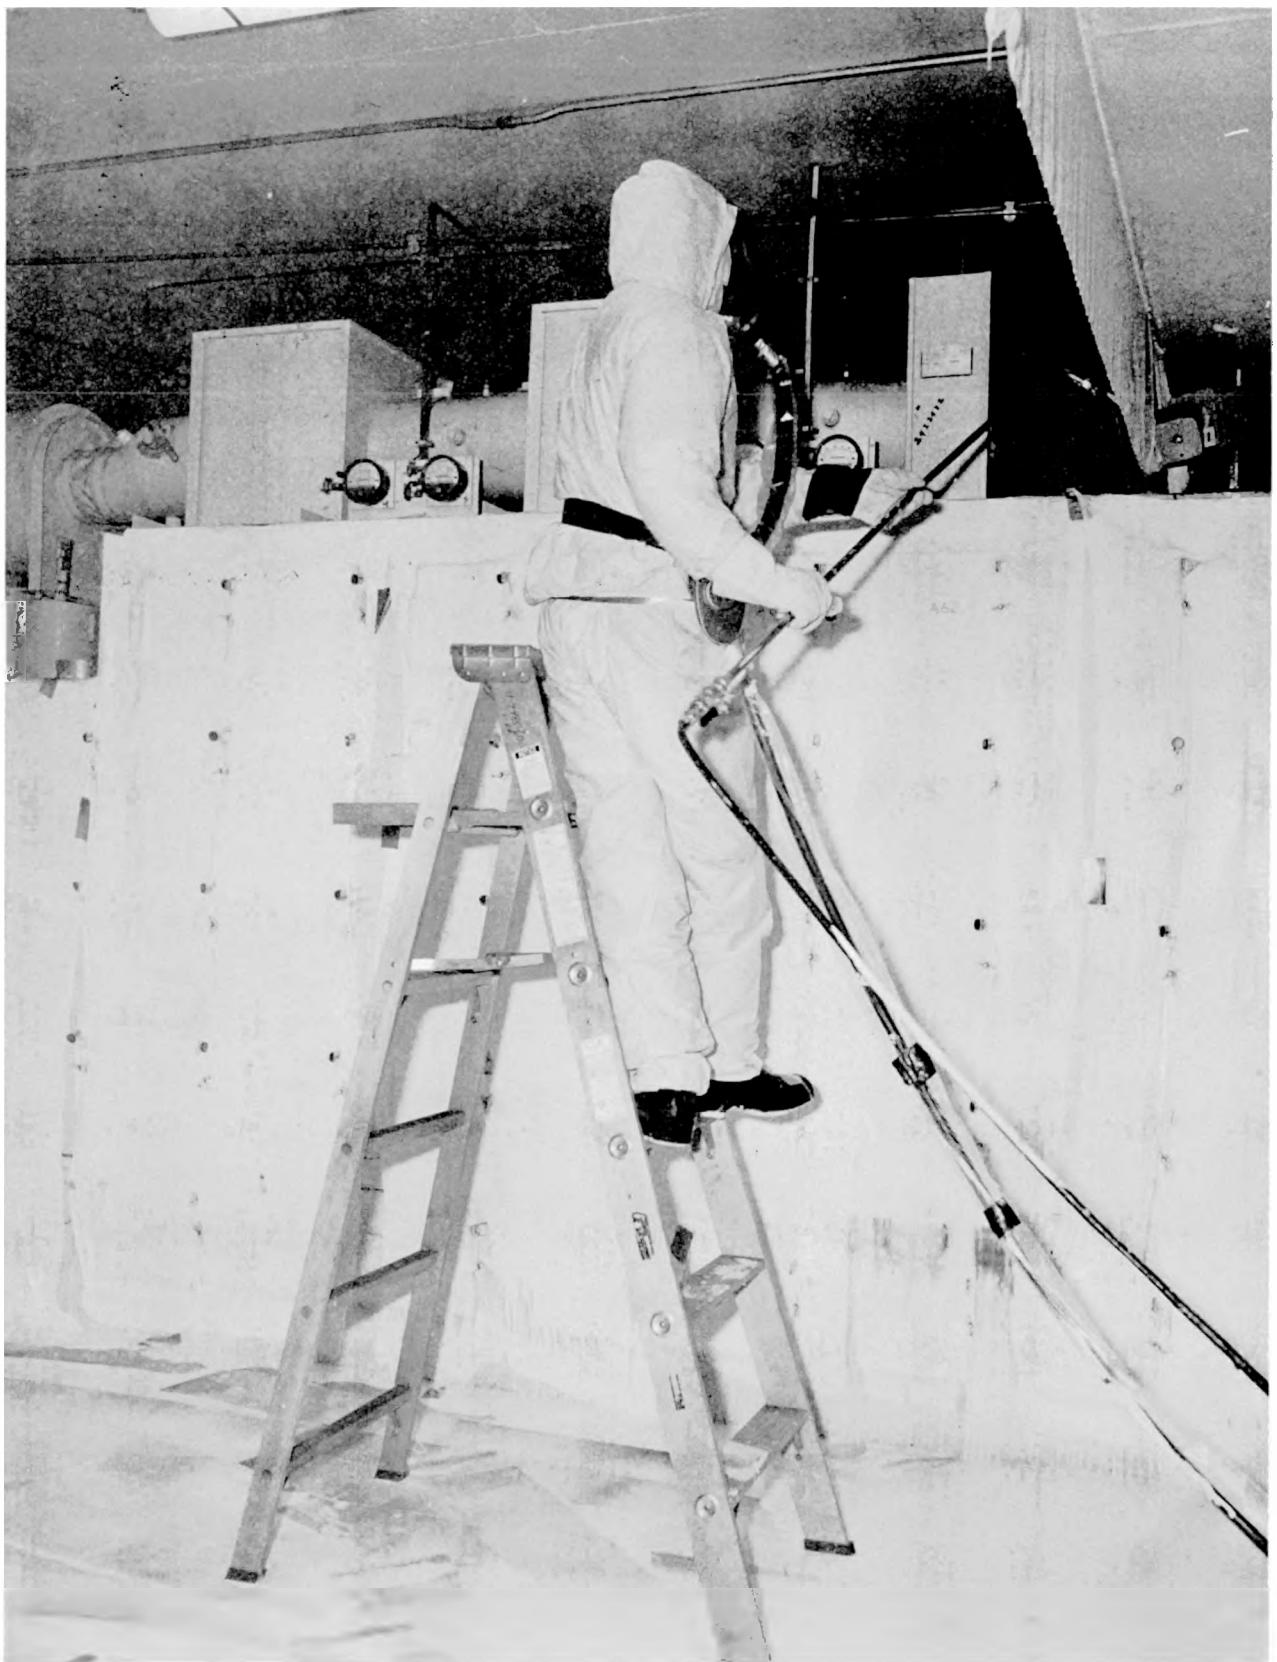
FIGURE 11. Application of Strippable Fixative for Decontaminating the 303-C Building

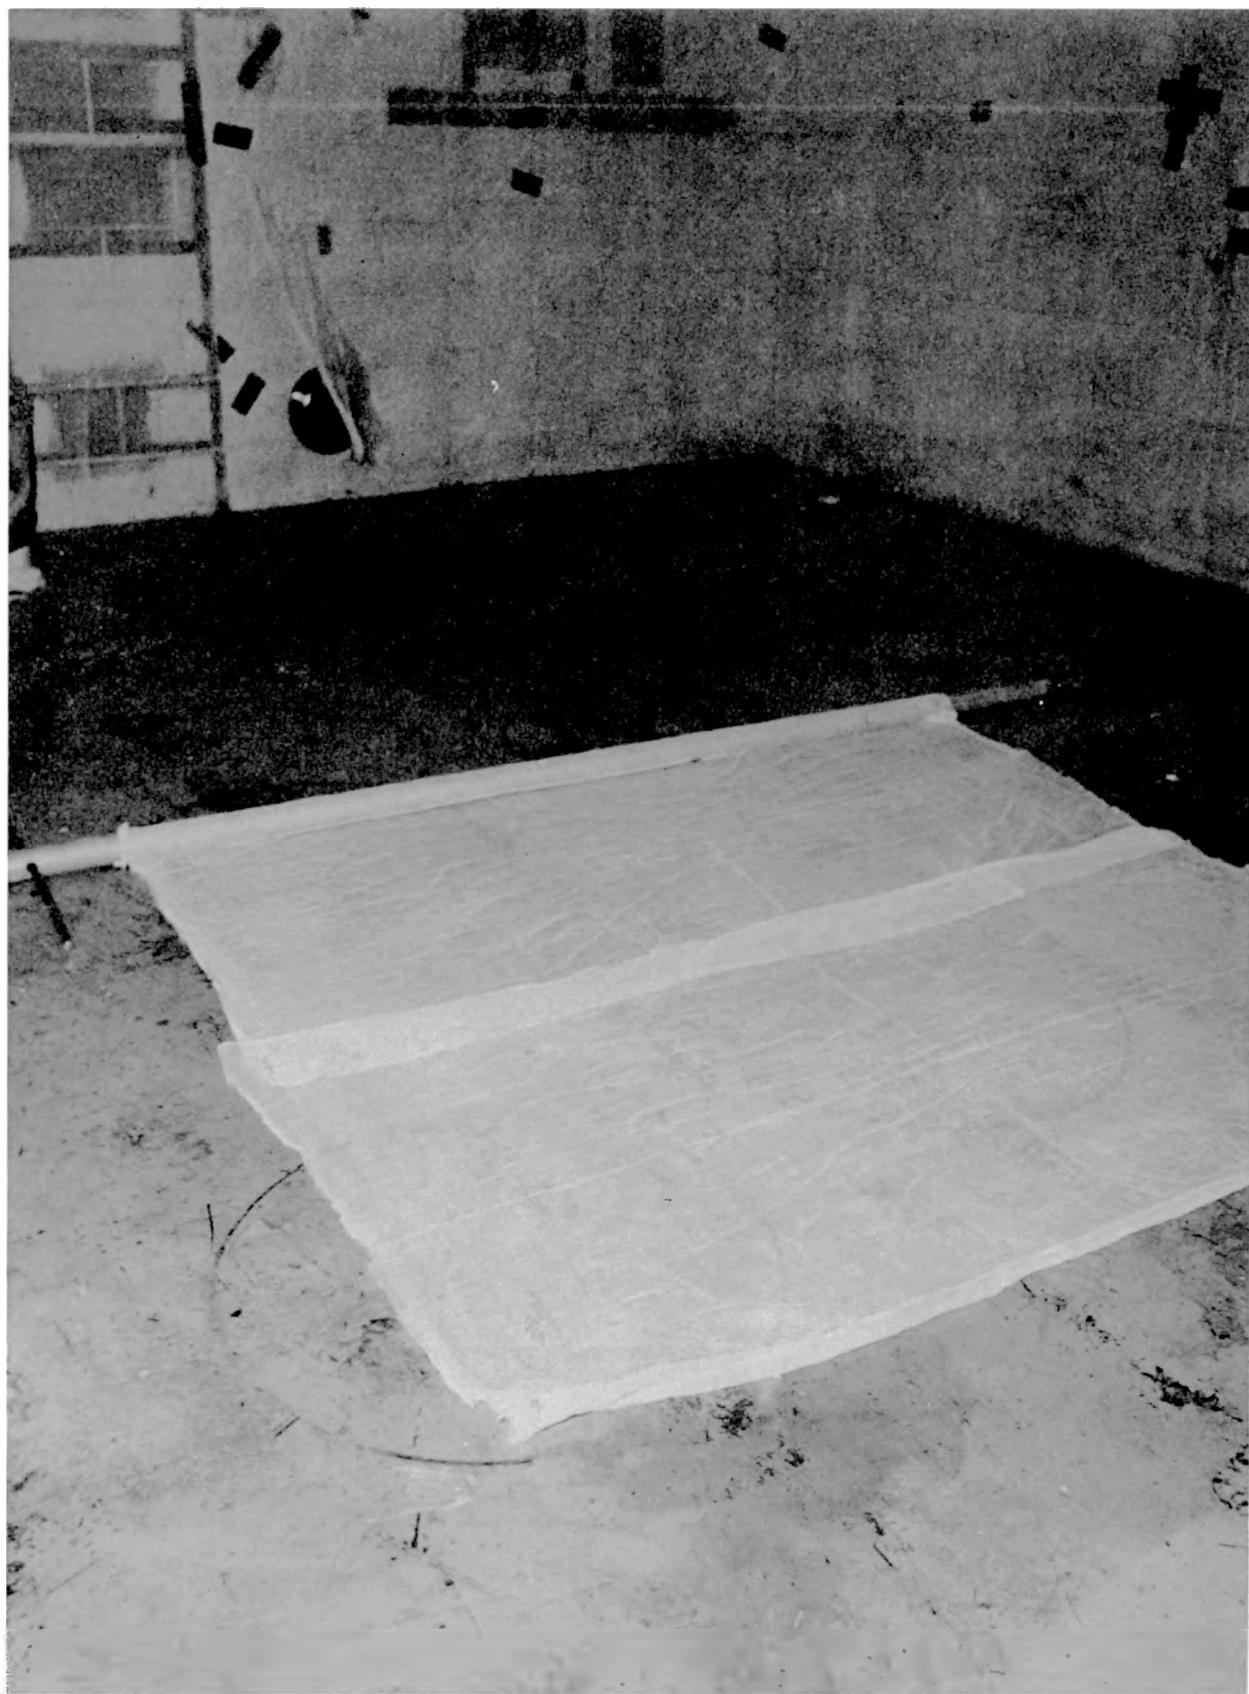
FIGURE 12. Cheese Cloth and Pipe Assembly for Decontamination of Difficult Access Areas in the 303-C Building

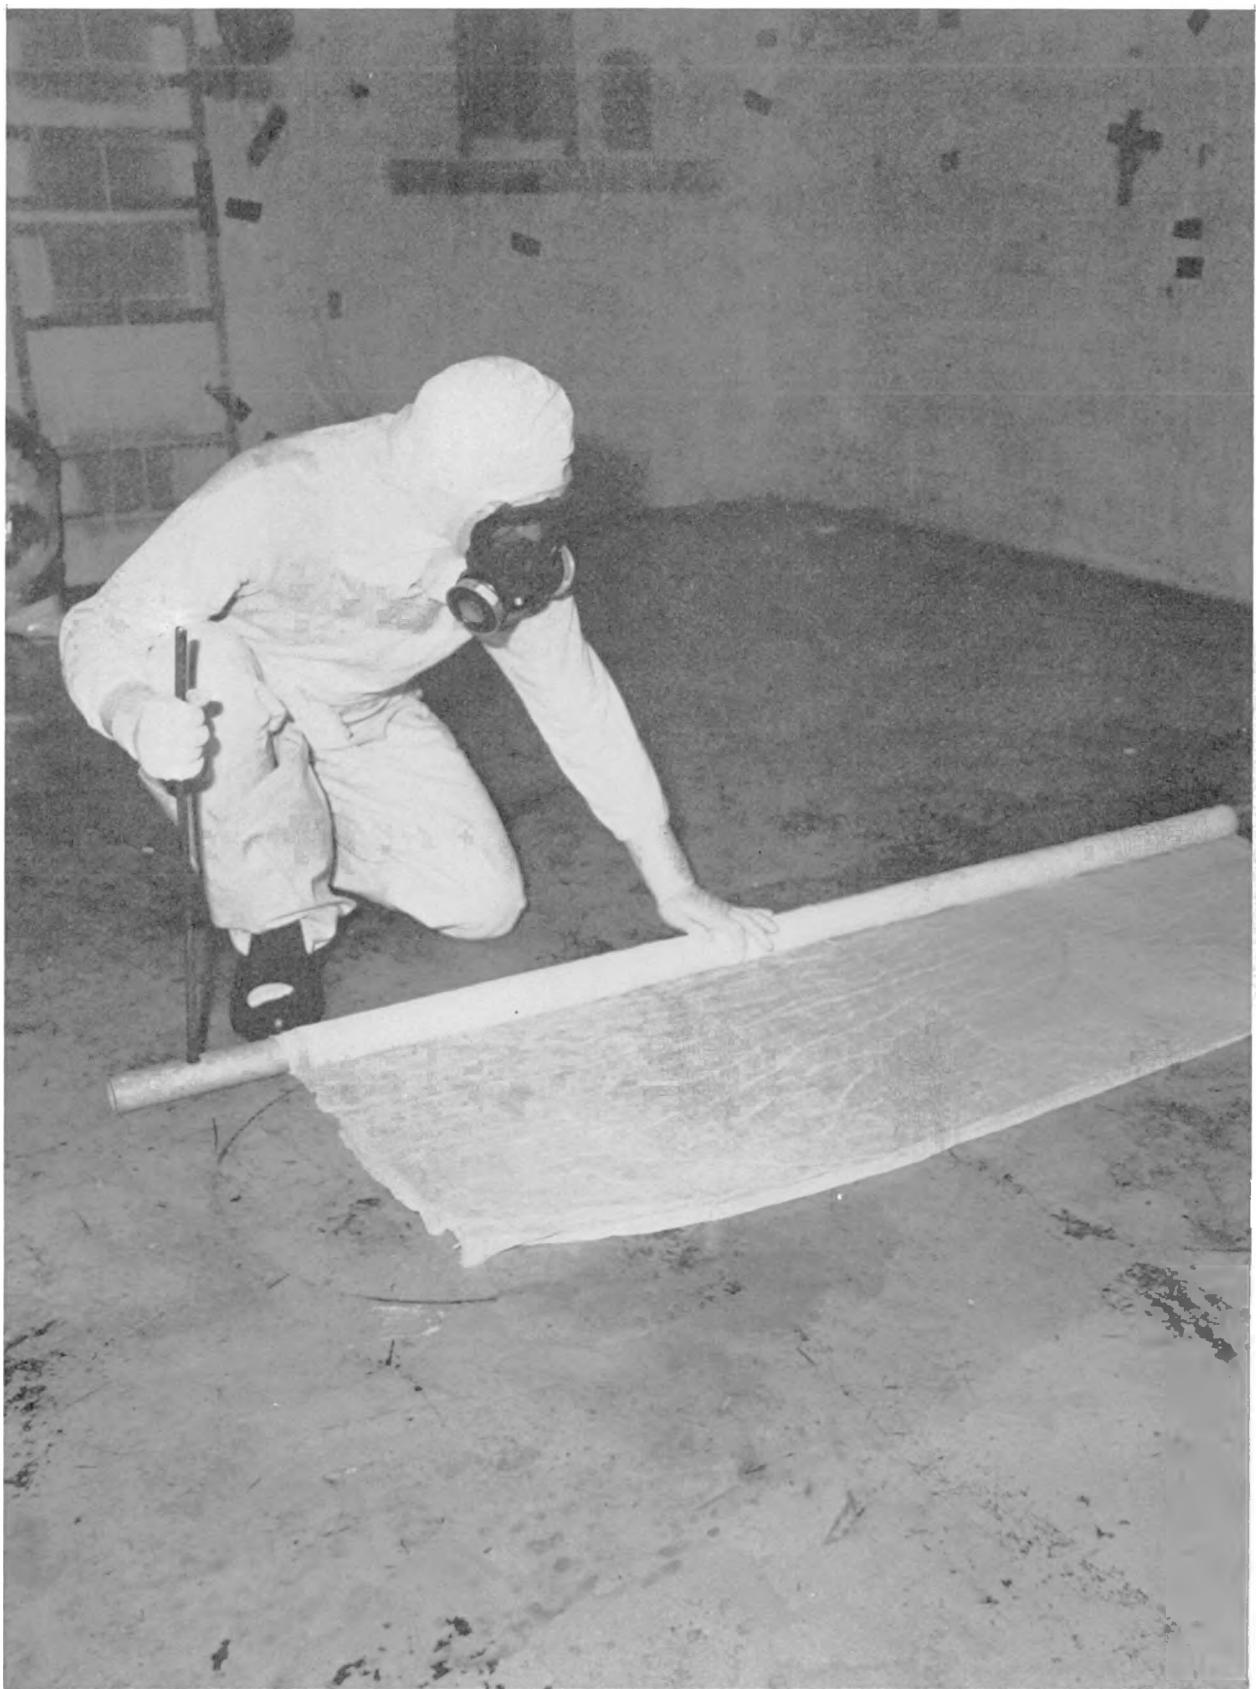
FIGURE 13. Preparation of Cheese Cloth-Strip Coat Decontamination Technique Assembly

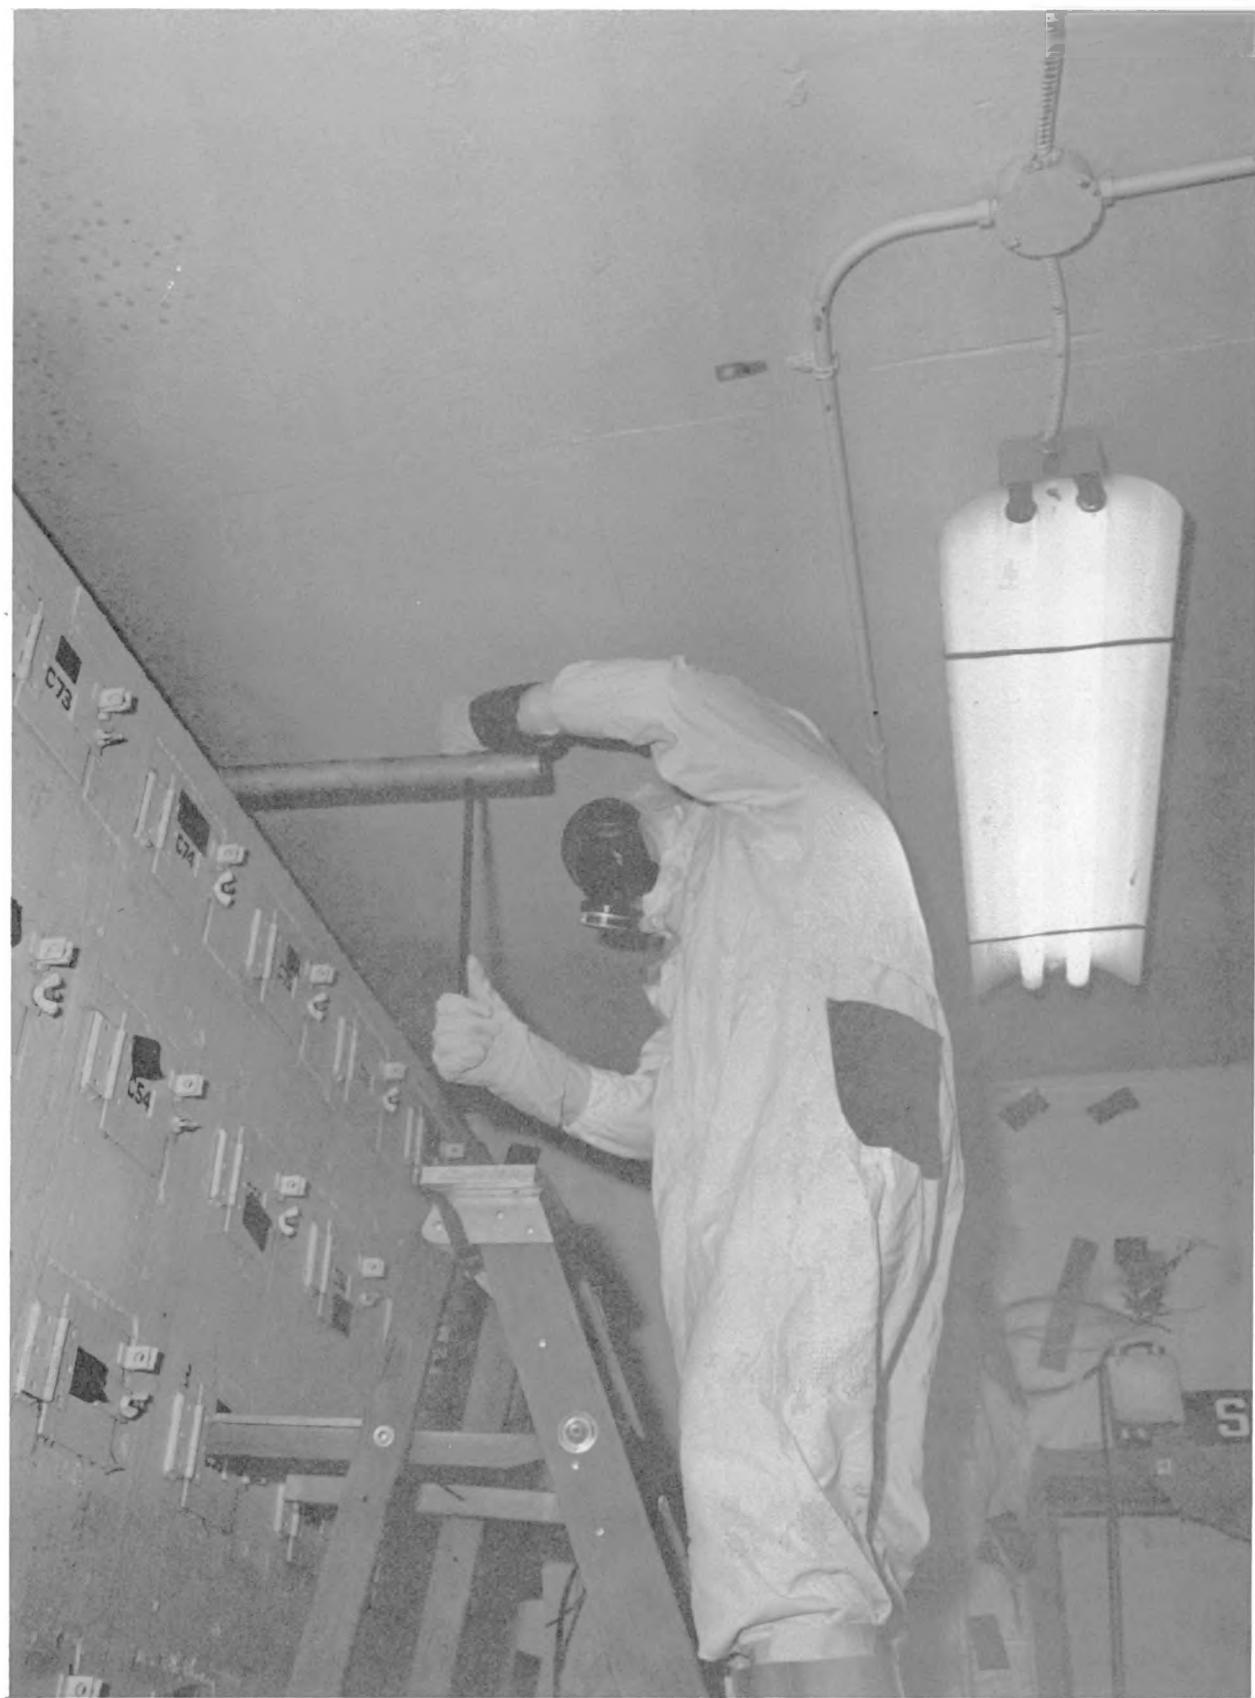
FIGURE 14. Application of Cheese Cloth-Strip Coat Decontamination Technique in the 303-C Building

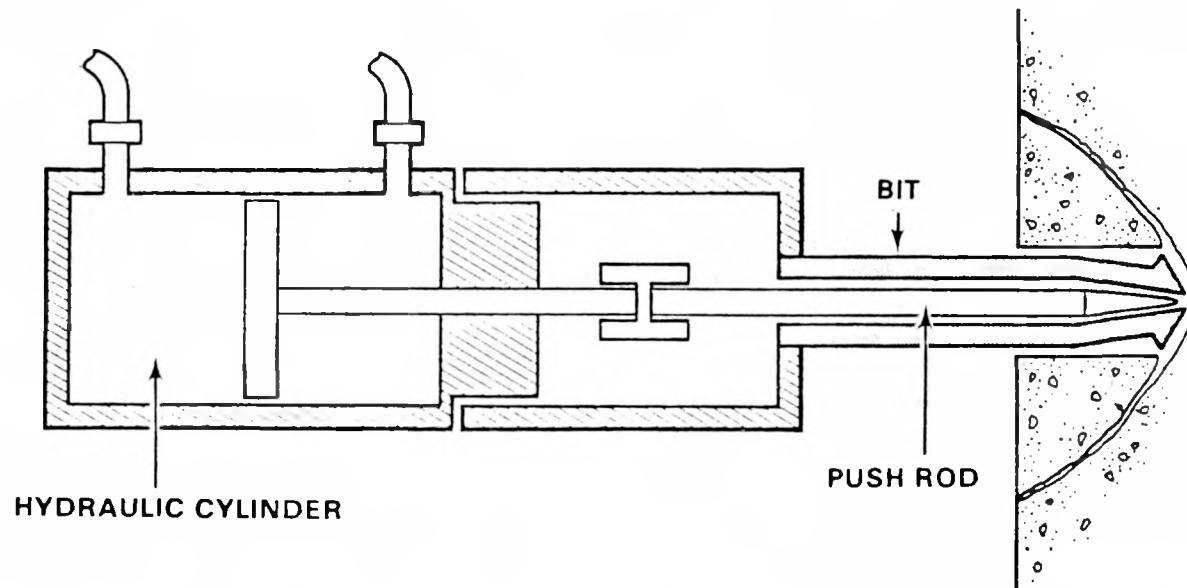
FIGURE 18. Concrete Spaller

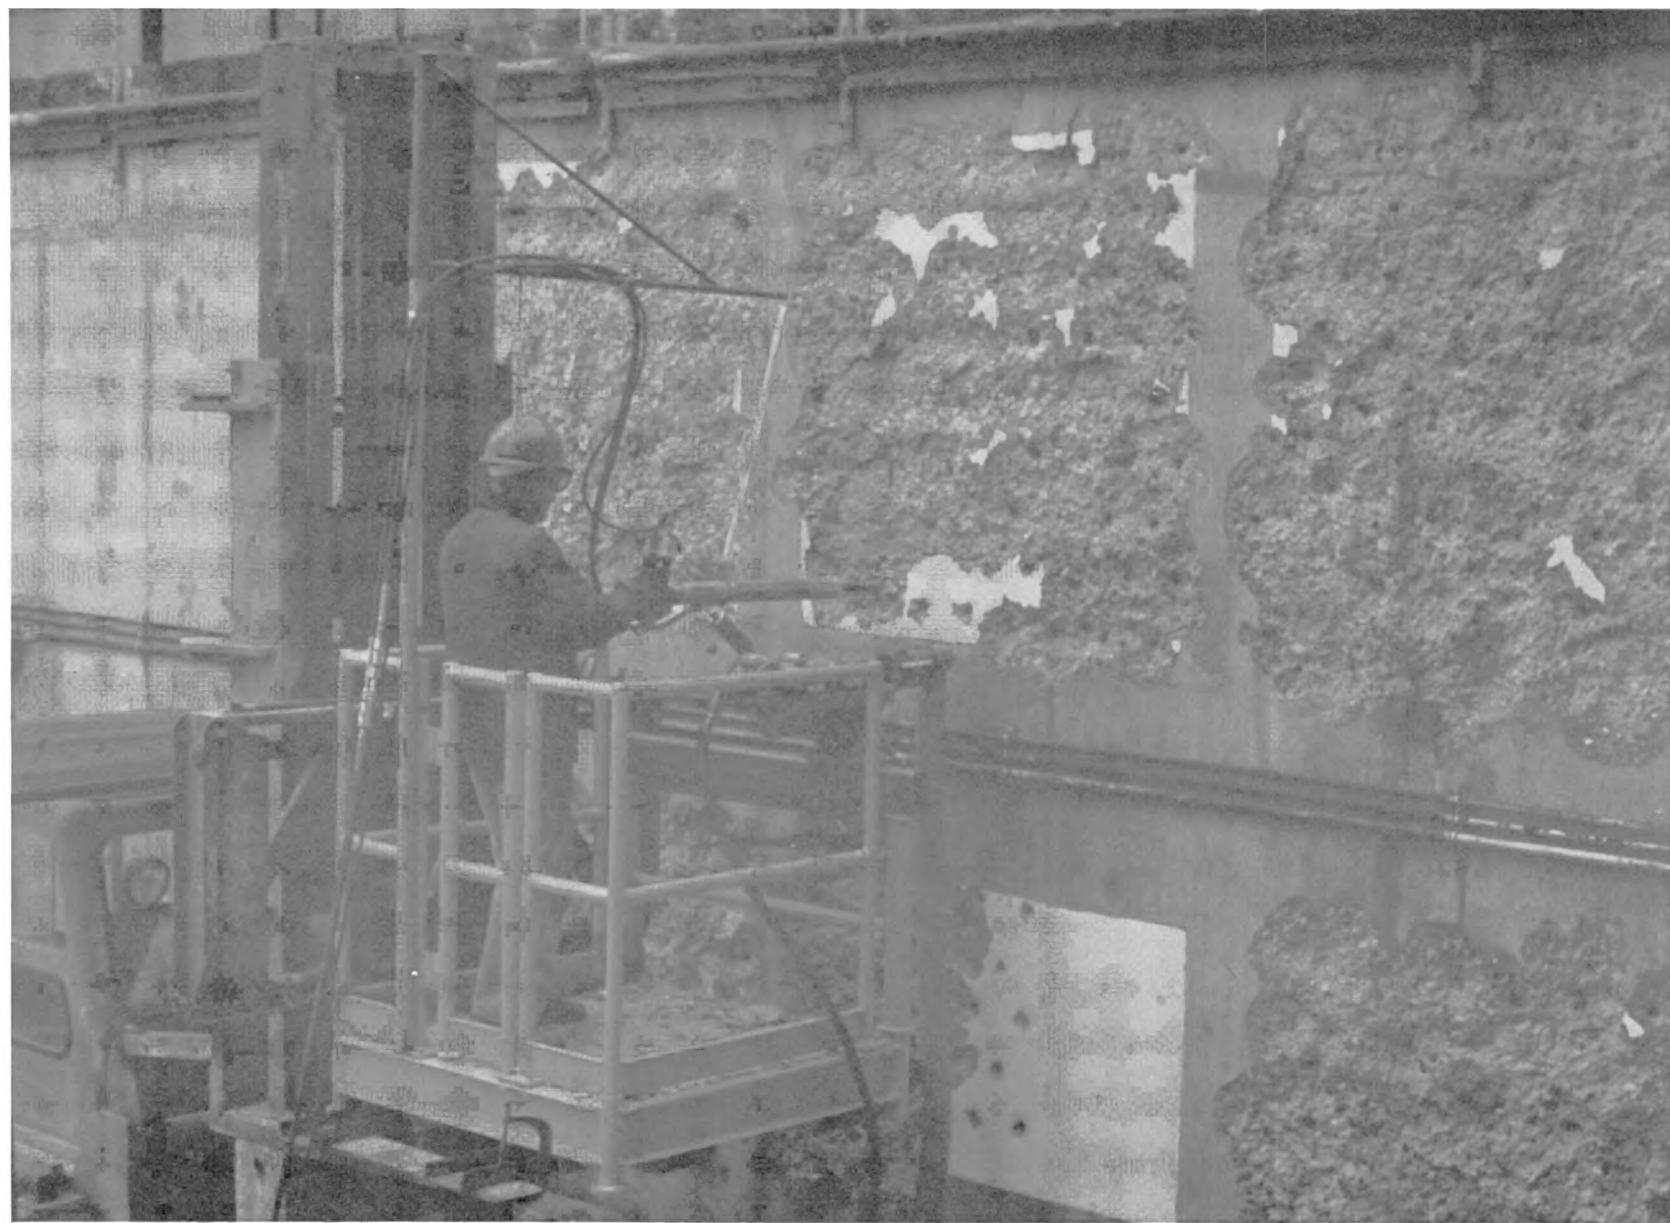
FIGURE 19. Example of the Concrete Spalling Technique Used in 303-C Building Decontamination

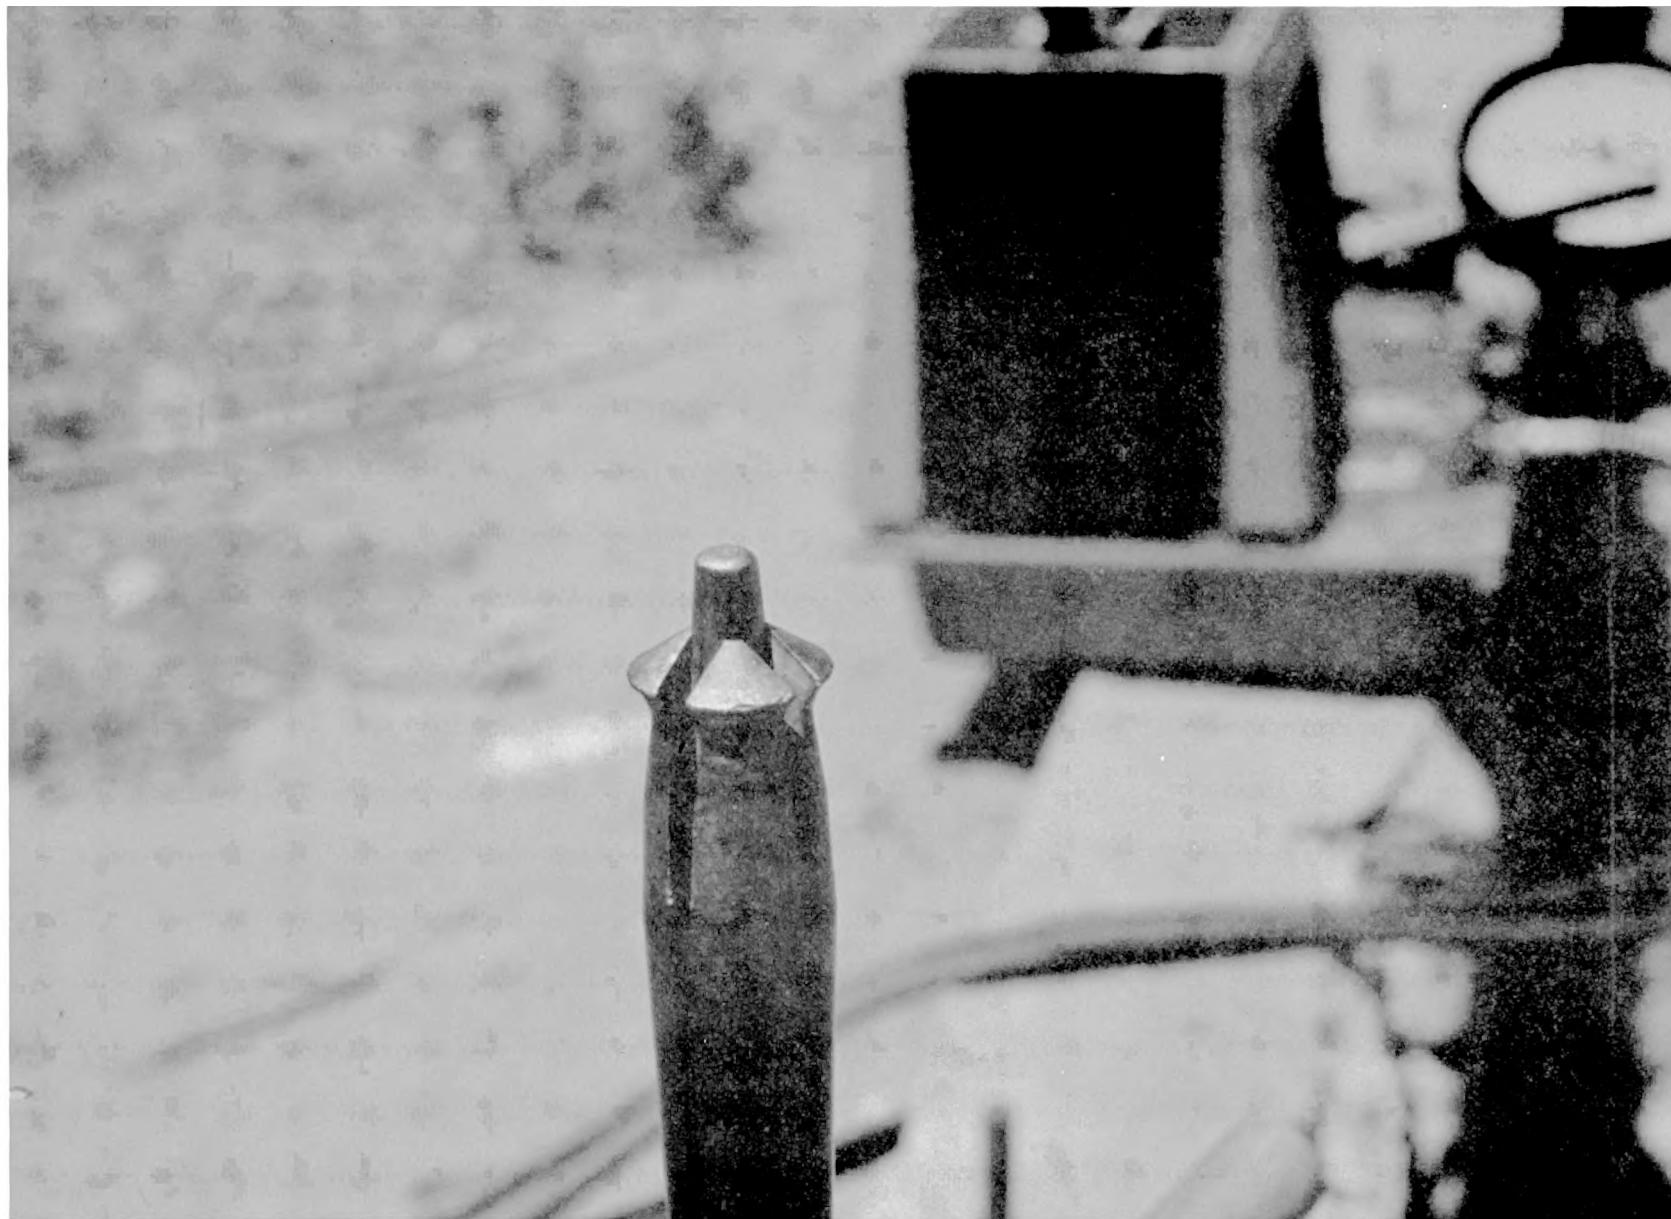
FIGURE 20. Expanding Bit Used in Concrete Spalling Technique

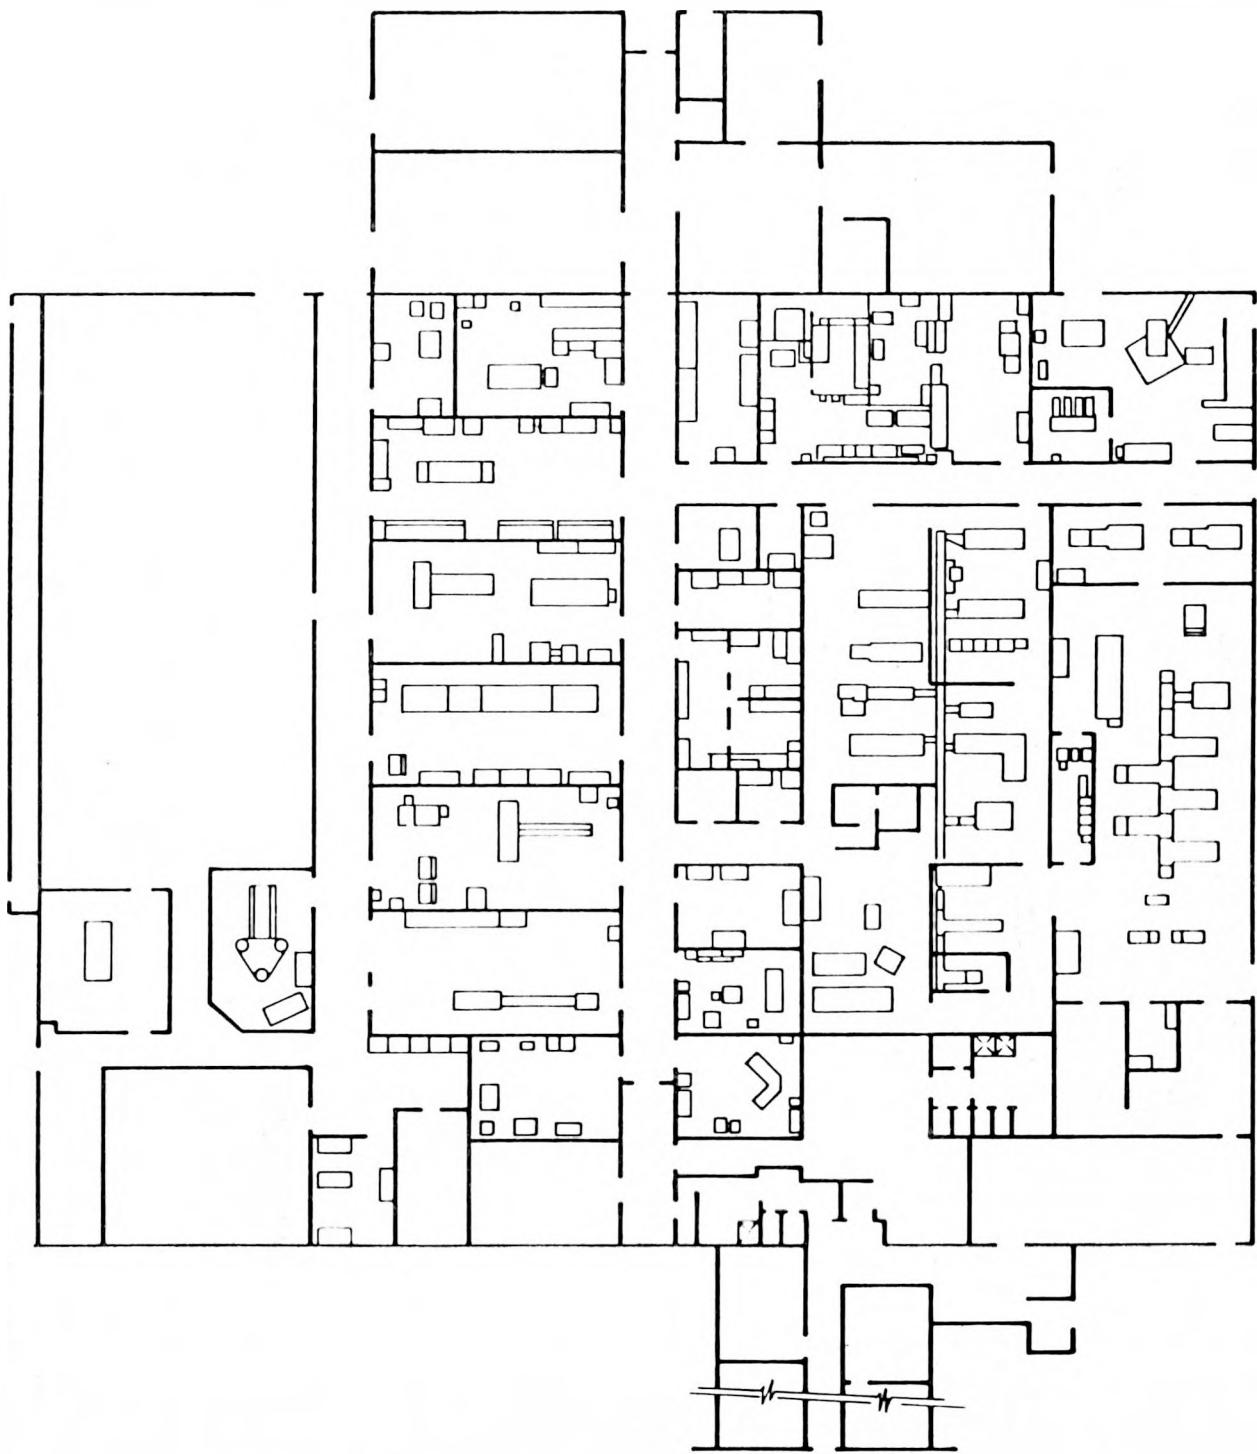
FIGURE 21. First Floor Arrangement of 231-Z Building

The second project involves, for those of you who are familiar with the Hanford project, the 231-Z building (Figure 21) in the 200 West area, a structure roughly 150 feet square. The facility had been in continuous operation

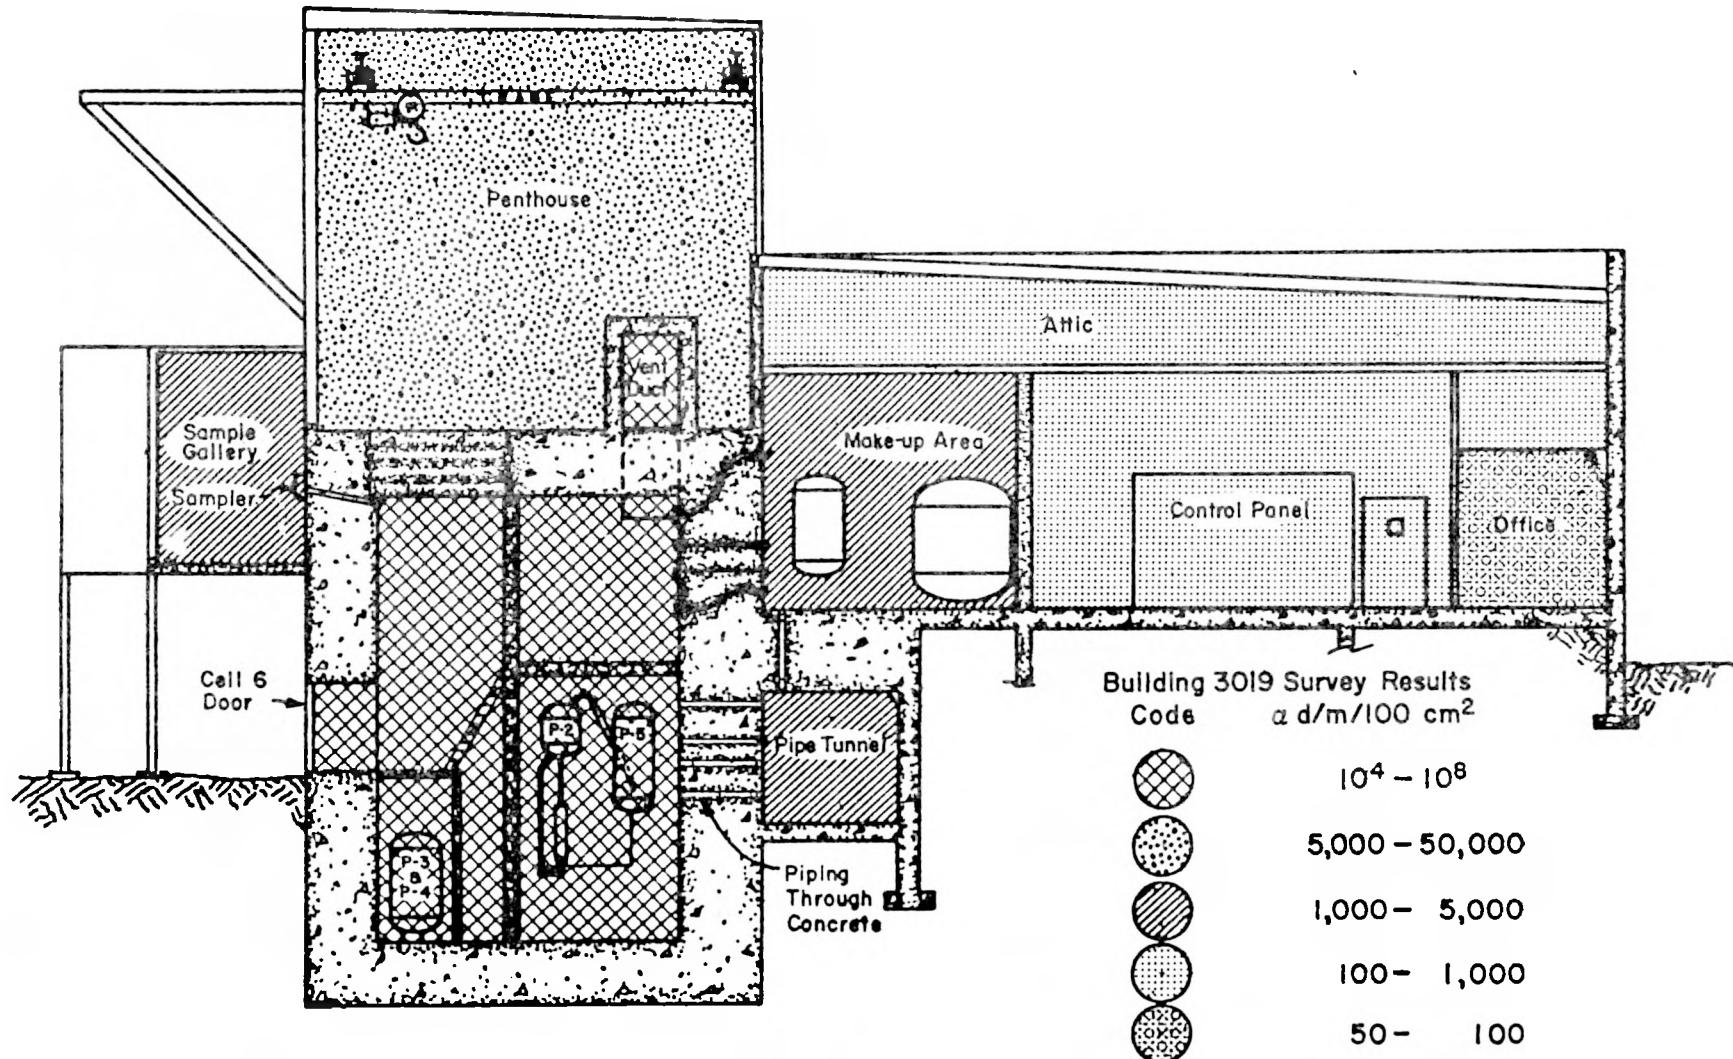
Fig. 1. Sectional elevation through cell 6, Radiochemical Processing Pilot Plant, showing inside contamination levels after explosion.

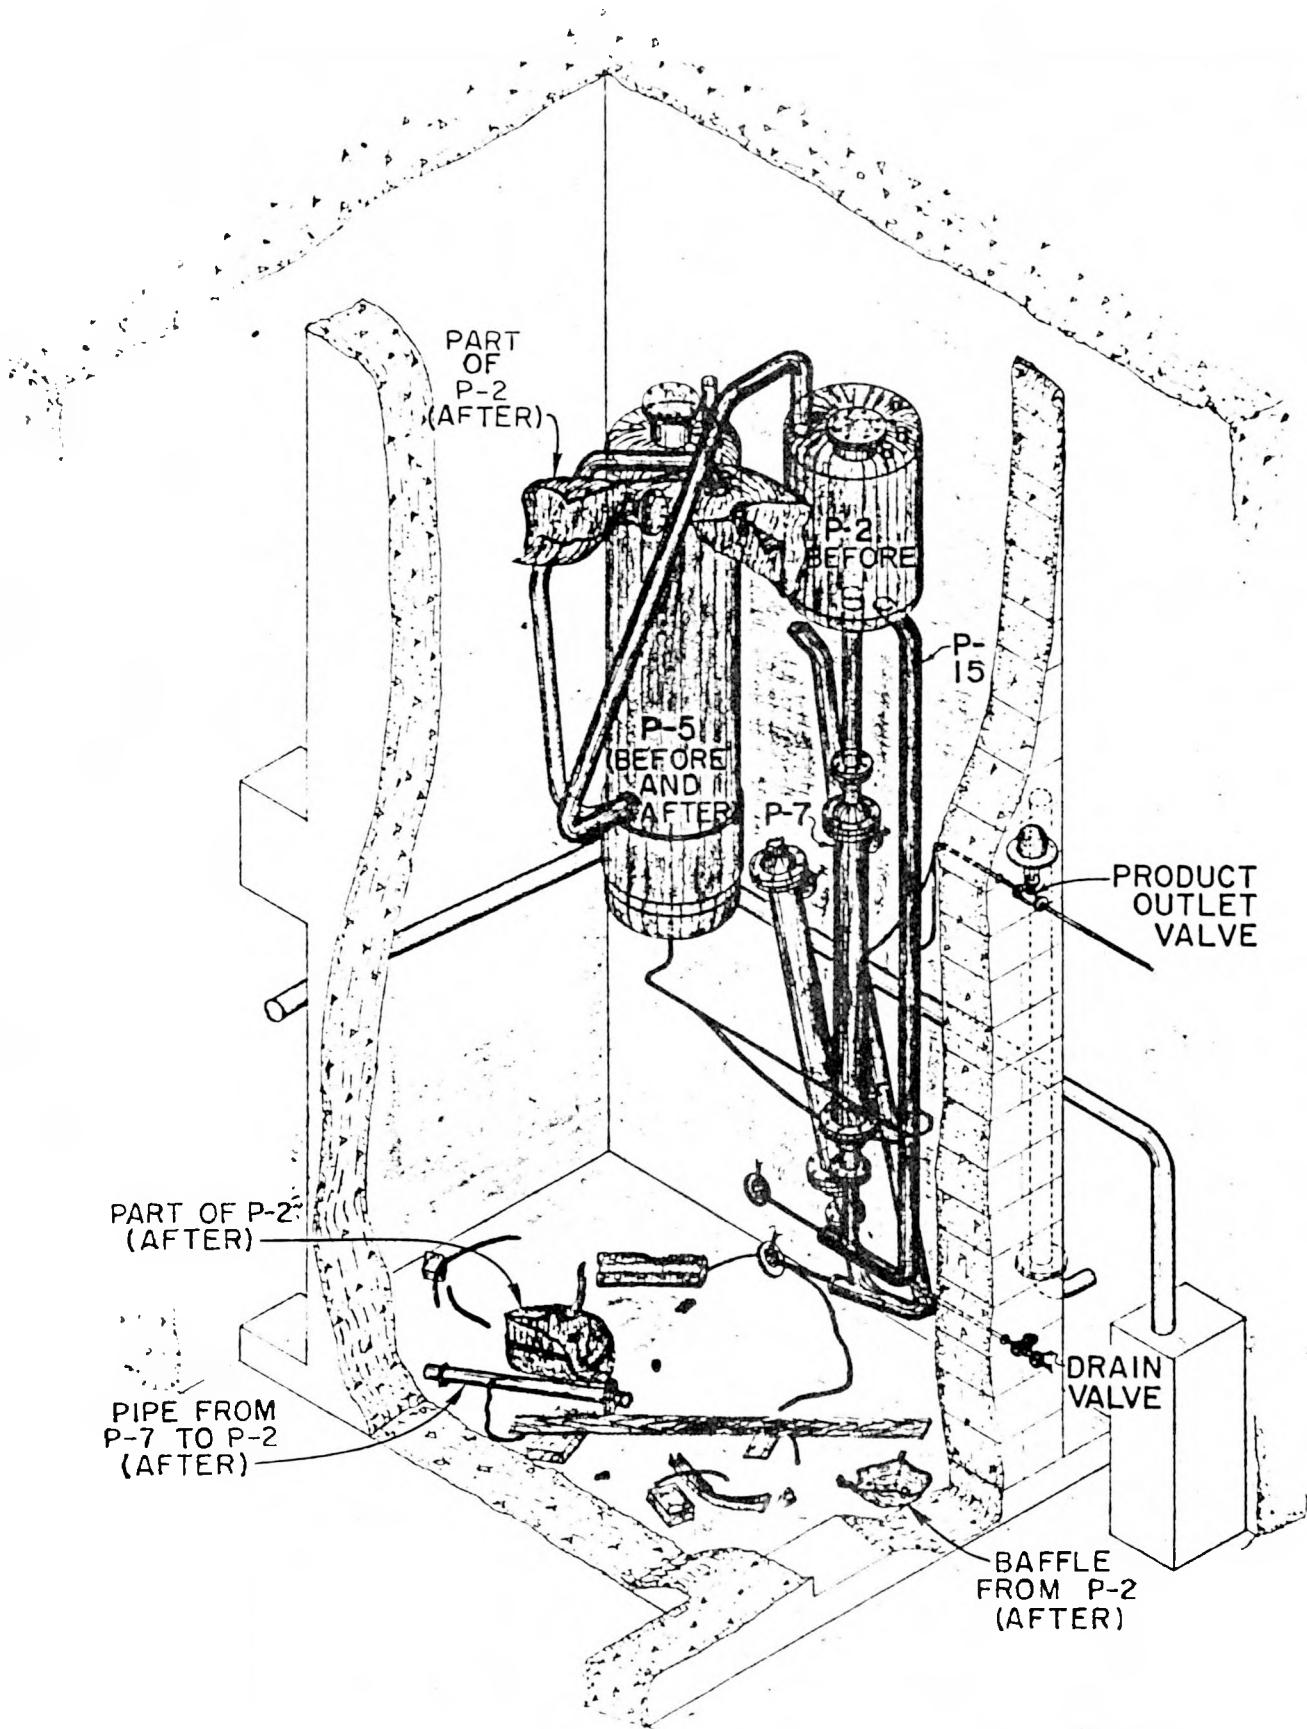
Fig. 2. Intercycle evaporator before and after explosion in Radiochemical Processing Pilot Plant.

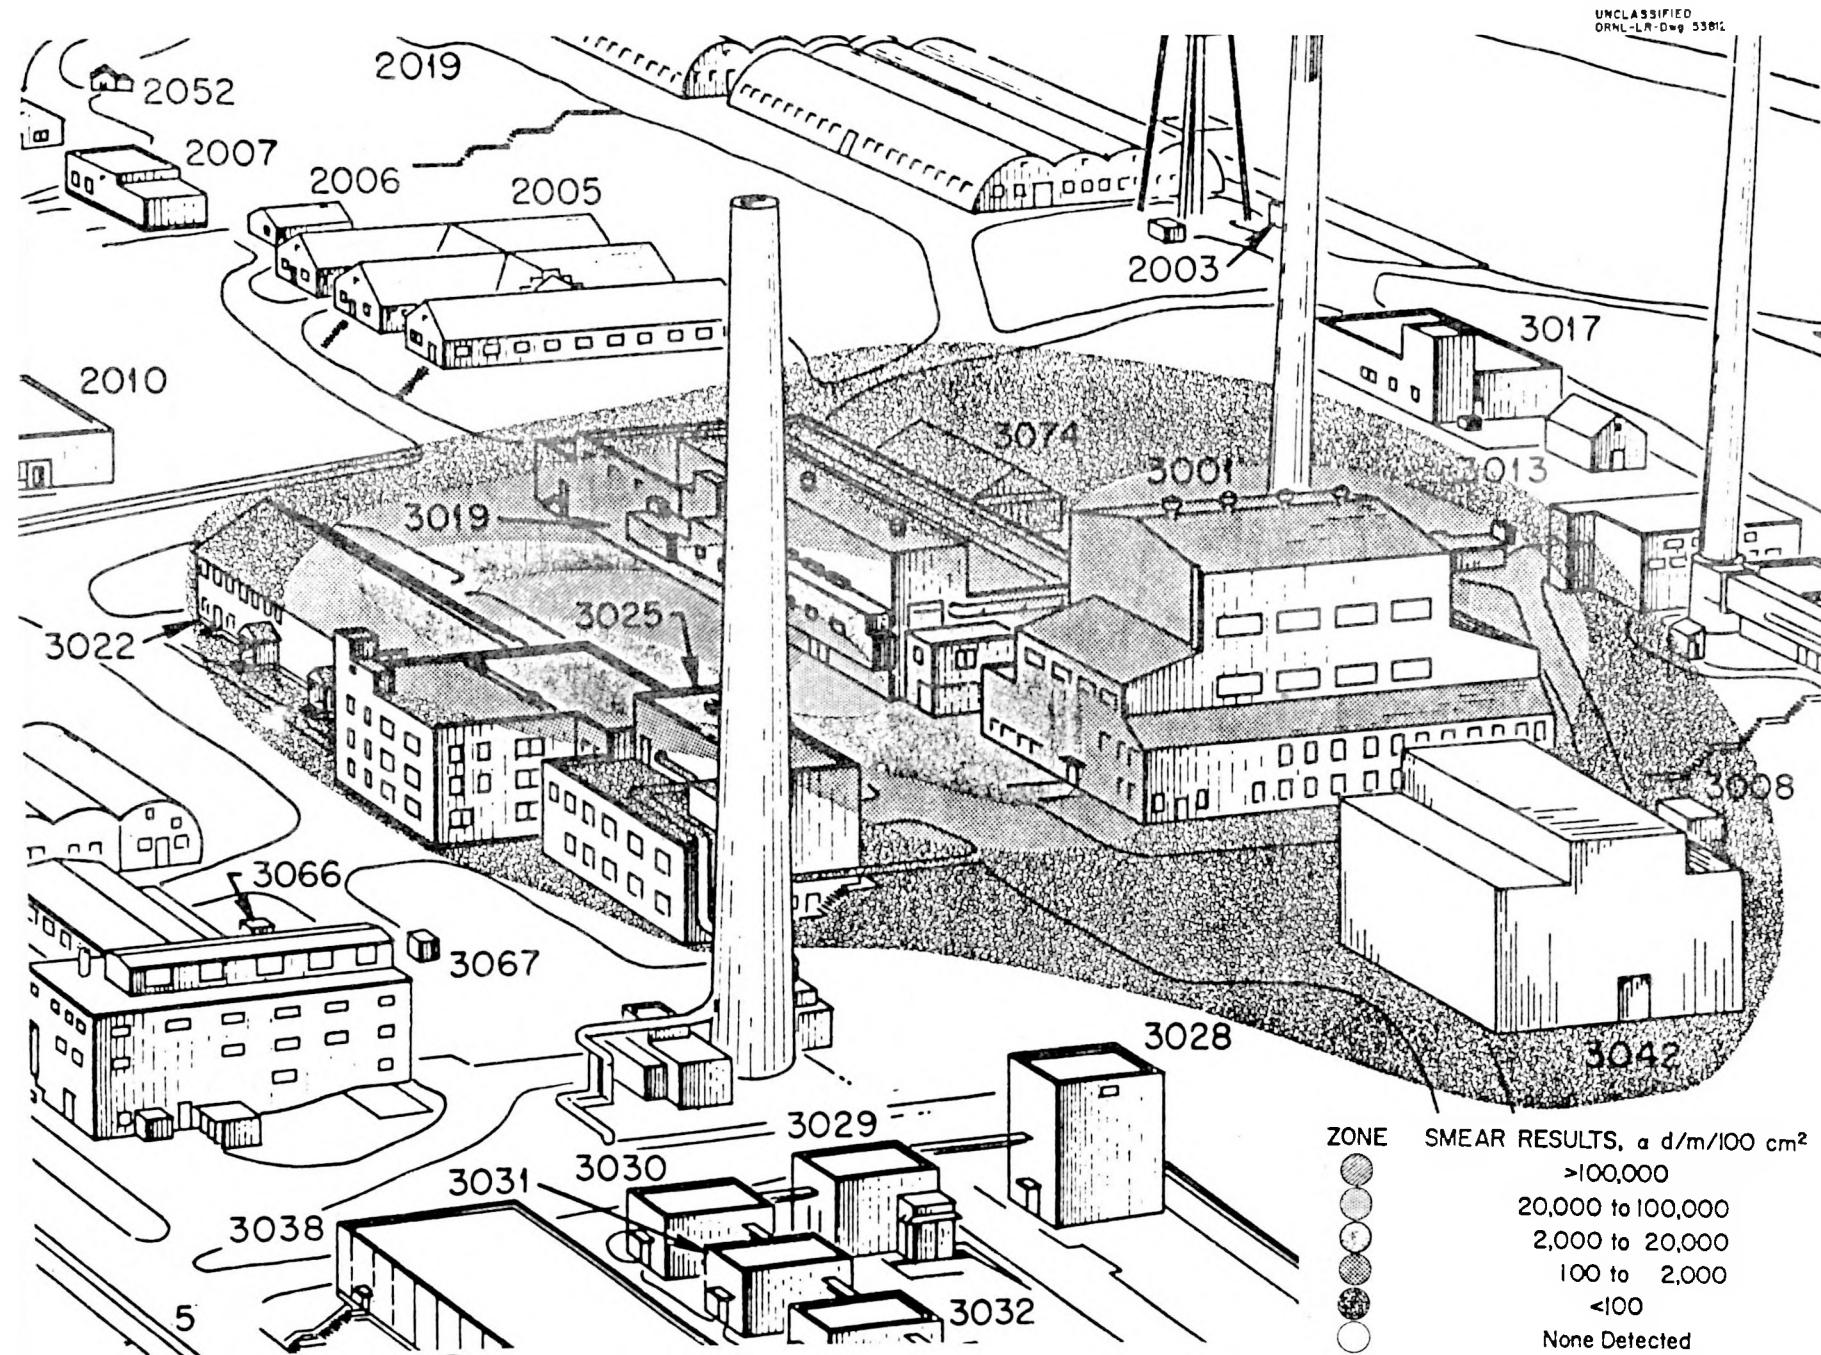
Fig. 3. Plutonium fallout after explosion in Radiochemical Processing Pilot Plant.
