Facility Decontamination Technology Workshop

November 27-29, 1979

Prepared for the
U.S. Department of Energy
Three Mile Island Operations Office
Under DOE Contract No. DE-AC07-76IDO1570

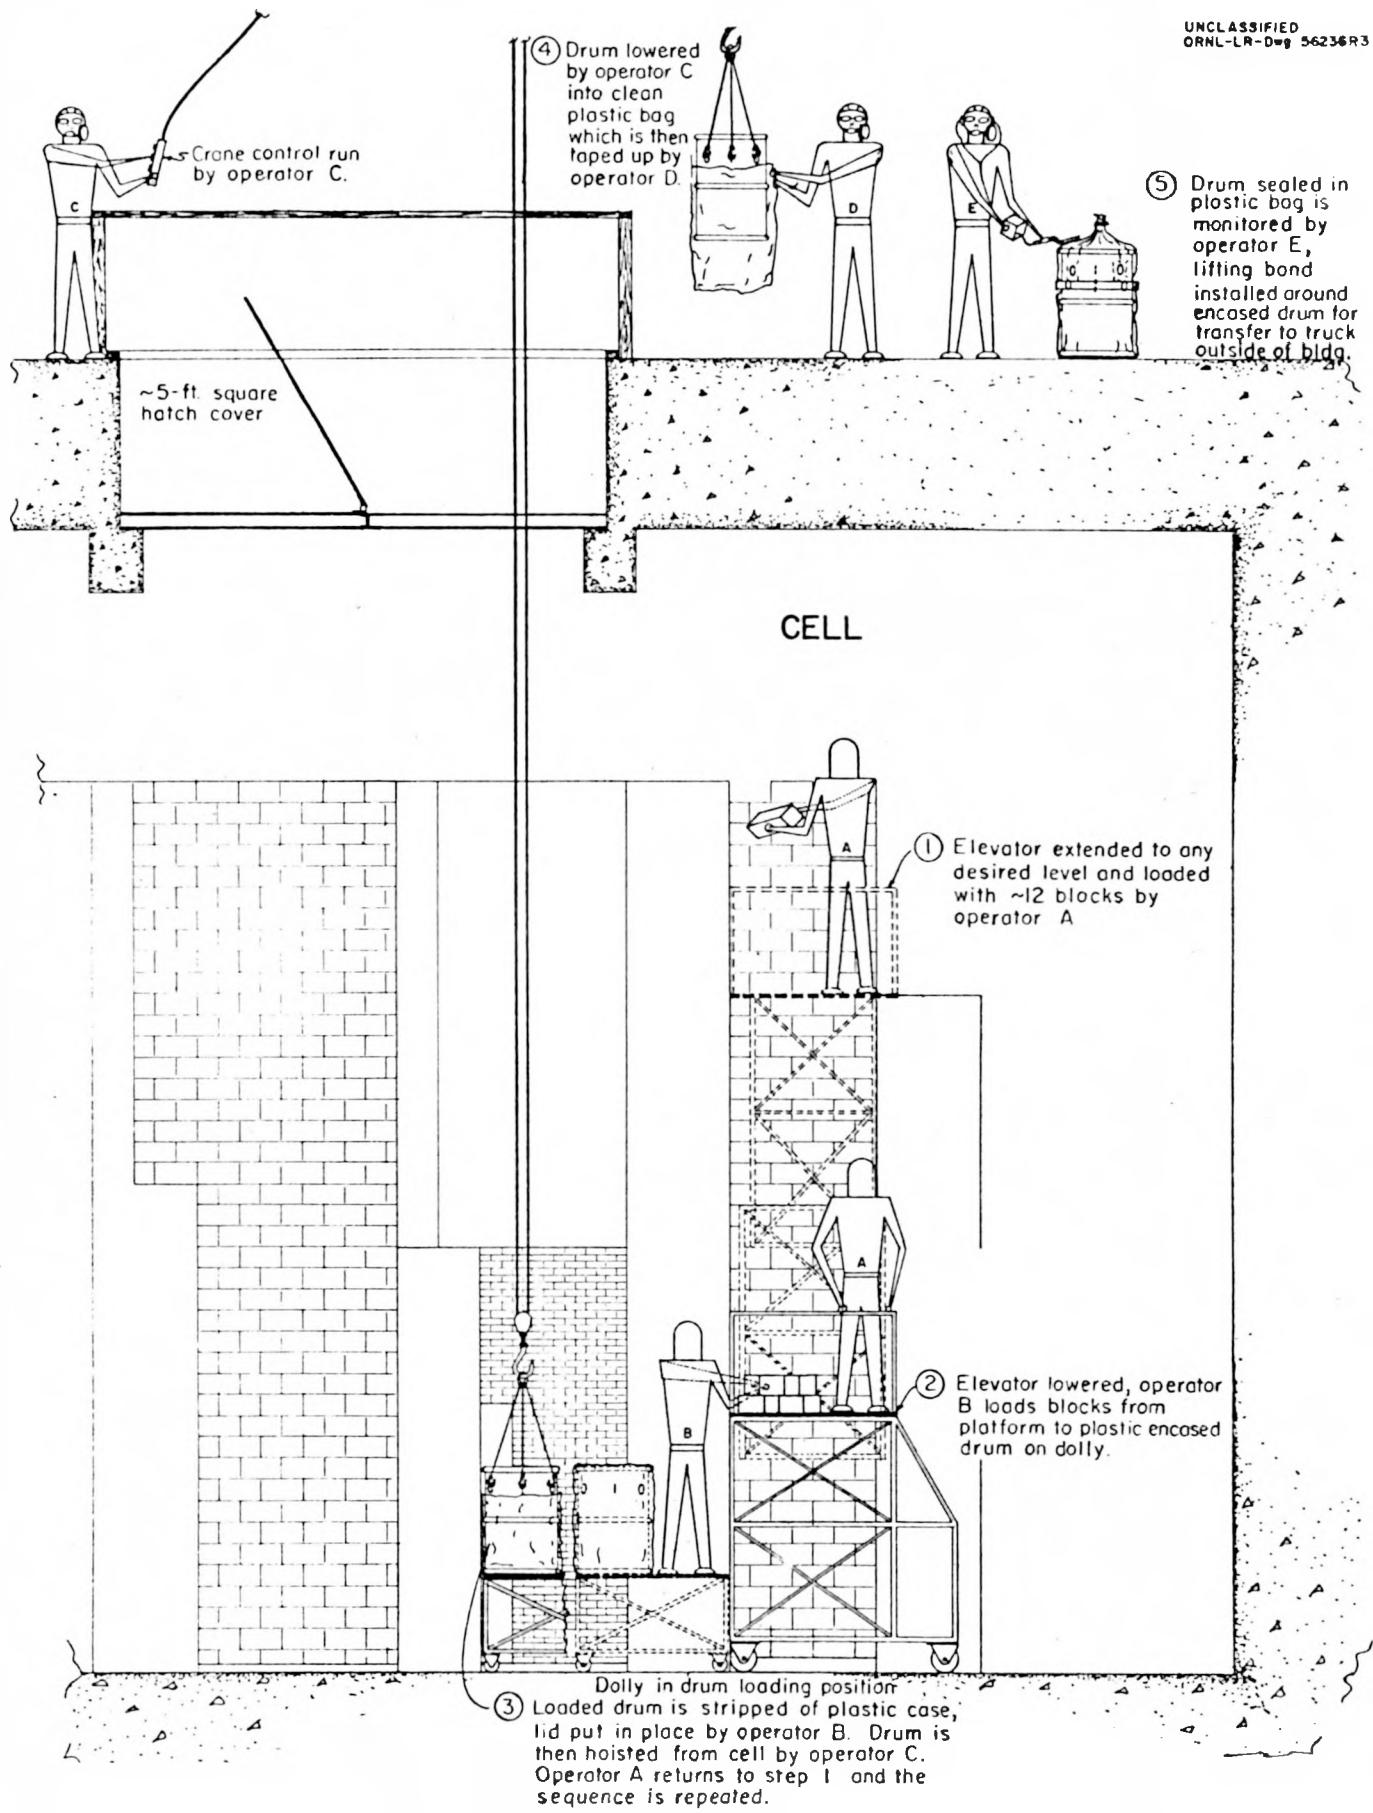
Fig. 4. Sequence of operations for removing contaminated concrete blocks from cells 6 and 7.

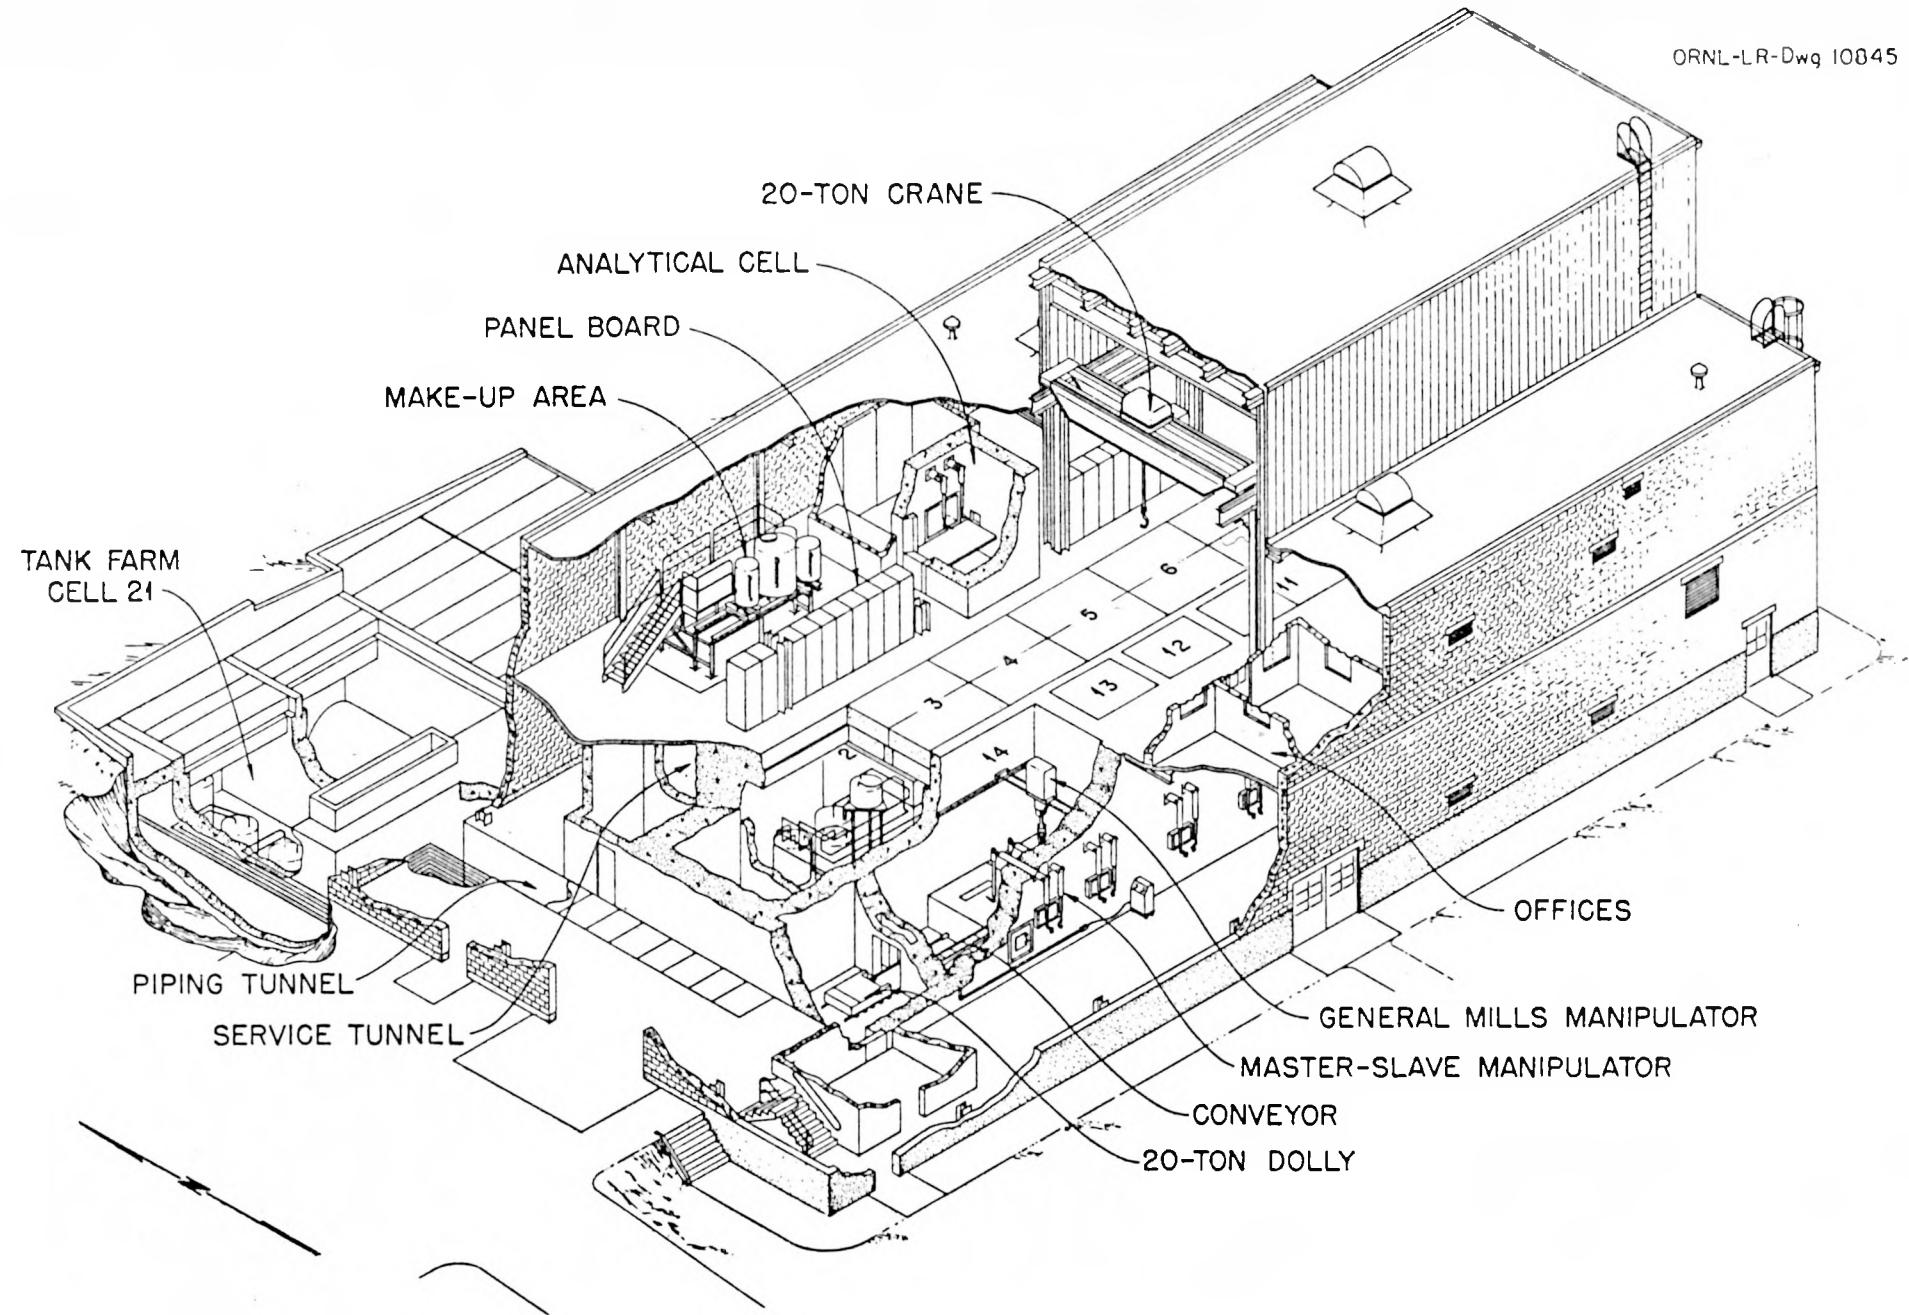
ORNL Dwg 79-19557A

Fig. 6. A schematic of the Multicurie Fission Products Pilot Plant at Oak Ridge National Laboratory.

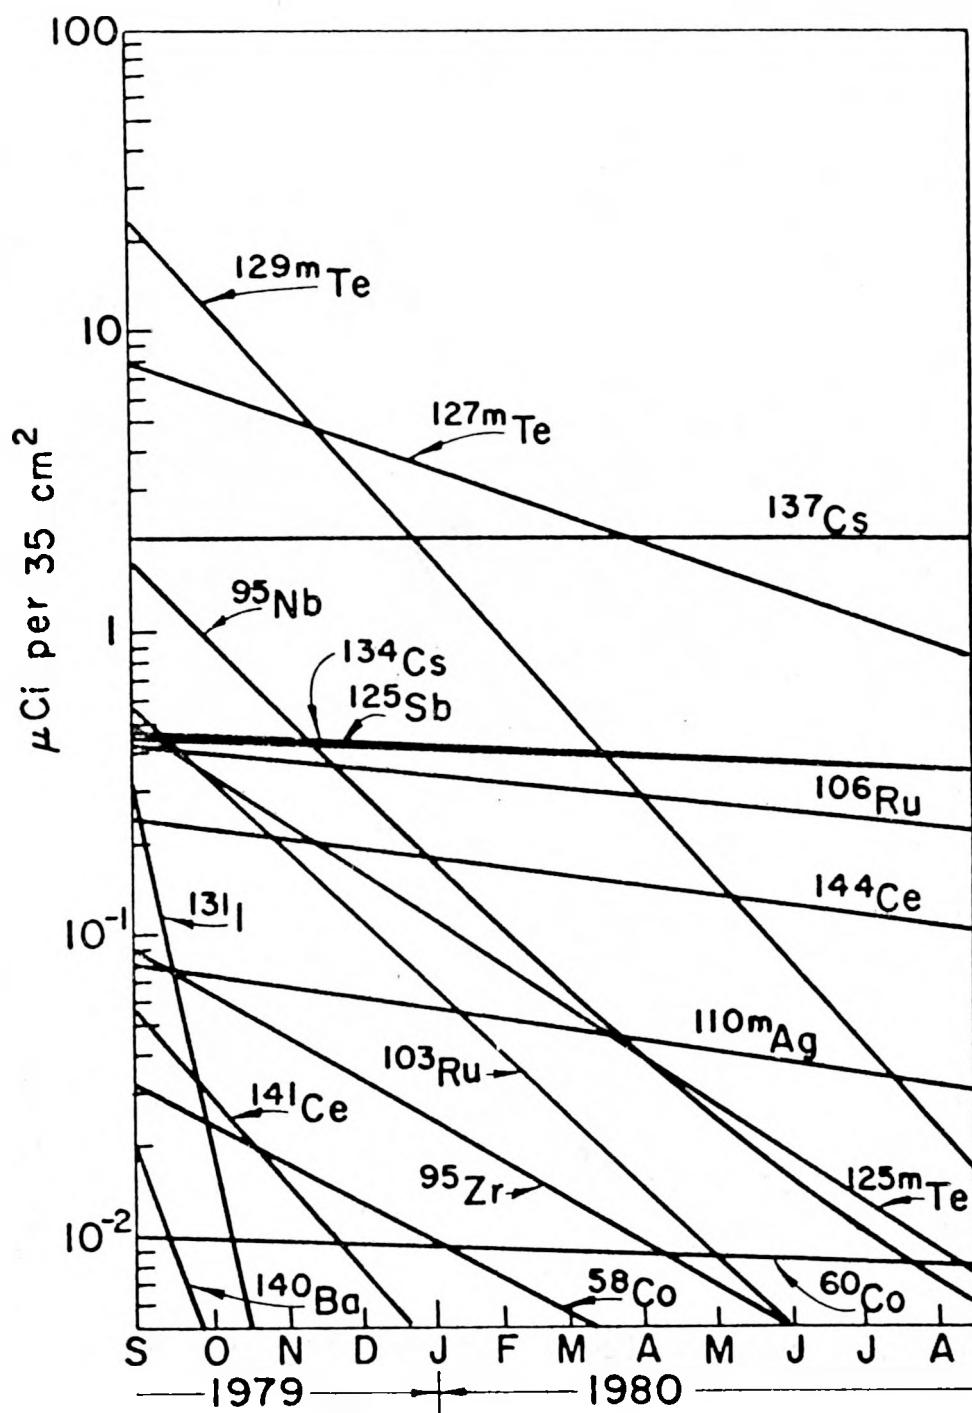
Fig. 8. Decay of radioelements on painted steel containment wall.

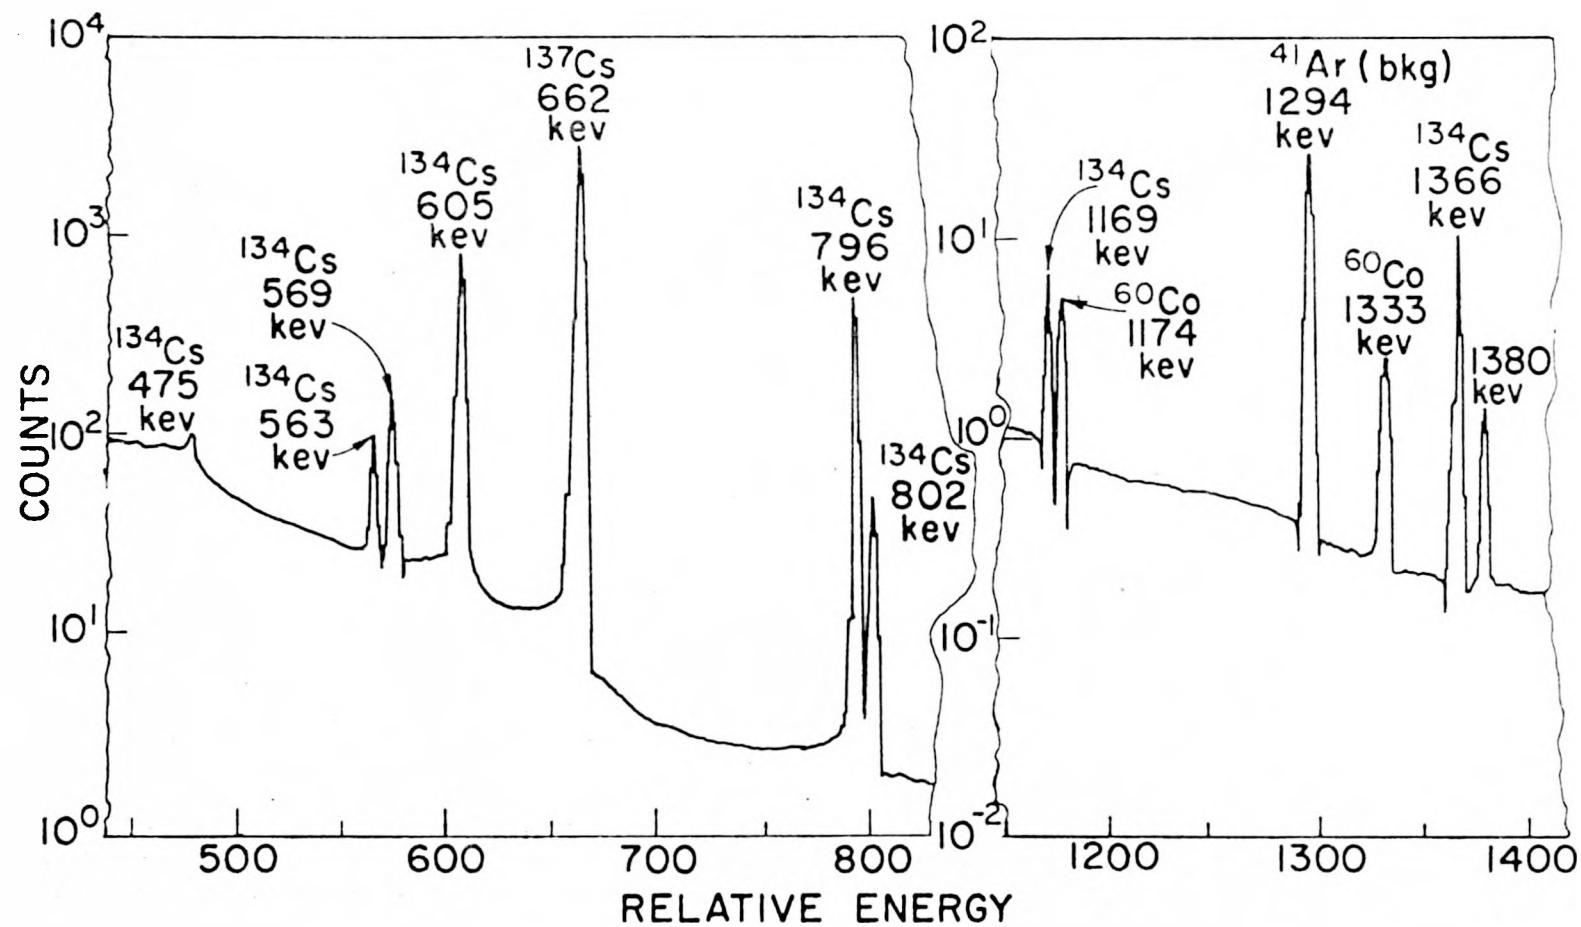
Fig. 9. Preliminary relative gamma scan of segment from TMI-R626 penetration.

Finally, the preliminary gamma scan of the 9-in. "cookie" recently removed from TMI-R626 penetration is presented (Fig. 9) for comparison purposes.

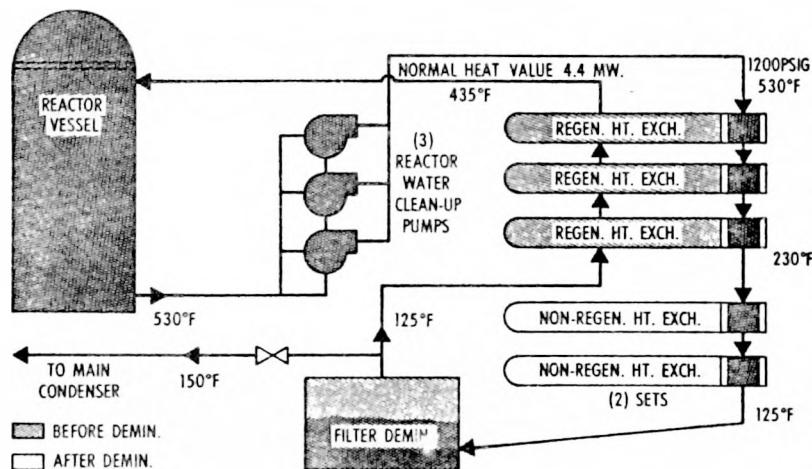
FIG. 1

PEACH BOTTOM UNITS 2&3
REACTOR WATER CLEAN-UP SYSTEM

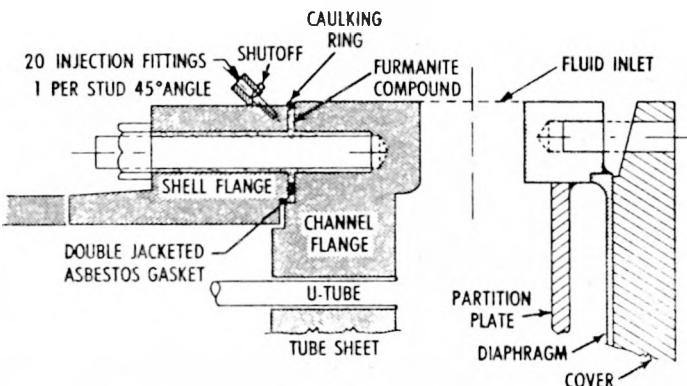
FIG. 2

**PEACH BOTTOM UNITS 2 & 3
REGENERATIVE HEAT EXCHANGER
INJECTION OF SHELL TO CHANNEL JOINT
WITH FURMANITE**

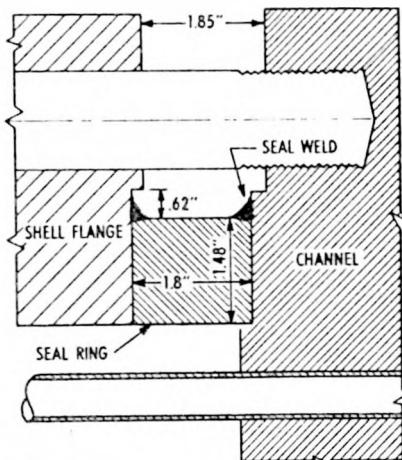
FIG. 4

PHILADELPHIA ELECTRIC COMPANY
PEACH BOTTOM UNITS 2&3 REGENERATIVE HEAT EXCHANGER
SHELL TO CHANNEL JOINT REPAIR-USING SEAL RING

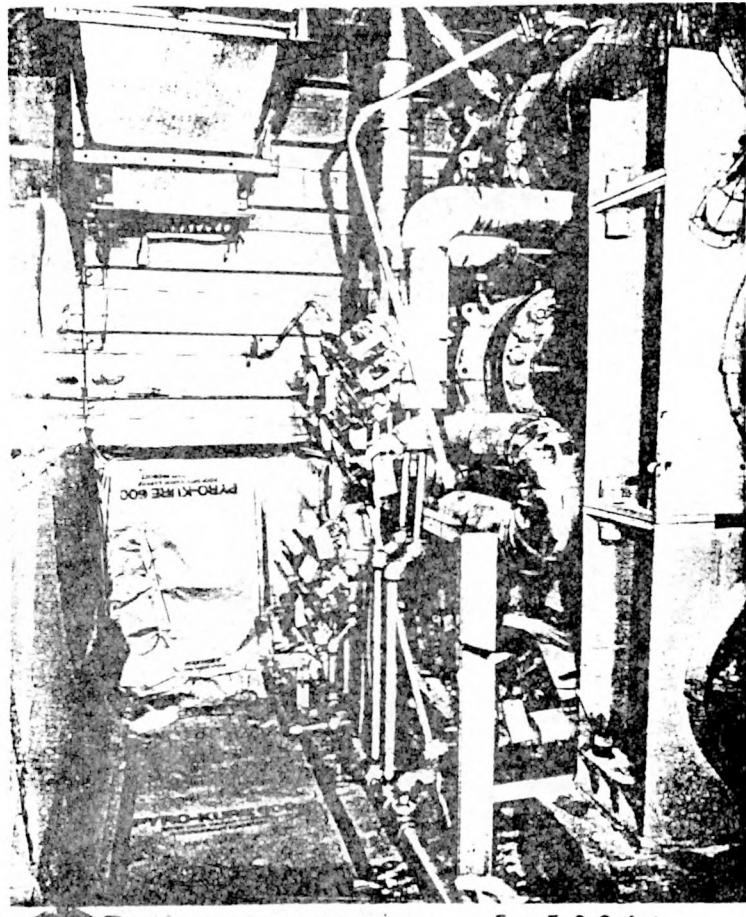
FIG. 7

Seal ring repairs consisted of removal of all vent and drain lines, relief valves, piping and piping supports. Shown on Figure 7 is one-half the piping.

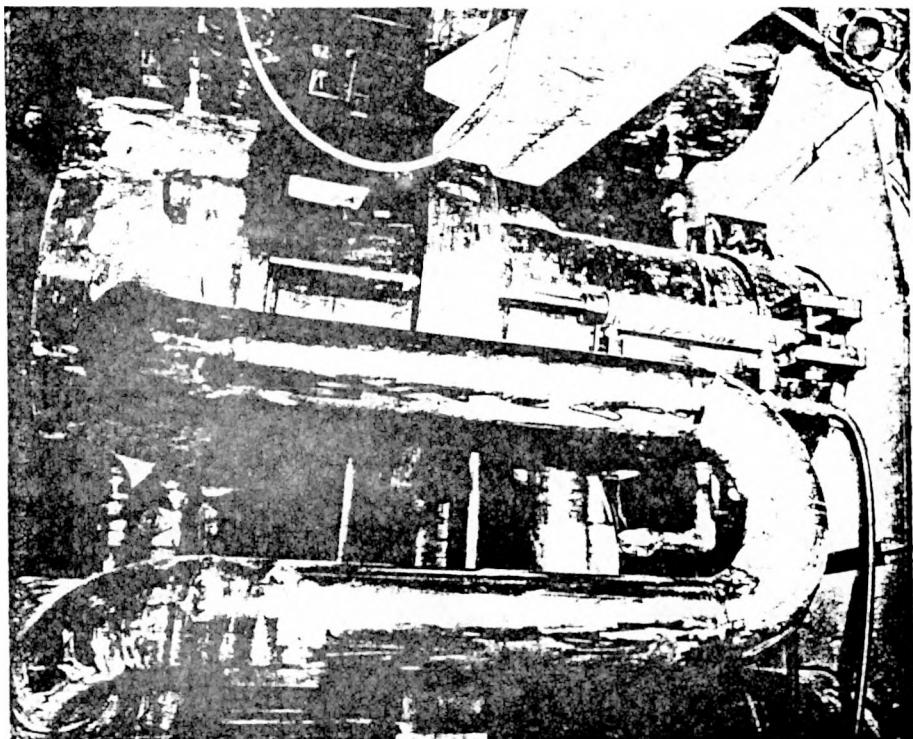
FIG. 9

A jacking assembly, consisting of a "T" beam fastened across the three channel heads and two 9 ton jacks, capable of jacking all three heat exchanger bundles (20,000 lbs.) apart simultaneously was utilized. This was done by mounting the jacking assembly around the middle shell and jacking the middle channel forward. Double acting jacks were used so that opening and closing operations could be performed with minimum set-up time. Jacking in this manner permitted repairs to be made without cutting the loop piping (2 loops) between heaters. The jacking collar and one jack is shown on Figure 9.

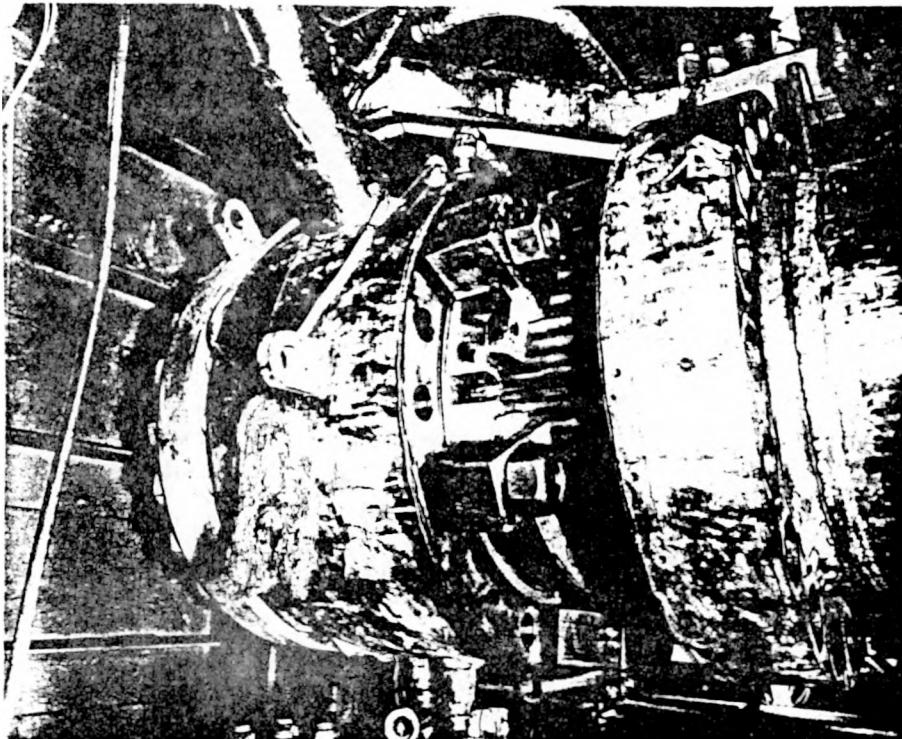
FIG. 10

Once the heaters were apart, split seal rings were mounted on each channel flange. A copper ring was temporarily used to protect the flange face. A stainless steel clamping ring with six clamps was used to prevent warpage during welding. See illustration in Figure 10.

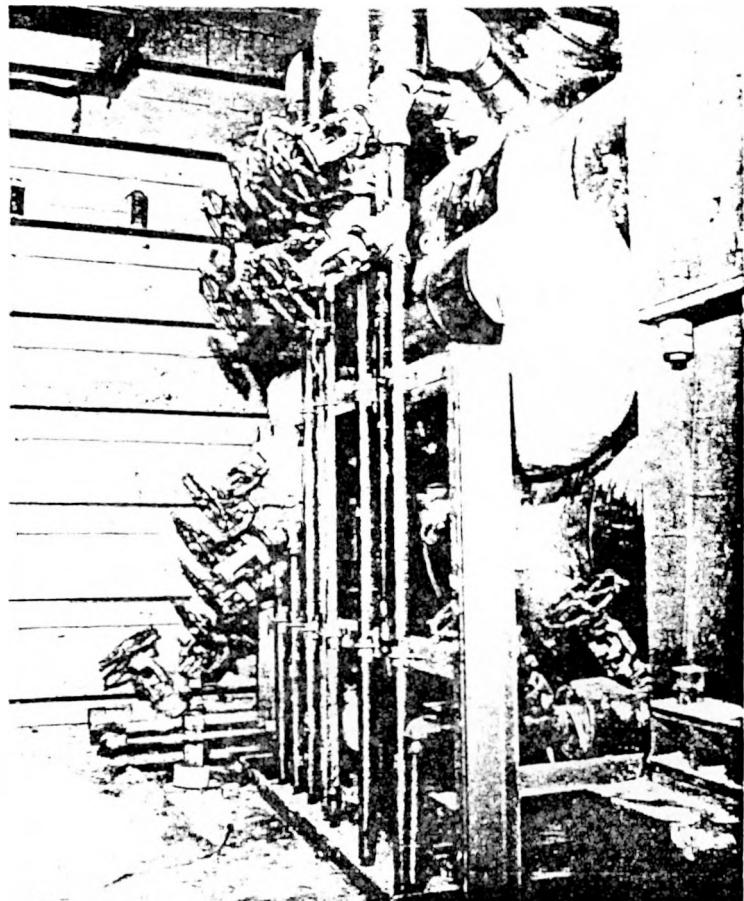
FIG. 13

Following completion of the job, all drain and vent piping was re-installed and insulated (See Figure 13). Approximately 40 shifts, utilizing 10 craftsmen/shift, were required for piping and insulation work. Repositioning of some of the piping was required to compensate for the 1-3/4" change in length caused by substituting a seal ring for a gasket. Prior to this, all valves (approximately 42) were repacked and repaired. Inspection of the tube sheet and channel boxes indicated all internal parts to be in good condition with the exception of an internal weld between the channel box and the channel pass cover which was cracked. This was repaired. Hydrostatic testing to 2180 PSIG was performed and performed and witnessed by an Insurance Inspector.

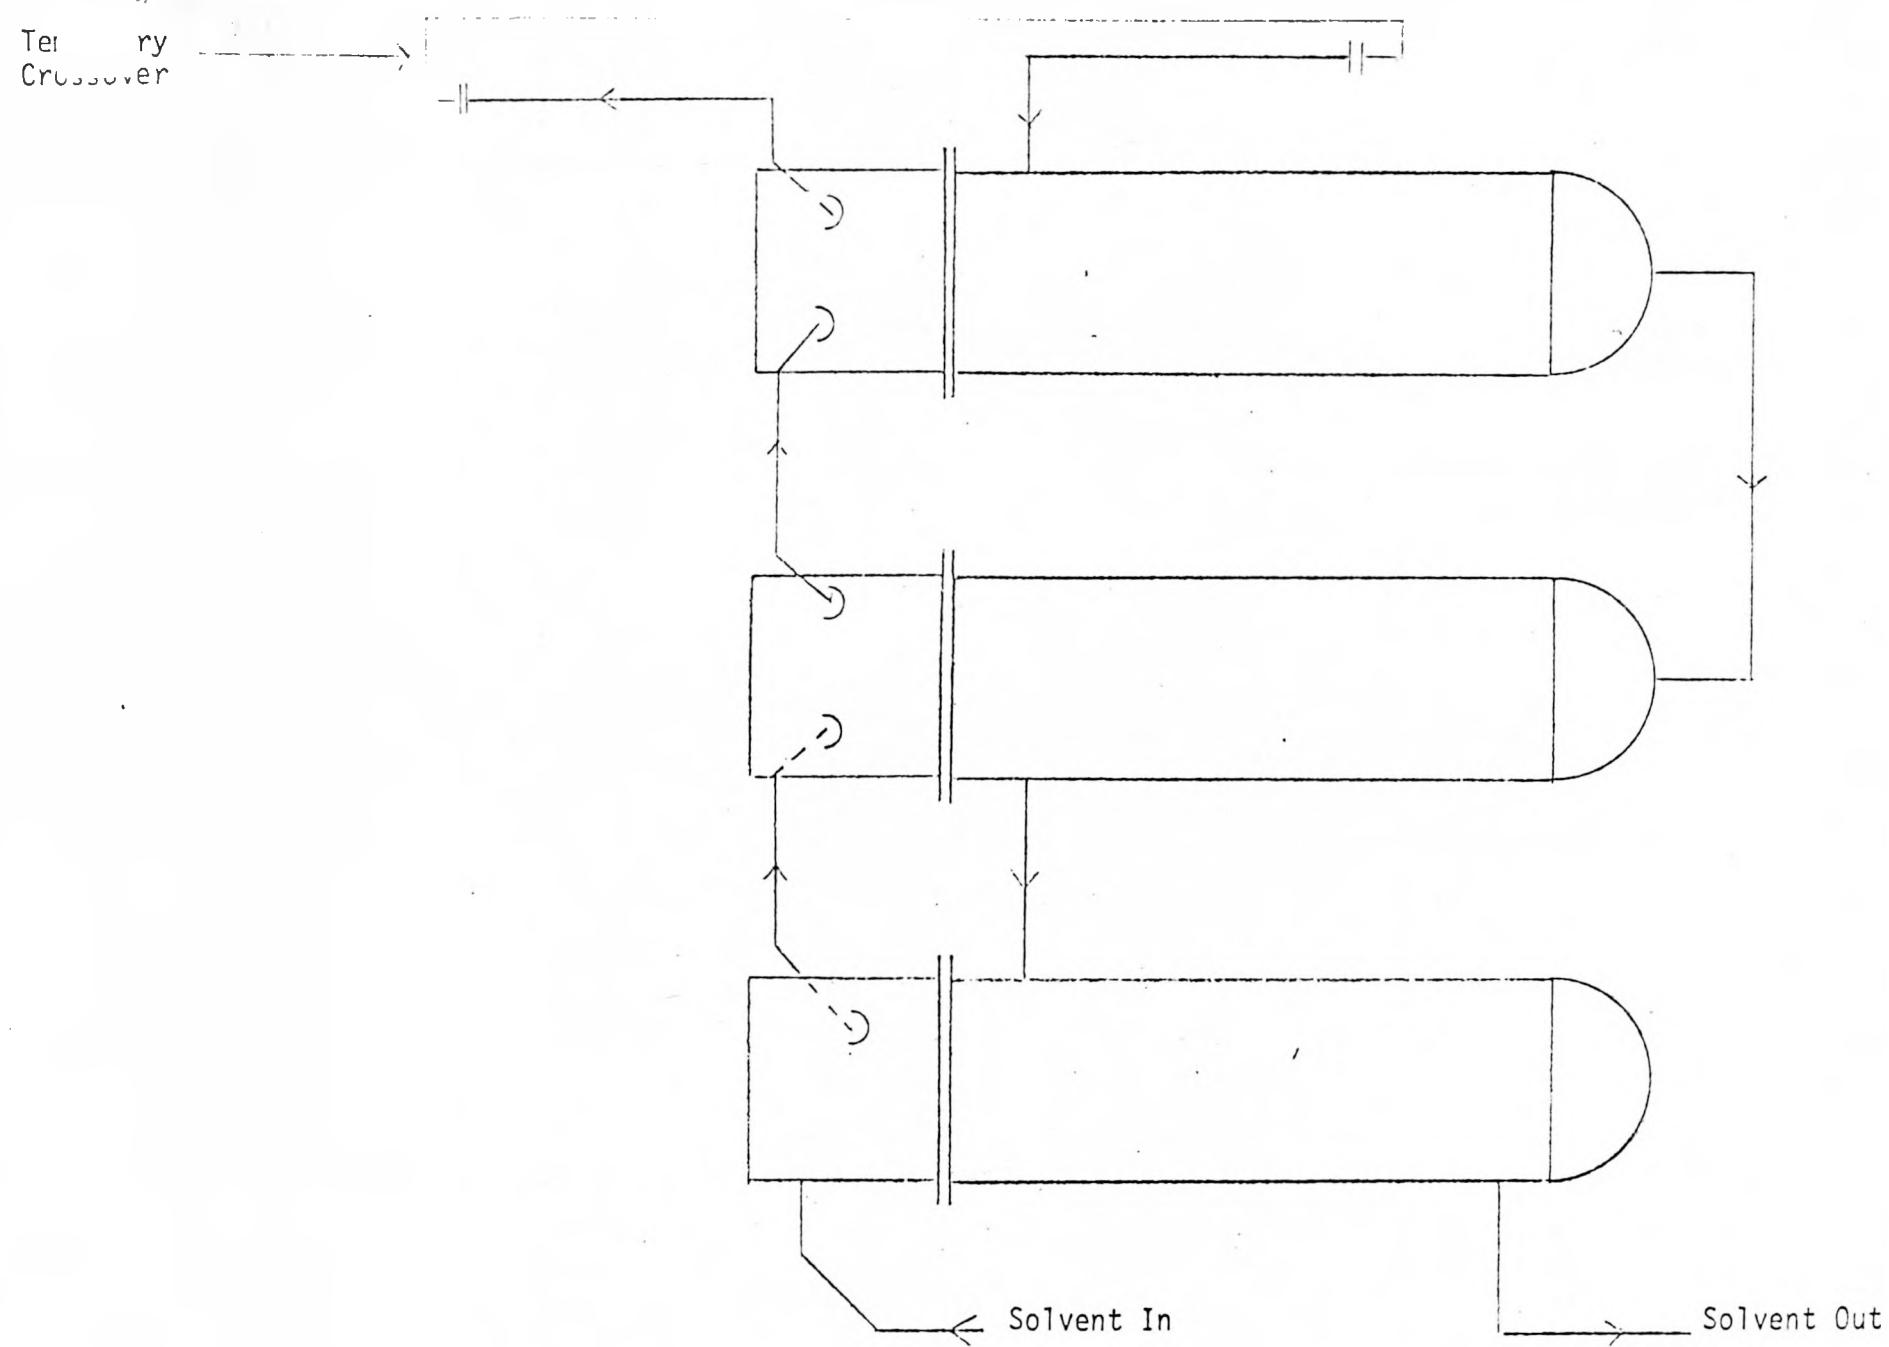
Figure 3

SOLVENT FLOWPATH
