MECHANICAL RESPONSE OF SHOCK
CONDITIONED HPNS-5 (R-1) GROUT

HARRY N. PLANNERER

Los Alamos National Laboratory
Earth and Environmental Sciences Division
Los Alamos, NM 87545

09 December 1997

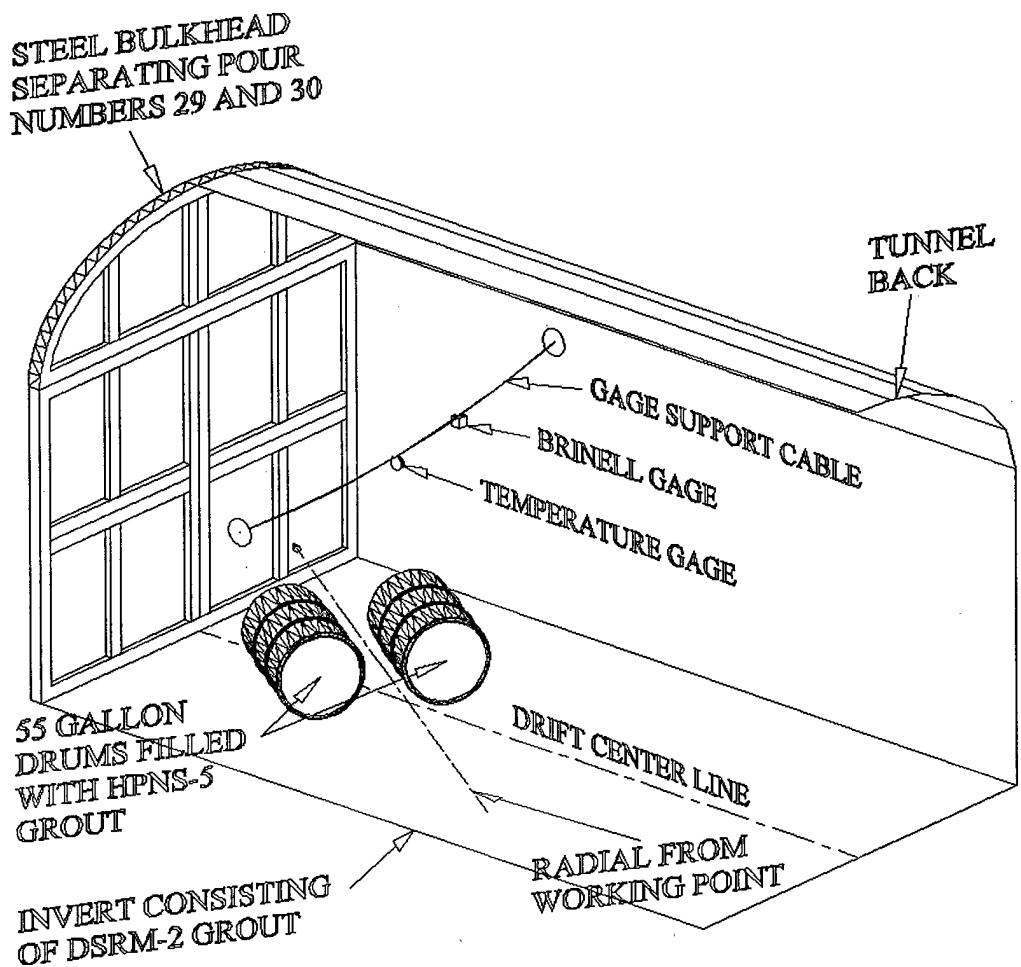
Fig. 1. Sketch portraying the configuration of grout-filled drums as emplaced in pour 30 of the U12p.04 by pass drift. The base of the drums (not visible in this perspective) were oriented toward the working point. The drift at pour 30 was 11 feet wide and 11 feet from invert to back.

Defense Nuclear Agency's DISTANT ZENITH line-of-sight event, executed in the NTS U12p.04 drift on 19 September 1991 (U. S. G. S., 1991), presented the opportunity to subject containerized stemming materials to a nuclear-driven stress wave and to retrieve them for characterization. The grout for this experiment was batched 30 August 1991 for the U3-jz handling exercise, placed in two 55-gallon drums and allowed to establish initial set prior to transport to the Area 12 portal. The grout-filled drums were then positioned in pour 30 of the U12p.04 by pass drift with their sides resting on the invert and flat circular bases oriented toward the working point (Fig. 1). It was planned that one drum each would be placed at two locations within the pour selected for their significantly different stress levels. However, as built they

were both placed side by side at the greater stress level location. The drums were enveloped in HSSL-50/50 (R-4) superlean grout (Table 1) during the button-up stemming operation of pour 30 on 03-04 September 1991. The HPNS-5 grout had cured 20 days at the time of the DISTANT ZENITH device detonation.

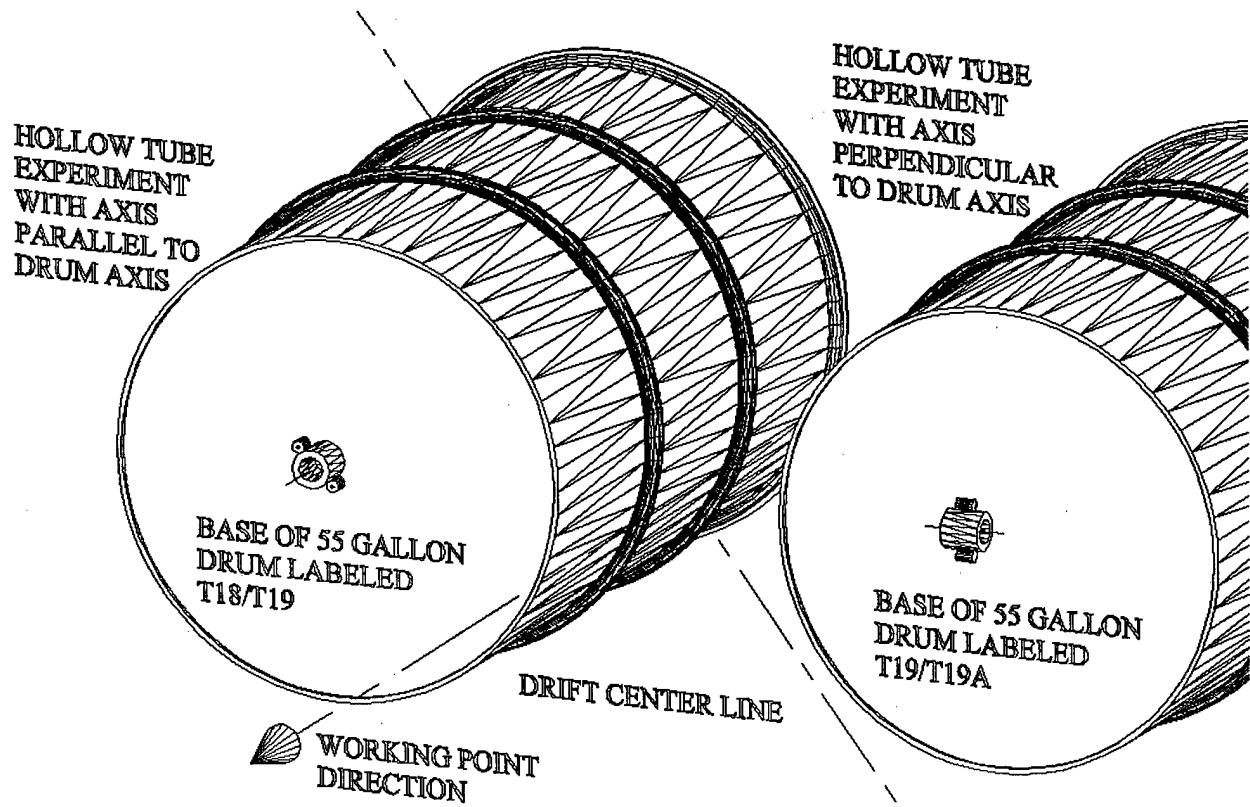
Fig. 2. Sketch portraying the orientation of the hollow tube experiments relative to the base of each grout-filled drum and to a radial from the working point.

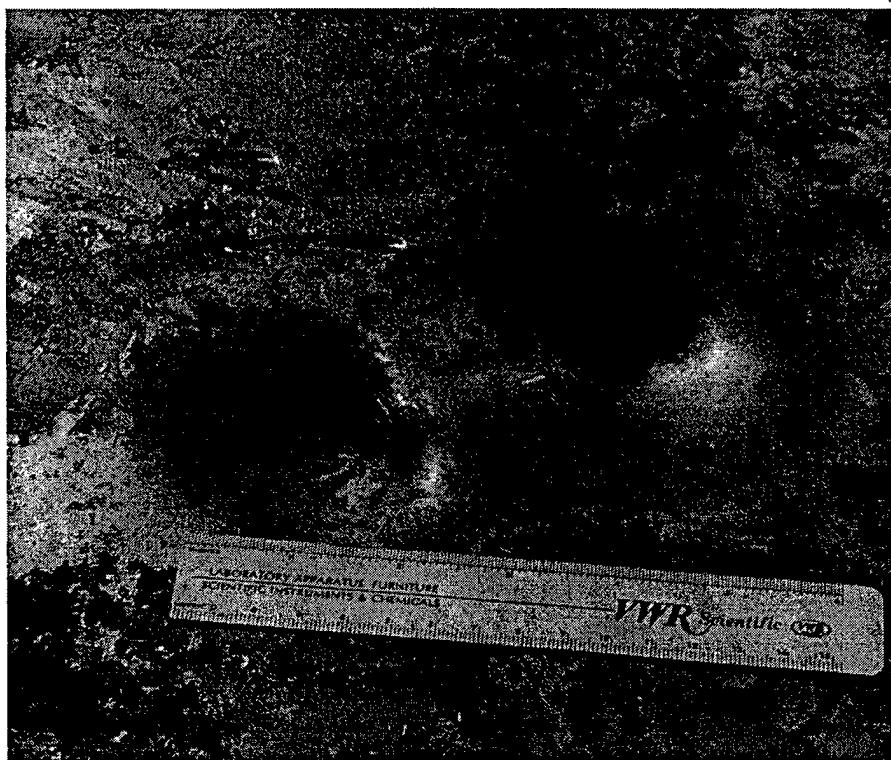
Fig. 3. View of sealed tube experiment exposed along the base of a grout-filled drum after shock conditioning. The axis of the tool steel cylinder is parallel with the flat circular base of the 55 gallon drum, and is aligned such that the extension of the axis passes through the two depressions visible in the figure. This view is shown with metal drum base removed. The two depressions, each measuring 2.5 inch to 2.75 inch diameter and 0.4 inch deep, were created when the differential stress between bulk grout and the interior of the steel cylinder was sufficient to favor ductile flow in the grout surrounding the cylinder end caps. The ductile behavior of the grout allowed its extrusion into the unoccupied volume (except for air) of the cylinder interior. Ductile flow ceased when the advancing extrusion front was confined by a similar front advancing from the opposite end of the cylinder (Fig. 4). Discoloration of the grout surface was caused by a coating on the interior of the 55 gallon steel drum. Top of scale is in inches, the bottom in centimeters.

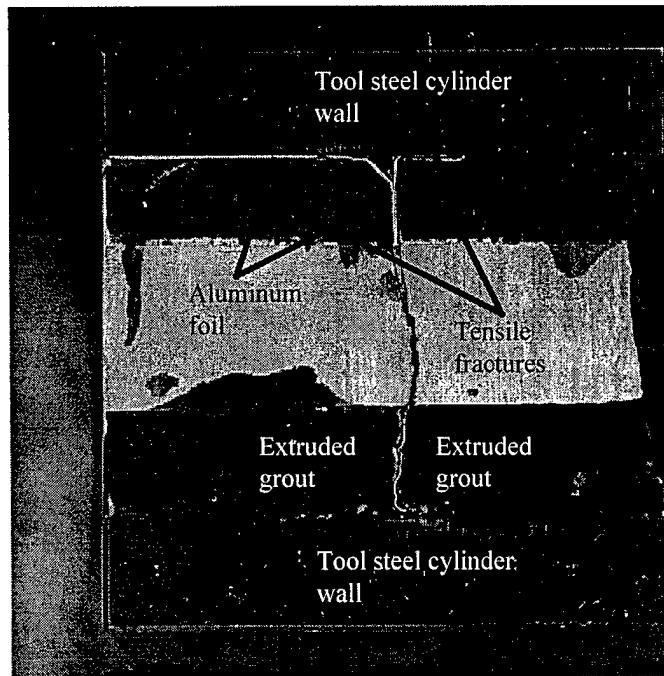
Fig. 4. Section along axis of tool steel cylinder extracted from one of two grout-filled drums which were subjected to a stress wave with average peak magnitude between 55.2 MPa and 74.8 MPa. The cylinder was originally void of material, sealed at both ends and placed in freshly poured HPNS-5 (R-1) grout at the base of a 55 gallon drum. The axis of the tool steel cylinder was oriented parallel with the flat circular base of the drum. Dark coloration of grout and adjacent tool steel in this figure is due to a stain. The light grey coloration is that of the grout exposed by extraction of a small diameter core along the axis of the experiment. In section, grout is observed to have extruded into the cylinder from both ends, pushing the aluminum foil end covers ahead of the advancing grout. A continuous, nearly planar aluminum foil - aluminum foil contact marks the meeting of advancing fronts. Aluminum foil is also observed between grout and the steel cylinder wall. The cylinder wall length is 2 inches.

With the package removed from the grout filled drum and sectioned along its cylindrical axis, HPNS-5 was found completely filling the center of the cylinder (Fig. 4). The aluminum foil and RTV sealant originally capping the ends of the cylinder were not ruptured, but rather were pushed from both ends to meet and form a nearly flat contact half way down the inside of the cylinder. No grout was found between the transported foil layers of aluminum. The foil and sealant were also found along the inside cylinder wall separating grout from the A2 tool steel. The grout, with its fine microscopic grain size, has nearly homogeneous texture and color. Several round-edged light colored inclusions similar to those found in unshocked material lie along the sectioned plane. These revealed no evidence of being fractured or distorted. Macroscopically, there was no appearance of shear banding or slip lines. There was also no evidence of turbulence along interfaces. These characteristics suggest that the grout was extruded into the air-filled space as a ductile material. Jagged hair-line tensile failure cracks perpendicular to the cylinder axis suggest a linear volume reduction parallel to the axis following full or partial extrusion into the original air-filled space.

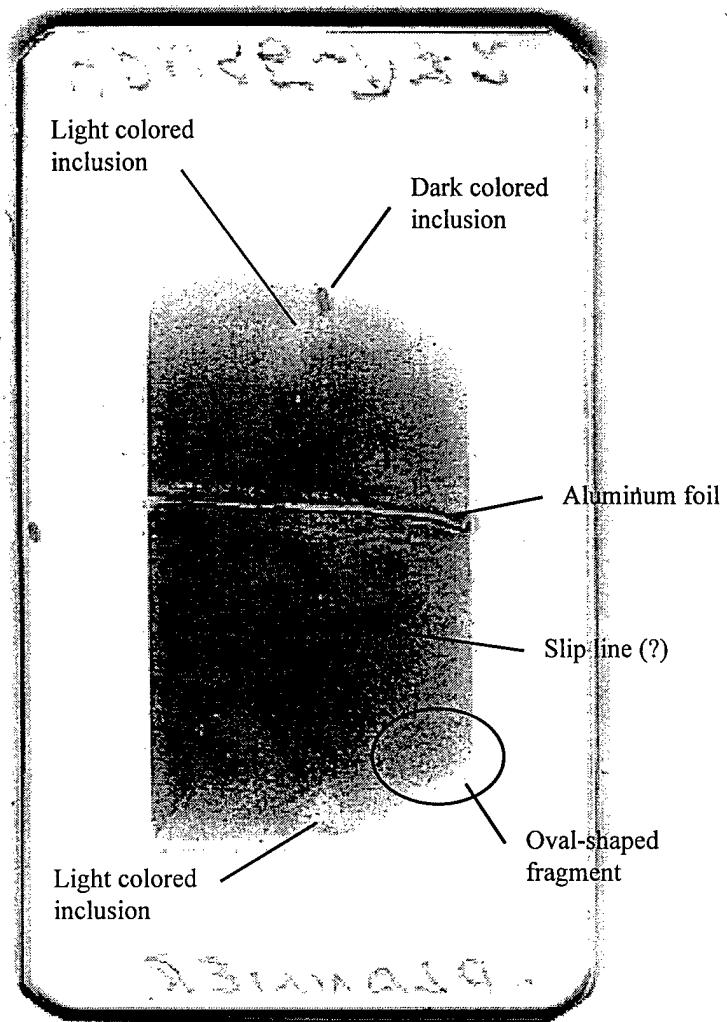
Fig. 5. Thin section view of grout - grout interface from sealed tube experiment shown in Fig. 4. The interface is marked by the thin dark line representing aluminum foil. Except for light and dark colored inclusions, the HPNS-5 grout appears largely homogeneous and featureless. Oval shaped fragments appear along the thinnest portions of the thin section. Slip lines appear as curved lines concave toward the interface. Width of glass plate outline (horizontal) is 1 inch.

Subtle features in a thin-section of the extruded grout provide evidence that the ductile flow is a microscopically brittle mechanism known as cataclastic flow (Paterson, 1978). Two features, noted in Fig. 5, are consistent with this mechanism. Their interrelationship, however, could not be deciphered from optical examination. The first feature consists of oval shaped structures with boundaries defined by slight grain size variations. These oval shaped structures appear to be fragments of grout that were available for rearrangement and relative transport past similar material. The second feature consists of curved lines suggestive of shear or sliding surfaces. These possible slip lines are not regularly spaced. Their curvature appears to be concave toward the extruding surface front which would be expected with

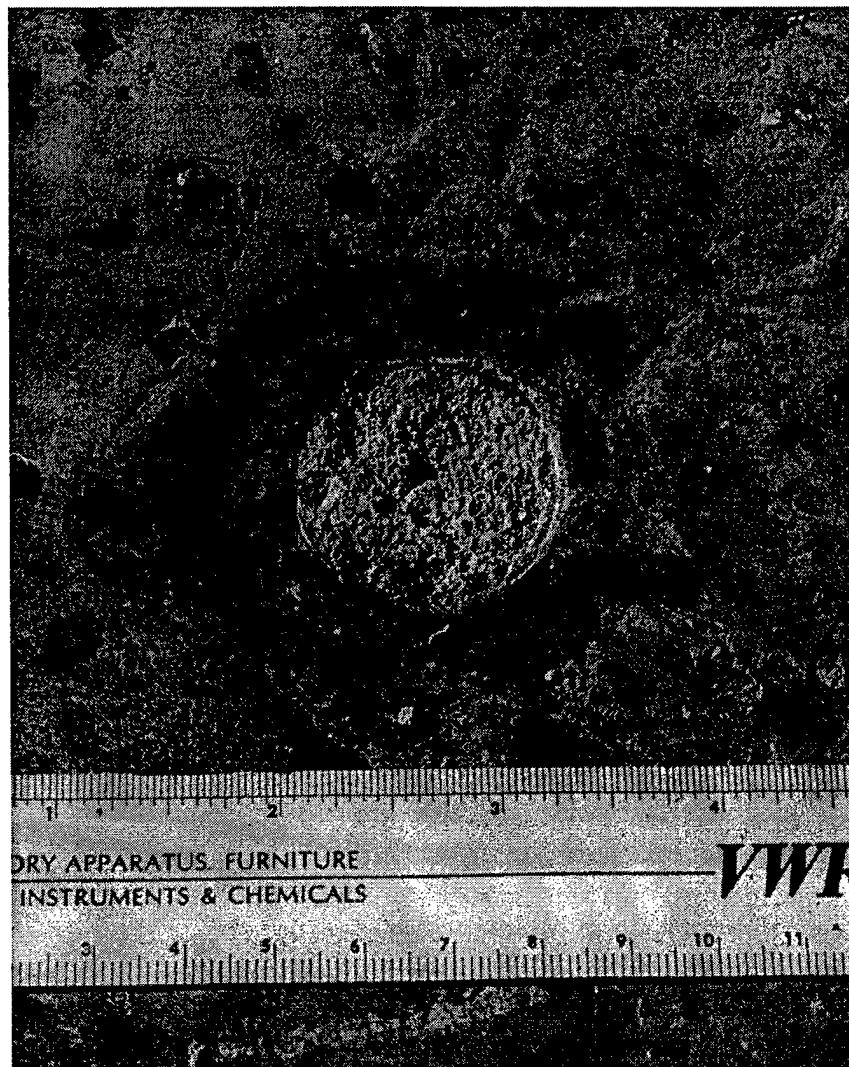
Fig. 6. View of sealed tube experiment exposed along the base of the second grout-filled drum after shock conditioning. The tool steel cylinder is oriented perpendicular to circular base of 55 gallon drum to yield a circular outline. This view is shown with metal drum base removed. Interior of the cylinder is filled with HSSL-50/50 (R-4) superlean grout, which originally surrounded the grout-filled drums after they were emplaced in the by pass drift of the DISTANT ZENITH event. HPNS-5 (R-1) grout surrounds the cylinder. Discoloration of the grout surface was caused by a coating on the interior of the 55 gallon steel drum. Top of scale is in inches, the bottom is in centimeters.

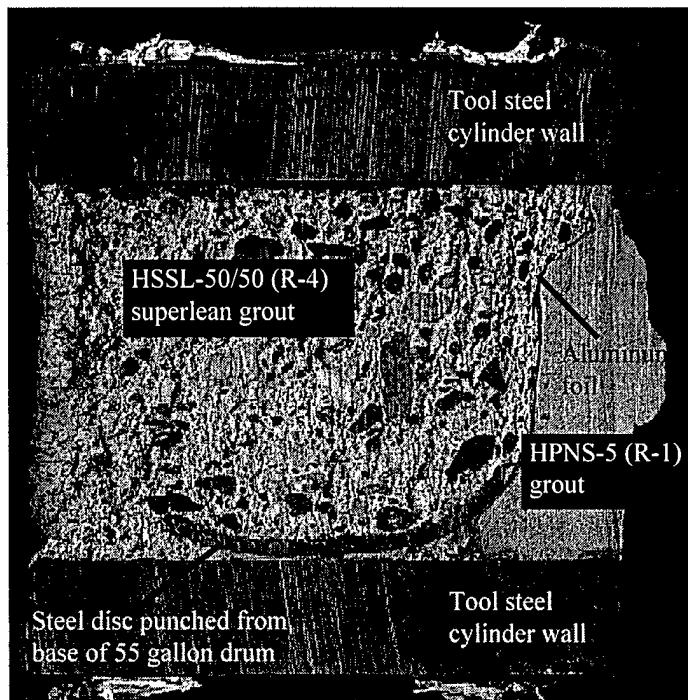
Fig. 7. Section along axis of the tool steel cylinder extracted from the second of two grout-filled drums which were subjected to a stress wave with average peak magnitude between 55.2 MPa and 74.8 MPa. The cylinder was originally void of material, sealed at both ends and placed in freshly poured HPNS-5 (R-1) grout at the base of a 55 gallon drum. The axis of the cylinder was oriented perpendicular to the flat circular base of the drum such that the left end of the cylinder, as viewed above, was against the base of the drum. The drum was then placed in the by pass drift of the DISTANT ZENITH event. In section, the cylinder was invaded from the left with HSSL-50/50 (R-4) superlean grout which punched a hole through the base of the 55 gallon steel drum. Superlean grout was the back fill used to button up pour #30 of the by pass drift. From the right HPNS-5 extruded a short distance into the cylinder pushing the aluminum foil end cap ahead of the advancing front. The cylinder wall length is 2 inches.

Sectioned along its axis, the A2 tool steel cylinder was also found filled with grout (Fig. 7). From one end of the cylinder came HSSL-50/50 superlean grout and from the other came HPNS-5 grout. At the conclusion of the flow processes, HSSL-50/50 occupied most of the tube volume. The HPNS-5 grout extruded 0.5 inch (1.25 cm) at most, and the extruding process pushed the original aluminum foil end cap ahead of it. The boundary between the two grouts is undulatory, evidently owing to the fluid-like mechanics of HSSL-50/50. The superlean grout was found to have encapsulated the circular piece of steel punched from the base of the drum, and transported it along the side of the tube's inner wall.

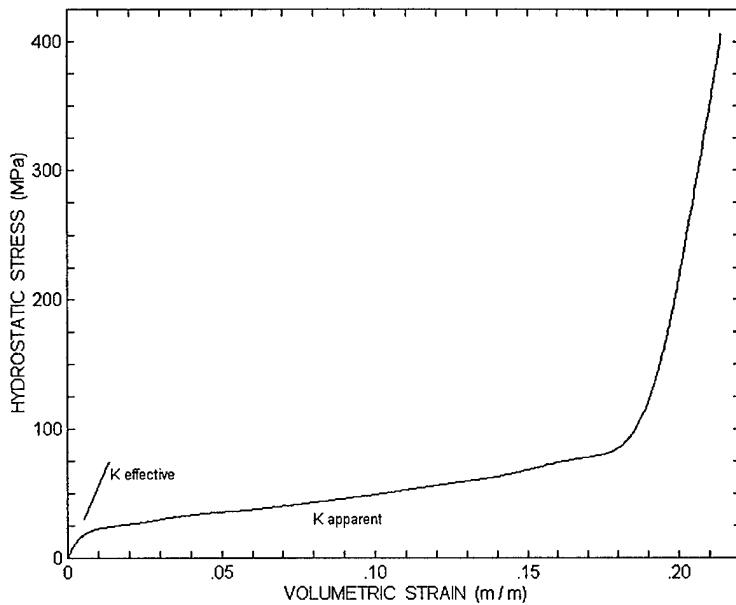
Fig. 8. Volume strain response of shock conditioned HPNS-5 (R-1) grout to hydrostatic stress. Linear elastic behavior occurs from ambient to 10.5 MPa stress. The effective elastic bulk modulus, $K_{\text{effective}}$, is represented with the slope of the indicated line segment. Between 10.5 MPa and about 80 MPa the grout is subjected to crushing and the elimination of pore volume. For this stress range the linear segment is represented with slope K_{apparent} , the apparent bulk modulus. Above 80 MPa the grout responds with stiffening or loading of the grout matrix.

The volumetric strain response of the shock conditioned grout to 400 MPa (58.0 ksi) hydrostatic stress is represented in Fig. 8. The curve in this figure displays an initial steep rise in response to linear elastic deformation that is interrupted with a long shallow slope corresponding to elimination of pore volume before the slope returns again to a steep rise. The proportionality between hydrostatic stress and volume strain occurs from ambient stress to 8.5 - 10.5 MPa (1.23 - 1.52 ksi). The average slope of the line representing this relationship is 5.51 ± 0.28 GPa (799.4 ± 40.6 ksi), which is the effective elastic bulk modulus ($K_{\text{effective}}$) for the shock conditioned HPNS-5 grout. This constant is known as an "effective" constant because the grout is not responding solely as a solid material but as a solid structurally modified with microcracks (microfractures) and pores. Individual elastic ranges determined for seven test specimens and their corresponding $K_{\text{effective}}$ values are listed in Table 2.

Above 10.5 MPa hydrostatic stress, the elastic behavior is lost. The stress is sufficient to cause microstructural damage to the grout matrix surrounding pores and incipient microcracks. The effect is one of crushing and elimination of pore volume. Depending on stress magnitude, the amount of volumetric compaction may be significant, i.e. volume strain will exceed 2% - 5% and can reach 17% or greater. The slope of this curve in Fig. 8 is shallow

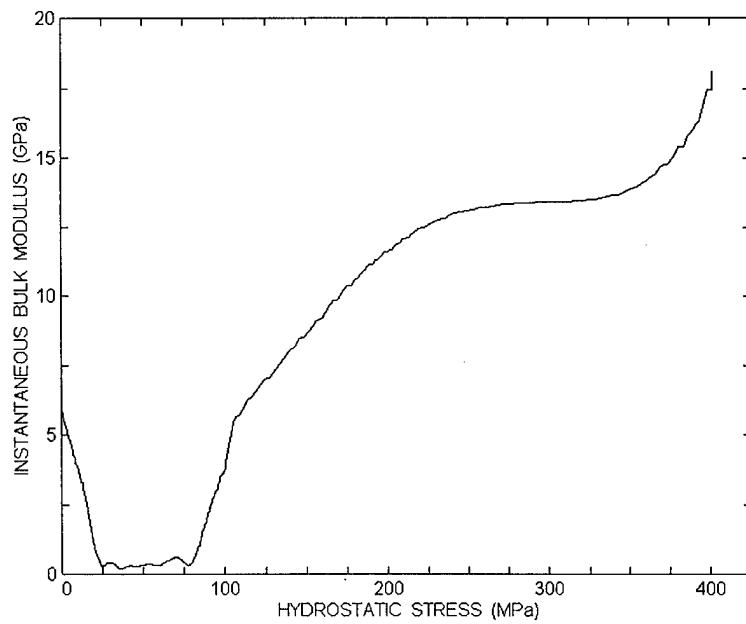
Fig. 9. Instantaneous bulk modulus of shock conditioned HPNS-5 (R-1) grout as a function of hydrostatic stress.

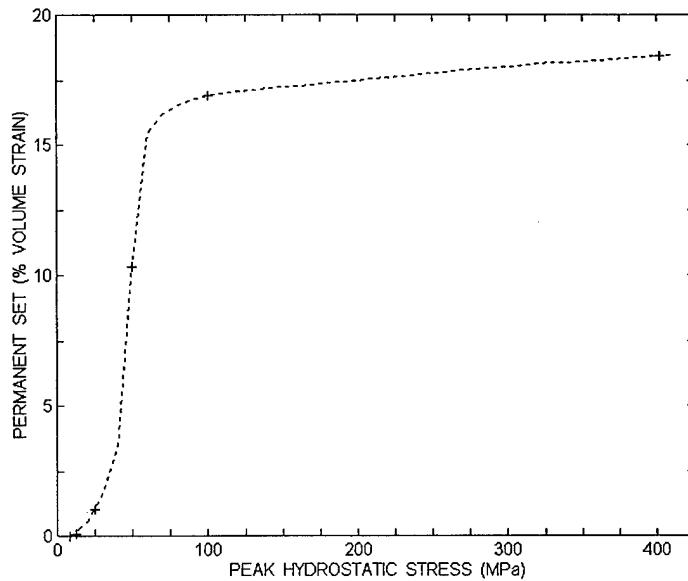
Fig. 10. Permanent set for shock conditioned HPNS-5 (R-1) grout as a function of peak hydrostatic stress. Data obtained from mechanical tests are indicated with '+' marker.

A load and unload cycle of hydrostatic stress with peak stress beyond the elastic range does not allow the grout full strain recovery. The unrecovered strain is known as permanent set. Permanent set as a function of peak hydrostatic load for stress conditioned grout is shown in Fig. 10. From about 25 MPa (3.6 ksi) to 60 MPa (8.7 ksi) peak stress the permanent set dramatically increases from about 1% volume strain to more than 15% strain.

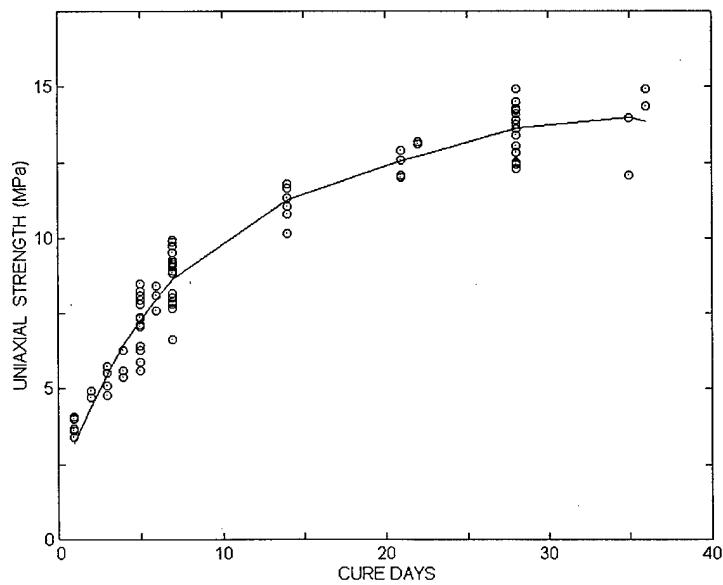
Fig. 11. Uniaxial compressive strength of pristine HPNS-5 (R-1) grout as a function of days cured. This data set was obtained from grout prepared for the U3-ml emplacement and satellite boreholes. A polynomial fit to the data set is shown with the curved line.

Ultimate strength of the unconfined grout as a function of cure time may be estimated from uniaxial compressive strength data obtained from break tests. These strength data represent the grout's fracture failure strength. Figure 11 shows the uniaxial compressive strength of HPNS-5 (R-1) grout as a function of days cured. These data were obtained for grout collected during several batching activities, including the deep rigid plug emplacement for the DIVIDER event in borehole U3-ml. The solid curve through the data represents a polynomial fit to the U3-ml data set. At a cure time of one day the grout exhibits an ultimate strength of about 3.5 MPa (510 psi) increasing to 12.7 MPa (1.84 ksi) at 20 cure days. The containerized grout placed in the

DISTANT ZENITH event would have exhibited an unconfined compressive strength of about 12.7 MPa at the time of event detonation.

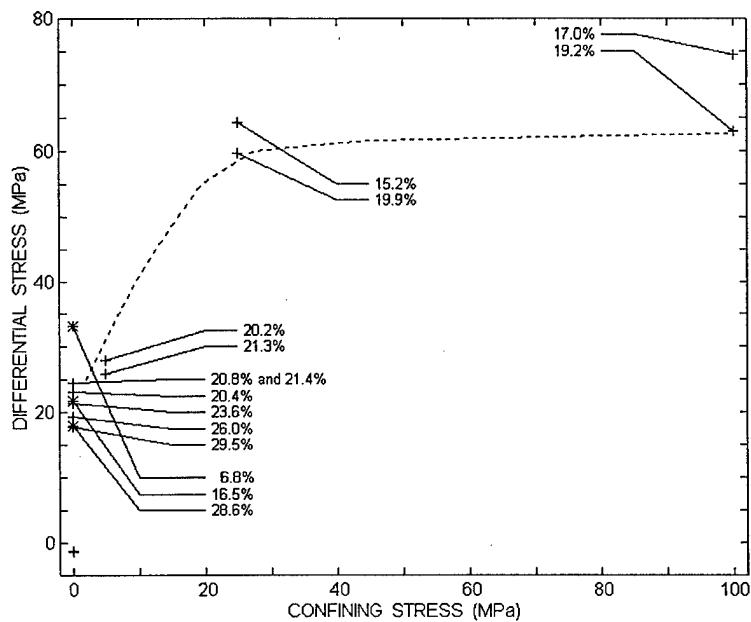
Fig. 12. Ultimate strength of pristine (*) and shock conditioned grout (+) cured for more than 374 days. Moisture content of test specimens are indicated with percentage values. Moisture contents for the two tensile tests were not determined. Dashed line approximately represents the ultimate strength of shock conditioned grout at 20% moisture content as a function of confining stress.

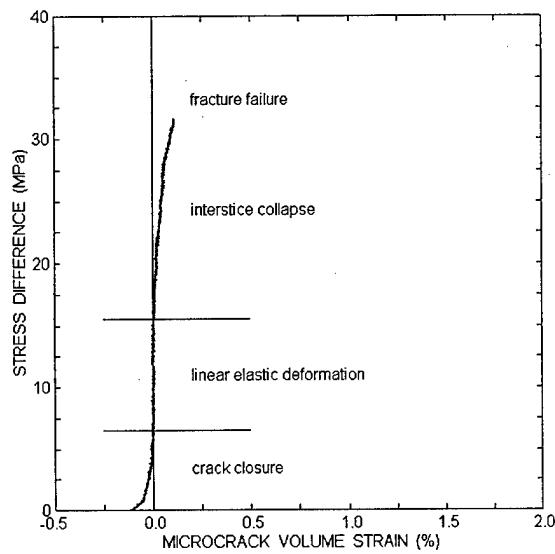
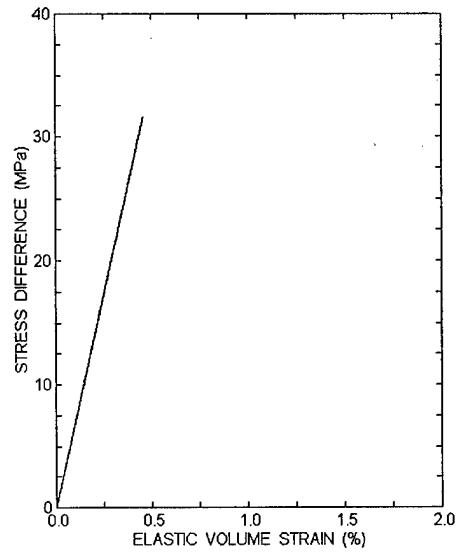
Fig. 13a. Deviation from linear elastic deformation for pristine specimen HPNS5-U3 subjected to uniaxial compression. Vertical line at zero strain represents elastic behavior. Deviations trending to more positive values with increasing stress imply compaction strain. Horizontal lines are stress levels separating types of mechanical behavior.

Fig. 13b. Elastic volume strain contribution to specimen HPNS5-U3 in uniaxial compression.

Three stages of mechanical response are recognized from Fig. 13a for pristine grout specimen HPNS5-U3 in uniaxial compression. The trace which starts left of zero and approaches zero strain with increasing stress identifies the initial stage as crack closure (compaction). Crack closure gives to linear elastic deformation as the crack volume approaches, and then maintains, a value of about zero strain. At this point the total contribution to specimen deformation shifts to linear elasticity. As the trace for crack volume deviates from zero strain it progresses to positive strain values (compaction) indicating interstice collapse. Dilatancy is not detected in this trace. As the differential stress approaches ultimate strength, the elastic strain contribution (Fig. 13b), which is also a compactional strain, dominates specimen deformation.

The effect of shock conditioning on strain response is evaluated by comparing specimen HPNS5-DZ-DRM2#2 (Fig. 14a) with HPNS5-U3 (Fig. 13a). Both specimens were tested in uniaxial compression. Overlooking the omission of a crack closure response, the significant difference in the traces comes with the magnitude of the microcrack strain response during interstice collapse. This compaction strain contribution overtakes that resulting from elastic deformation, and dominates up to ultimate strength. This behavior among shock conditioned specimens continues and is more pronounced at a confining

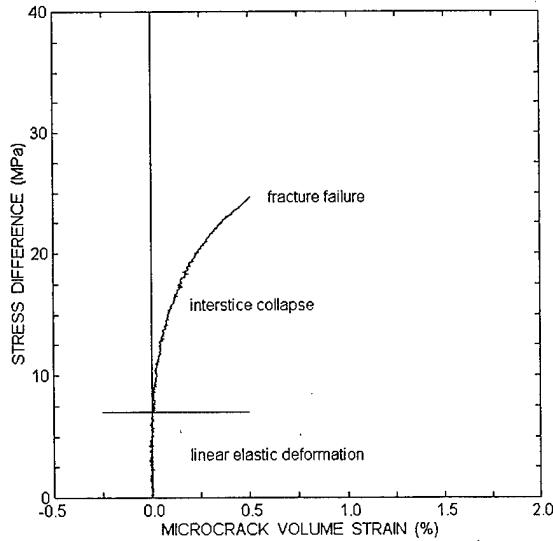
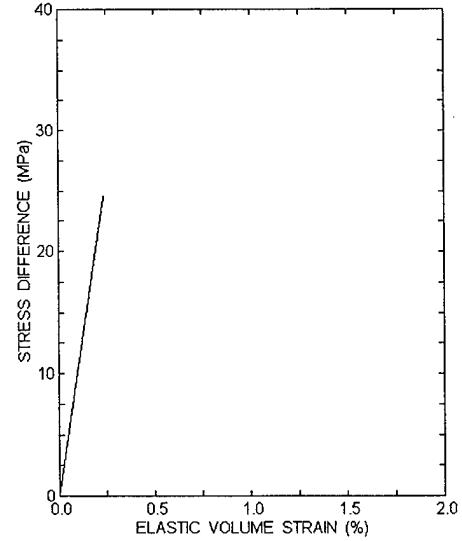
Fig. 14a. Deviation from linear elastic deformation for shock conditioned specimen HPNS5-DZ-DRM2#2 subjected to uniaxial compression.

Fig. 14b. Elastic volume strain contribution to specimen HPNS5-DZ-DRM2#2 in uniaxial compression.

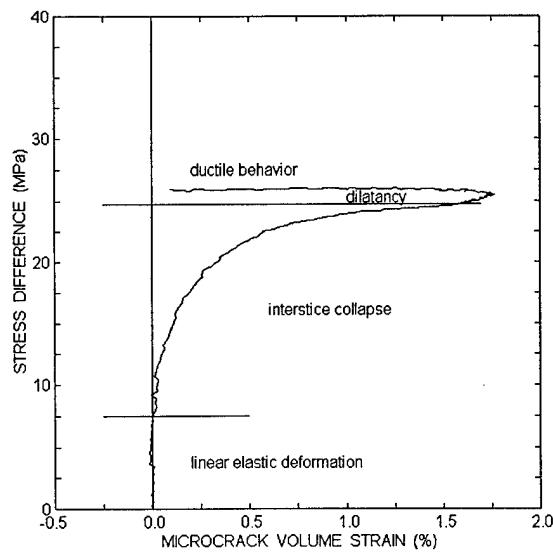
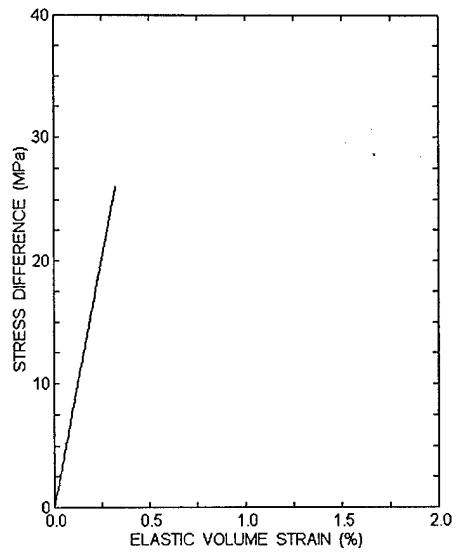
Fig. 15a. Deviation from linear elastic deformation for shock conditioned specimen 301 subjected to a differential stress while maintained at 5 MPa confining stress.

Fig. 15b. Elastic volume strain contribution to specimen 301 in triaxial compression.

stress of 5 MPa (Figs. 15a and b). The characteristic is lost in specimens maintained at 100 MPa confining stress (Fig. 16a and b).

In Figs. 15a and 16a a stress level is indicated for the transition between interstice collapse and dilatancy marking the initiation of microcrack growth. Microcrack growth creates volume strain and counters the contributions to compaction strain due to both elastic response and interstice collapse. The net result is a decrease in compaction strain. Ultimately the specimen exhibits a net volume change that is expansive. That is, it is possible to have the final grout volume, intact with no macroscopic fractures, equal or exceed its original volume.

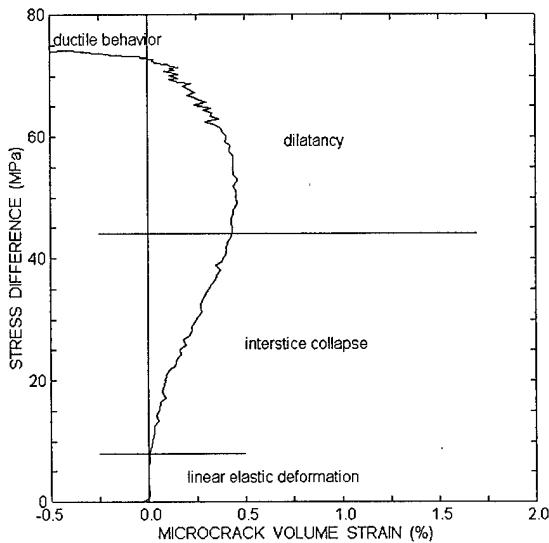
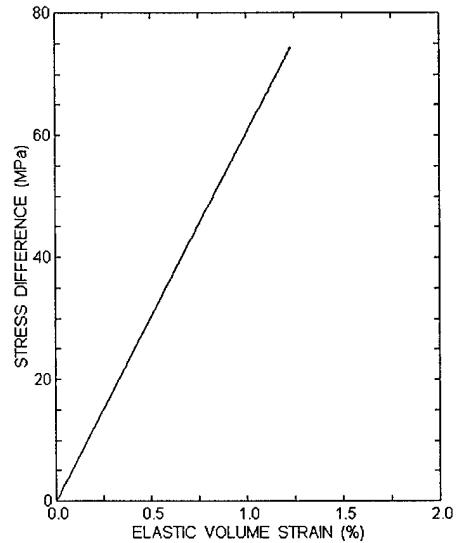
Fig. 16a. Deviation from linear elastic deformation for shock conditioned specimen 306 subjected to a differential stress while maintained at 100 MPa confining stress.

Fig. 16b. Elastic volume strain contribution to specimen 306 in triaxial compression.

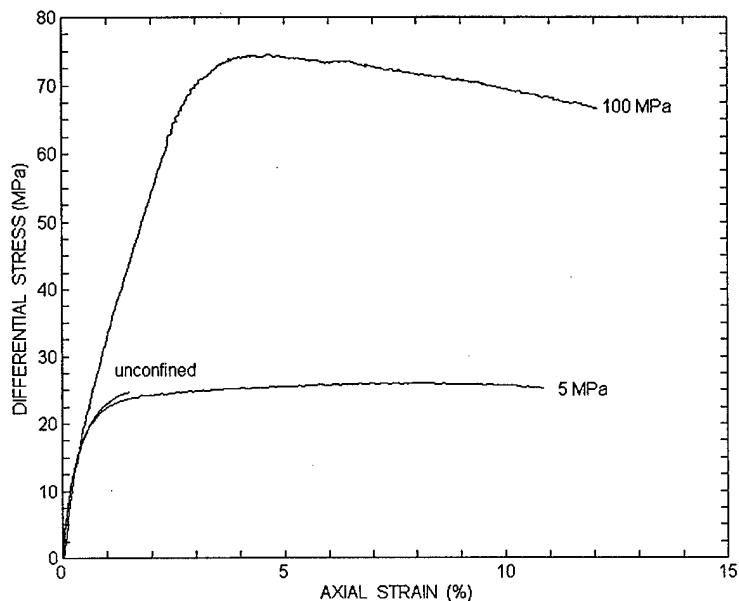
Fig. 17. Comparison of axial strain response of shock conditioned HPNS-5 (R-1) grout to triaxial loading at three different confining stresses. Confining stress is indicated at terminus of each trace. Trace for unconfined specimen HPNS5-DZ-DRM2#2 culminates with brittle fracture failure at 24.6 MPa differential stress and 1.53% compaction strain. At 5 MPa confining stress, specimen 301 followed nearly an identical strain response as HPNS5-DZ-DRM2#2, but instead of failing in brittle fracture made the transition to ductile behavior. As a ductile material the grout sustained a differential stress of about 25.9 MPa. With this sustained stress the specimen was capable of flowing until restricted by some physical boundary. The mechanical test was terminated prior to ductile fracture failure. Specimen 306, having a significant reduction in pore volume resulting from hydrostatic loading to 100 MPa confining stress, attained an ultimate strength of 74.5 MPa differential stress at 4.6% compaction strain. Like specimen 301, this grout made the transition to ductile behavior, however, could not sustain the ultimate strength of 74.5 MPa. As the specimen continued to deform, its instantaneous strength diminished. Again, the mechanical test was terminated before the grout failed in ductile fracture.

Figure 17 shows axial strain as a function of differential stress for three shock conditioned specimens, one specimen that was tested unconfined, and one specimen each at 5 MPa and 100 MPa confining stress. The form of this figure conveys the characteristics of ductile behavior. For the unconfined specimen the trace of its axial strain rises steeply with stress to about 17.5 MPa (2.54 ksi) before the slope of the trace yields, significantly decreases, and finally terminates with fracture failure at 24.6 MPa (3.57 ksi). The specimen maintained at 5 MPa confining stress follows nearly the identical trace as the unconfined specimen. However, specimen distortion with greater than 10% axial strain is observed as the specimen attains and sustains ultimate strength. This specimen was incapable of sustaining a differential stress greater than 25.9 MPa (3.76 ksi) but as long as that stress was sustained the specimen was capable of flowing until restricted by some physical boundary. This characteristic reasonably describes 'fully ductile' behavior (Jaegar and Cook, 1979) as the terminology is applied to ductile metals.

At 100 MPa confining stress the trace of the axial strain shows that the specimen achieved an ultimate strength of 74.5 MPa. Unlike the specimen at 5 MPa confining stress, this specimen was incapable of maintaining ultimate strength. As the grout lost strength it continued to show large strain distortions. By maintaining instantaneous ultimate strength the specimen was capable of flowing indefinitely unless physically restricted. This characteristic of the stress-strain envelope reasonably describes work softening.
