MATERIALS CORROSION AND MITIGATION
STRATEGIES FOR APT, END OF FY '97 REPORT:
INCONEL 718 IN-BEAM CORROSION RATES FROM
THE '97 A6 IRRADIATION

**Materials Corrosion and Mitigation Strategies for APT,
End of FY '97 Report:**

I. Inconel 718 In-Beam Corrosion Rates from the '97 A6 Irradiation

R. Scott Lillard, Donald L. Pile, Darryl P. Butt

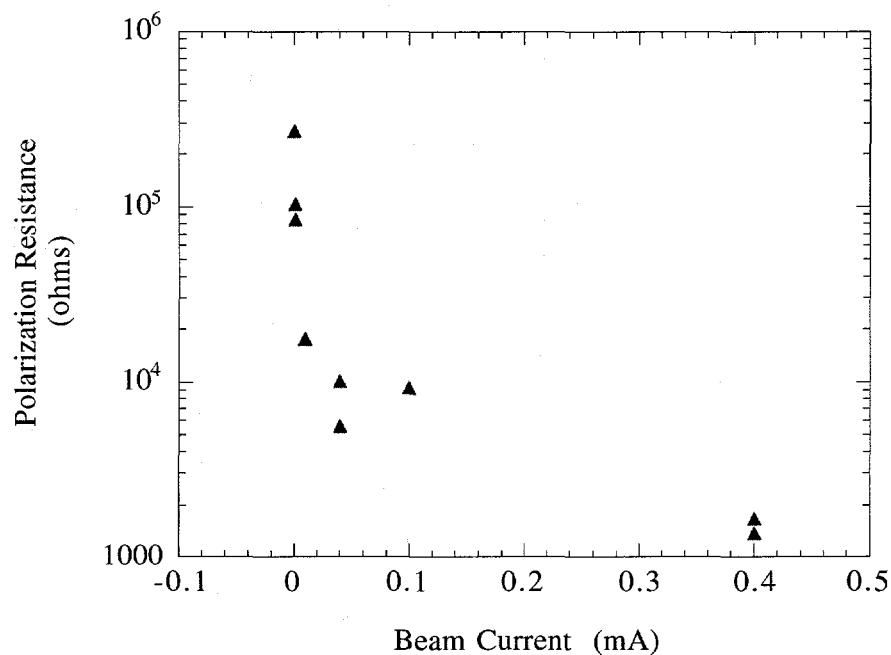
Figure 1.es IN718 polarization resistance as a function of beam current measured during irradiation at the LANSCE A6 Target Station.

During the FY '97 irradiation period, EIS was used to measure the polarization resistance (R_p) of Inconel 718 (IN718) as a function of beam current. Values of R_p as a function of beam current are shown in Figure 1.es. Because the beam spot was small relative to the size of our IN718 corrosion probe (the beam width at 2σ was equal to 3 cm vs. the cylindrical probe dimensions of 1.3 cm in diam. x 15.9 cm in length), several methods for determining corrosion rate from R_p were derived. The first method used beam profile as a criteria for determining the area of highest damage. This damage profile may be anticipated if peak current were the controlling factor in the corrosion materials during proton irradiation. The beam spot intensity profile at LANSCE has been characterized and found to be a Gaussian distribution rotated about a central axis. The relationship between beam spot intensity and radial position is given by:

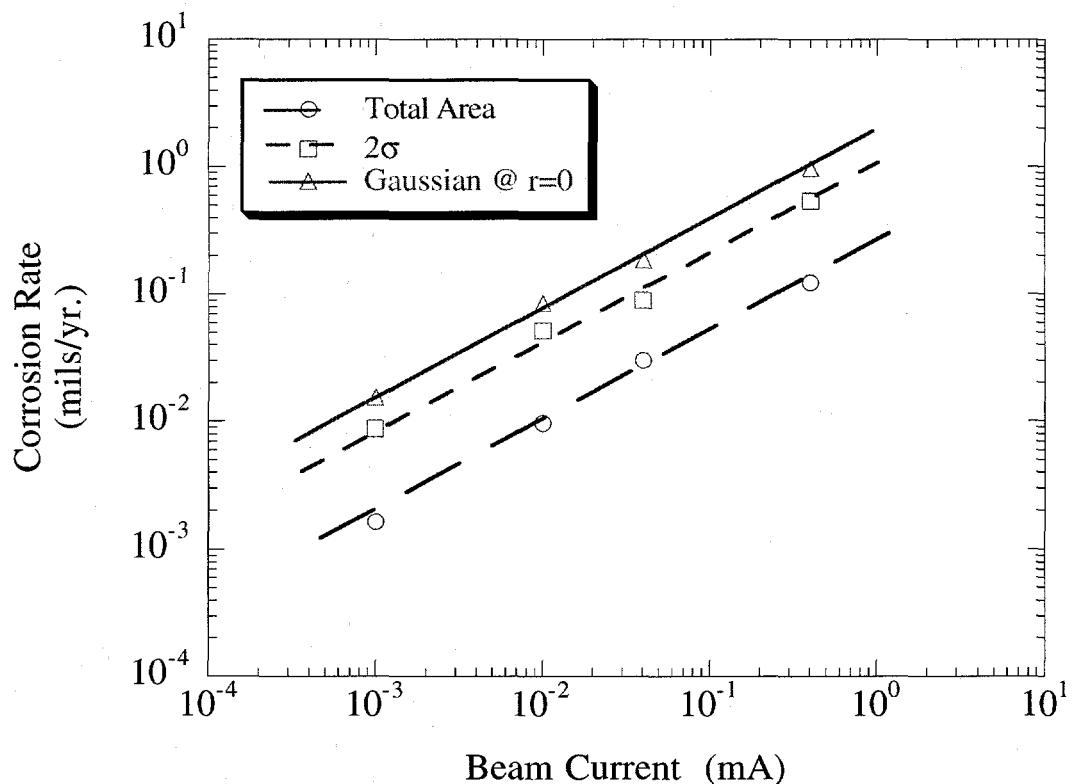
Figure 2.es Corrosion rate of in-beam IN718 probe as a function of beam current. Data has been calculated for several assumptions about the corroding area: 1) corrosion was uniform over the entire sample surface, 2) corrosion was limited to but uniform over an area defined by 2σ , and 3) corrosion was a function of proton flux as defined by Equation 1.es.

As seen in Figure 2.es, the corrosion rate increases with increasing proton beam current for all three scenarios. Not surprisingly, the greatest corrosion rates are found when a Gaussian distribution is assumed. Physical evidence which suggests that a Gaussian distribution is an accurate depiction of corrosion rate as a function of position was found in the post-mortem analysis of a W rod in the front most bundle of the FY 96 17A insert. This insert was irradiated at 1 mA for approx. 2 months [Sommer, Maloy, Zaslawsky, Butt, Lillard, unpublished data]. Thickness

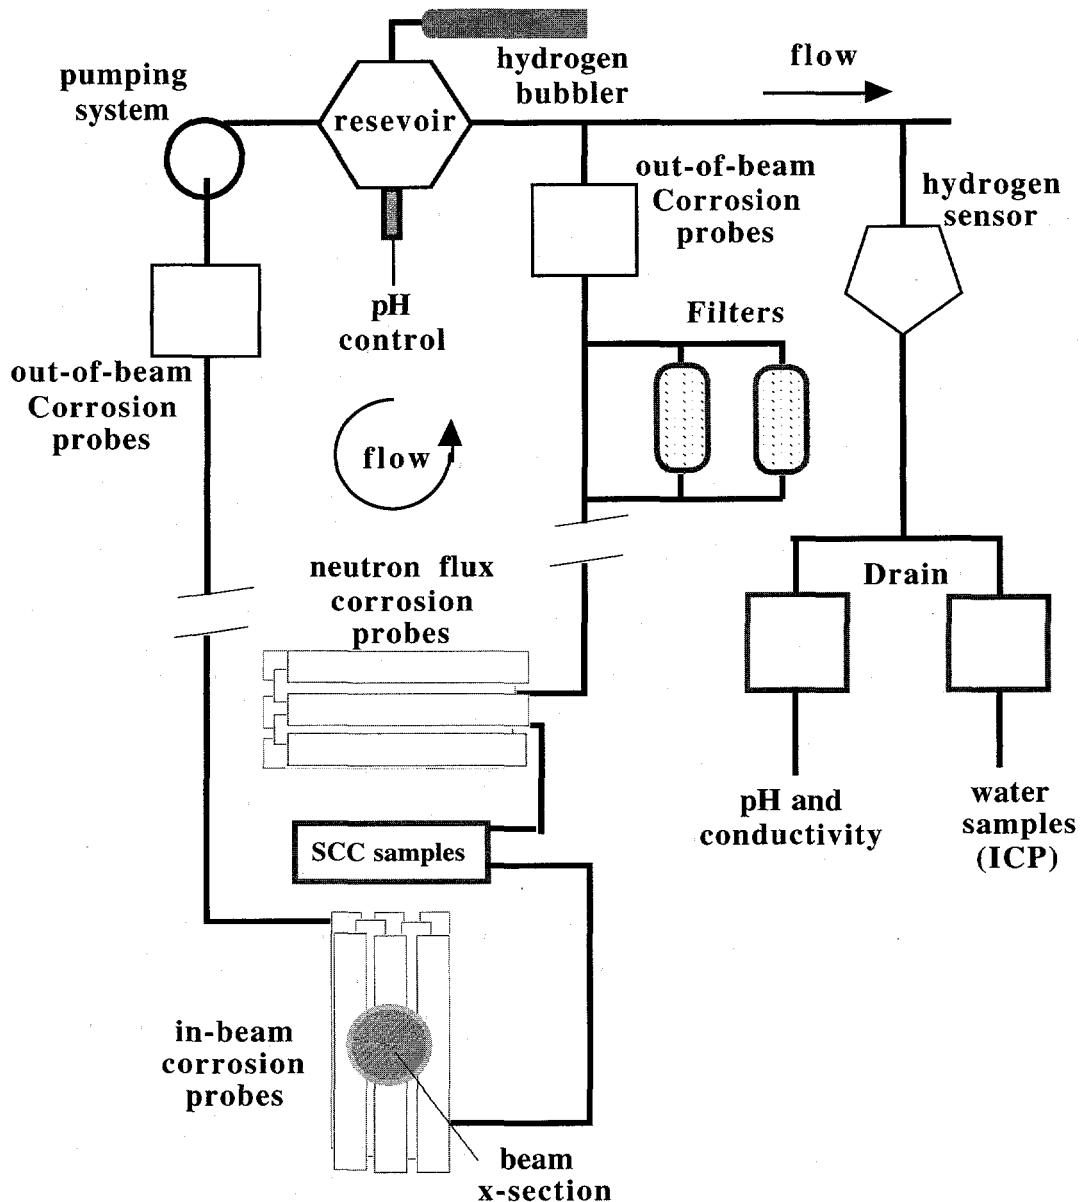
Figure 1 A diagram representing the corrosion diagnostics to be used on the cooling water loop at the LANSCE A6 target station. The proton beam is perpendicular to the diagram and is represented by the oval over top the in-beam corrosion probes

The in-beam corrosion probes are represented by the rectangular tubes at the bottom of Figure 1. The beam path is perpendicular to the page. These probes were placed directly in the proton beam to evaluate the effects of the proton beam interactions as well as short lived and long lived radiolysis products on corrosion rate.

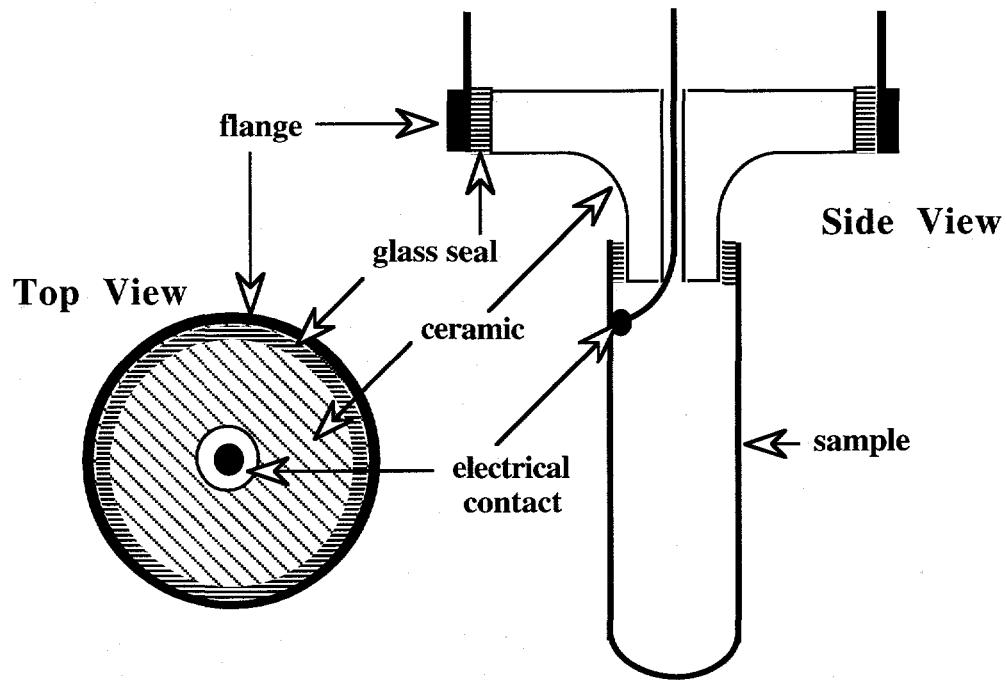
Figure 2 In beam corrosion probe showing ceramic feedthrough and compression seals (not drawn to scale).

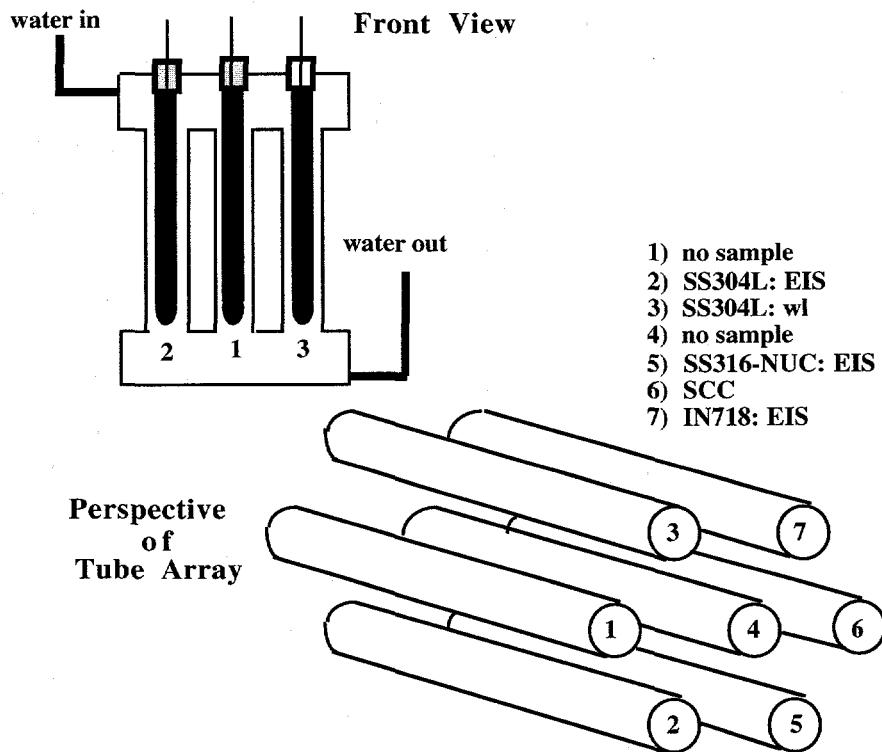
Figure 3 A diagram representing the placement of the in-beam corrosion probes in the manifold section of the cooling water loop.

A diagram of the water manifold that housed the in-beam corrosion probes is presented in Figure 3. This manifold consisted of 7 tubes arranged in a close packed array with tube #1 being in the front-most position. Each tube contained either an in-beam corrosion probe with ceramic (noted as EIS) or a weightloss foil (2" x 5/16" x 1/16") made from W, SS 304L, or Ta (noted as wl in Fig. 3). This manifold was welded to the bottom of an 11' supporting insert which not only supported the manifold but also provided the necessary conduits for electrical and water connections. A diagram depicting the corrosion insert and its relative position at the target station is presented in Figure 4 as insert 17B.

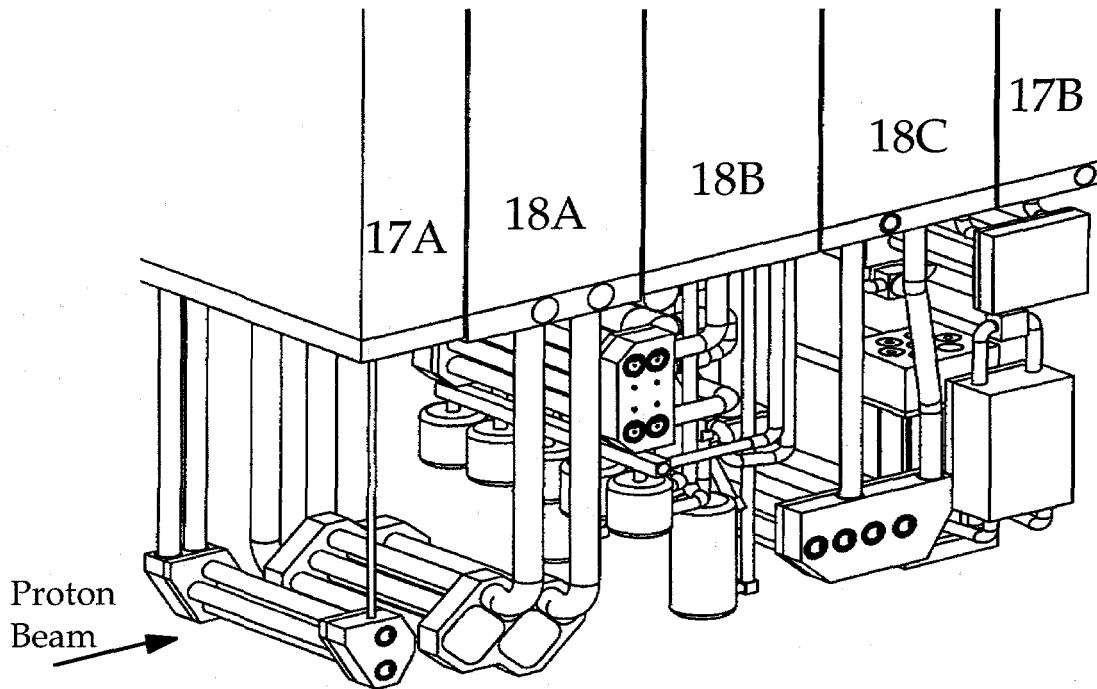
Figure 4 Diagram depicting inserts at the LANSCE A6 Target Station. The insert containing the corrosion samples is labeled 17B. The approximate length of the insert (including the manifold) is 11'. The associated closed loop water system is not shown.

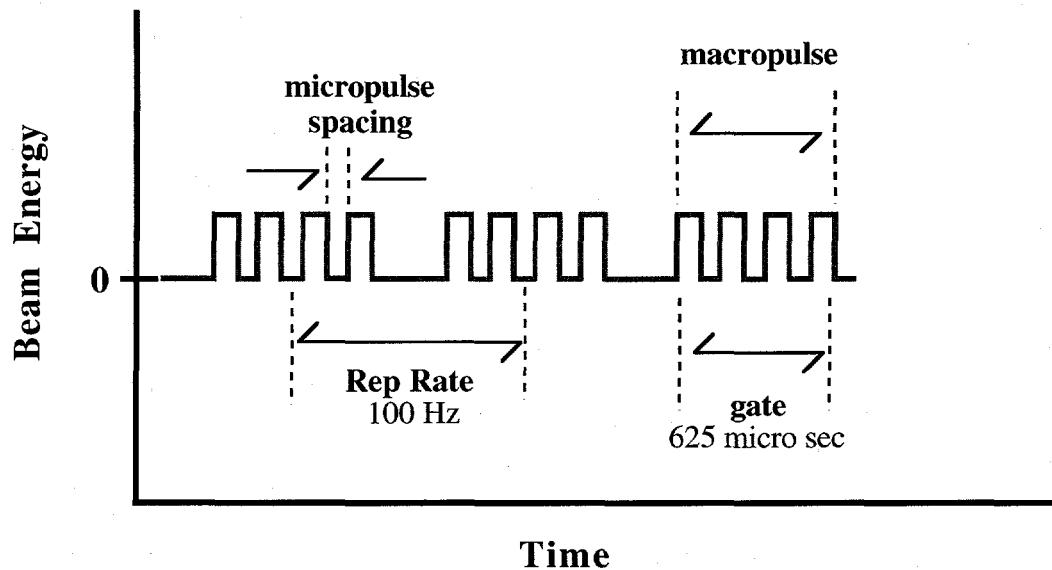
Figure 5 Diagram depicting the characteristics of the proton beam at the LANSCE A6 Target Station

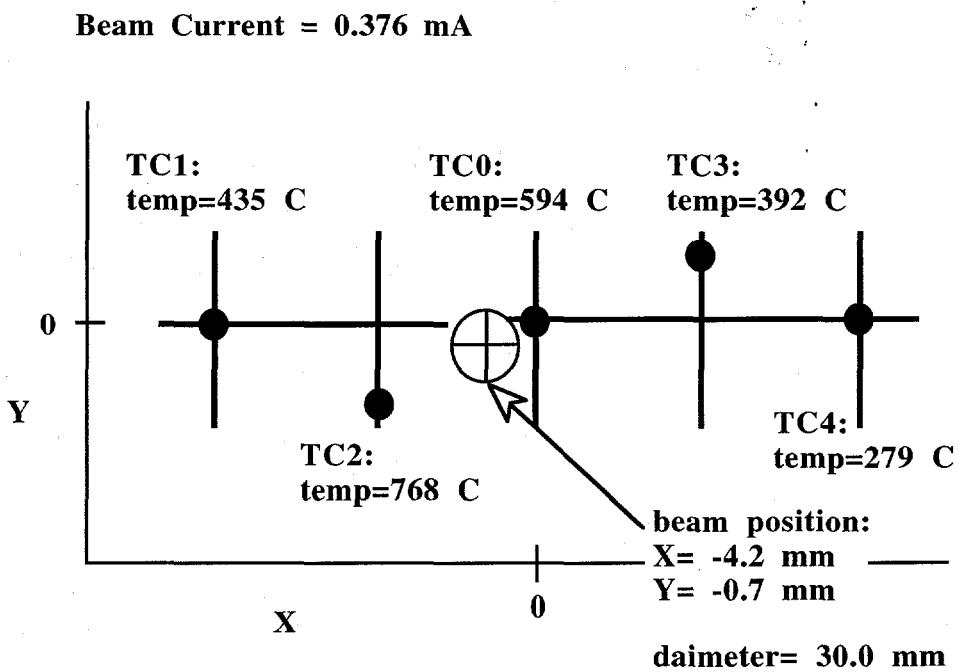
Figure 6 Diagram representing the thermocouple grind welded to the front of the 17A insert. An algorithm based on thermocouple temperature was used to steer the beam as close as possible to the center of Tube 1 (0,0) and calculated its approximate diameter. Thermocouple temperatures and calculation of beam size and position are shown for a beam current of 0.4 mA and no other inserts in front of 17A.

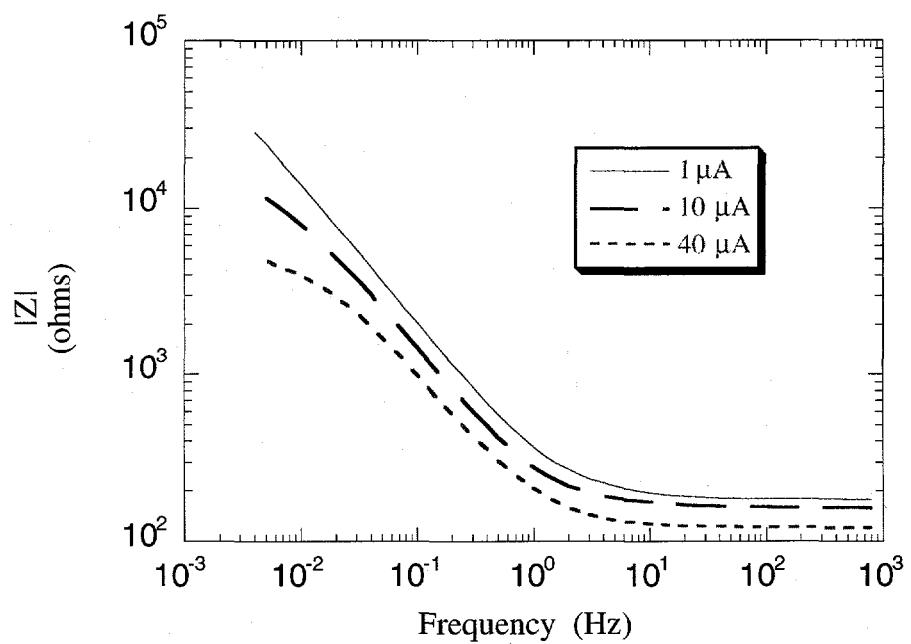
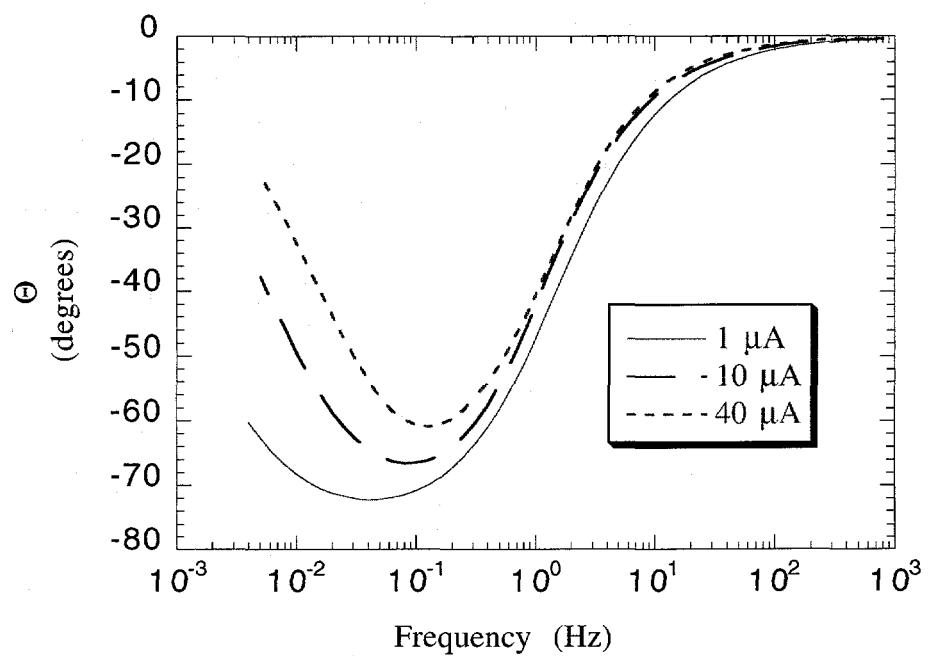
Figure 7 Typical **a)-top** Bode Magnitude and **b)-bottom** Bode phase plots from the in-beam IN718 probe as a function of beam current

In-beam EIS Measurements Typical EIS data from the IN718 in-beam corrosion probe as a function of beam current are presented in Figure 7 in the form of Bode magnitude and phase plots. It may be noted that the magnitude of the impedance ($|Z|$) is presented in ohms and not the traditional $\text{ohm}\cdot\text{cm}^2$. A complete discussion of area, relative to the proton beam spot size is addressed in the following section. As seen in Figure 7a, the low frequency limit of the IN718 data decreased with increasing proton beam current. As only one time constant was observed, the EIS data were modeled by the simplified Randles equivalent circuit (EC) shown in Figure 8 where: R_p is the polarization resistance, C_{dl} is the capacitance associated with the double layer, and R_{sol} is the geometric solution resistance between the sample and the water system. A complex non-linear least squares (CNLS) fit of the in-beam data at a proton current of 0.400 mA to this EC is presented in Figure 9. As seen in this figure, good agreement between the model and the data

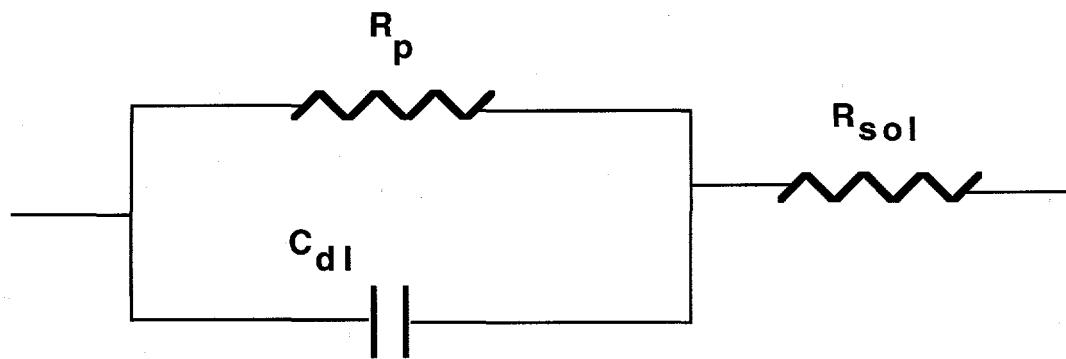
Figure 8 Simplified Randles circuit used to model EIS data taken at early irradiation times

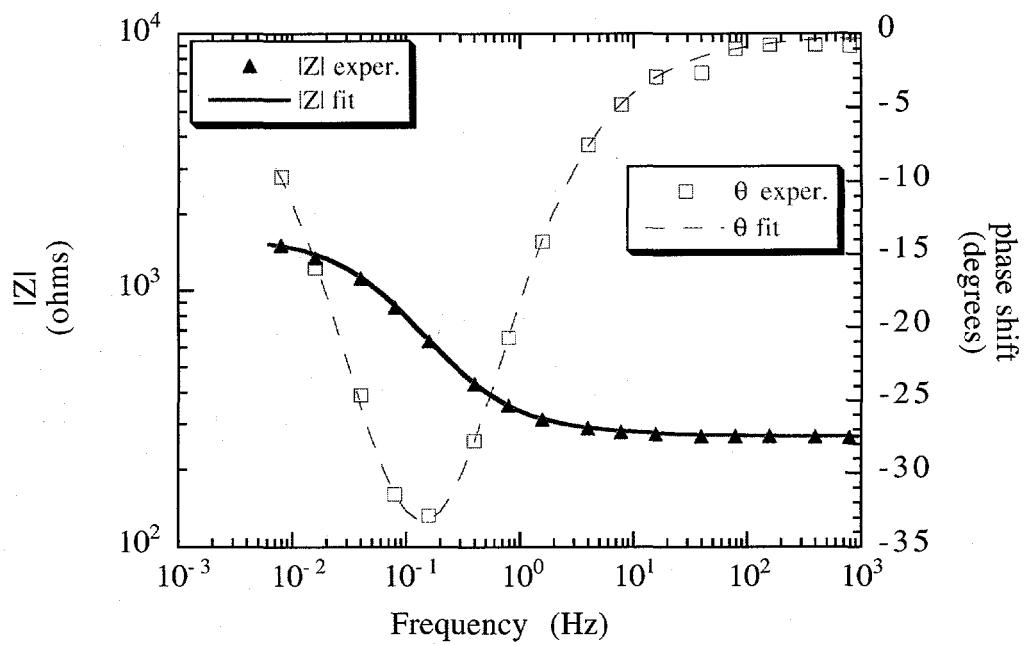
Figure 9 Experimental EIS data taken at 0.40 mA with no other inserts in front of 17B and the CNLS fit of the EC in Figure 8 to the data. Note, only 20% of the experimental data are shown for clarity.

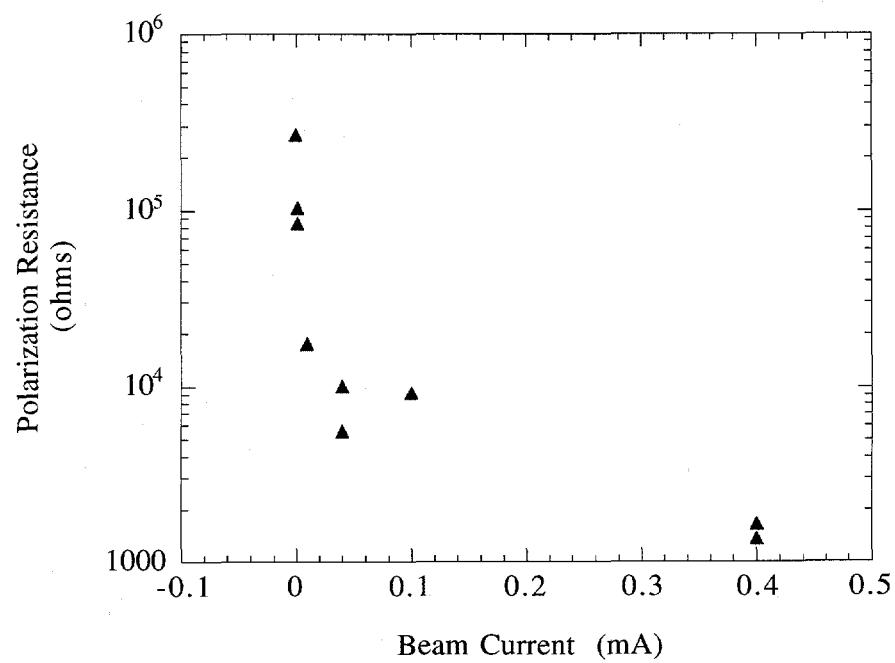
Figure 10 Polarization resistance from the in-beam IN718 probe (measured by EIS) as a function of beam current.

exists. The polarization resistances obtained from CNLS fitting as a function of proton beam current are presented in Figure 10. The corresponding beam current as a function of time is presented in Figure 11. As seen in Figure 10, an exponential decrease in R_p with increasing beam current was observed.

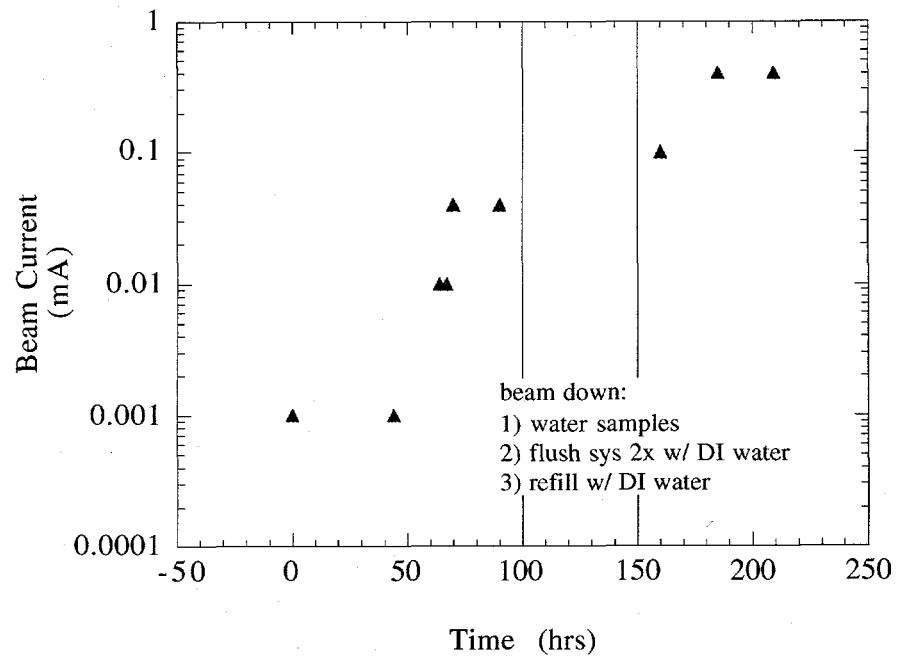
Figure 11 Beam currents from Figure 10 as a function of time.

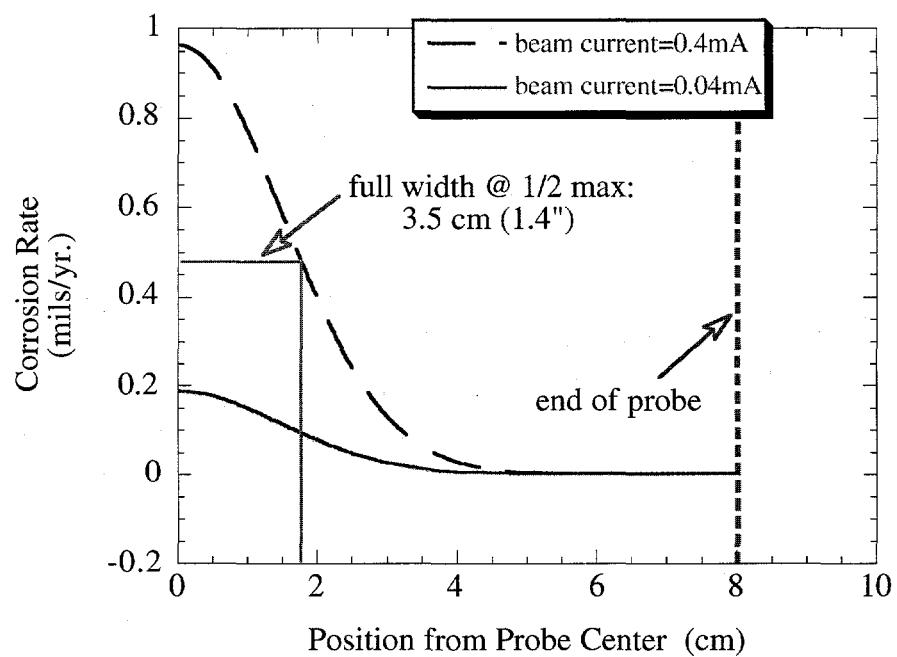
Figure 12 Corrosion rate as a function of radial distance from the beam (probe) center as calculated from Equation 6.

The Gaussian distribution of the corrosion rate ($CR^G(r)$) for the in-beam IN718 probe for beam currents of 0.04 and 0.4 mA is presented in Figure 12. As may be anticipated for this distribution, the highest corrosion rates are found at the center of the probe ($r=0$). For a beam current of 0.40 mA the theoretical value for the FWHM is 3.26 cm. As shown in Figure 12, the FWHM for the calculated corrosion profile at a beam current of 0.40 mA is 3.5 cm. Physical evidence which suggests that this distribution is an accurate depiction of the corrosion rate as a function of position is presented in Figure 13. These data were taken from a W rod in the front most bundle of the 17A insert after the Fall 1996 irradiation period [Sommer, Maloy, Zaslawsy, Butt, Lillard, unpublished data]. The insert was irradiated at a beam current of 1.0 mA for approximately 2 months. As shown in this plot, there appears to be two modes of corrosion damage, mass transport effects (water velocity) and proton damage. The mass transport effects are characterized by a thinner rod diameter on the inlet side as compared to thickness differences on the outlet side. There is also a possibility that this is an erosion effect, however, particle concentration was controlled by filters (200 and 2×10^{-6} m) and regular flush/refill of the water system. The beam effects are characterized by the Gaussian shape of the rod thickness near its center. Although the corrosion damage near the center of the probe appears to be mixed mode, it is interesting to note

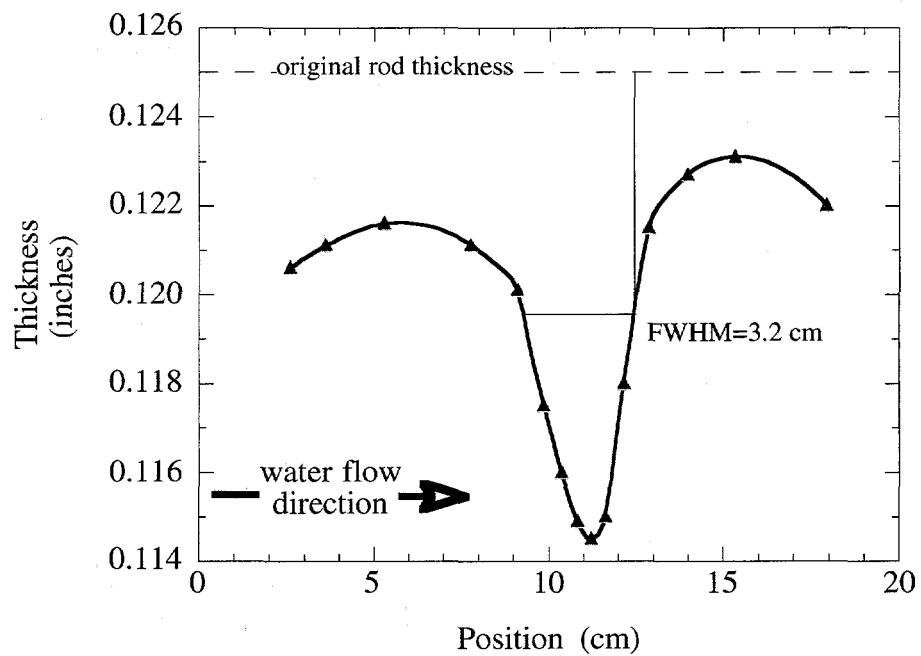
Figure 13 Thickness changes in a 0.125" diameter tungsten rod after proton irradiation at 1.0 mA for 2 months (Maloy, Sommer, Zaslawsky, Butt, Lillard, unpublished data).

that the full width at half of the maximum (FWHM) is approximately 3.2 cm. The theoretical FWHM for a beam current of 1.0 mA is 3.46 cm. Moreover, the data in Figure 13 is an indication that corrosion rate is dependent upon peak beam current and not average flux.

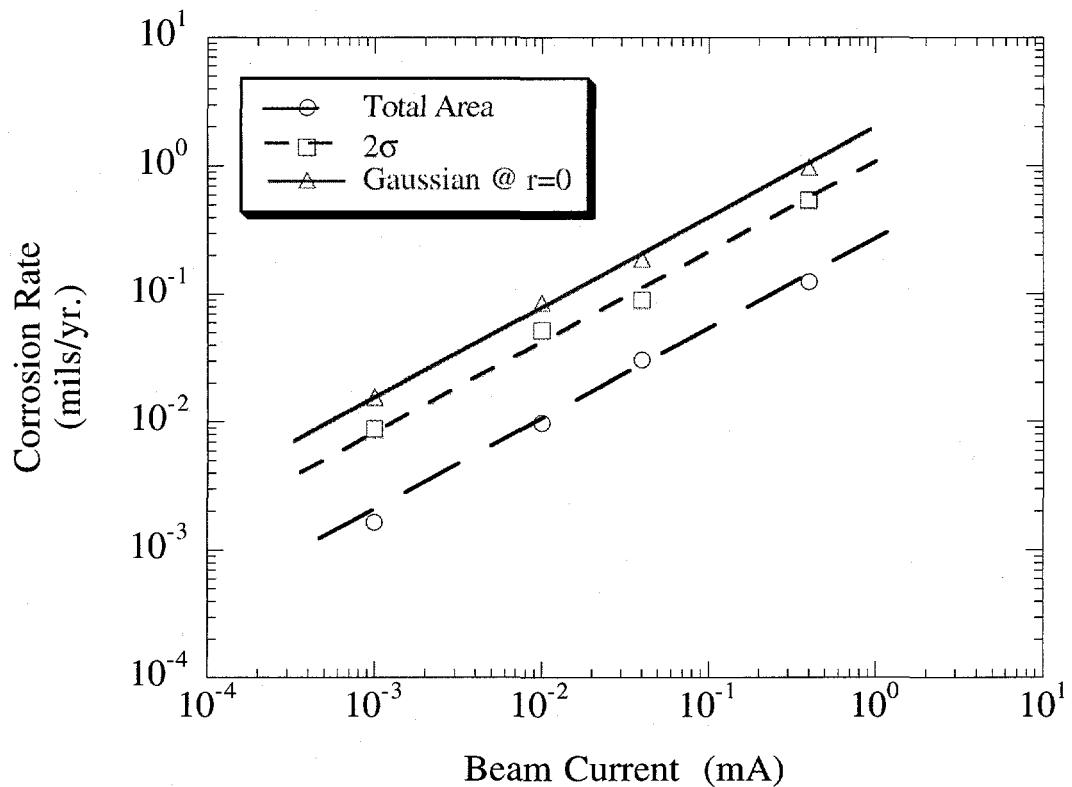
Figure 14 Corrosion rate of in-beam IN718 probe as a function of beam current. Data has been calculated for several assumptions about the corroding area: 1) corrosion was uniform over the entire sample surface, 2) corrosion was limited to, but uniform over an area defined by 2σ , and 3) corrosion was a function of proton flux as defined by Equation 1.

The peak corrosion rates (i.e., at $r=0$) are presented in Figure 14 as a function of beam current. The data points in this plot are the average of three measurements. In addition to the corrosion rates at $r=0$ from the Gaussian distributions, Figure 14 also plots corrosion rate as a function of proton beam current for two other scenarios. The first scenario assumed that the predominant contributor to the corrosion current comes from an area defined by 2σ . Further, it assumed that the corrosion rate was uniform over this area. Specifically, R_p was multiplied by the area $\pi d \times 2\sigma$ where d was the diameter of the probe and equal to 1.3 cm. The second scenario assumed that the distribution of corrosion was uniform across the entire surface. To calculate CR, the measured polarization resistance (R_p) was multiplied by the total probe area (approximately 63.3 cm^2). This rate is non-conservative and should be used to assess the minimum corrosion rate only. As seen in Figure 14, the change in corrosion rate as a function of beam current was similar for all three assumptions and can be defined by the relationship:

where BC is beam current in mA and α is a constant and is dependent of the method used to calculate corrosion rate. The values for α are: 0.25, 0.043, and -0.68 for the Gaussian, 2σ , and total probe area assumptions, respectively as discussed above.

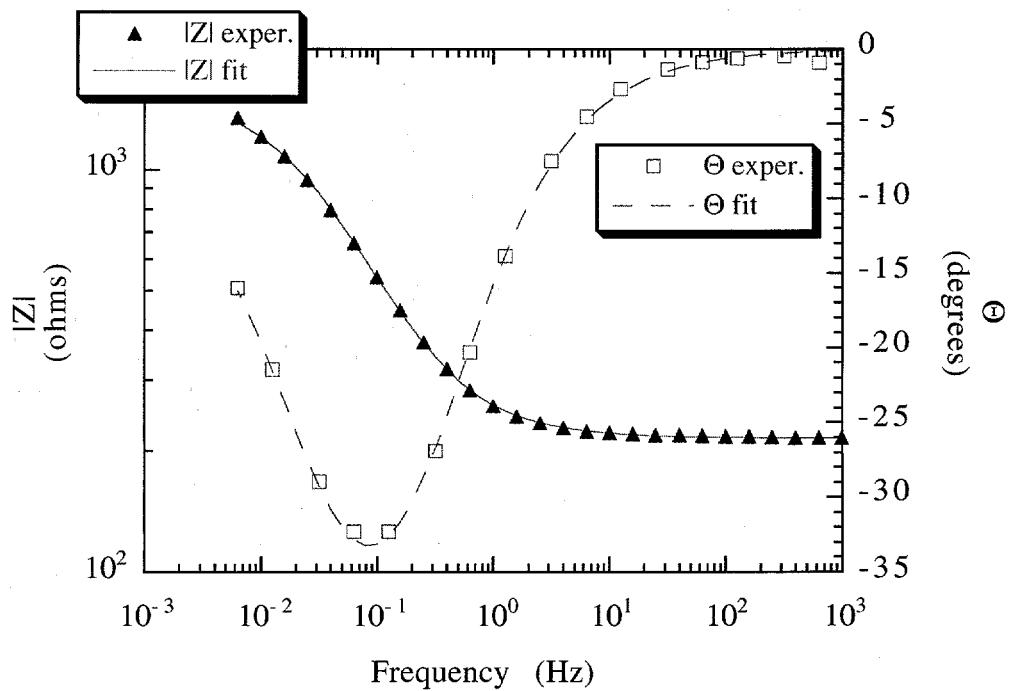
Figure 15 Typical EIS data from the in-beam IN718 probe taken after 1440 hrs of immersion. The Warburg impedance is noted by the change in slope at 0.04 Hz from -1 at higher frequencies to $-1/2$ at lower frequencies. Note, only 20% of the experimental data is shown for clarity.

characteristic response of a capacitor. Below approximately 0.04 Hz the Bode magnitude data has a slope of $-1/2$ which is the characteristic response of a diffusional (Warburg) impedance. Therefore, the data collected after 60 days of immersion was model by a slightly different equivalent circuit than that used for data gathered at earlier immersion times. This EC is presented in Figure 16 where W represents the traditional Warburg type impedance and all other elements are as before (Figure 8). The CNLS fit of the model to the experimental data is also presented in Figure 15. As seen in this figure, excellent agreement between the model and the experimental data exists.

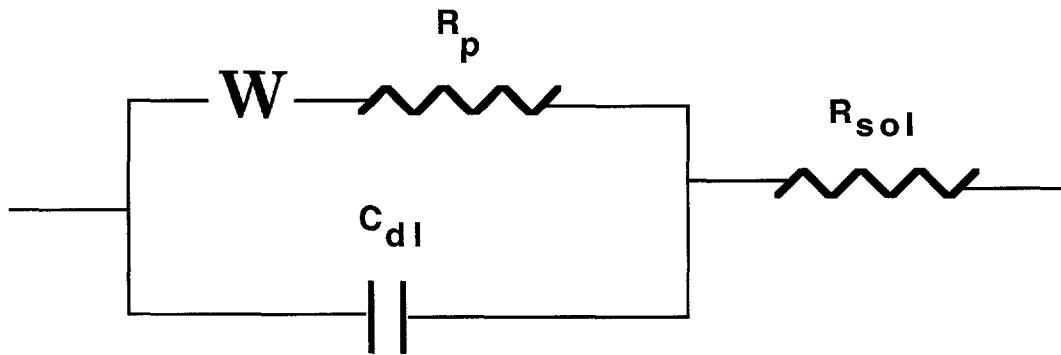
Figure 16 Equivalent circuit used to model the in-beam EIS data at longer irradiation times.

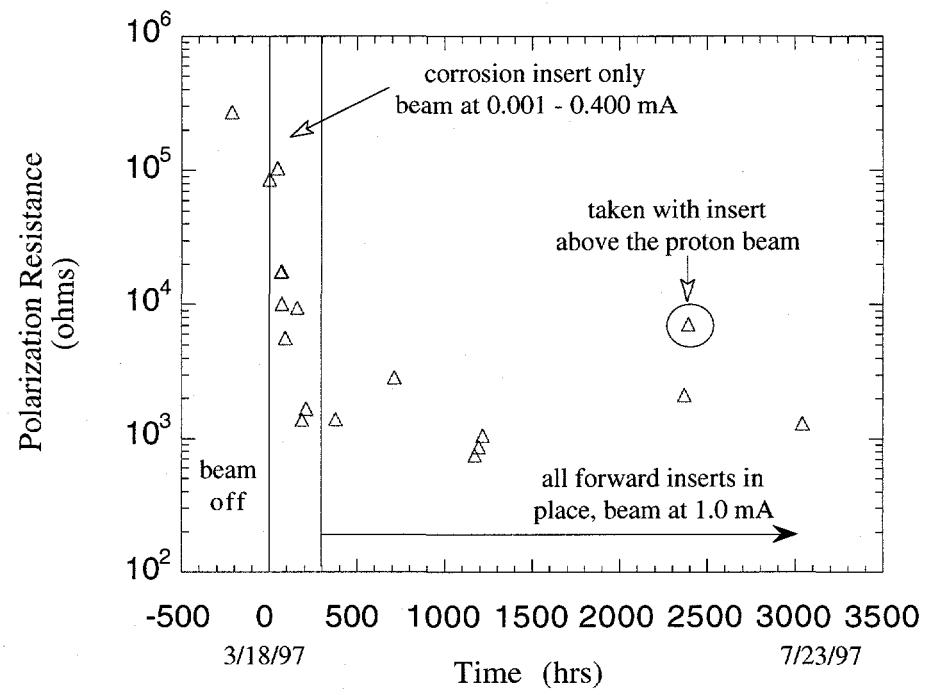
Figure 17 Polarization resistance of the in-beam IN718 probe as a function of irradiation time.

The polarization resistance of the IN718 probe as a function of irradiation time is presented in Figure 17. The data are presented in units of ohms and not $\text{ohm}\cdot\text{cm}^2$ for the reasons addressed above. Although some scatter in the long-term data was observed, R_p remains fairly constant as a function of time with all inserts in place and the beam operating at 1.0 mA. The observation that R_p did not decrease upon increasing the beam current to 1.0 mA (at 300 hrs) is likely due to spreading of the beam after striking the four front inserts. The data taken at 2400 hr with the beam on and the 17B insert raised approximately 1-2 feet above the beam also shows the effect of the 4 front inserts. With the beam on and the insert in place, R_p was 2.0×10^3 ohms. The effect of raising the insert two feet above the beam is seen in the data collected 24 hrs later where R_p was 6.8×10^3 ohms, a value that is only slightly below the scatter. The observation that R_p did not return to its pre-irradiation value is likely due to the spreading of the proton beam and the high neutron flux in this area that arises from the beam striking high Z-number materials (such as tungsten) in the front inserts.

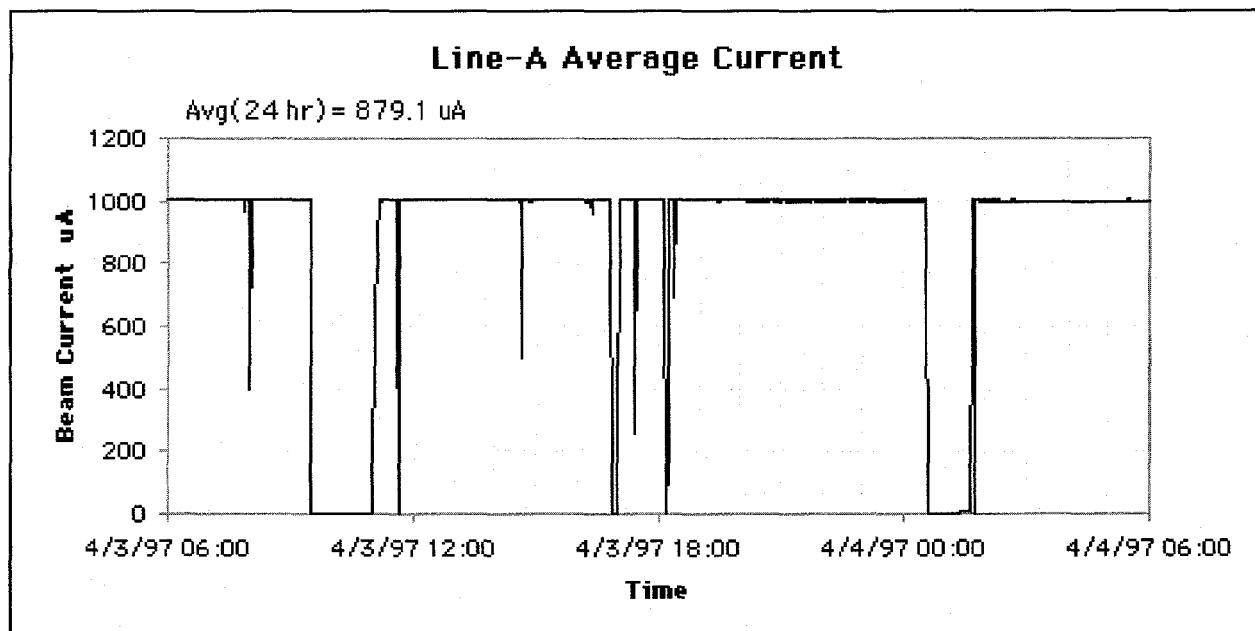
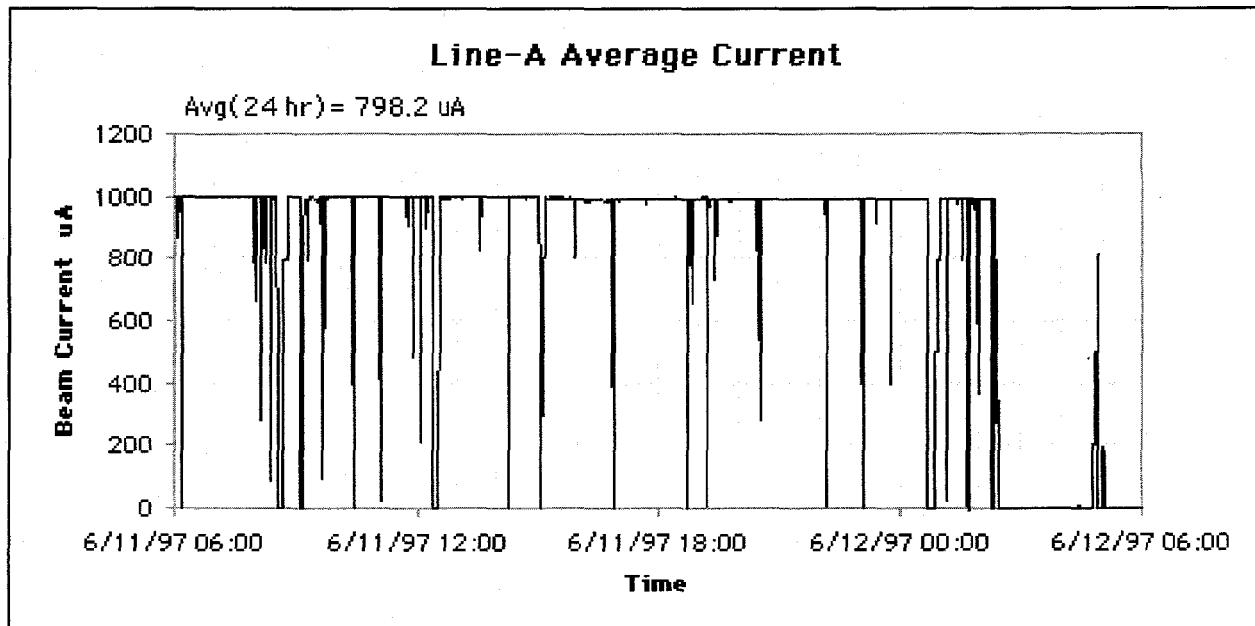
Figure 18 Beam current to the LANSCE A6 Target Station for two 24 hr periods. During **a)-top** early irradiation times beam on/off cycles were less frequent as compared to **b)-bottom** later times in the irradiation cycle. The only data presented in this study were collected during periods where the beam current maintained a steady current over the course of the EIS measurement (approx. 1.75 hrs).

It may also be noted that by the end of the irradiation period beam trips (the on/off cycling of the beam) became very frequent (Figure 18). The only data presented in this study were collected during periods that contained no beam trips.

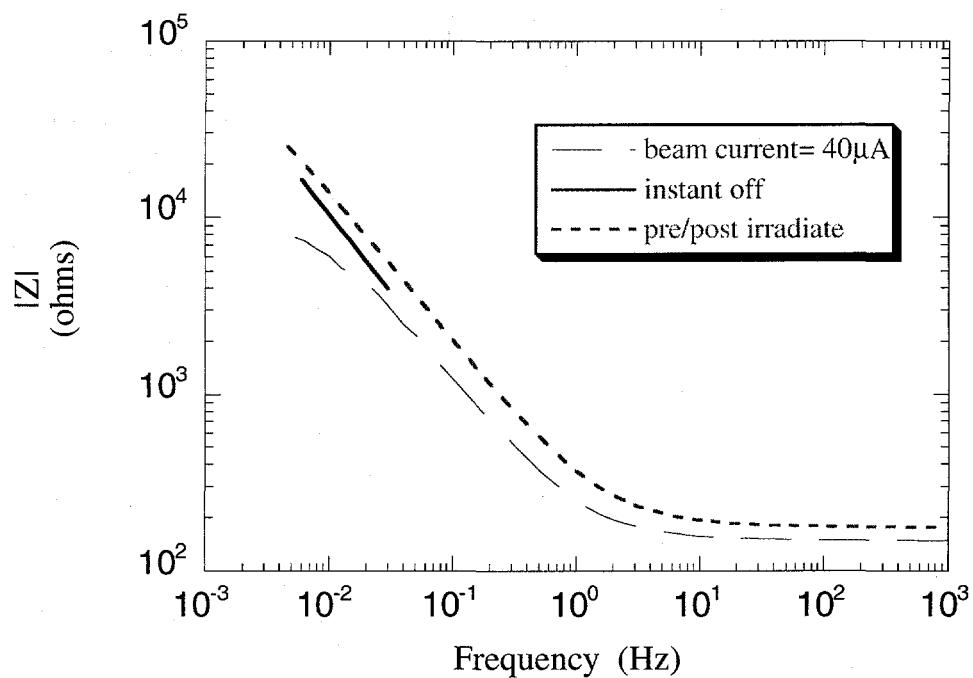
Figure 19 Bode magnitude data for the in-beam IN718 probe (corrosion insert only) showing gradual decay of the impedance to its original pre-beam value after irradiation at 40 μ A.

data and pre/post irradiation data between 0.03 and 1.0 Hz are equal to -1, as anticipated for capacitive behavior. For the instant off measurement, $|Z|$ the magnitude of the impedance ($|Z|$) is greater than the $|Z|$ during irradiation but less than the pre/post irradiation value. Moreover, the instant off data as a slope greater than -1. This behavior is indicative of a changing system, that is, the instant off data was non-steady state and the probe's response became more post-irradiation-like (and consequently less in-beam like) with increasing time after the beam was turned off.

Mechanism 2: short lived radiolysis products. Short-lived water radiolysis products are defined here as those species which are not thermodynamically stable in this water system, such as OH , e_{aq}^- , HO_2 , and O_2^- to name a few. These species do not build up in the system over the course of days or weeks as they typically have a life-time of less than 1×10^{-3} sec before recombining with other radiolysis products. For this reason any effect they may have on corrosion rate would be anticipated to only occur at the proton beam / water / IN718 interface as they are continuously formed and annihilated at this point. As may be anticipated, short lived species should not effect the OCP or corrosion rate of out-of-beam samples. However, the slow decay (> 20 min.) of the in-beam IN718 polarization resistance back to its pre-beam value as seen in Figure 19 would tend to rule this mechanism out.

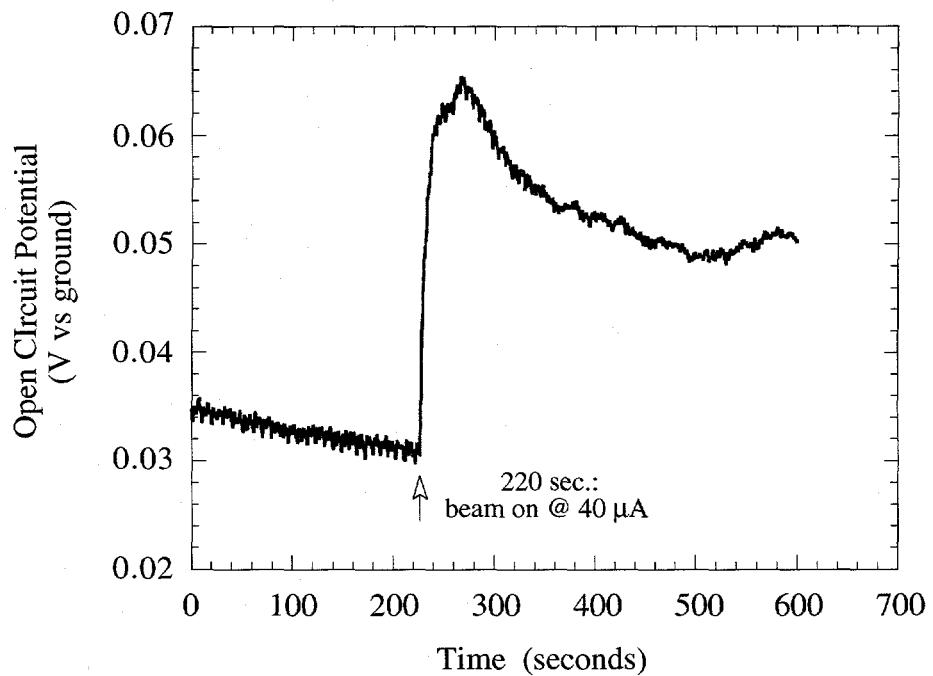
Figure 20 Open circuit potential as a function of time for the in-beam IN718 probe prior to and during irradiation at $40 \mu\text{A}$. Because no reference electrode capable of withstanding irradiation by an 800 MeV proton beam exists, the OCP was measured with respect to the SS304 water system (ground).

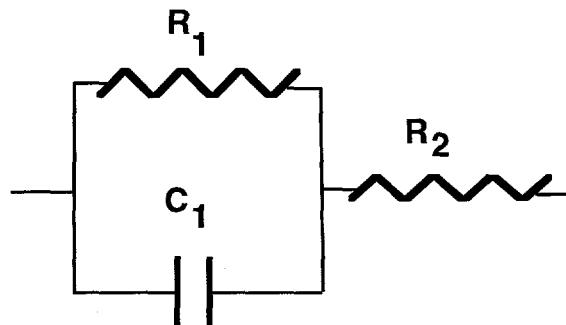
Figure 21 Diagram of the circuit used to verify the calibration of the EIS systems used to make the in-beam measurements presented in this study.

circuit used in these tests simulated an electrochemical response of an electrode in solution (Figure 21). The values used for the components were varied, and chosen to cover the range of values measured during the FY '97 irradiation. Representative Bode magnitude and phase data from the test circuit are shown in Figure 22. Also shown in this figure are the results from a complex non-linear least squares (CNLS) fit to the data. Excellent agreement between the experimental data and the curve fit were observed. A summary of the parameters from CNLS fitting of the data is presented in Table 1. The experimental data in Table 1 is in good agreement with the values of the resistors and capacitors quoted by the manufacturer. As these tests were performed after the '97 irradiation, we conclude that the experimental equipment was functioning properly and the data obtained from the irradiation were reliable.

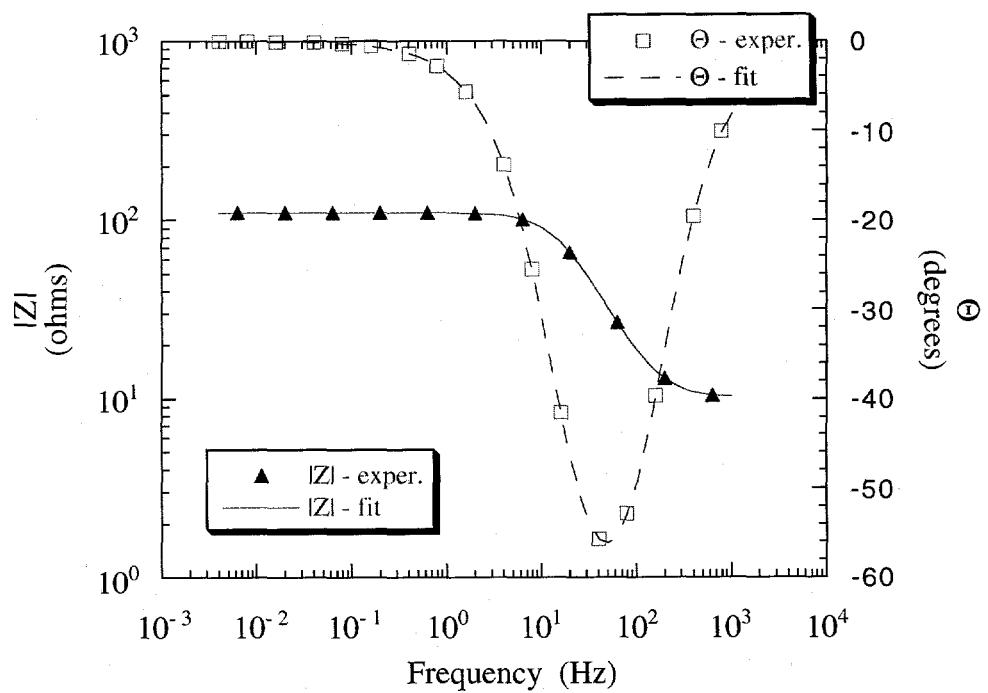
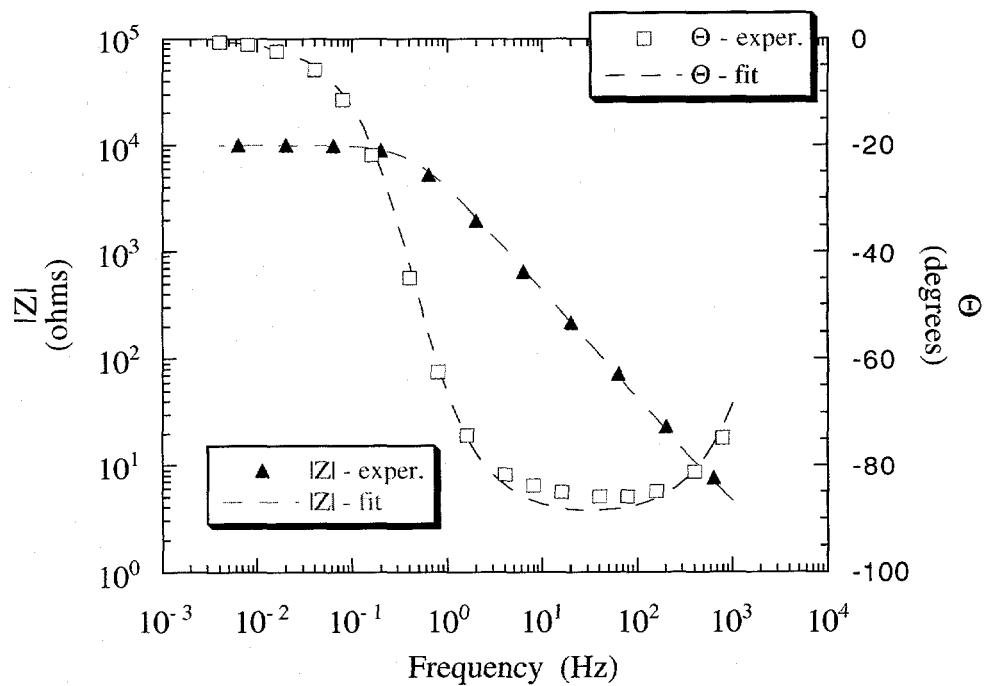
Figure 22 Typical Bode magnitude and phase data from the test circuit of resistors and capacitors (Figure 21) for **a)** $R_1=100 \Omega$, $C_1=1 \times 10^{-4} F$, $R_2=10 \Omega$ and **b)** $R_1=1 \times 10^4 \Omega$, $C_1=3.3 \times 10^{-5} F$, $R_2=1 \Omega$.
