Operating the WAND and HERCULES Prototype Systems

Kathleen M. Gruetzmacher, Charles L. Foxx, and Steven C. Myers

Kathleen M. Gruetzmacher, Los Alamos National Laboratory, FWO-SWO
Charles L. Foxx, Los Alamos National Laboratory, NMT-7
Steven C. Myers, ThermoRetec Inc.

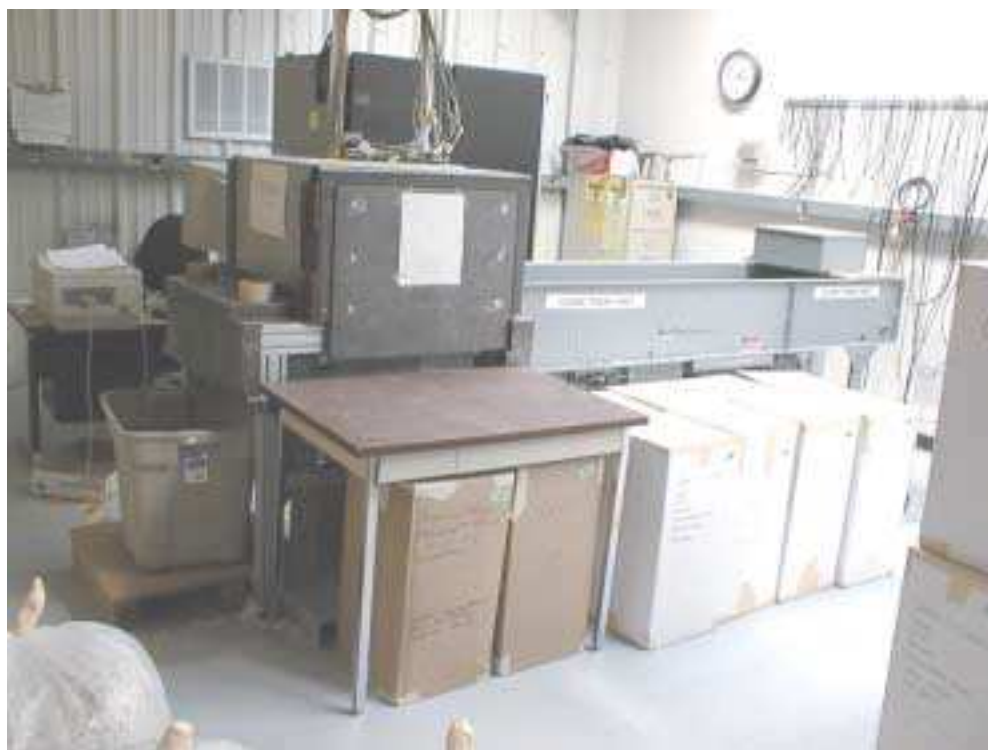
Figure 1. The WAND System. Detectors are housed to the left of the conveyor belt.

the county landfill. Paper that does not pass verification is treated as radioactive waste and the system is decontaminated prior to re-use. Figure 1 is a picture of the WAND system.

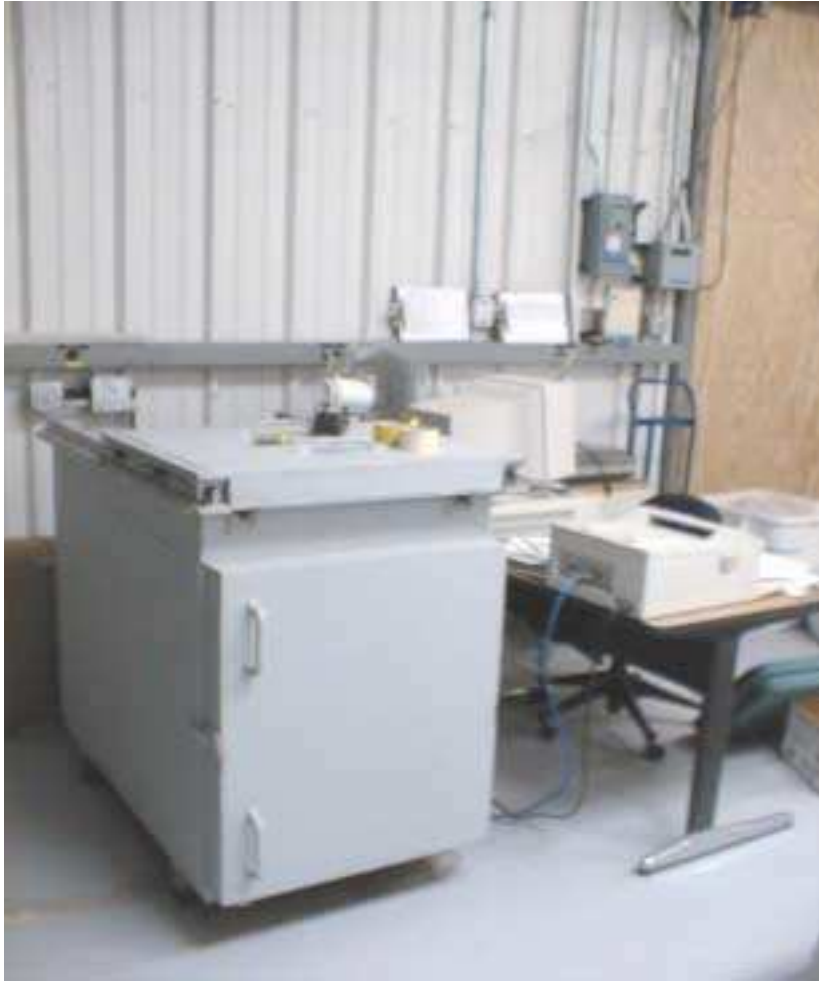
Figure 2. The HERCULES System. Detectors are housed on the near side of the chamber, waste is placed on the far side.

The HERCULES system was designed to maximize detection sensitivity for the same radionuclides as the WAND system (e.g., Am-241, Pu239, U-235, U-238). HERCULES assays a variety of low-density waste including paper, plastics, wood, and cloth. This system consists of a bank of three shielded detectors that screen the waste in 2 ft³ (0.06 m³) cardboard boxes or in bags placed in a plastic 30-gallon (114 liter) drum on a turntable. The detector array is located 1.5 inches (3.8 cm) adjacent to the rotating drum with the detectors evenly spaced in the vertical plane. Both the detector array and the assay chamber are shielded with lead and lined with 1/32 inch (0.8 mm) copper and cadmium sheets. Waste that passes the verification step is put into a dumpster outside the building, which is destined for the county landfill. Waste that does not pass the verification process is handled as radioactive waste. This waste can be examined within the facility to determine the type and quantity of the contamination and its origin within a waste container. Corrective actions are undertaken with the waste generator to upgrade their AK. Figure 2 is a picture of the HERCULES system.

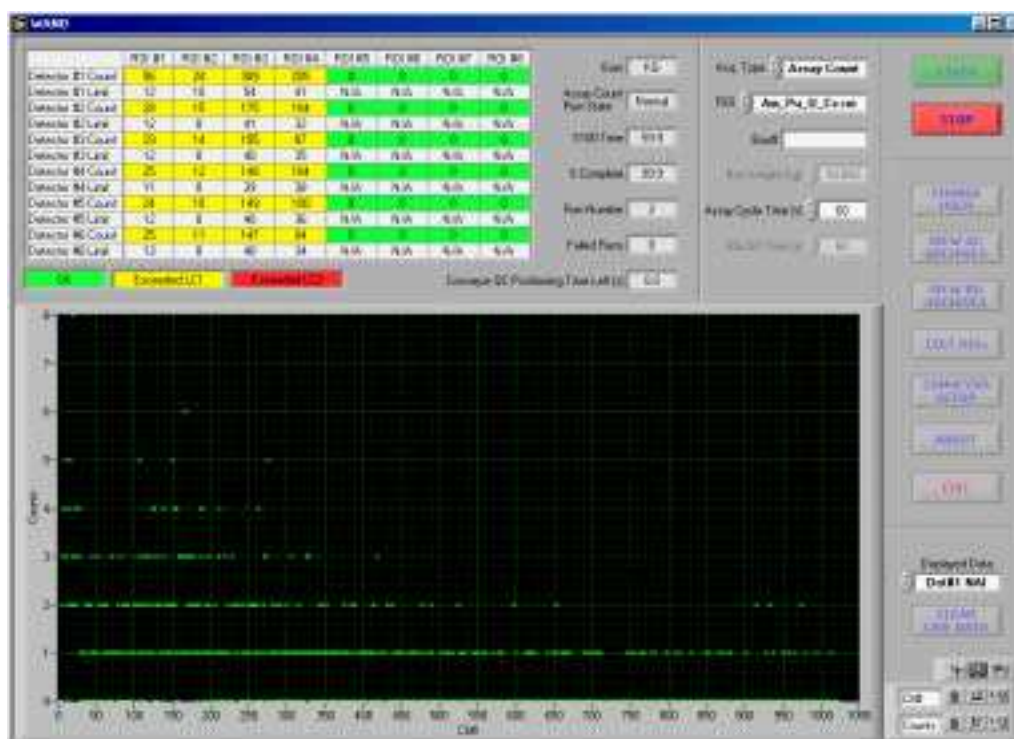
Figure 4. Detail of NaI spectrum from Detector #1 on a WAND system assay of a known plutonium source with an artificially long count.
