# Expert Panel Recommendations for Hanford Double-Shell Tank Life Extension

C.W. Stewart, Editor

June 2001

Prepared for the U.S. Department of Energy  
Under Contract DE-AC06-76RL01830

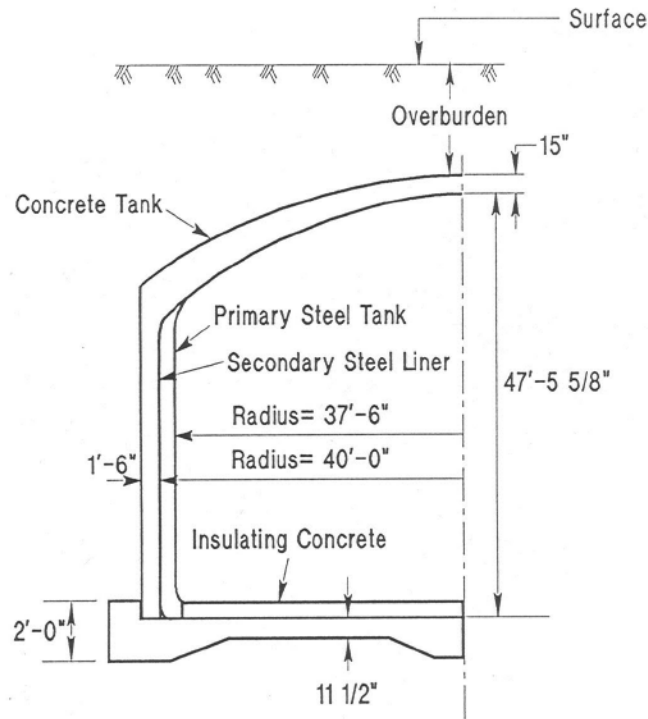
**Figure 1.2.** Cross-Section of a Typical Double-Shell Tank

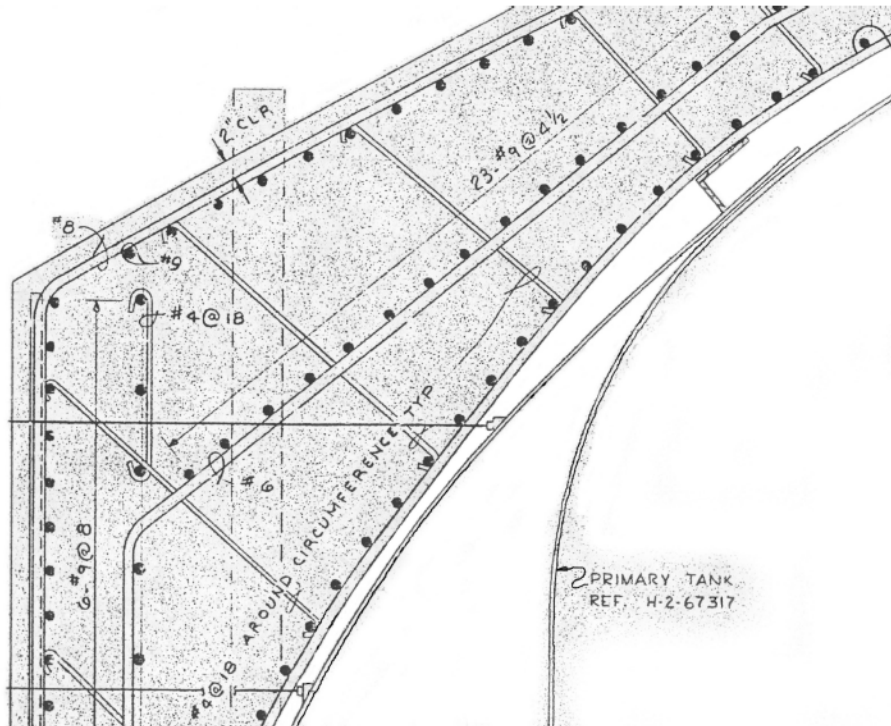
**Figure 1.3.** Interface of Primary and Secondary Liner in Haunch Region

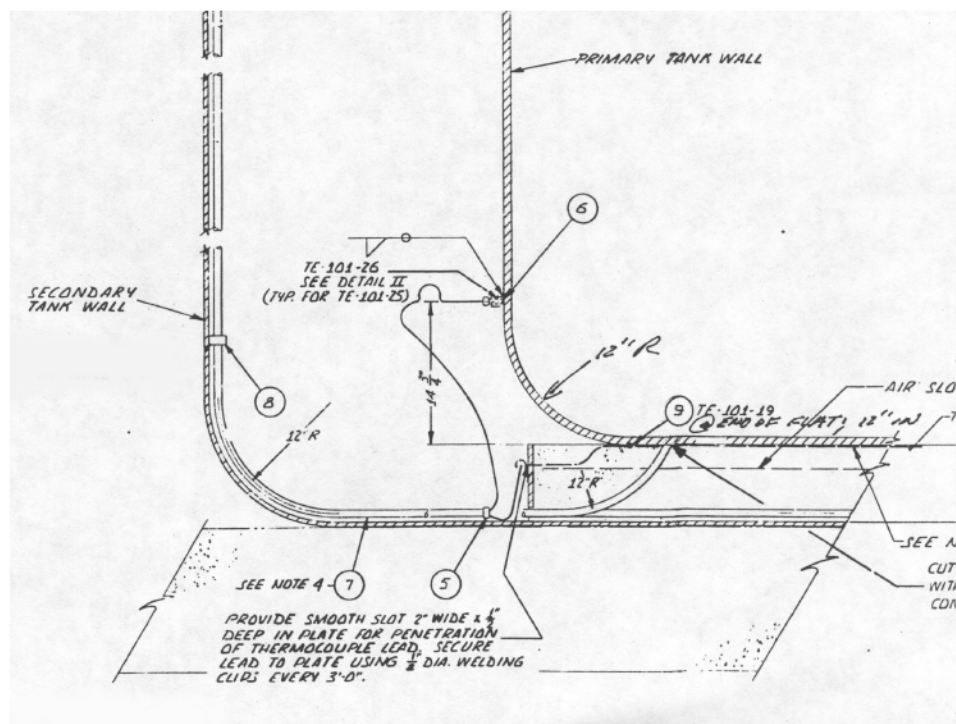
**Figure 1.4.** DST Cross-Section in Lower Knuckle Region

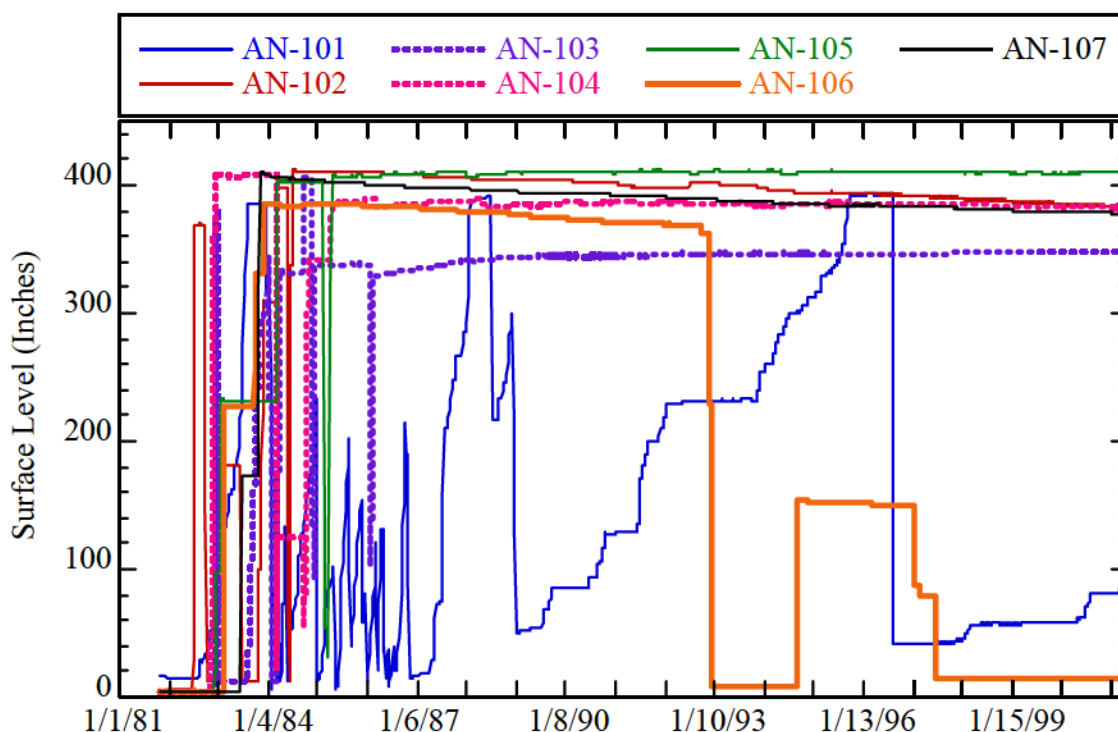
**Figure 1.5.** Level History of Tanks in the AN Farm

Figure 1.5 shows that the waste level has been essentially static in all but two of the tanks in the AN farm. Tanks AN-102, AN-103, AN-104, AN-105, and AN-107 show essentially no level change since 1986 or before except for small additions of flush water and normal evaporation. (AN-103, AN-104 and AN-105 have been on the Flammable Gas Watch List [FGWL], which precludes waste additions.) The most operationally active tank in this farm is AN-101, which has seen multiple transfers of SST waste since 1994. Transfers in AN-106 have been mainly DST waste to and from AP and AW farm tanks. AN-106 has been essentially empty since 1997.

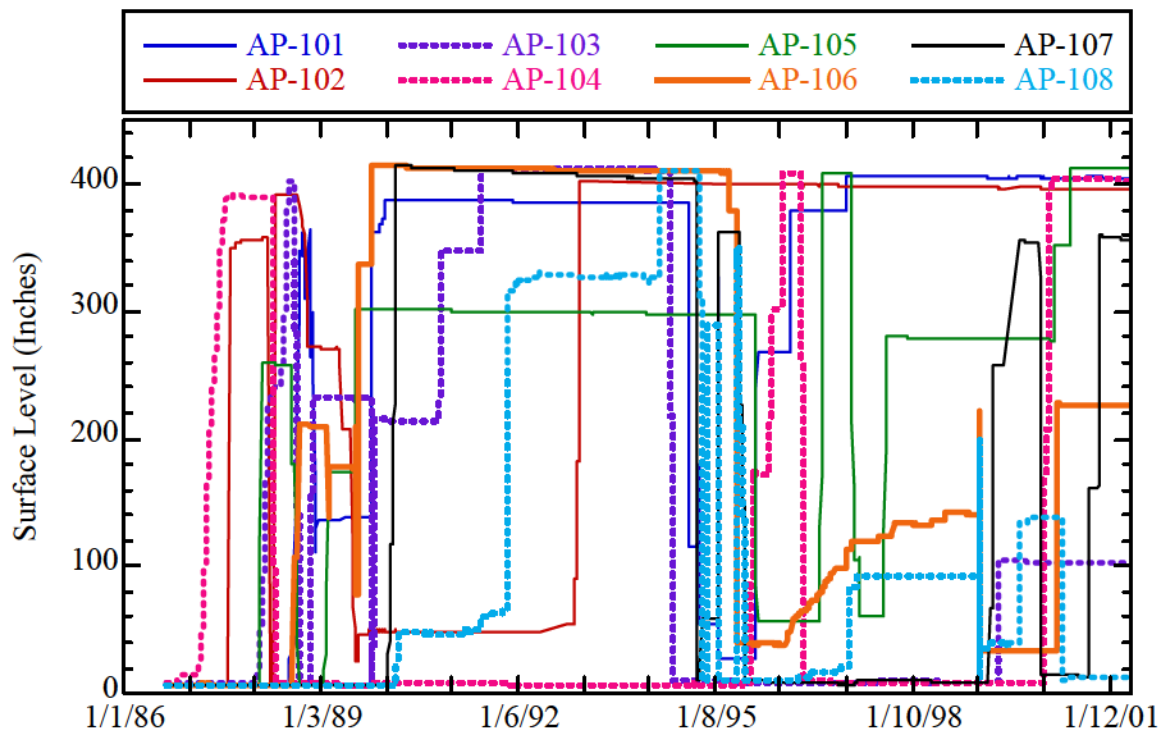
**Figure 1.6.** Level History of Tanks in the AP Farm

The other four tanks in the AP farm show multiple transfers. AP-103 was emptied out in 1994, and since then has received only one major transfer, in early 1999, which filled it to about 24% of capacity. AP-108 shows a similar history except that it was again emptied in 1999 and has not been refilled since then. AP-106 and AP-107 show the most activity of all tanks in the AP farm,

with many small transfers of waste from miscellaneous sources, including B-Plant, S-Plant, and T-Plant, and 300 and 400 Area waste, as well as transfers to and from other DSTs.

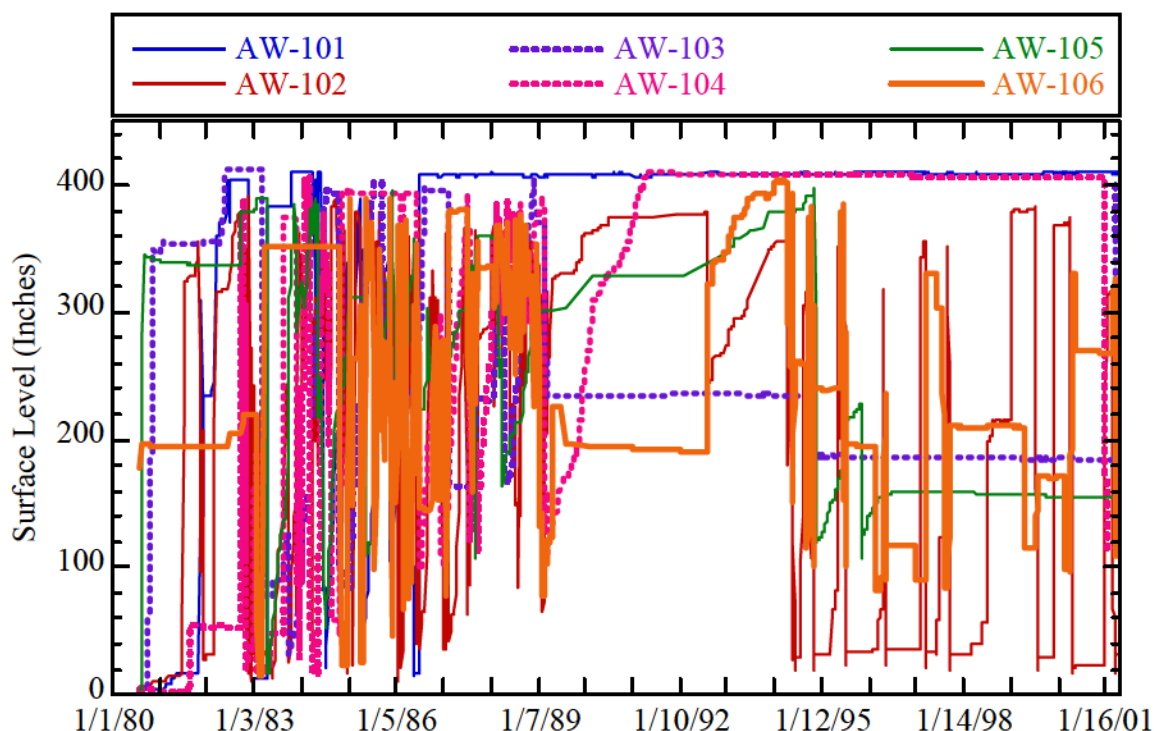
**Figure 1.7.** Level History of Tanks in the AW Farm

There was a relatively large number of transfers to and from AW-105 up until 1995, after which it was emptied to approximately 37% of its capacity in a series of transfers completed by the end of 1996. Since then, there have been no significant level changes in this tank. In contrast, AW-102 and AW-106 have seen almost continual transfer activities throughout their service life, experiencing level changes of over 50% on at least a yearly basis. AW-102 is nearly empty, and AW-106 is filled only to about 26% of capacity.

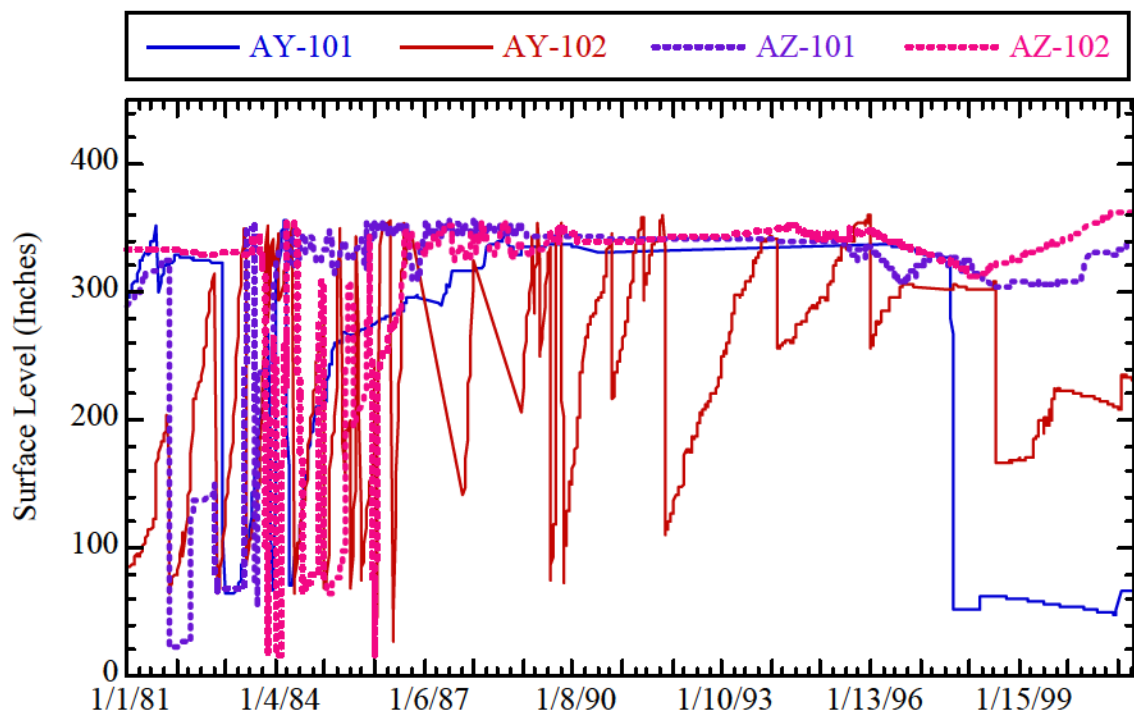
**Figure 1.8.** Level History of Tanks in the AY and AZ Farms

Figure 1.8 shows the level history for the four tanks in the AY and AZ farms. Until late 1988, AY-101 was receiving saltwell liquor from the SSTs. It has been relatively stable since then, with only small caustic and water additions. A large volume of AY-101 waste was transferred to AW-101 in 1997. There have been no big changes since then. Activity in AY-102 has been almost continuous throughout its service life, with many small transfers, including B-Plant, S-Plant, and 300 and 400 Area waste. In 1998–99, the waste in C-106 was transferred to AY-102 in a series of sluicing operations (Cuta et al. 2000), bringing the waste to its present level. The two AZ farm tanks were filled nearly to capacity by 1987 and have been relatively stable ever since. The level increases from 1994 on are due mainly to flush water additions. All decreases in waste level since 1989 in Tanks AZ-101 and AZ-102 are ascribed to evaporation or instrumentation changes.

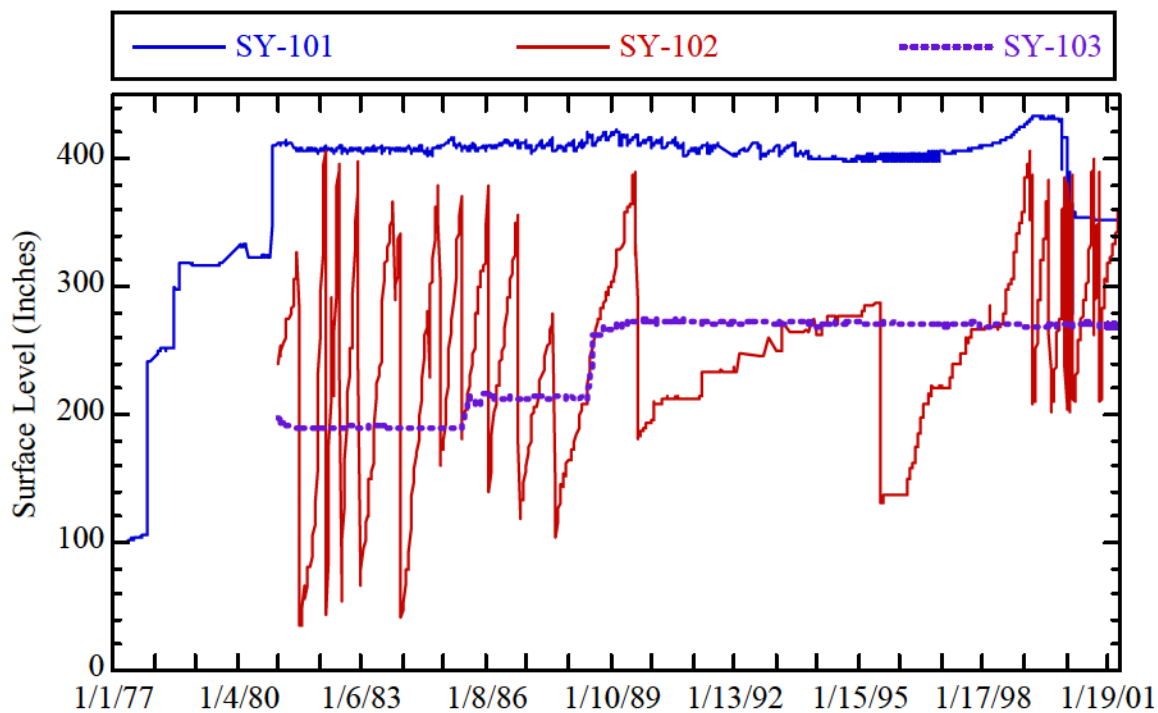
**Figure 1.9.** Level History of Tanks in the SY Farm

Figure 1.9 shows the level history of the three tanks in the SY farm. The level history of SY-101 shows oscillations of 6 to 12 inches starting shortly after it was first filled in 1981 and resulting from buoyant displacement gas release events (BD GREs) that were mitigated by the installation of a mixer pump in 1993. The level rise due to uncontrolled crust growth, which became a safety issue in 1997, is shown to be remediated finally by the series of transfers and back-dilutions with water in late 1999 and early 2000 (Mahoney et al. 2000). The level history of SY-103 also appears very stable, with only two noticeable additions (in 1985 and 1988) since initially being filled in 1981. There has been no significant level change in this tank since 1989 except for smaller peaks from BD GREs that still occur. In contrast, SY-102 served as a staging tank for cross-site transfers to the DSTs in the 200-East area. It has also received waste from many other sources, including saltwell liquor from the 200-West area SSTs, PFP labs, S-Plant, 222-S Laboratory, and double-contained receiver tanks, as well as SY-101 waste.

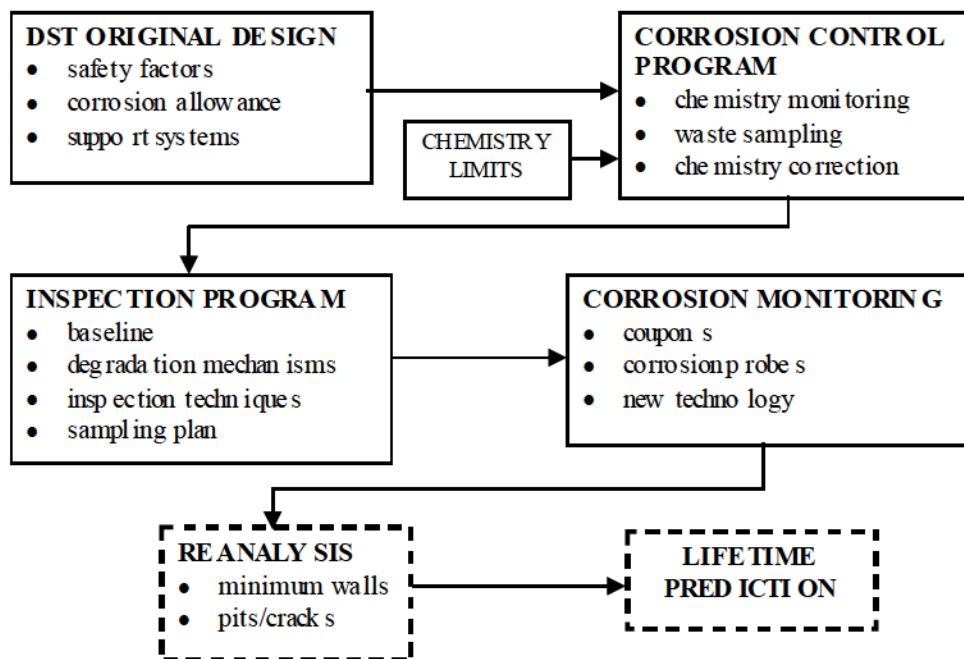
**Figure 1.10.** Components of the DST Integrity Program

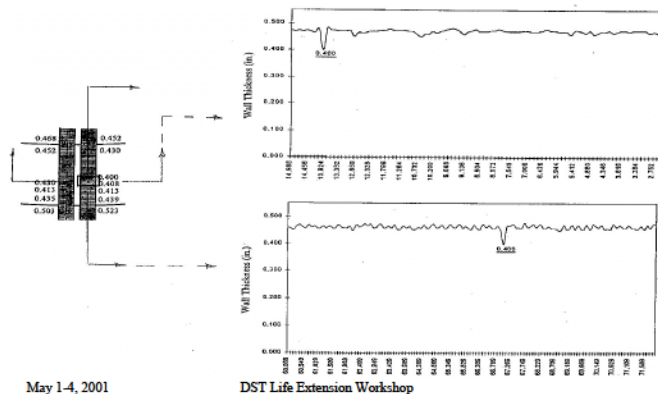
# AN-105 "Pit-Like" Indication (horizontal and vertical cross sections)

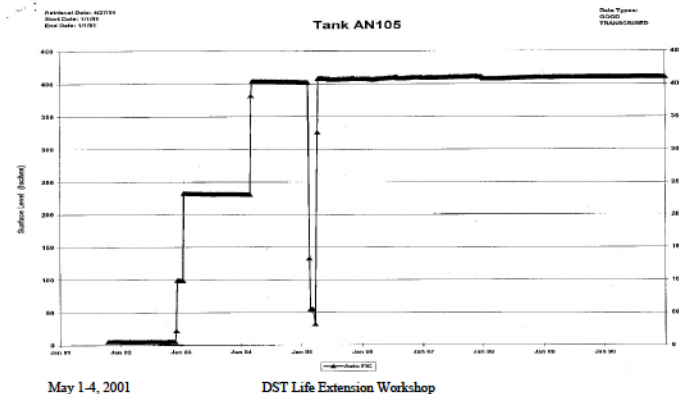
# AN-105 Liquid Level (Jan '81 through Jan '91)

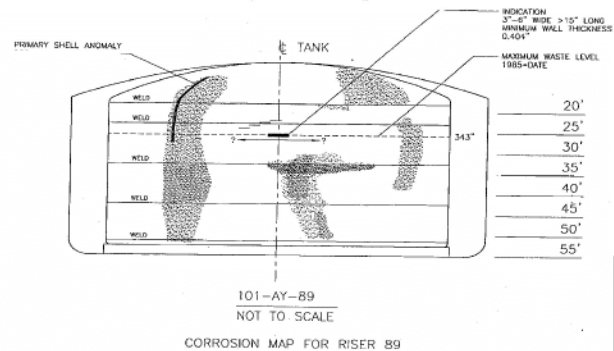
### AY-101 Wall Thinning Illustration ("Corrosion Map for Riser 89")

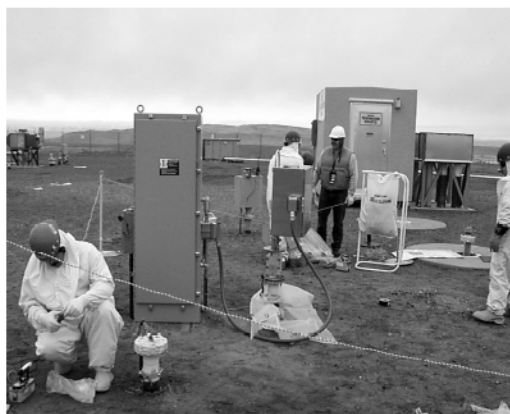
### 4<sup>th</sup> Generation Probe for AN-104

Field installation: Outdoor cabinet with probe and indoor cabinet

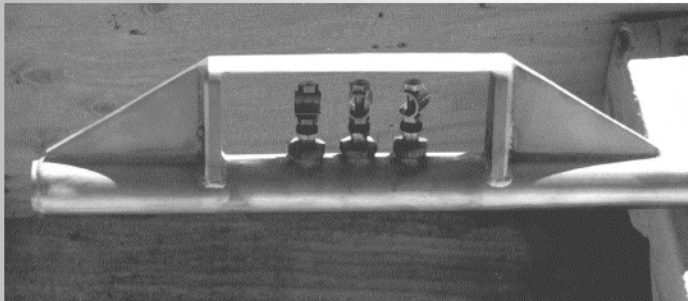
## AZ-101 System Electrodes

- System worked well in field for two years
- System detected pitting during water additions
- Gasket material/design caused concern
- Voltage sensitivity issues (+/- 0.1 mV)
- Multiplexed vs. simultaneous data collection
- Remote operating system absolute mess
- Need better range of available depths
- Communications with operations personnel

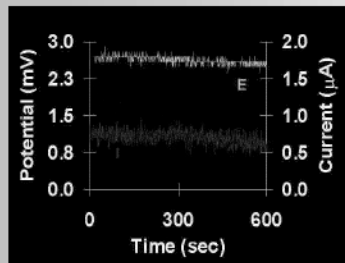
## AZ-101 Raw Data

2 days prior to 26,000 gal H<sub>2</sub>O dump

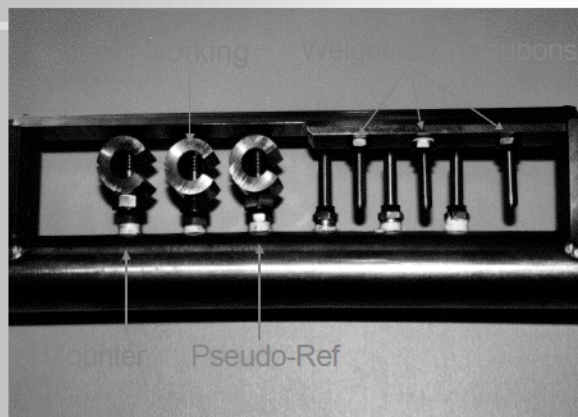
## AN-107 System Electrodes

- Moved to larger pre-cracked C-rings
- Improved remote access system
- Corrected shortcomings in voltage sensitivity
- Achieved full range of tank depths
- Electrostatic interference common to all channels
- Gasket material/design concerns
- Excessive signal loss down long lengths of cable
- Y2K non-compliant hardware
- No funding provided for data analysis following installation

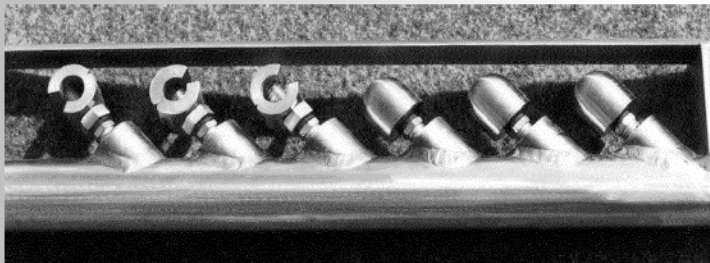
## AN-102 System Electrodes

- Second full-scale probe: approximately 55 length
- 1" schedule XXS 304L pipe 4" riser
- 4 channels of C-ring and 4 channels bullet electrodes
- 44 cm<sup>2</sup> C-rings, 10 and 25 cm<sup>2</sup> bullets
- Angled mounting ports for electrodes
- 300' above ground cabling, grounded shield
- Windows based software, no remote access
- Simultaneous 8-channel data collection, EN & LPR

- Angled mounting ports helped wiring and install
- Simultaneous EN and LPR on 8 channels
- Specialized software for plotting/data analysis
- Electrostatic interference and signal loss in field common to all channels on 300' analog data cable
- Gasket design issues persist
- Lack of timely funding for AN-107 led to build of AN-102 system with similar cabling/data transmission issues

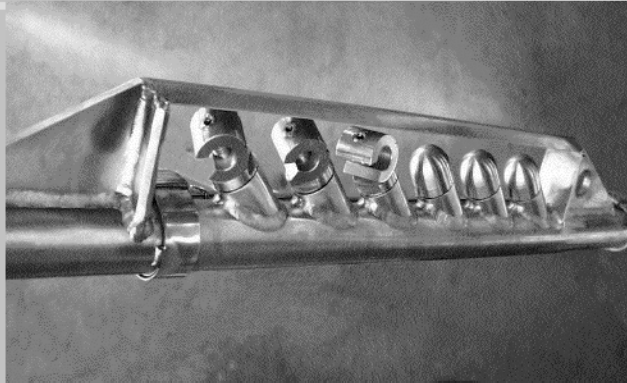
## AN-105 System Electrodes

- 55' in length, 1 schedule XXS 304L pipe 4" riser
- 44 cm<sup>2</sup> C-rings, 25 cm<sup>3</sup> bullet electrodes
- Angled mounting ports for electrodes
- New dual gasketed, round-cut O-ring design
- Moved data collection hardware to field table
- Driven screens on each channel
- 1 analog cable with 18 individually shielded pairs
- Analog signal converted to digital before transmit
- 22 thermocouples, 3 gas sampling ports, adjustable collar, set of strain gauges

- System now functioning as designed
- Returning full-time EN data with periodic LPR
- System hardware proven to be field hardy
- Internet based remote access system very stable
- System showing primarily uniform corrosion
- System showing *uniform* corrosion rate of  $\sim 0.3$  mpy
- Occasional system hang demands instrument techs
- Driven shields improperly applied/removed 4/00
- System showing occasional voltage EN pitting transients on channels 7 & 8

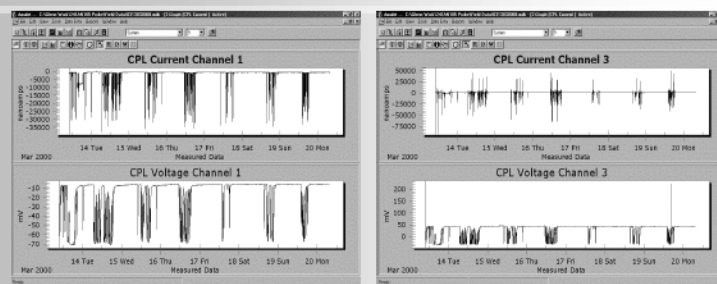
## Data With Driven Screens

Vapor space channel

Liquid phase channel

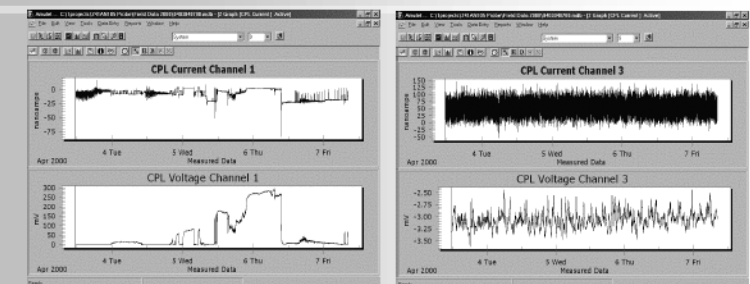
## Data Without Driven Screens

Vapor space channel

Liquid phase channel

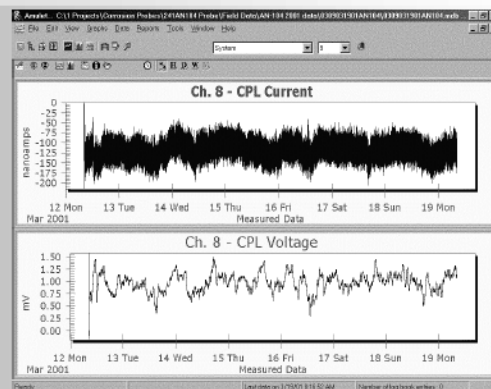
## AN-104 Typical Data

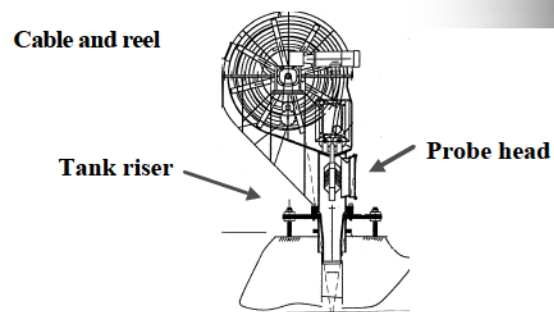
### *SRS Corrosion and Chemistry Probe* **Deployment Assembly Schematic**

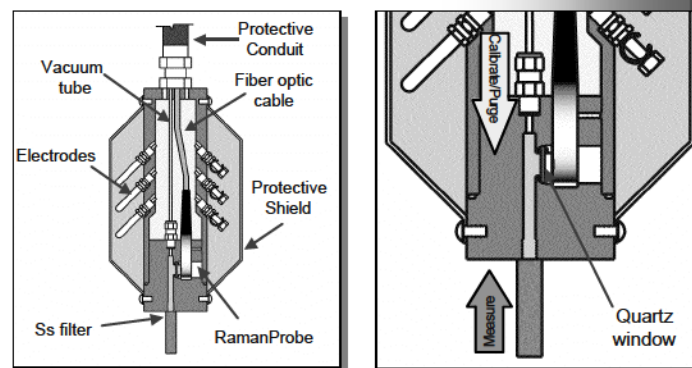
### *SRS Corrosion and Chemistry Probe* **Probe Head Design**

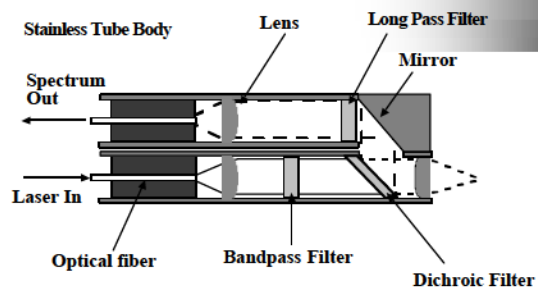
### *SRS Corrosion and Chemistry Probe* **Raman Probe Schematic**

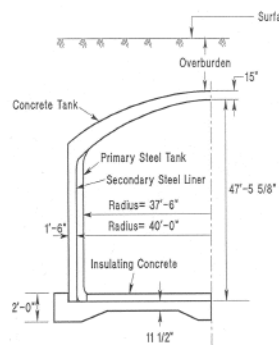
## DST Design

- Carbon steel fully-enclosed primary inner tank contains waste
  - 75-ft diameter by 46 ft 9 in. tall.
  - Anchored to dome of concrete structure.
  - Welded (full penetration) steel plates.
  - Welds stress relieved (1,100 °F for 1 hr/in. of thickness) to mitigate nitrate-induced stress corrosion cracking (SCC).
  - Weld examination (100% x-ray, magnetic particle).
  - Hydro leak test (39 ft of water for 24 hr).
- Carbon steel secondary liner.
  - Provides containment barrier if primary tank should leak.
  - Anchored to wall of concrete structure.
- 8-in. thick insulating concrete pad with radial air flow passages and surrounded by steel ring.
  - Protects foundation concrete during stress relieving and operation.
- Reinforced concrete outer tank.
  - Resist soil and surface live loads.
- Reinforced concrete foundation with drain slots connecting to leak detection system.

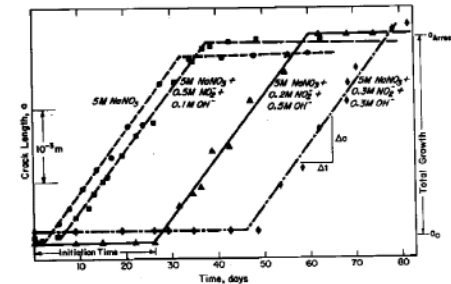
FIGURE 11. Crack Length as a Function of Time<sup>18</sup>
