# A Systems Approach to Retrofitting Residential HVAC Systems

*J.A. McWilliams and I.S. Walker*

**Environmental Energy  
Technologies Division**

**May 2004**

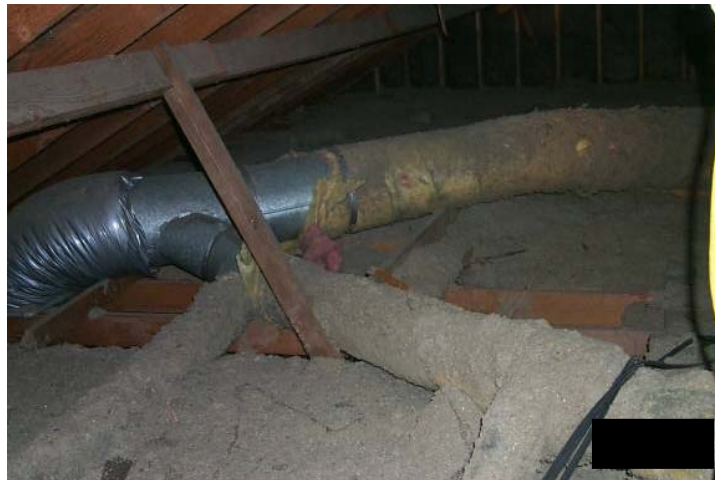
**Figure 2. Poorly insulated sheet metal ducts and blown-in insulation in the attic before retrofit**

attic, with RSI 4.5 (R-26) glass fiber insulation between the 50 mm by 200 mm (2 by 8 inch joists) on 40 cm (16 inch) centers. The house had the following combination of problems: low-efficiency heating and cooling equipment, leaky (see Figure 1) and poorly insulated ducts (see Figure 2), low air handler flow, low refrigerant charge, and a leaky exterior envelope. In addition, the air handler, furnace, cooling coils and most of the duct system were located outside the conditioned space in the garage and attic. A few major components of the shell leakage were easily identified in this house: several large mechanical chases were open to the attic, and a building cavity return was open to the garage and the attic. The HVAC system was undercharged and operating at only two-thirds of its rated capacity. Lastly, the homeowner reported problems in cooling the upstairs of the house.

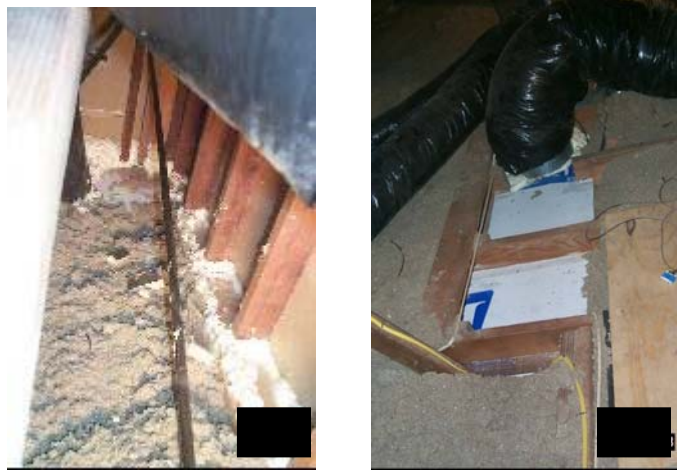
**Figure 3. Sealing cavities connecting the house to the attic. Foam was used for sealing small holes and cracks at building component intersections (left). Duct board insulation was used to block off large open areas (right)**

The sealing of the envelope was very successful – mostly because this particular house had significant large leaks that we were able to access. We sealed over 570 L/s (1200 cfm) of leakage at 50 Pa (0.2 in. water)) - about one-quarter of the total leakage. The sealing included: air-sealing the attic floor plane (2 large chases) as shown in Figure 3, leaks between the old cavity return (which communicated with the garage) and the conditioned space, and plumbing penetrations in the conditioned space.

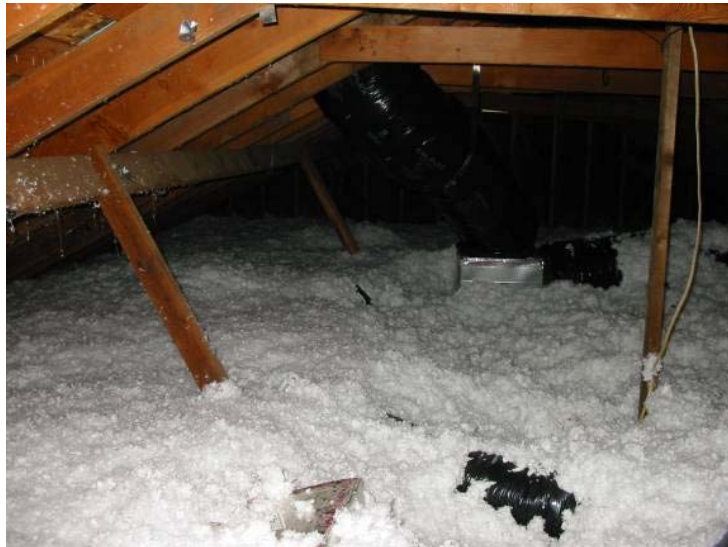
**Figure 4. New flex ducts in attic covered by additional blown-in insulation.**

- The metal ducts in the attic were replaced with new R-4 flexible ducts (despite clear and repeated instruction to retain the original ducts) because the contractor thought they were undersized. Initially the contractor hung the flex-ducts from the attic ceiling with smooth bends. However, to allow covering the ducts with insulation the contractor then placed the new ducts on the floor, but unfortunately did not take the time to lay the ducts with smooth bends.
