Sealing Large-Diameter Cast-Iron Pipe Joints Under Live Conditions

**Quarterly Report
June 25, 2004 – September 24, 2004**

***By:*
Kiran M. Kothari
(Gas Technology Institute)
and
Gerard T. Pittard
(Maurer Technology Inc.)**

DE-FC22-02NT41316

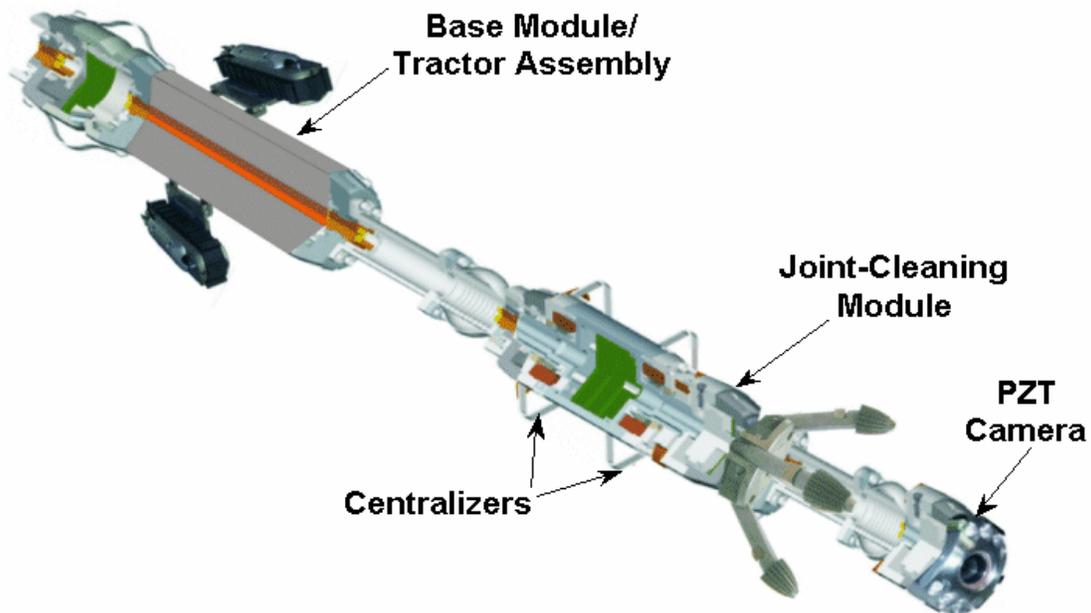
Figure 1. Pipe Wall Preparation Robot Train

Based on the analysis completed to date, two in-pipe robot trains will be required. The first robot train has a front-mounted camera that is used to visually locate each bell and spigot joint (**Figures 1 and 2**). Directly behind this camera is a counter-rotating brushing module whose function is to remove debris from the pipe wall within the cast-iron bell and spigot joint. This module will now be fitted with a retractable brush to remove debris piles from the immediate vicinity of the joint. The third and final module consists of a combination base/supplemental locomotion module. The base module provides all power and micro-controller control of the camera and brush modules. The supplemental locomotive will be used to provide additional axial movement forces as necessary.

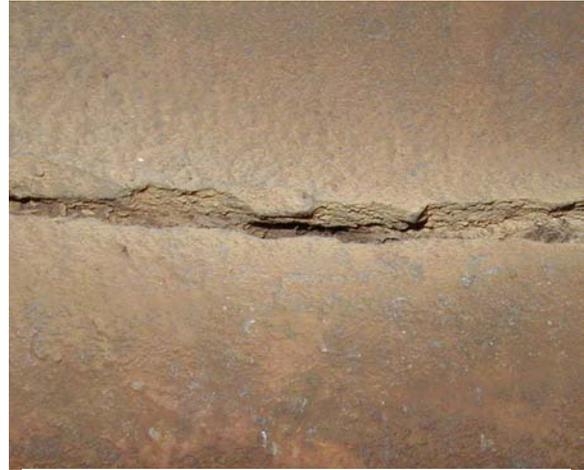
Figure 2. Camera's View of Bell and Spigot Joint Seam

In operation, the camera/brush/base module train will be pushed by the CT to the farthest cast-iron bell and spigot joint to be repaired from a given launch location. The brushing module will then be activated to clean the joint by moving the brushing assembly back and forth across the joint location. Proper cleaning of this joint will be visually confirmed by the operator through the camera and may require one or more passes depending on the amount and tenacity of the debris coating the pipe wall. The CT unit is then used to withdraw the train back to the next joint where the cleaning process is repeated. This sequence is continued until all joints have been prepared for patching and the pipe-wall preparation train has been brought back into the pipe-access fitting and withdrawn from the main.

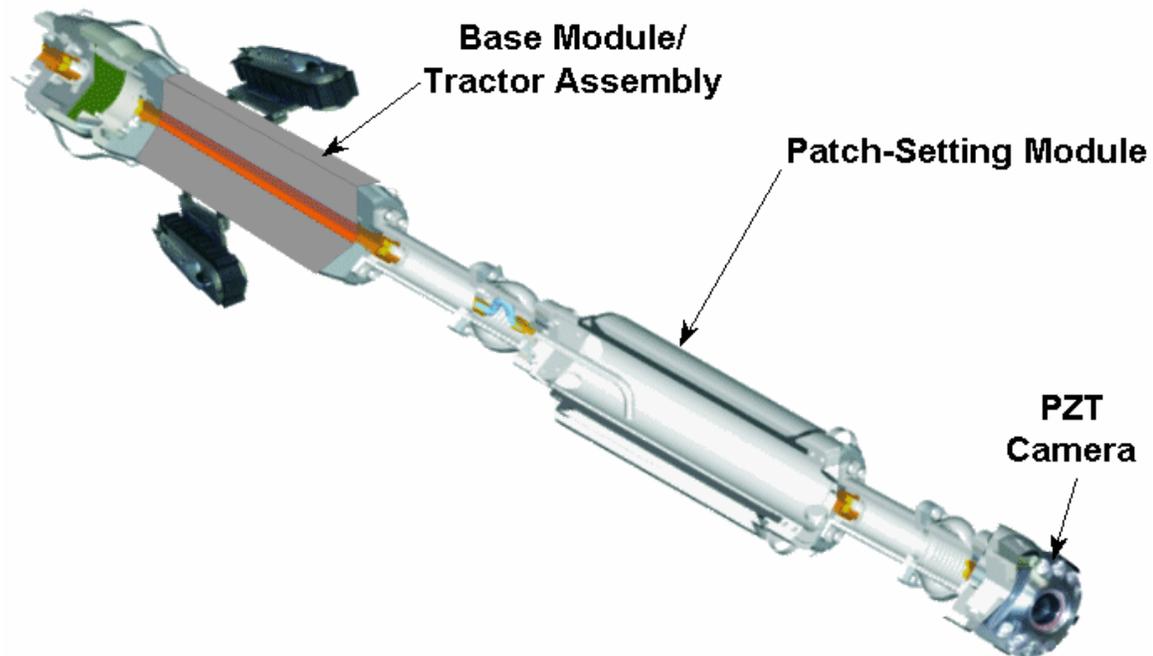
Figure 3. Patch-Setting Robot Train

The brush module is then removed from the train and replaced with the stainless-steel patch-carrier/patch-setting module (**Figure 3**). The stainless-steel sleeve is slid over the carrier along with its polymer sleeve and polyester felt, which has been saturated with epoxy. The CT unit is then used to deliver the patch-setting train to the most distant bell and spigot joint. This location is confirmed both with the quadrature encoder footage counter and visually with the camera. Once the camera is located exactly at the bell and spigot-joint gap, the fine-resolution odometer on the camera is set to zero. The CT unit is then used in conjunction with the camera's odometer to move the patch setting train forward by a known, fixed distance which assures the

patch is properly aligned with the bell and spigot joint. A control command is then issued from the surface unit to the base unit to release nitrogen from a stainless-steel pressure vessel on-board the patch-setting module into its expandable rubber bladder. This causes the bladder to inflate and locks the stainless-steel sleeve into position via its interlocking, ratcheting barbs. The epoxy is allowed to cure and reaches full strength within 12 hours. During the interim, a gas-tight seal is assured by the polymer sleeve which has been energized against the joint by the hoop stress of the stainless-steel sleeve. (Note: The volume and rate at which the nitrogen is bled from the inflation bladder results in no appreciable dilution of the BTU quality of the natural gas.)

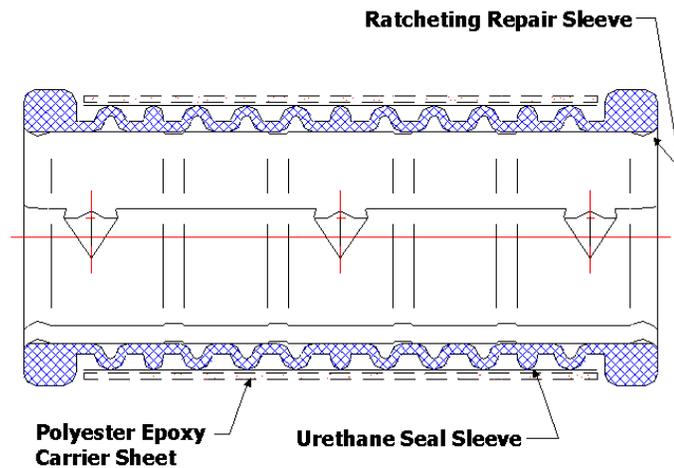
Figure 4. Ratcheting Repair Sleeve

Figure 4 illustrates the critical design features. A 28-gage, corrugated stainless-steel sleeve (316 SS) is used as the innermost member. Its function is to provide a mechanical means for energizing the urethane seal sleeve against the cast-iron wall to form the first leak seal and to allow the epoxy-saturated polyester carrier to cure to form a second (redundant) leak seal.

The sleeve gage (28) is a reduction from the 24 gage normally used. Its use will enable the sleeve to be coiled in a smaller diameter without yielding. Preliminary analysis indicates that the design can be rolled into a diameter of about 55% of the pipe ID versus 75 % of the pipe ID for the 24-gage thickness sleeves (**Figure 5**). Corrugations, consisting of folds spaced on 1-inch centers, improve the structural stiffness of the device so it does not deform during setting.

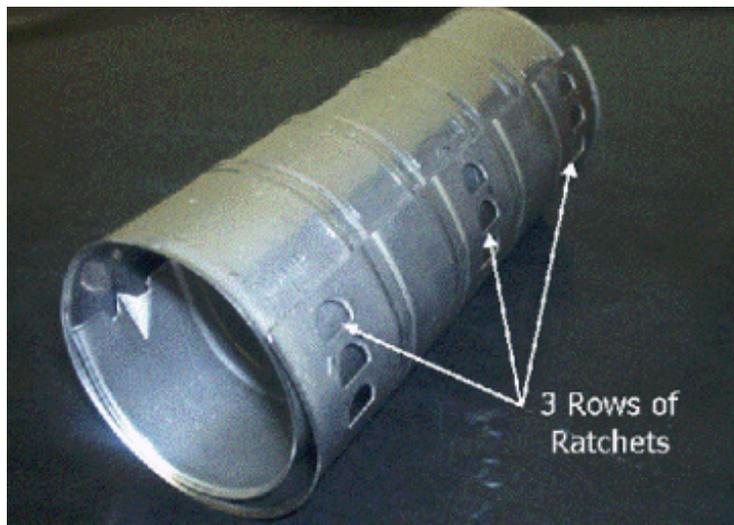
Figure 6. Sleeve Ratcheting Design

The most obvious visual trait of the urethane seal sleeve is its grooves (ribs). This new design compensates for the axial shortening that would otherwise occur if a non-ribbed sleeve were allowed to radially expand significantly. The end elements feature increased thickness and act as an O-ring once the seal is expanded. Their thickness, coupled with low durometer, should provide an effective pressure seal across a range of cast-iron surface conditions as well as easily compensate for variation in pipe ID. AutoCAD machine drawings of the molds to produce these sleeves in both 8- and 12-inch sizes were prepared.

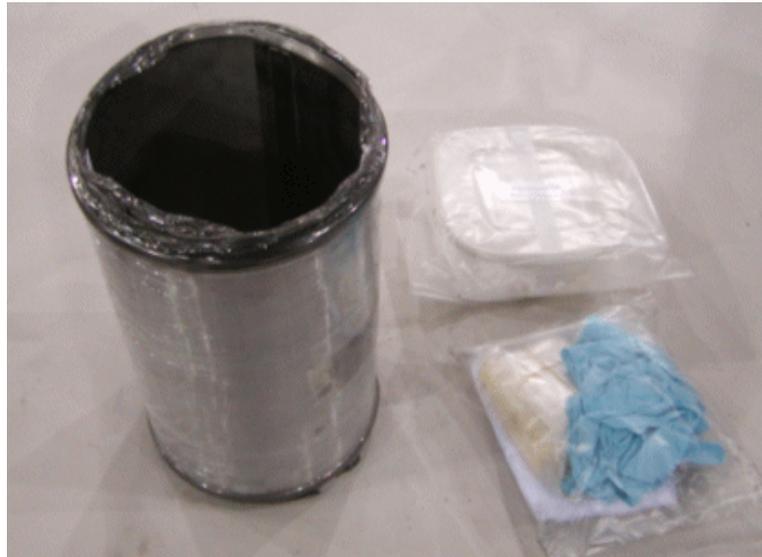
Figure 7. Repair Sleeve Components

Work in last quarter progressed to the fabrication and testing of the second-generation 12-inch repair sleeves featuring ratchets and polyurethane seal sleeves. Components of the most recent sleeve design are shown in **Figure 7**. The sleeve measures 13 inches long x 7.75 inches diameter in its collapsed (unset) state. **Figure 8** shows a sleeve with epoxy applied ready for insertion into the gas main via the inflation module.

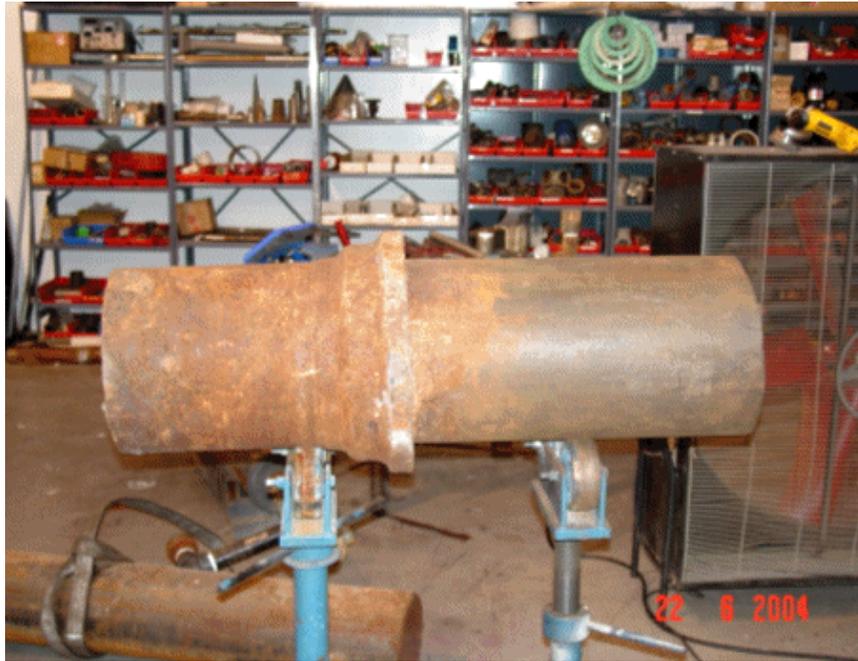
Figure 9. 12-Inch Cast Iron Pipe Sample

Several tests were recently conducted to set new 12-inch sleeves in the laboratory inside sample cast-iron joints (**Figure 9**). The first step was to use the cleaning module (see Figures 25 and 26 under Task 5) to clean debris and scale from the inside of the joint in preparation for running the sleeve (**Figure 10**).

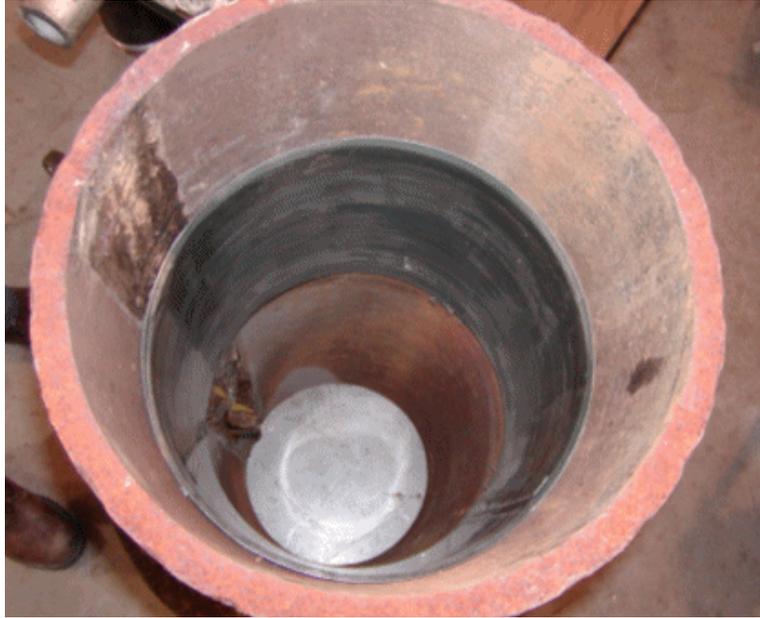
Figure 11. Successfully Installed Repair Sleeve

The sleeve was successfully set at a maximum inflation pressure of 30 psig (**Figure 11**). A few challenges yet remain for running and setting the patch (see below). However, pending further testing, this patch design is expected to represent the final design.

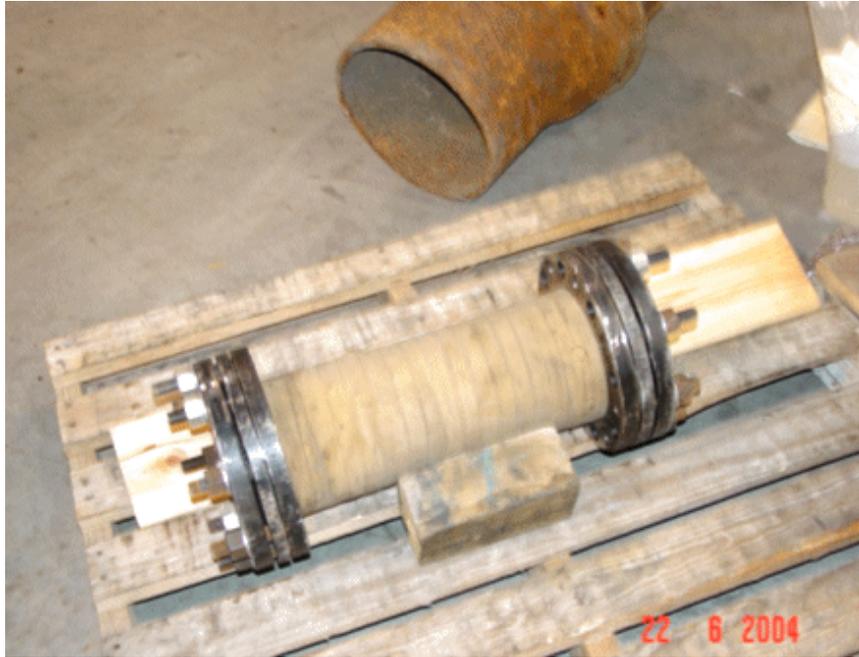
Figure 12. Inflation Bladder

While setting new patches, it has become apparent that the existing material used in the inflation bladder (**Figure 12**) needs to be improved. The bladder was observed to fail after a limited number of inflation cycles along the line where the end of the inner sleeve contacts the gum rubber. Options for modifying the bladder include using another compound having a higher tensile strength, or further increasing the thickness of the gum rubber. **Figure 13** shows a failed gum rubber sleeve. Both alternatives for modifying the gum rubber sleeve are now being investigated.

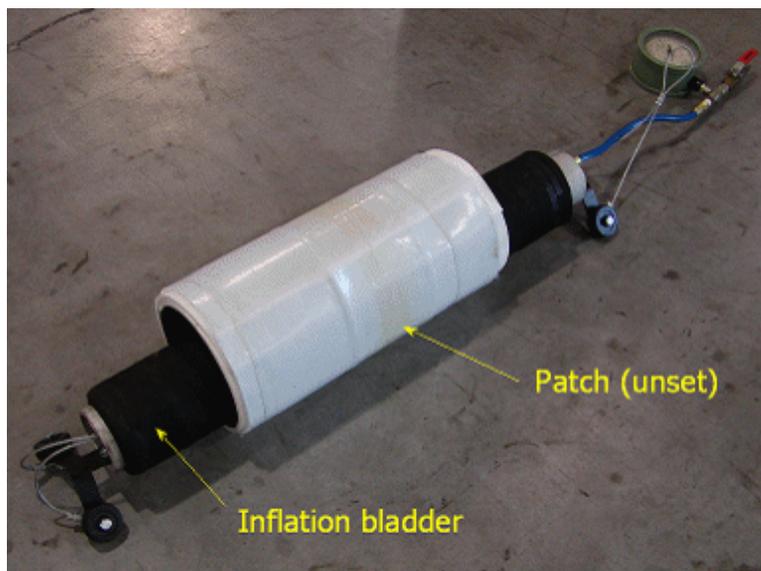
Figure 14. Patch-Setting Module

Setting tests have been successful, so efforts progressed to the design of the control electronics to operate the solenoid-controlled valve attached to a pressurized canister of nitrogen. **Figures 14-16** illustrate key aspects of the equipment. Unlike the other robotic elements, bypass of natural gas to prevent interruption of customer service occurs through the central pipe and not in the annular space between the robotic element outside diameter and the inside diameter of the cast-iron main.

Various patch-setting inflation modules have been designed, built and used to install the different generations of ratcheting repair sleeves. The latest sleeves are set by inflating the patch setting bladder to 30 psig which is held for a period of 5 minutes before deflation is allowed.

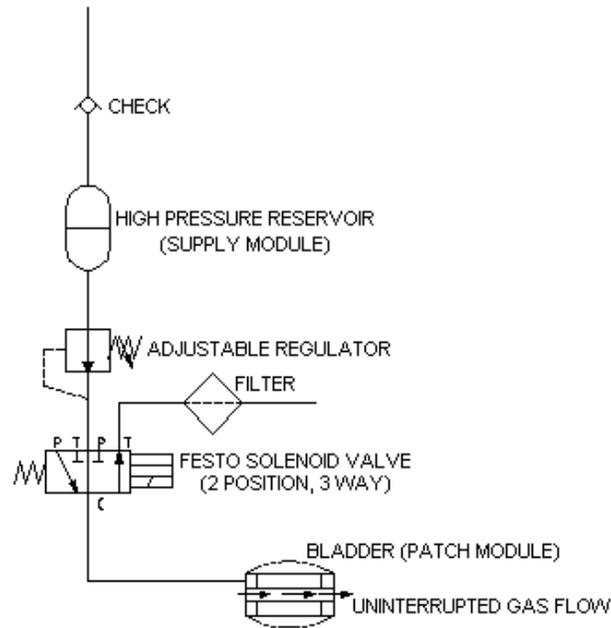
Figure 17. Pneumatic Inflation Circuit

The patch setting control system consists of a solenoid valve which allows the air pressure to be admitted into the inflation bladder under computer control, a pressure chamber for storing the nitrogen charge and pressure relief valves which allow adjustment of the charge pressure to compensate for differences in the gas main operating pressure. **Figure 17** summarizes the pneumatic inflation circuit.

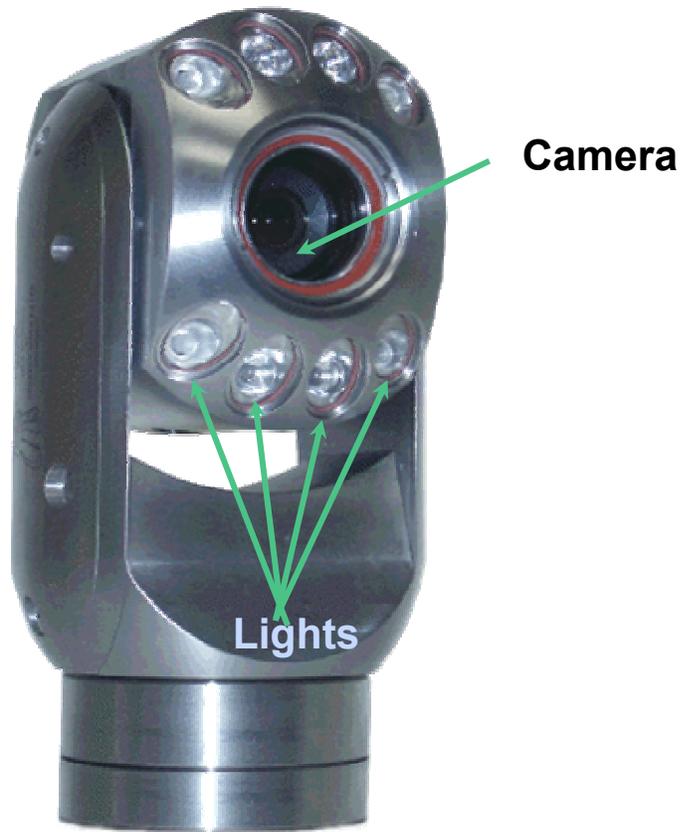
Figure 18. PZT Camera

The analysis of different PZT cameras was completed in the second quarter and a preferred design selected. The camera measures 4 inches OD x 10.5 inches overall length as shown in **Figure 18**. It features 270° of tilt, 340° of pan and a 72:1 zoom ratio. Its eight, high intensity argon lights were found to provide excellent illumination in tests conducted inside sealed 12- and 24-inch pipes. Specifications are summarized in **Figure 19**. In normal operations where the camera tether is 100 feet or less, a 16-conductor bundle is used as defined in **Table 1**.

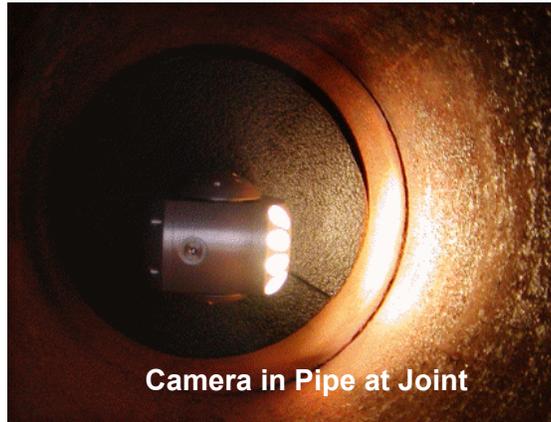
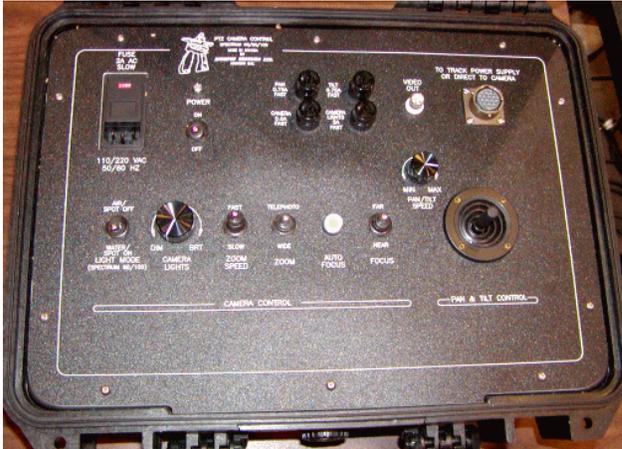
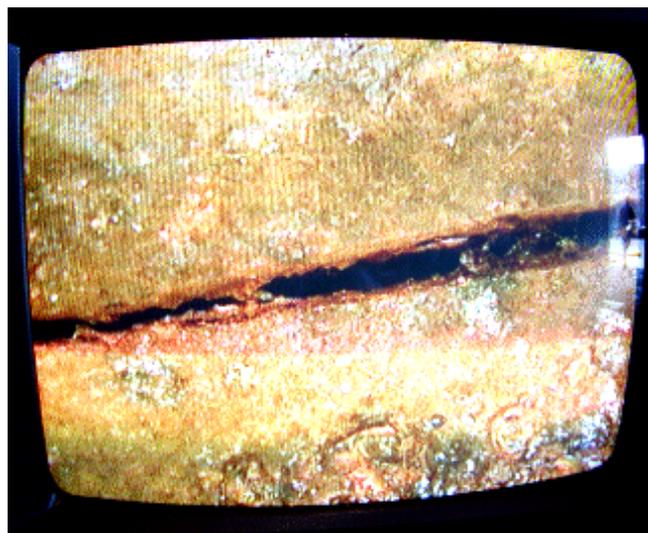
Figure 19. Camera Specifications

Illumination: 3 lux

Horizontal FOV: 48° wide, 2.7° tele (in air)

Lights: 8 x 6 W Argon lights, variable intensity

Pan Range: 340° Mechanical, (360° Visible)

Pan/Tilt Control: Proportional

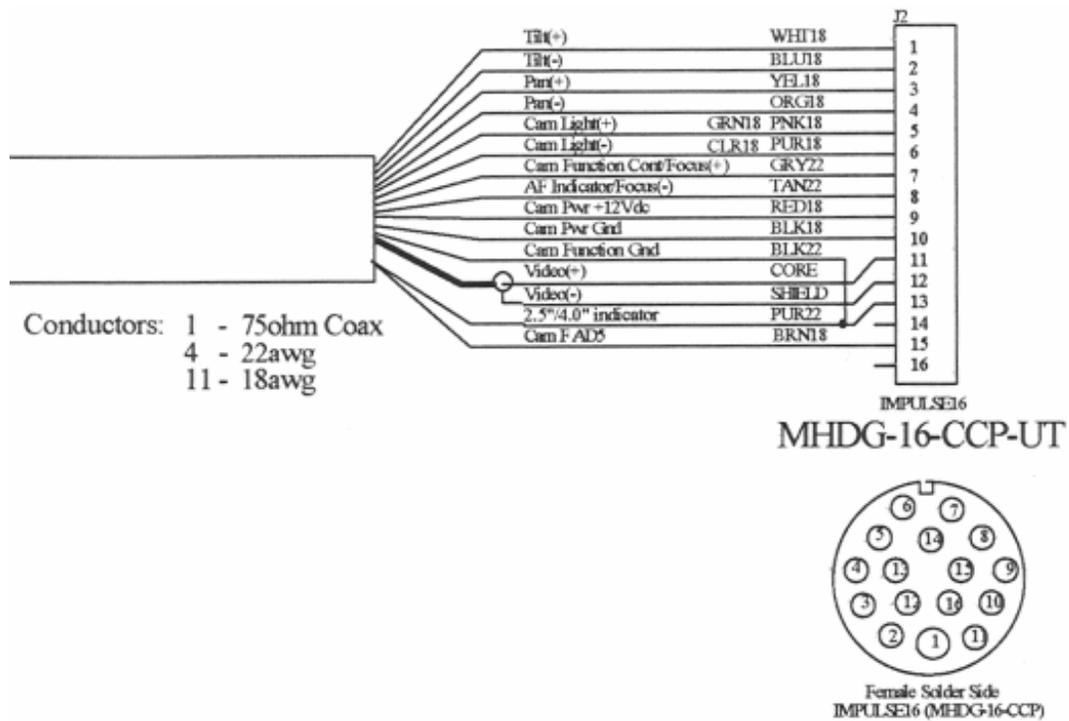
Figure 20. Conventional Camera Control Cable Design

DC power is supplied to the downhole camera control electronics over an 18-gage twisted pair of conductors. Use of a single high-voltage power source at the surface was chosen over individually supplying all of the regulated voltages needed to operate the camera for two important reasons: 1) it is a highly efficient means of transferring electrical power down the long cables residing inside the steel coiled tubing and 2) it minimizes the total number of conductors required for the umbilical. The current design employs a total of seven wires to operate the camera. These include two wires for electrical power, four wires for the RS-485 digital communications link and one micro-coax for the video signal. This compares with a total of 15 wires that would be needed to operate the camera using a conventional analog circuit design such as shown in **Figure 20**.

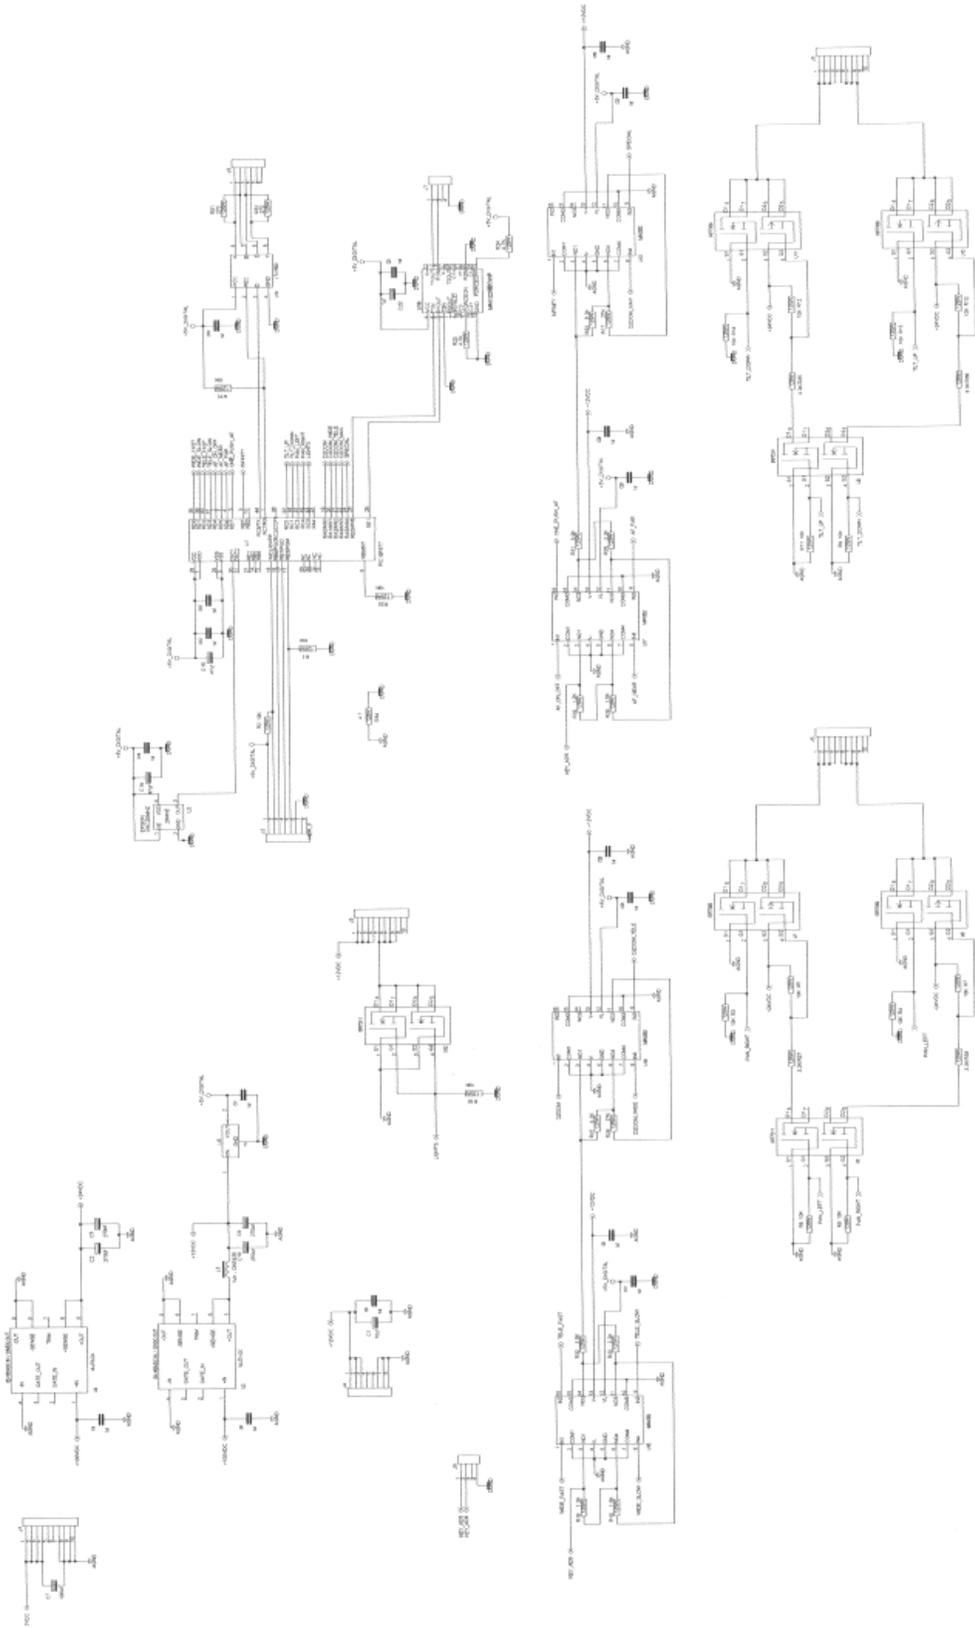
Figure 21. Downhole Camera Control Circuit Schematic

The LabView platform features excellent visual appeal through its virtual instrument displays, can be easily reconfigured and expanded to add new control capability as each new robot module is brought on line, and has excellent digital and analog support libraries. The user-selected commands are digitized and then communicated to the downhole camera control electronics via the RS-485 communications link. The RS-485 design and protocols were selected on the basis of their ease of implementation, low cost, and its demonstrated ability to support reliable communications over conductors up to 4000 ft in length, well in excess of the 1000-ft span required for this effort. A 20-MHz PIC micro-controller receives the RS-485 messages and actuates the commands accordingly. The electrical schematic for the downhole camera control electronics is shown in **Figure 21**.

Figure 22 is a photograph of the physical printed circuit board produced from this schematic. The board is a four-layer board made of FR4 material, measures 3 inches wide x 10 inches long, and is housed inside the robotics base module. Worthy of note are the large heat sinks for the DC-to-DC power converters used to take the single DC voltage supplied from the surface and generate +24V, +12V and +5 VDC regulated power for the various camera functions.

The PIC controller (PIC16F877) is a 20-MHz CMOS FLASH-based 8-bit microcontroller. It features 256 bytes of EEPROM data memory, self-programming, an ICD, eight channels of 10-bit Analog-to-Digital (A/D) converter, two additional timers, and two capture/compare/PWM functions. The synchronous serial port can be configured as either three-wire Serial Peripheral Interface (SPI™) or the two-wire Inter-Integrated Circuit (I²C™) bus and a Universal Asynchronous Receiver Transmitter (USART). This controller is designed for more advanced A/D applications in automotive, industrial, appliances and consumer applications.

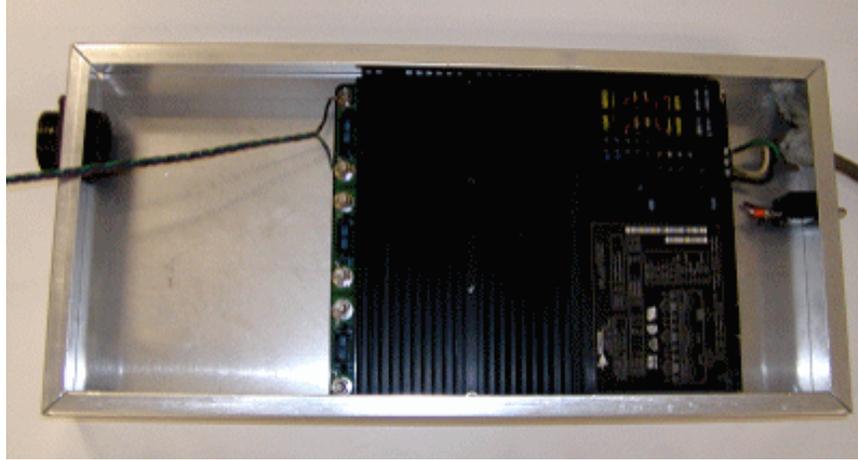
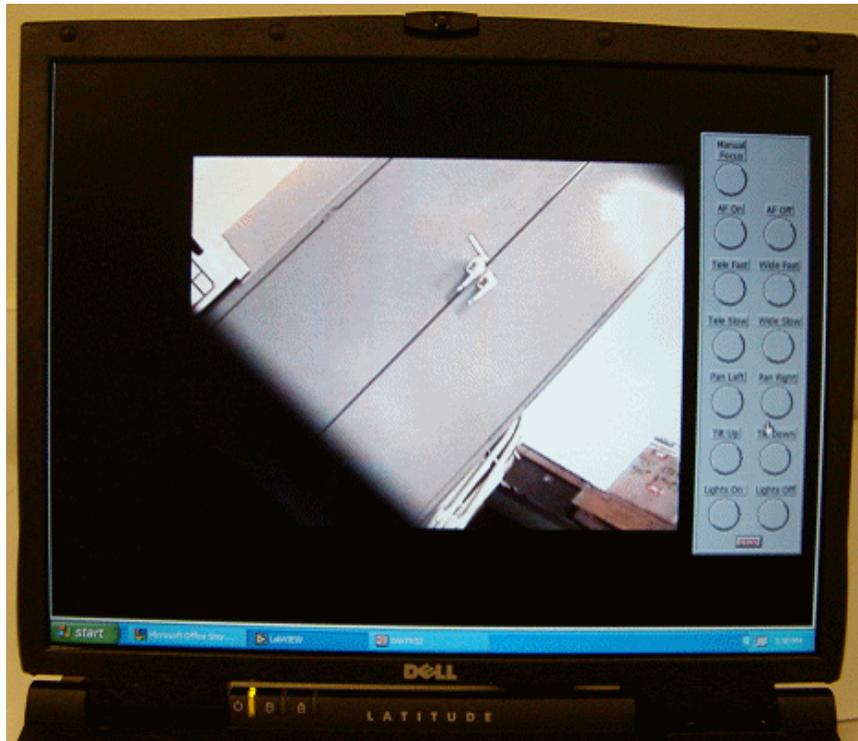
In the fifth quarter, the camera control software and display were finalized. **Figures 23 and 24** show the packaged electronics and camera display/control functions as presented on a laptop computer.

Figure 23. PZT Camera Power Supply

Figure 24. Camera Display and Control Software

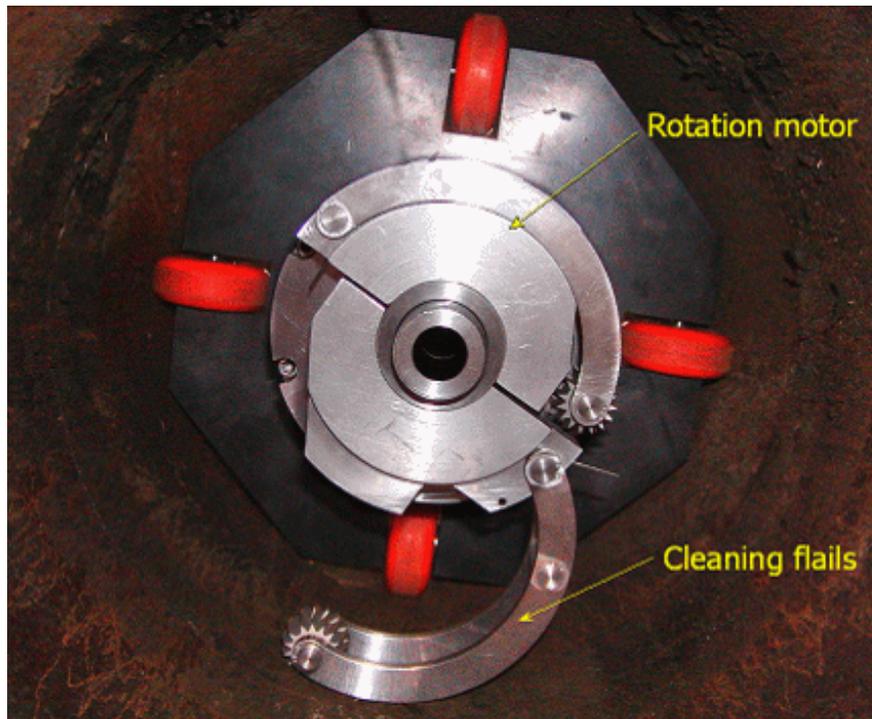
Figure 25. Pipe Wall Cleaning Element

A four-arm assembly for cleaning the pipe wall prior to installing the repair sleeve, initially built during the second quarter, was further developed during the third and fourth quarters. It was suitable for removing a wide range of debris including very hard deposits. It had a collapsed diameter of 6.4 inches and could open up to 13 inches under centripetal action.

During the fifth quarter, the arm assembly was redesigned to be packaged as a complete robotic element. This included both design and fabrication of the drive motor, motor controller electronics, cleaning head housing and collapsible arm (**Figure 25**). The completed robot assembly was tested to clean across several 12-inch cast-iron bell and spigot joints (**Figure 26**). The preliminary tests were very promising. The most efficient cleaning occurs at rotary speeds of 300 rpm with forward and backward movement across the joint at speeds of 4 inches per minute, for approximately 5 minutes per joint.

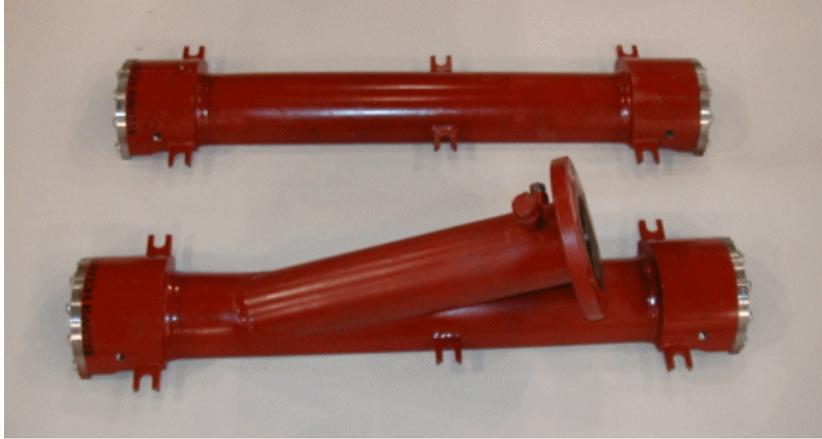
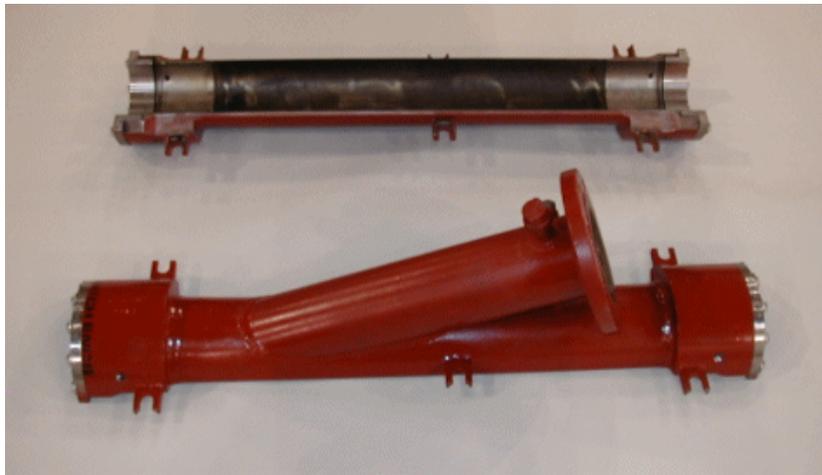
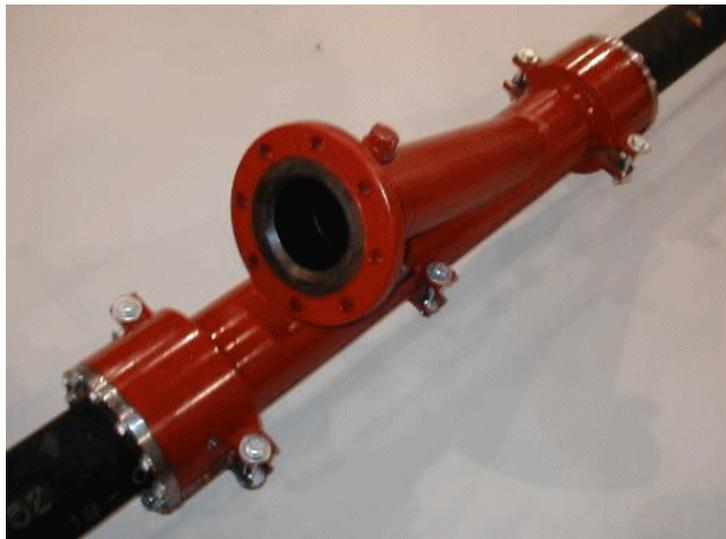
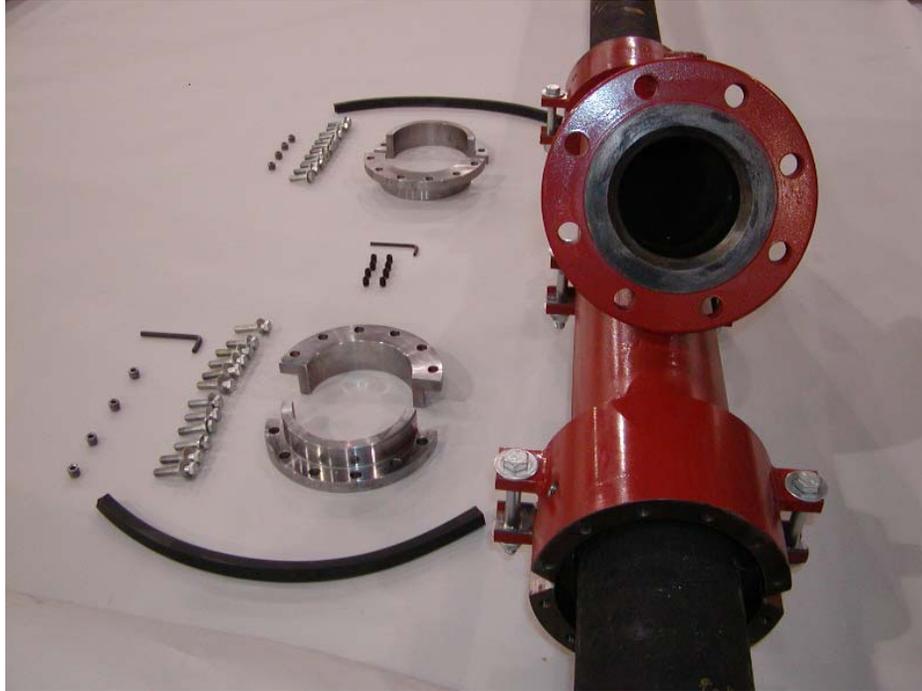
In the previous quarters the fitting was produced in a 4-inch prototype size to validate the design prior to embarking on the fabrication and testing of a 12-inch version which will be considerably more expensive. Sealing tests at pressures up 100 psig were successfully conducted in the quarter along with preliminary drilling tests. **Figures 27 - 30** illustrate its key components.

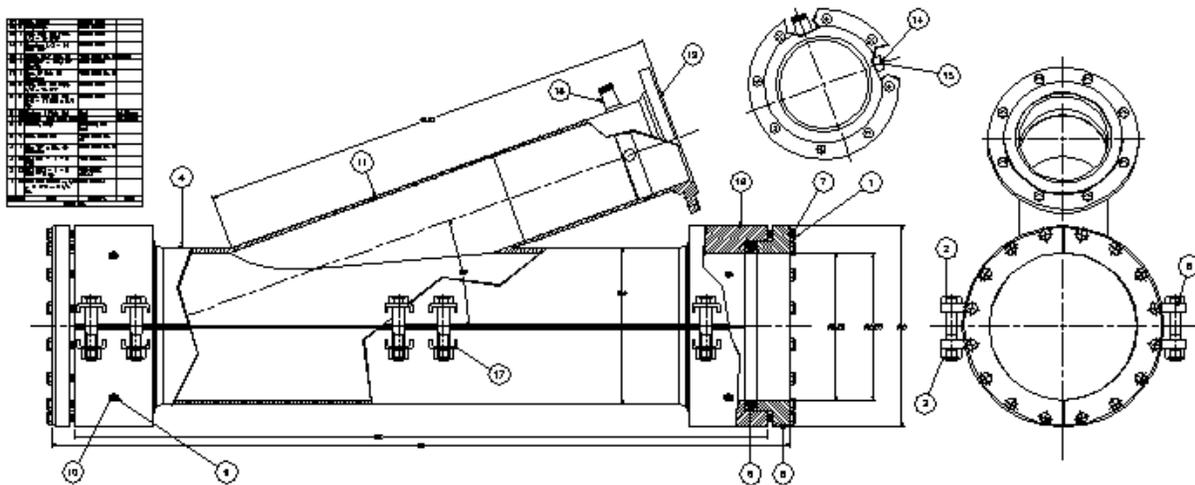
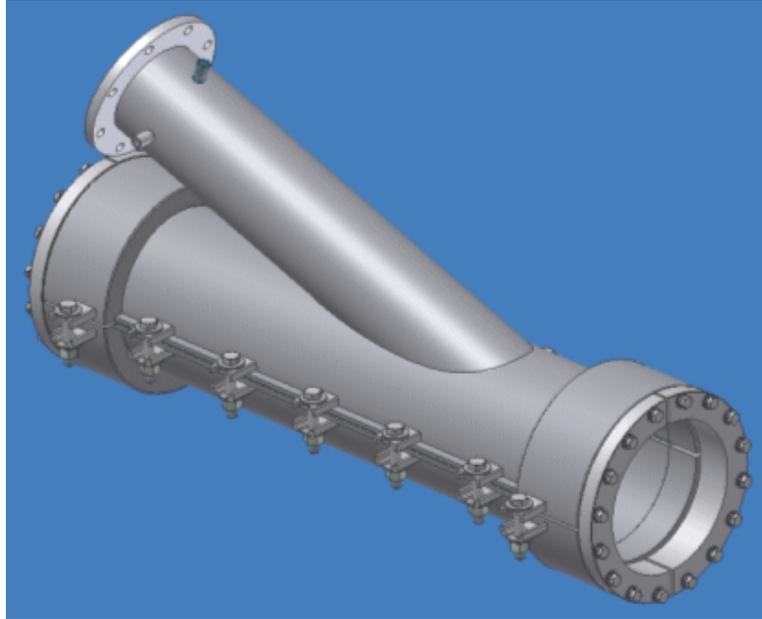
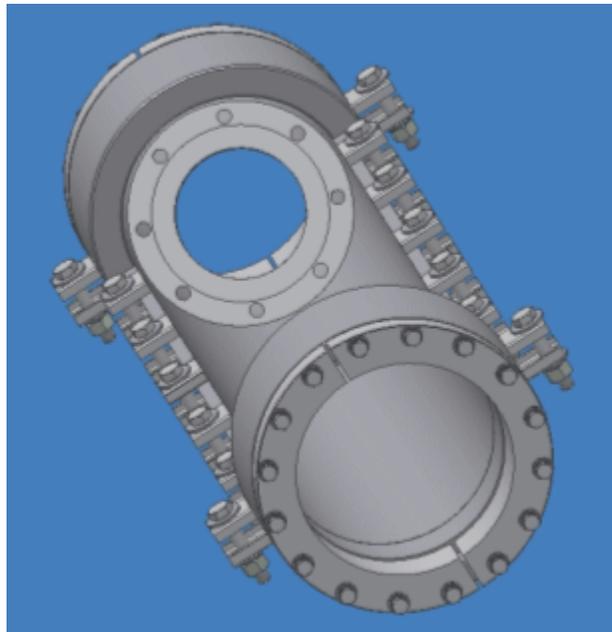
In this quarter, detailed designs of the 12-inch fitting were completed and the design is now in manufacture. **Figures 31-33** identifies the primary aspects of the entry fitting for 12-inch diameter pipes. In addition, to selecting the preferred machine shop for fabrication, the team met with a leading manufacturer of gaskets and seals to make the molds for the elastomer end seals. In addition, a ball valve for supporting the insertion and removal of the robot trains under no blow conditions was also procured.

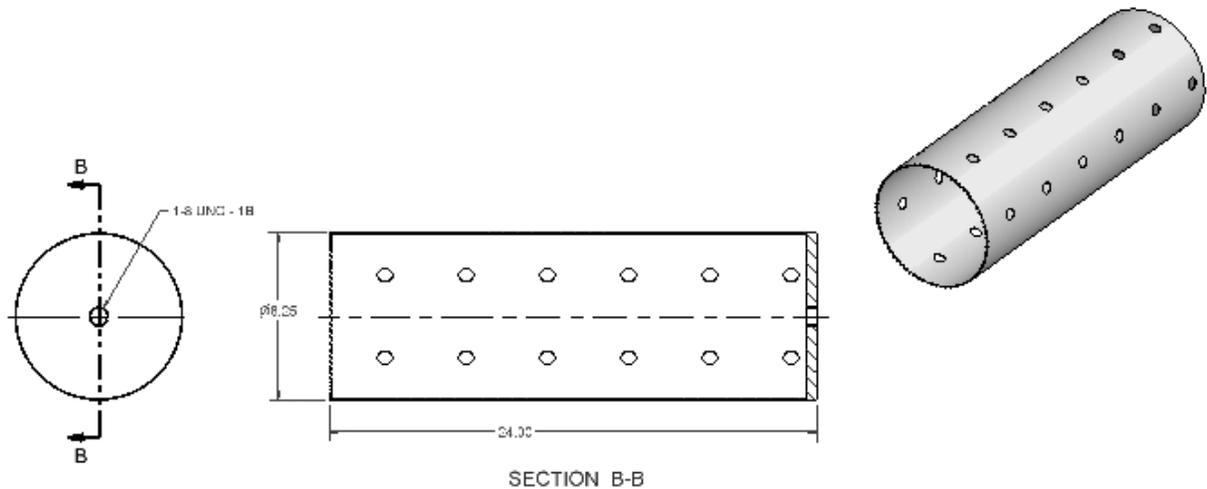
Figure 34. Bi-Metal Hole Saw

To support use of the 12-inch entry fitting, it is also necessary to design the saw cutting system that will cut the angled hole into the pressurized cast iron gas main. A bi-metal hole saw capable of cutting an 8-inch diameter hole has been designed (**Figure 34**). The hole saw has been built and is now scheduled for testing. It will be powered by a 50 horsepower, diesel-driven hydraulic power supply. This same power supply also operates the coiled tubing unit.

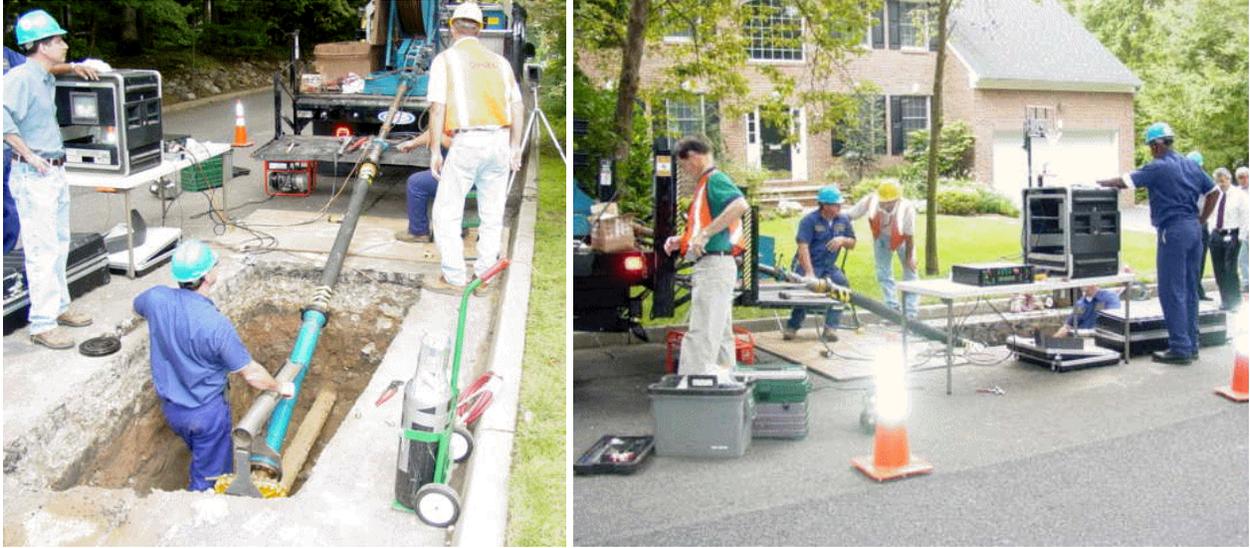
Figure 35. Field Test Site

On August 24-26, 2004, MTI/GTI conducted field tests of the small robotic joint-repair system in a gas main provided by Public Service Electric & Gas (**Figure 35**). The location was in a residential neighborhood on Woodland Avenue in the town of Oradell, New Jersey.

Over three days of field testing, a range of operations were performed representing a typical joint-patching operation of bell and spigot joints on cast iron pipe. After the main was uncovered and prepared for the tests, the coupon retention fitting was welded to the pipe. Next, the 20° angled entry fitting was secured to the pipe (**Figure 36**) and then seam-welded to the main.

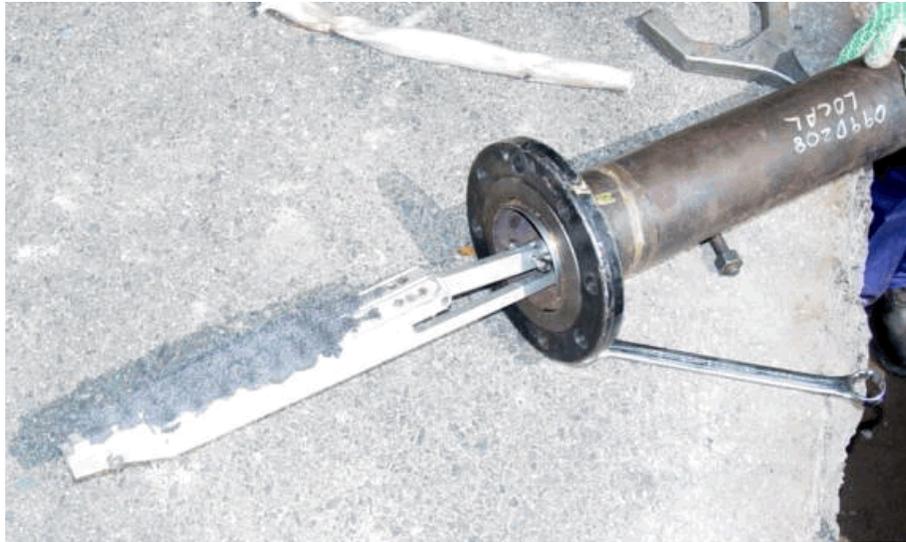
Figure 37. Magnet Assembly for Removing Filings

The coupon was successfully retrieved. Next, a magnetic cleaning assembly (**Figure 37**) was run into the pipe for three passes to remove the vast majority of metal filings created by the sawing process.

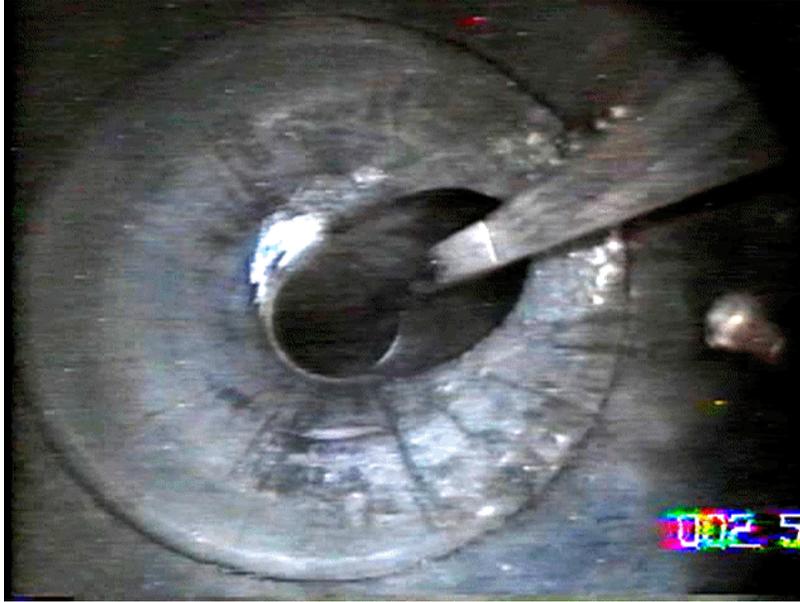
Figure 38. Moving through Entry Fitting

The first train assembly consists of 1) a CCD camera to inspect the main, 2) a brush module for cleaning the bell and spigot joints selected for repair, and 3) a base module which supplies electrical power, communication and control signals between the surface hardware and the in-pipe robot elements. After the assembly was passed through the entry fitting (**Figure 38**), the first run down the pipe was to inspect the environment and log the location of potential target joints and other features.

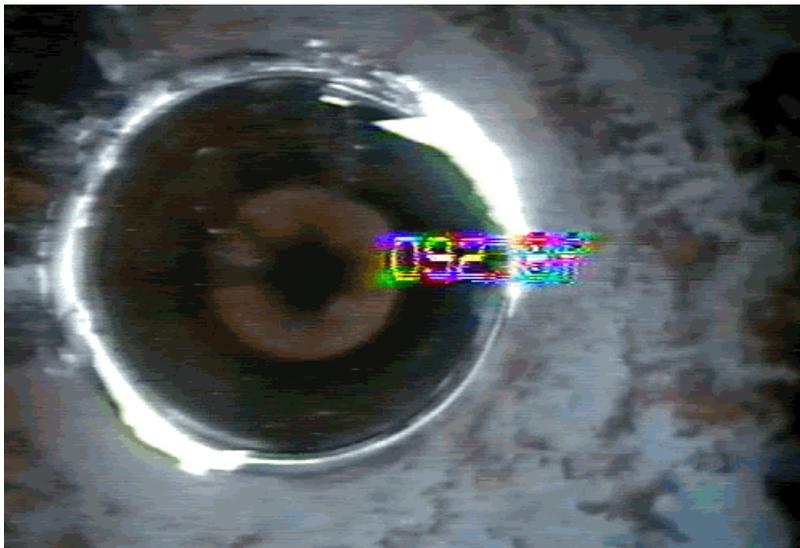
Figure 39. Successfully Set Patch at 93.7 ft

- Two sleeves (at 128.8 ft and 93.7 ft) were run and set 100% successfully (**Figure 39**).

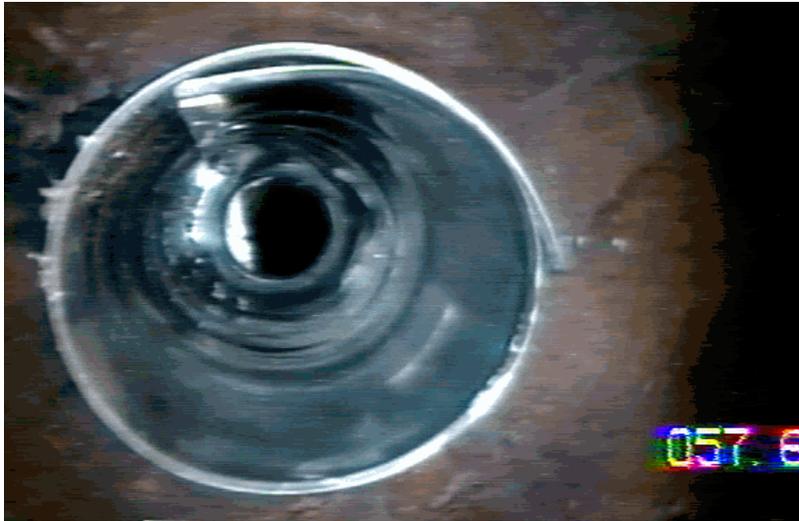
Figure 40. Partially Engaged Patch at 58.6 ft

- One sleeve (at 58.6 ft) failed in the first attempt to set it, was carried with the assembly back to the entry point, and was then rerun and set successfully (although the ratchets did not engage completely (**Figure 40**)).

Potential causes for the failure of two patches to set are 1) pipe ID may have been smaller than the first row of ratchets at these two bell and spigot locations, 2) the debris levels may have been too high or 3) the bell and spigots were angularly misaligned. No problems were observed with the repair sleeve setting train either in the field or after its return to Houston. Consequently, the team believes that the patch-setting failures were due to geometric issues.

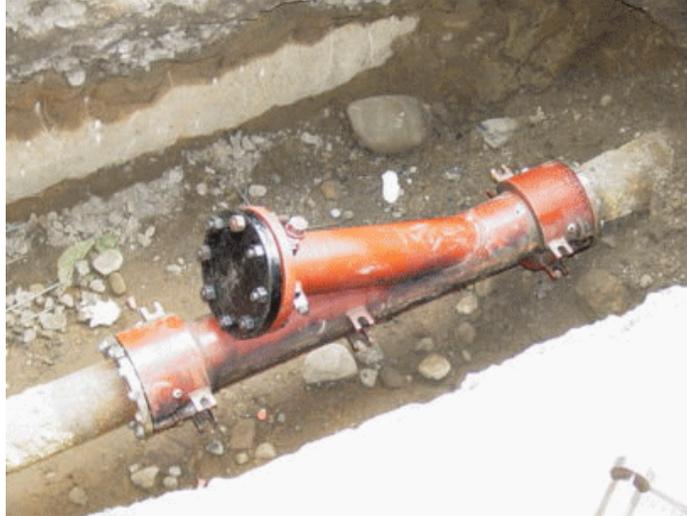
Figure 41. Entry Fitting Ready for Burial

After all in-pipe operations were complete, the equipment was removed from the pipe and disassembled. A seal plug was then inserted into the 20° riser section of the entry fitting. Once the seal plug is set, the gate valve was then removed from the main. A blind flange was then attached to the 20° riser to create a second (redundant) gas seal and allow future re-entry into the pipe is so desired. The sealed entry fitting ready for burial is shown in **Figure 41**.
