ANL-MGR-GS-000004 REV 00

February 2005

Peak Ground Velocities for Seismic Events at Yucca Mountain, Nevada

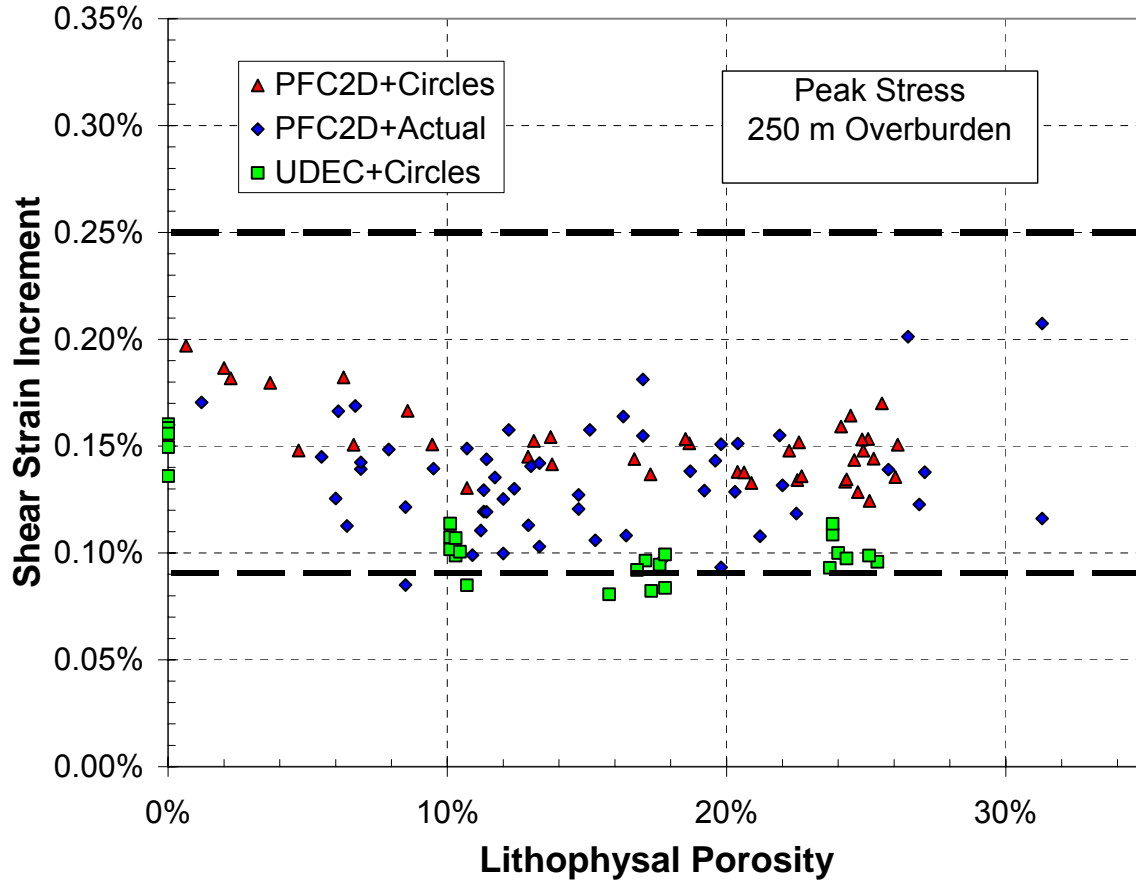
The shear strain increments are calculated and, as an example, Figure 6-6 shows the results for the state at peak stress at 250 m overburden. The results for three types of 2D simulation are superimposed on the graph shown in Figure 6-6: (a) circular voids, modeled by PFC2D; (b) actual complex shapes traced from geologic field maps (stenciled voids), modeled by PFC2D; and (c) circular voids, modeled by UDEC. In Figure 6-6, the engineering shear strain (axial strain minus lateral strain) increment for a peak stress state is plotted against lithophysal porosity. Mean shear strain increments and standard deviations are listed in Table 6-2.

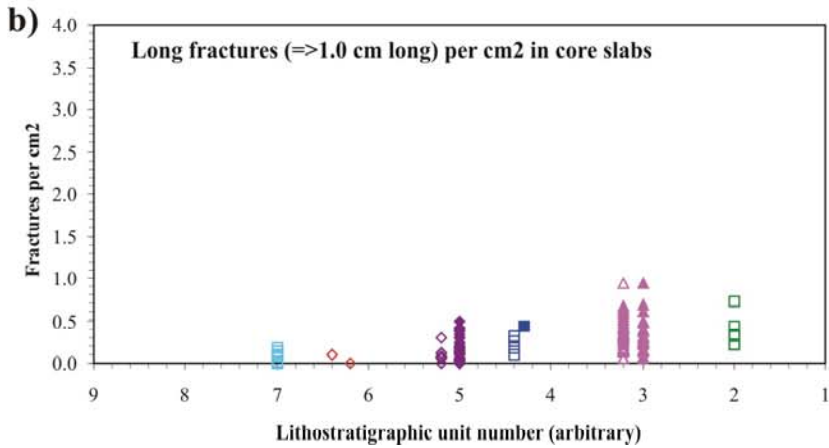
The number of fractures per unit area (cm²) of slab varies by lithostratigraphic zone and subzone with the (1) larger values in the deepest part of the section and (2) the lower lithophysal zone having the larger individual values (Figure A1-8a). These trends are similar where the fractures are divided into fractures longer than 1 cm and especially for those that are shorter than 1 cm (Figure A1-8b and c). Similar relations of the total area and total fractures per total area compared to the lithostratigraphic zone or subzone also indicate that the lower parts of the section, especially the lower lithophysal zone, have more fractures per unit area than the upper parts of the section (Figure A1-9). Because there are only a few samples from lithostratigraphic units other than the upper and lower lithophysal zones, some bias to the data is possible. These fractures-per-area relations indicate that the various lithostratigraphic units responded differently in the formation of fractures and support the stratiform characterization of fractures.

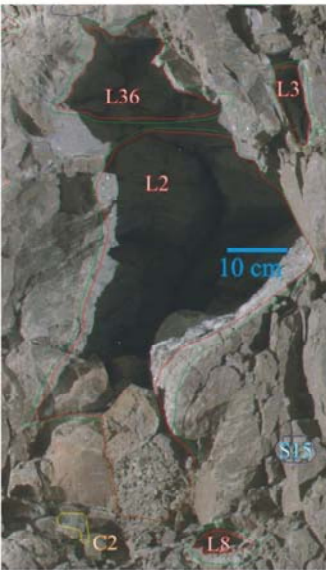
b) "Simple" lithophysae (L45 & L44). L44 has small expansion cracks. (from Panel Map 1493R)

c) Merged lithophysae (L2 & L36). (from Panel Map 1641L)
L2 itself is merged and has "backfilled" fracture at the base.
