# **Sealing Large-Diameter Cast-Iron Pipe Joints Under Live Conditions**

**Quarterly Report  
December 25, 2004 – March 24, 2005**

***By:*  
Kiran M. Kothari  
(Gas Technology Institute)  
and  
Gerard T. Pittard  
(Maurer Technology Inc.)**

**DE-FC22-02NT41316**

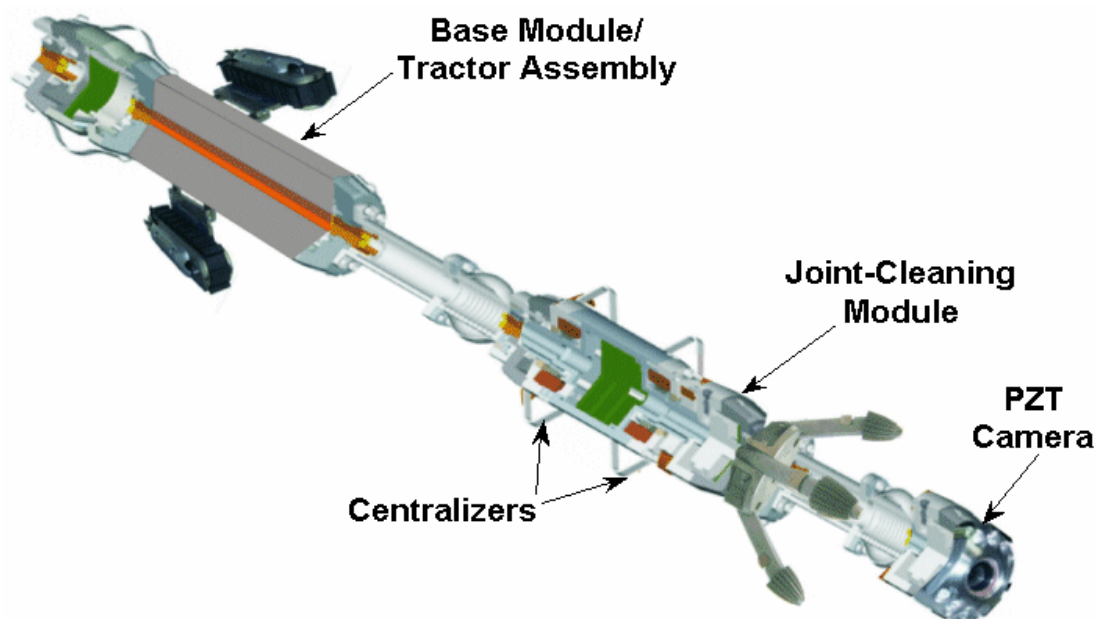
Figure 1. Pipe Wall Preparation Robot Train

Based on the analysis completed to date, two in-pipe robot trains will be required. The first robot train has a front-mounted camera that is used to visually locate each bell and spigot joint (Figure 1 and Figure 2). Directly behind this camera is a counter-rotating brushing module whose function is to remove debris from the pipe wall within the cast-iron bell and spigot joint. This module will now be fitted with a retractable brush to remove debris piles from the immediate vicinity of the joint. The third and final module

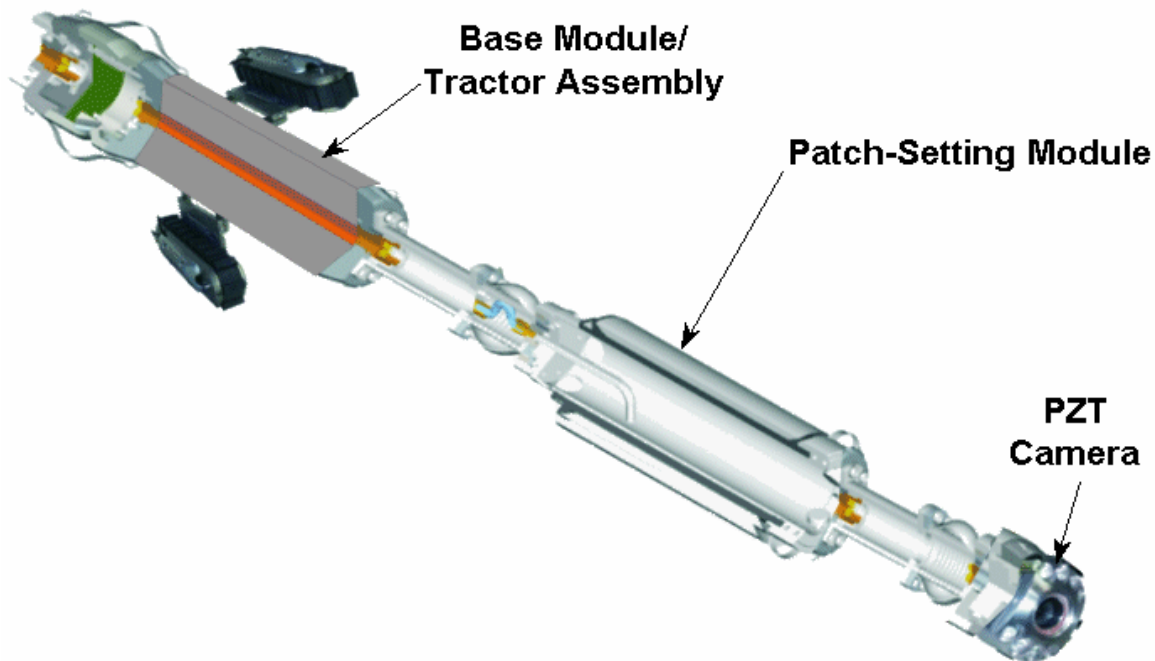
Figure 3. Patch-Setting Robot Train

The brush module is then removed from the train and replaced with the stainless-steel patch-carrier/patch-setting module (Figure 3). The stainless-steel sleeve is slid over the carrier along with its polymer sleeve and polyester felt, which has been saturated with epoxy. The CT unit is then used to deliver the patch-setting train to the most distant bell and spigot joint. This location is confirmed both with the quadrature encoder footage counter and visually with the camera. Once the camera is located exactly at the bell and spigot-joint gap, the fine-resolution odometer on the camera is set to zero. The CT unit is then used in conjunction with the camera's odometer to move the patch setting train forward by a known, fixed distance which assures the

patch is properly aligned with the bell and spigot joint. A control command is then issued from the surface unit to the base unit to release nitrogen from a stainless-steel pressure vessel on-board the patch-setting module into its expandable rubber bladder. This causes the bladder to inflate and locks the stainless-steel sleeve into position via its interlocking, ratcheting barbs. The epoxy is allowed to cure and reaches full strength within 12 hours. During the interim, a gas-tight seal is assured by the polymer sleeve which has been energized against the joint by the hoop stress of the stainless-steel sleeve. (Note: The volume and rate at which the nitrogen is bled from the inflation bladder results in no appreciable dilution of the BTU quality of the natural gas.)

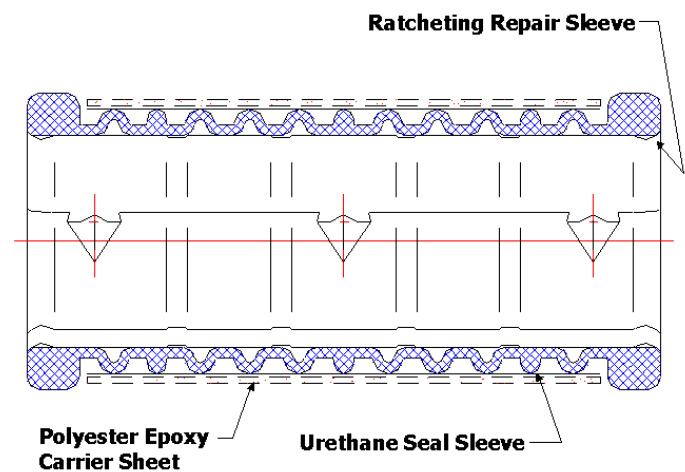
Figure 4. Ratcheting Repair Sleeve

Figure 4 illustrates the critical design features. A 28-gage, corrugated stainless-steel sleeve (316 SS) is used as the innermost member. Its function is to provide a mechanical means for energizing the urethane seal sleeve against the cast-iron wall to form the first leak seal and to allow the epoxy-saturated polyester carrier to cure to form a second (redundant) leak seal. The sleeve gage (28) is a reduction from the 24 gage normally used. Its use will enable the sleeve to be coiled in a smaller diameter without yielding. Preliminary analysis indicates that the design can be rolled into a diameter of about 55% of the pipe ID versus 75 % of the pipe ID for the 24-gage thickness sleeves (Figure 5). Corrugations, consisting of folds spaced on 1-inch centers, improve the structural stiffness of the device so it does not deform during setting.

The most obvious visual trait of the urethane seal sleeve is its grooves (ribs). This new design compensates for the axial shortening that would otherwise occur if a non-ribbed sleeve were allowed to radially expand significantly. The end elements feature increased thickness and

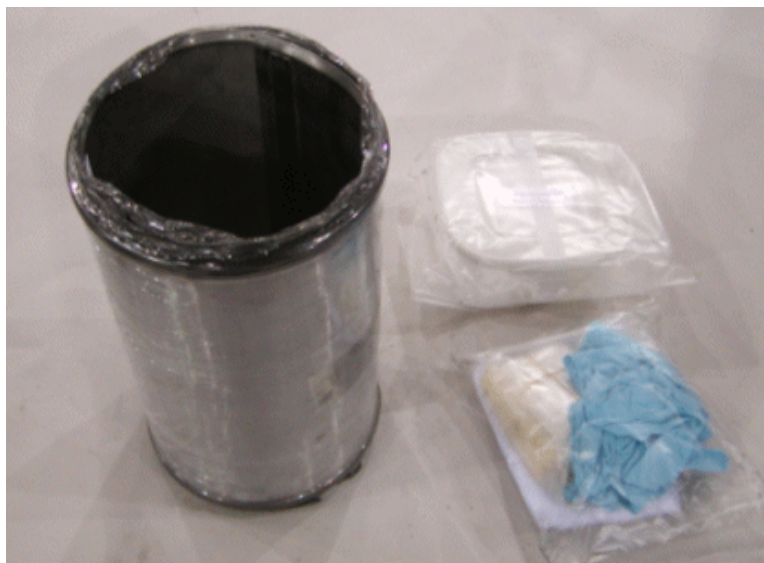
Figure 6. Repair Sleeve Components

Work has progressed to the fabrication and testing of the second-generation 12-inch repair sleeves featuring ratchets and polyurethane seal sleeves. Components of the most recent sleeve design are shown in Figure 6. The sleeve measures 13 inches long x 7.75 inches diameter in its collapsed (unset) state. Figure 7 shows a sleeve with epoxy applied ready for insertion into the gas main via the inflation module.

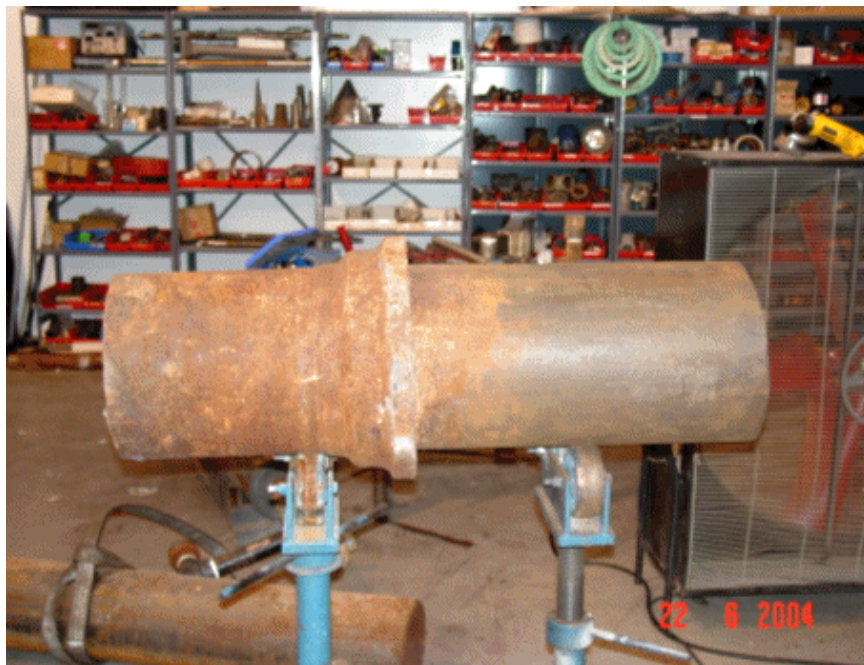
Figure 8. 12-Inch Cast Iron Pipe Sample

Several tests were previously conducted to set new 12-inch sleeves in the laboratory inside sample cast-iron joints (Figure 8). The first step was to use the cleaning module to clean debris and scale from the inside of the joint in preparation for running the sleeve (Figure 9).

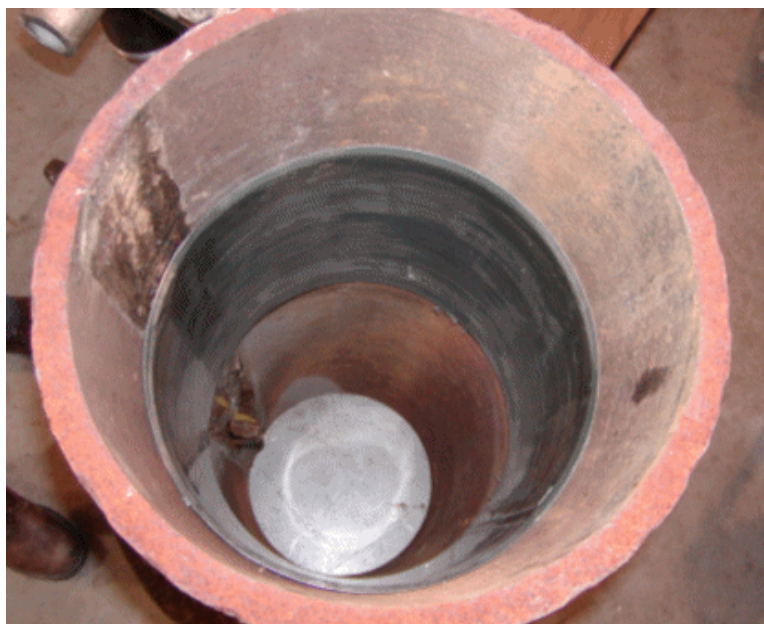
Figure 10. Successfully Installed Repair Sleeve

The sleeve was successfully set at a maximum inflation pressure of 30 psig (Figure 10). A few challenges yet remain for running and setting the patch (see below). However, pending further testing, this patch design is expected to represent the final design.

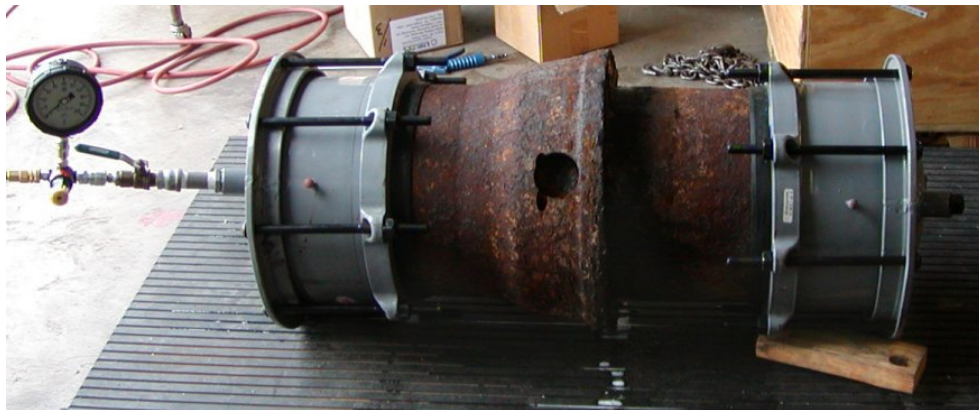
Figure 14. Cast Iron Joint Tested for Leaks

1. The ends of sample cast-iron joint were capped (Figure 14) and the internal pressure raised to 2 psi to check for leaks around the bell and spigot joint. Two small leaks were observed using soap spray in the jute area of the joint. These were marked.

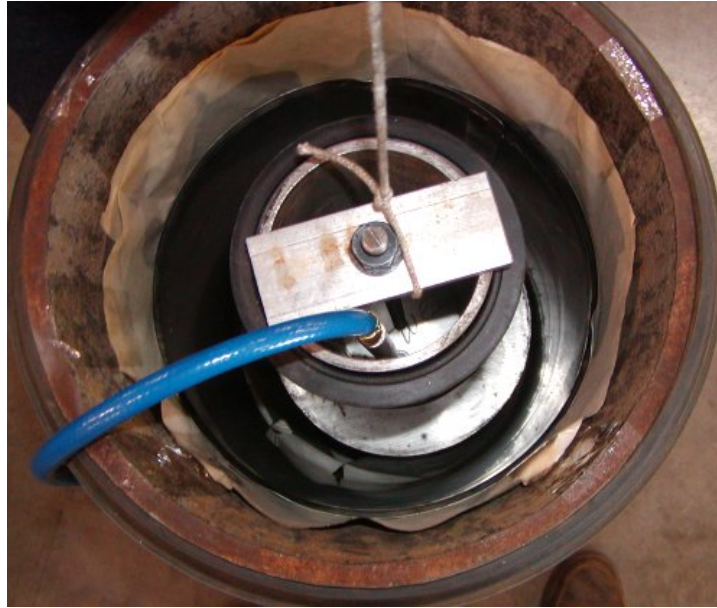
Figure 15. Bladder/Patch Assembly Hung in Joint

2. Caps were removed from the test joint and the pipe ID was cleaned across the joint area prior to patching.
3. A new patch and patch setting bladder assembly were prepared. The patch was placed at the center of the length of the bladder, and was held in place by slightly inflating the bladder to grip the patch.
4. The patch/bladder assembly was inserted into the joint via a special fixture that allowed the patch to hang in the center of the joint (Figure 15).

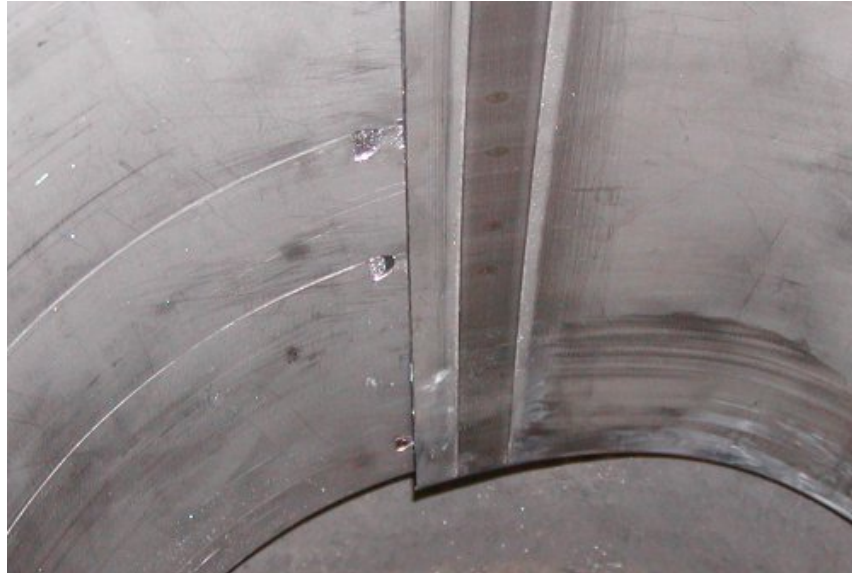
Figure 16. Ratchet Engagement After Patch Setting

After the tests were completed, a careful inspection of the set patch indicated that the two outermost rows of ratchets did not engage as deeply as the two inner rows (Figure 16). It appeared that the inflation bladder needs to be about two inches longer on each end to fully engage the patch sleeve ratchets as currently configured.

Even though the patch set successfully and all leaks were sealed, it was desired to modify the patch or bladder design to allow deeper ratcheting toward the outer edges of the patch. Since use of a standard bladder design is preferred, changes to bladder design were avoided. Another solution was conceived and pursued. The patch manufacturer was asked to stamp two additional rows of ratchets into the sleeve midway between the existing rows. A prototype sleeve with this modification (a total of six rows of ratchets) was ordered and will be tested soon.

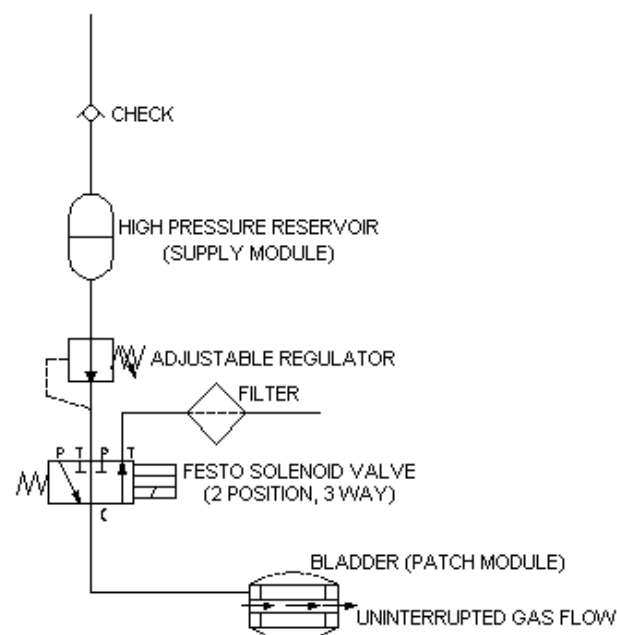
Figure 20. Pneumatic Inflation Circuit

The patch-setting control system consists of a solenoid valve which allows the air pressure to be admitted into the inflation bladder under computer control, a pressure chamber for storing the nitrogen charge and pressure relief valves which allow adjustment of the charge pressure to compensate for differences in the gas main operating pressure. Figure 20 summarizes the pneumatic inflation circuit.

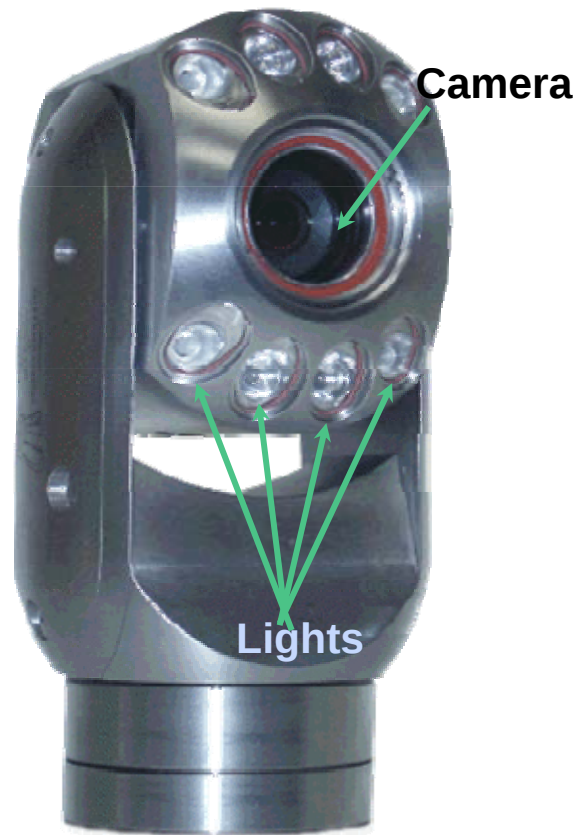
Figure 21. PZT Camera

The analysis of different PZT cameras was completed in the second quarter and a preferred design selected. The camera (Figure 21) measures 4 inches OD x 10.5 inches overall length. It features 270° of tilt, 340° of pan and a 72:1 zoom ratio. Its eight, high intensity argon lights were found to provide excellent illumination in tests conducted inside sealed 12- and 24-inch pipes. Specifications are summarized in Figure 22. In normal operations where the camera tether is 100 feet or less, a 16-conductor bundle is used as defined in Table 1.

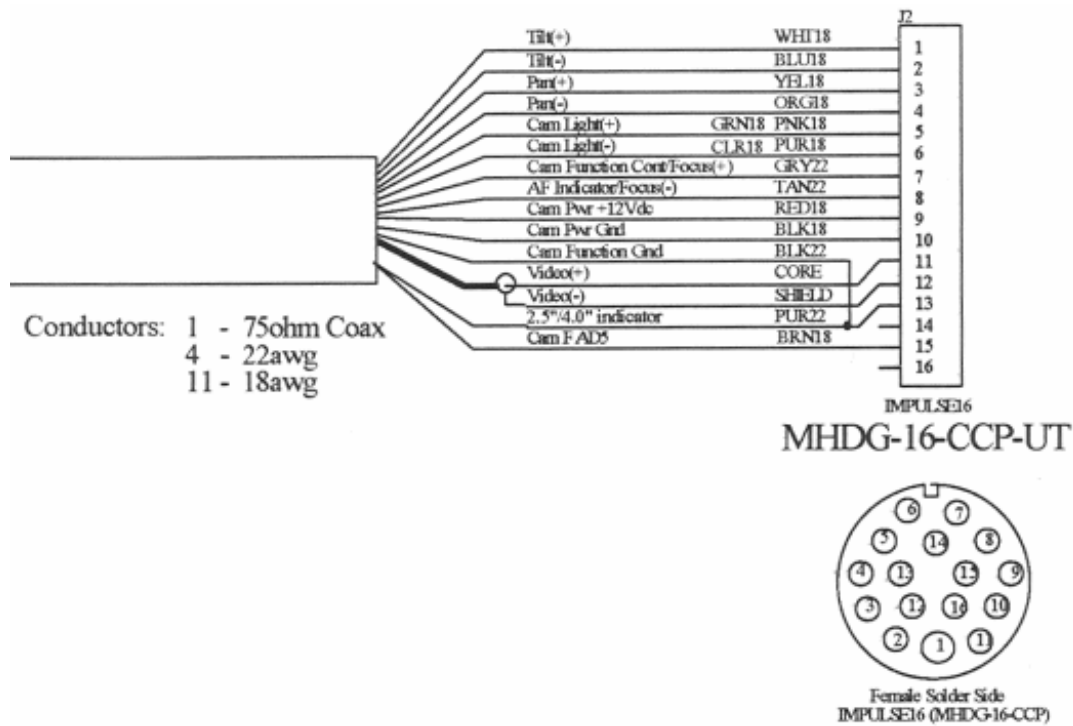
Figure 23. Conventional Camera Control Cable Design

DC power is supplied to the downhole camera control electronics over an 18-gage twisted pair of conductors. Use of a single high-voltage power source at the surface was chosen over individually supplying all of the regulated voltages needed to operate the camera for two important reasons: (1) it is a highly efficient means of transferring electrical power down the long cables residing inside the steel coiled tubing and (2) it minimizes the total number of conductors required for the umbilical. The current design employs a total of seven wires to operate the camera. These include two wires for electrical power, four wires for the RS-485 digital communications link and one micro-coax for the video signal. This compares with a total of 15 wires that would be needed to operate the camera using a conventional analog circuit design such as shown in Figure 23.

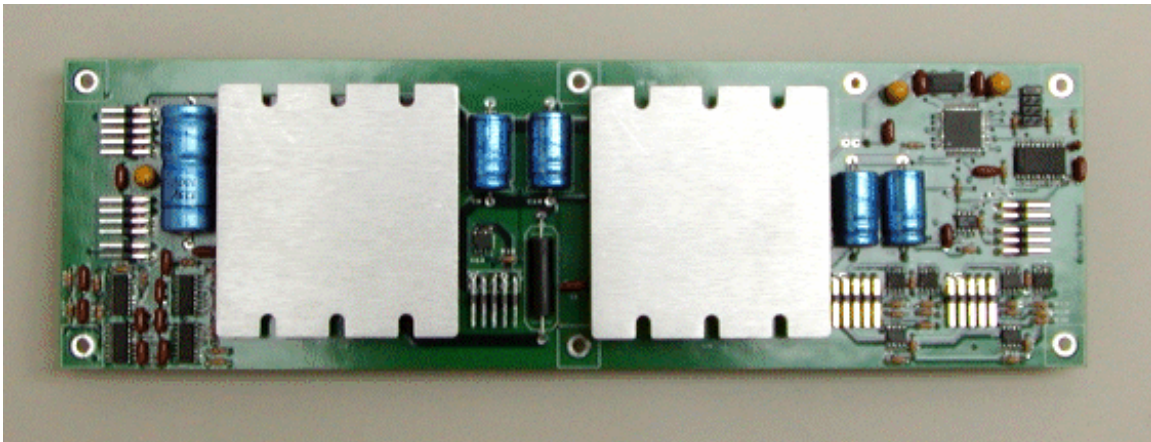
Figure 24. Downhole Camera Control Circuit Board

Figure 24 shows the physical printed circuit board produced from this schematic. The board is a four-layer board made of FR4 material, measures 3 inches wide x 10 inches long, and is housed inside the robotics base module. Worthy of note are the large heat sinks for the DC-to-DC power converters used to take the single DC voltage supplied from the surface and generate +24V, +12V and +5 VDC regulated power for the various camera functions.

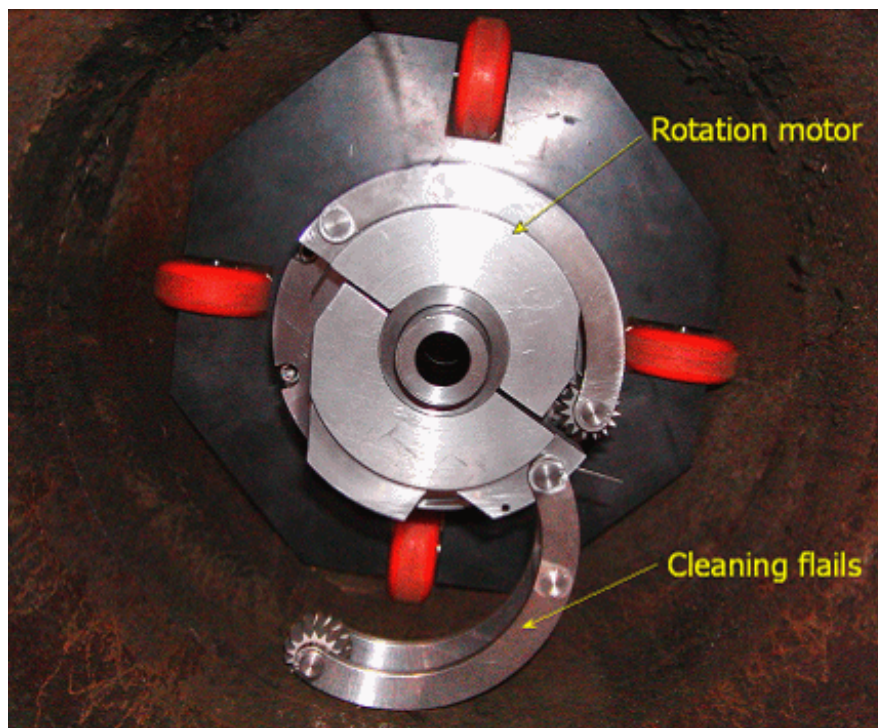
Figure 27. Pipe Wall Cleaning Element

During the fifth quarter, the arm assembly was redesigned to be packaged as a complete robotic element. This included both design and fabrication of the drive motor, motor controller electronics, cleaning head housing and collapsible arm (Figure 27). The completed robot assembly was tested to clean across several 12-inch cast-iron bell and spigot joints (Figure 28). The preliminary tests were very promising. The most efficient cleaning occurs at rotary speeds of 300 rpm with forward and backward movement across the joint at speeds of 4 inches per minute, for approximately 5 minutes per joint.

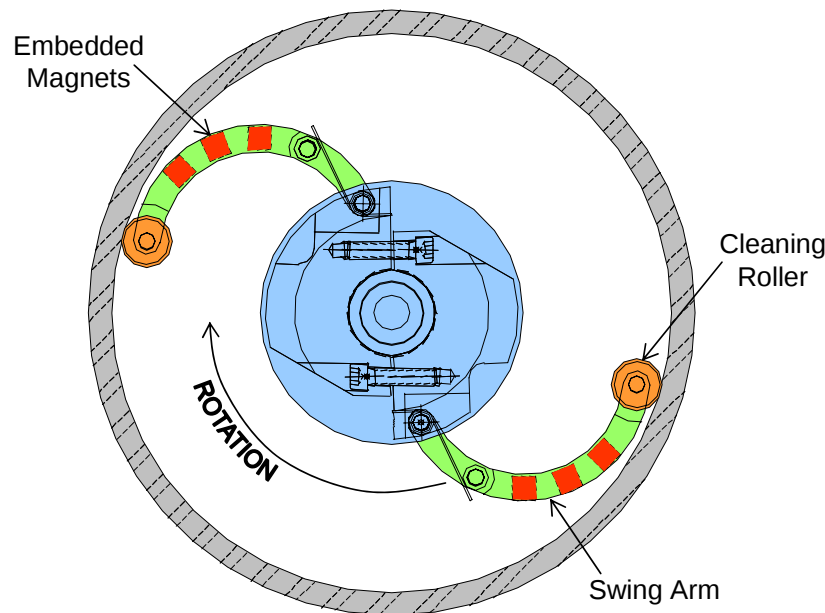
Figure 29. Embedded Magnets to Collect Debris

The first option for modifying the system to improve removal of ferromagnetic debris consists of embedding magnets in the existing pipe cleaning arms (Figure 29). These magnets would capture ferromagnetic debris as it is dislodged from the pipe wall. This design would not require any additional tooling/attachments and would improve debris removal during the cleaning run without requiring any changes to current operating procedures.

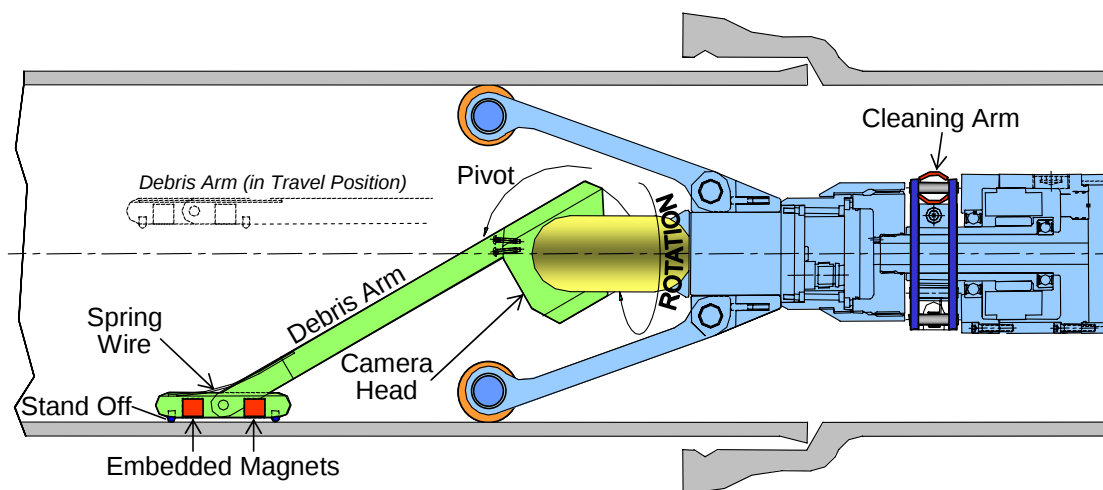
Figure 30. Camera-Mounted Debris Arm

Another option for enhancing debris removal is to add a special debris-collection arm assembly to the camera head (Figure 30). The debris arm would be manipulated via existing camera movements (pivot and rotation). The arm would incorporate a spring-loaded pivot bar at the end. This bar would have magnets embedded along the length and non-metallic standoffs at each end. These standoffs on the pivot arm will prevent the magnets from attaching to the wall of the main (preventing the need for the camera motor to break the magnet from the pipe wall).

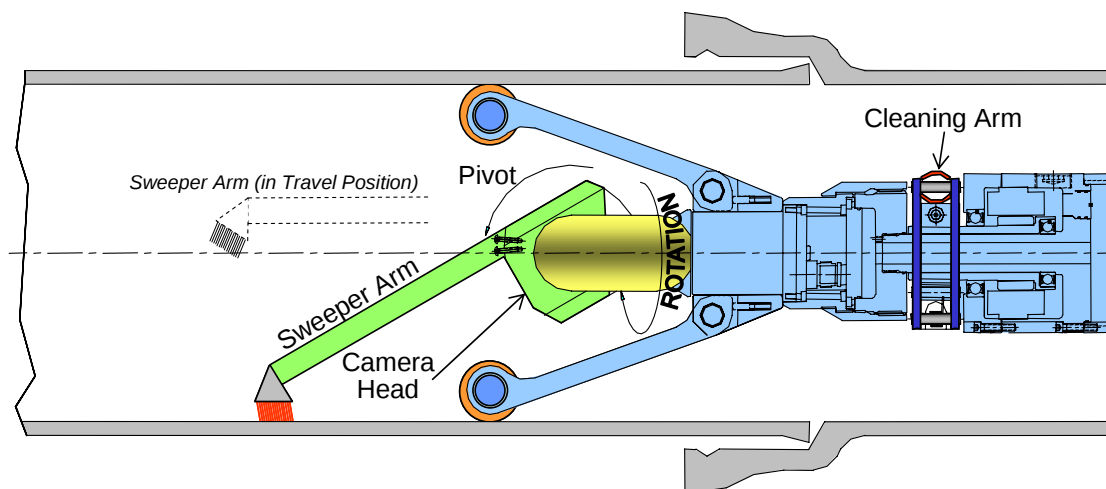
Figure 31. Camera-Mounted Sweeper Arm

In addition to concepts that allow ferromagnetic debris to be collected and removed, it will still be necessary to clean non-magnetic debris such as dirt from the joint area. It will likely be sufficient to sweep (or plow) the debris forward so that the area surrounding the pipe joint is clean prior to running a patch. The most straightforward approach is to attach a sweeper arm to the camera assembly (Figure 31). This provides the capability to position the brush anywhere on the circumference of the pipe.

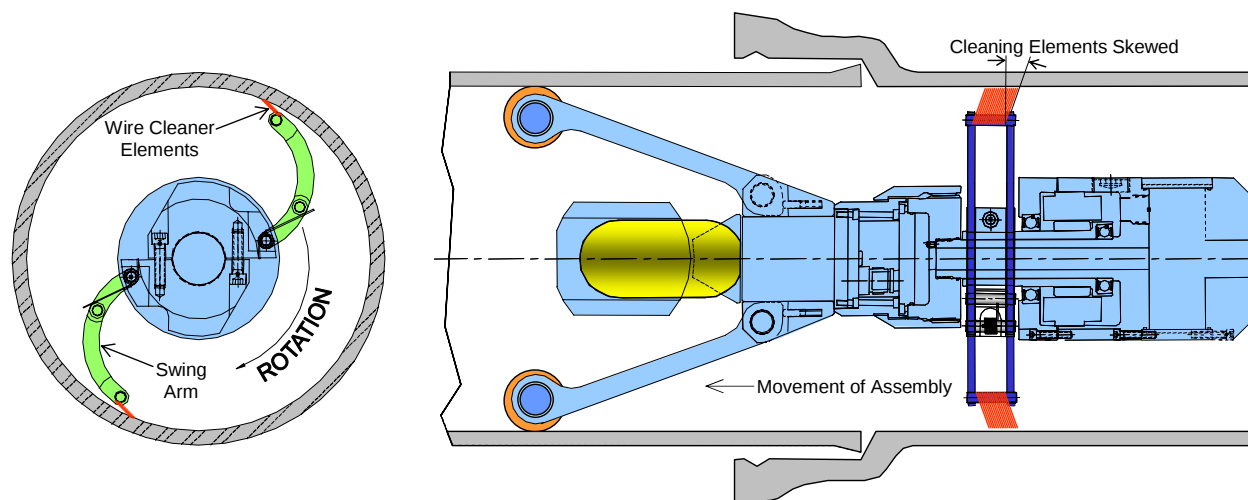
Figure 32. Cleaning Elements Modified to Sweep Debris Forward

Another concept would promote axial sweeping of the debris during the cleaning operation (Figure 32). Here, the rotating cleaning arms would be redesigned with wire elements instead of a serrated roller. Wire elements mounted at an angle (skewed) might promote debris displacement axial away from the area being cleaned. This option would require the operator to manipulate the robot train from the surface in the forward direction after the motor has commenced rotation.

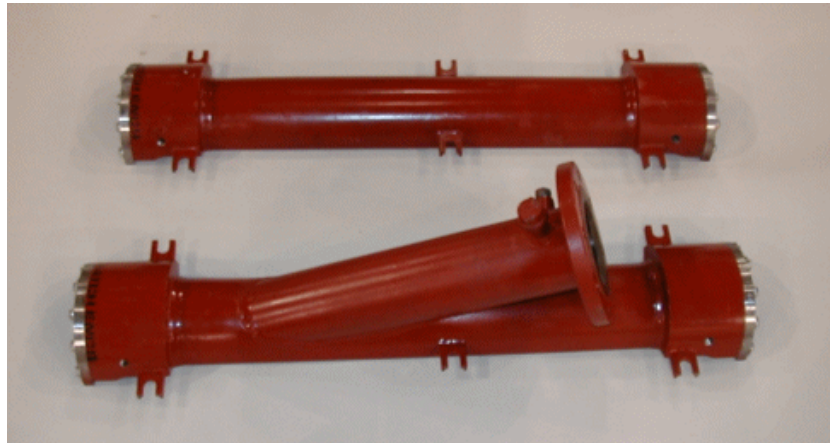
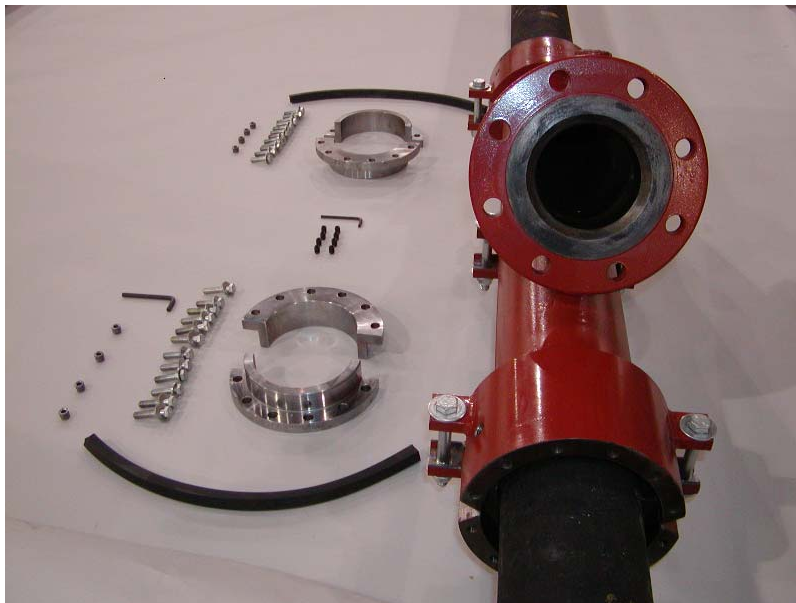
Figure 33. Cast Iron Entry Fitting (4-inch Prototype)

In the previous quarters the access fitting was produced in a 4-inch prototype size to validate the design prior to embarking on the fabrication and testing of a 12-inch version (which will be considerably more expensive). Sealing tests at pressures up 100 psig were successfully conducted along with preliminary drilling tests. Figure 33 and Figure 34 illustrate its key components.

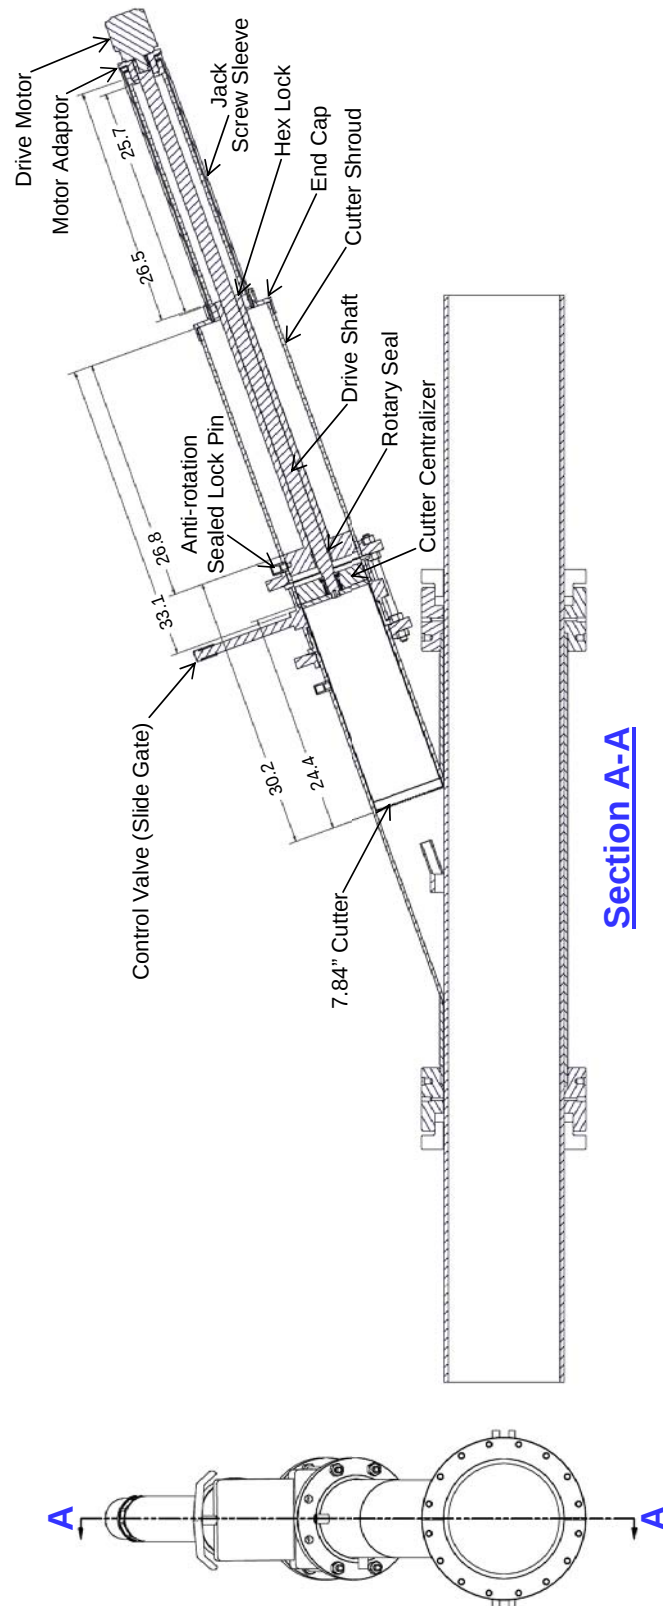
Figure 36. Drilling Assembly for Cutting Access Hole in 12-in. Cast-Iron Mains

A cutter centralizer guides the cutter through the riser inside bore as it moves toward the main. A wire spear mounted on the end of the drive shaft engages the core catcher as the cutter is advanced. Once engaged and the entry hole is cut, the spear retains the coupon within the cutter as the drilling assembly is retracted into the cutter shroud.

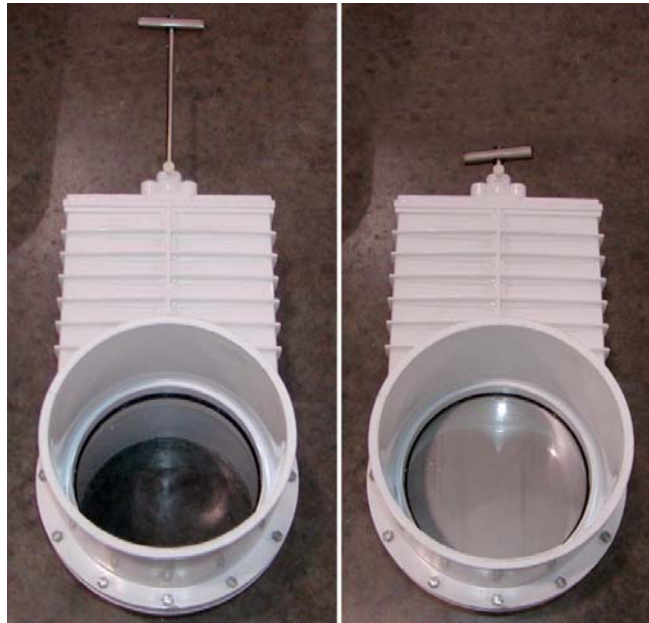
Figure 37. PVC Control Valve

The project team sought to minimize the weight of each component. Several items are to be manufactured from aluminum. In addition, a lightweight thermoplastic gate valve was acquired for use with the assembly (Figure 37). This option reduces the valve weight and overall drilling assembly length dramatically. Conventional ball valves for this size are about 18 inches flange to flange and weigh about 400 lb. They are not manufactured commercially using lightweight materials. The lightweight gate valve obtained is about 8 inches flange to flange and weighs only 22 lb.

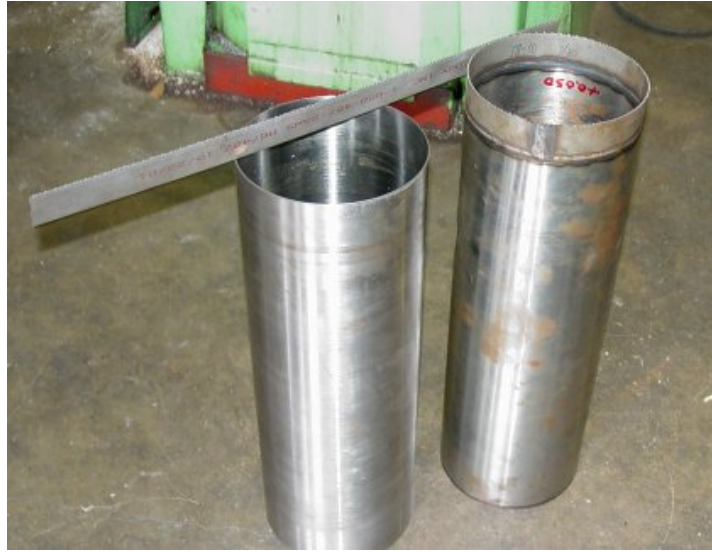
Figure 38. Hole Saw for Cutting Access Hole in Gas Main

To support use of the 12-inch entry fitting, a saw cutting system was designed to cut an angled hole into the pressurized cast iron gas main. Since the angle of entry is near 20°, the body of the saw must be very deep to receive the elliptical coupon as it is cut. A hole saw for cutting an 8-inch hole was designed and is currently being manufactured (Figure 38). In the left side of the figure, a saw blade is shown on top of a saw body prior to attachment. The hole saw will be powered by a hydraulic motor which is powered by a 50 horsepower, diesel-driven hydraulic power supply. This same power supply also operates the coiled tubing unit.

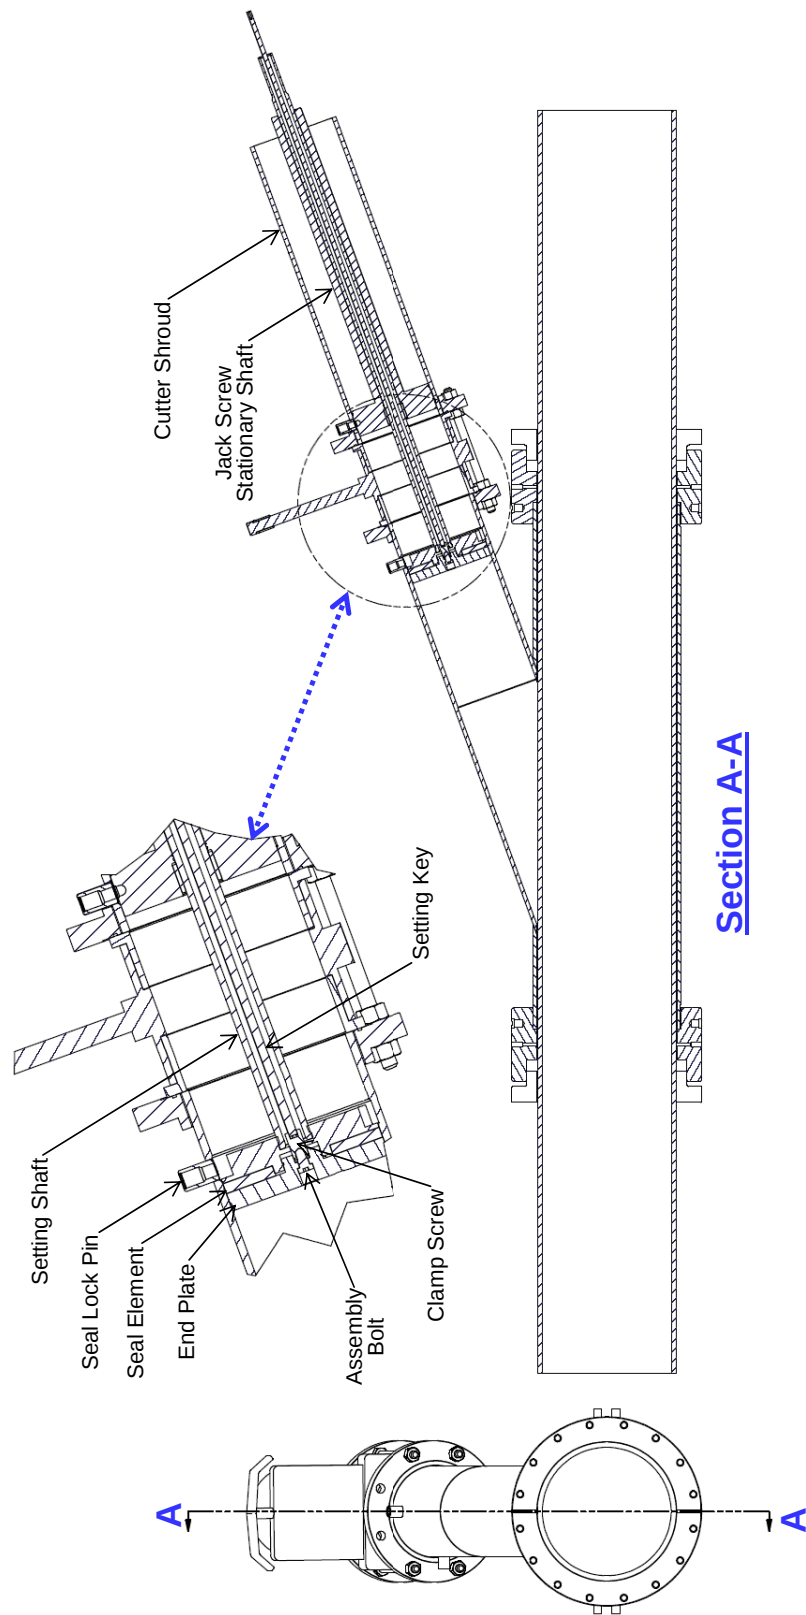
Figure 39. Plug-Setting Assembly for Resealing 12-in. Cast-Iron Mains

The expandable plug consists of an end plate, a body, a clamp screw and an assembly screw. An elastomer element is placed between the end plate and body for sealing to the riser inside diameter when compressed. The element is relaxed while lowering into the riser. The plug assembly is attached to a setting shaft which is placed inside the jack screw stationary shaft. Once in place a sealed lock pin is threaded through a side port provided on the riser. The lock pin serves as an anti-rotation stop for the expandable plug body. A hex key is placed through the setting shaft and engages the clamp screw. Rotating the clamp screw with the hex key causes the end plate and the plug body to move together and compress the elastomer element. The element expands until it contacts the wall. The setting shaft and setting key are removed from the plug by retracting through the control valve and cutter shroud. After the shroud and control valve are removed, a second lock pin may be installed through a second port provided on the riser of the bolt-on fitting and a blind flange mounted to the riser flange.

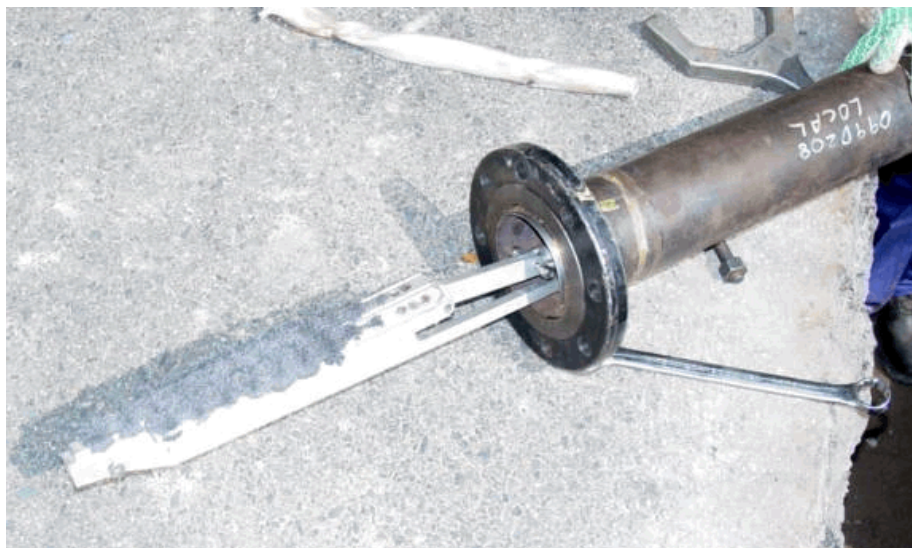
Figure 42. Magnet Assembly for Removing Filings

The coupon was successfully retrieved. Next, a magnetic cleaning assembly (Figure 42) was run into the pipe for three passes to remove the vast majority of metal filings created by the sawing process.

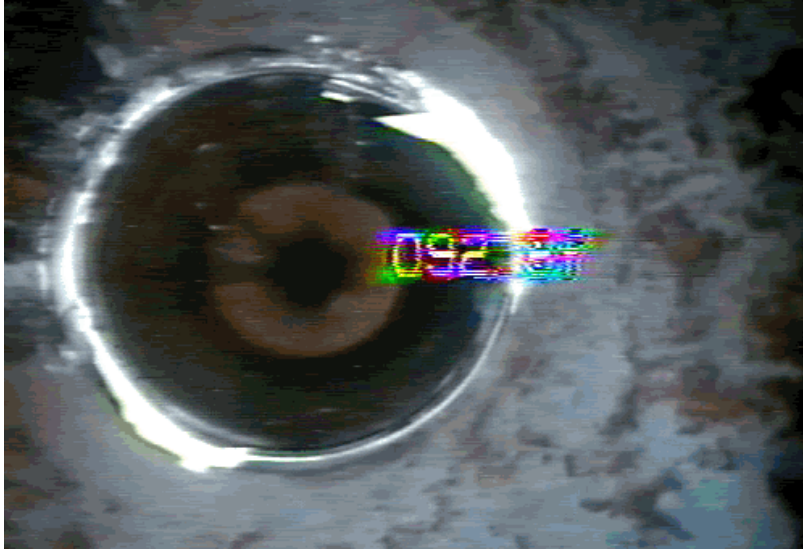
Figure 44. Successfully Set Patch at 93.7 ft

- Two sleeves (at 128.8 ft and 93.7 ft) were run and set 100% successfully (Figure 44).

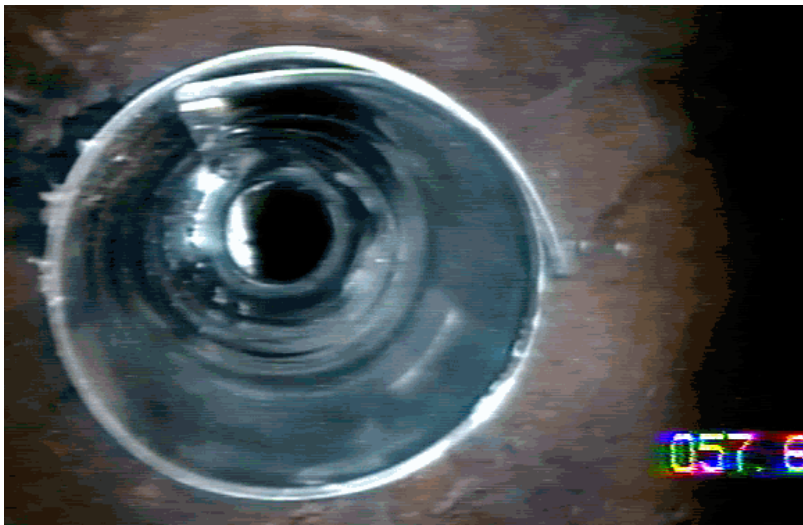
Figure 45. Partially Engaged Patch at 58.6 ft

- One sleeve (at 58.6 ft) failed in the first attempt to set it, was carried with the assembly back to the entry point, and was then rerun and set successfully (although the ratchets did not engage completely (Figure 45)).

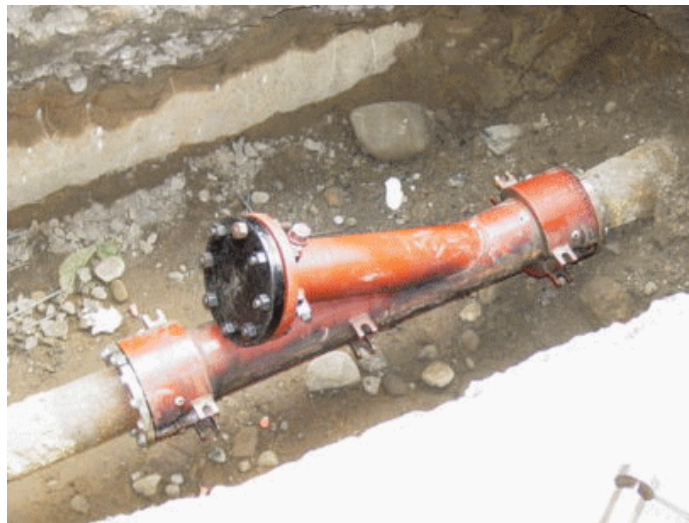
Figure 46. Entry Fitting Ready for Burial

After all in-pipe operations were complete, the equipment was removed from the pipe and disassembled. A seal plug was then inserted into the 20° riser section of the entry fitting. Once the seal plug is set, the gate valve was then removed from the main. A blind flange was then attached to the 20° riser to create a second (redundant) gas seal and allow future re-entry into the pipe is so desired. The sealed entry fitting ready for burial is shown in Figure 46.
