The Integration Of The 241Z Building Decontamination And Decommissioning Under CERCLA With RCRA Closure At The Plutonium Finishing Plant

E. M. Mattlin
S. L. Charboneau
Department of Energy - Richland Operations Office

To Be Presented at
Waste Management Symposia 2007

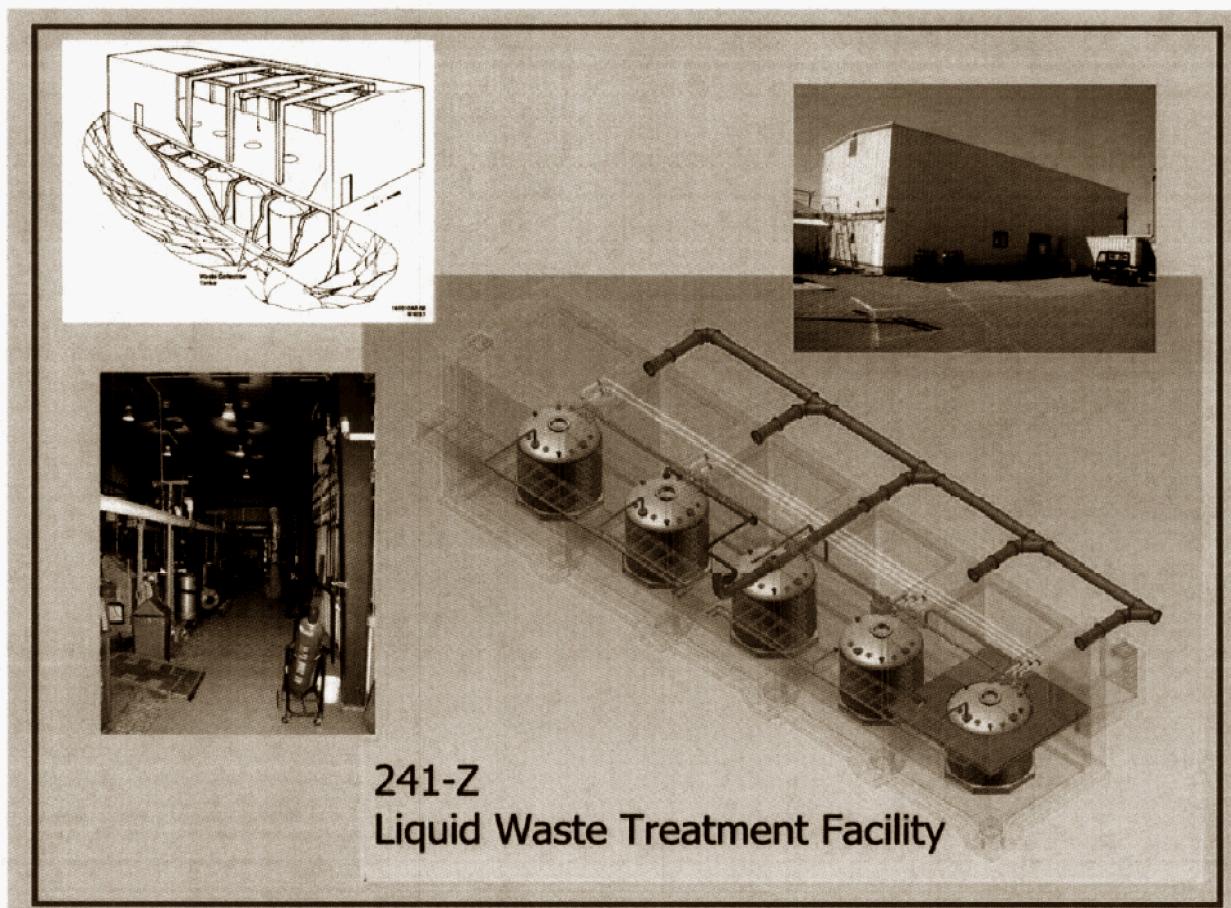
The 241-Z Liquid Waste Treatment Facility consists of five 5,000 gallon stainless steel tanks (10 ft high by 10 ft diameter), ancillary piping and equipment; and containment vault. The tanks are housed individually in a ventilated below grade, reinforced concrete vault that is divided into five separate cells. The tank cells are each 17 ft square and 22 ft deep. Access to the below grade cells is via either a 2.5 ft square man hatch or a 3.25 ft diameter port opening in the center cover block. An above grade, pre-engineered corrugated metal enclosure was built in 1981 to provide weather protection for the vault, ventilation system high-efficiency particulate air filters, and other equipment. This enclosure is part of the CERCLA removal action and not part of the RCRA Closure. The 241-Z facility is approximately 28 ft wide, 92 ft long and 24 ft high and is located about 300 ft south of PFP's 234-5Z Building. A graphical overview of the 241-Z facility is provided in Figure 1.

Figure 1 – Graphical Overview of the 241-Z Facility

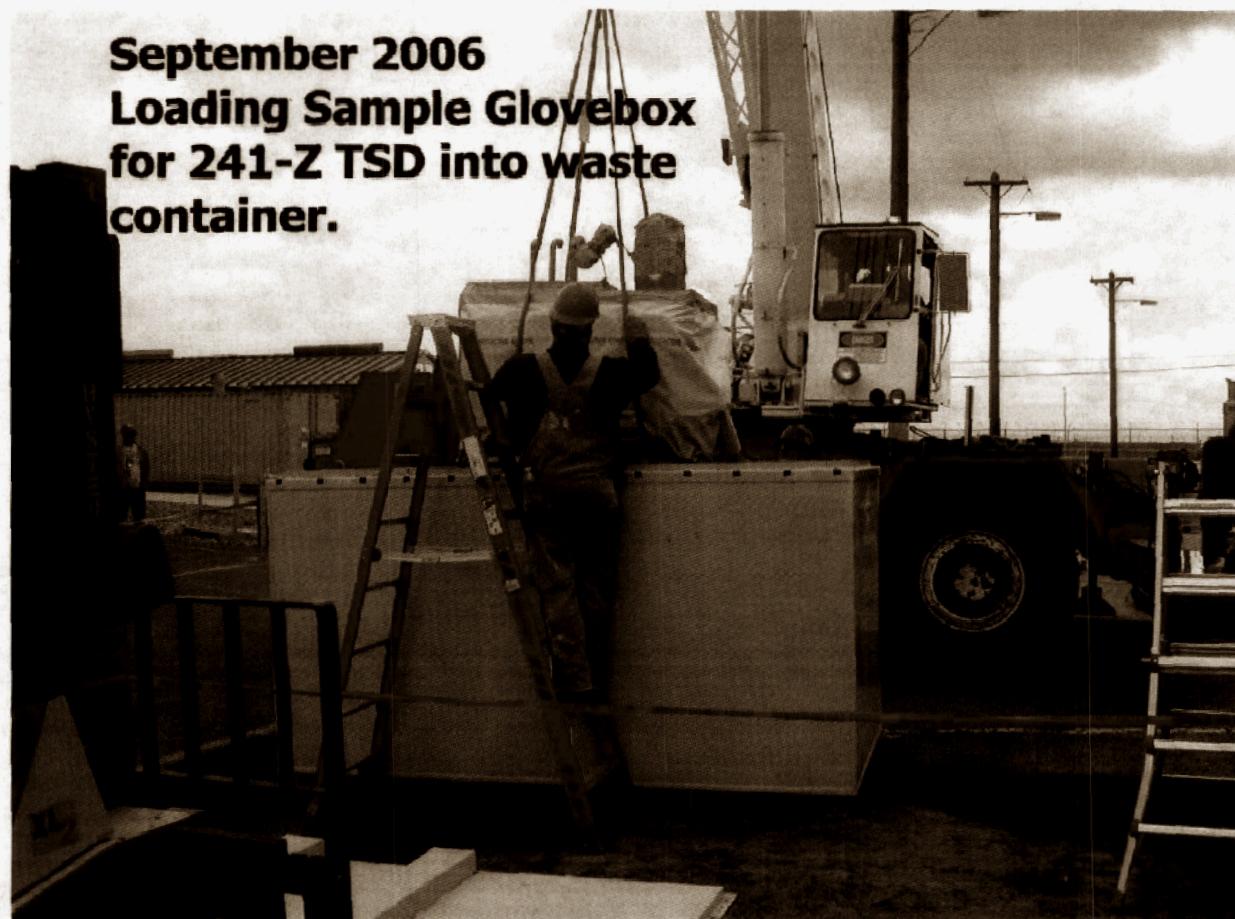
When the decision to close the tank system to further waste treatment was made, the RCRA closure plan was developed for the treatment and storage tanks, sample glovebox GB-2-241-ZA, and ancillary piping and equipment. Figure 2 shows a photograph during RCRA closure activities of the removal of the sample glovebox.

Figure 2- RCRA Closure Activities: Removing Sample Glovebox

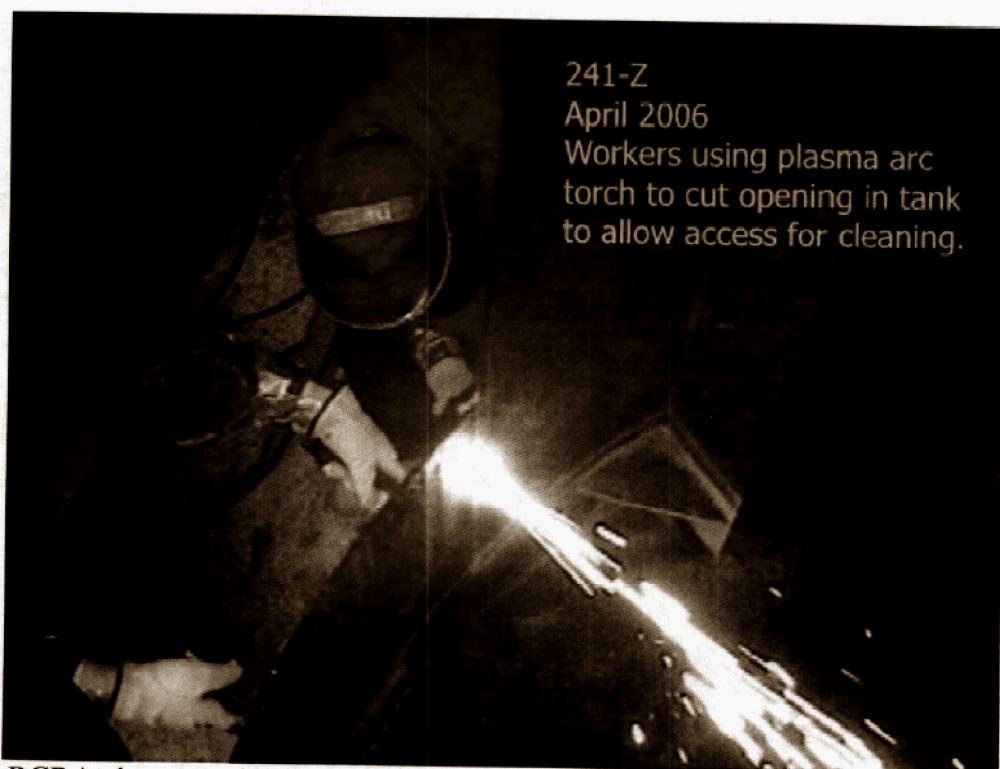
The 241-Z TSD unit closure plan provides the process for closing the RCRA Storage Facility Permit for the 241-Z tank system at PFP, and describes the process for the integration of the closure activities with CERCLA as appropriate. Under this closure plan, the 241-Z TSD unit is undergoing clean closure to the performance standards of the *Washington Administrative Code* (WAC), with respect to dangerous waste contamination from RCRA operations. Figure 3 shows a photograph during RCRA closure activities of workers cutting an access hole in a tank wall. Figure 4 shows photographs of a tank interior before and after tank cleaning.

Figure 3- RCRA closure activities: cutting access hole in tank wall

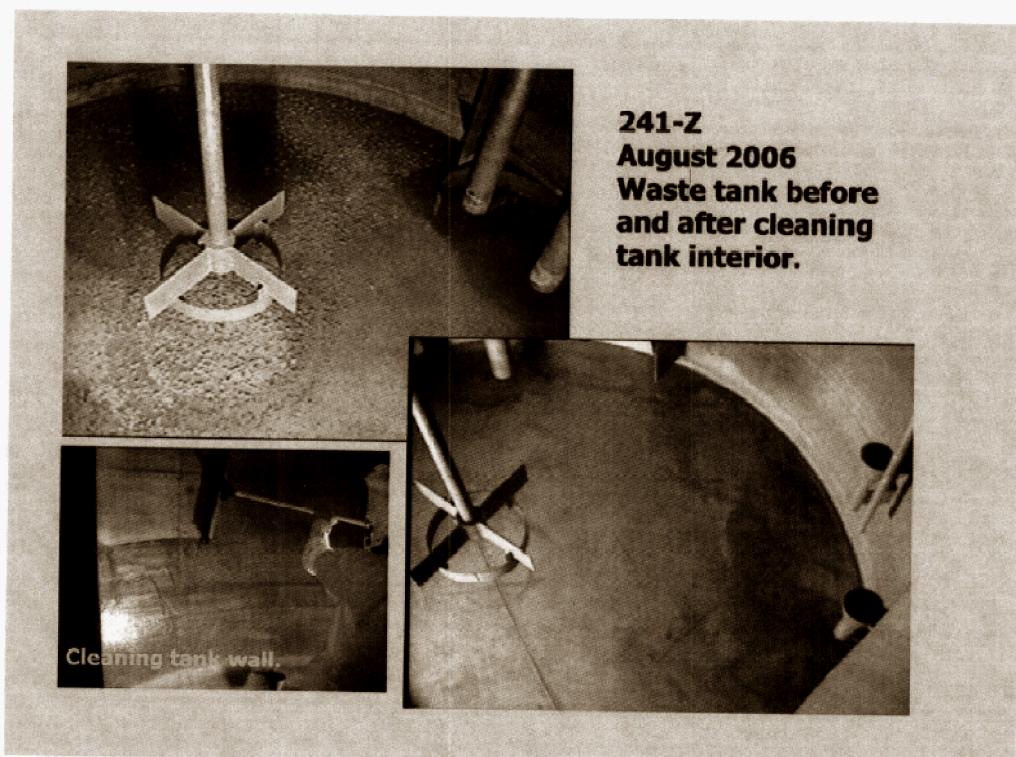
Figure 4 - RCRA closure activities: cleaning tank interior
