Restore McComas Meadows

Meadow Creek Watershed

Annual Report 2005 - 2006

DOE/BP-00021728-1

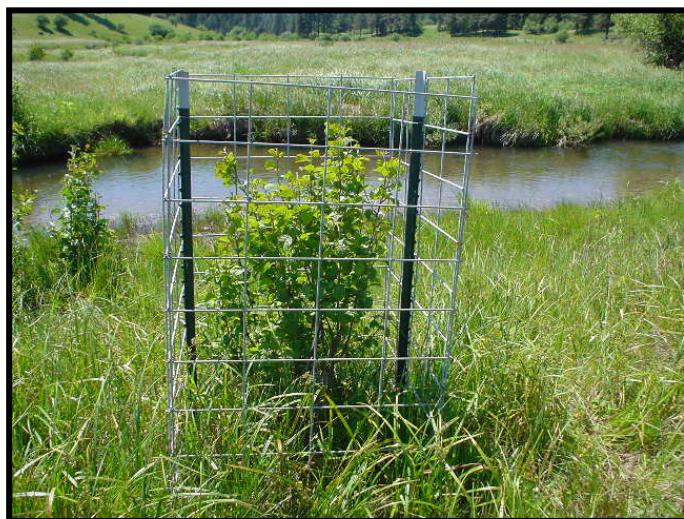
Figure 1. McComas Meadows riparian planting with protective cage.

Approximately 3,500 trees were planted including: Drummond willow, Red Osier dogwood, alder, and Douglas hawthorn. These trees were planted in the riparian zone of Meadow Creek with the majority of trees planted within McComas Meadows, where cattle grazing has been excluded since 1992. Trees are planted along the riparian zone to provide streambank stabilization, and large woody debris recruitment for shade, which reduces stream temperatures. Steel cages were erected around selected hawthorn trees to reduce the browsing impact by wildlife. Planting and protection are part of the implementation of native species restoration within McComas Meadows.

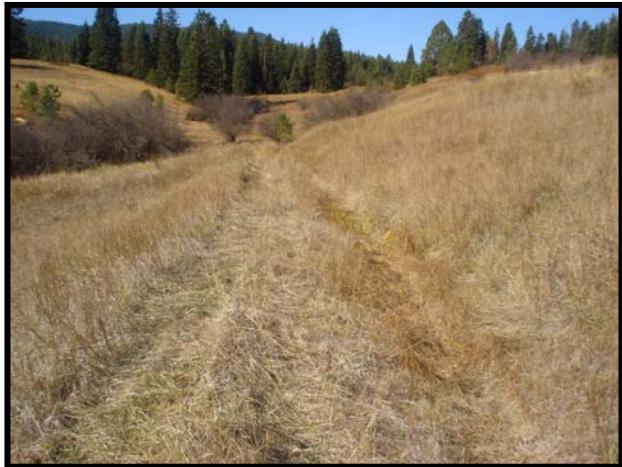
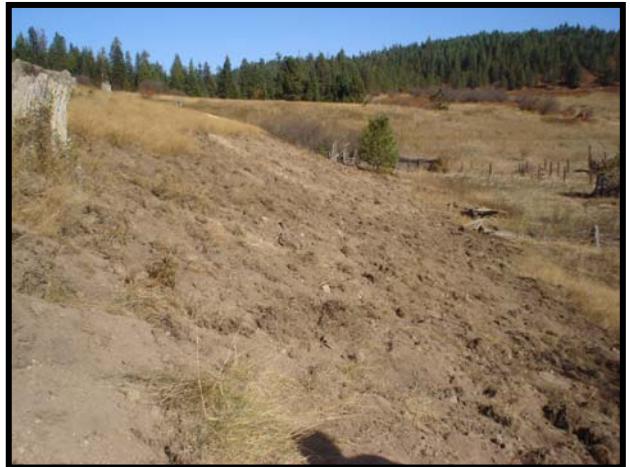
Figure 2. McComas ditch restoration before and after construction.

Restoration of 3,130 feet of man-made ditch surrounding McComas Meadows was obliterated and natural drainage patterns were restored and 1,300 feet of existing road were obliterated and re-contoured. The ditch and road were constructed around the meadow approximately 50 years ago and cause ponding surface water, surface erosion, and mass failures which cause sediment to enter the stream and degrade fish habitat.

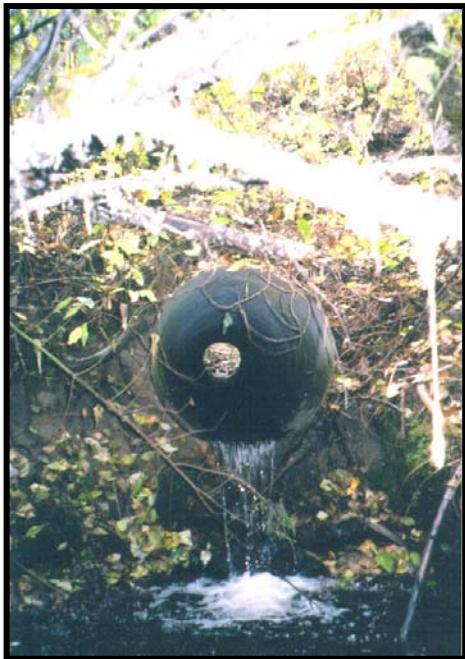
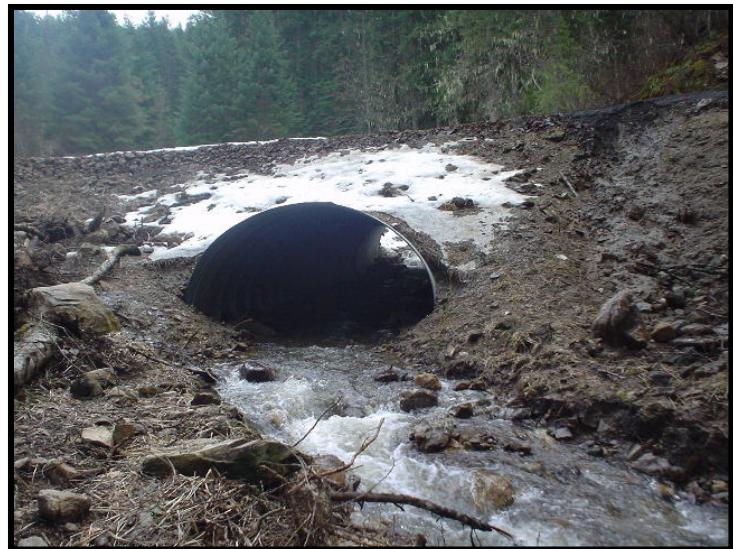
Figure 3. Outlet of the culvert at Doe Creek before and after replacement.

Over 40 culverts were identified by the Nez Perce National Forest for replacement in the Meadow Face EIS. In partnership with the Nez Perce National Forest three culverts were selected for replacement in 2005. The Doe Creek and a tributary stream to Meadow Creek were replaced, the Storm Creek culvert was rescheduled for replacement in 2006. Design surveys were completed in the fall of 2004, and the final designs were completed during the winter. These projects were cost-shared with other partners, with the Idaho Office of Species Conservation (IOSC) contributing a total of \$80,000 and the Nez Perce National Forest contributing \$45,000. Pre-bid tours were conducted in May through June and the bids were subsequently reviewed and awarded for construction. The construction work was completed in August of 2005.
