San Joaquin Valley Drainage Authority

San Joaquin River Up-Stream DO TMDL Project ERP - 02D - P63

Task 4: Monitoring Study

Interim Task Report # 3

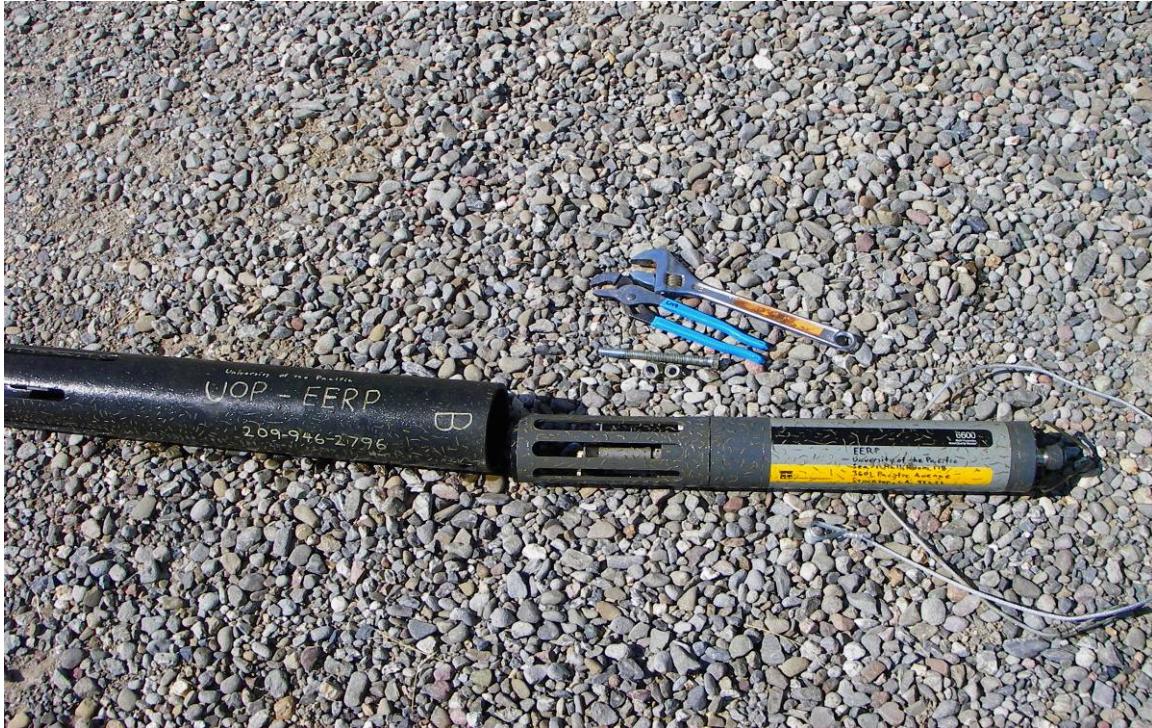
Fig.1 Waterquality Sonde with custom protective housing.

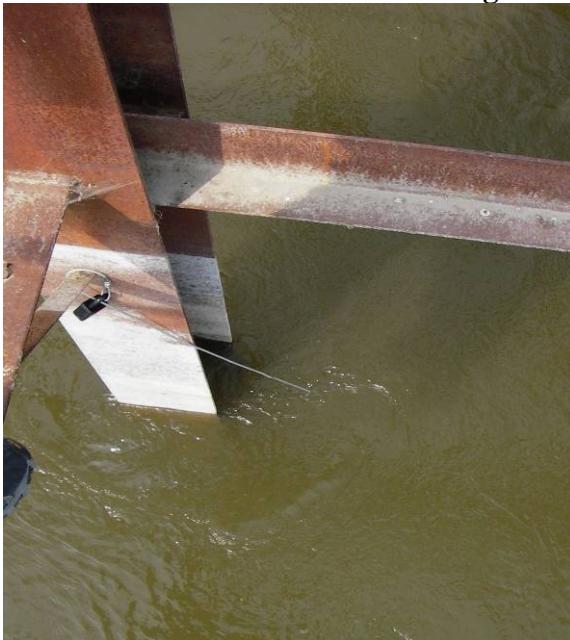
Fig.2 (Left) Sonde hanging at DO-07, San Joaquin River at Patterson pump platform for deployment on 06/27/06. **Fig.3 (Right)** Sonde hanging at DO-07 before retrieval two weeks later on 07/13/06 showing dramatic drop in river stage during this period.

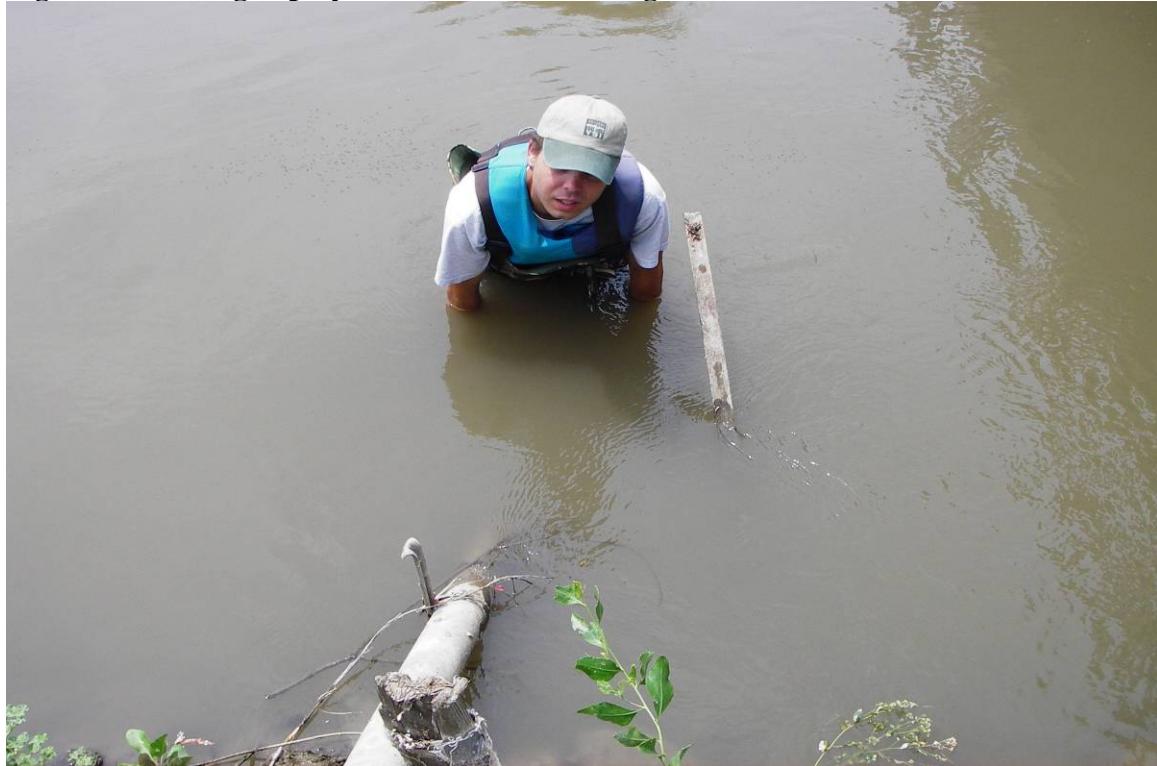
Fig.3 Sonde being deployed at DO-19 Salt Slough at Lander Ave. on 06/27/06

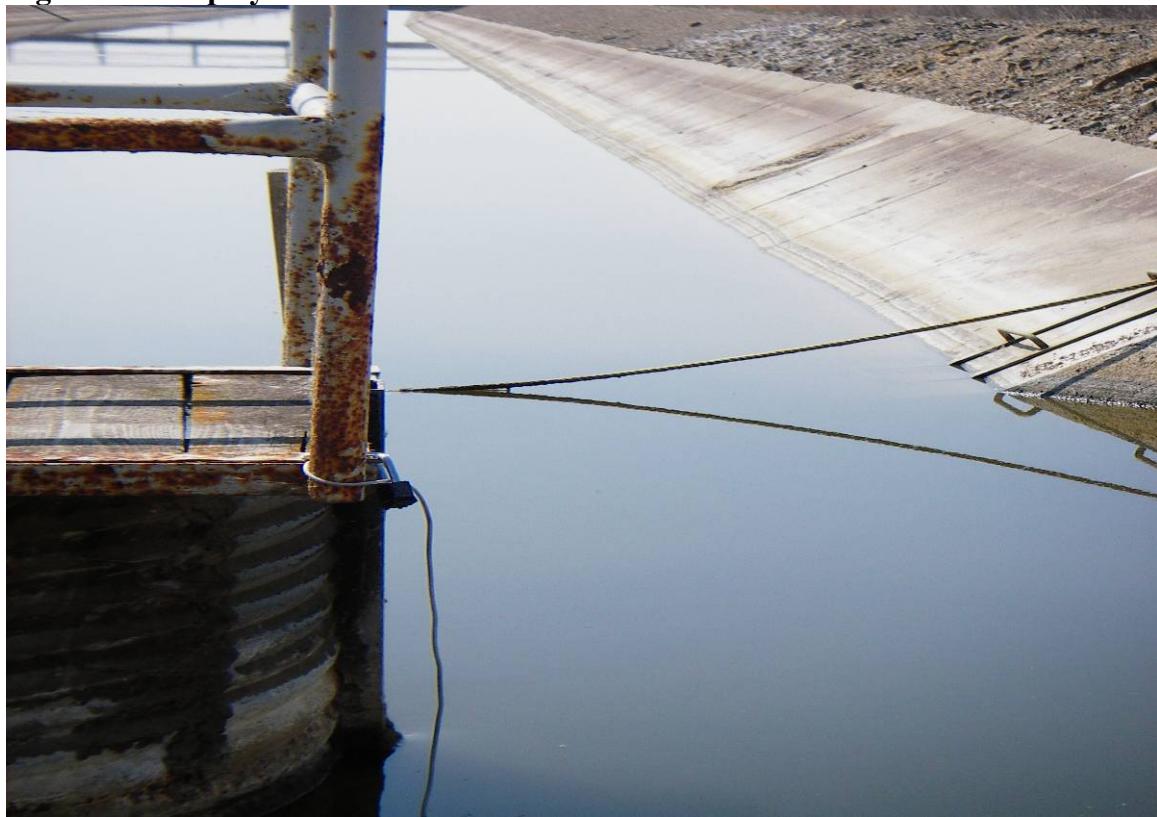
Fig.4 Sonde deployed at DO-44 San Luis Drain End on 06/27/06.

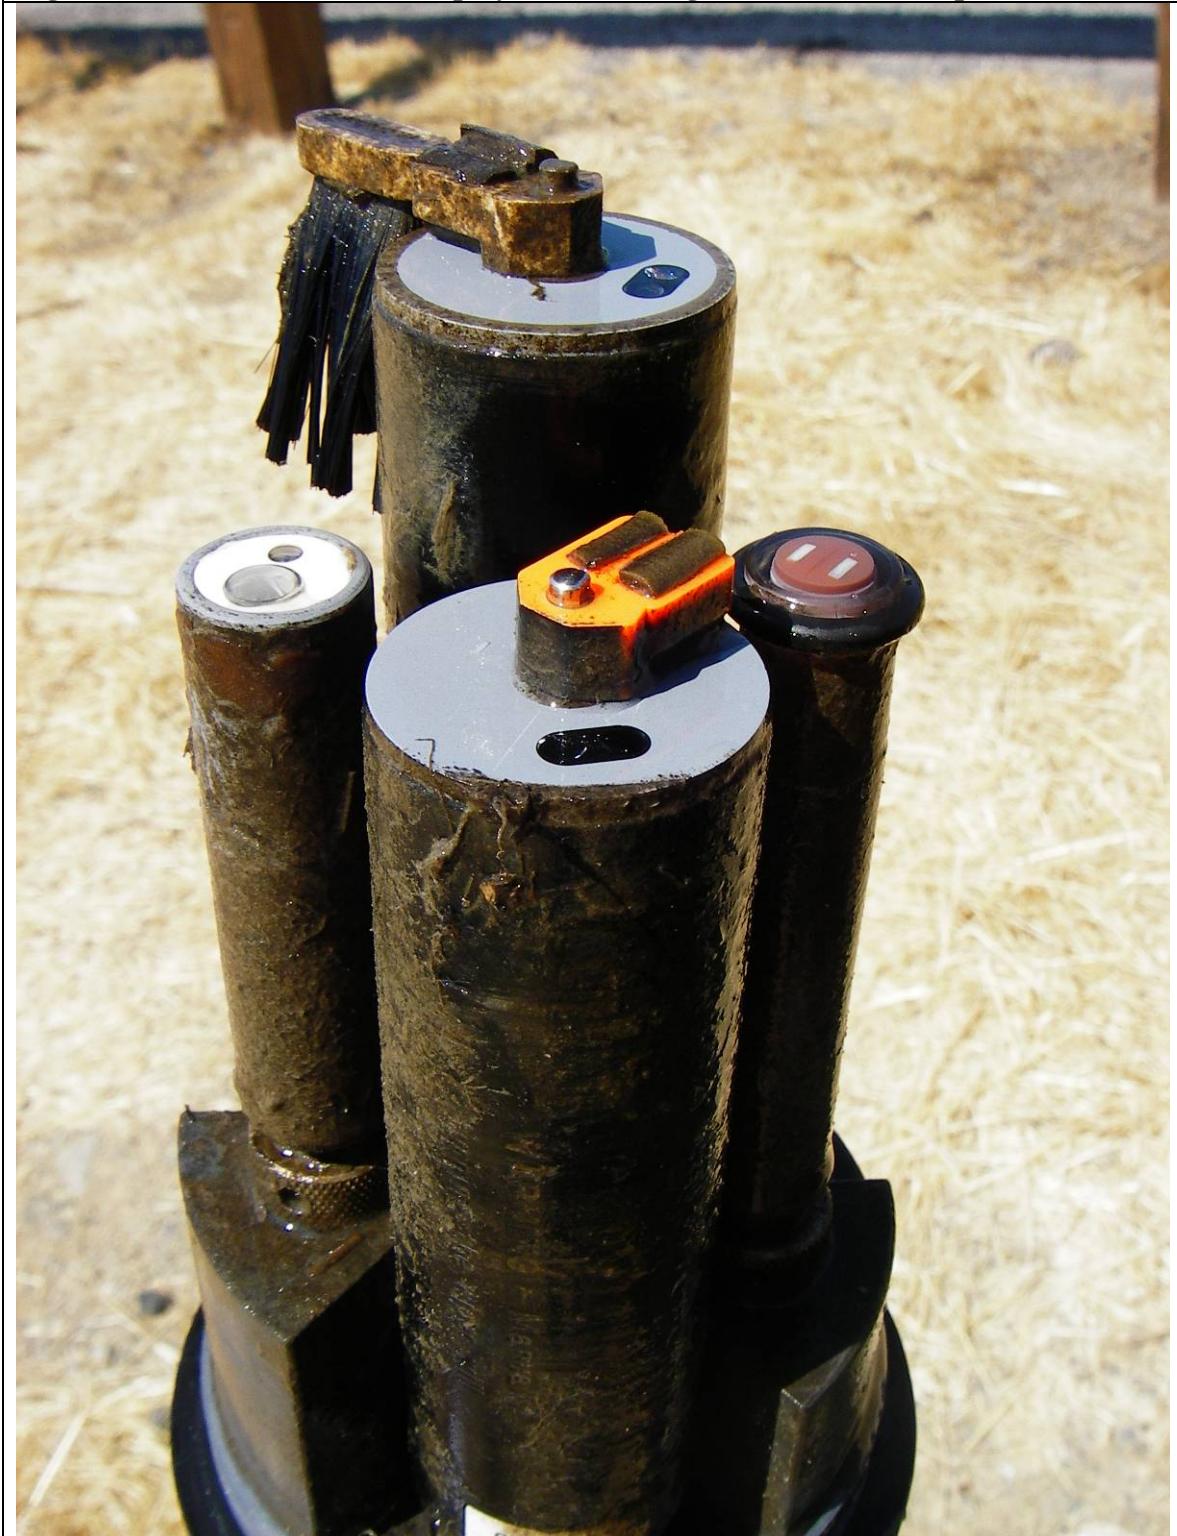
Fig. 5 Sonde at end of 2 week deployment showing effectiveness of wipers

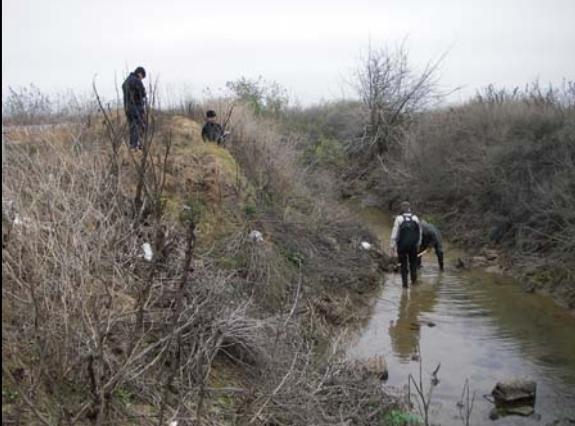
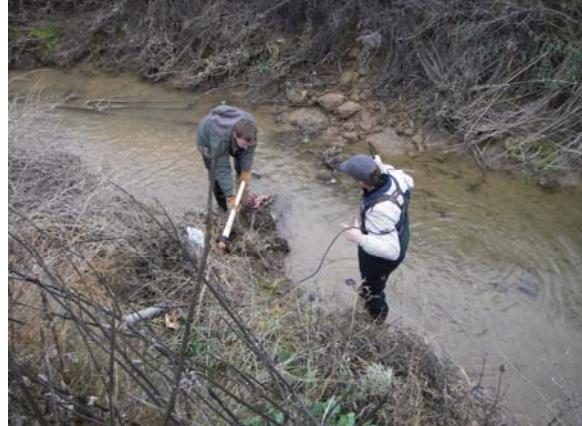
DO-34 Ingram Creek

(left) Student Intern, Kyle Kearney, Jeremy Hanlon, and Chris Linneman removing EC probe which had been encased in sediment. (right) Chris and Jeremy clearing away sediment buildup.

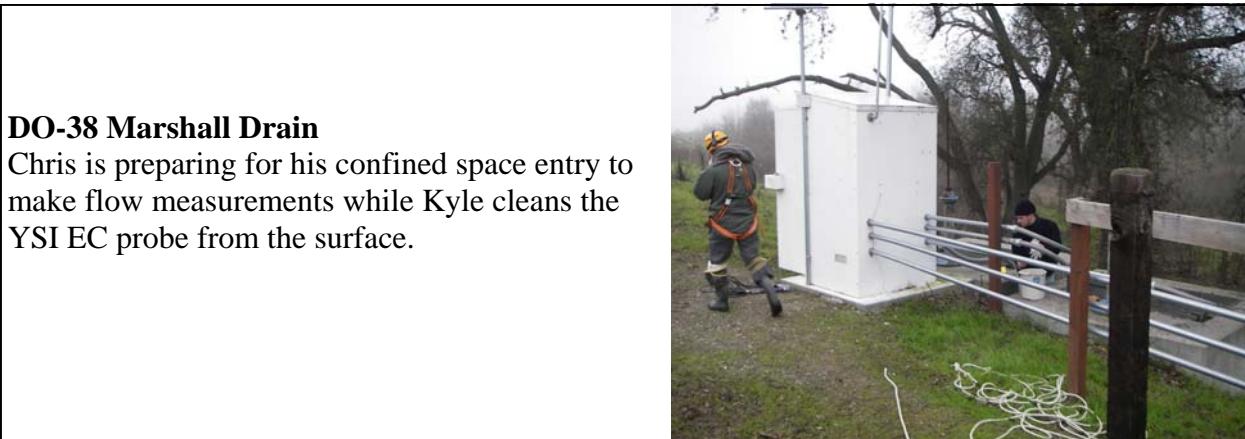
DO-38 Marshall Drain

Chris is preparing for his confined space entry to make flow measurements while Kyle cleans the YSI EC probe from the surface.

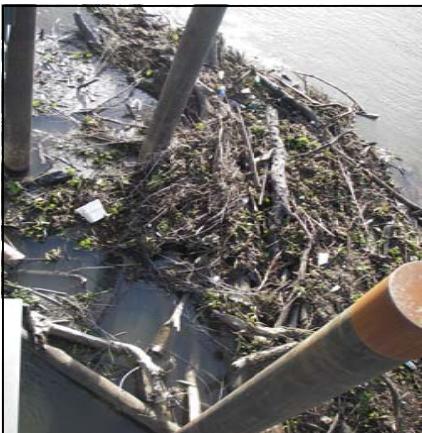
DO-05 SJR at Vernalis
Debris caught on DWR platform pylons.

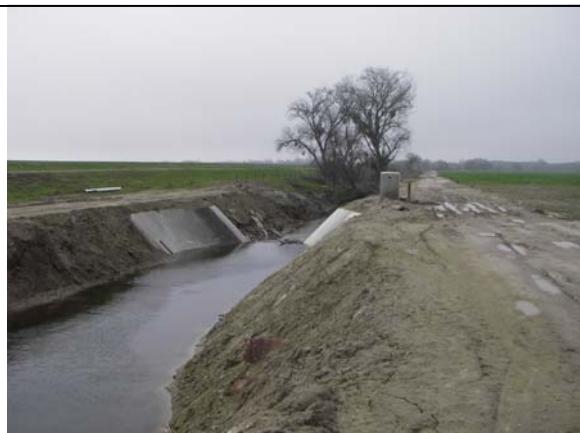
DO-28 TID Westport Drain Flow station
Newly Installed flume and SCADA monitoring system, about 300 ft downstream of the previous station location.

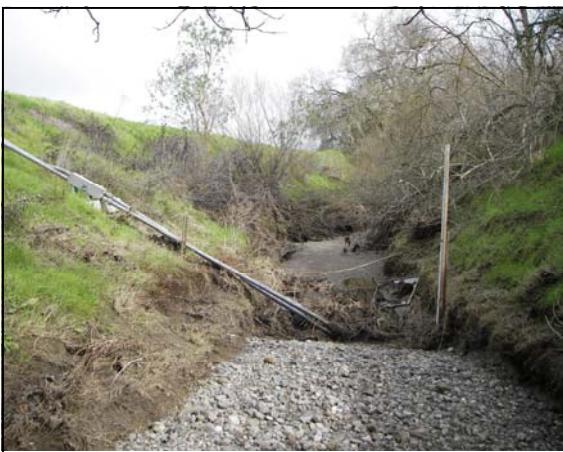
DO-36 Del Puerto Creek monitoring site
Streambed is dry despite recent rains and high levels in SJR.

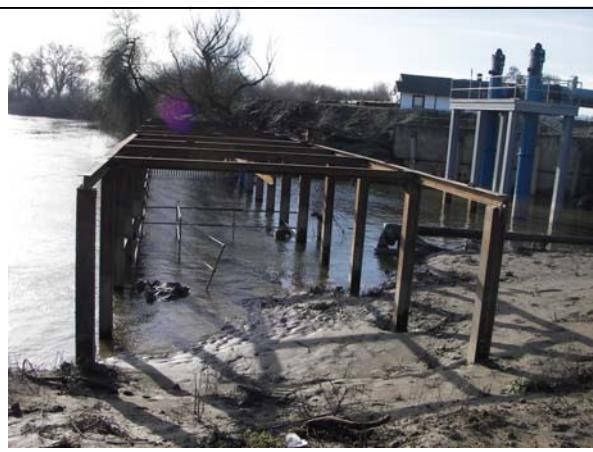
DO-06 SJR at Maze Blvd.
El Solyo pump platform submerged under swollen SJR.

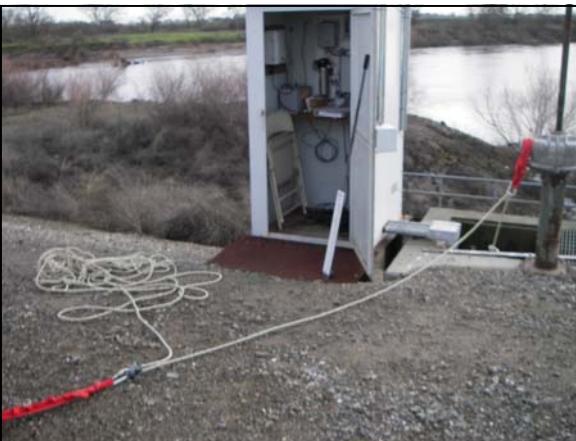
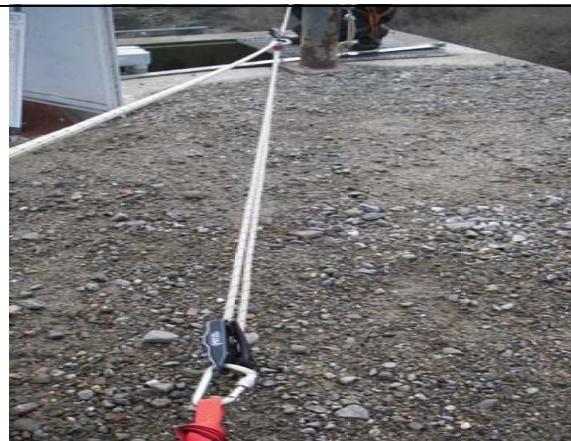
(left) Station house on top of levee with SJR behind. Ropes are rigged for lowering or belaying confined space entrant. (right) Rope system rigged for hauling up of confined space entrant.

DO-31 New Jerusalem Drain was visited in response to the discovery of a leaky bubbler line. The Swagelok fitting was removed and properly re-inserted, the connection was tightened, and checked for leaks. No leaks were found. The weir was rated for correlation to the bubbler reading. DO-34 Ingram Creek was visited to remove some of the sediment from behind the weir-board. The Sontek Doppler instrument at DO-53 Salt Slough at Wolfsen Road was re-installed because the mounting had been discovered to be completely rusted through the previous month. A new mount with stainless steel attachments was used. Met with Karl Stromayer of USFWS while at DO-53 to discuss upcoming training on station maintenance and QA procedures.

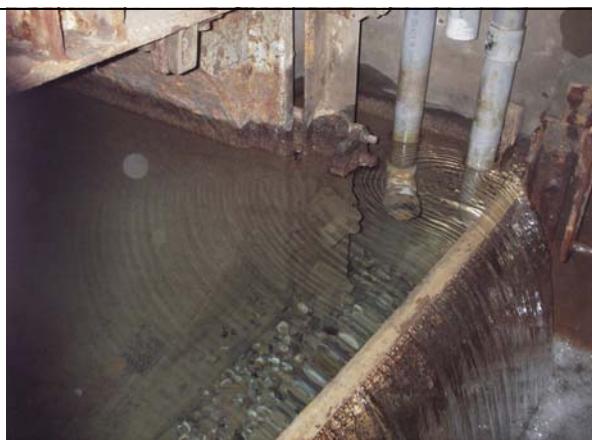
DO-31 New Jerusalem Drain

Shows location of bubbler line orifice and YSI EC meter just upstream of weirboards. The unusually clear water here made the Starflow unable to read velocity and so it was removed and eventually upgraded to a MACE Agriflo unit that was placed downstream of the weirboards.

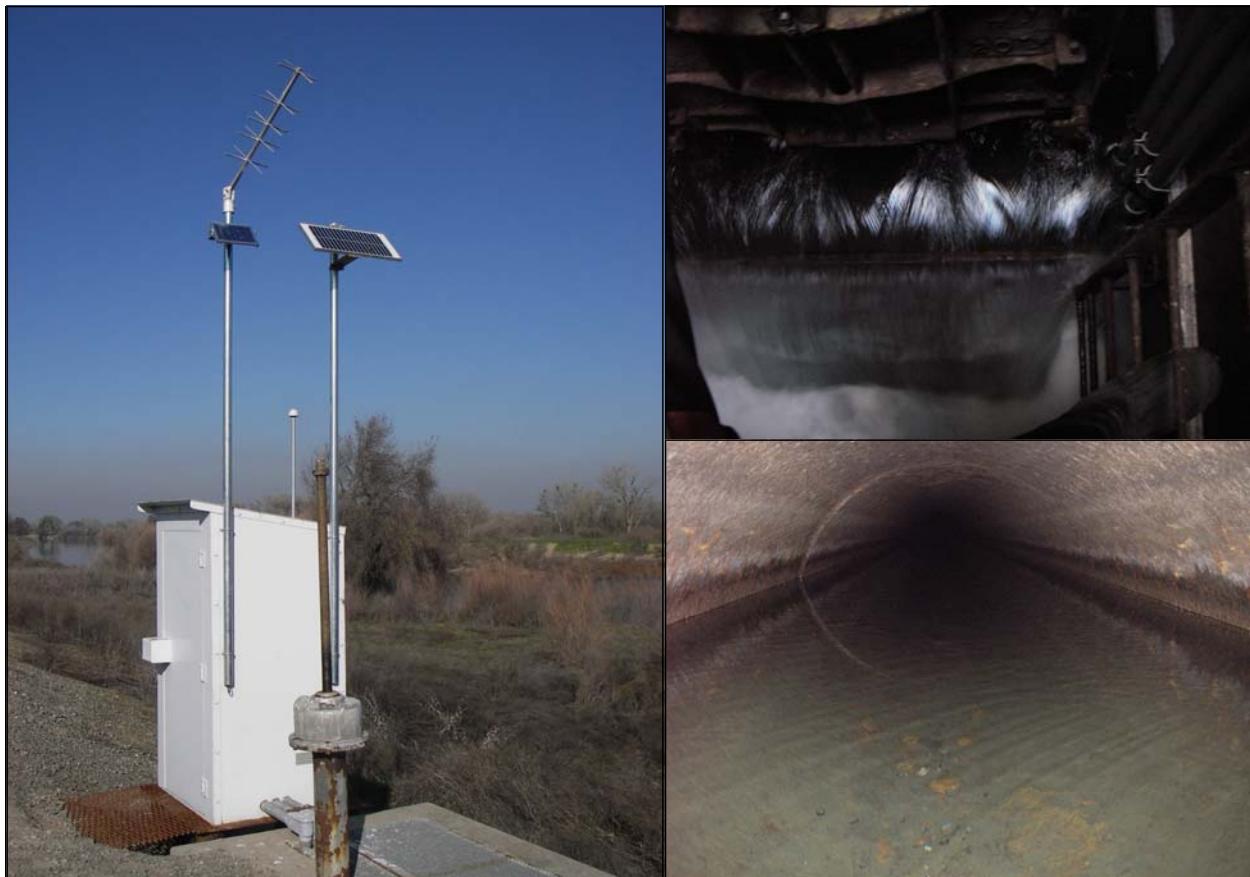
DO-31 New Jerusalem Drain

Installed new MACE Agriflow Doppler flow meter. Note new smaller solar panel in picture (left) provides 6V power supply for Agriflo unit. Picture of water flowing over weir boards (top right) and picture looking upstream of pipe under levee (bottom right).

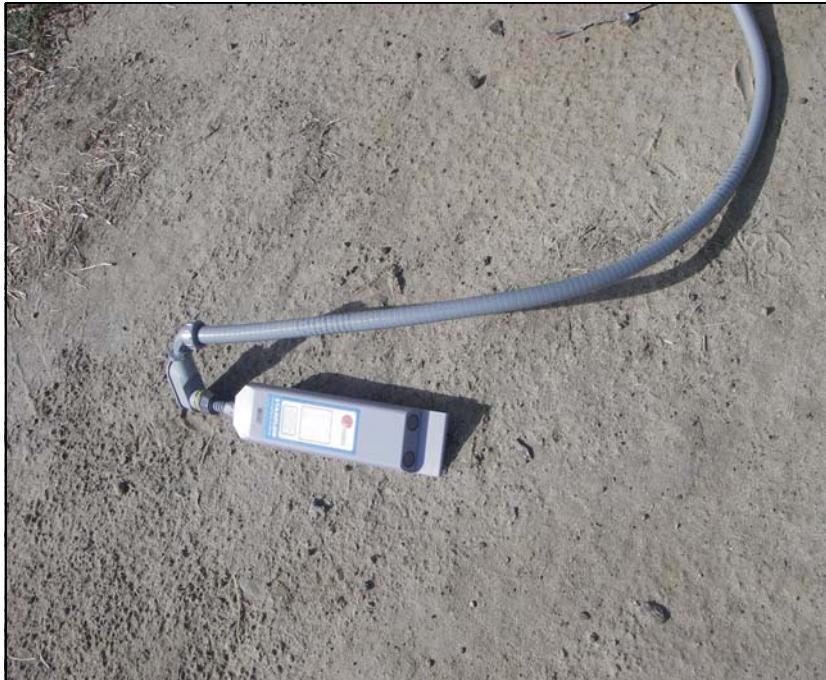
Starflow Doppler flow meter
Picture of Sontek Doppler flow meter with protective tubing around cord. The Starflow is put on the bottom of the channel to measure flow.

had a leaky bubbler line that was fixed by having the line removed and connections retightened. DO-35 Westley Wasteway Flow Station had a short circuit with the Starflow, due to a damaged cable, that made the logger freeze. The logger was removed on February 8th and reinstalled on February 14th and the Starflow cable was disconnected from the logger. On May 9th DO-38 Marshall Drain Road had a leaky bubbler that was fixed by removing the "T" valve. The Design Analysis (Logan, Utah) logger unit at DO-31 New Jerusalem Drain was reporting errors when downloading data on November 17th and December 8th. The logger was replaced on December 18th.

Major equipment failures, such as the Starflow short circuit from DO-35 Westley Wasteway, were nearly all caused by outside factors. The short circuit in the Starflow was the result of a backhoe accidentally slicing the cable while clearing debris from the channel. At the end of the year, when data for December was downloaded from Westside monitoring stations, a faulty data collection card failed to retrieve data from loggers at the same time caused the loggers to stop recording data for the rest of December. This error was not discovered until January 2007.

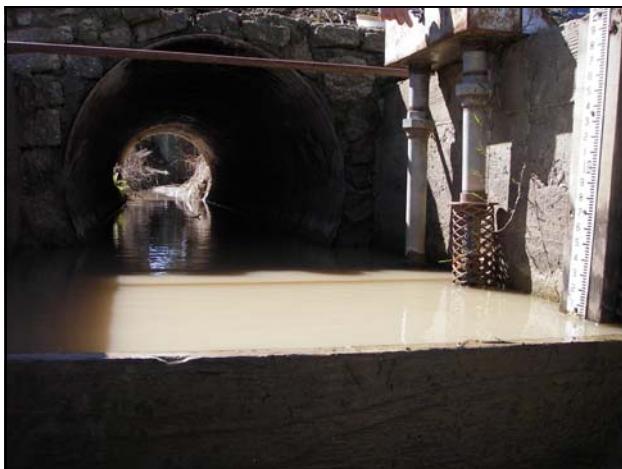
DO-33 Hospital Creek

Close-up photo of installation showing bubbler pipe, EC meter in cage, and stream gauge all just upstream of weirboard.

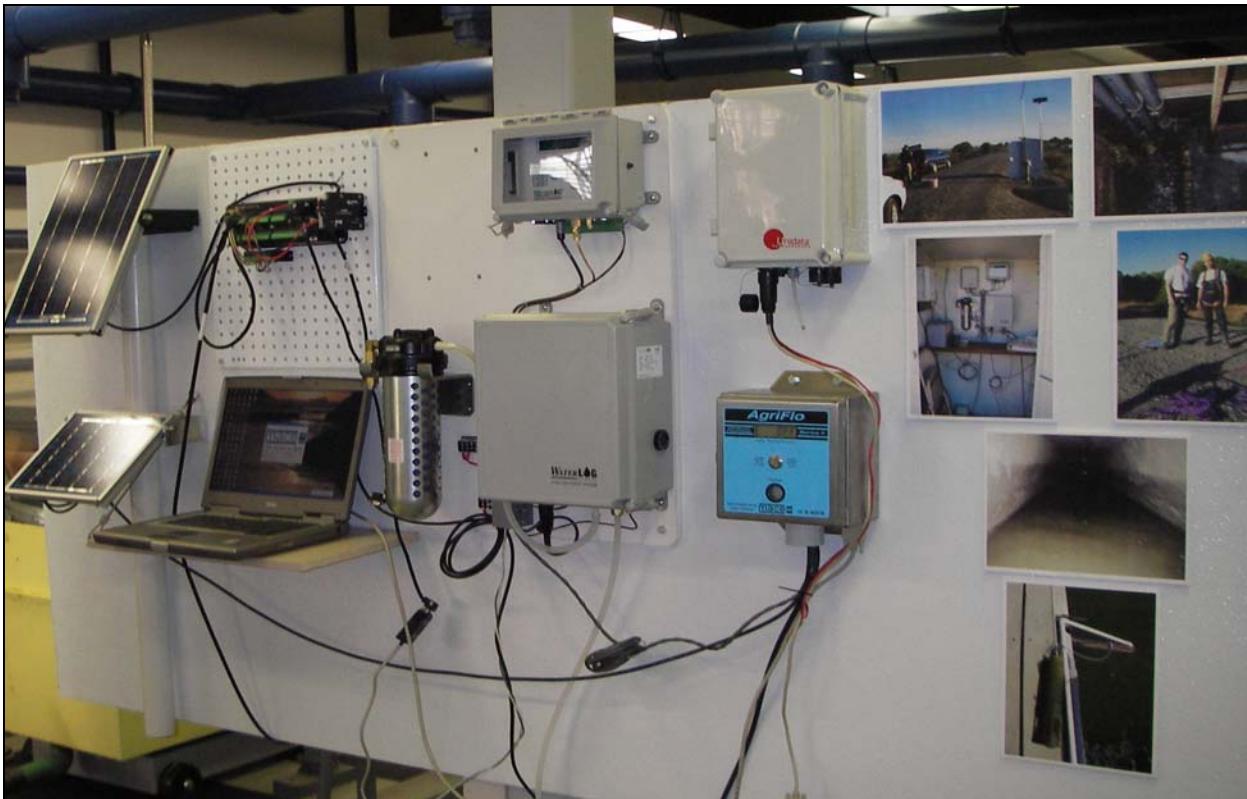
Field Monitoring Training Station in UOP Hydraulics Laboratory

The training station set up at the UOP Hydraulics laboratory was used to simulate a real field monitoring station and allowed trainees the opportunity for hands-on practice.

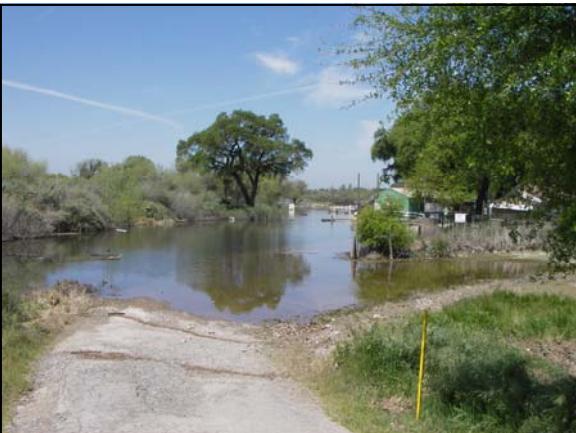
DO-08 SJR at Crows Landing

Turlock Sportsman Club under water after flooding. Grab samples are normally pulled from a site just beyond the big tree in the center of the picture.

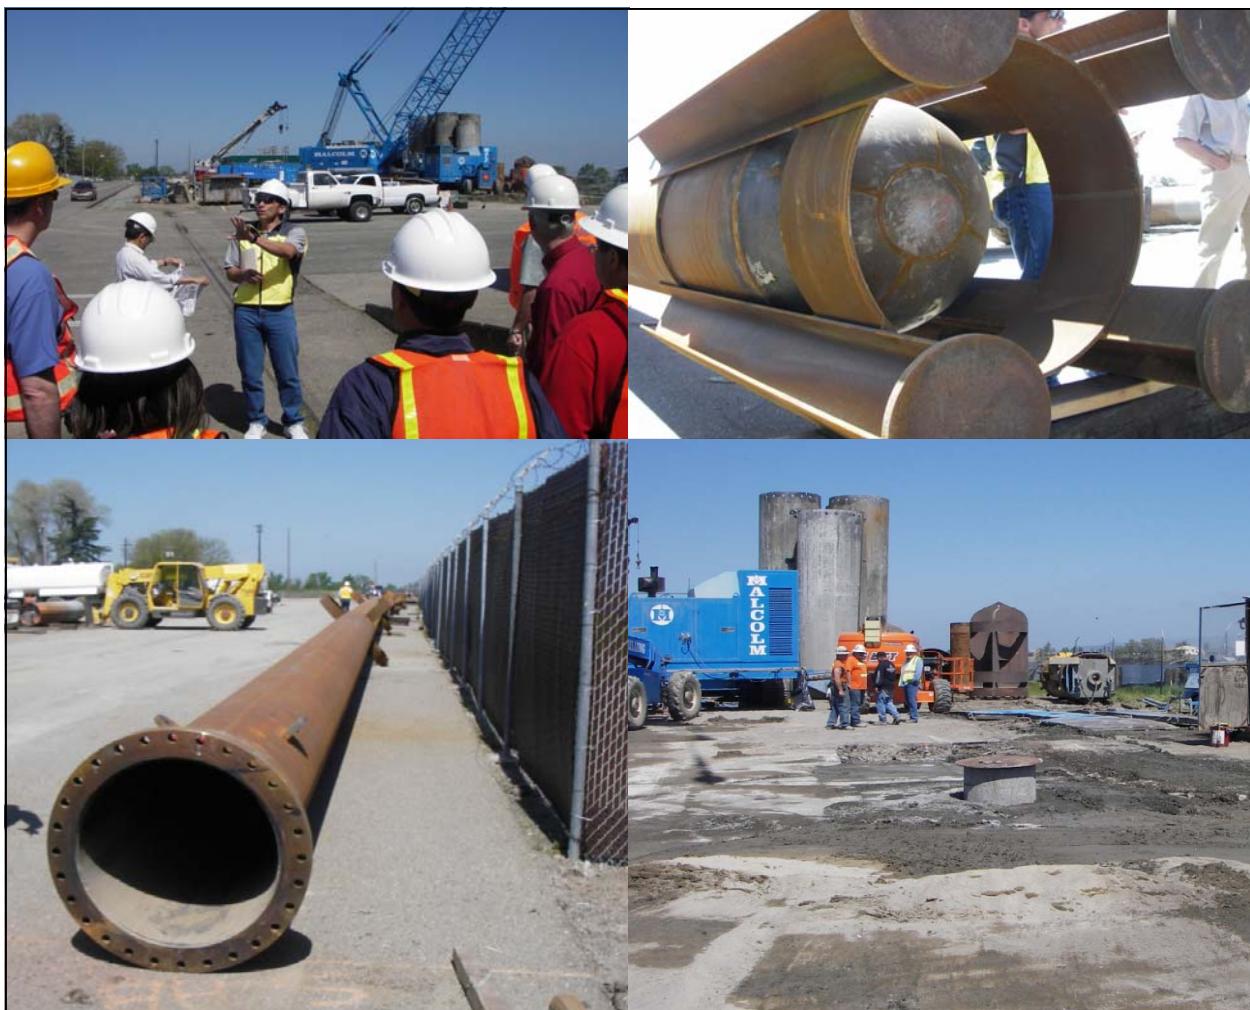
Port of Stockton

Site Visit for Demonstration of Dissolved Oxygen Aeration Facility U-Tube Drilling at the Port of Stockton, Warehouse 20. The Department of Water Resources and Jones & Stokes invited the DOTMDL Technical Work Group to participate in a tour of the aeration device site.

Photos of tour of Dissolved Oxygen Aeration Facility.

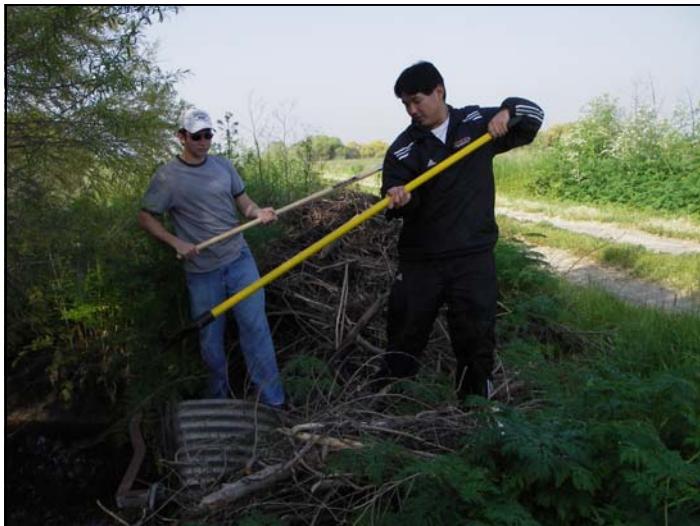
DO-60 Moffit 1 South

Student Interns clear debris from a weir in the wetlands.

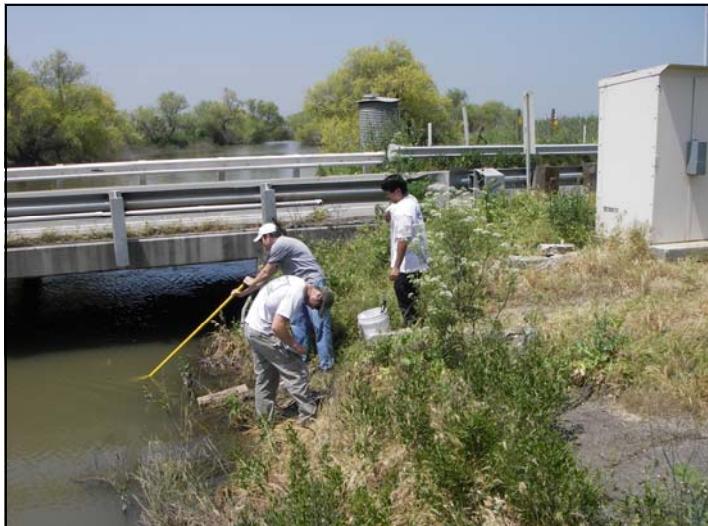
DO-19 Salt Slough at Lander Avenue

Collecting water samples and recording sonde data.

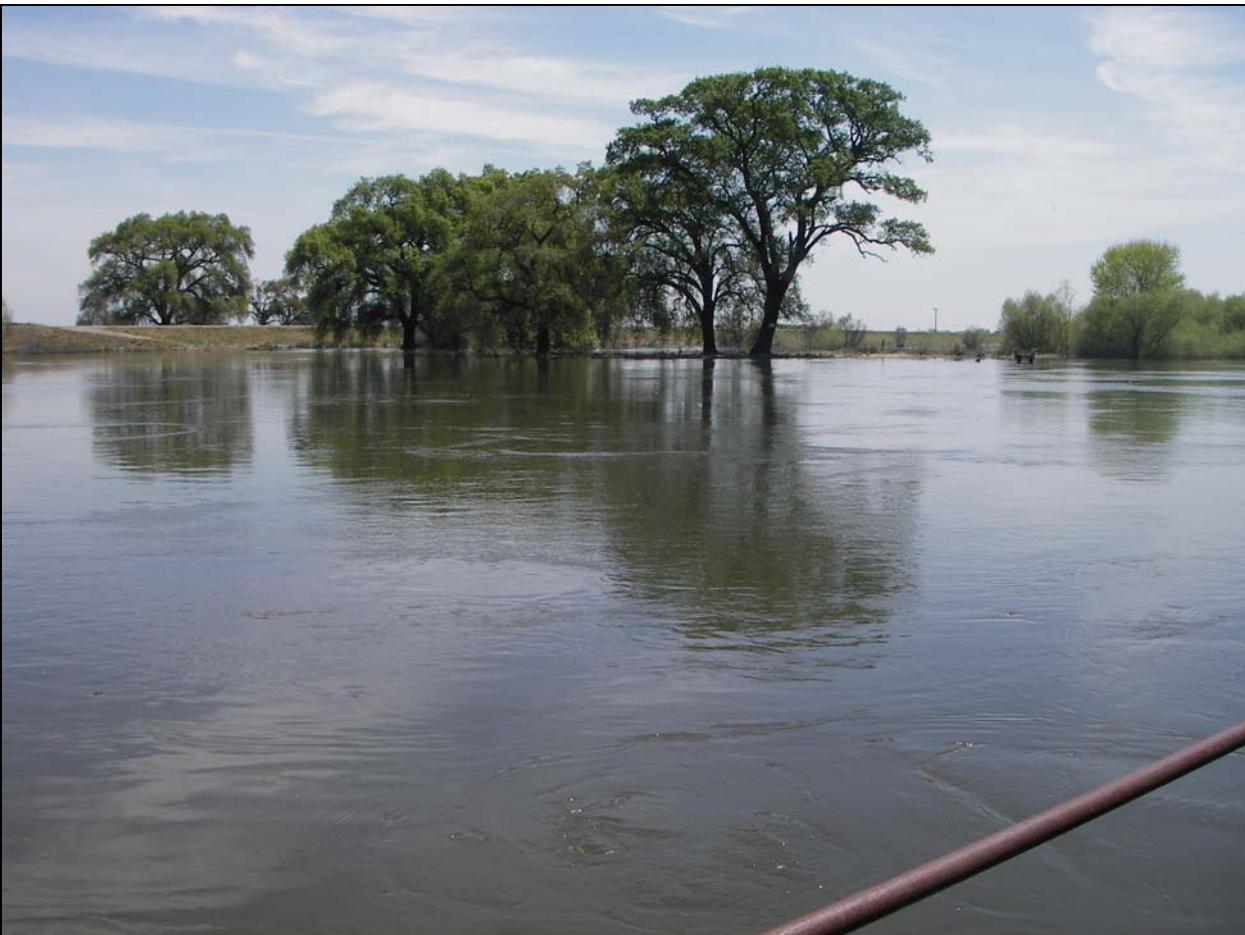
DO-07 SJR at Patterson

Photo of SJR near Patterson during flood conditions.

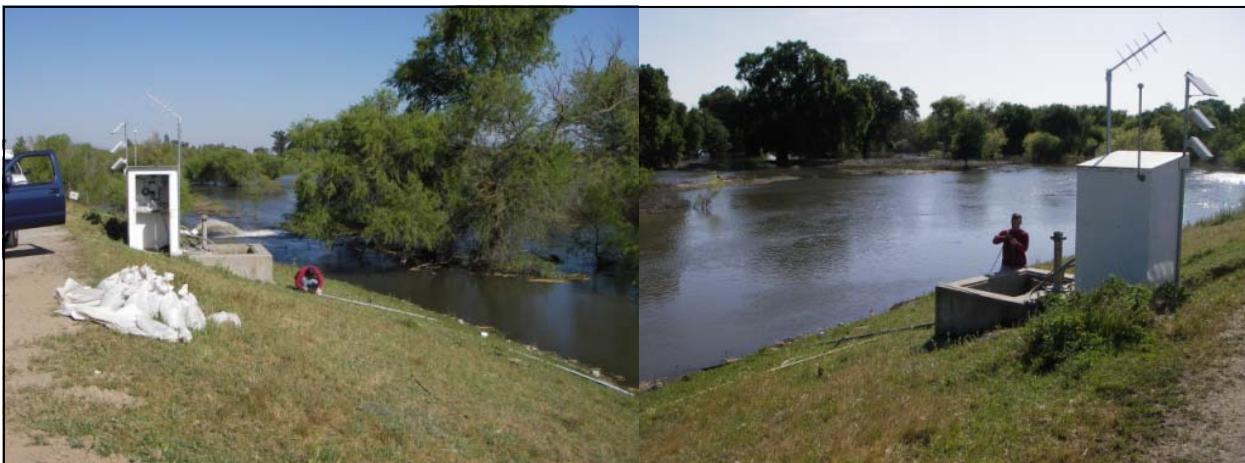
DO-57 Ramona Lake

Doing maintenance at the field station at Ramona Lake. The station at DO-57 was destroyed from high water levels in the SJR.

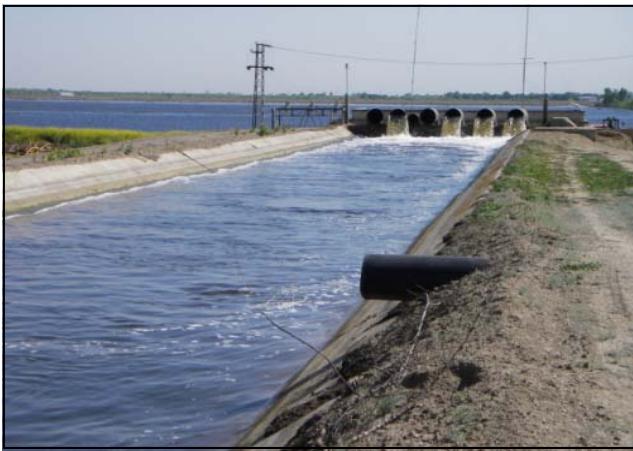
DO-41 West Stanislaus Irrigation District Diversion

Photo looking upstream of West Stanislaus Irrigation District Diversion monitoring station house.

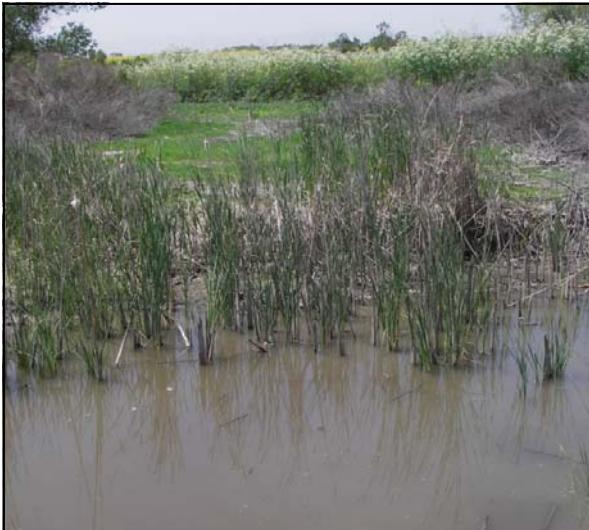
DO-80 Marsh 1 Inlet

No flow at site, so no samples where taken.

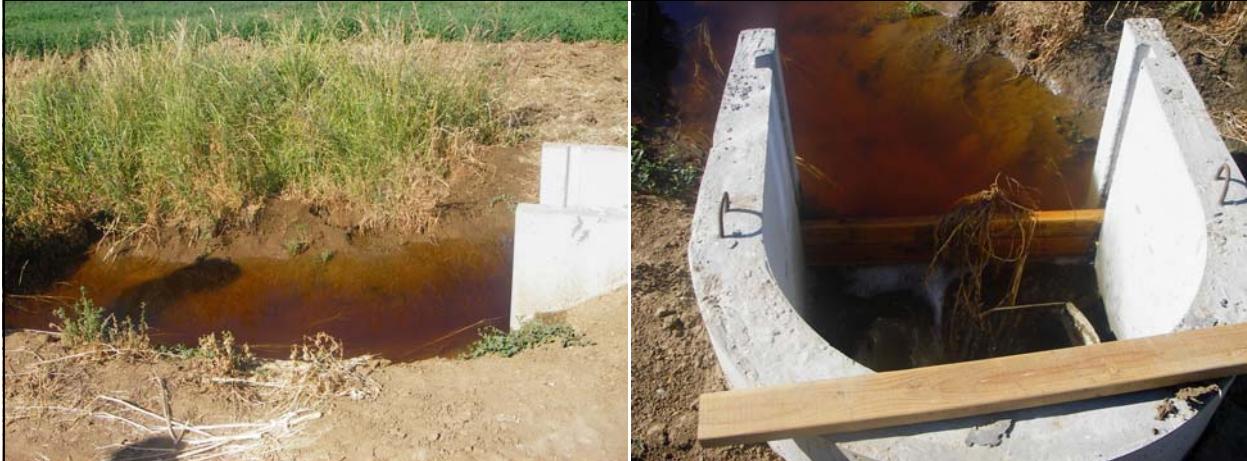
Drainage Ditch at Perez Farms

Cement weir structure at end of drainage ditch. Water is colored brown with tannins from the alfalfa field.

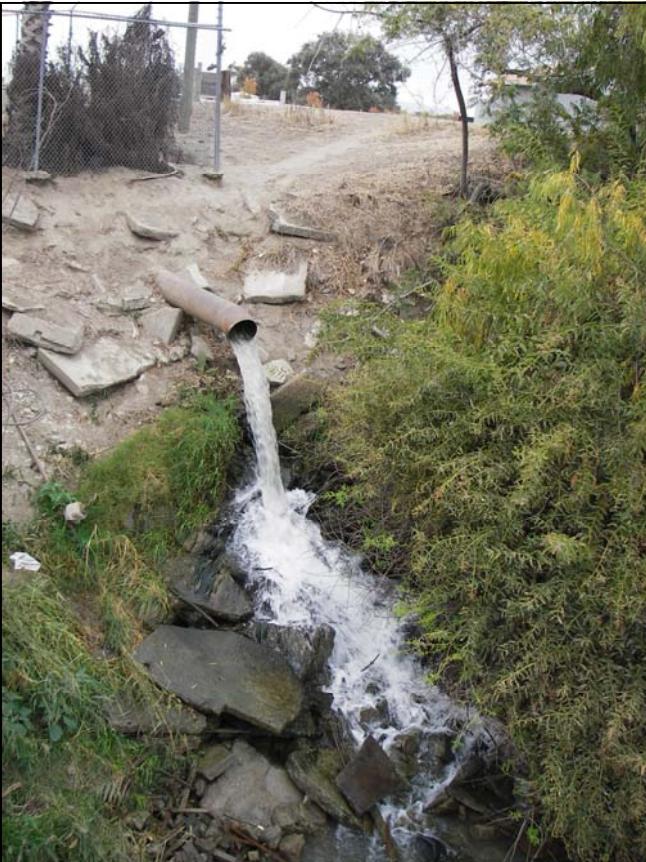
DO-7 SJR at Patterson

Photo of pipe structure near DO-07 SJR at Patterson.

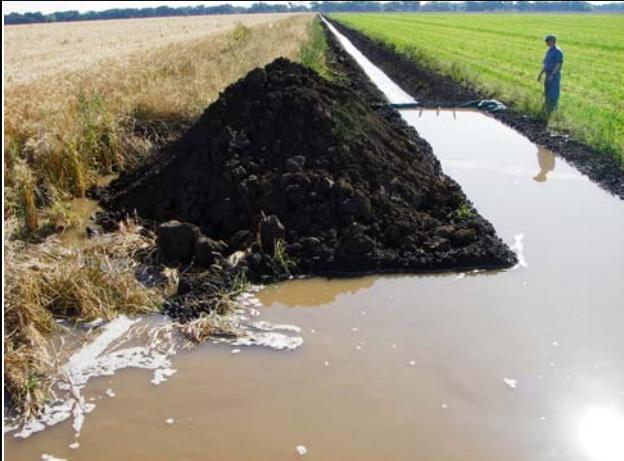
Head of Vegetated Ditch

Dirt pile from digging out canal. Notice the un-vegetated ditch next to the vegetated ditch.

Will Stringfellow and Jeremy Hanlon met with Chris Linneman (Summers Engineering) at Westside Patterson Farms. Crew installed weir in un-vegetated ditch and created vegetated ditch for water to flow down. Survey work was done on the two ditches.

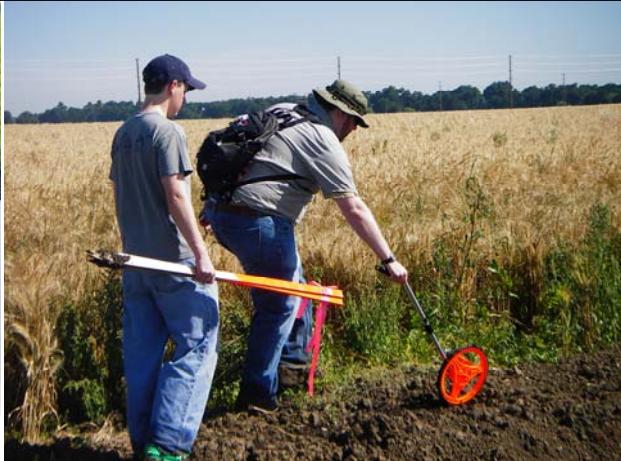
Un-vegetated Ditch

Student Intern and Matt Rogers (LBNL) surveying ditch on Westside Patterson Farms.

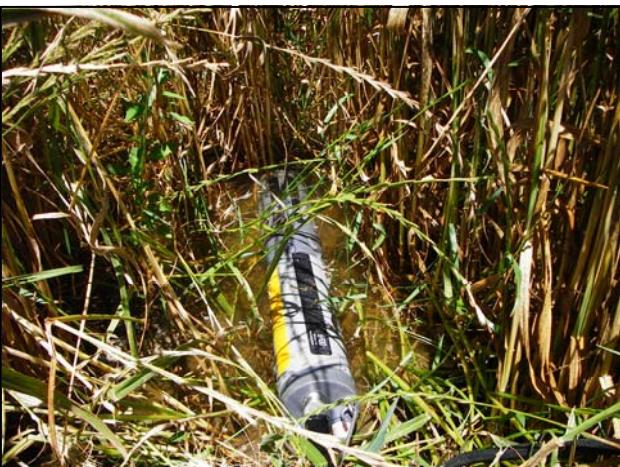
Vegetated Ditch

Sonde in vegetated ditch. Water barely covered the sensors.

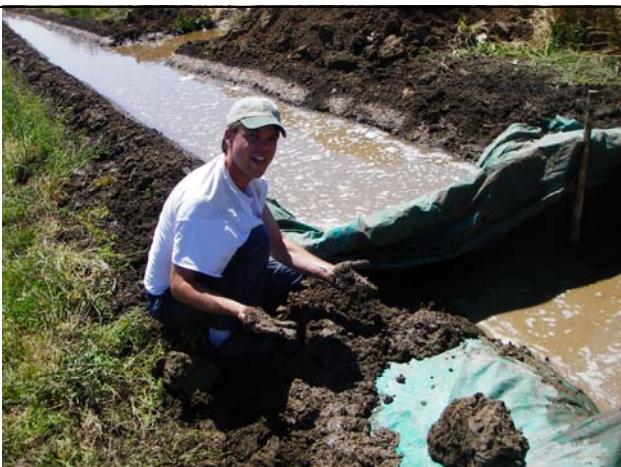
DO-101 WPF-UD-IN

Jeremy Hanlon working on weir structure for inflow into un-vegetated ditch.

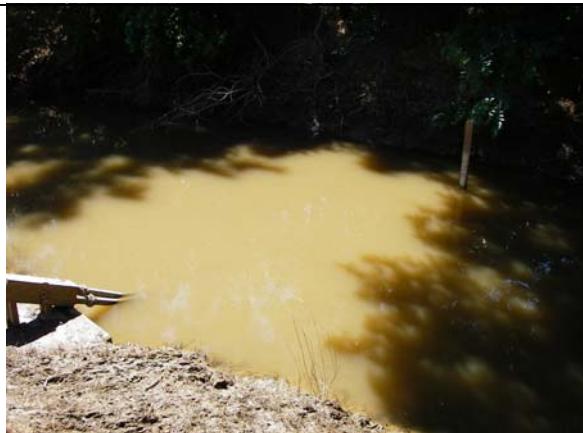
DO-35 Westley Wasteway
Westley Wasteway pond before being re-installed (see July 07, 2006 and August 01, 2006).

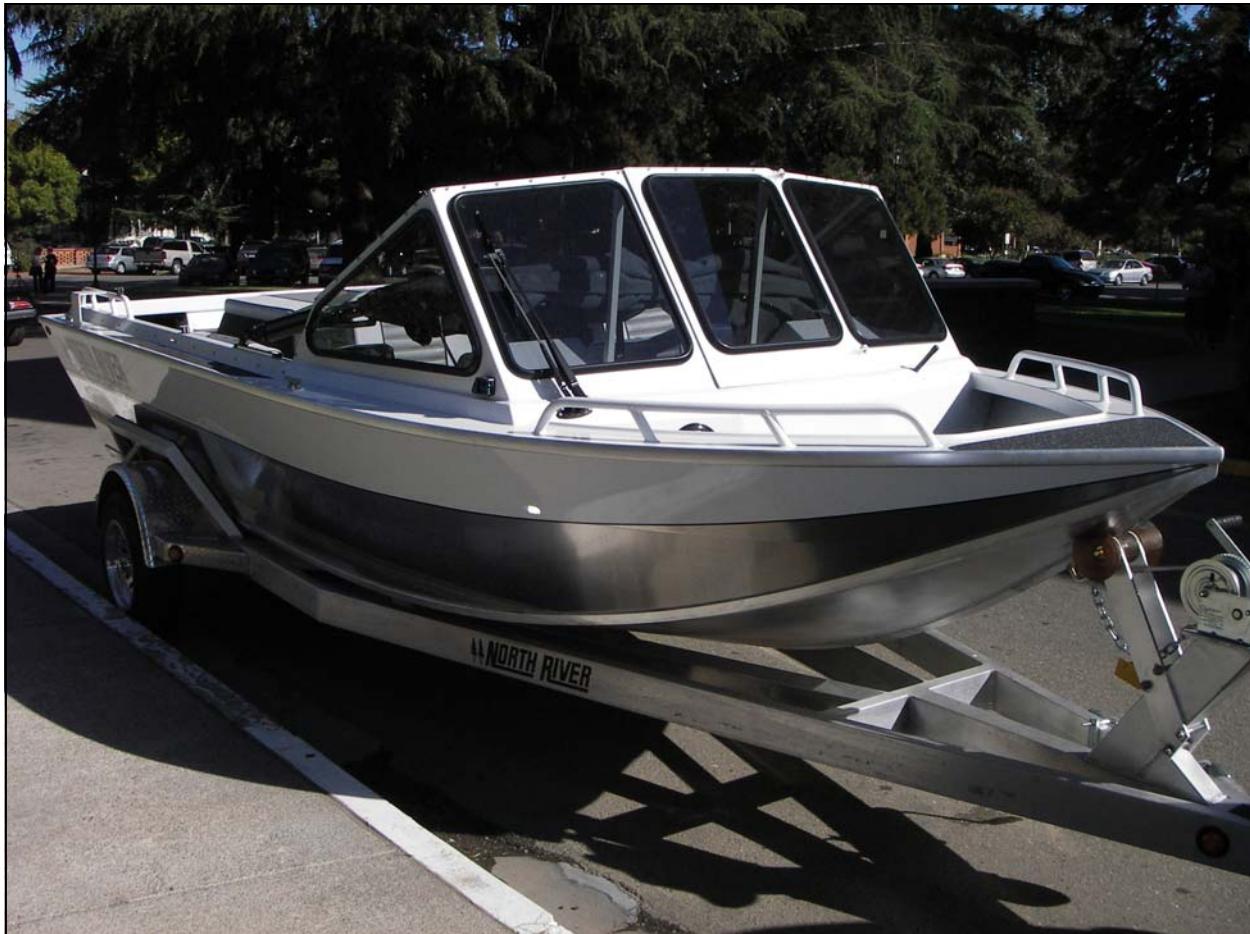
Photo of Boat

The boat is used in boat sampling events and boat studies on the San Joaquin River.

Tried to take the boat out for sampling. Started to go out, but engine kept lagging. Went back to dock and tried to locate problem. Called boat manufacturer, suggested fuel filter problems or auxiliary fuel intake getting air into it. Took boat out of water. Replaced fuel filter and capped off extra auxiliary fuel line at a later date. No further problems were encountered.

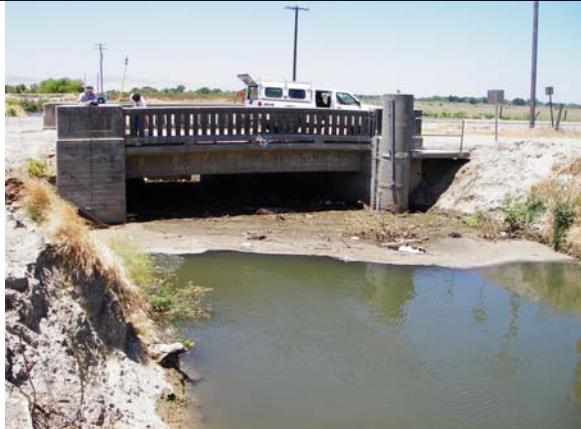
DO-29 Harding Drain

Drain was backed up and full of debris.
Crew sampled from clear area on the side.

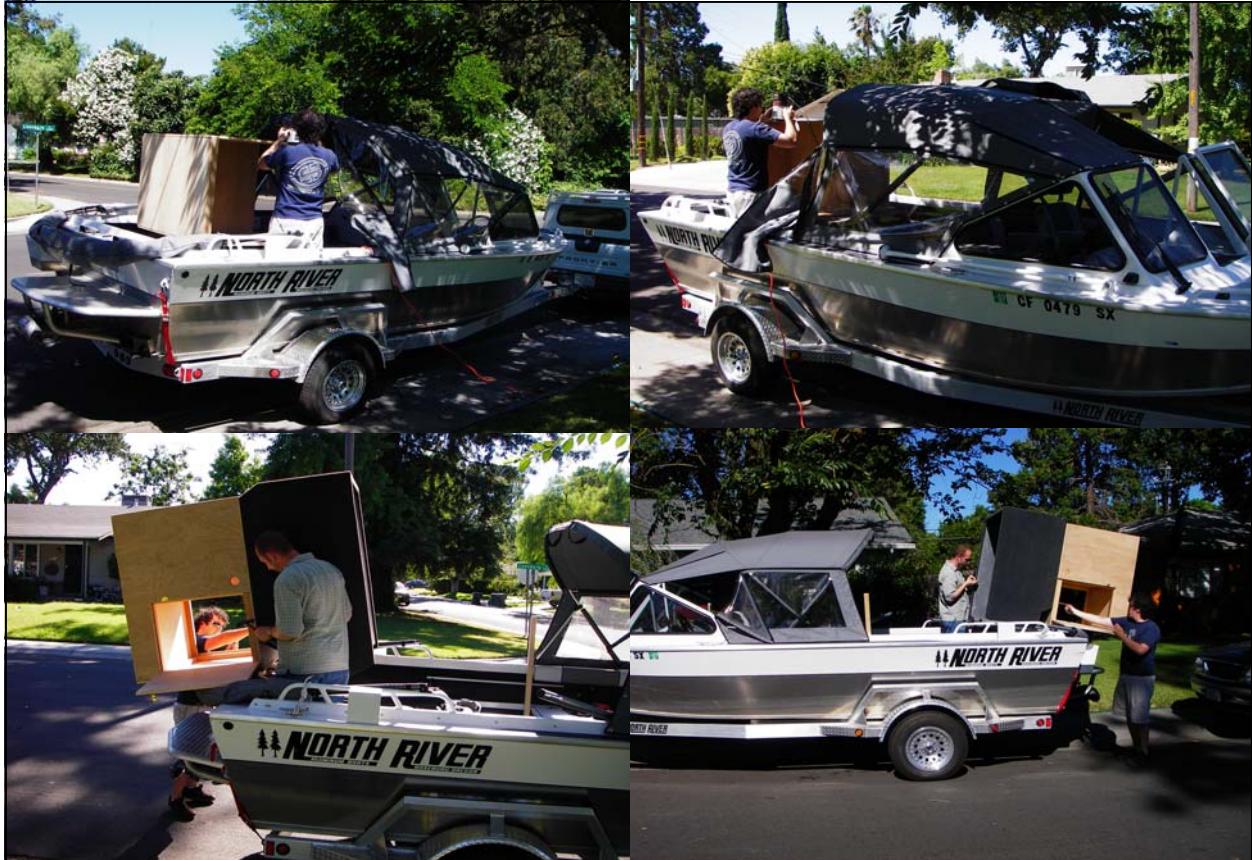
Boat Work

Student Intern and Justin Graham worked on building and installing a cabinet for the boat. The cabinet houses boat equipment and a laptop for sampling (See July 27, 2006).

Cabinet was built and installed on back of boat to house gear and laptop for sampling trips.

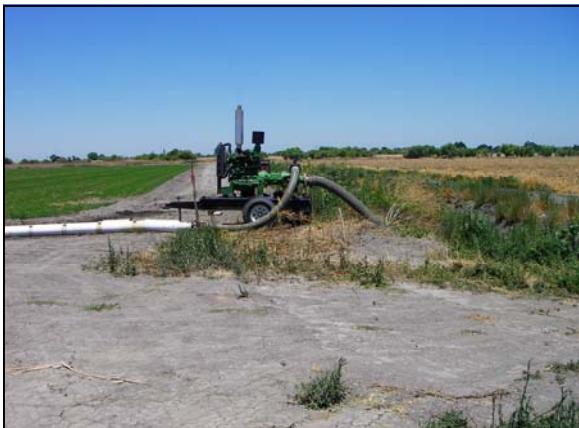
DO-94 Paradise at Almond

Pump was blocking access to actual sample site. Pump was taking water out of paradise drain and putting it onto adjacent fields. Velocity was flowing towards the pump intake.
