San Joaquin Valley Drainage Authority

San Joaquin River Up-Stream DO TMDL Project ERP - 02D - P63

Task 4: Monitoring Study

Interim Task Report # 3

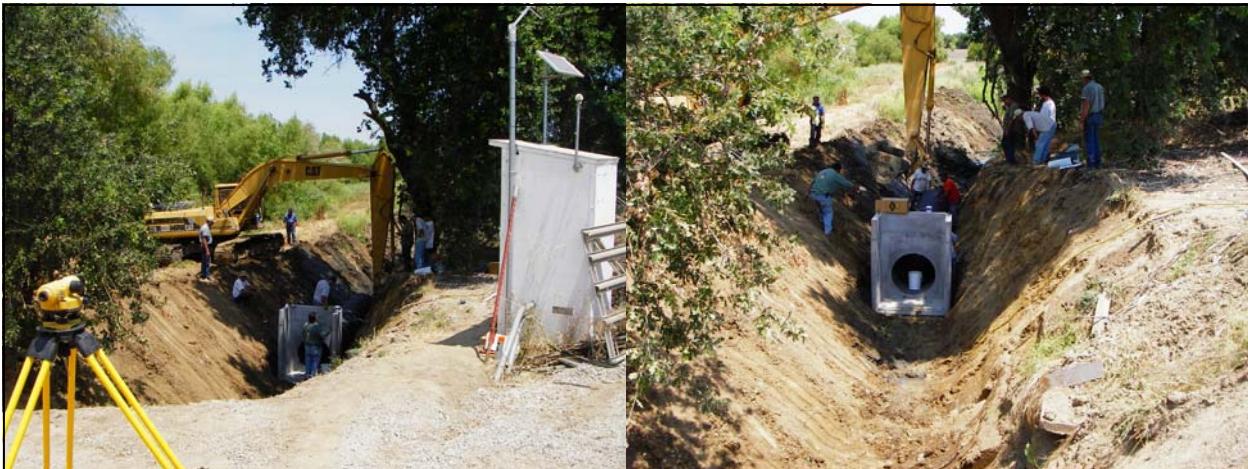
DO-35 Westley Wasteway

Checked on progress of Westley Wasteway. Irrigation District was installing a new weir board structure and reshaping canal. Installed new bubbler and EC line at a later date (see Aug 01, 2006).

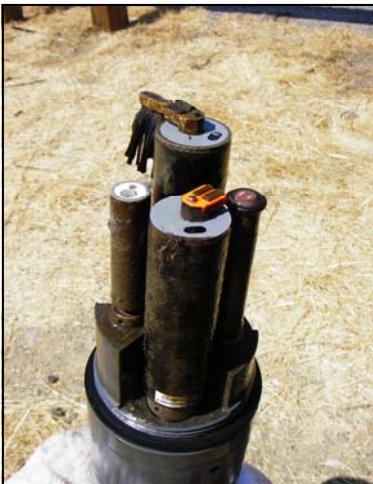
Post Deployment Sonde

Sonde covered in algae after extended deployment. Notice how the wipers kept the sensors free of algae.

Sondes were covered in algae and small aquatic macro invertebrates after being left in the field for an extended deployment. Sondes were put into coolers to keep the sensors moist while transporting.

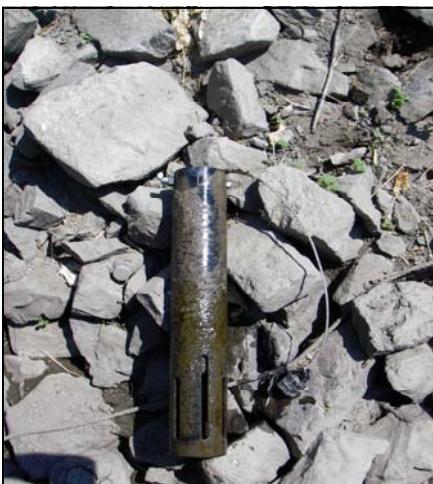
DO-19 Salt Slough at Lander

Custom fabricated PVC housing covered in algae.

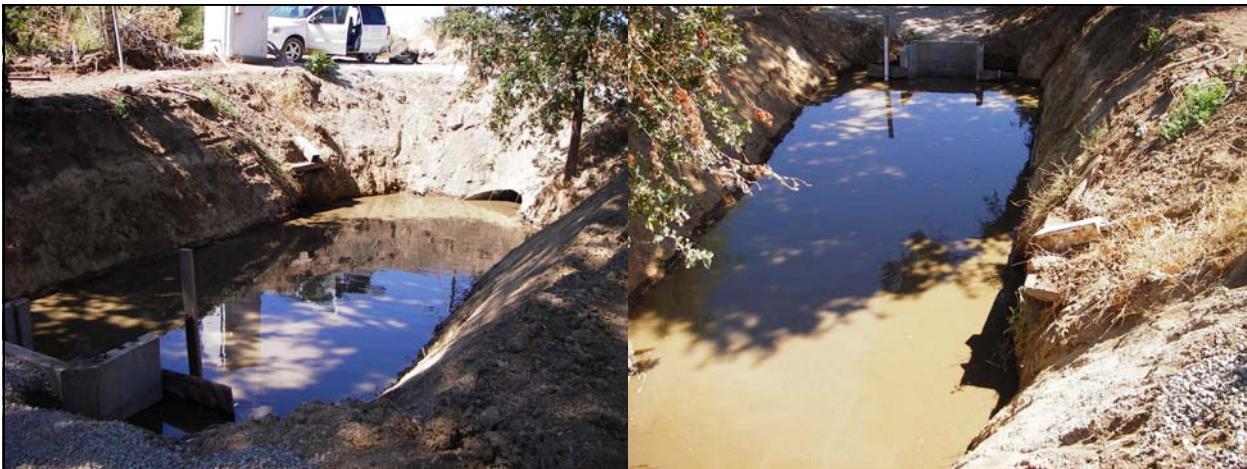
Pictures taken after weir boards installed. Bubbler and EC line have not yet been installed.

Visited DO-35 Westley Wasteway Flow station. Cut and installed five weir boards for a total of eight. Allowed pond to fill up and equilibrate. Took measurement for installation of bubbler line and EC probe (see September 5, 2006).

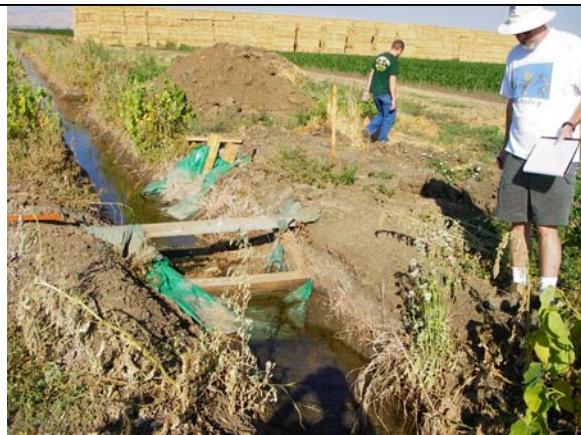
DO-101 WFP-UD-IN
Will Stringfellow looking at weir structure at start of un-vegetated ditch on Westside Patterson Farms.

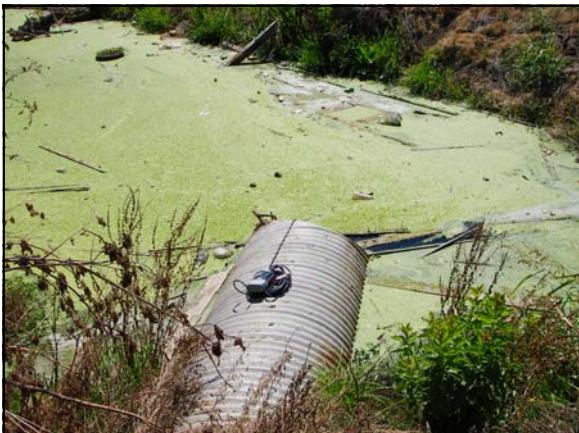
DO-88 Ramona Drain at Apricot Ave.
Sonde deployed off of pipe. The site has large amounts of duck weed and other aquatic vegetation.

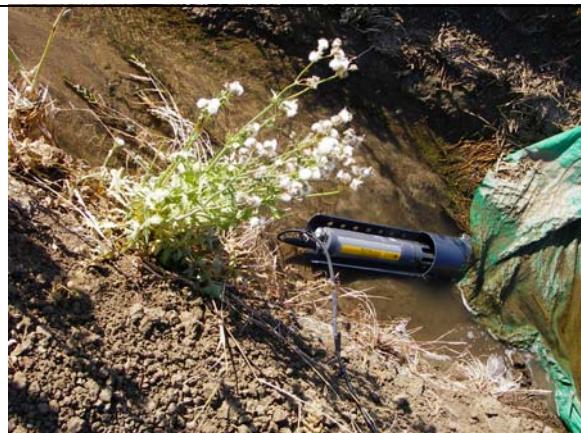
DO-101 WFP-UD-IN
The Sonde is in the un-vegetated ditch with a custom made shield to protect it from the plants in the ditch.

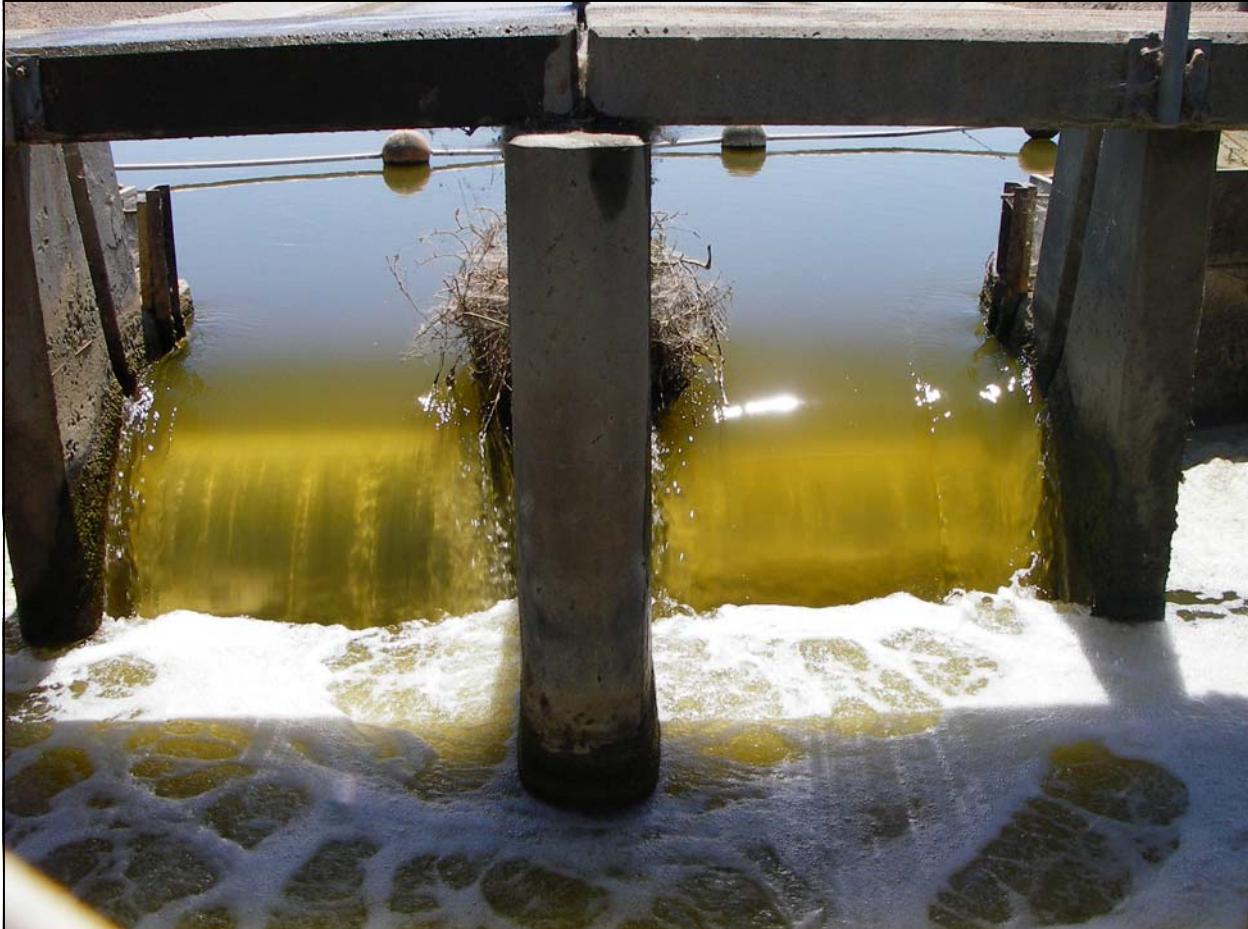
DO-115 Check 5

Photo of water flowing over weir structure during extended deployment. Note the green color due to algae in the water.

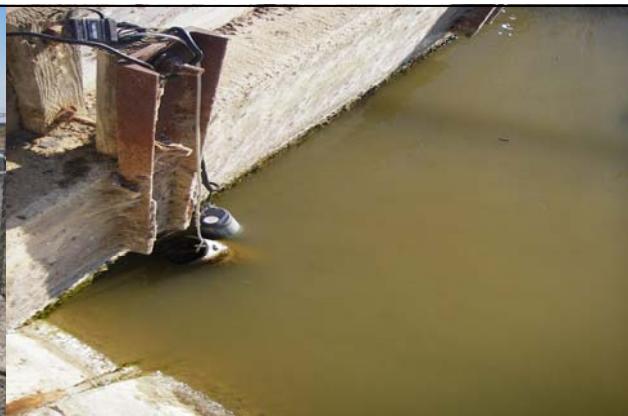
DO-103 Check 18

Sampling sonde next to extended deployment sonde in PVC housing.

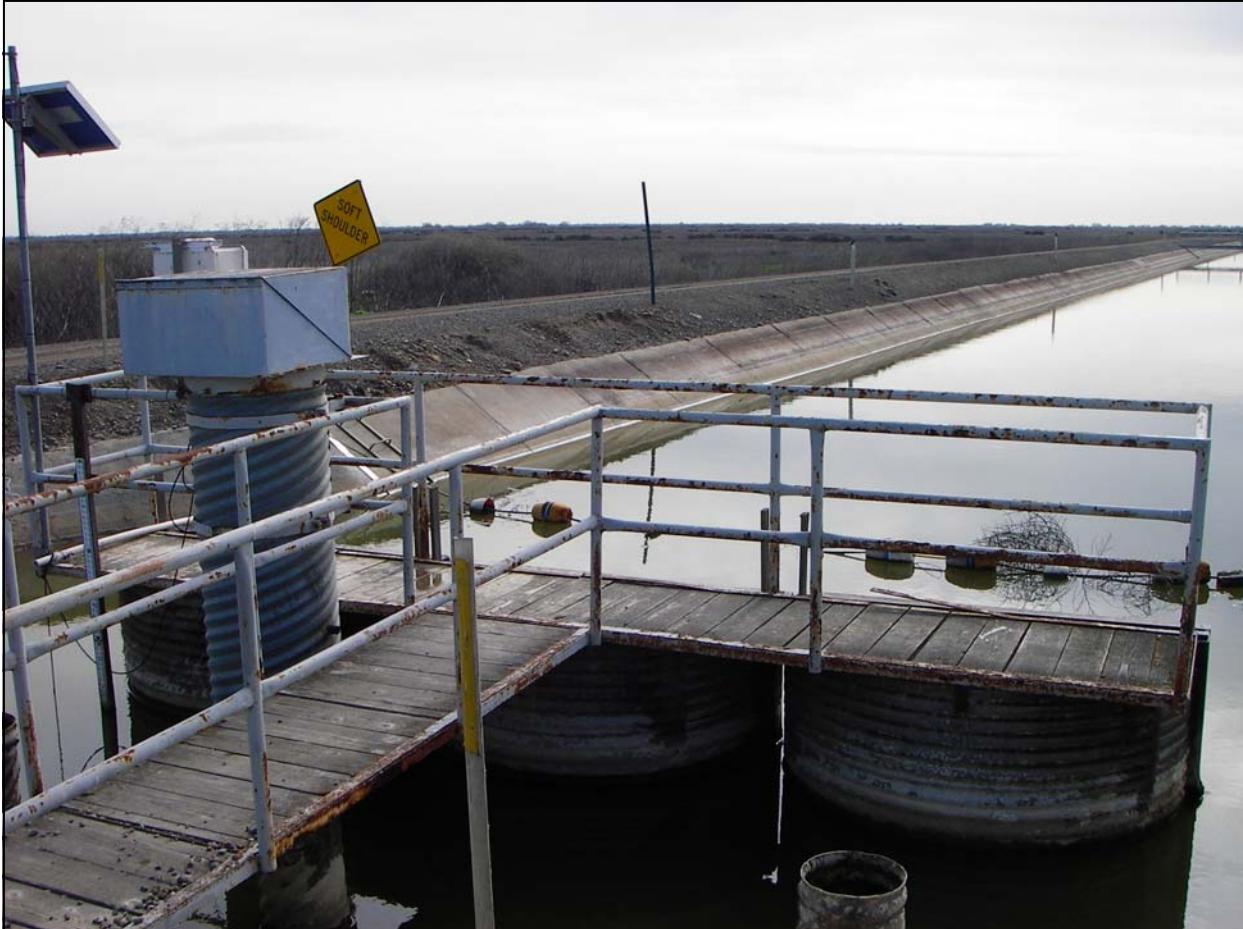
DO-44 San Luis Drain End

Photo of platform at San Luis Drain End.

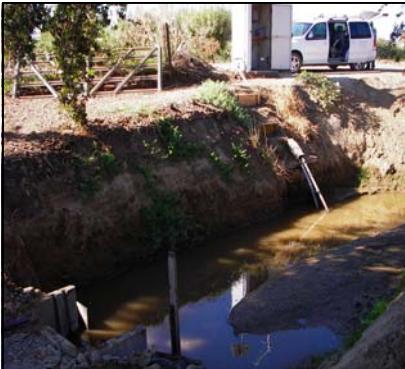
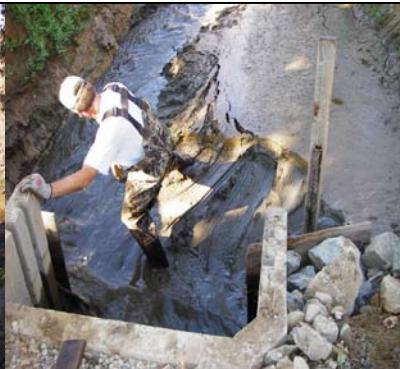
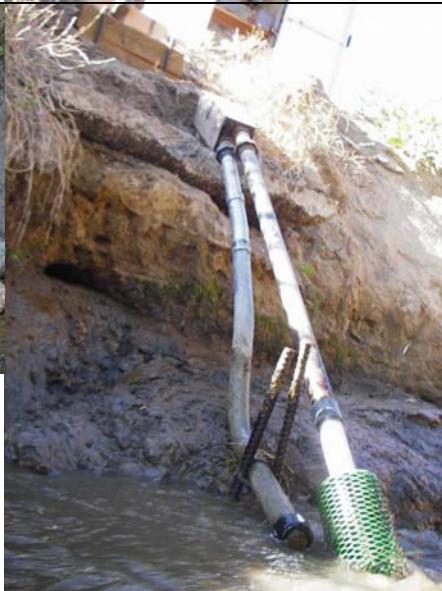
DO-35 Westley Wasteway Flow Station

A new bubbler and EC line were installed at DO-35. The green basket on the EC probe (right) protects the probe from debris. The picture in the middle shows Jeremy Hanlon clearing sediment in front of the weir boards.

DO-35 Westley Wasteway Flow station and DO-20 Los Banos Creek were upgraded. A new bubbler and EC line were installed at DO-35. A junction box and bubbler liner were installed at DO-20. Two weir boards were added at DO-65 Spanish Grant Drain.

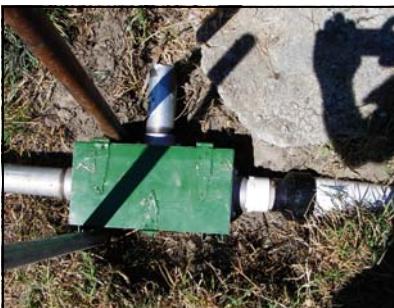
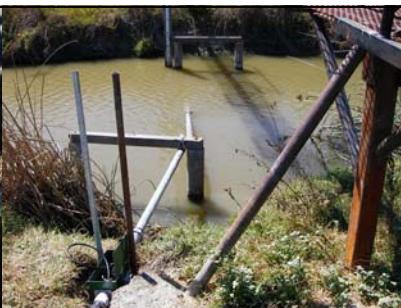
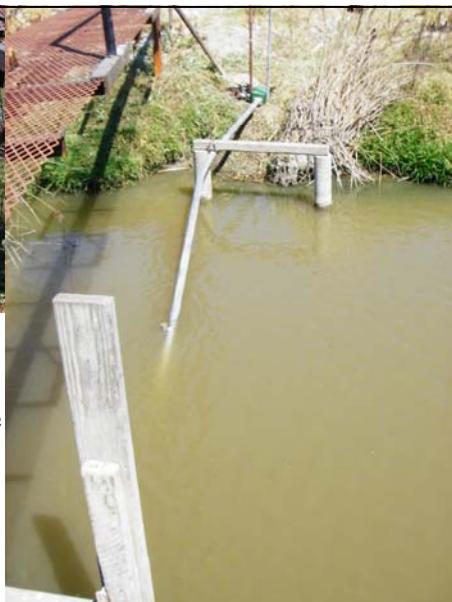
DO-20 Los Banos Creek

A new bubbler line was installed at DO-20. A junction box (left), fabricated by Jeremy Hanlon, was installed at the edge of the water. A separate EC and Sontek line were run from this junction box across the bridge at a later date (See October 31, 2006).

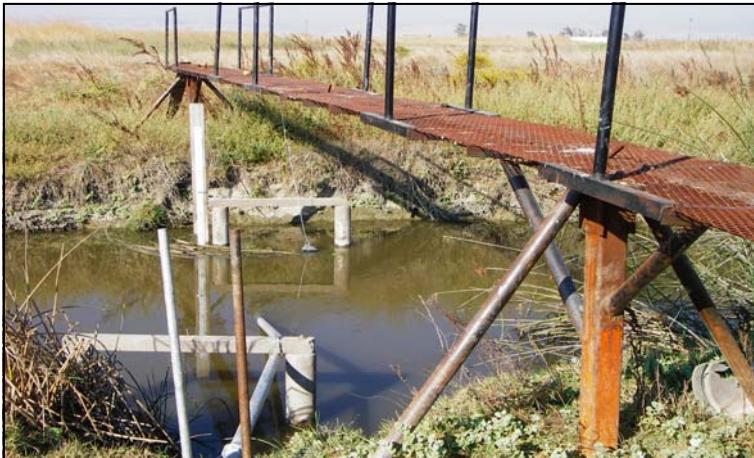
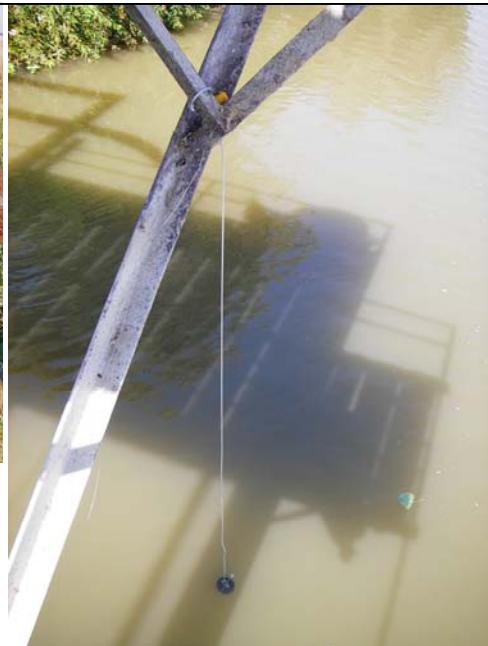
Sonde Deployment

At DO-20 Los Banos Creek (left) Sonde was deployed from bridge in a pvc housing using cable. At DO-07 SJR at Patterson (Right) Sonde was deployed from pump housing platform.

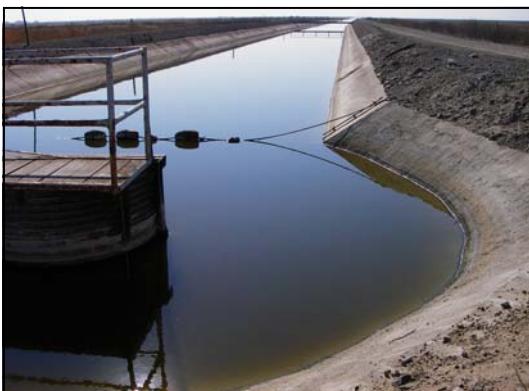
DO-44 San Luis Drain End

Sonde was deployed along the side of the outflow pipe at DO-44. The Sonde was secured using a cable and padlock.

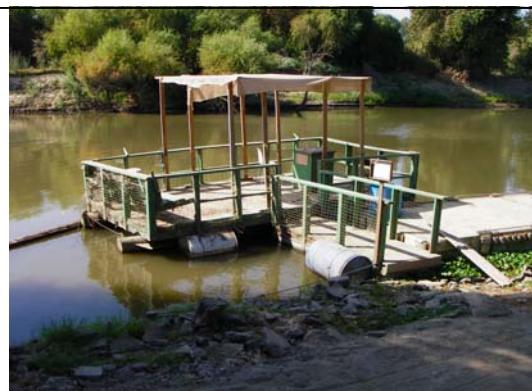
DO-08 SJR at Crows Landing

Picture shows the dock structure at the Turlock Sportsman Club. The Sonde was deployed on the far side of the dock.

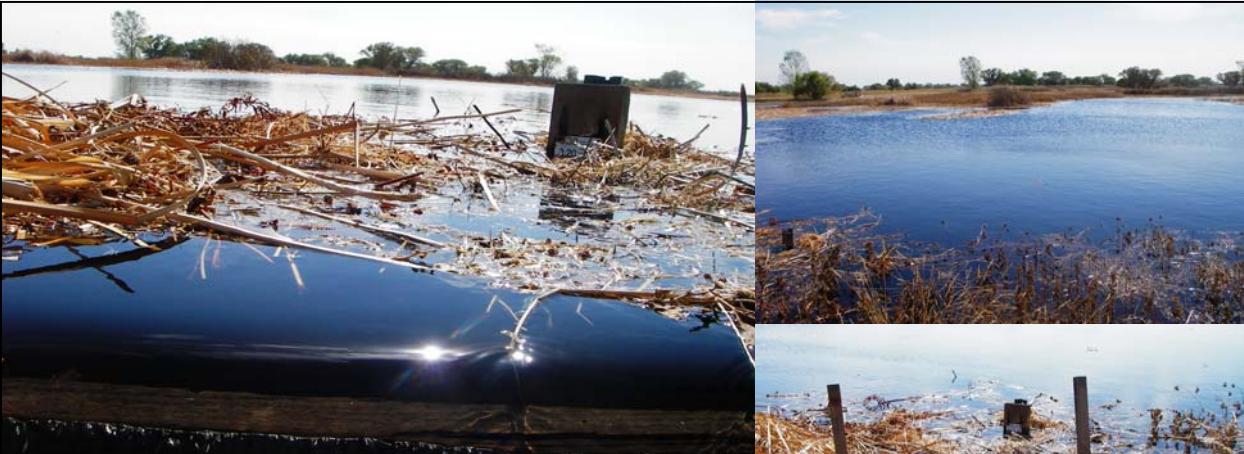
DO-81 Marsh 1 Outlet

Pictures of flooded marsh and outflow structure of Marsh 1 in San Luis National Wildlife Refuge.

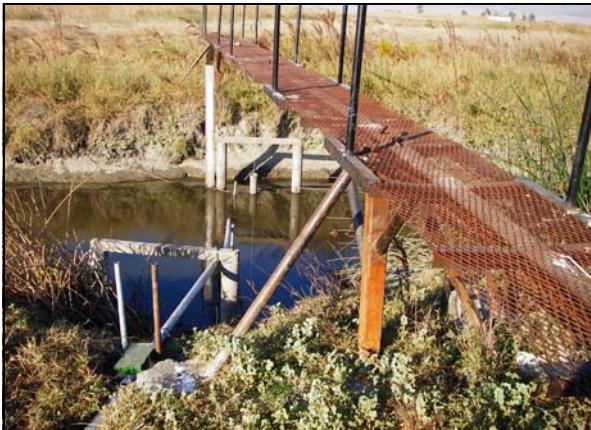
DO-20 Los Banos Creek

Sonde was deployed from bridge in a pvc housing using cable. Sonde was halfway out of water, but sensors were still submerged

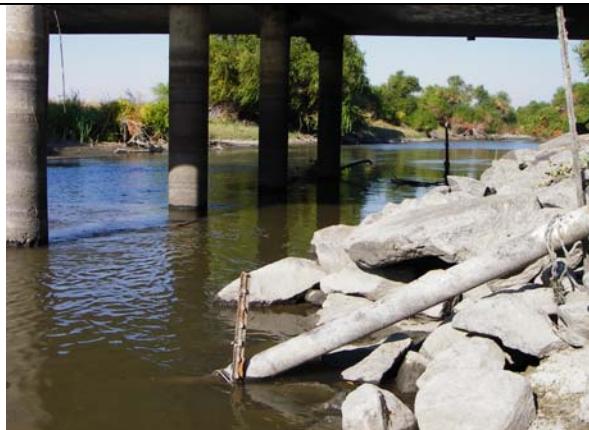
DO-19 Salt Slough at Lander

Sonde was deployed next to pipe running into the water. Cable was secured around the metal fence post.

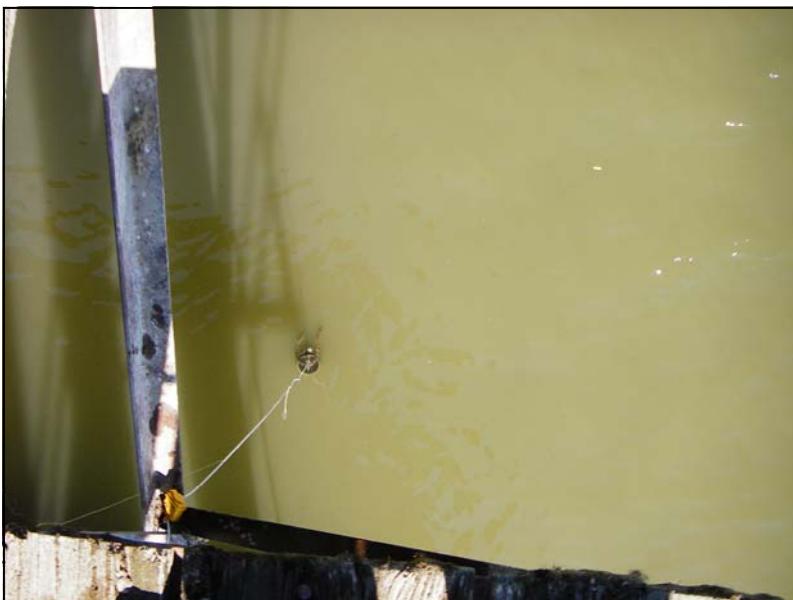
DO-07 SJR at Patterson

Sonde was hung from bottom of pump platform. All cables were padlocked to the structure they were secured to.

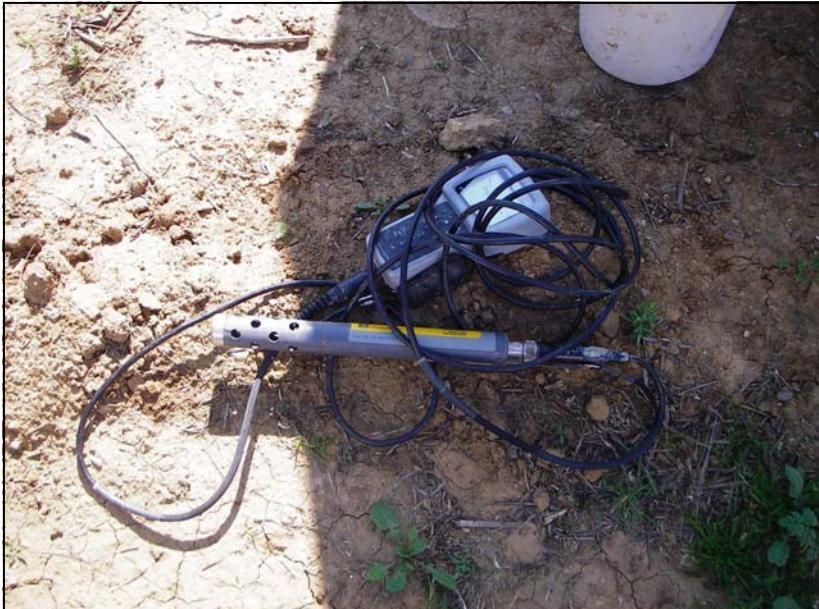
YSI 600 XL EC Probe

Photo of YSI 600 XL and handheld used to measure independent EC for QA.

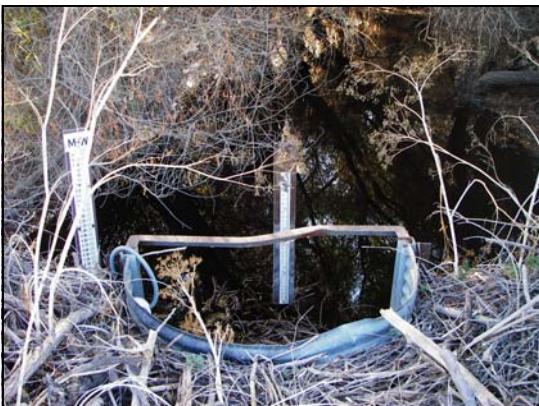
DO-60 Moffit 1 South

Water was below weir and site was not sampled.

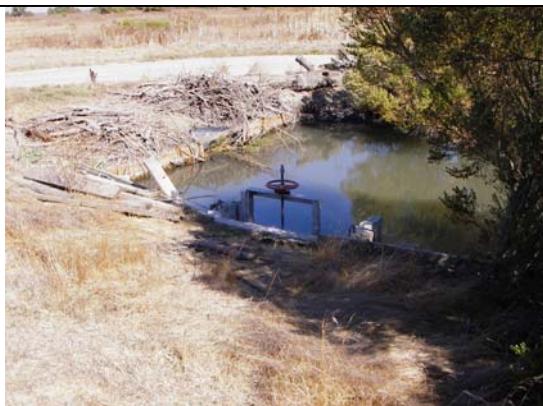
Canal inlet for Marsh 1. DO membrane became punctured and had to be changed.

Sampling for DOTMDL wetland sites. DO-60 Moffit 1 South was not sampled because it had no flow. Dissolved Oxygen values for DO-80 Marsh 1 Inlet were not valid because the DO membrane on YSI sonde # 1 became punctured and had to be changed.

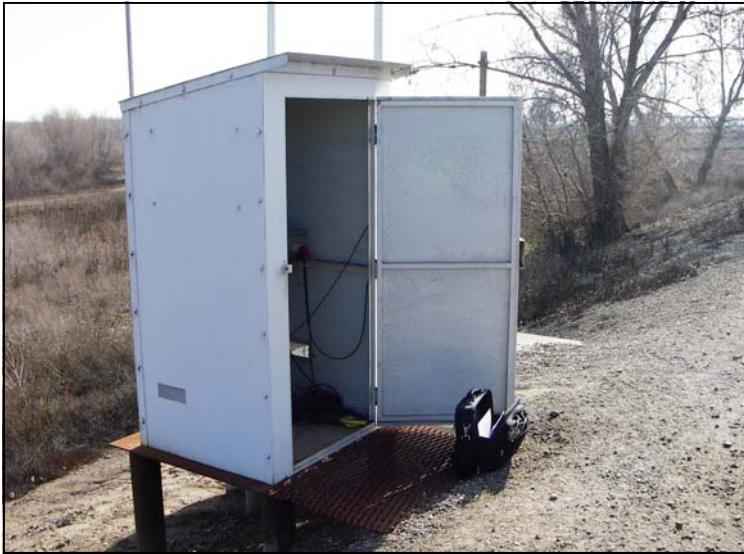
DO-31 New Jerusalem Drain

Station shed at DO-31. Data from monitoring equipment was stored on a data logger located in the station shed and downloaded during station maintenance.

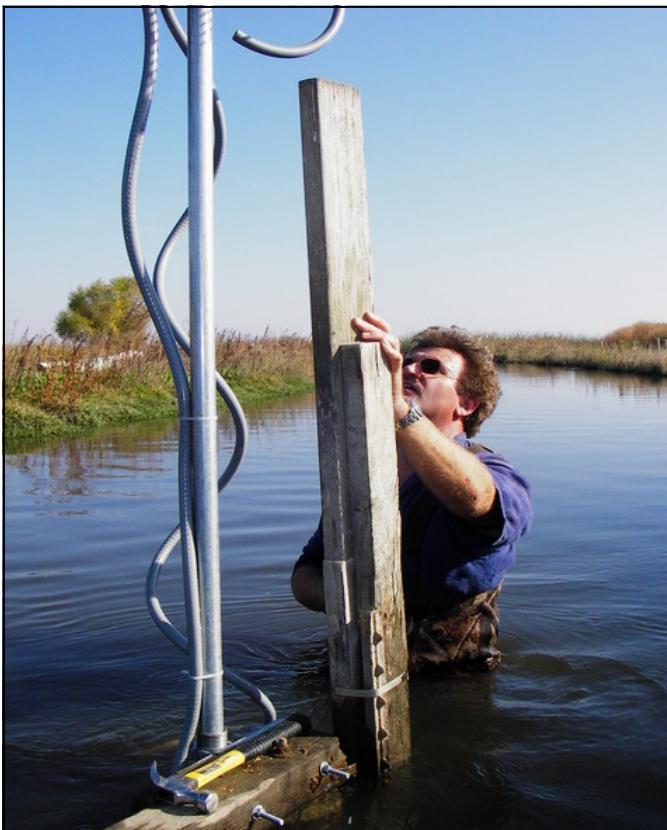
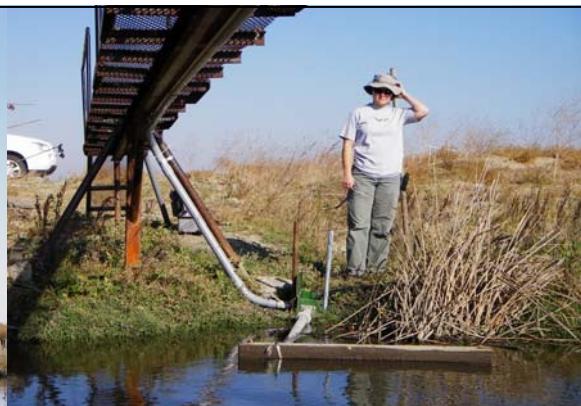
DO-20 Los Banos Creek

(Above) Nigel Quinn (LBNL) helping install Sontek mount to pylon. (Top right) Lara Sparks (Grasslands Water District/Department of Fish and Game) next to junction box for bubbler, EC, and Sontek lines. (Middle right) Jeremy Hanlon and Nigel Quinn installing Sontek mount.

Upgraded DO-20 Los Banos creek and DO-53 Salt Slough at Wolfsen. Installed Sontek mount to bridge at DO-20 and ran Sontek and EC line across bridge. Installed a solar panel at DO-53. Station was taken off of land power because it kept tripping the circuit breaker of a nearby house.

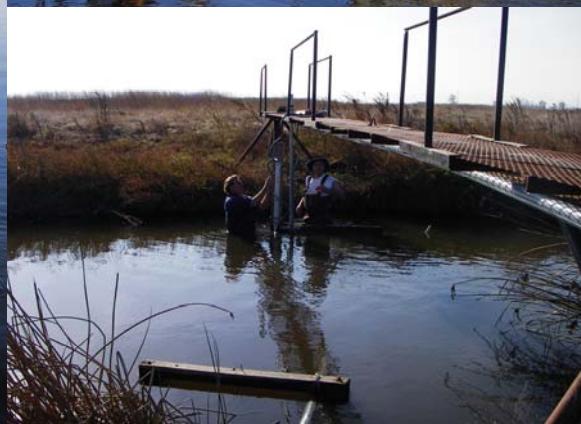
DO-53 Salt Slough at Wolfsen

(Bottom right) New solar panel installed at Salt Slough at Wolfsen.

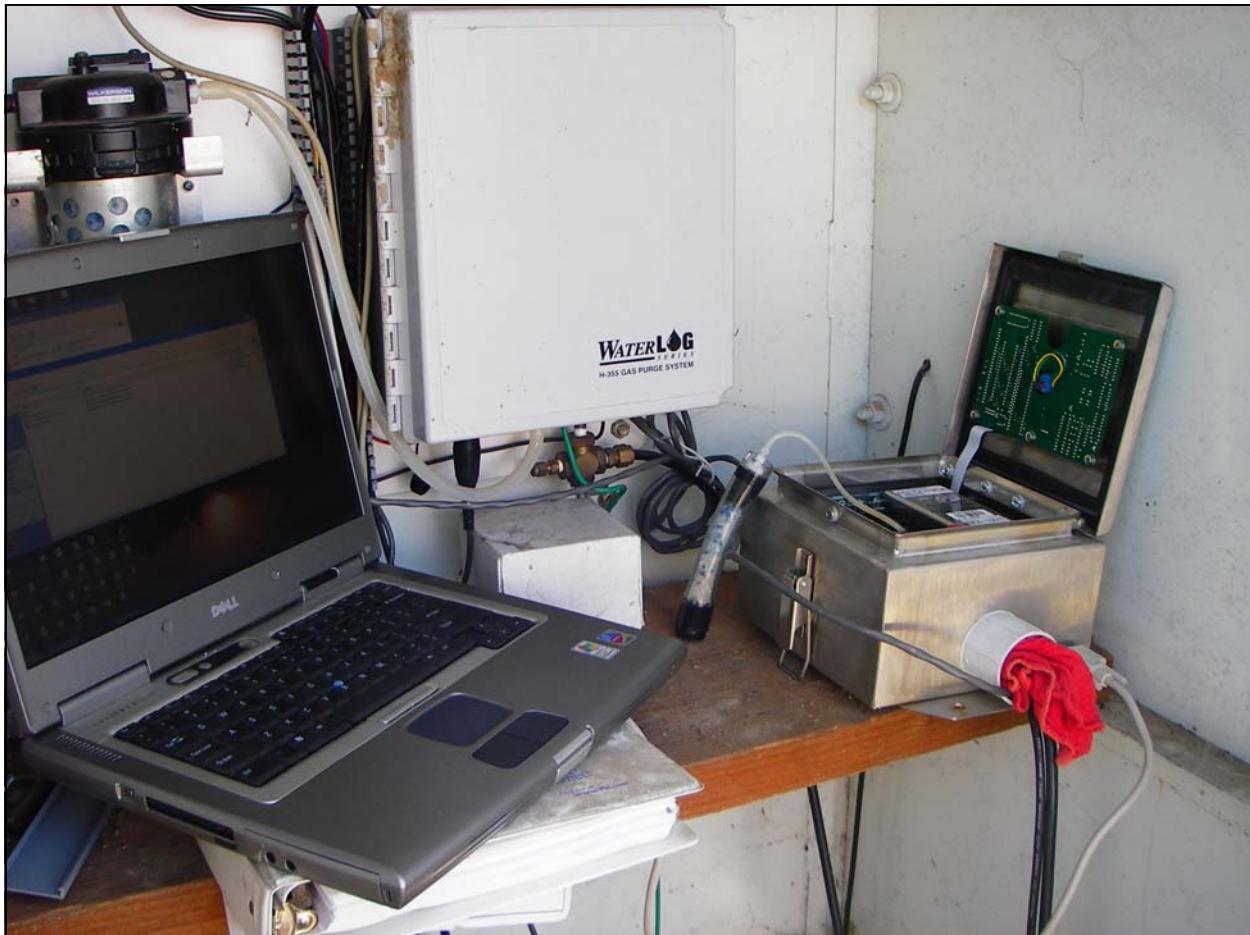
Photo shows general setup of equipment in station shed. The MACE unit is on the right. Flow data is downloaded from the unit with a laptop connected via com port.

Visited DO-31 New Jerusalem Drain for maintenance. Tried downloading data from MACE unit but got error. Downloaded config file. Restarted unit and downloaded data again. Cleared stored memory and ran bubble line test for three minutes.

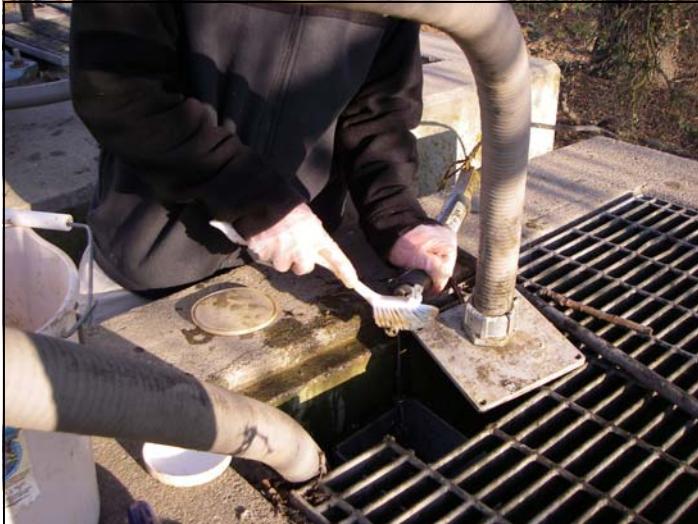
Station Maintenance

YSI EC probe being cleaned at the three drain site.

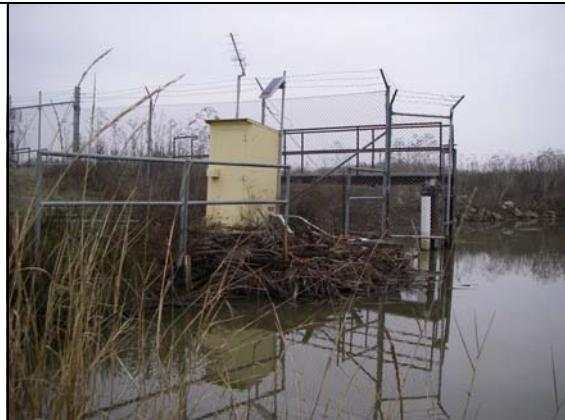
DO-61 Deadmans Slough

Weir boards were blocked by debris, making an accurate flow rating impossible.

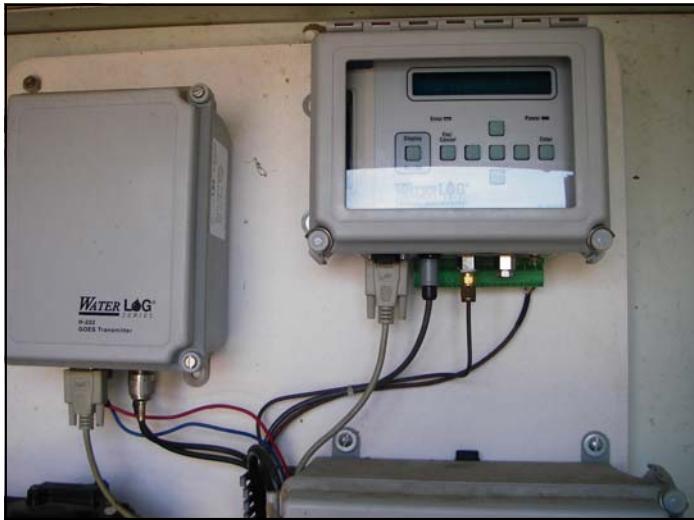
H-350XL Design Analysis Logger

Photo of data logger used in the Westside stations.

Jeremy Hanlon switched out the logger at DO-31 New Jerusalem Drain with the logger from the Hydraulics lab training station. The logger at DO-31 randomly shut off and stopped logging data. It was taken to the Hydraulics lab training station to be tested.

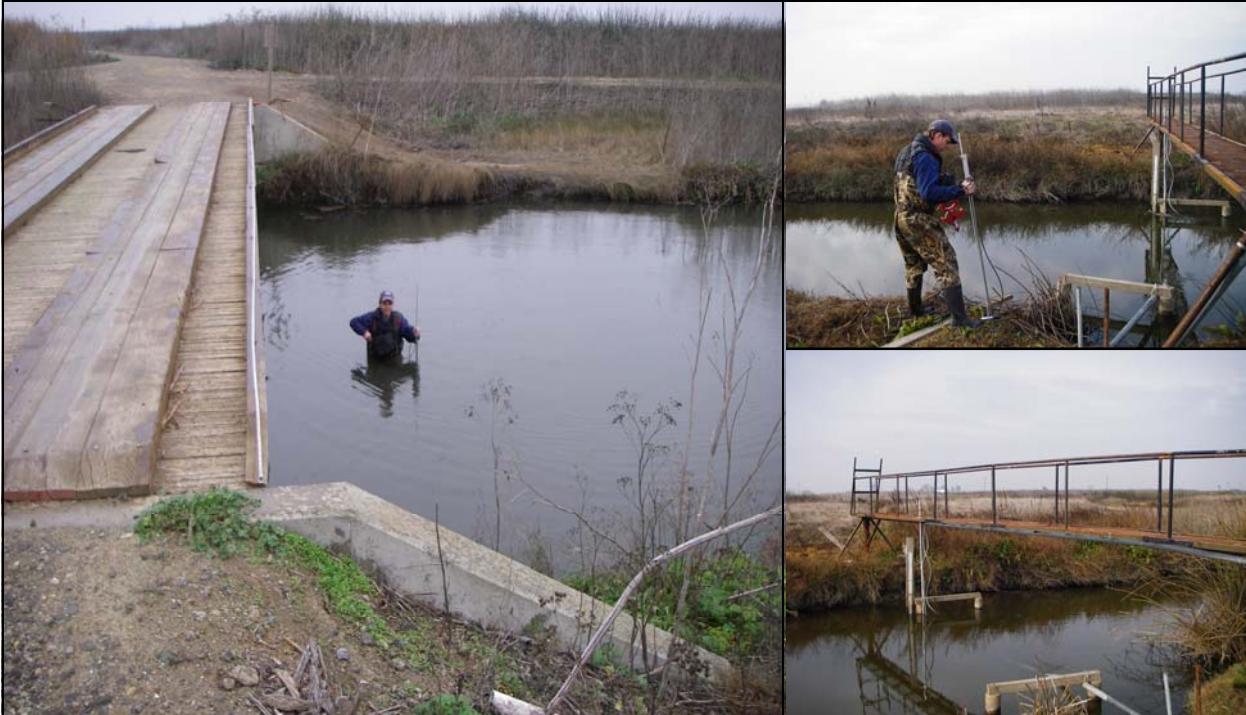
Stream Ratings

(Left) Jeremy Hanlon performing a stream rating at Volta Wasteway Flow Station. Water was too deep to complete rating safely. (Right) Jeremy Hanlon at DO-20 Los Banos Creek performing another stream rating. Note completed bridge with handrails along both sides and hinged ramps.
