SANDIA REPORT

SAND2004-4859
Unlimited Release
Printed October 2004

Natural Gas Production Problems: Solutions, Methodologies, and Modeling

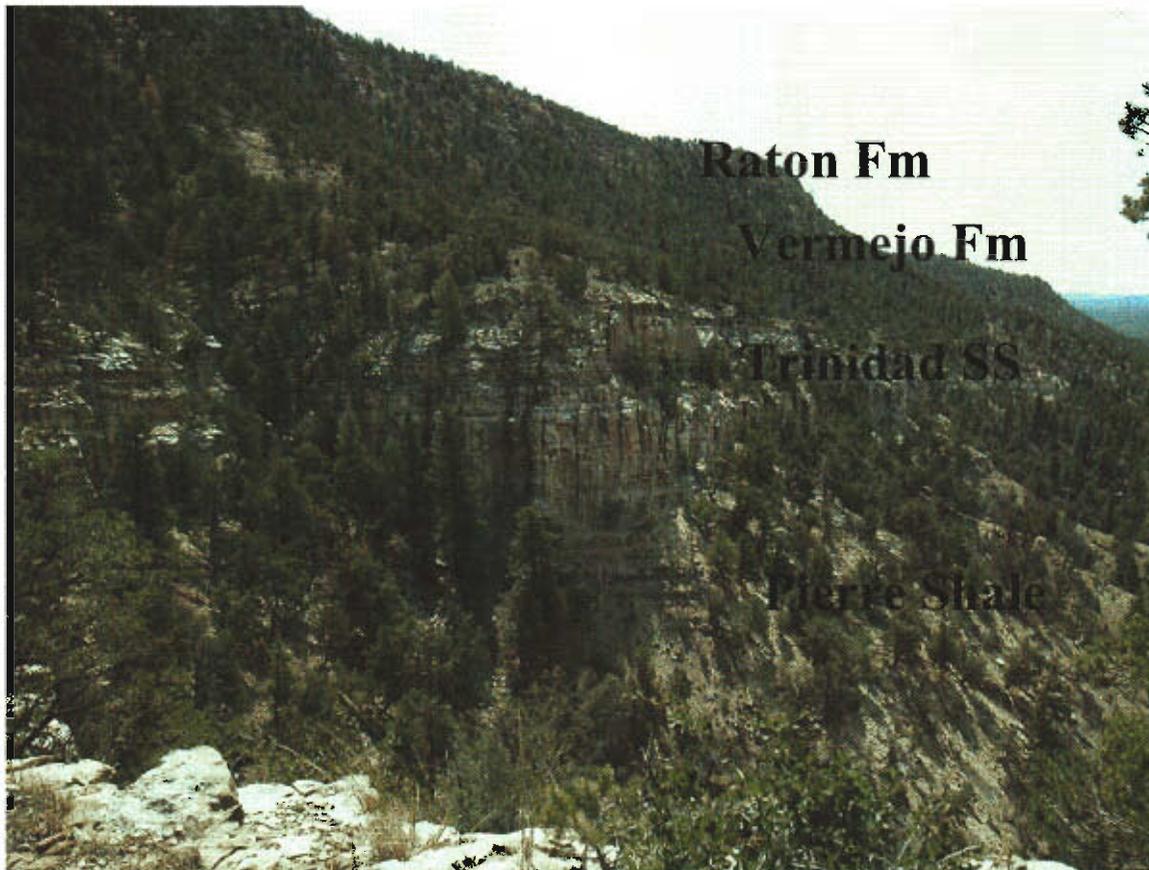
Figure 3: Outcrop exposures of the major coalbed methane producing intervals; Raton and Vermejo Formations along the NE flank of the Vermejo Park anticline.

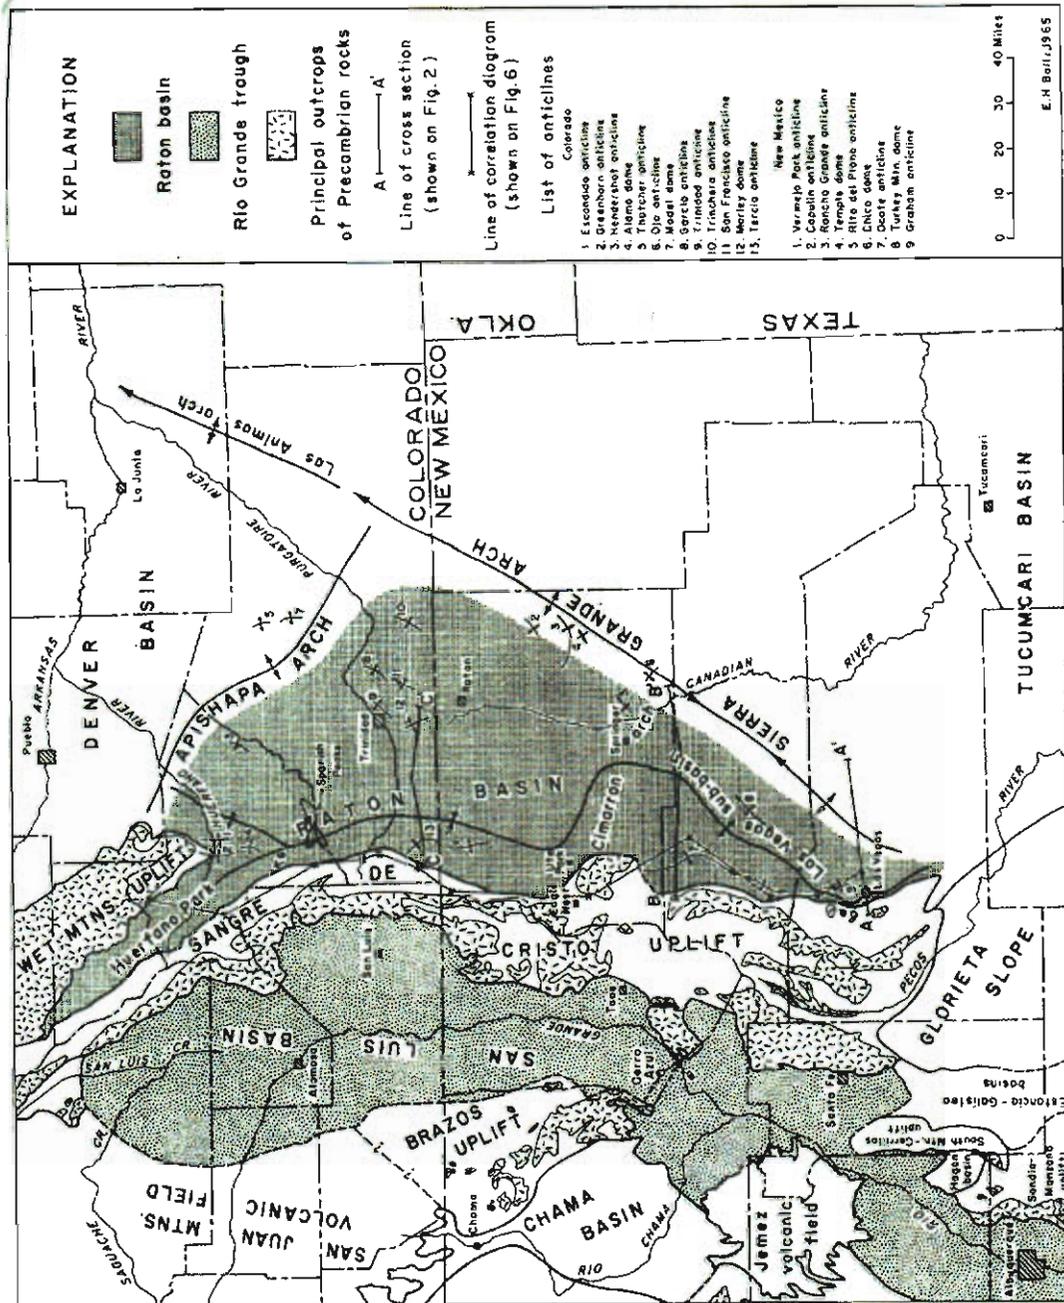
Figure 7: Raton Basin and major structures in southeastern Colorado and northeastern New Mexico (Baltz, 1965).

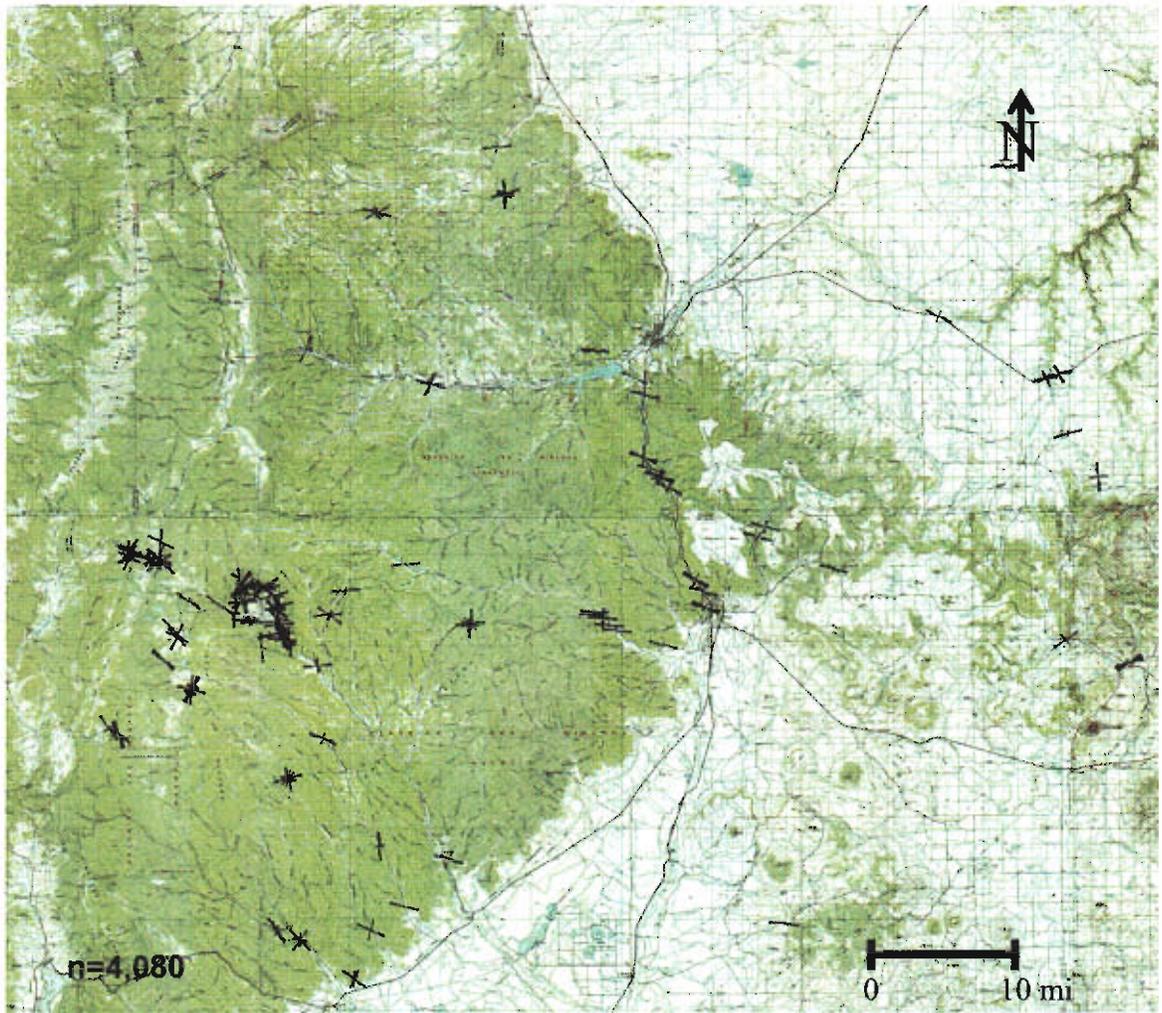
Figure 14: Map of fracture orientations across the Raton Basin (n=4,080).

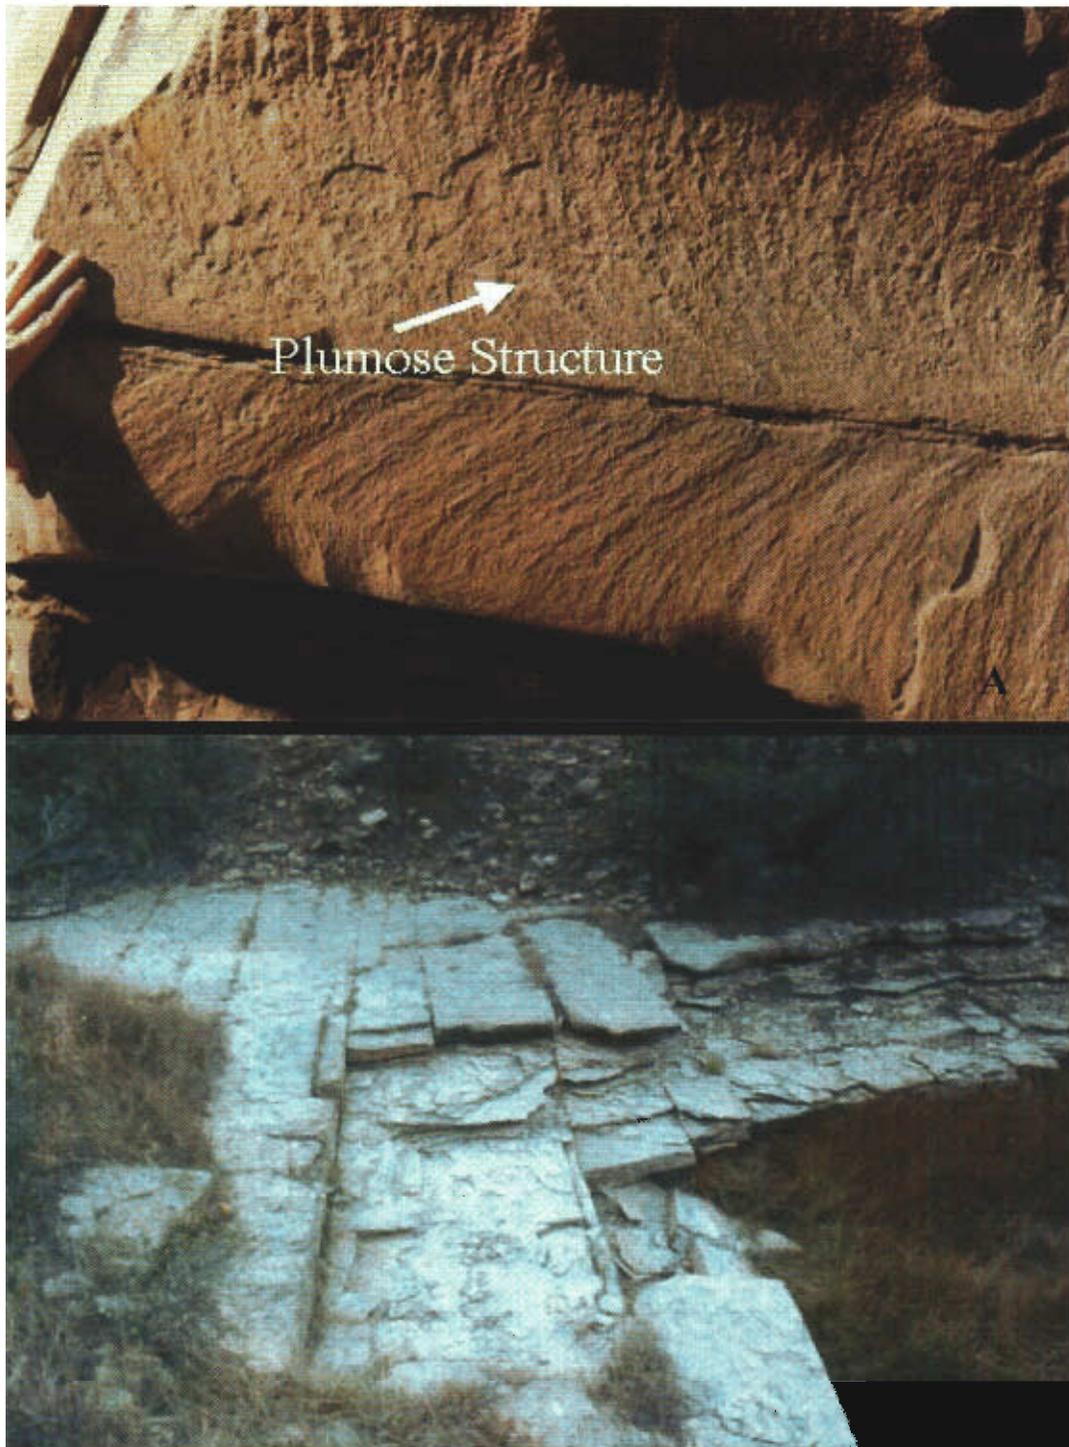
Figure 16: A. Formation of fractures in extension is evidenced by plumose structure. This example is from the Vermejo formation. B. Many of these fractures are parallel in strike.

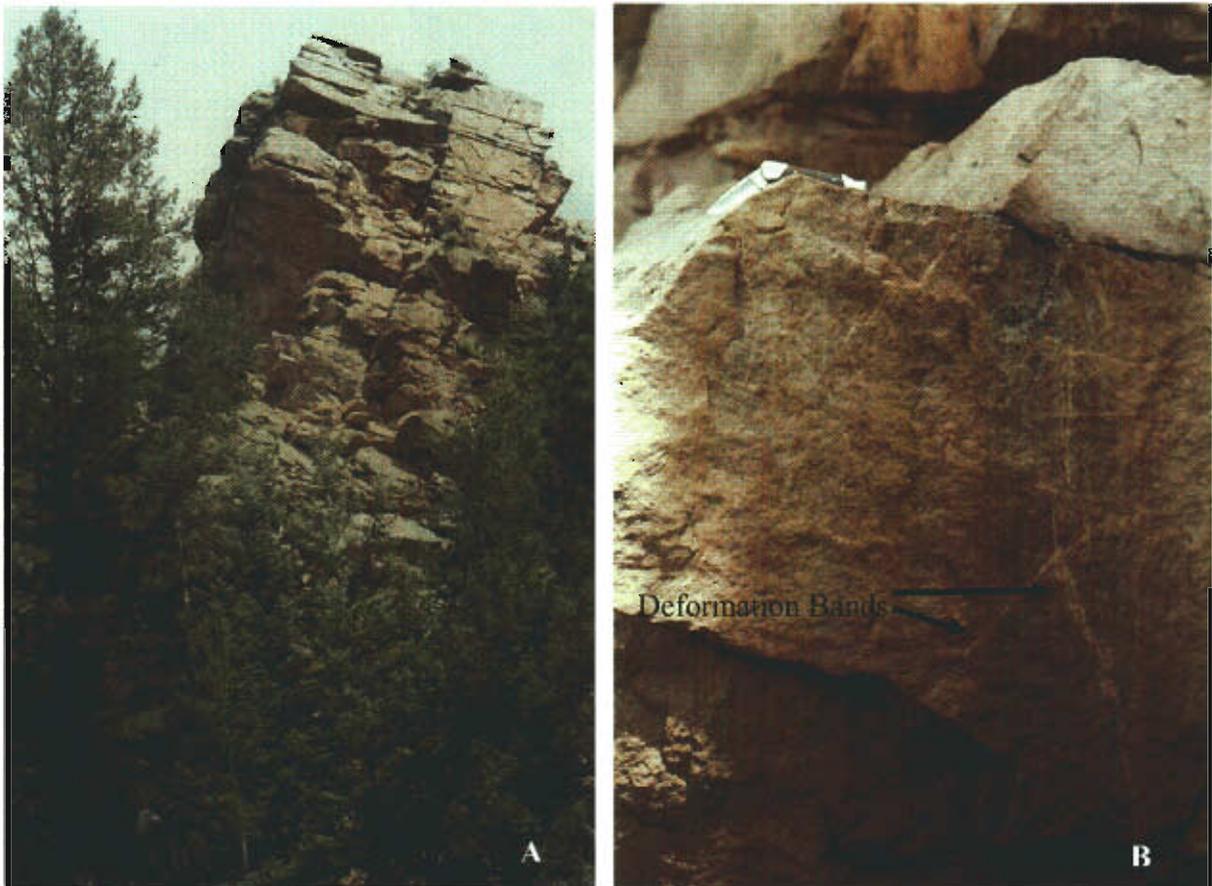
Figure 21: Photograph A shows an overturned portion Dakota Sandstone “Wall” along the western margin of the Raton Basin. Photograph B highlights deformation bands within the Dakota sandstone at this location. Deformation bands were also observed within the Raton Formation along the “Little Wall”.

Exposures of the Dakota Sandstone along the western margin of basin are visible along what is locally called “The Wall”. The outcrops contain near vertical to overturned beds of Dakota Sandstone (Figure 21). Deformation bands were observed within some of these sandstones. Deformation bands typically form in high porosity sandstones suggesting they formed early before the Dakota Sandstone was altered to its current low-porosity, well-cemented state. Bed-parallel stylolite surfaces and well developed bed-normal shear planes are also common at this location. The Dakota Sandstone at these locations is highly fractured with variable fracture orientations (Figure 22). However, once the bedding is rotated to horizontal many of the fractures strike parallel or perpendicular to the strike of the folded “Wall”. This suggests that the fractures are genetically related to the formation of the fold along the western margin of the basin.

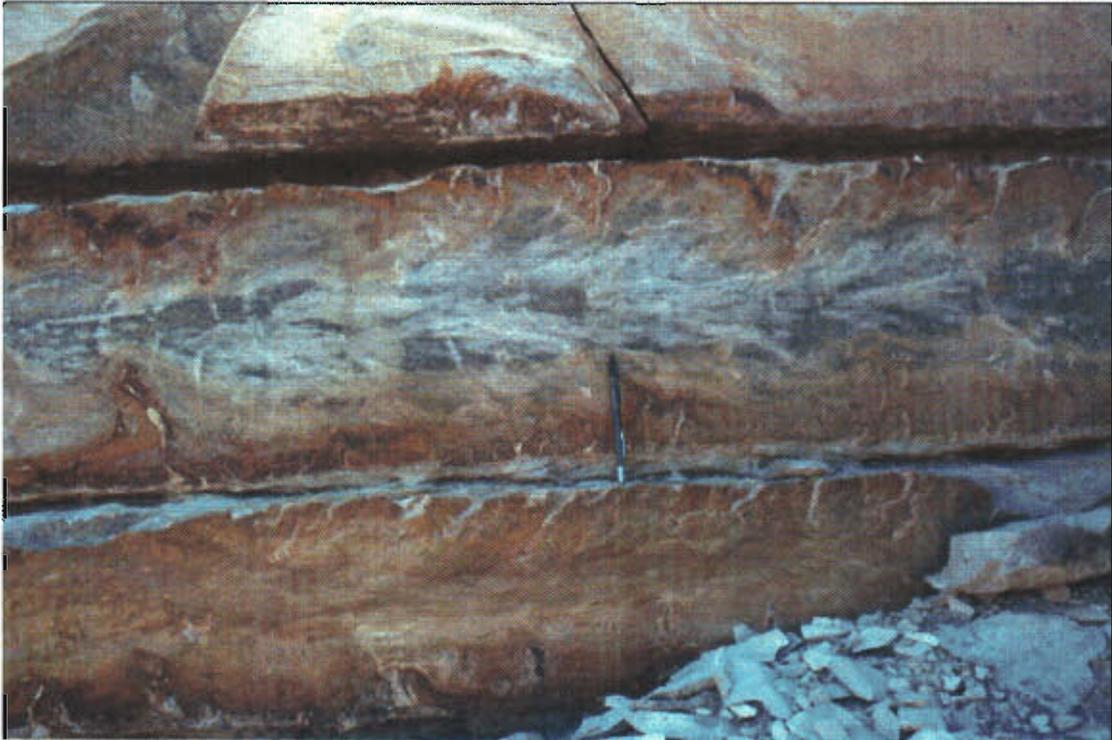
Figure 23: Plume structure on fracture surface within the Fort Hayes member of the Niobrara Limestone along Hwy 160 between mile markers 365 and 366.

Fractures in the Fort Hayes Member of the Niobrara Limestone, located within ten miles of the previously described Dakota Sandstone outcrops on the eastern margins of the Raton Basin (Figures 17, 18, 19 and 20), have a more uniform extension-fracture pattern. Plumose structures are observed on the surfaces of the Niobrara fractures indicating these are extension fractures (Figure 23). Fractures were found to curve near intersections with normal faults, indicating stress reorientations near the faults. The main lobe of the Niobrara Limestone rose diagram (Figure 24) bisects the acute angle of the two nearby Dakota Sandstone fracture sets. This indicates these two seemingly dissimilar fracture patterns (extension fractures in the Niobrara and conjugate shear fractures in the Dakota) could most easily be interpreted as dynamically compatible fracture sets formed in a single stress regime, where σ_3 was ESE and equal to σ_1 (Figure 25). Since the orientation of σ_3 is nearly perpendicular to the Sangre de Cristo thrust front, this suggests horizontal tectonic loading by the thrust over 70 miles to the west. A geomechanical analysis of this hypothesis is provided in Section 2.2.

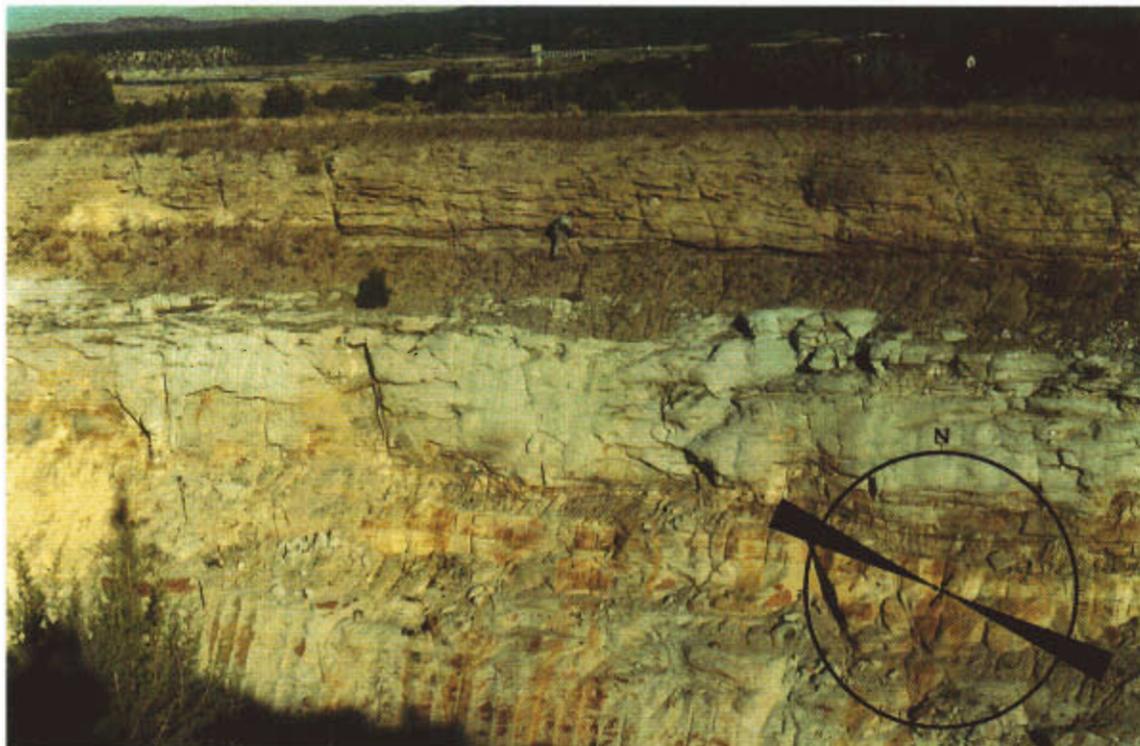
Figure 29: Photograph and rose diagram of fractures in a 15+ meter thick sandstone in a railroad cut near the SE corner of Trinidad Lake. Ring equals 60%, $n = 25$. Fracture orientations within this unit are highly ordered.

Fractures within the Trinidad sandstone along the eastern margins of the Raton Basin were found to be highly ordered, with the majority of fractures striking perpendicular to the Sangre de Cristo thrust front. Units that are thicker, such as a 15 m thick unit in the railroad cut near the southern edge of Trinidad Lake, typically have a very tightly constrained fracture pattern (Figure 29).

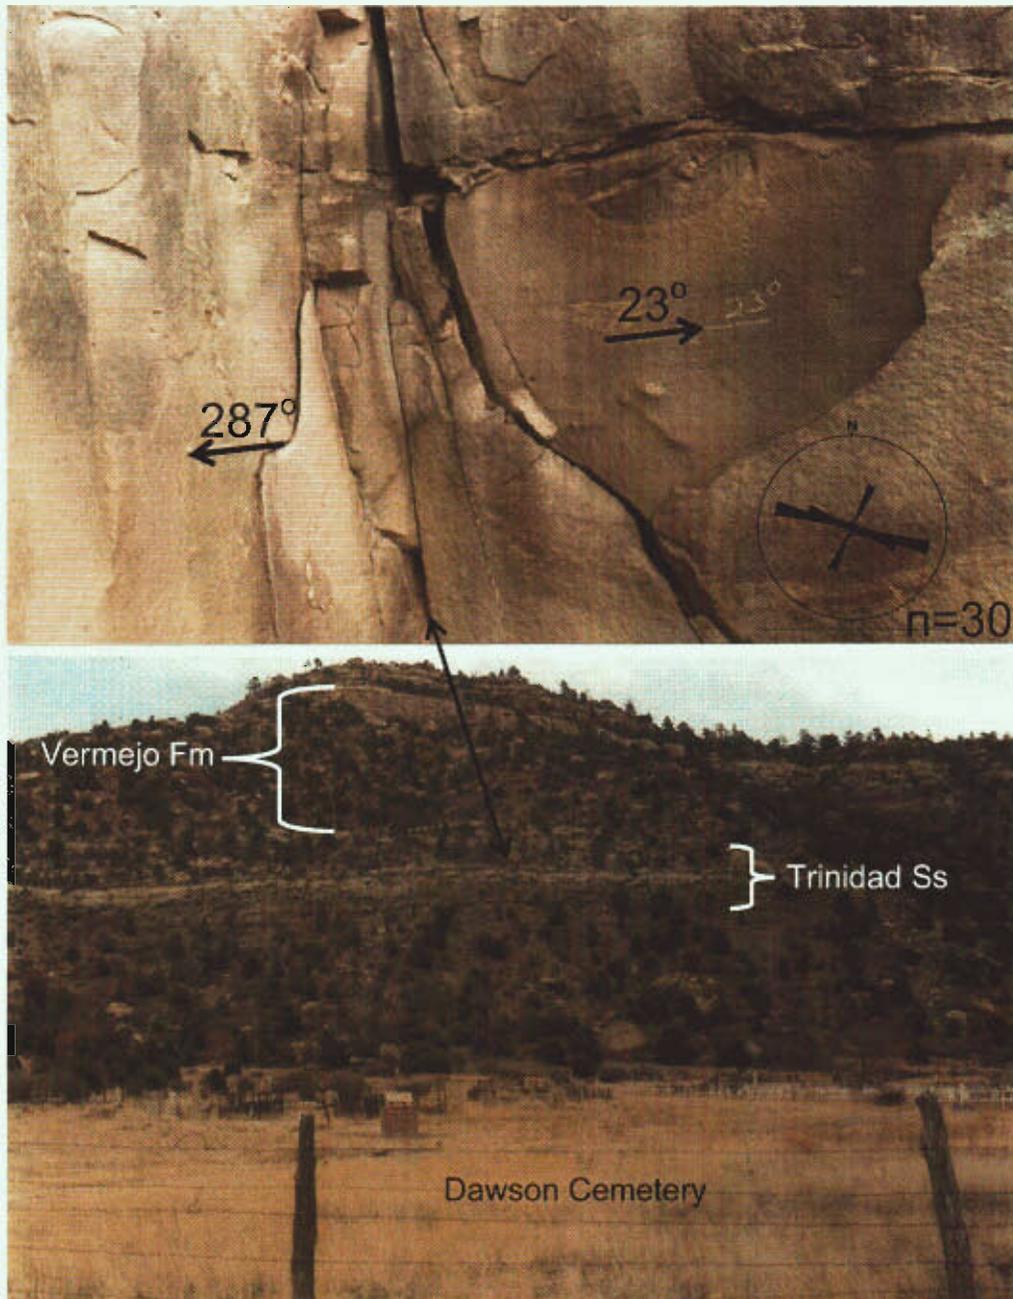
Figure 30: Fractures within the Trinidad sandstone near the Dawson Cemetery on the south eastern margins of the Raton Mesa show a distinct fracture patterns that is near normal to the Sangre de Cristo thrust front. Note that the fracture striking 23° terminates at the intersection of the fracture striking 287° . This relationship indicates the 23° striking fracture is younger than the 287° striking throughgoing fracture.

A second example of tightly constrained fracture orientations within the Trinidad Sandstone along the eastern edge of the basin is shown in Figure 30. Again these fractures are near normal to the Sangre de Cristo thrust front. Numerous other sites along this margin of the Raton Mesa were documented to also have this characteristic (Figure 31).

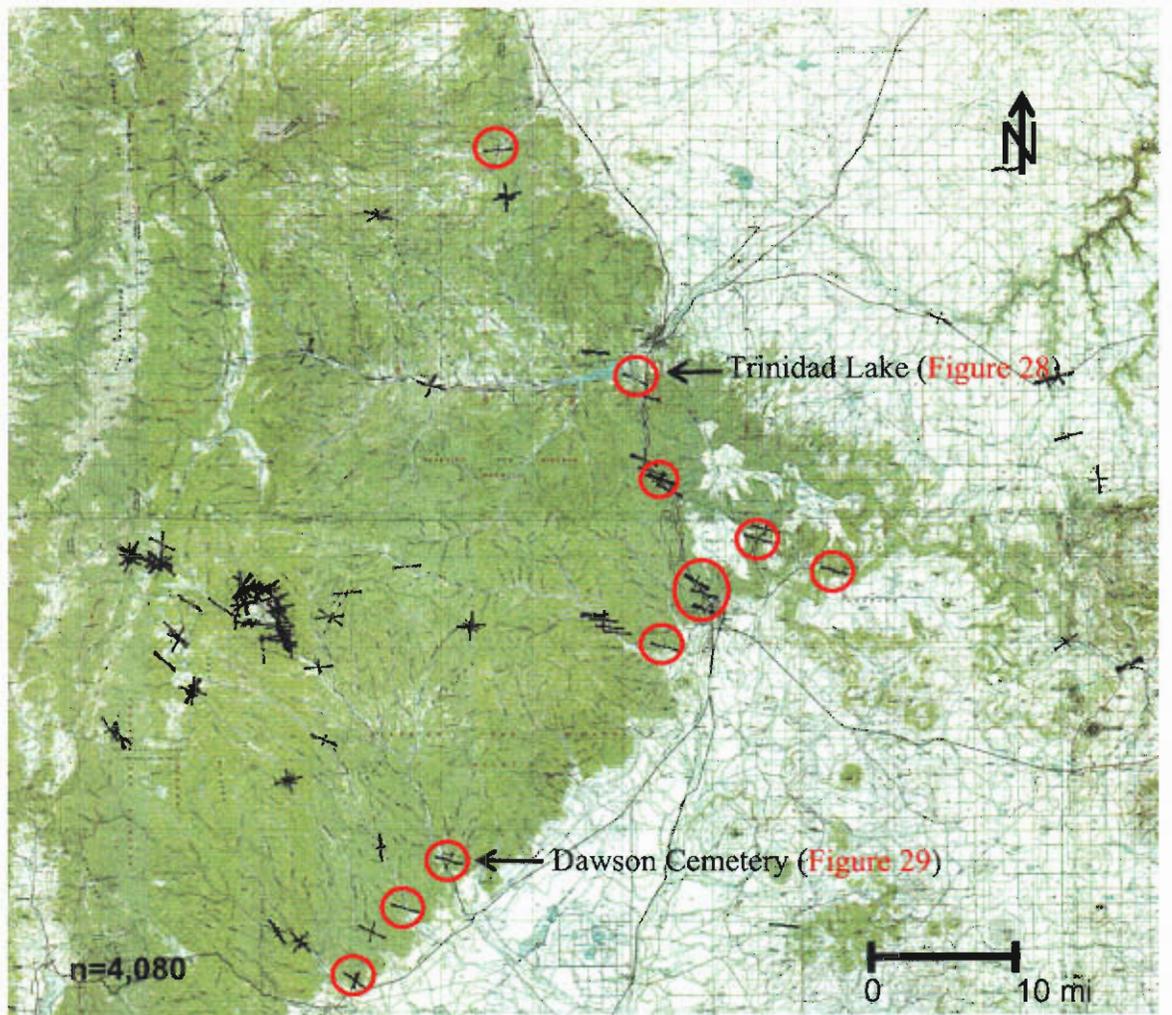
Figure 31: Map of fracture orientations across the basin. Some of the Trinidad Sandstone outcrop sites are located in red with the examples from Figures 29 and 30 highlighted.

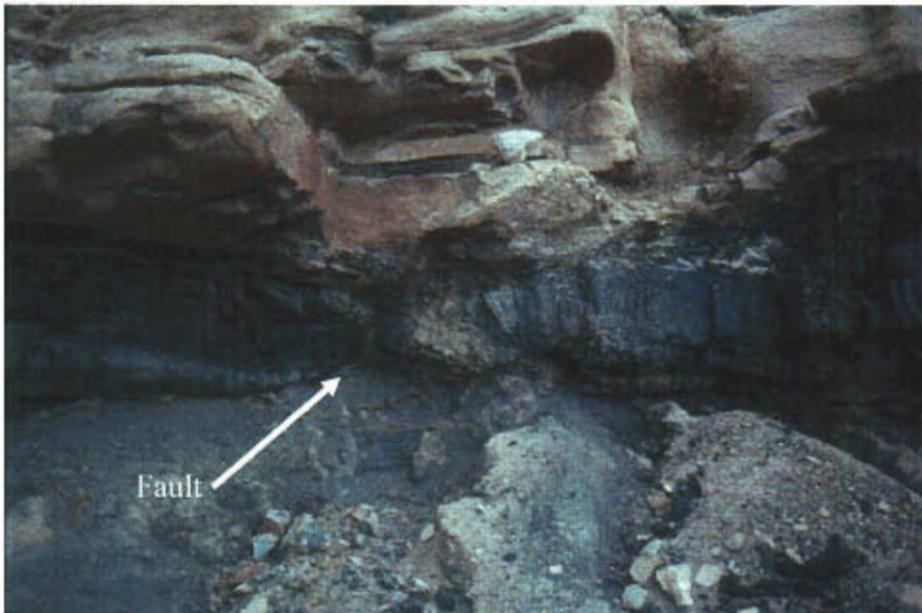
Figure 36: Slickensided fault in coal two miles south of Trinidad, CO. Fault at this location is located below a slump in the overlying sandstone. Underlying shale is squeezed into the fault plane and dislocation area near the point of the arrow. These relationships suggest the fault is related to early compaction.

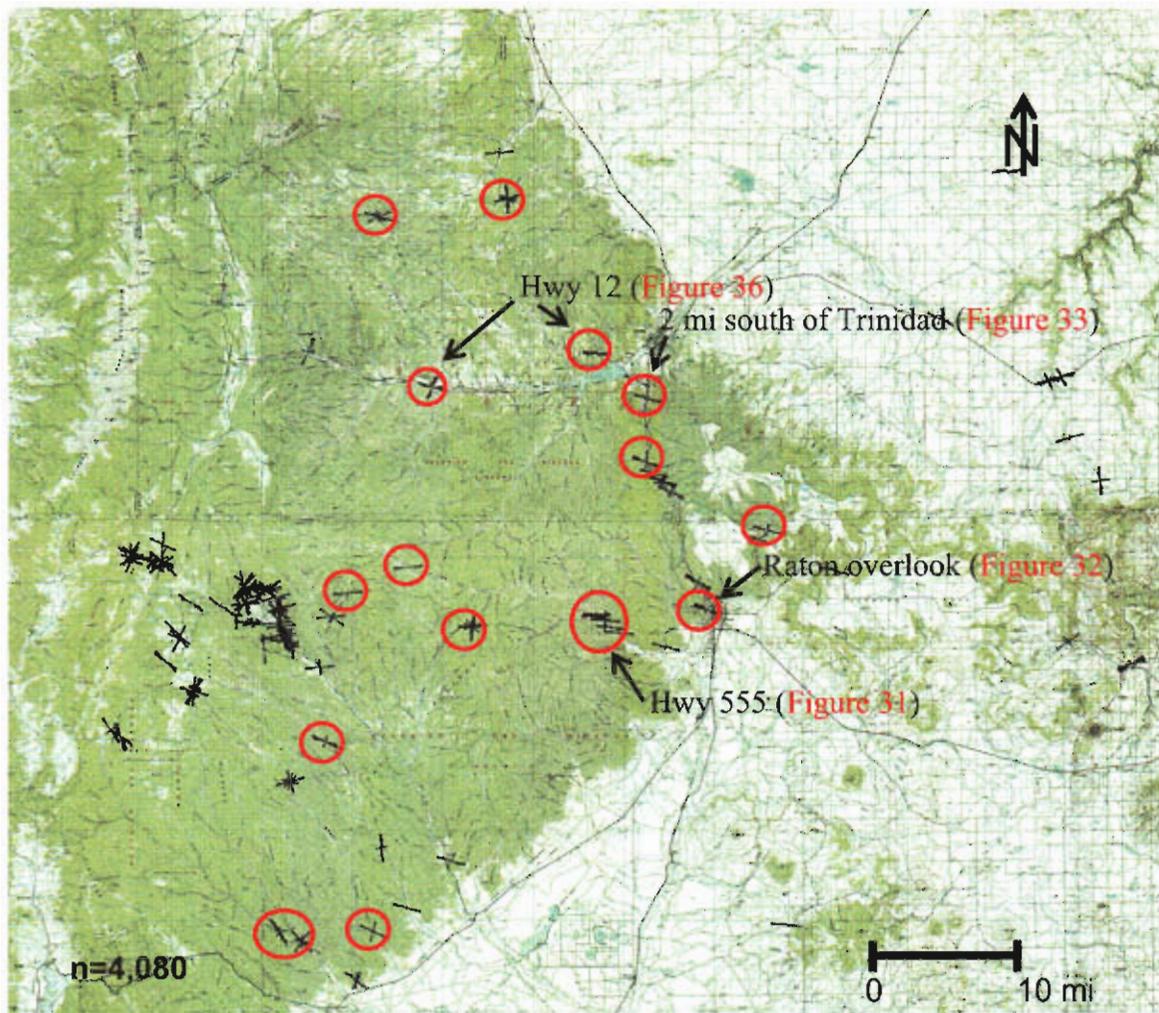
Figure 38: Map of fracture orientations across the basin. Some of the Vermejo and Raton Formation outcrop sites are located in red with examples from Figures 32, 33, 34, and 37 are highlighted.

In summary the oldest throughgoing fracture sets within the Vermejo and Raton Formations along the eastern margin of the Raton Mesa typically strike WNW and are parallel to face cleats within adjoining coals. This relationship is true only for those sites on the eastern side of the mesa and those sites at a distance from secondary structures such as faults, folds and igneous intrusions. A map of some typical Vermejo and Raton Formation locations and rose diagrams highlights this type of orientation characteristic (Figure 38).

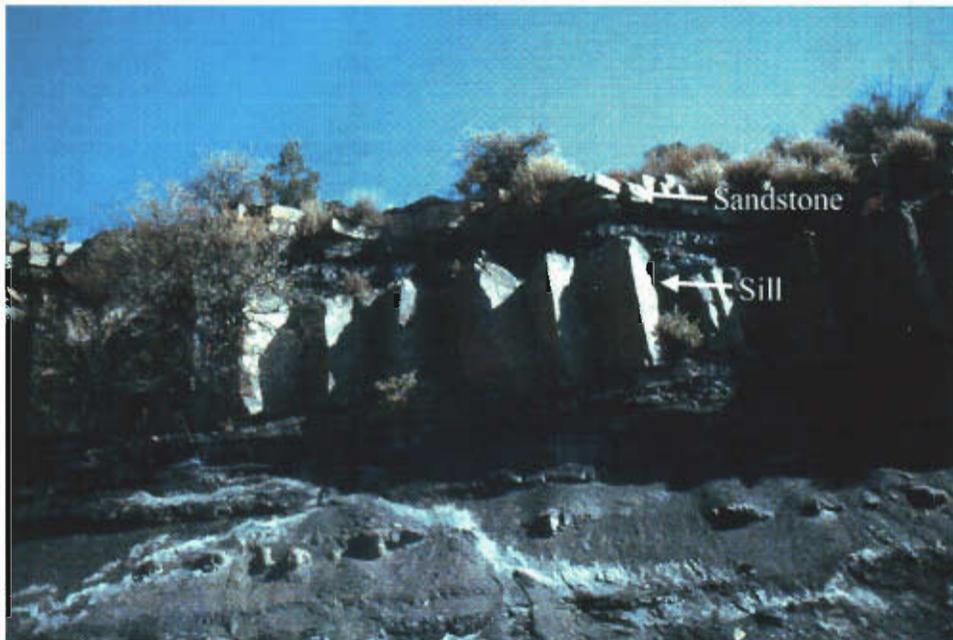
Figure 39: Photograph of a portion of the outcrop at milepost 50 on Highway 12 west of Trinidad, CO. Sandstones overlie an igneous sill and a coal bed at this site.

A site near Valdez CO, milepost 50 on Highway 12 west of Trinidad, provides an interesting comparison of fracture orientation within sandstones, an igneous sill and cleats within a coal bed (Figure 39). Extension fracture orientation is well constrained within a series of 10-30 cm thick sandstones above an igneous sill. Interestingly there is some parallelism between fracture orientation in these sandstones and the underlying sill (Figure 40). A comparison of the rose diagrams shows a slightly more distributed pattern and an extra set of fractures that strike NW-SE within the sill (Figure 41). The parallel nature of fractures in these differing rock units can be very apparent in the outcrop. Cleats within coals at this location have a more diverse pattern than the sandstones or the sill (Figure 42). In part this is due to different orientations of face cleats also having associated butt cleats at near right angles to the face cleat. It is also possible the diverse cleat pattern is due to compaction.

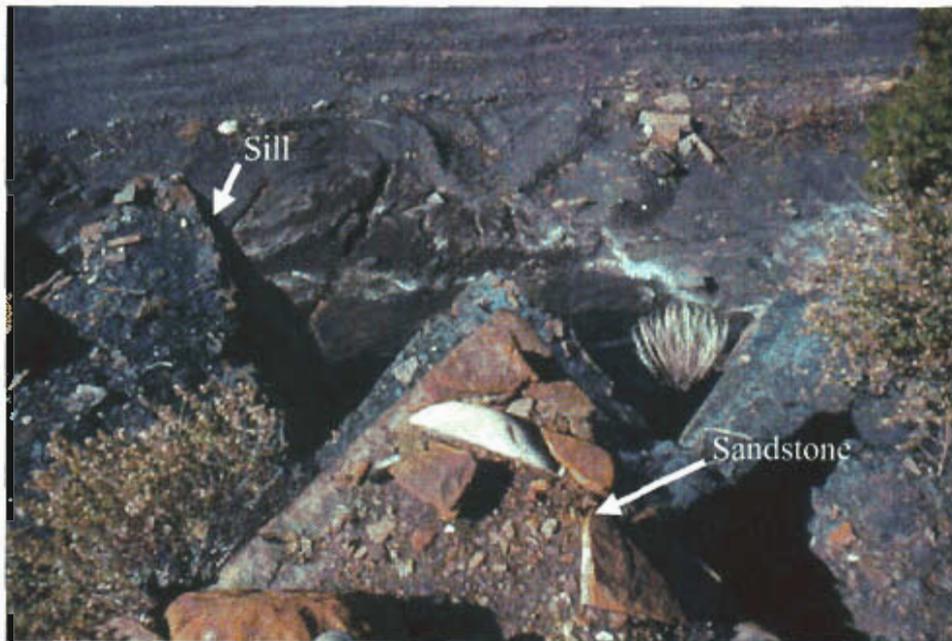
Figure 40: This photograph, oriented with the viewer looking straight down, illustrates the parallel nature of fractures in a sandstone and an igneous sill. The upper red colored rock unit is a sandstone. The intersection of two fractures forms a wedge pointing toward the top of the photograph within this unit. The dark colored wedge in the rock below the first wedge is within an igneous sill. Note the parallel nature of fractures within these two very different units, and the repetitive nature of these fractures.

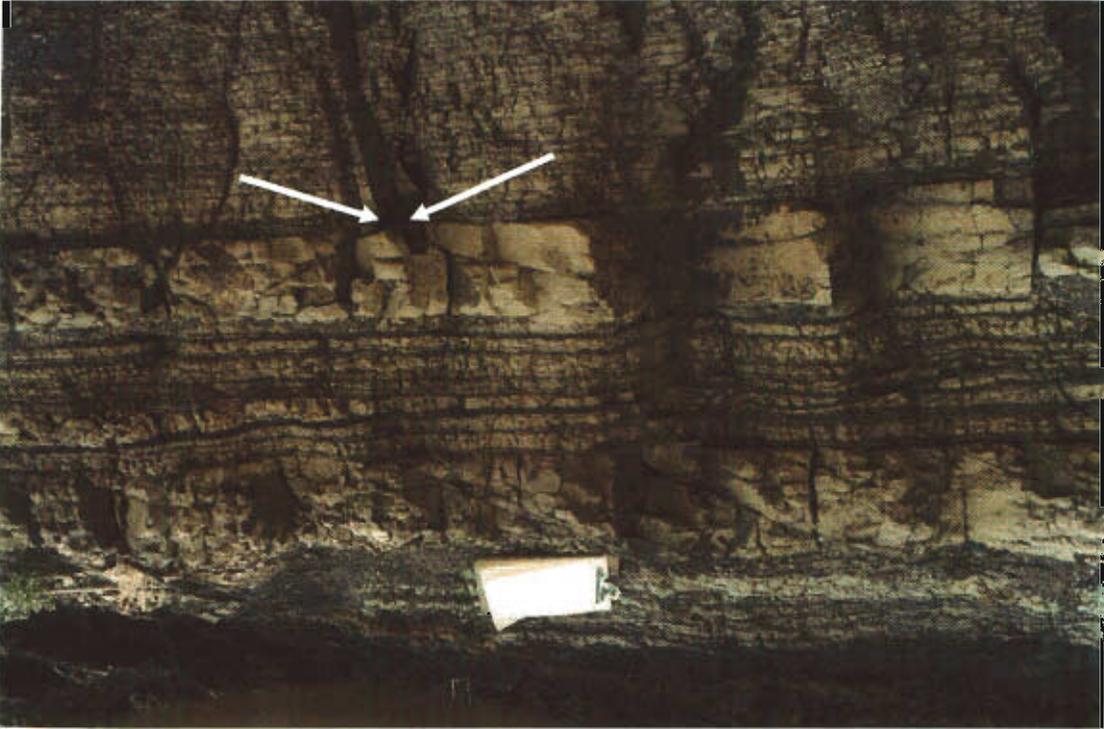
Figure 43: Low-angle thrust plane shown here has slickenside lineations striking perpendicular to the wall of the igneous dike. View is looking down (map view).

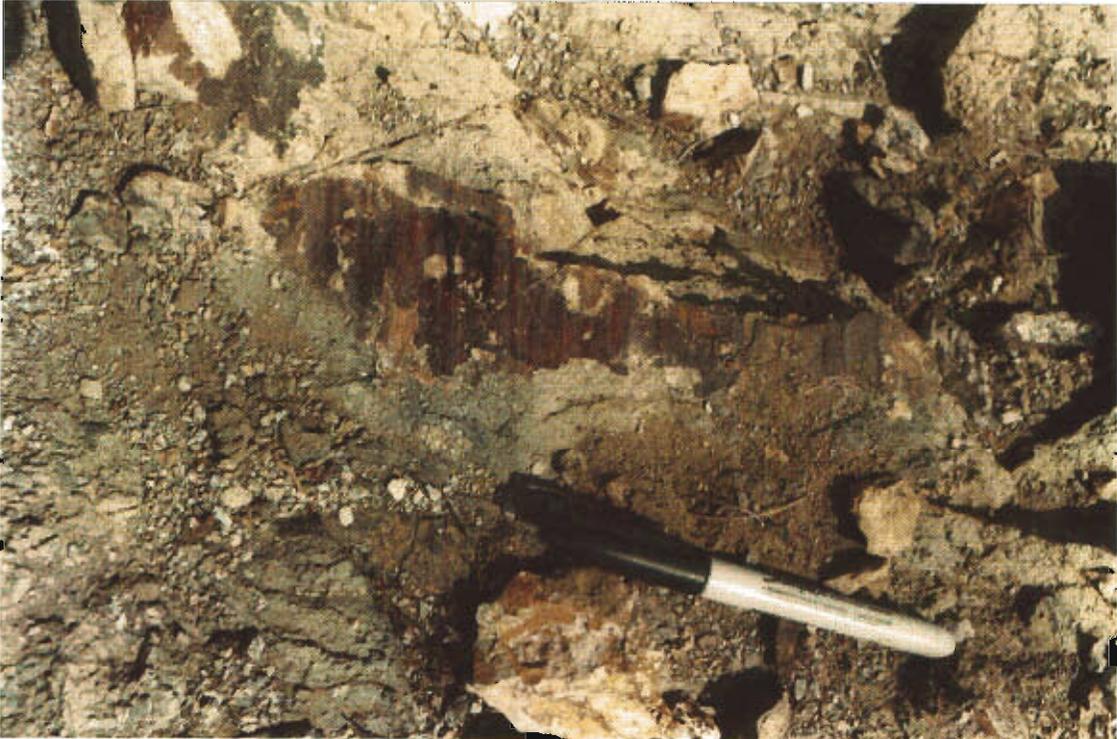
Figure 44: The thrust planes shown here indicate that the maximum compressive stress was normal to the dike at the time of intrusion. White arrows point in the direction and intersection point of two of the low angle thrust planes.

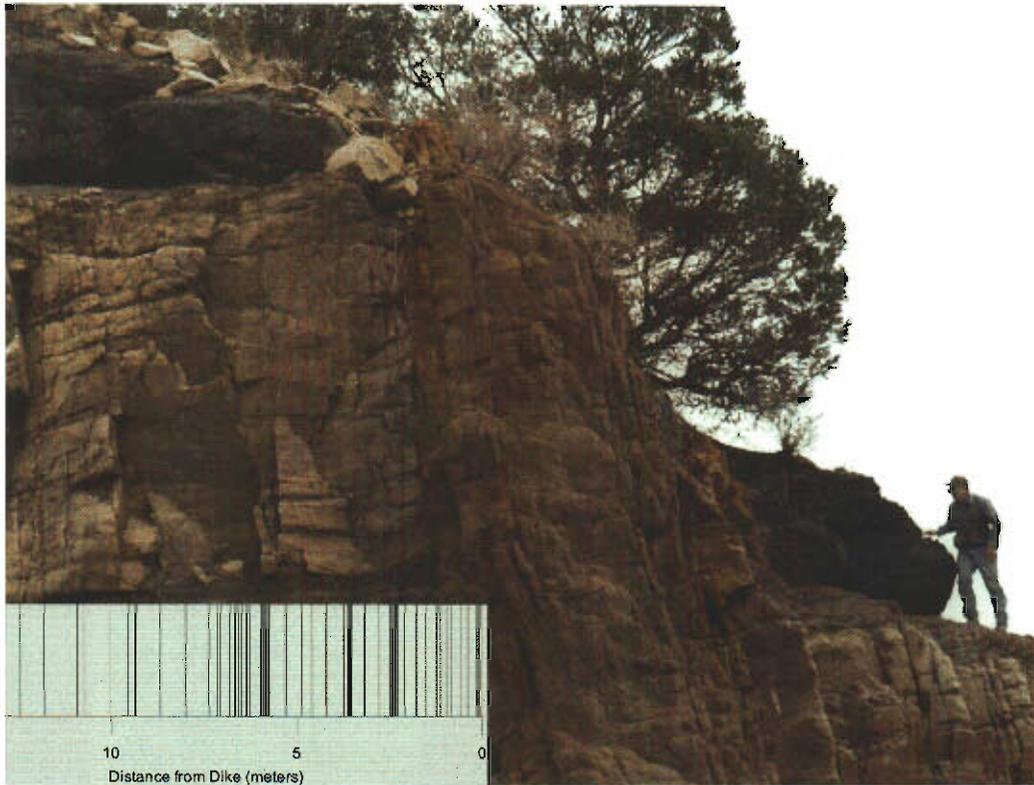
Figure 47: Scan-line of fractures within Vermejo Sandstones immediately adjacent to an igneous dike. Fracture intensity and number of fractures swarms increase with increased proximity to the dike.

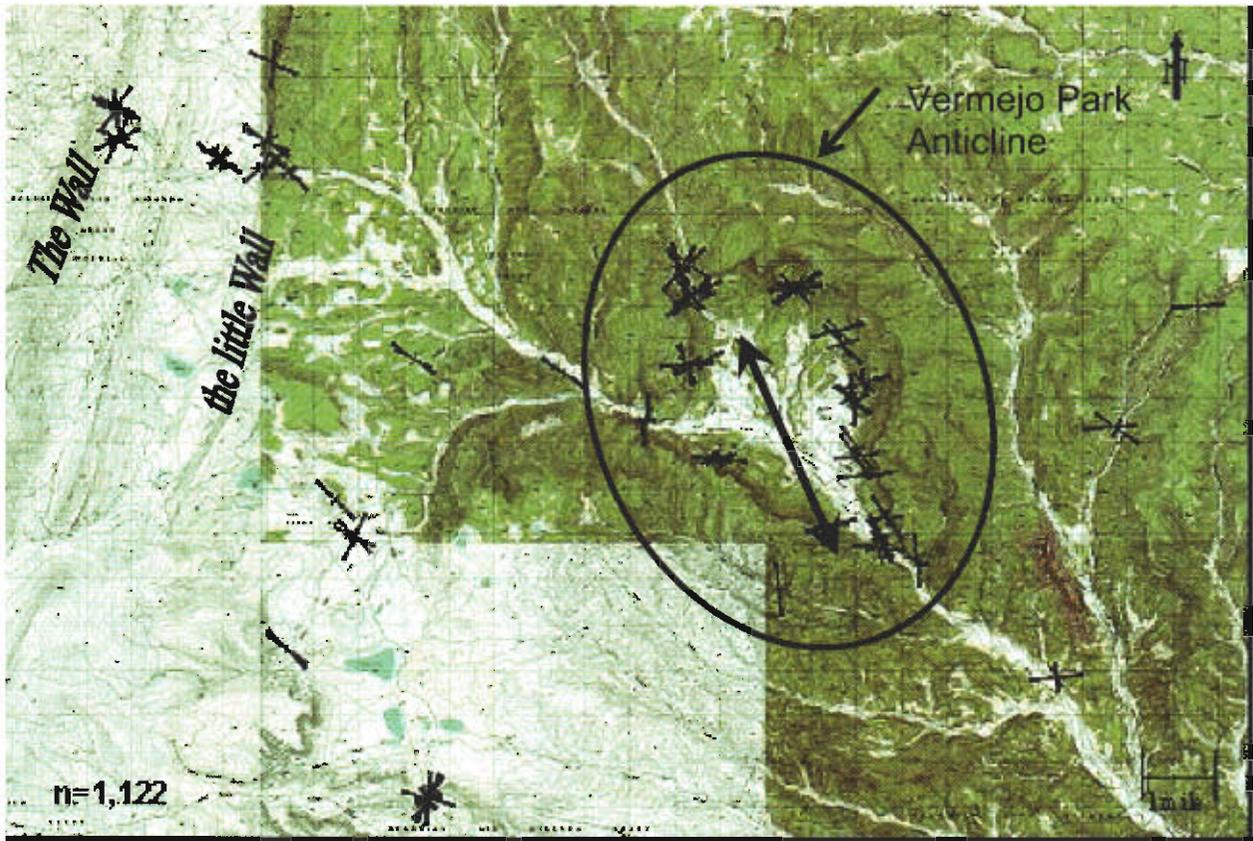
Figure 48: Fracture map close-up of area around the Vermejo Park Ranch Headquarters. Fractures in this area show a variety of orientations.

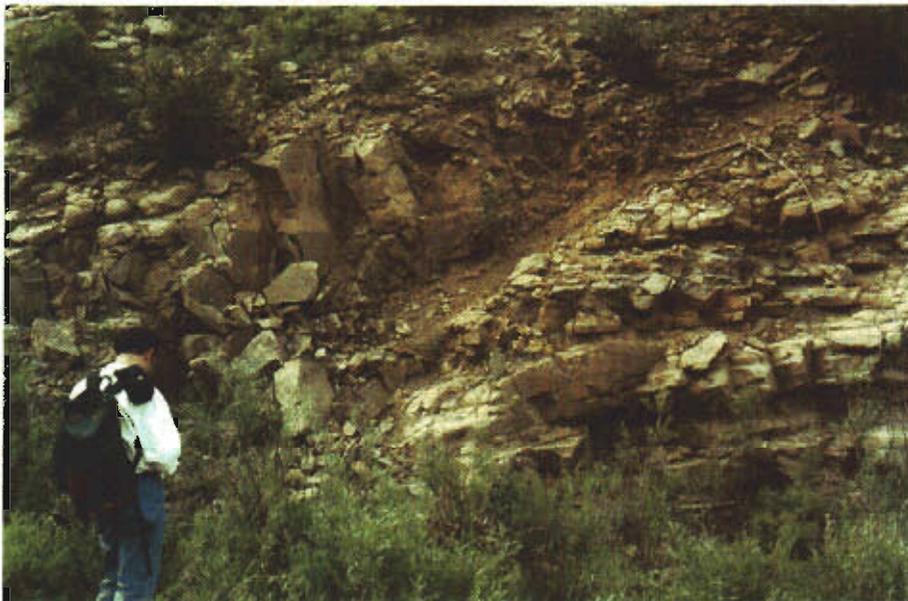
Figure 49: Photograph of a thrust within the Trinidad Sandstone along main road at the west side of the Vermejo Park Anticline.

Figure 51: Photograph of minor thrust fault within Trinidad sandstone near Spring Canyon on the northwest rim of the Vermejo anticline and 4-5 miles to north of the thrust in Figure 49. Orientation and sense of motion are similar.

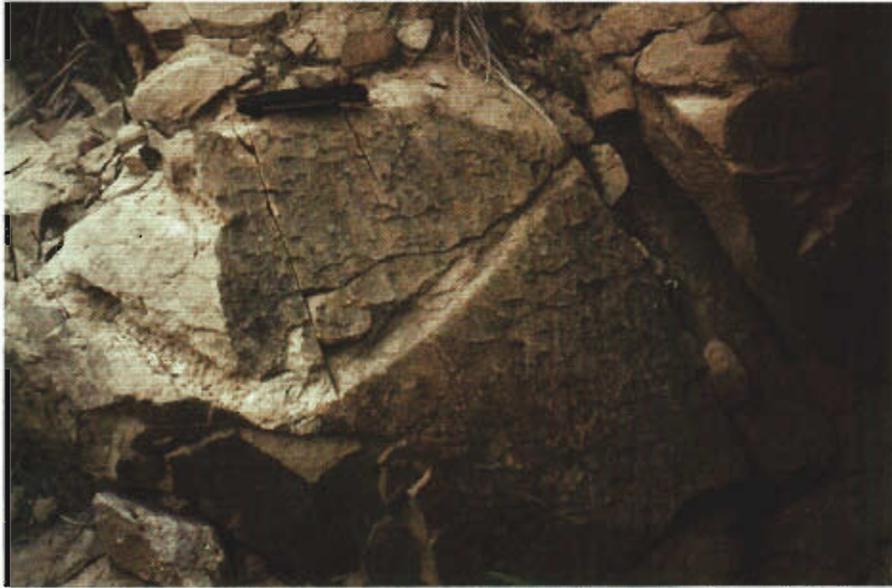
Figure 50: Photograph of back thrust, striking parallel to the thrust fault but dipping east to intersect it.

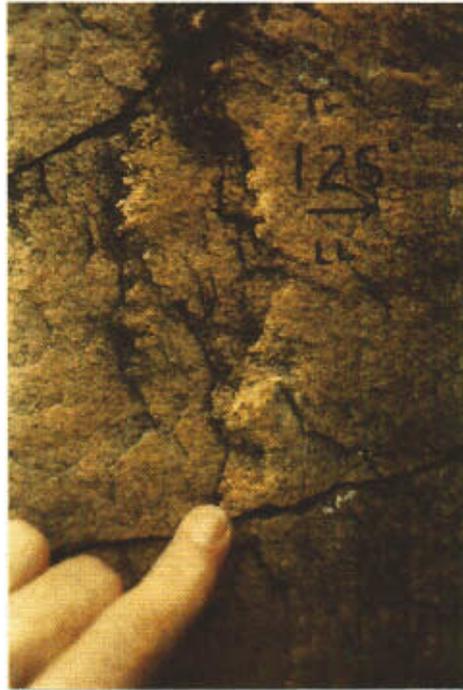
Figure 52: Steps instead of plumose structures on fracture surfaces indicate an origin in shear rather than extension. Horizontal steps (like those shown above) indicate strike-slip movement.

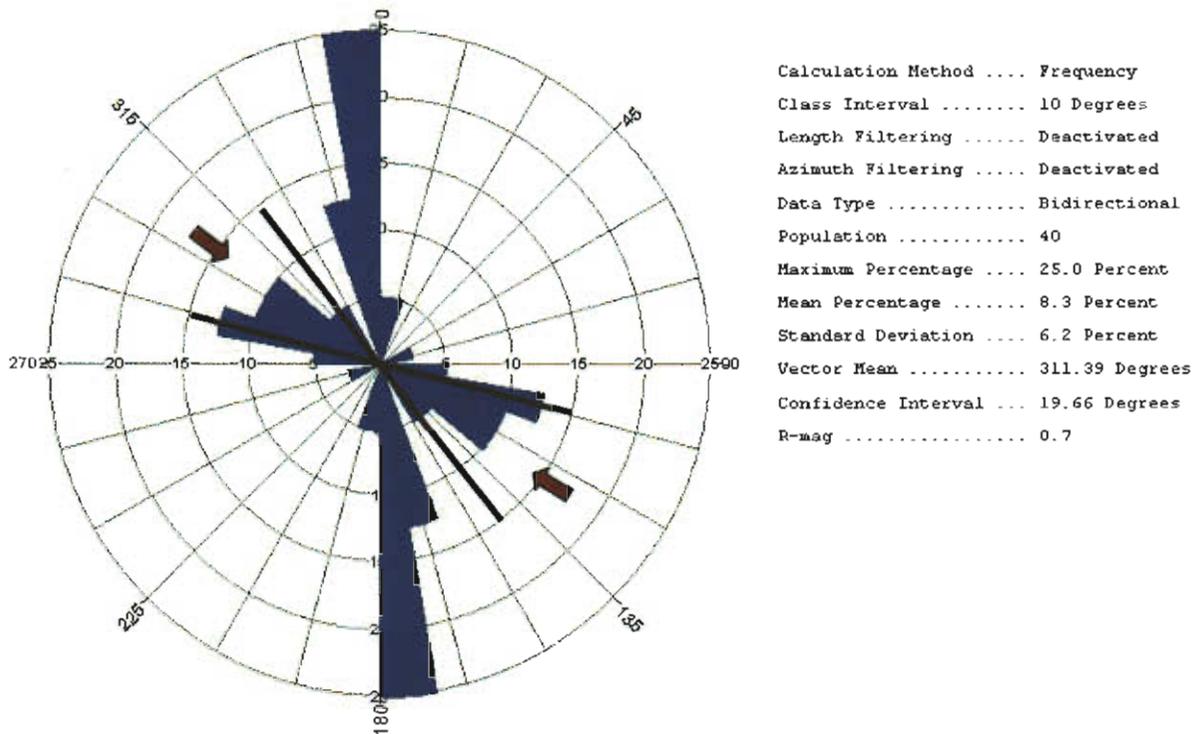
Figure 53: Conjugate shear fracture system within the Raton Conglomerate, n=40. This strike-slip system is displayed as an X in plan view and on the rose diagram above. Black lines and red arrows added to highlight the conjugate system and orientation of maximum compressive stress. The north-south lobe is a younger extensional fracture set superimposed on the conjugate shear fracture system.

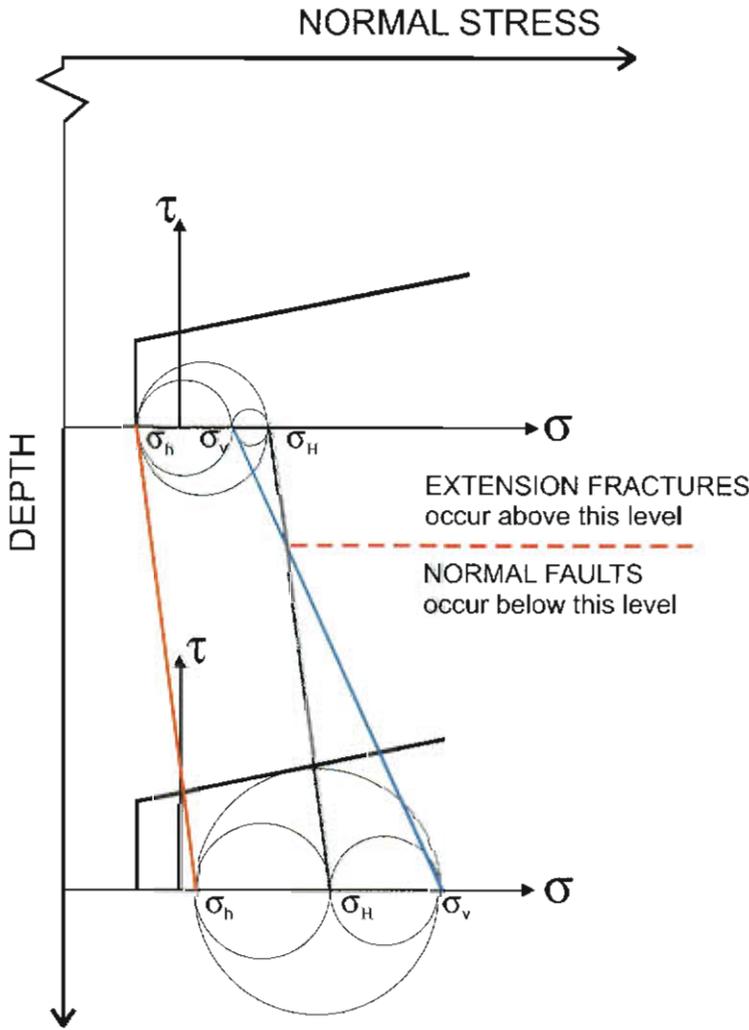
Figure 57: States of stress in relation to the failure condition at the two different depths referred to in the text.
