SANDIA REPORT

SAND2004-4859
Unlimited Release
Printed October 2004

Natural Gas Production Problems: Solutions, Methodologies, and Modeling

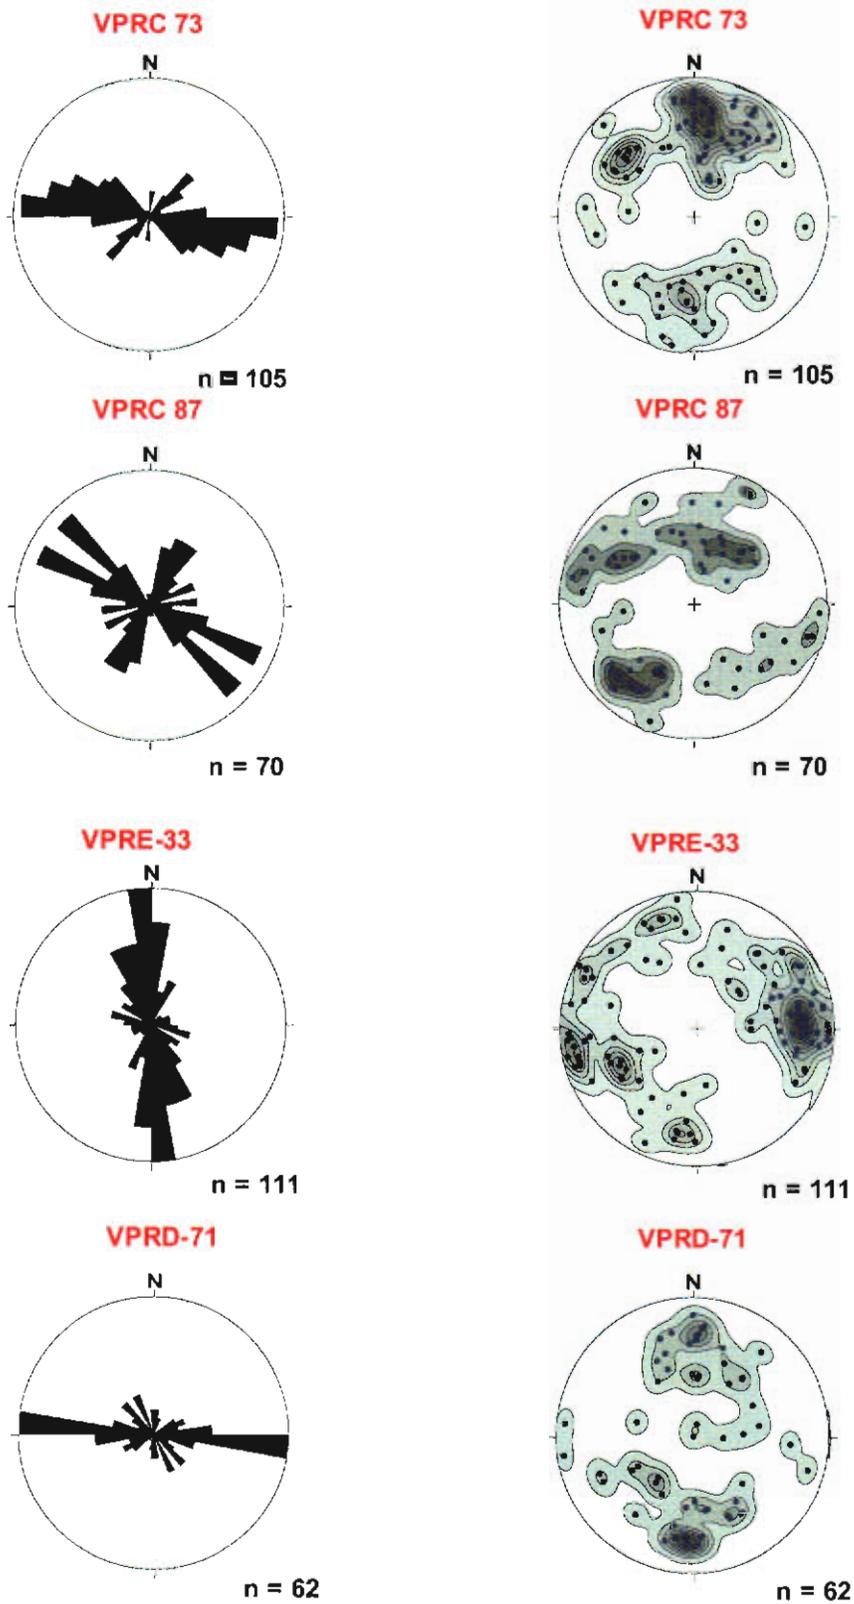
Figure 59: Orientations of open fractures from FMI logs of four wells. Plots on left show rose diagrams of fractures and plots on right show lower hemisphere stereonet plots of fracture poles.

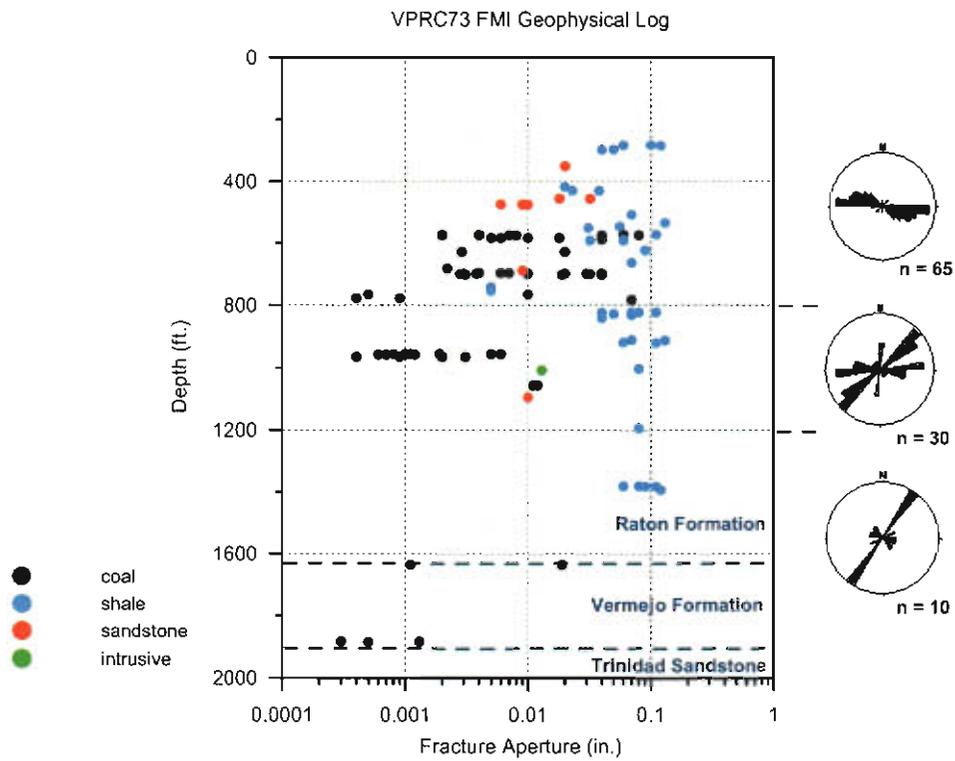
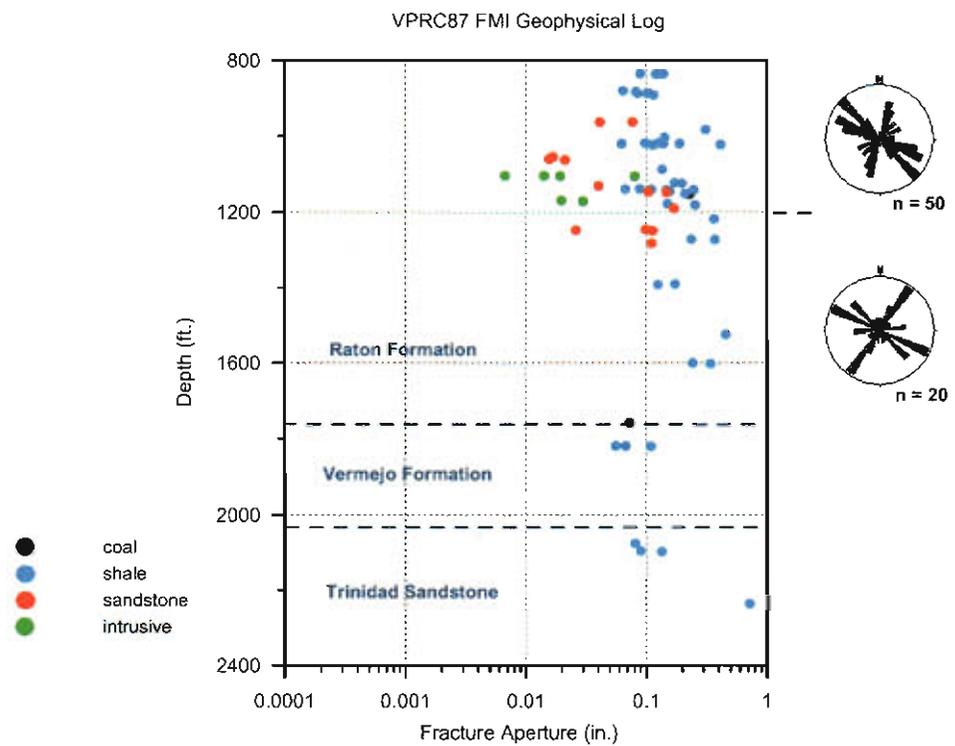
Figure 60a: Fracture hydraulic aperture estimated from the FMI logs for wells VPRC 73 and VPRC 87 versus depth. Lithology of fractures indicated by colored symbols. Rose diagrams of fracture strike are shown for different depth ranges to the right of the plot.

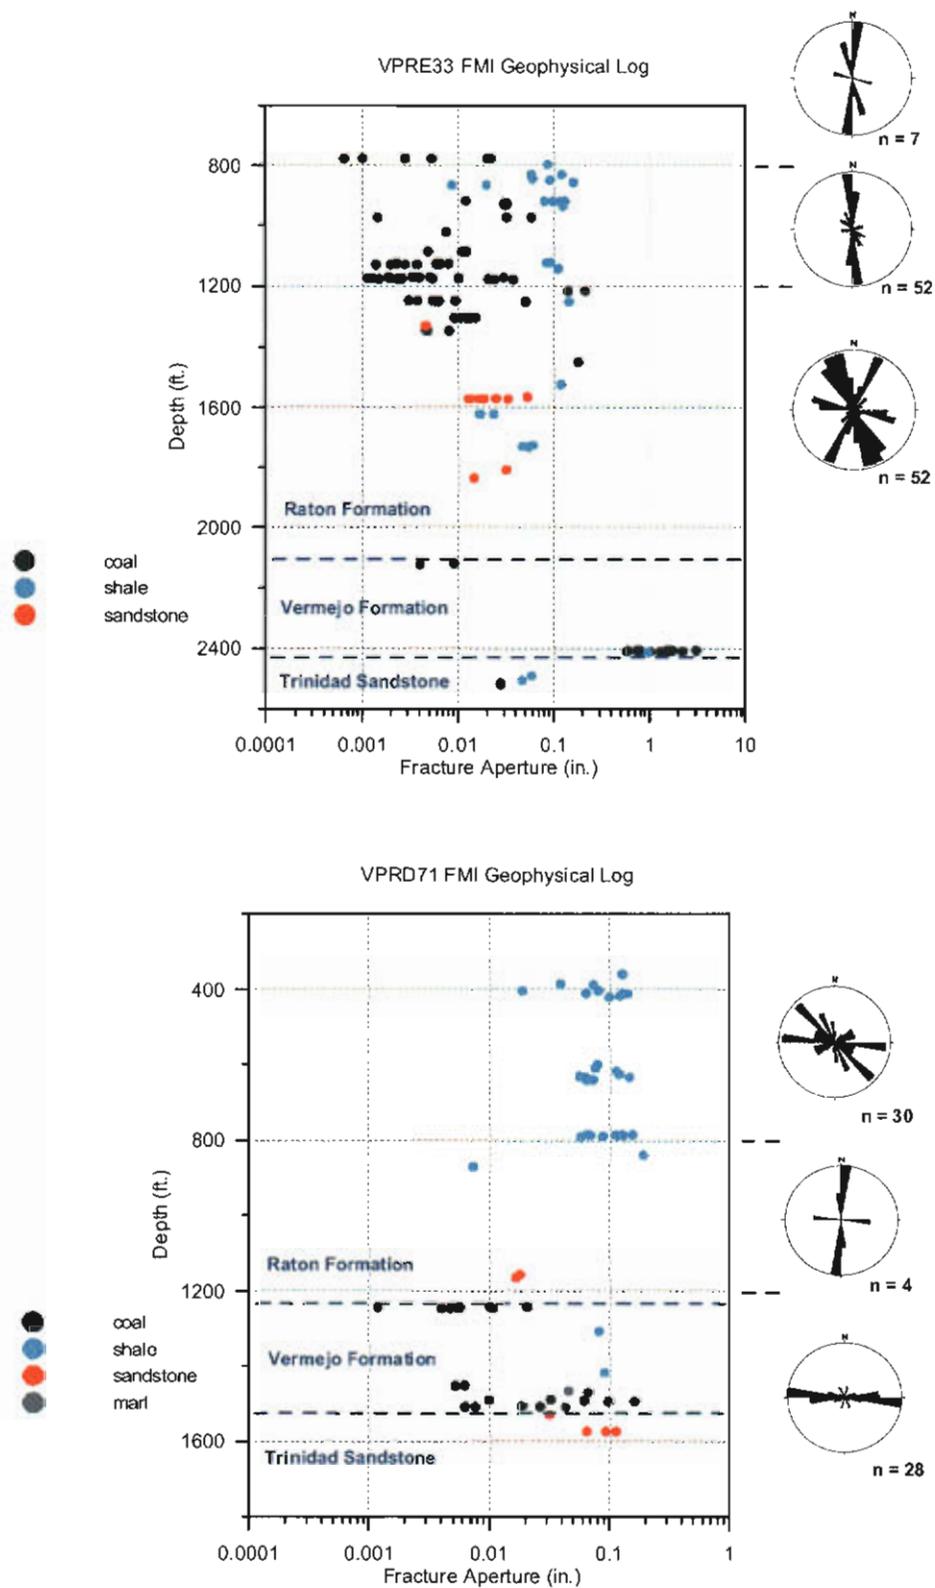
Figure 60b: Fracture hydraulic aperture estimated from the FMI logs for wells VPRES 33 and VPRD 71 versus depth. Lithology of fractures indicated by colored symbols. Rose diagrams of fracture strike are shown for different depth ranges to the right of the plot.

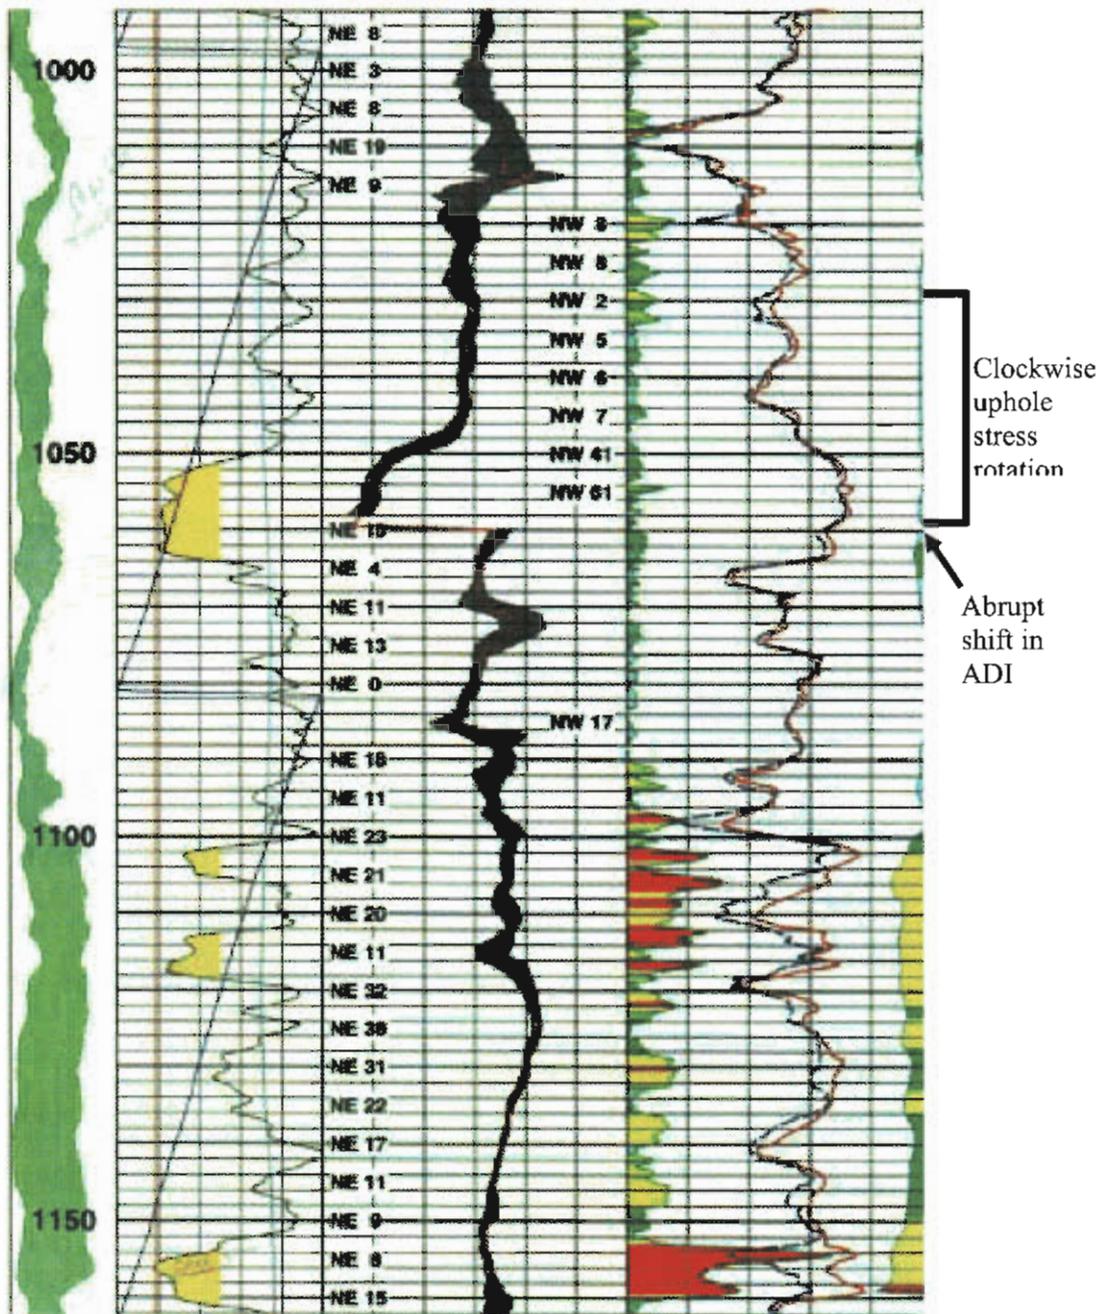
Figure 65: An example of the irregular uphole stress rotation typical within upper sections of the VPRC 87 and 73 holes. An abrupt shift at 1060 ft correlates to a fractured interval in the FMI log (Figure 66).

Figure 66: Highly fractured zone at 1060 ft correlates to an abrupt shift in the stress orientation on ADI log (Figure 65).

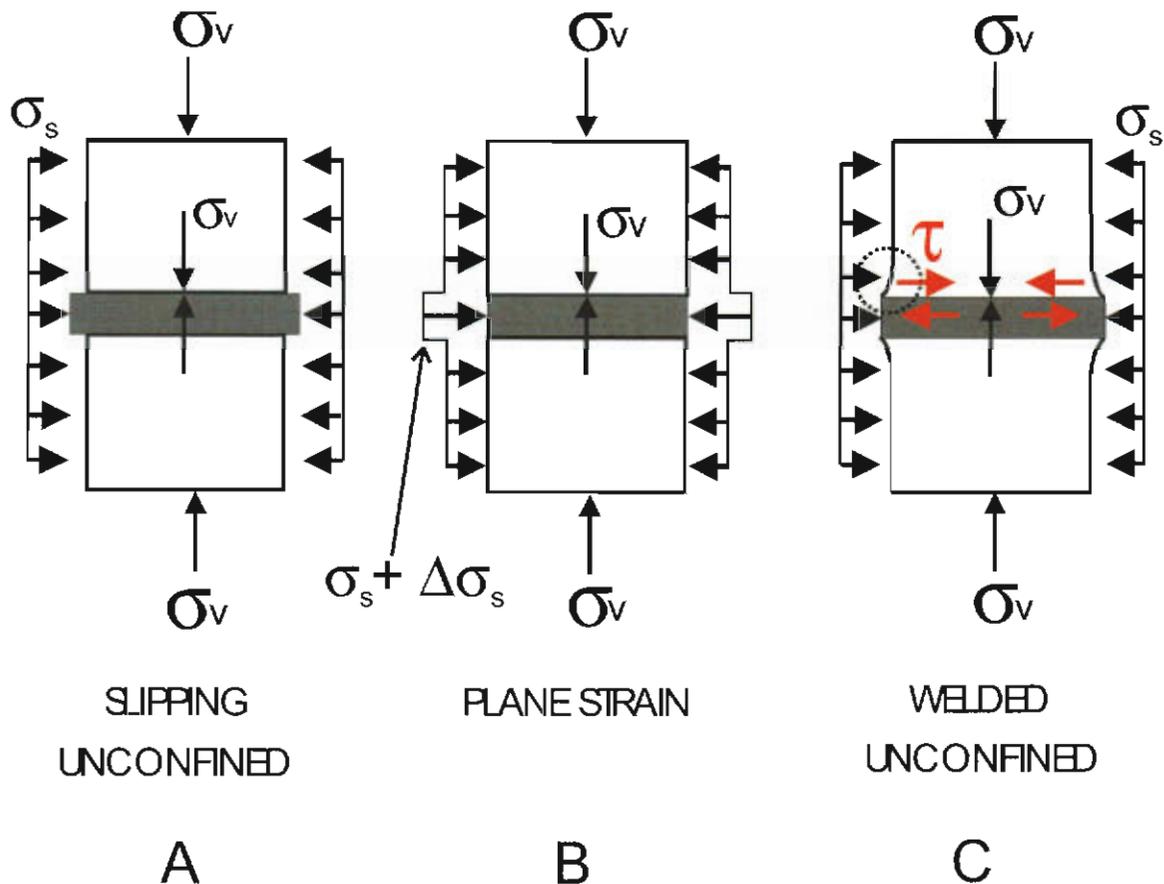
Figure 69: A) Three-layer model with frictionless contacts. Loaded vertically with σ_v and laterally with σ_s . Both σ_v and σ_s are continuous across the bedding planes. The coal layer is allowed to “squeeze out”. B) Same with sufficient additional σ_s applied to push coal layer back to the original size. Vertical stress continuous, σ_s discontinuous at contacts. C) Same three-layer model with welded contacts. Applied vertical and lateral stresses are continuous. The additional lateral deformation of the coal induces shear stresses along the contacts and distorts the host rock as indicated in the dotted circle.

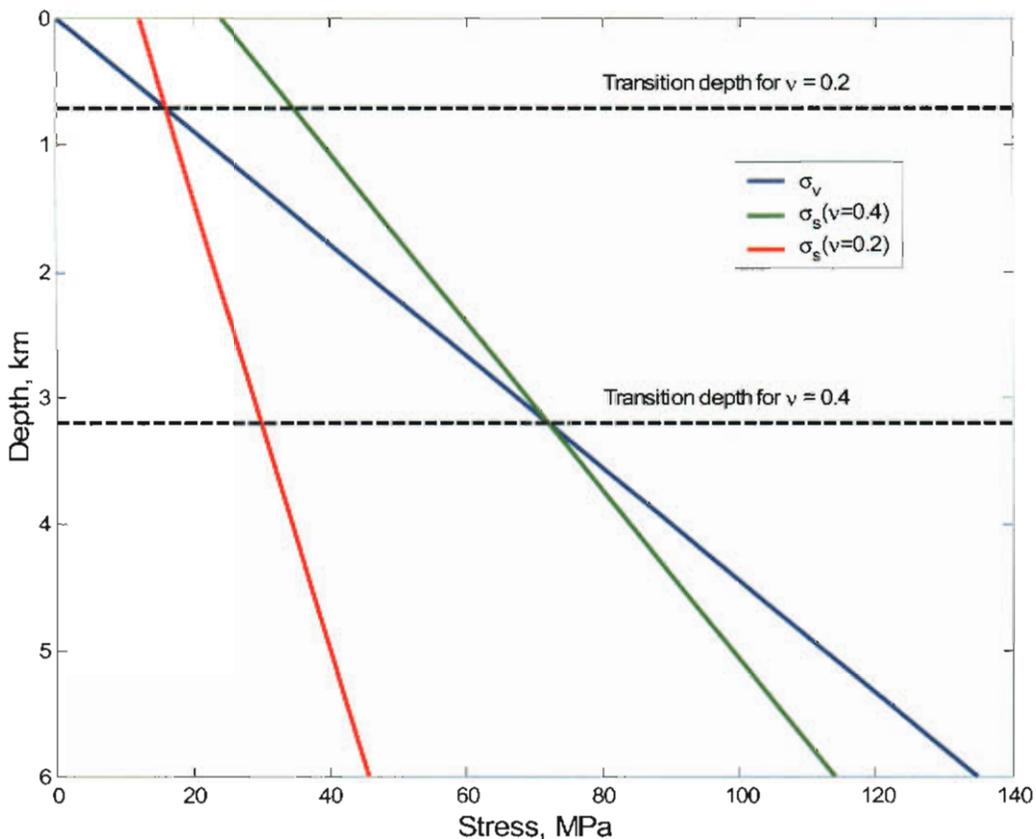
Figure 70: Vertical stress σ_v and σ_s plotted against depth for $\nu=0.2$, typical of sedimentary rocks, and $\nu=0.4$, representative of coal. The depth where σ_v exceeds σ_s is the transition depth from sills to dikes. This transition occurs at 0.72 km (2362 ft) for $\nu=0.2$. For $\nu=0.4$, the transition occurs at 3.21 km (10,531 ft).

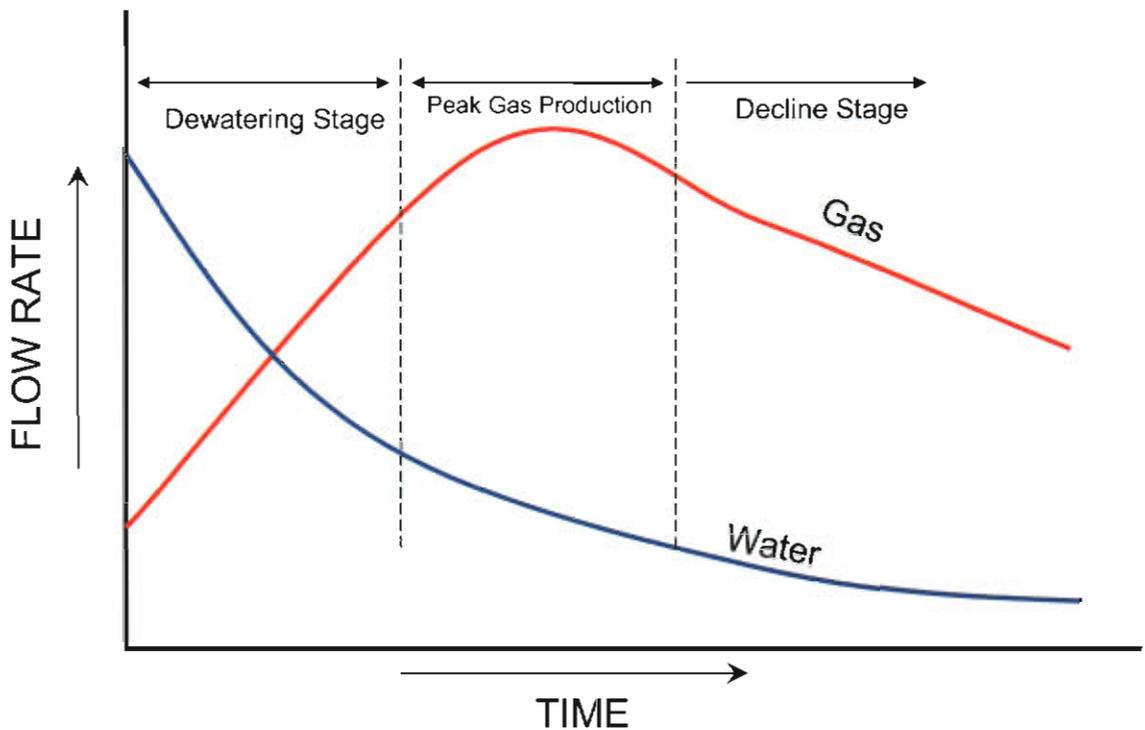
Figure 93: Idealized production behavior of a typical coalbed methane well. Pressure in the coal seam is reduced by pumping off formation water. Methane production increases with decreasing formation pressure.

Figure 102: Example of gas and water production curves for a single well in Pod A. Compare with the idealized CBM production behavior in Figure 93. Wells of this type exhibit high initial water production and little gas production. Withdrawal of water from the formation decreases hydrostatic pressure and induces methane gas to desorb from the coal matrix. As formation pressure is reduced further, more gas desorbs from the coal, resulting in a gas incline curve.

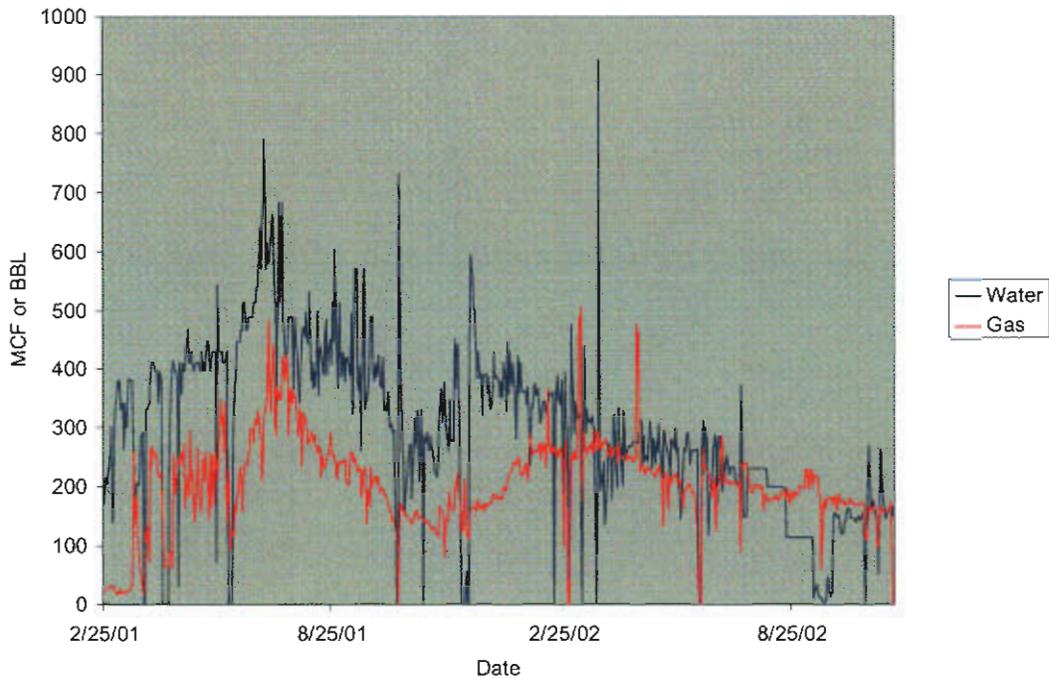
Figure 103: Gas and water production curves from a single well in Pod A. Contrast this production behavior with than in Figure 12. There is no well defined water decline, gas incline curve. Instead, peaks on water production are typically followed soon after by a peak in gas production.

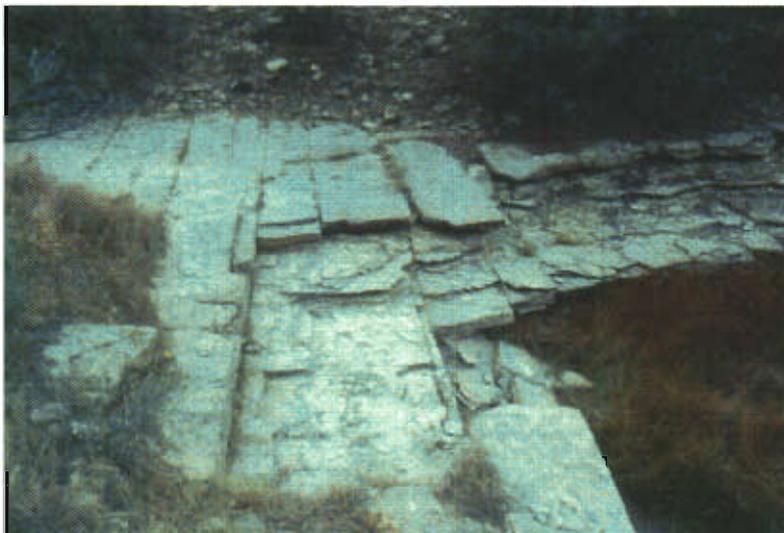
Figure 4. Near-vertical, parallel extension fractures in outcrop of a sandstone unit of the Vermejo Formation (Upper Cretaceous).

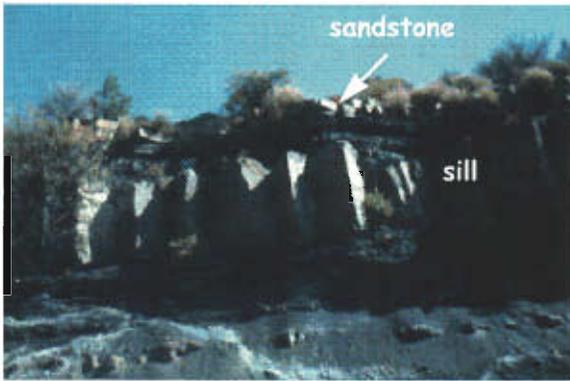
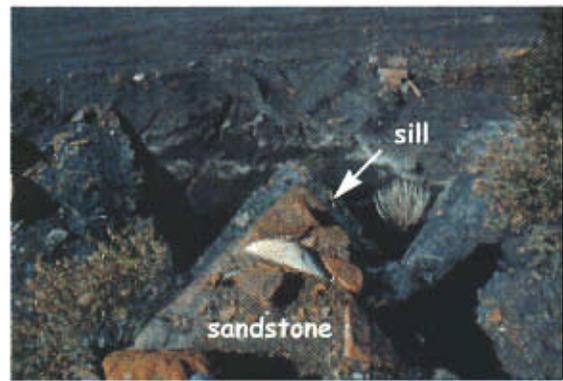
Figure 7. Parallel extensional fracturing in sandstone and igneous sill. (a) normal outcrop view; (b) view looking vertically downward, showing parallelism of fractures.

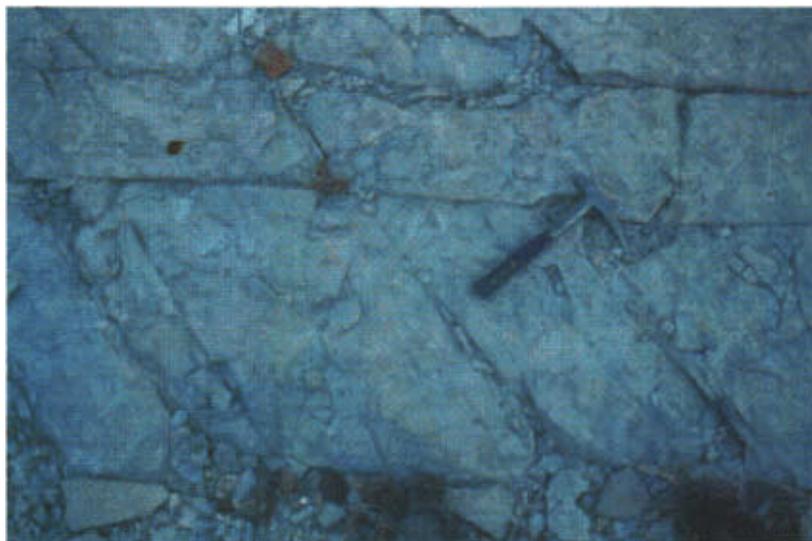
Figure 8. Conjugate fracture sets developed in outcrop of the Ft. Hayes Limestone Member of the Niobrara Formation (Upper Cretaceous). View is vertically downward.

A somewhat less-evident style of fracturing is vertically dipping conjugate-fracture pairs. These sets are developed both in sandstones and in limestones (fig. 8), and there appears to be spatial and/or stratigraphic variation in the orientation of the acute-angle bisectrix of the conju-

the outcrop indicates that the fracture surfaces exhibit definite plumose structures, implying that the style of fracturing is almost unquestionably extensional in nature. Such close-up examination of what are moderately large mesoscale features is possible only in outcrop exposure, and the angular relationships alone might lead to a wholly different structural interpretation.

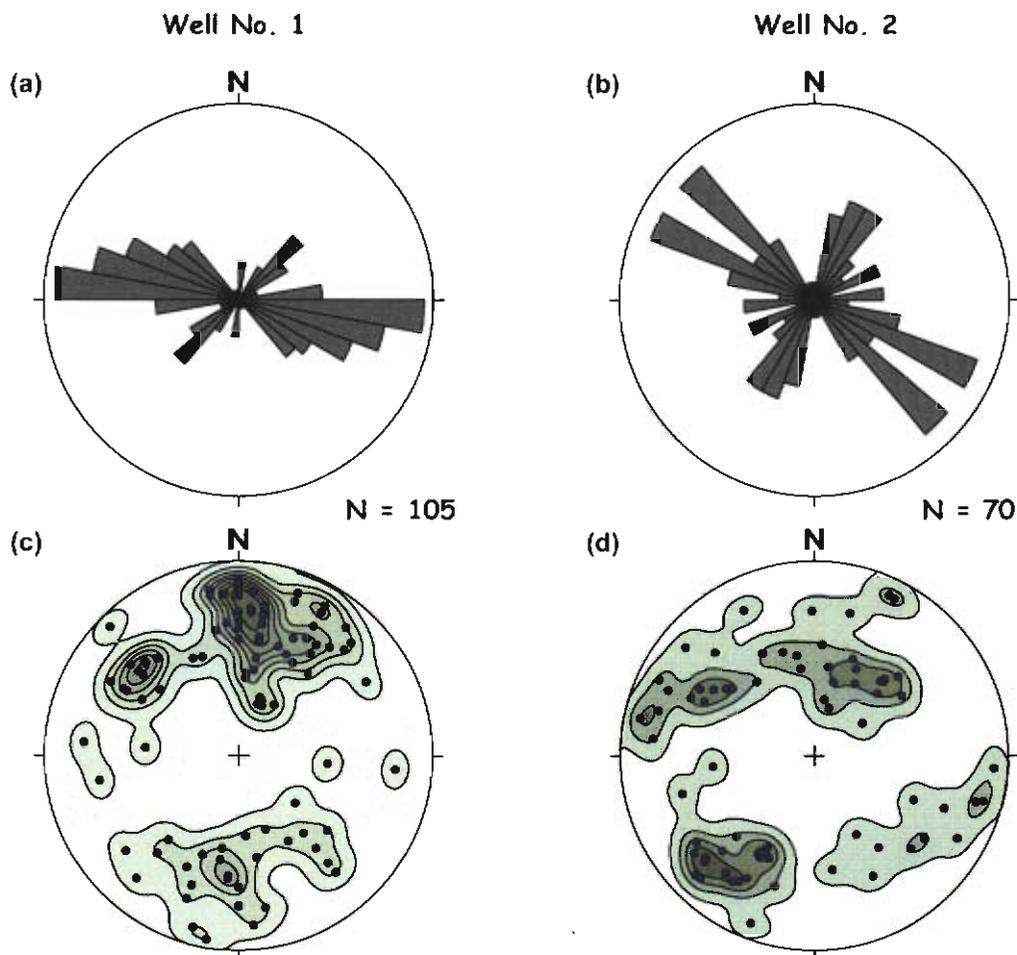
Figure 10. Orientations of open and partially open fractures as inferred from FMI logs from two holes in the southernmost Colorado portion of the Raton Basin. (a) and (b) Rose diagrams of fracture strikes; (c) and (d) lower-hemisphere stereonet diagrams for the same fracture populations shown in the rose diagrams immediately above showing poles to the fracture planes.

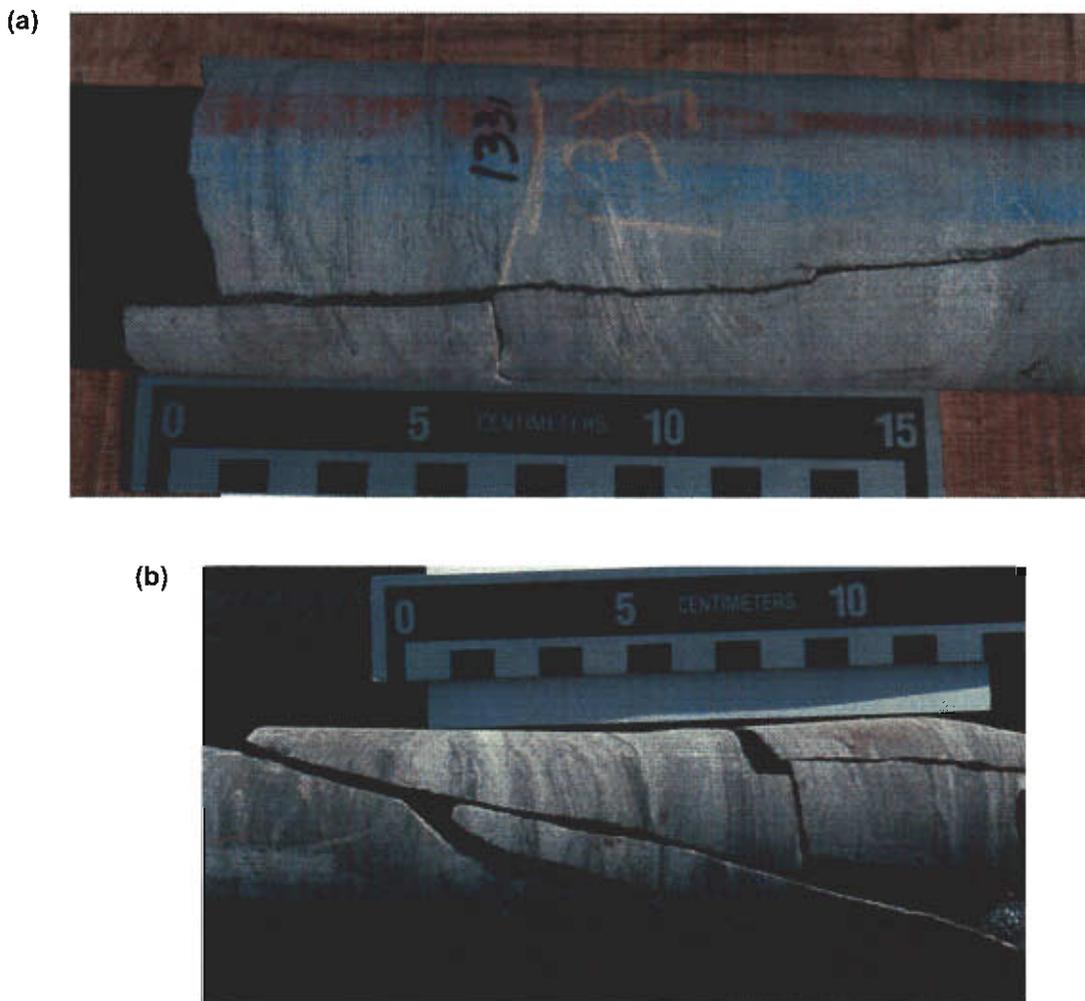
Figure 13. Near-vertical (approximately parallel to core axis) extension fractures in sandstones of the Raton Formation in core. Stratigraphic top is to the left. (a) Typical expression; (b) example of parallel fracturing.

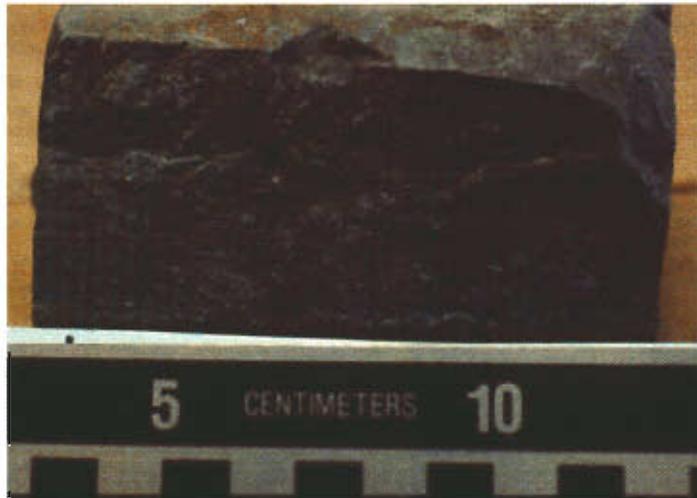
Figure 14. Plumose structure on an extension-fracture surface in core from the Raton Formation.

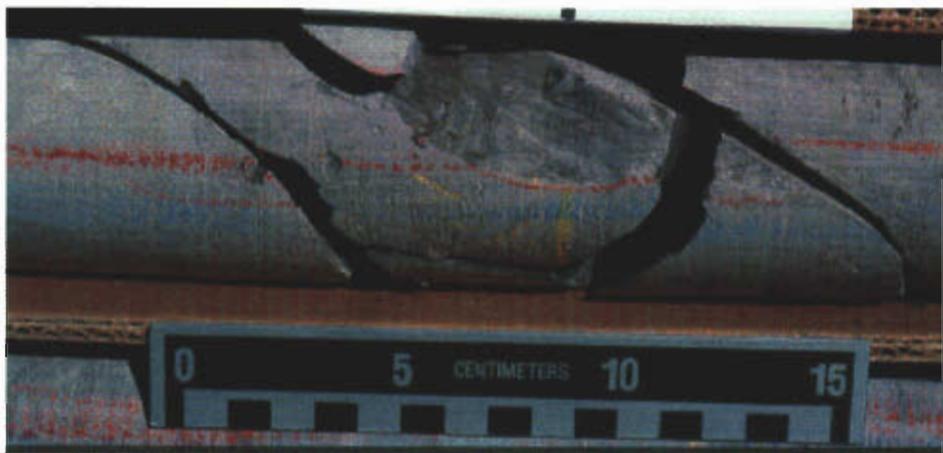
Figure 17. Shear fractures in muddy siltstone of the Raton Formation. Note alignment of slickensides on the outward-facing fracture with the dip direction of the other two fractures.

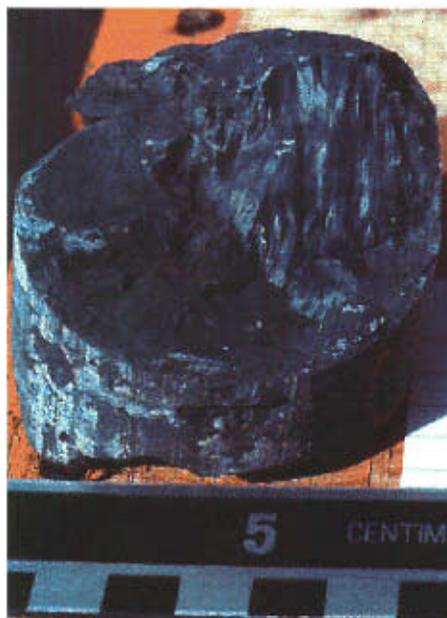
Figure 18. Compaction fracture in fine-grained silty mudstone of the Raton Formation.

An additional class of fracturing observed in core is ubiquitously distributed throughout the fine-grained portion of the section, particularly in the mudstones. These features appear to be randomly oriented “compaction” fractures (fig. 18). Typically, a compaction fracture is of short extent (many are less extensive than the diameter of the core), abruptly curved or otherwise non-

planar, slickensided, and can be observed to die-out into unfractured material over a short distance. Additionally, previously unbroken core may fracture (at least partially) along these planes during handling associated with examination of the core. Given the markedly different initial porosities and mechanical properties of muddy sediments and sands shortly after deposition, it would not seem surprising that significant differential compaction during dewatering and consolidation might occur, creating these fractures a syndepositional features.

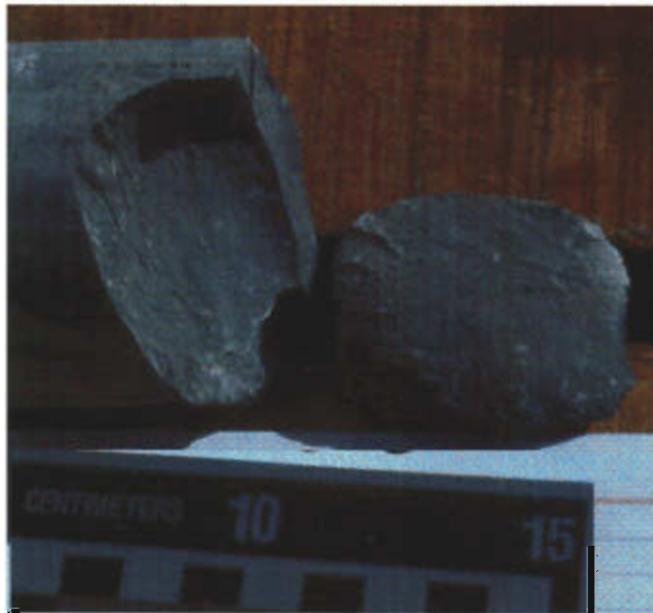
Figure 19. Drilling-induced petal fracture in siltstone of the Raton Formation. Stratigraphic top is to the left.

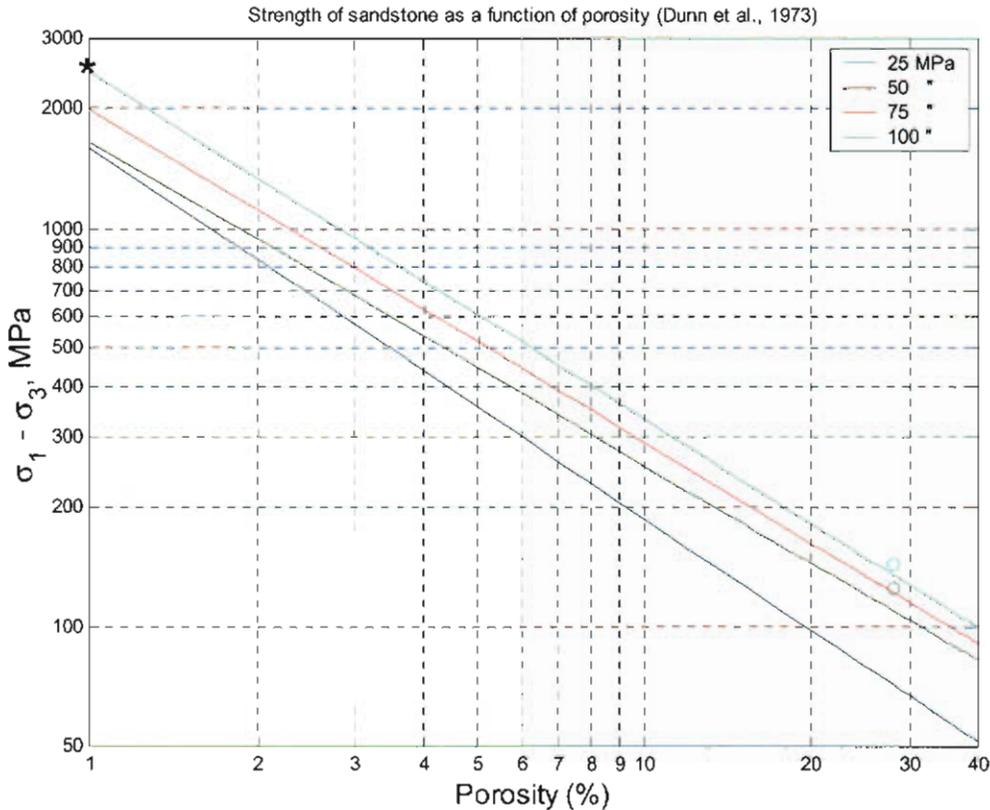
Figure 1: Maximum stress difference at failure for various sandstones plotted against porosity. Lines for the four different confining pressures indicated in the upper right. Circles are Sandia data for Castlegate sandstone of 28% porosity. The confining pressures for Castlegate are indicated by the same color code as the lines: cyan is 100 MPa, and (light) green is 50 MPa.

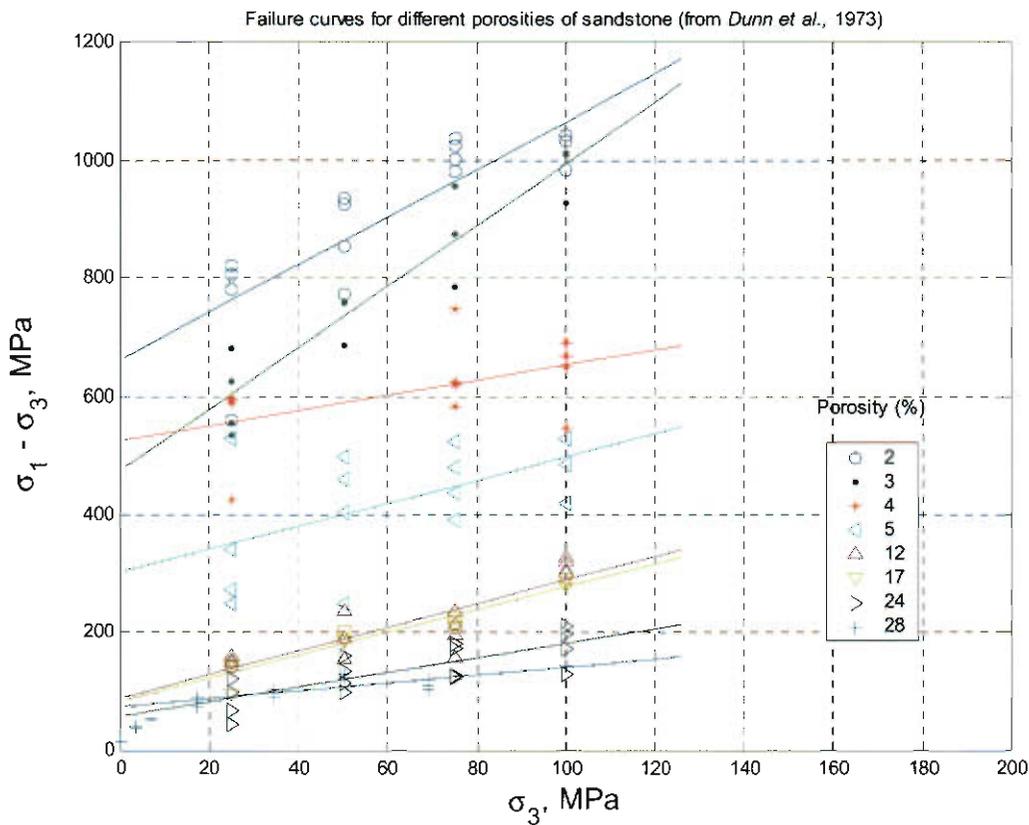
Figure 2: Strength versus confining pressure for sandstones of differing porosities. The 28-percent-porosity rock is from *Olsson* (unpublished, and 1999) for Castlegate sandstone.

Figure 2 shows this data as a plot of equation (1) for the different porosities studied by *Dunn et al.* (1973).

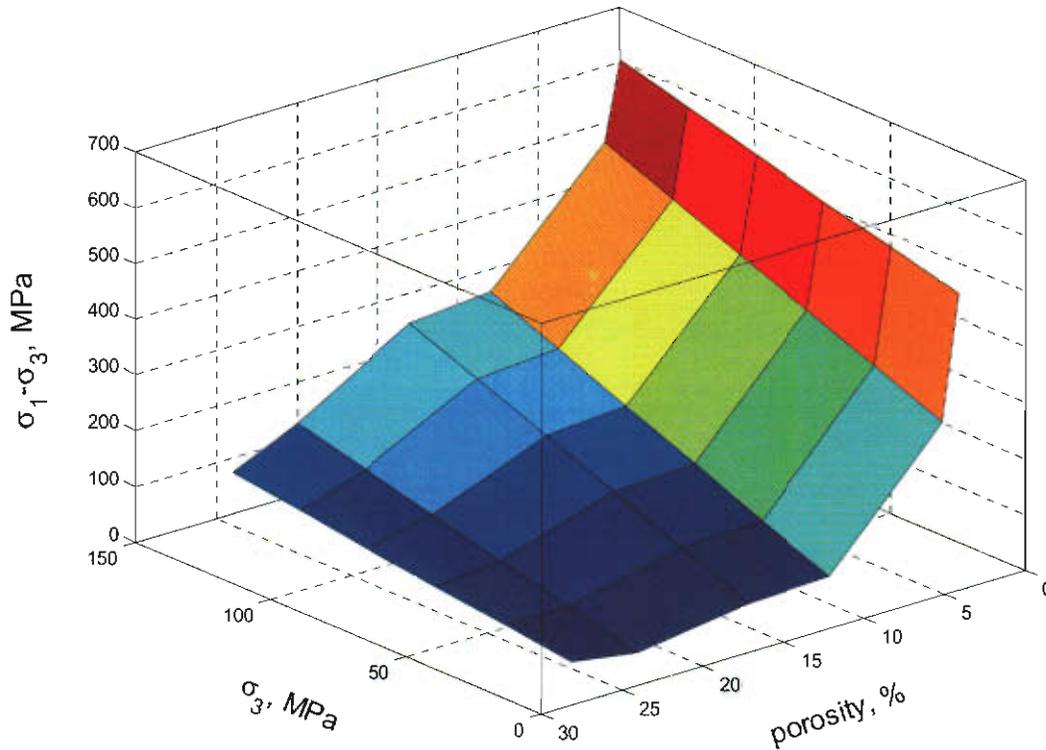
Figure 3: Strength versus confining pressure and porosity for sandstones. Same data set as Figure 2 with the quartzites omitted.

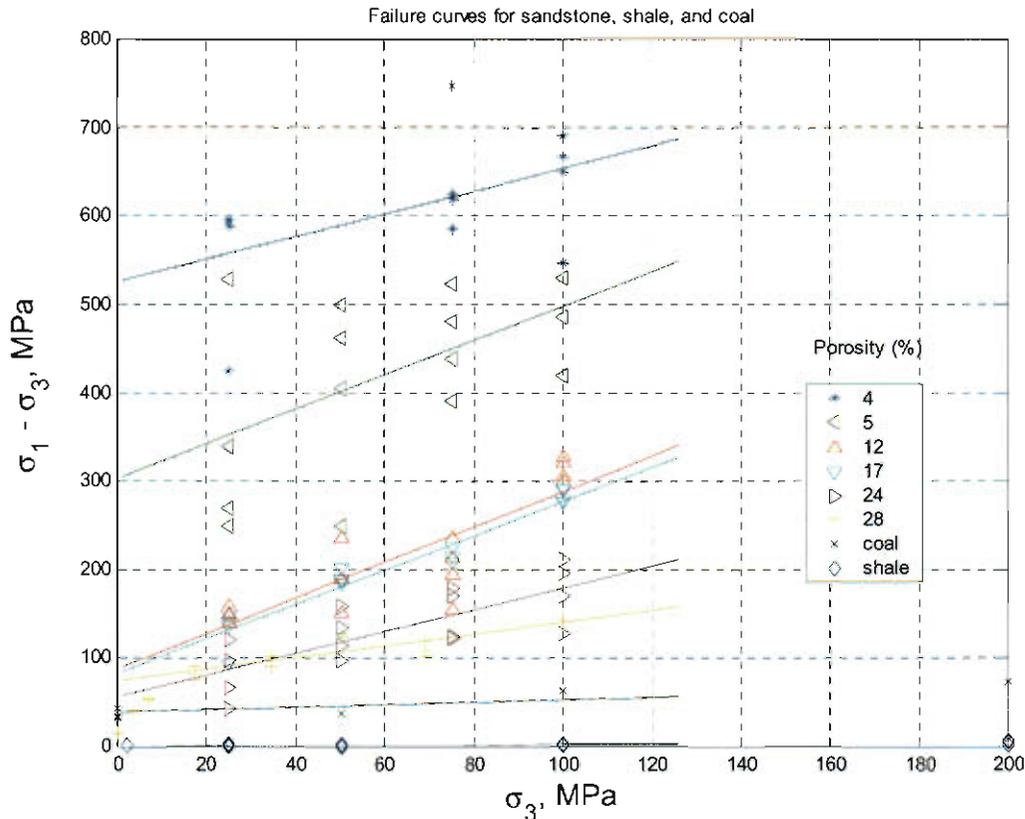
Figure 4: Strength map for clastic rocks and coal that may be typical of the Raton basin. Same as Figure 2 with the addition of curves for Pierre shale and sub-bituminous coal from Wyoming. Note that shale has a very low σ_0 and vanishingly small (B-1). See Table 1.

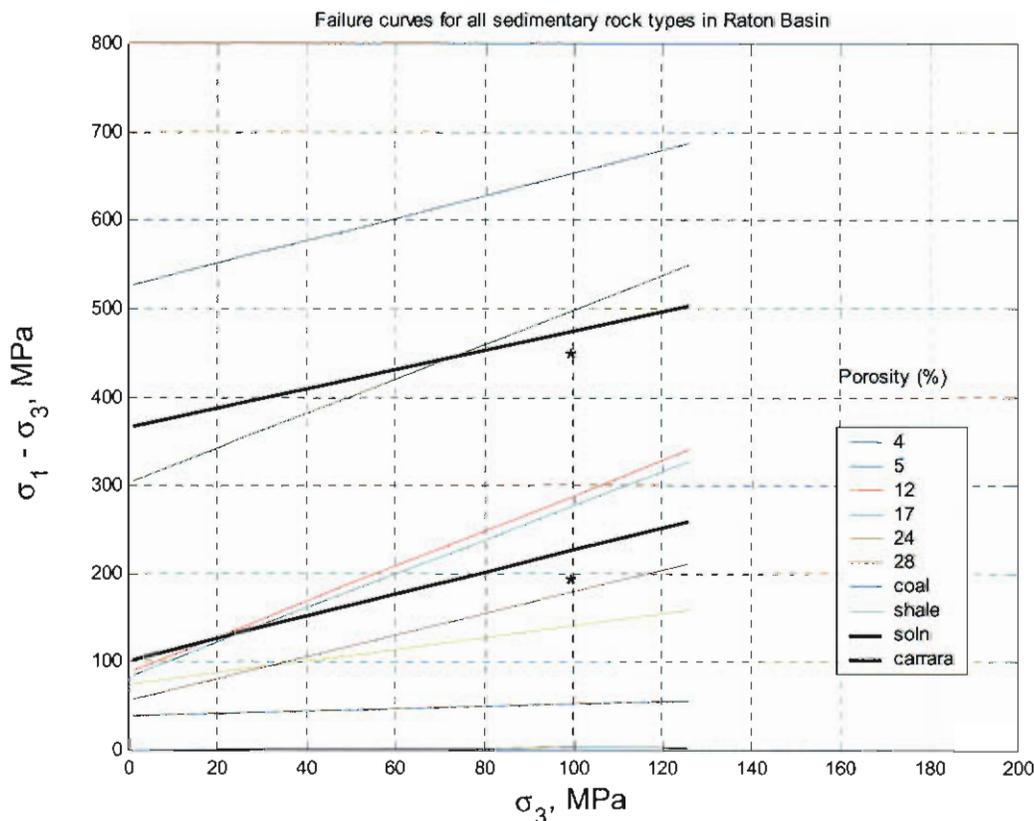
Figure 5: Failure curves for all major sedimentary rocks found in the Raton basin. All limestones fall between the two heavy black lines. The individual data points have been omitted for clarity. The two asterisks are for data from *Hugman and Friedman* (1979).

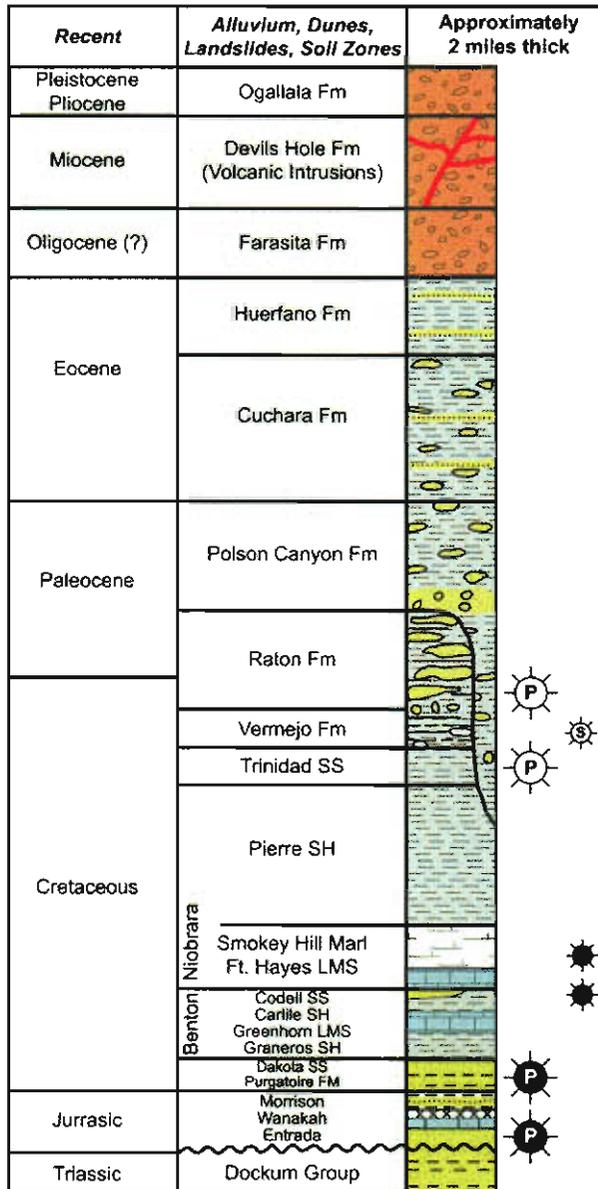
Figure 2: Geologic column of the Raton Basin area. Symbols to the right of the column indicate gas (white/open symbols) and oil (black/closed symbols) shows and/or production (modified after Dolly and Messier, 1977).

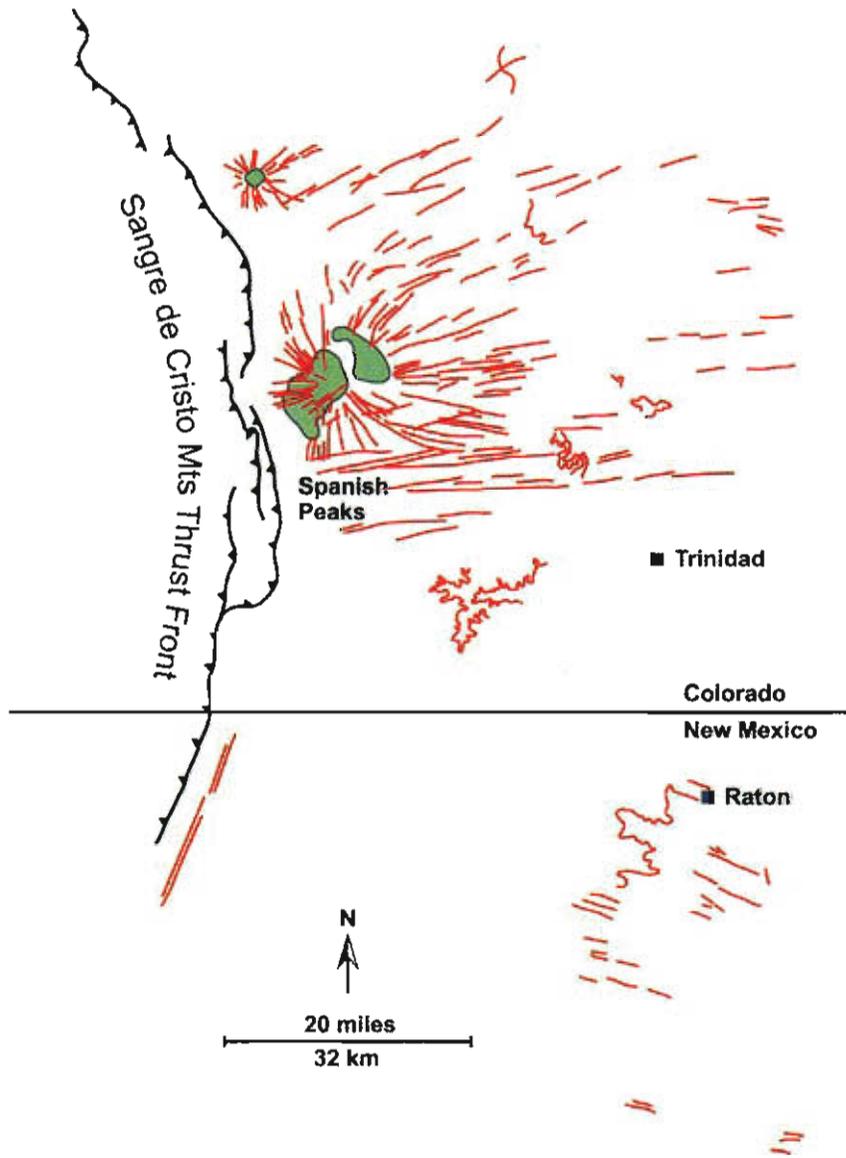
Figure 3: Map of larger scale intrusions within the Raton Basin. Due to the map scale numerous small dikes and sills are not shown. Volcanic intrusions are paleostress indicators.

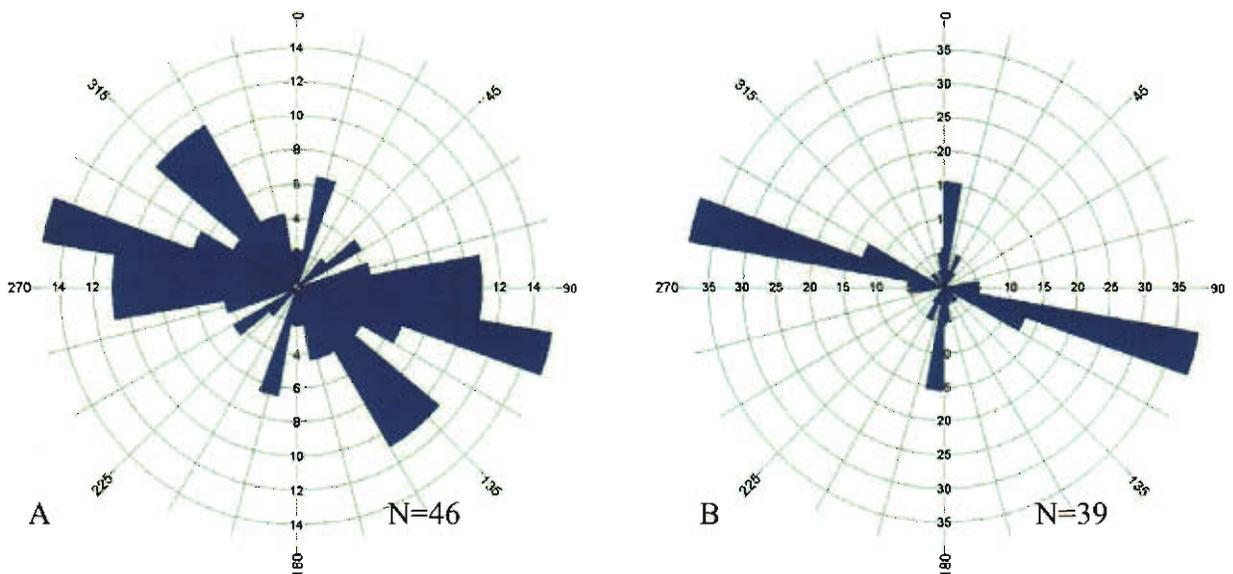
Figure 6: Fracture orientations within A) siltstone units, and B) sills.
