SANDIA REPORT

SAND2004-4859
Unlimited Release
Printed October 2004

Natural Gas Production Problems: Solutions, Methodologies, and Modeling

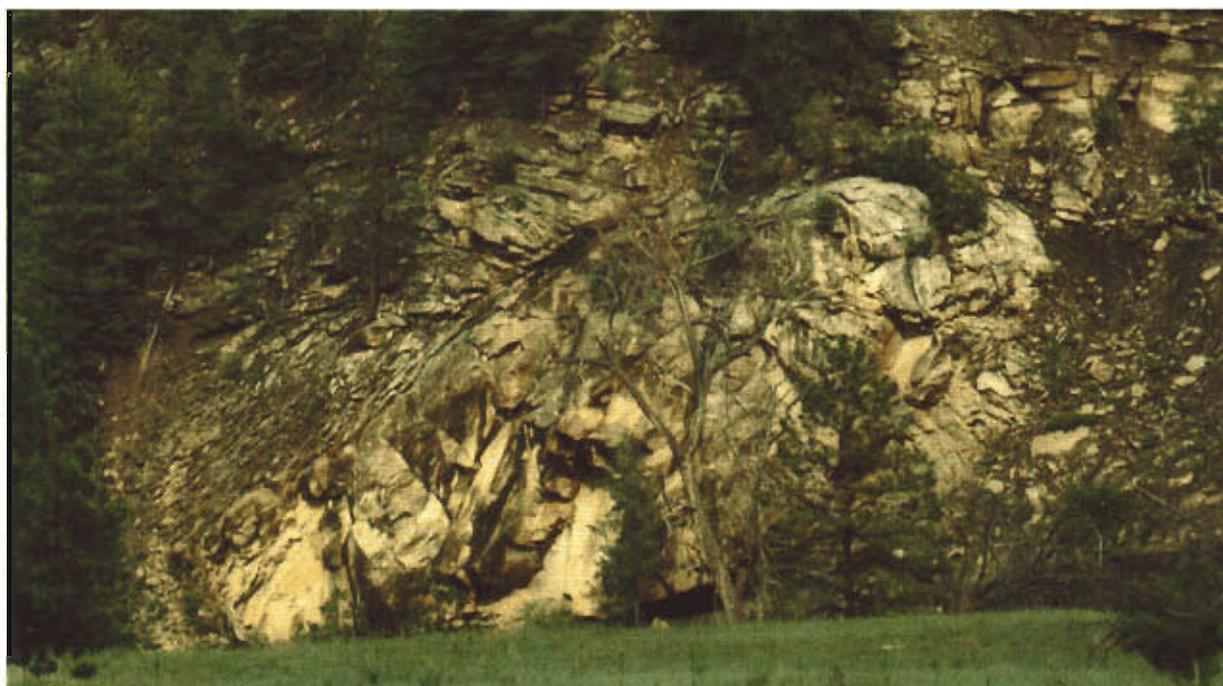
Figure 7: Syn-sedimentary deformation in “The Whale”

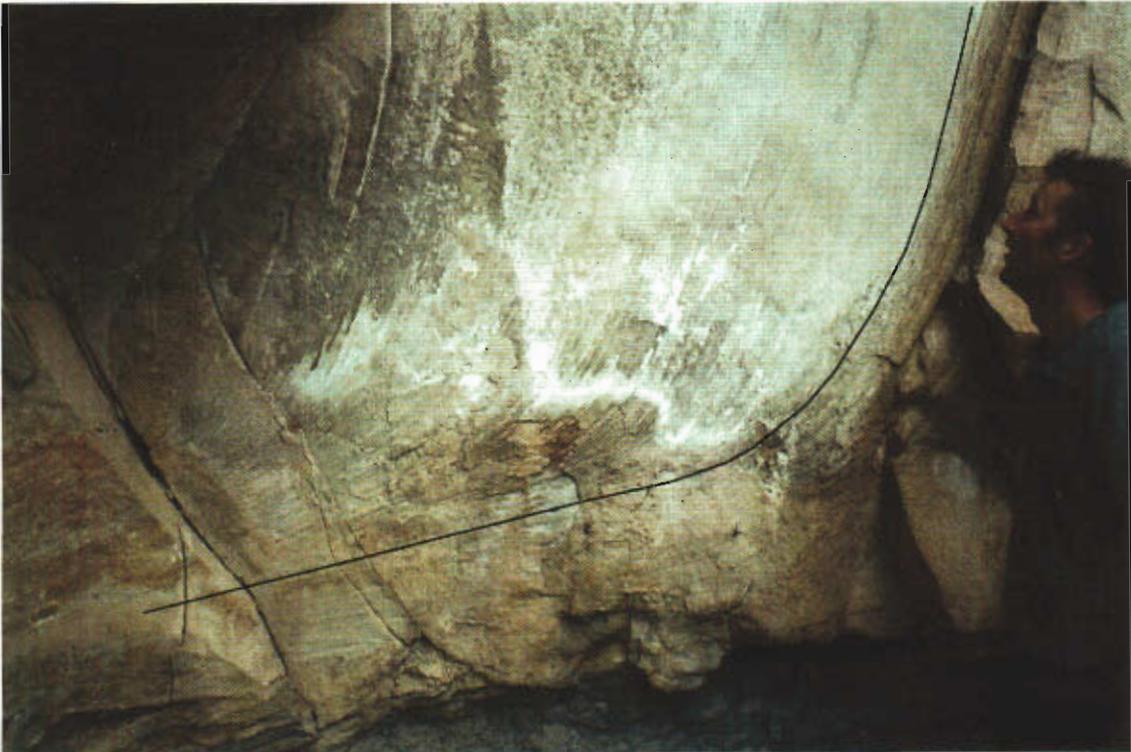
Figure 8: Progressively steeper bedding within the sandstone at lower edge of "The Whale". The black line was added to highlight bedding.

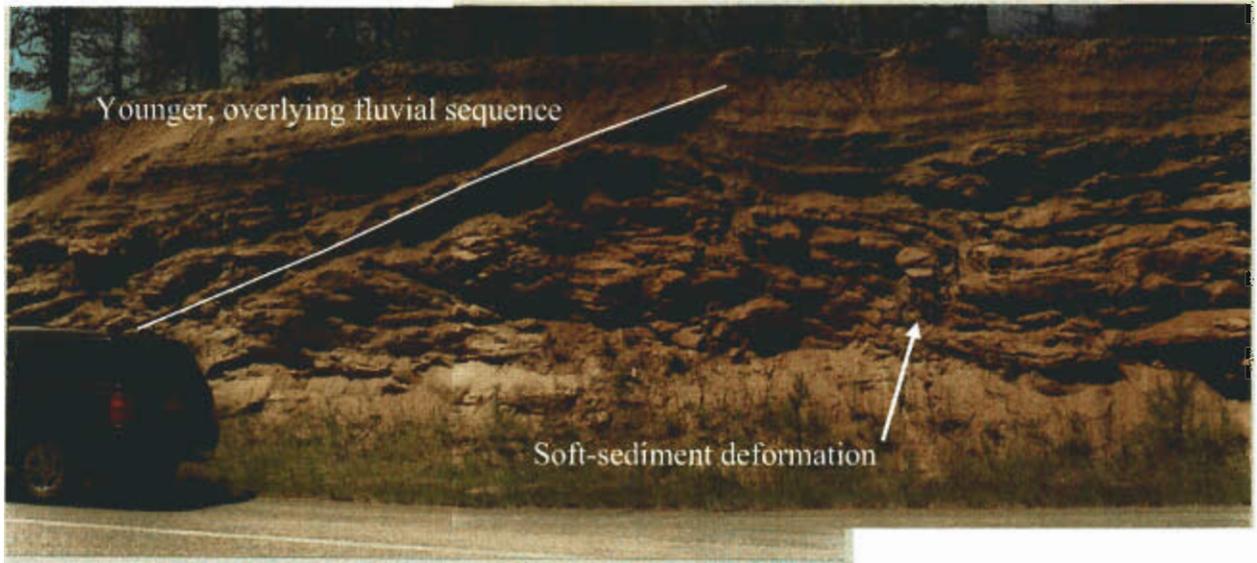
Figure 9: Prograding fluvial sequences and soft-sediment deformation structures within the Poison Canyon Formation can be observed here.

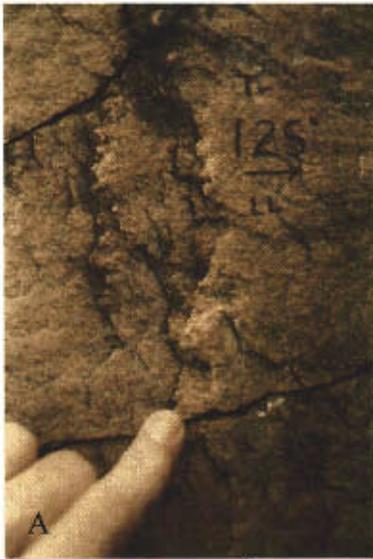
Figure 10: A) Steps instead of plumose structures on fracture surfaces indicate an origin in shear rather than extension. Shear indicators were found in the Raton Conglomerate in many locations around the Vermejo Park Ranch. Rose diagrams show difference in dominant orientation for shear fractures (B) versus extension fractures (C).

Conjugate fractures dictated by the more brittle nature of the quartzose Raton Conglomerate indicate a different mechanical response to the same compressive stresses than less brittle rock units. Conjugate fracture systems are better connected and should provide a better reservoir plumbing system.

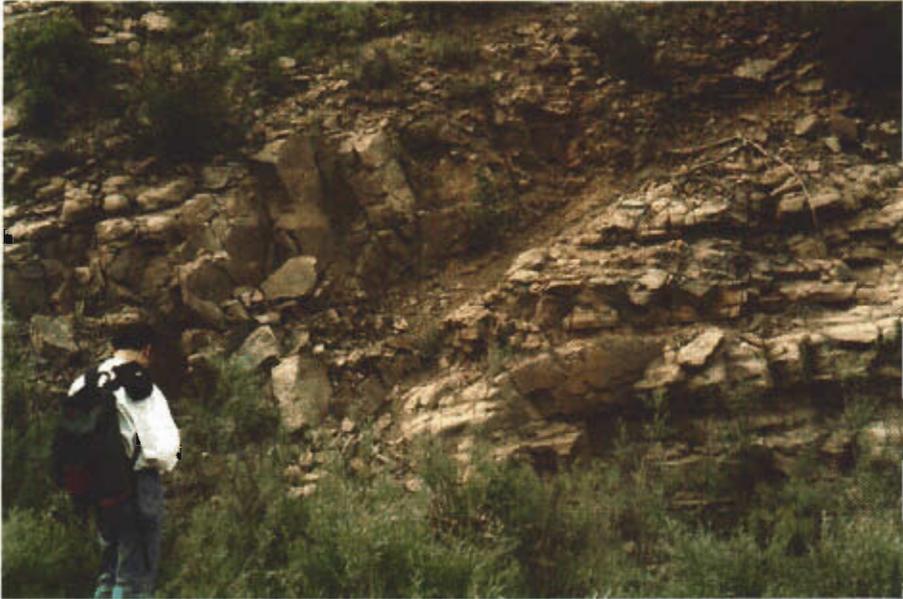
Figure 11: Thrust within the Trinidad Sandstone places lower *Ophiomorpha* burrow bearing sandstone against upper non-*Ophiomorpha* bearing sandstone (approximately 10-15 meters of vertical offset).

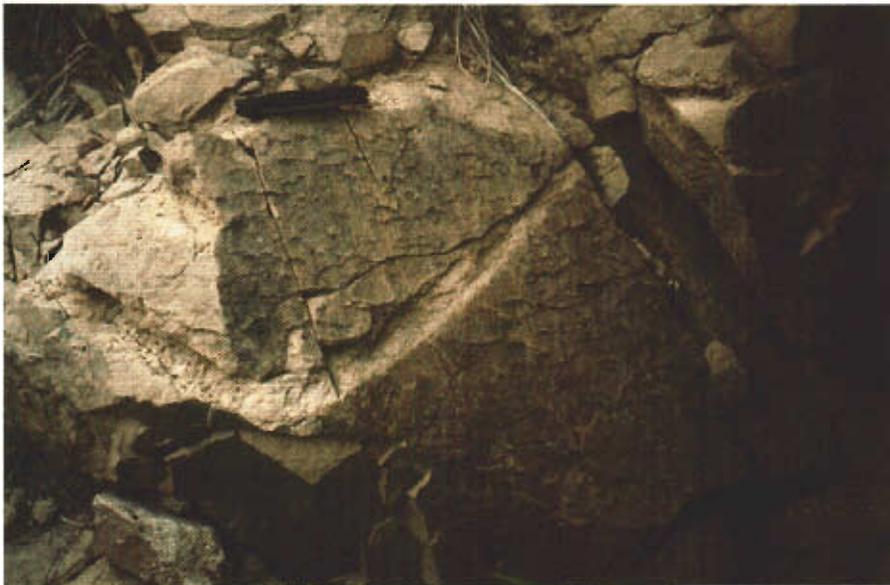
Figure 12: Photograph of back thrust, striking parallel to the thrust fault but dipping east to intersect it.

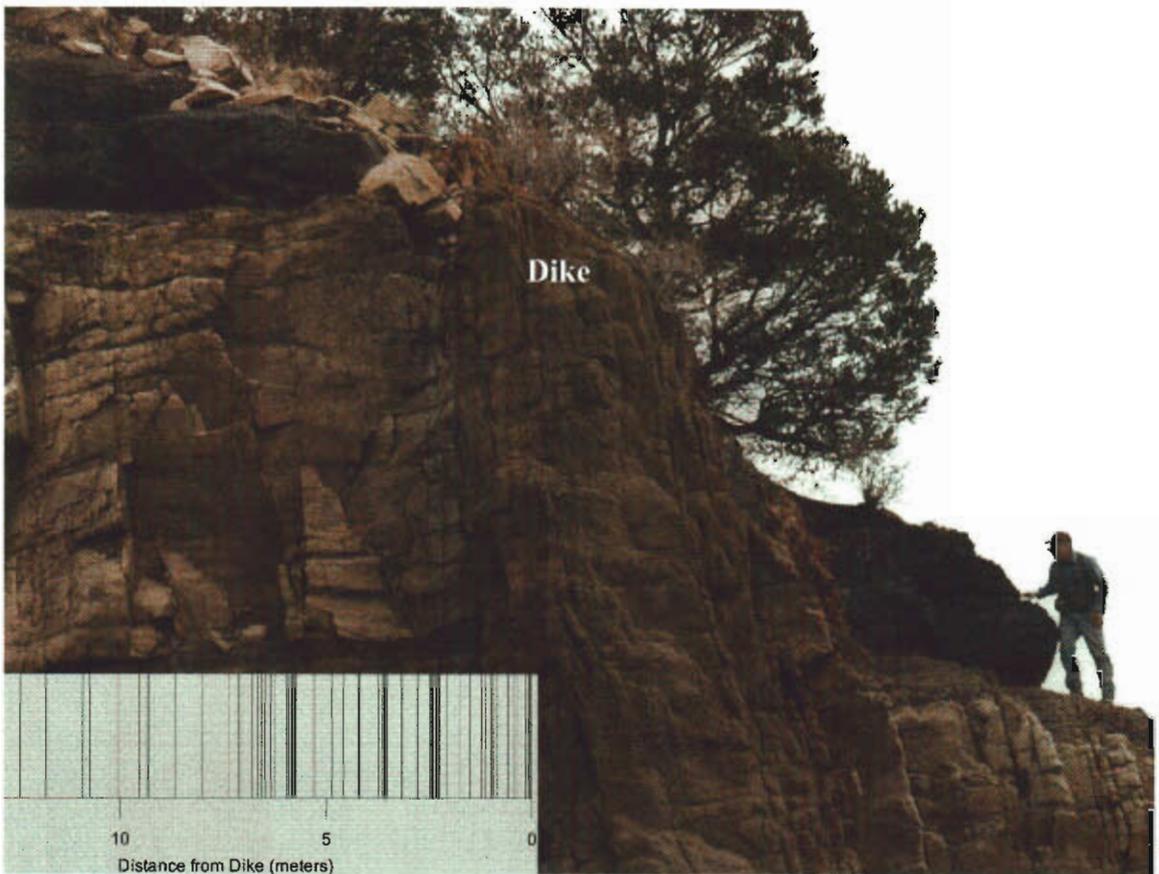
Figure 19: Fracture scan line shown above illustrates that the fractures within the Vermejo formation are related to emplacement of an igneous dike at SE side of the Morley anticline.

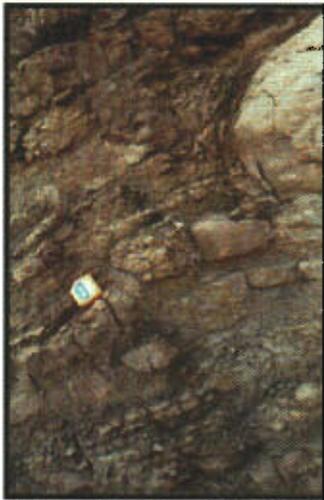
Soft-sediment back-thrusting is less obvious than at Ludlow but present. Horizontal compression in the pre-lithification stage is also suggested by the blunt edge of the sandbody at the upper right and the apparent flow of the shaley sediments around it.

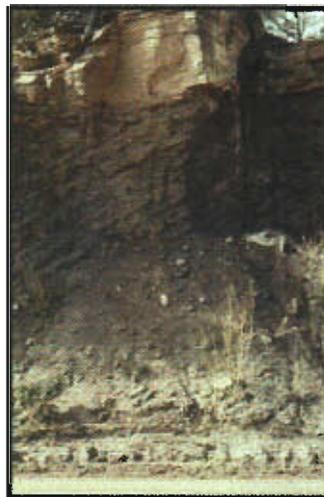
Angular relationship and erosional unconformity between inclined overbank strata and flat-lying fluvial strata above.

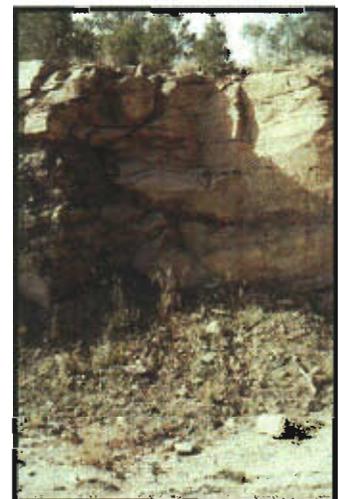
Thicker sandstone of the main fluvial channel to the right of previous photo, in erosional contact laterally against the deformed overbank strata that constrained the channel axis

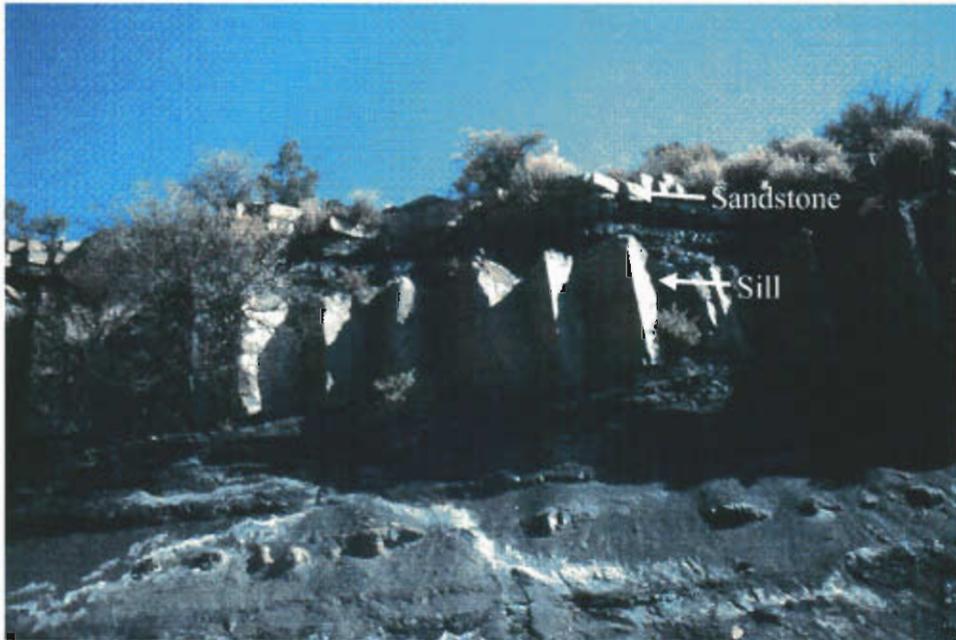
Figure 24: Photograph of a portion of the stop 13 outcrop. Sandstones overlie the igneous sill.

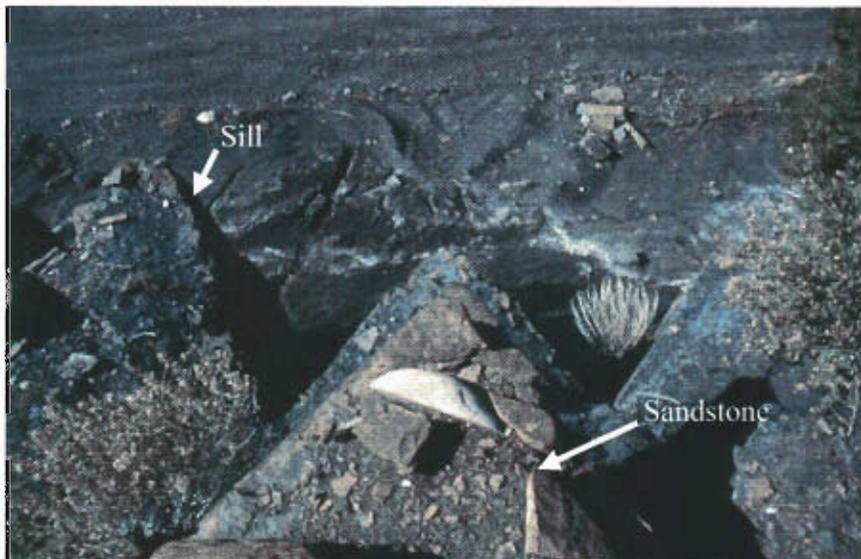
Figure 25: This photograph, oriented with the viewer looking straight down, illustrates the parallel nature of fractures in a sandstone and an igneous sill. The upper red colored rock unit is a sandstone. The intersection of two fractures forms a wedge pointing toward the top of the photograph within this unit. The dark colored wedge in the rock below the first wedge is within an igneous sill. Note the parallel nature of fractures within these two very different units and the repetitive nature of these fractures.

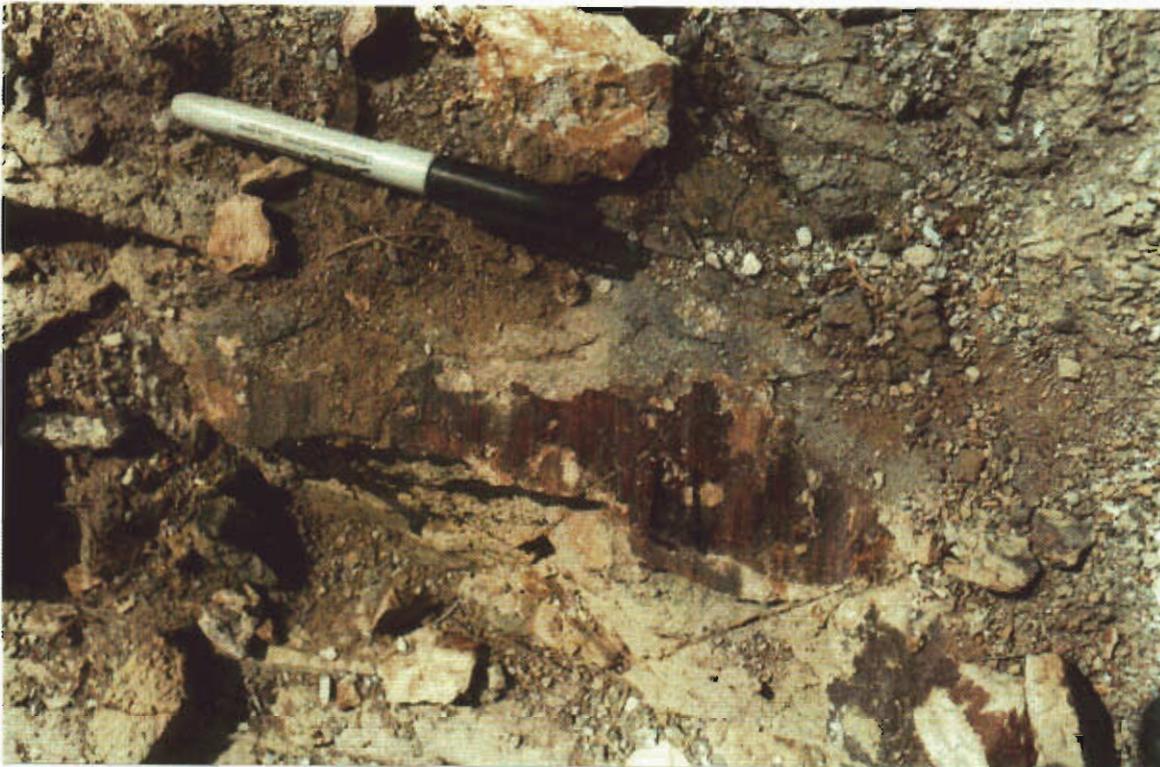
Figure 26: Low-angle thrust plane shown here has slickenline lineations striking perpendicular to the wall of the igneous dike.

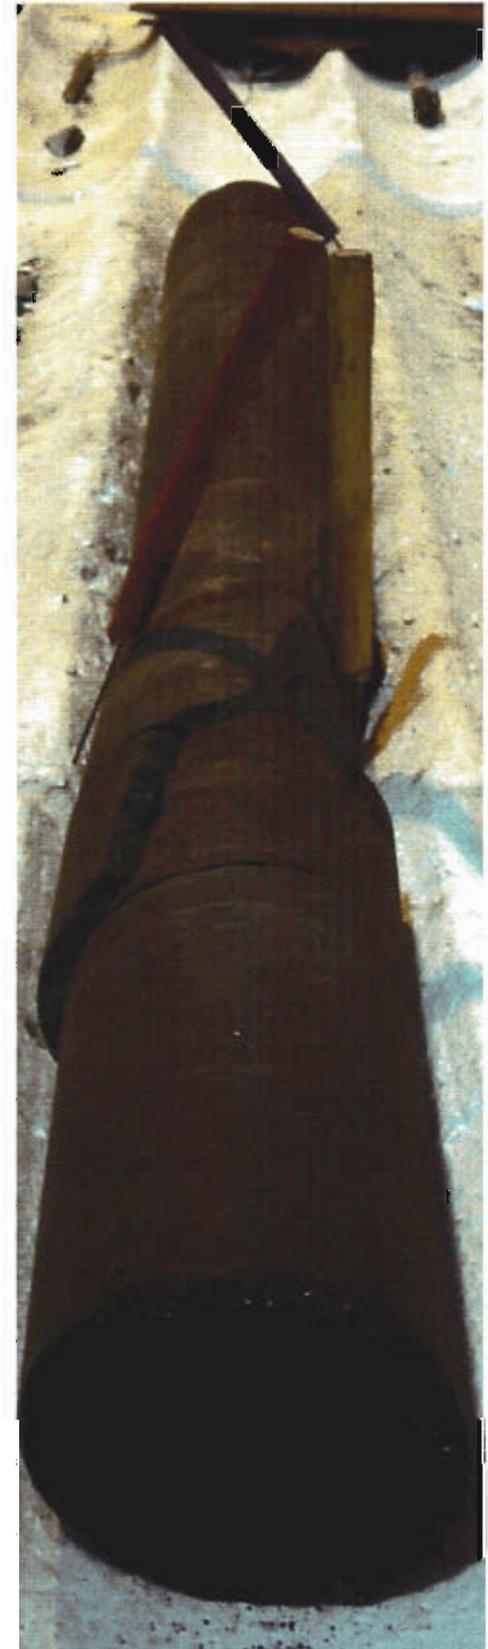
B: The purple stick shows the strike of the petal fracture at 1295.5'. The red and yellow pencils show the strikes of two vertical extension fractures that have a strike intersection angle of 30° . The extension fracture marked with the red stick strikes approximately normal to the petal fracture. The extension fracture marked with the yellow stick strikes approximately 30° clockwise from the petal fracture.

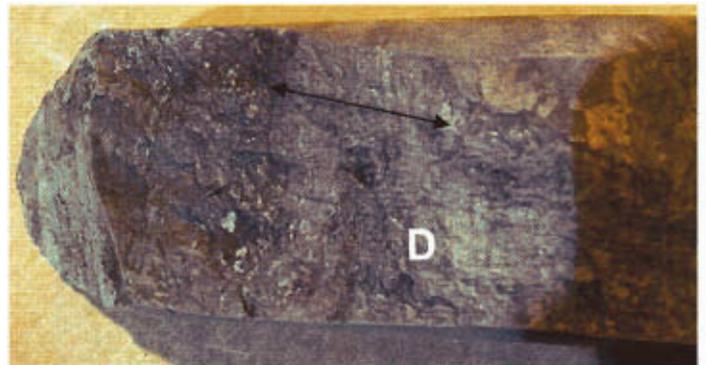
Parallel Shears and Extension Fracture

The photos shown in Figures A through E are from core depths 1336' – 1337'.

Fracture A is a vertical extension fracture. Fractures B and C are 60° dipping shears. The surface of Fracture C is shown in Figure B. Both fractures B and C exhibit 0° rake. Fracture D (shown in figure C) is classified as a vertical shear. The fracture surface is non-planar. (See figures C and D.) Near vertical slickenlines and patches of slickencryst are present on the surface of Fracture D.

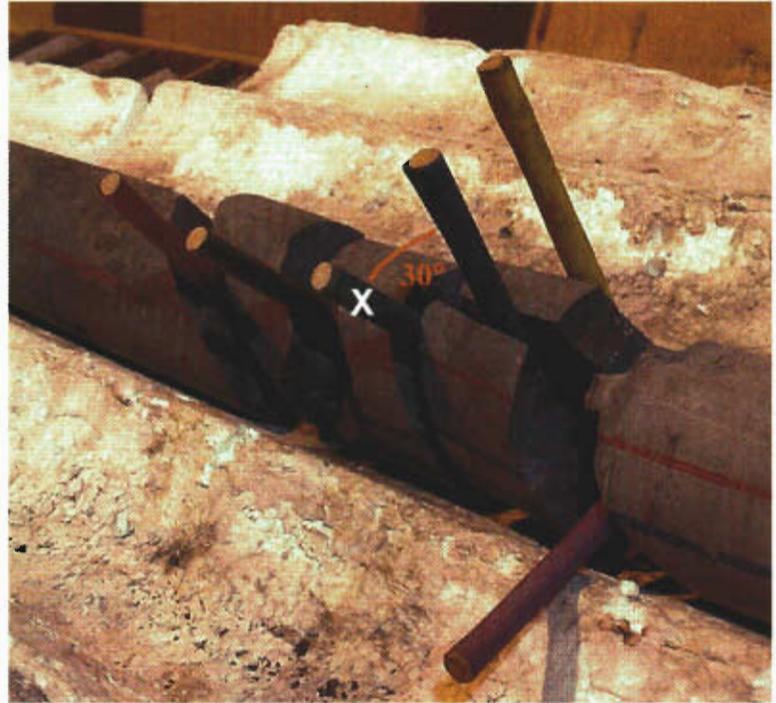
Fracture strikes are shown with colored probes. All of the fractures are extensional except for the fracture shown with the green probe and marked with an X. The red, brown and green (X) fractures have parallel strikes. The red and brown fractures dip at 60° angles, and the green (X) fractures dips at a 30° angle. The strikes of the blue and yellow fractures are parallel with one another. These two fractures have a strike intersection of 30° with the red, brown, and green fractures. The purple fracture is a vertical shear that strikes normal to the blue and yellow fractures.

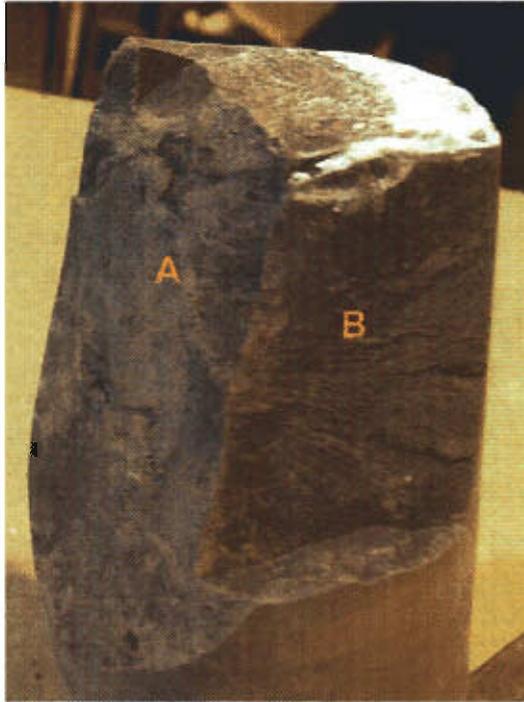
Intersecting Extension Fracture and Vertical Shear

Depth: 1332'
Host Rock: Siltstone

Fracture A is a vertical extension fracture. Fracture B is a vertical shear. The strike intersection angle of the two fractures is 30° .

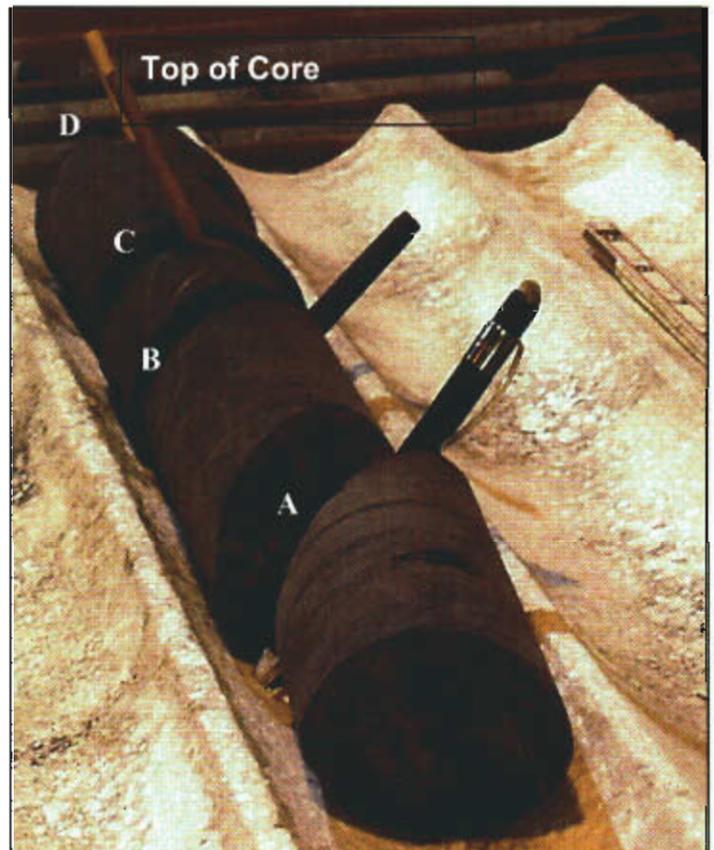
Fracture dips: A=60°, B=30°,
C=60°, D=60°

The lower set of fractures (A&B) dip in opposite directions from the upper set (C&D). Pens, which are aligned with rake striations, indicate that movement on the lower set of fractures was normal to that on the upper set of fractures.

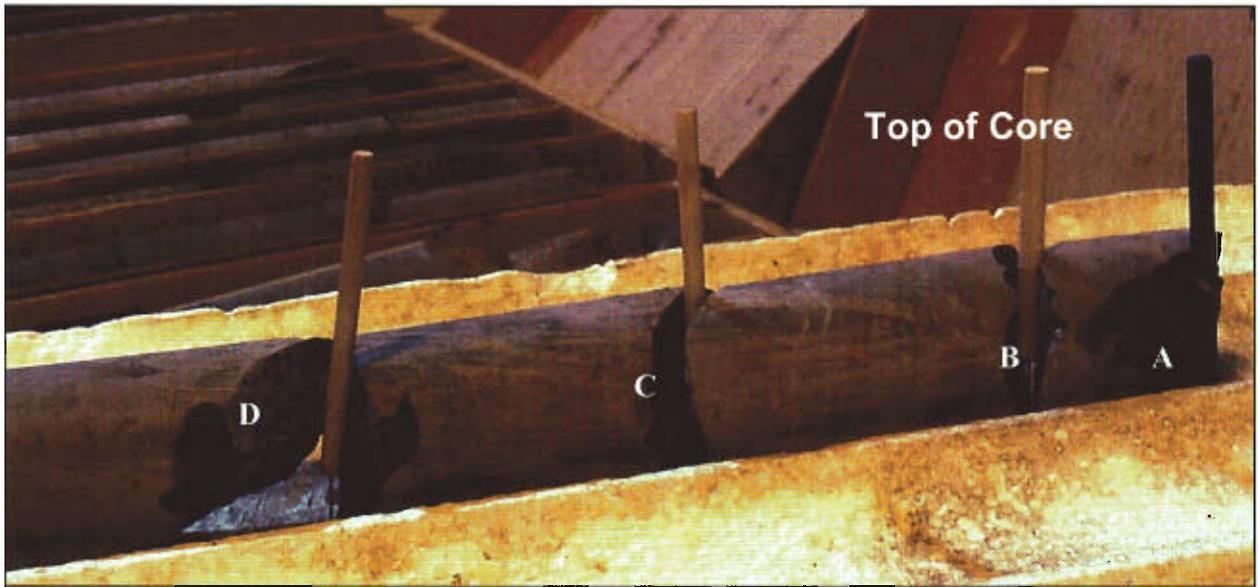
Shears with Parallel Strikes

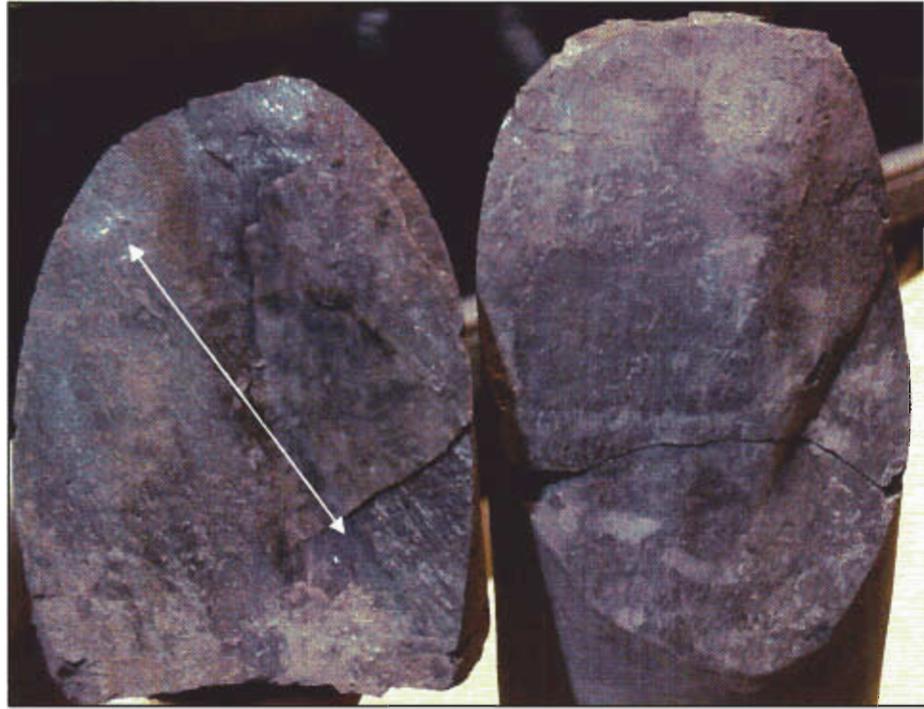
This is a typical shear in shale. Slickenlines are shown with an arrow.

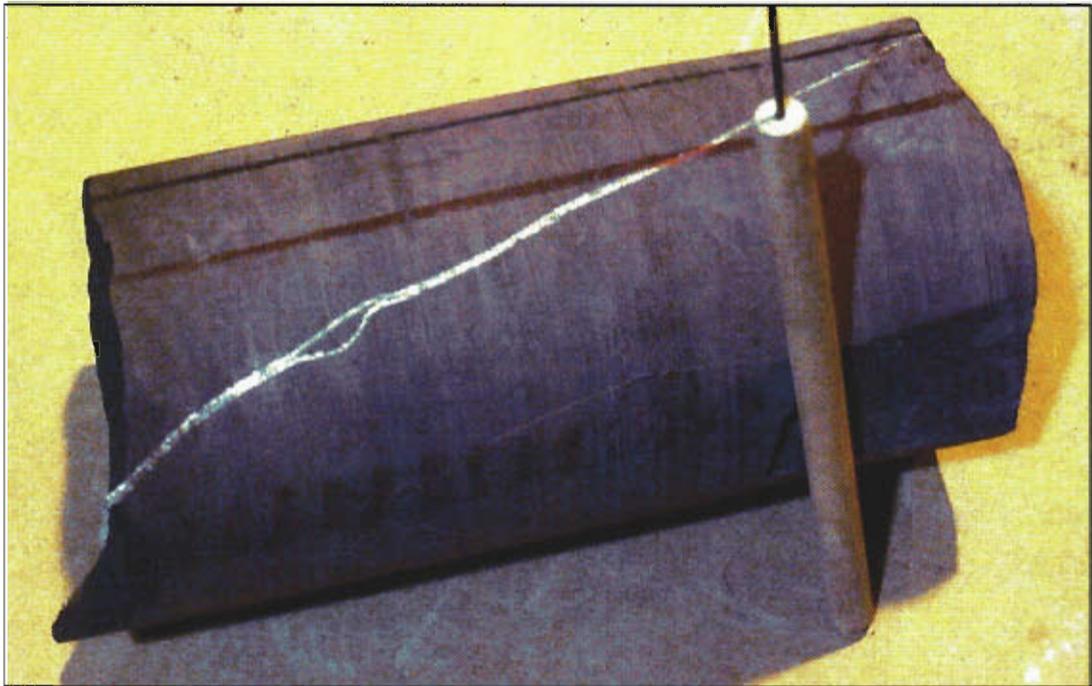
High Angle Reverse Fault

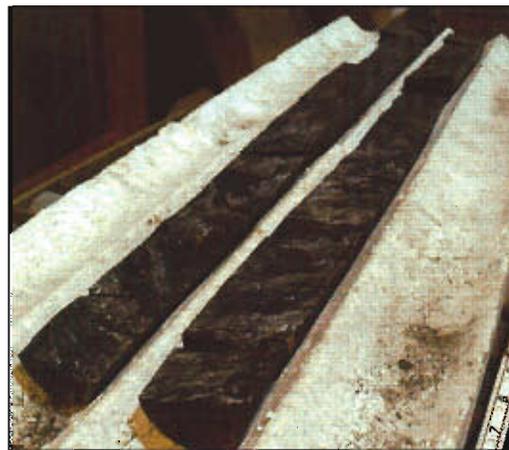
Slickenlines indicating oblique slip

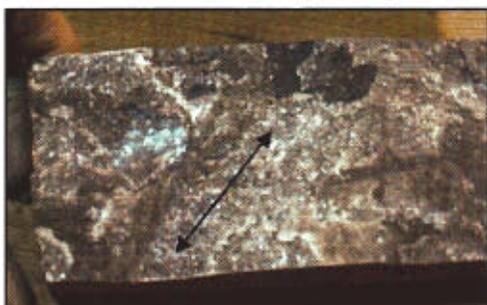
Mineralized Plume structure

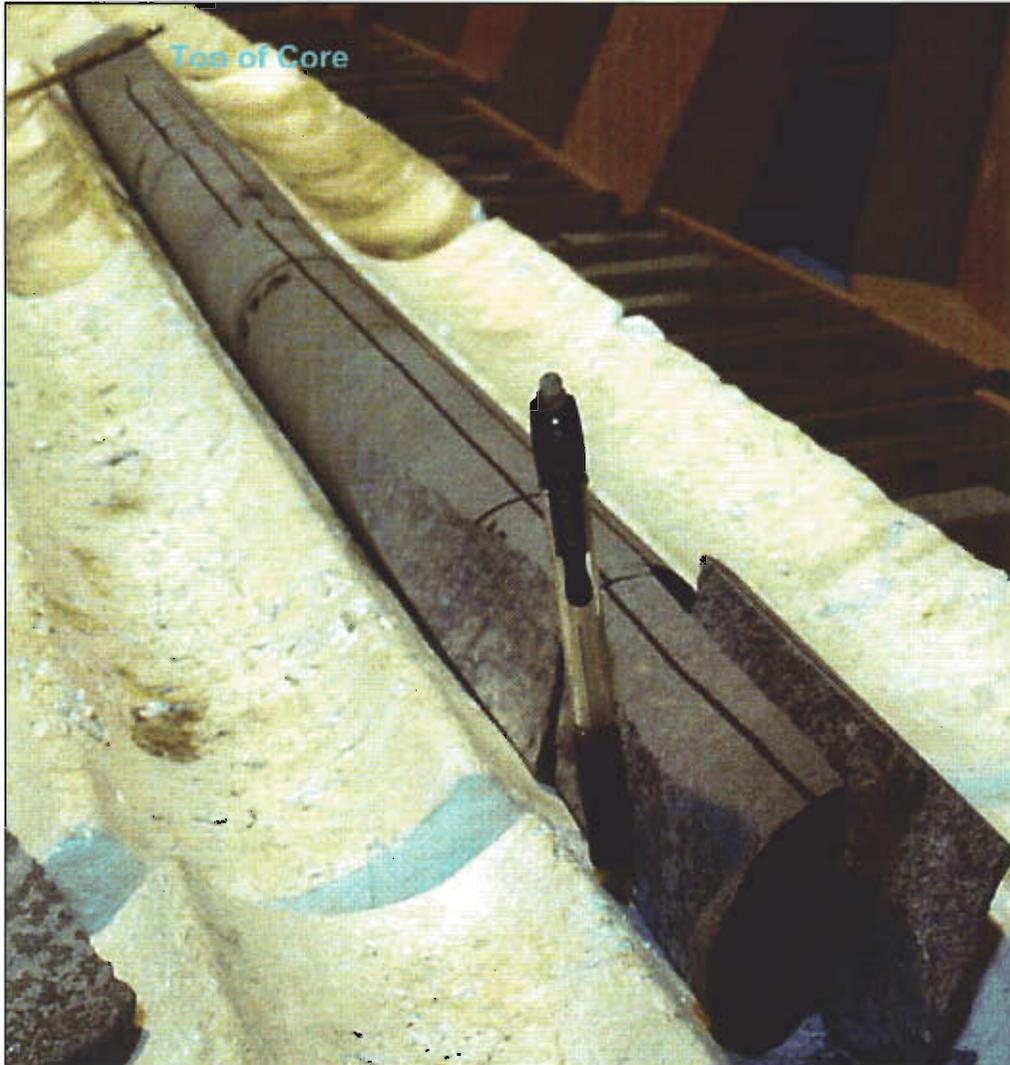
Extension Fractures with Parallel and Normal strikes

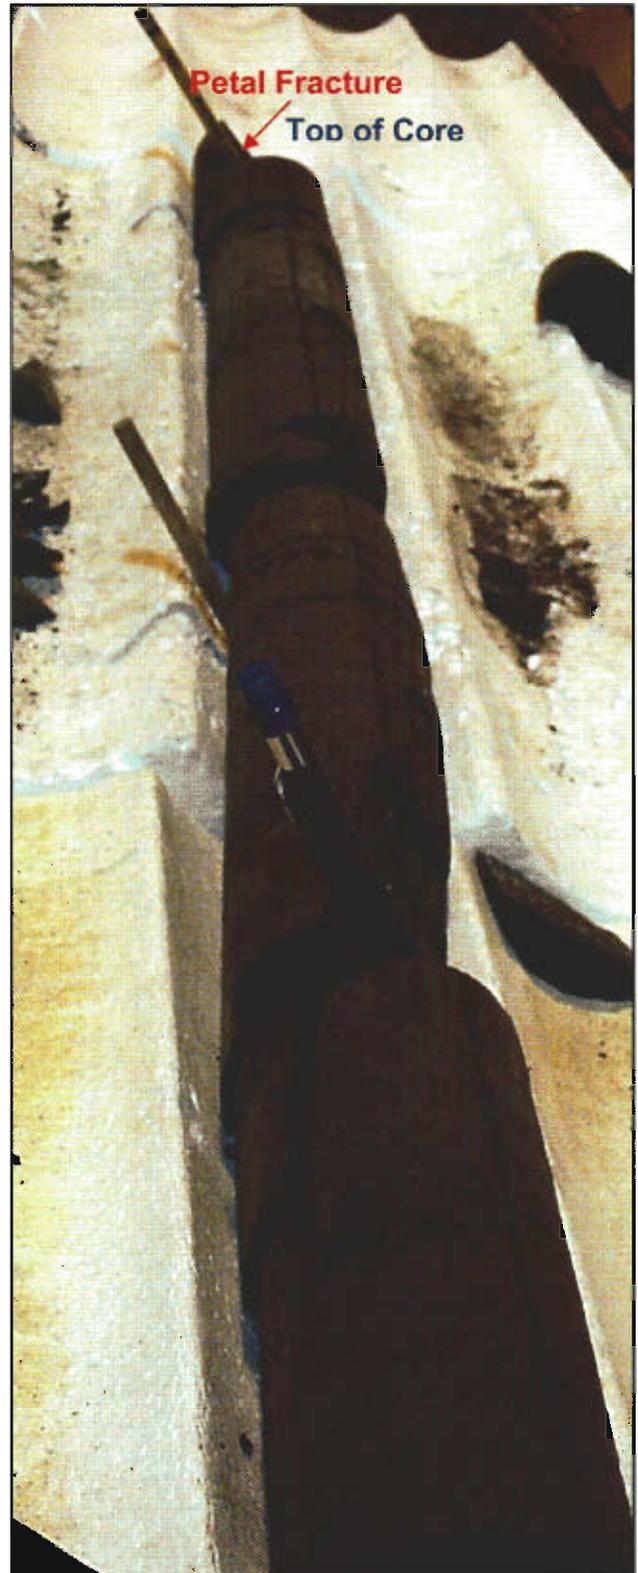
Orientation of Extension Fractures relative to *insitu* stress

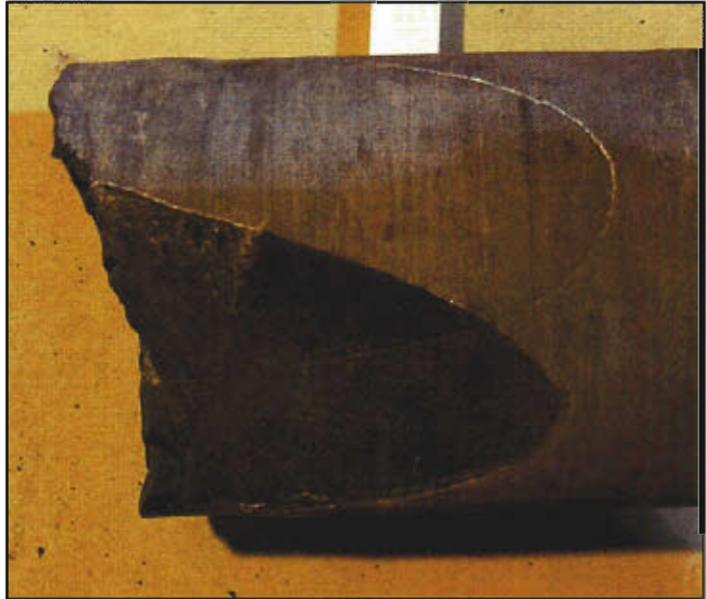
Mineralized Extension Fracture in Coal

Depth: 3016'

Extension fractures identified in upper beds extend into the coal. Mineralized fractures were also found in coals at other depths (2993.6 and 2996.6).

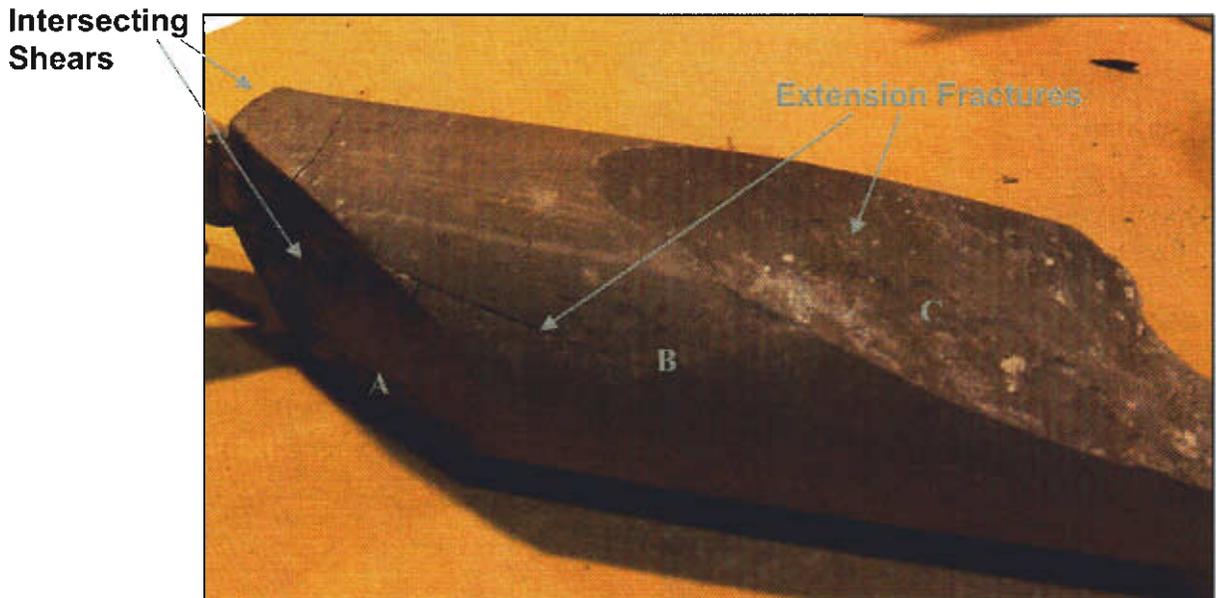
Intersecting Shears and Two Extension Fractures

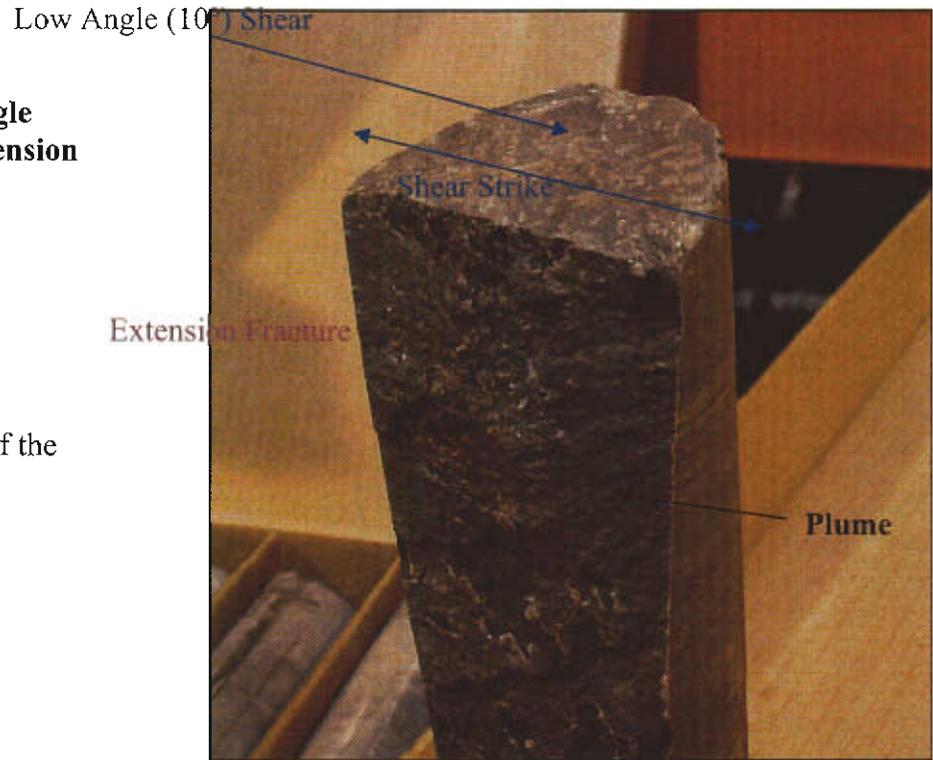
Intersection of a Low Angle Shear and a Vertical Extension Fracture

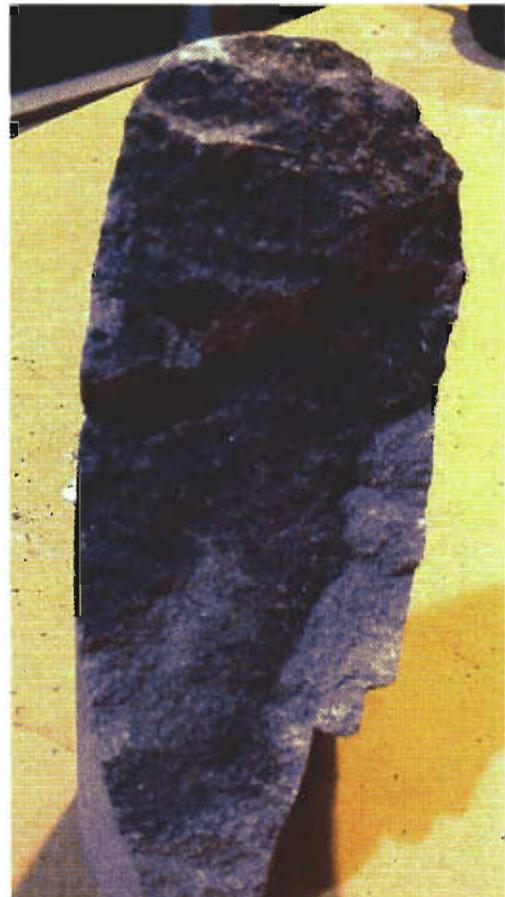
This fracture is highly cemented, and the break along the fracture is non-planar. The rock surrounding this fracture is well indurated and difficult to break apart.

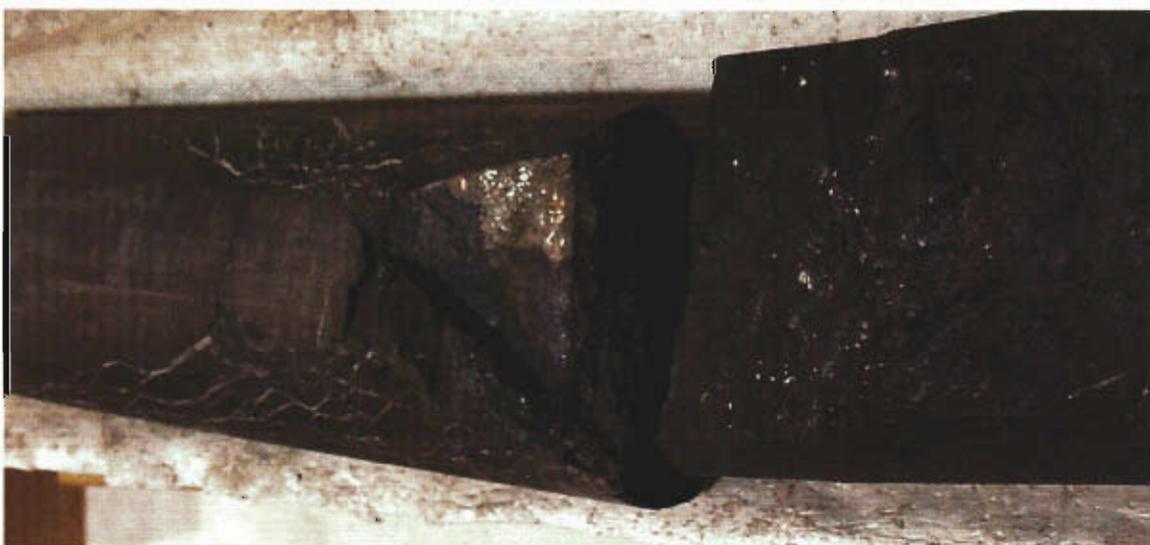
Depth: 1346

This small dike extends over 2.4 feet of core. A coal bed is present at 1345 feet.

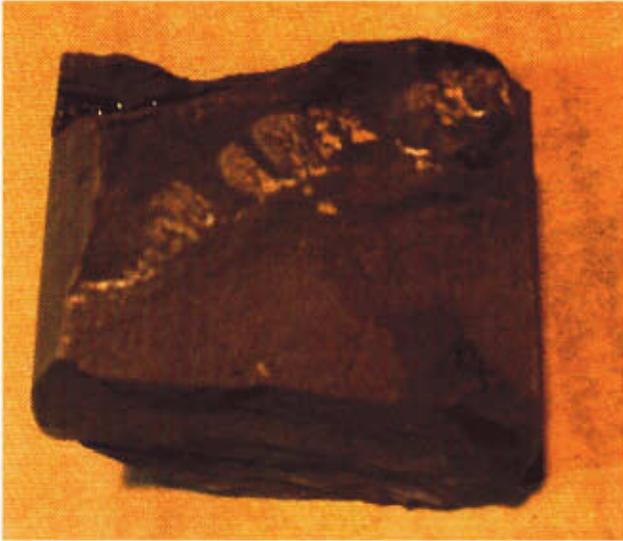
Termination of an extension Fracture
Depth: 1261.1 '
Host Rock: siltstone

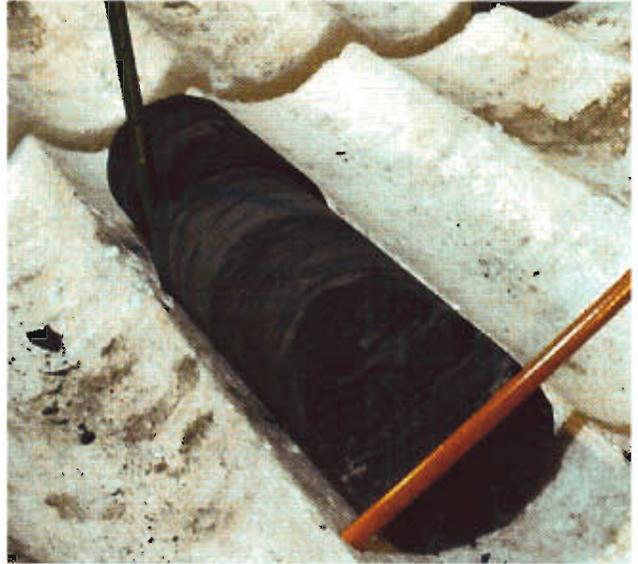
Perpendicular Extension Fractures
Depth: 1192'
Host Rock: Shale

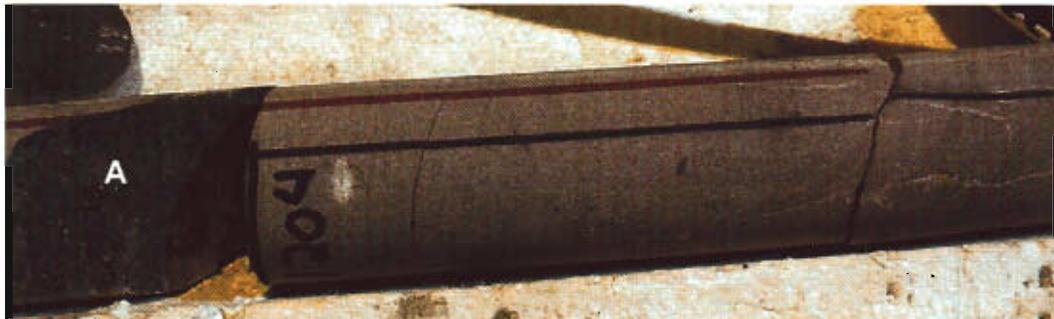
Parallel Extension Fractures
Depth: 1204'
Host Rock: Sandstone
Fracture A may have dead oil stain on the surface. The fracture spacing is 0.05.

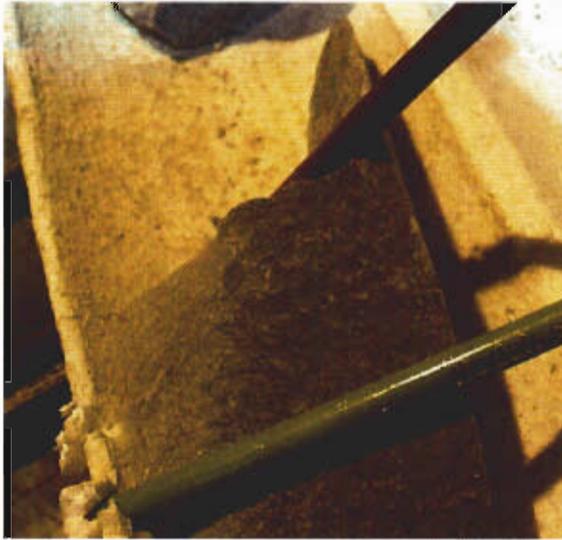
Two Intersecting Extension Fractures

Depth: 1208.5'
Host Rock: Sandstone

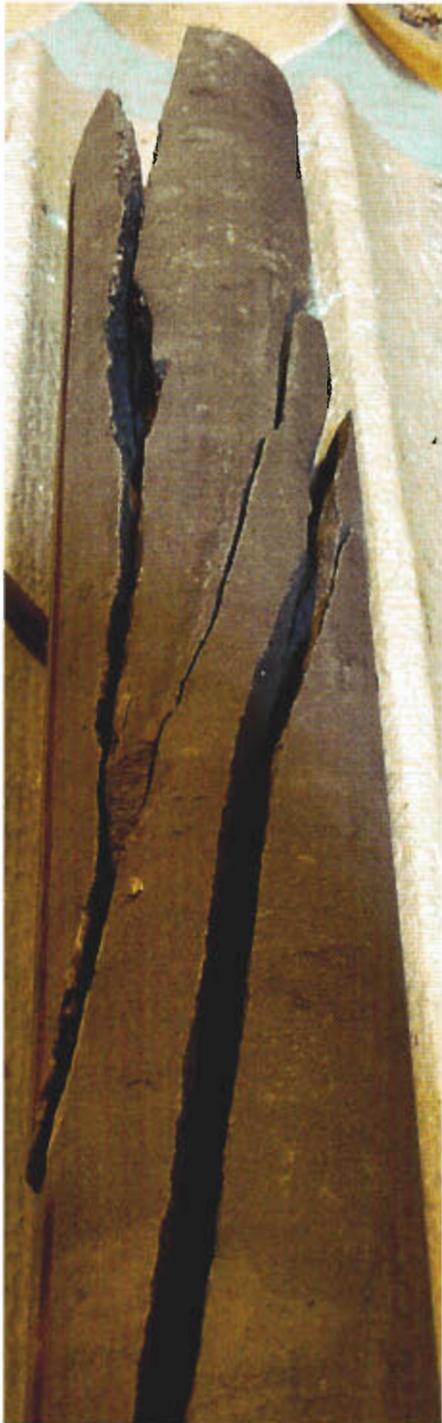
Multiple Extension Fractures

Depth: 1425'

Host Rock: Sandstone.

Large druze crystals are present on some of the fracture faces.

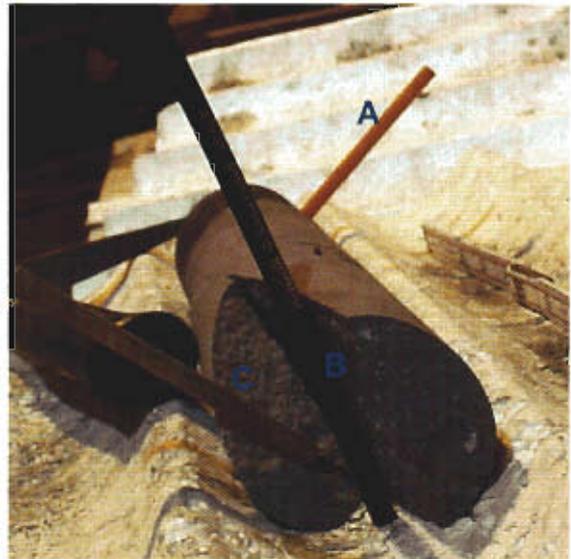
Three Intersecting Extension Fractures

Depth: 1201.4 – 1202.4

Fracture dip angles = 60 -70°

Host Rock: Sandstone

Fractures A and C strike normal to one another. The C-B strike intersection angle is 30°. The A-B strike intersection angle is 60°.

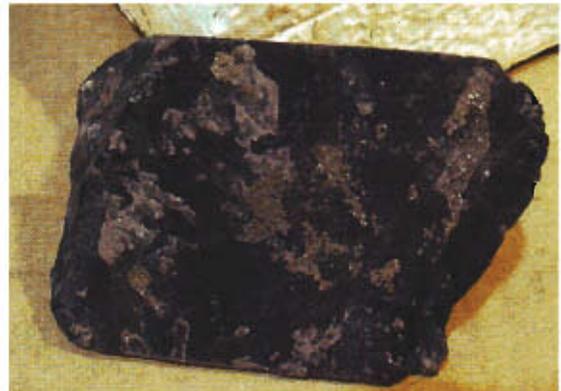
Calcite and Pyrite Fracture Filling

Depth: 1223.4

Host rock: Shale

The most common fracture filling is calcite. When pyrite is present, the fractures are more completely cemented and are difficult to break apart.

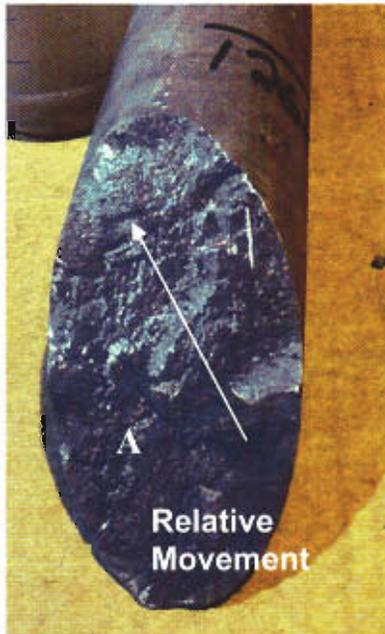
Intersecting Shear and Extension Fractures

Depth: 1268'

Fracture A is a reverse shear with a 65°- dip angle. Fracture B is a vertical extension fracture that terminates at Fracture A. The two fractures strike normal to one another

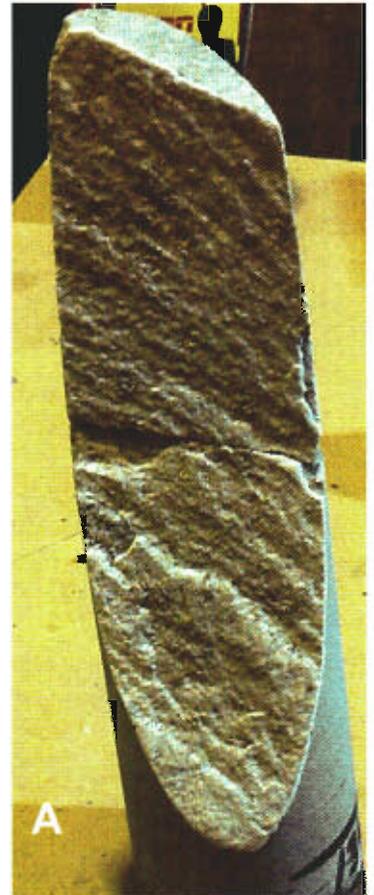
Figure A: Vertical Extension Fracture with Calcite (and Pyrite) Filling
Depth: 1339'

A well-developed plume structure is present.

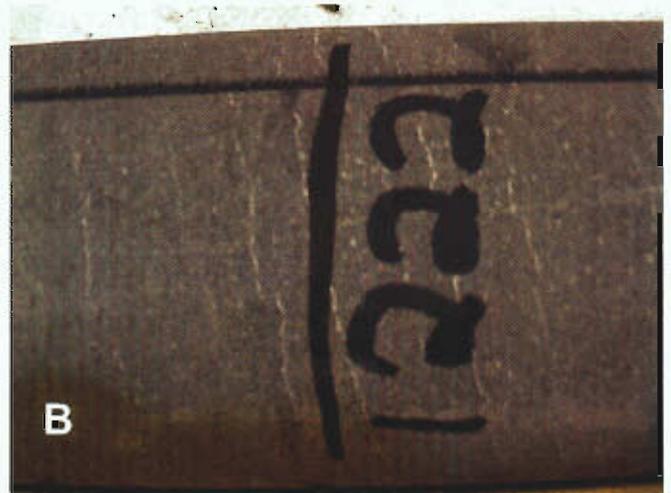
Figure C: “Chicken-wire” fracturing

Depth: 1219’

Host Rock: Igneous Sill

A fine network of quartz veinlets are found in an igneous sill.

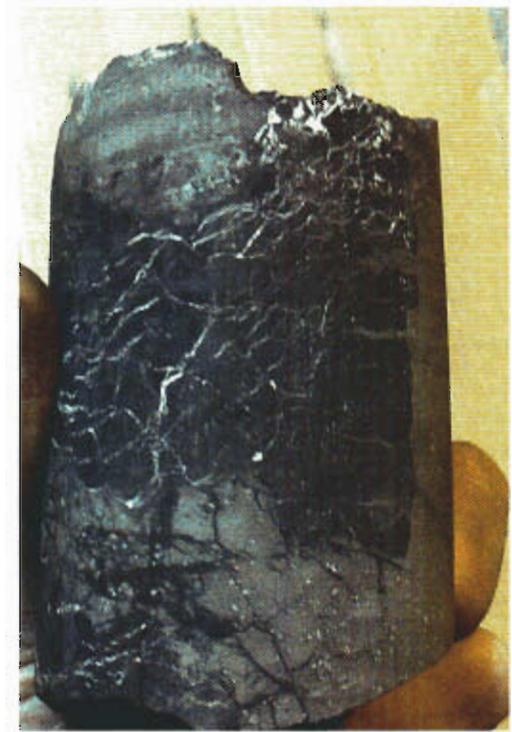
Columnar Jointing

Depth 1352.8'

Host Rock: Altered Coal or
High Carbonaceous Shale

Several feet of vertically jointed
rock occurs in association with
igneous intrusion. Calcite
fracture fillings are common.
