SANDIA REPORT

SAND2004-4859
Unlimited Release
Printed October 2004

Natural Gas Production Problems: Solutions, Methodologies, and Modeling

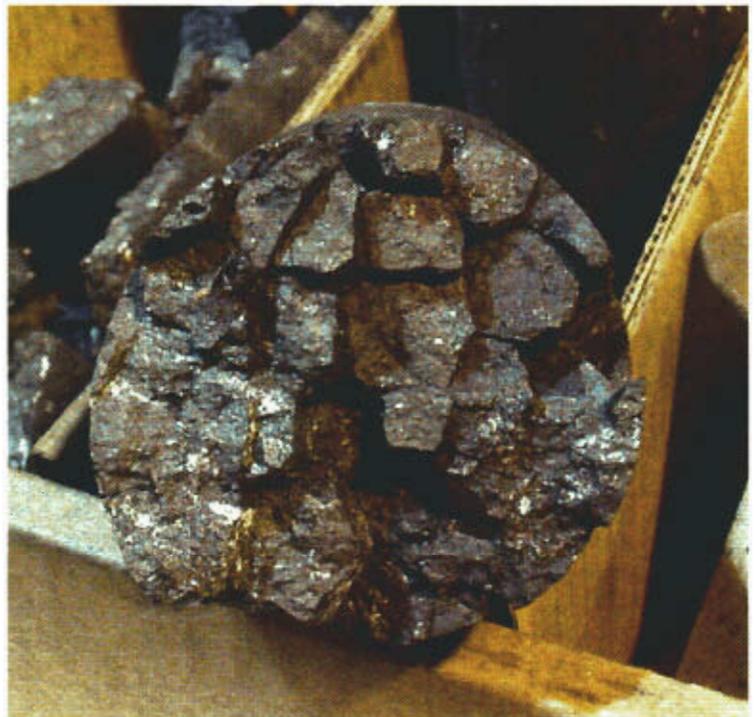
Interpreted Fault Zones

Possible fault zones (shown on Figure 1) were interpreted where intervals of core were highly broken and also possessed numerous shears. In some cases, “shattered” core, as shown here, is associated with these intervals

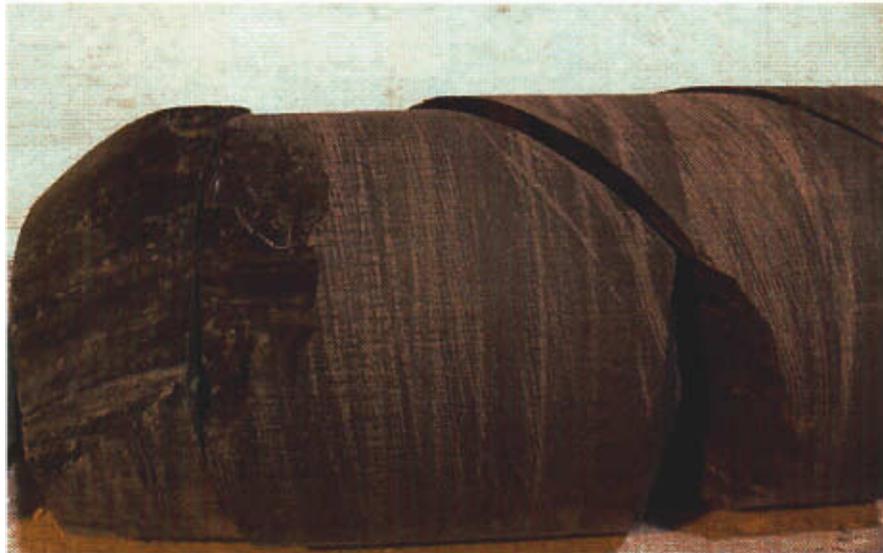
Bedding Plane Slip

Depth: 1752.2', Host Rock: Shale

A three-foot zone of shale from 1751 to 1753 is highly broken. Evidence for fracturing and bedding-plane horizontal slip is ample. Six fractures within two feet of core were described. Also, dislodged pieces of core possessing slickenlines are common. This zone may represent a fault zone intersecting the borehole.

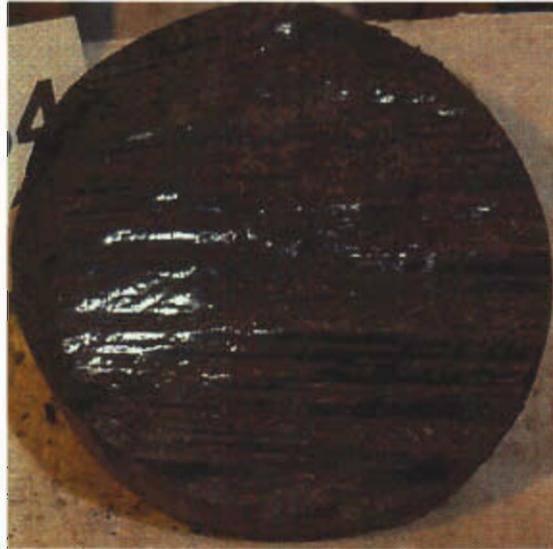
Shear showing two sets of slickenlines

Depth: 1769.5'

Fracture description: Fracture dip: 50°

Fracture Spacing: 0.6 ft.

Fracture strike intersection: parallel

Two episodes of movement are implied by two sets of slickenlines. A fracture 0.6 feet deeper in the core has a sub-parallel strike to this fracture. The slickenlines of the lower fracture are perpendicular to those showing 40° rake in the photo.

(The slickenlines on this fracture face intersect at a 30° angle. On page 11 two small thrusts are shown to have strikes that intersect at a 30° angle.

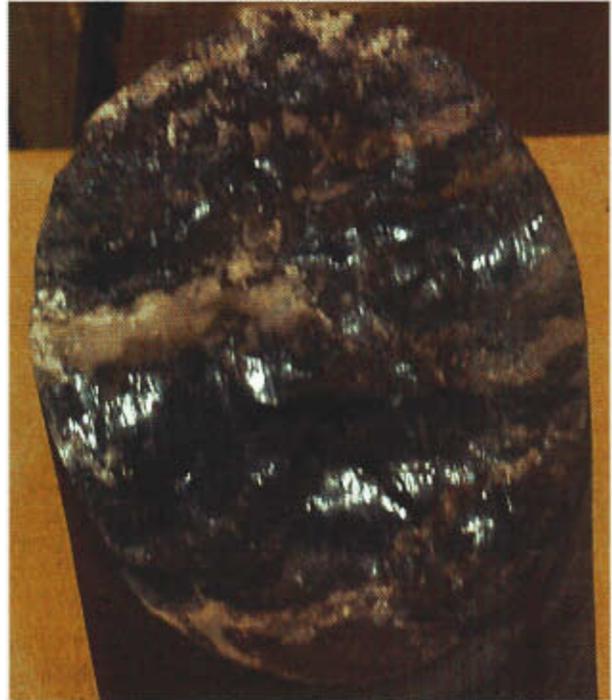
Small Thrust Fault

Depth: 1879.3'

This thrust is in a shale bed immediately above a thin coal seam. Petals in the coal indicate that the direction of sH_{max} is normal to fault movement. This is a small-scale compressional feature.

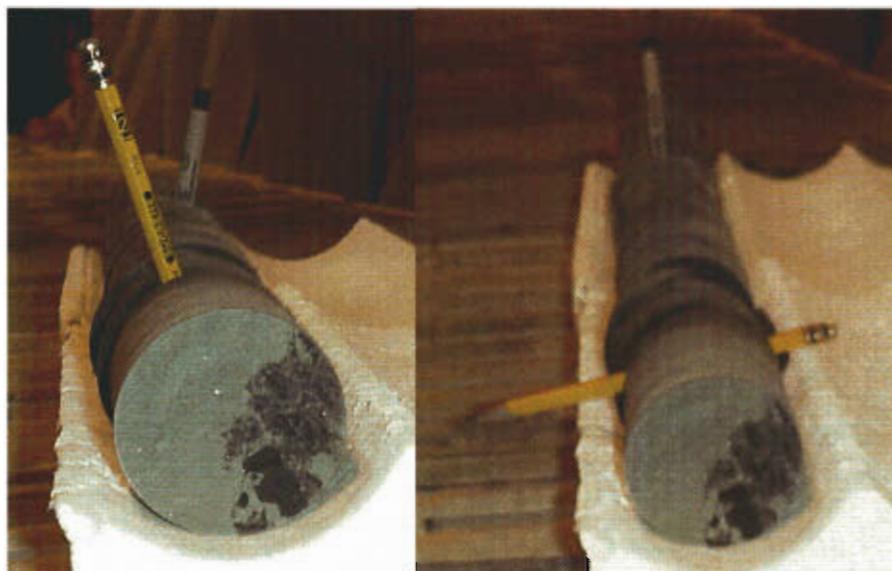
a.) Fracture Dip Directions of two fractures with a strike intersection of 30° are shown with a pen and pencil.

b.) The strike-orientation of Slickenlines on the same shears shown in a.) are now indicated with a pencil and pen. The fractures intersect at a 30° angle, The rakes of the fractures are normal to one another.

Fracture dips: $50^\circ - 55^\circ$

Some of the fractures from this interval have parallel dips and parallel rakes. Other fractures have a strike intersection of 30° . However the rakes of the discordant fractures are perpendicular to one another.

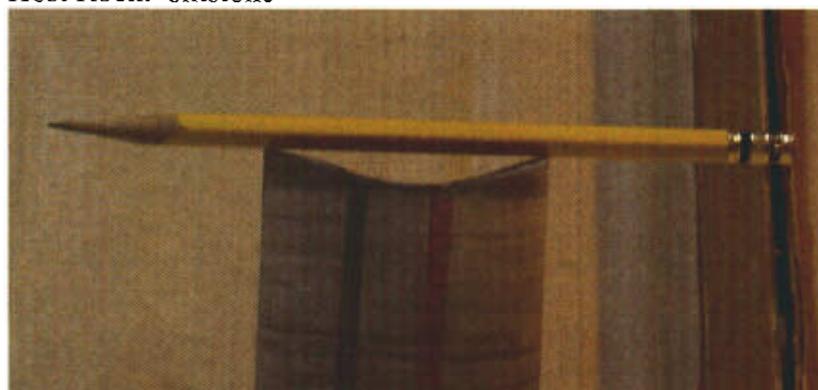
Petal Fracture

Depth: 1942'
Host Rock: siltstone

The pencil on this petal fracture is normal to the petal strike and shows an orientation direction normal to sH_{max} . The pencil is parallel to a plume propagation direction on the fracture surface. The plume indicates that the fracture (which represents the S_{max} in the local stress region imposed on the formation by the weight of the bit) opened from right to left.

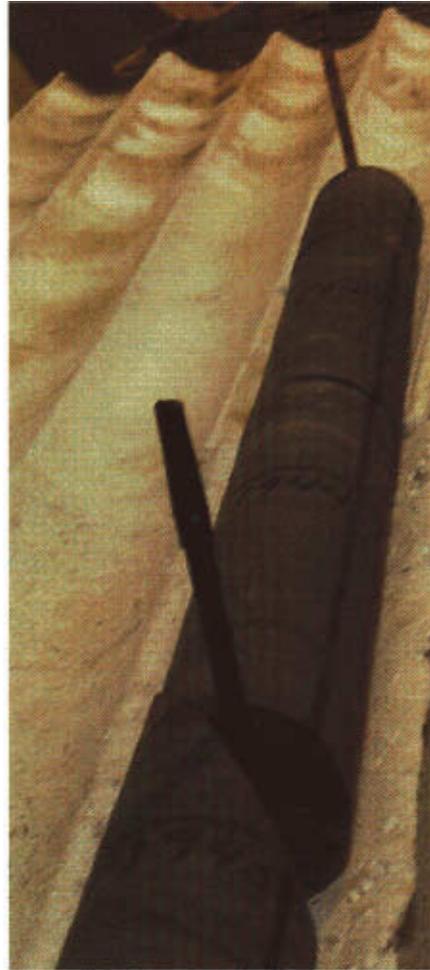
Shear with possible reverse oblique slip

Depth: 1944.6

Photo of fracture surface shown in previous photo.

Fracture Dip: 55°

Relative strike: Normal to sHmax

Irregular pattern on surface striations imply possible reverse oblique shear movement.

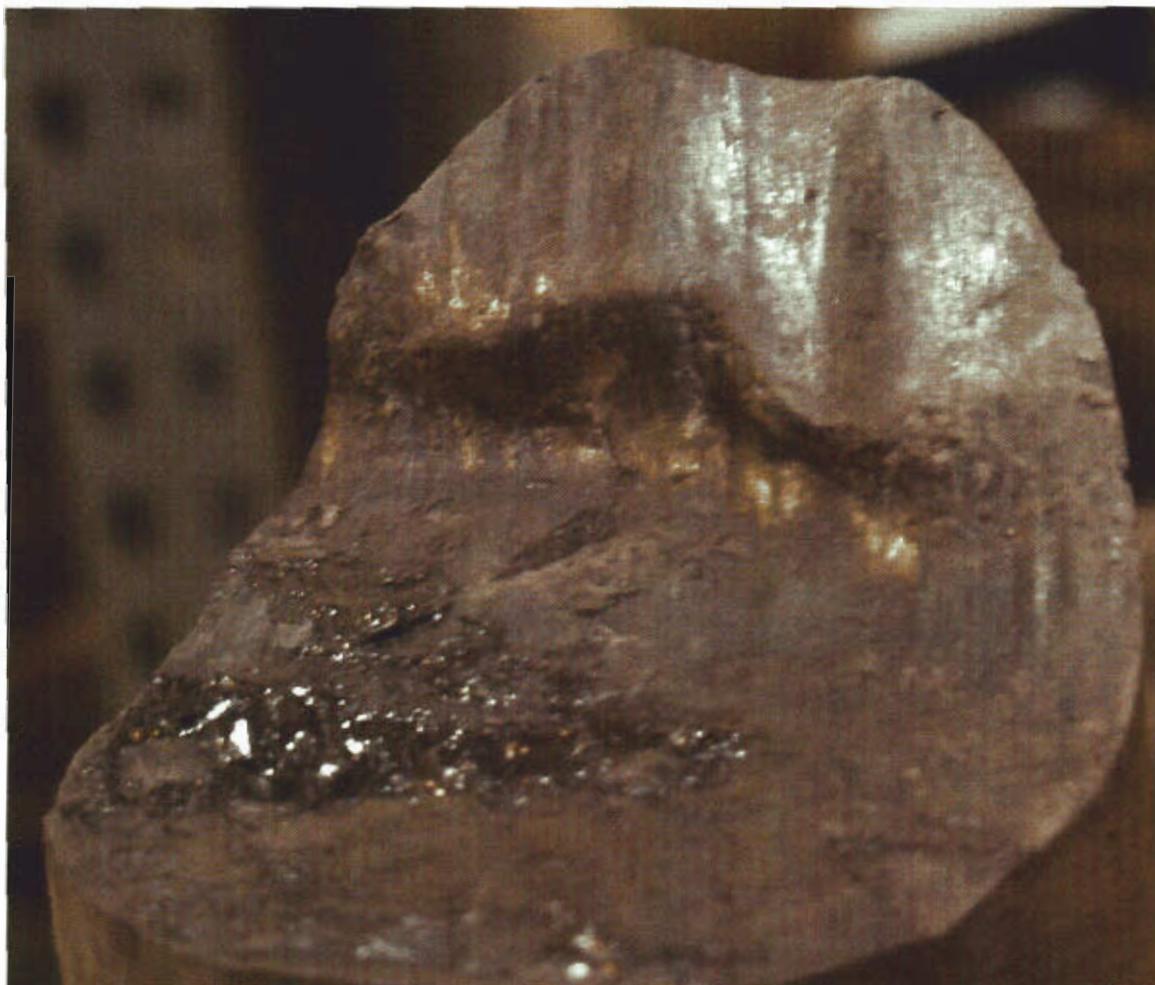
Shear with possible normal dip slip

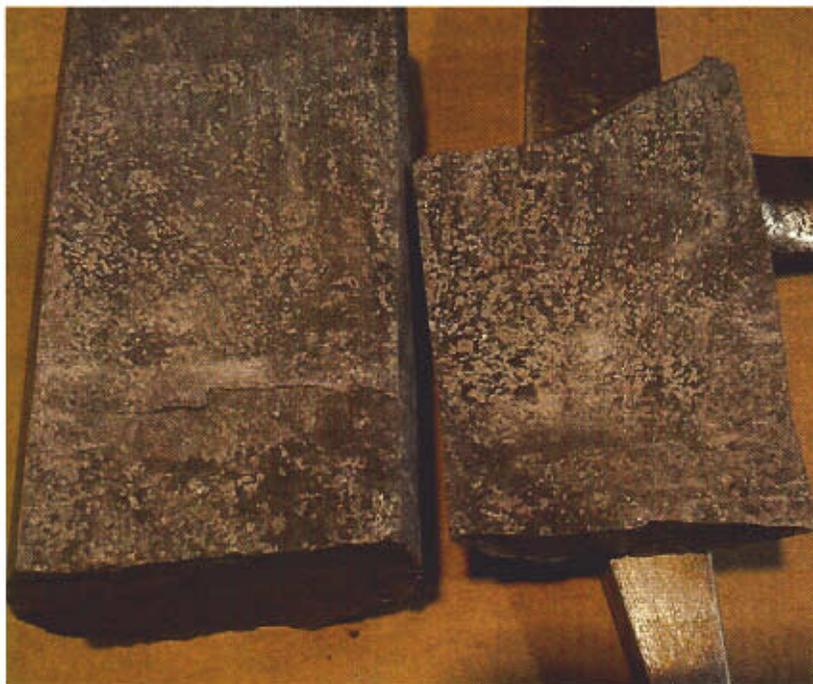
Extension Fractures with a 90° intersection

Depth: 1949.7'

Fracture dip = 80°

Fracture spacing = 0.7 ft.

Host Rock: Siltstone

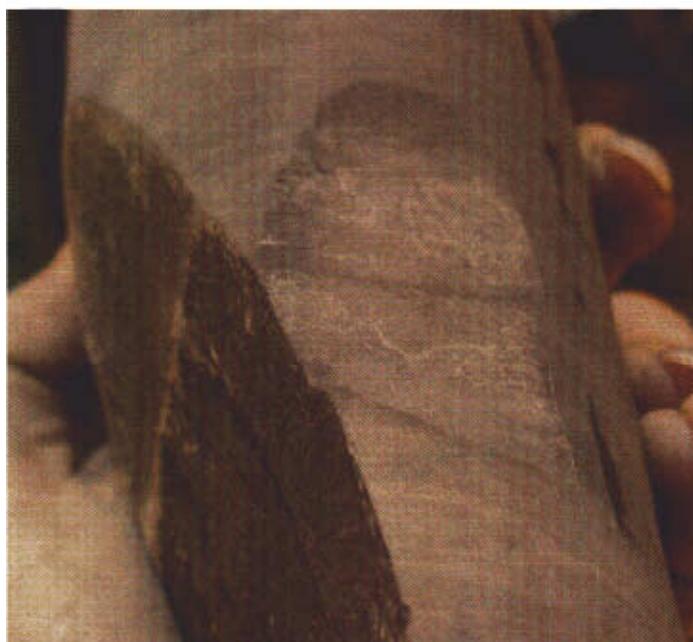
**Surface View of one Extension Fracture
seen in previous photo**

Depth: 1949.7'

Fracture dip = 80°

Fracture spacing = 0.7 ft.

Lower fracture termination: subtle bed
boundary

Host Rock: Siltstone

Plume structure that propagated from bottom
to top is apparent.

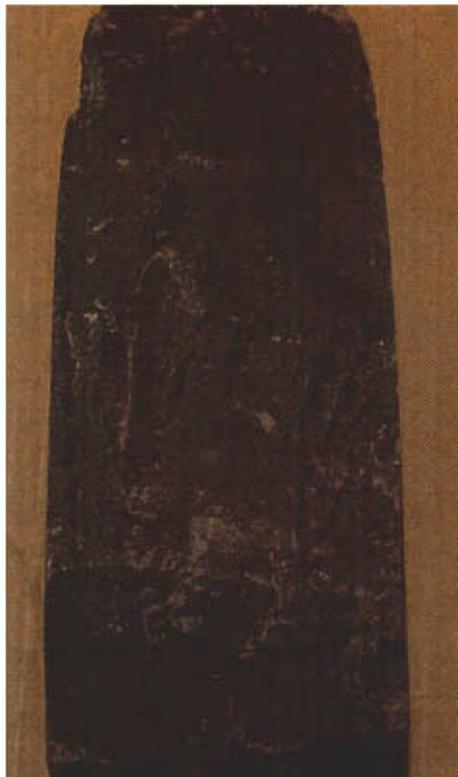
**Intersecting Extension
Fractures**

Depth: 1957.6

Fracture terminations: in
lithology

Dip strikes are parallel,
but fractures dip in
opposite directions with
an intersection angle of

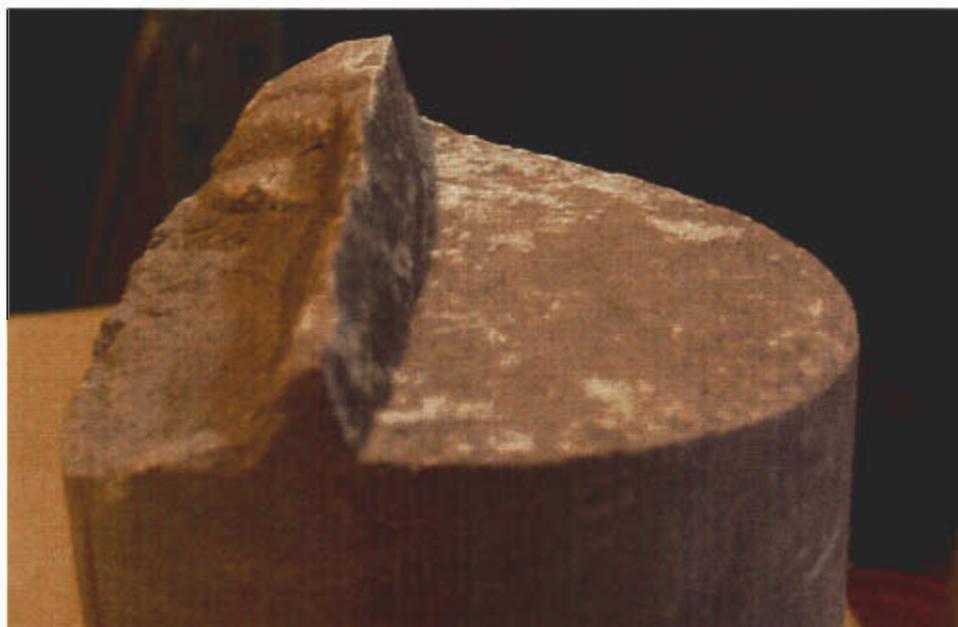
Surface View of one Extension Fracture seen in previous photo

Depth: 1957.6'

Fracture dip = 70°

Host Rock: Siltstone

A plume structure that propagated horizontally is apparent. This surface shows patchy calcite fracture filling. Also the surface has an uneven oil stain that exhibits no to dull fluorescence.

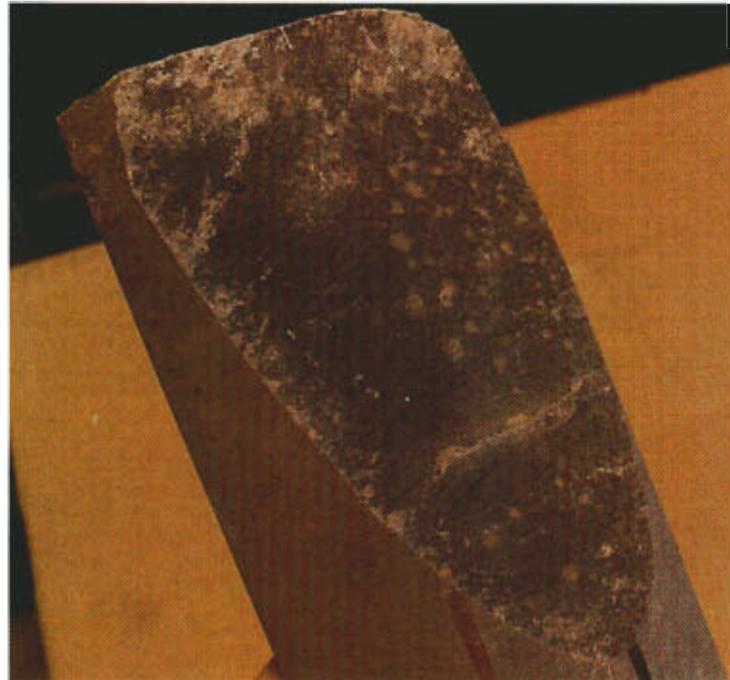
Relationship of Extensional Fractures to Thrust Shears

Depth: 1987.1'

The upper blue pen shows the strike to two parallel hairline extension fractures:

Fracture dip angles: 85°

The strike intersection of the extension fractures and this thrust is 30°.

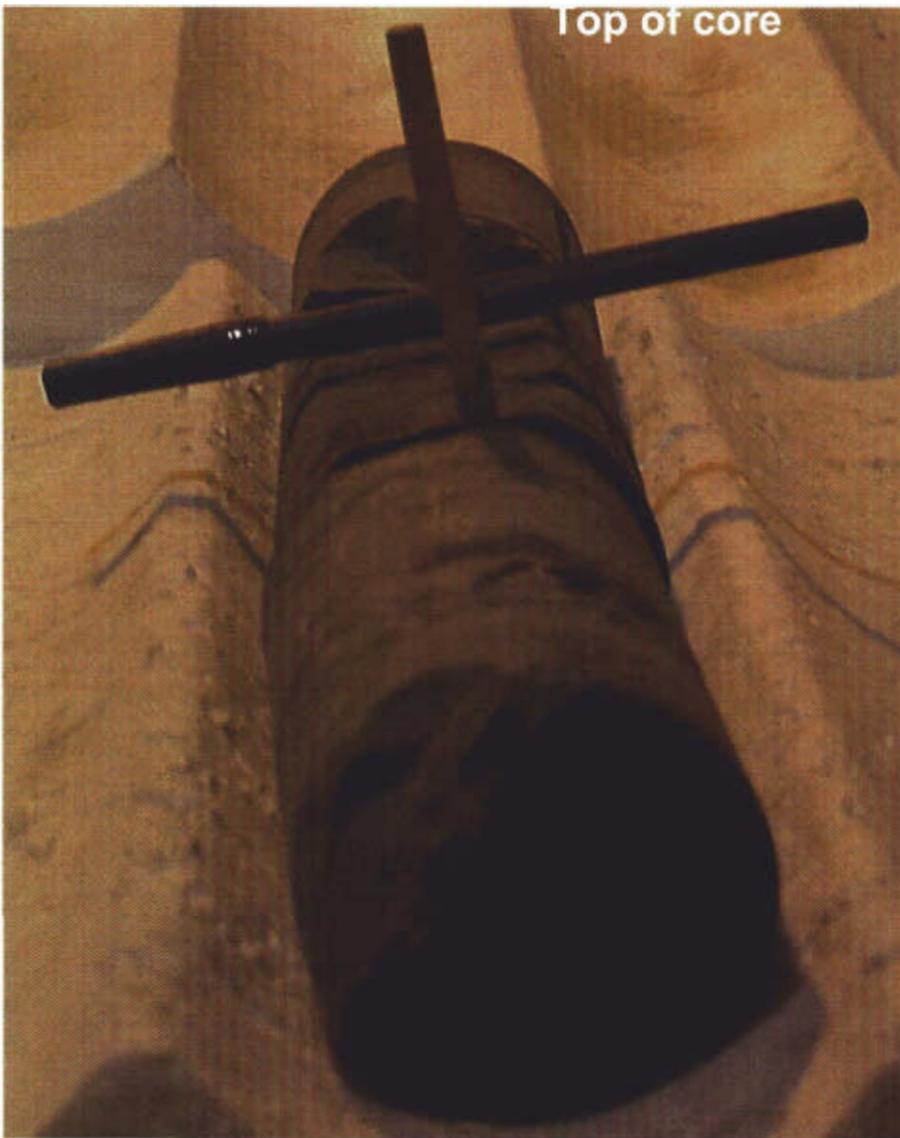
Relationship of Extensional Fractures to Bedding-Plane Slip Lineations
