## **Examination of the platinum effect on the oxidation behavior of nickel-aluminide coatings**

P. Y. Hou<sup>1</sup> and V. K. Tolpygo<sup>2\*</sup>

<sup>1</sup>Lawrence Berkeley National Laboratory, Materials Sciences Division, Berkeley, CA  
94720

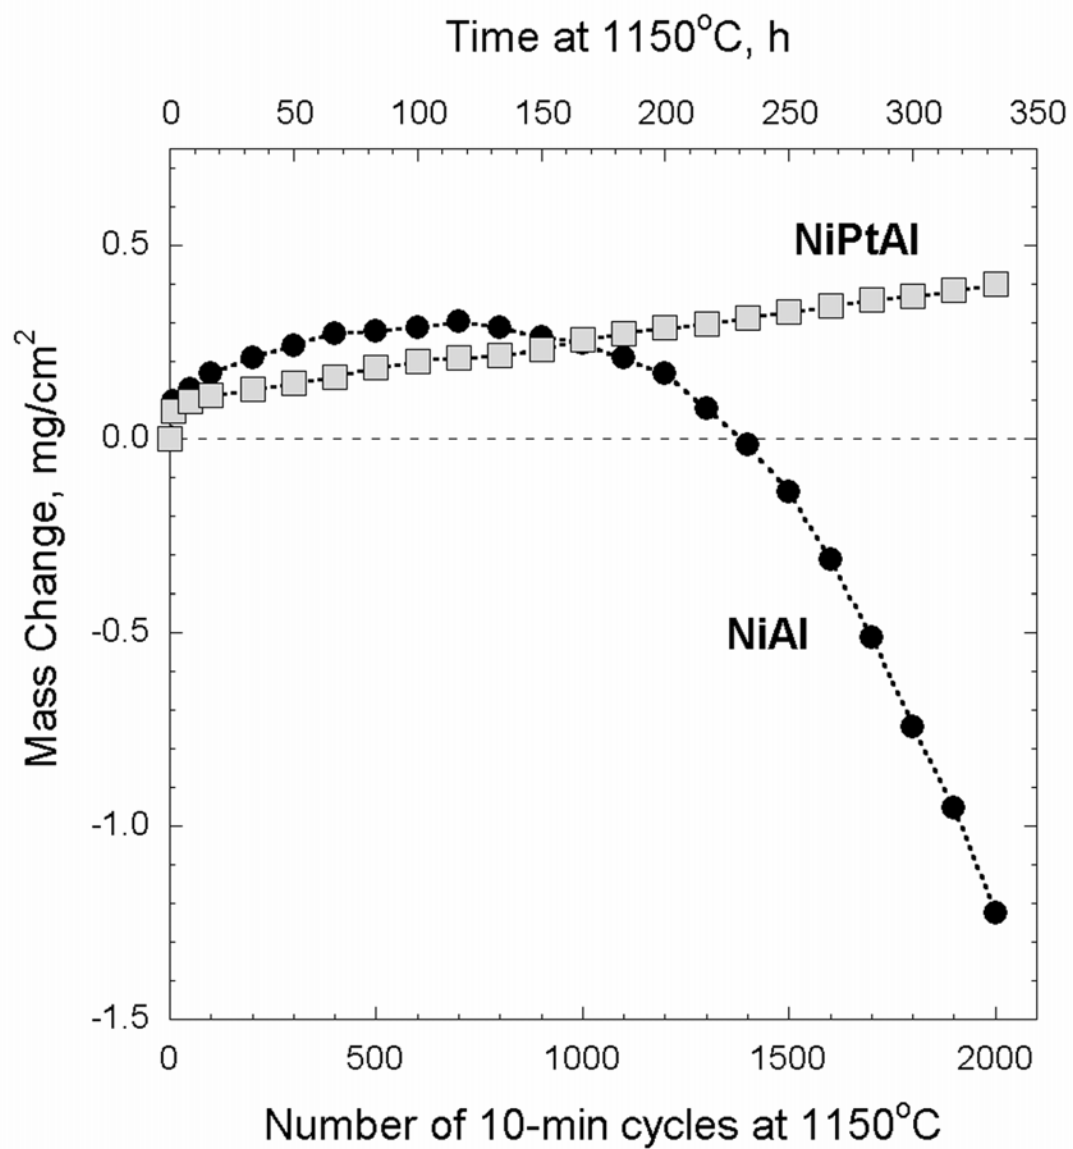
Figure 1: Cyclic oxidation behavior of NiAl and NiPtAl coatings tested in air.

Figure 1 illustrates the difference in cyclic oxidation behavior between the NiAl and NiPtAl coatings. While the NiPtAl sample displayed continuous weight gain throughout the 2000-cycle test, the NiAl started to show weight loss after 600 cycles. Visual observation revealed oxide spallation on the NiAl coating after ~200-300 cycles, but fully adherent scale on the NiPtAl coating even after 2000 cycles.

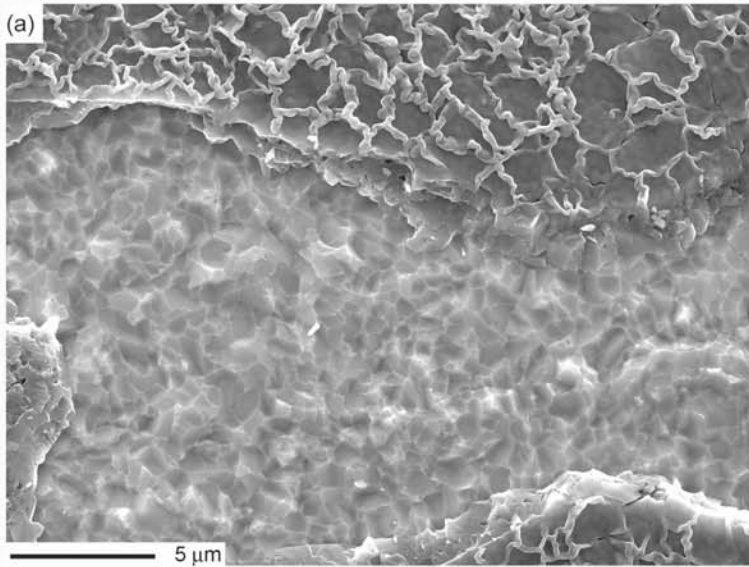
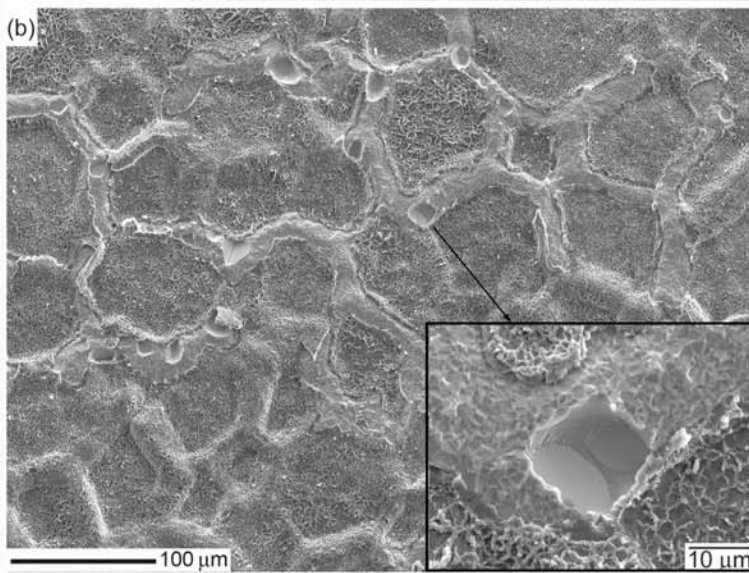
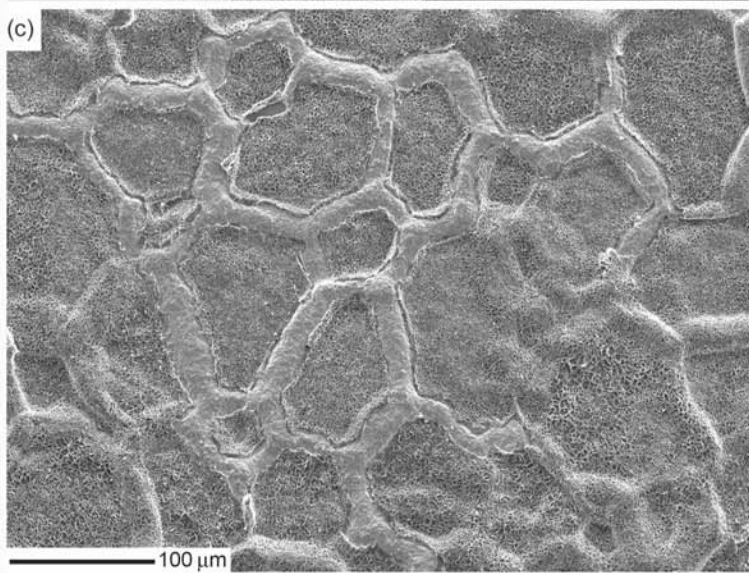
Figure 2: Surface of the NiAl coating after isothermal oxidation for 10h (a) and 250h (b),(c): after 10h, no voids are observed in the areas exposed by scratching; after 250h, spallation along grain boundary ridges exposes areas with (b) and without (c) interface voids. The insert in (b) shows a magnified view of the interface void.

No spallation was observed on the NiAl coating after isothermal oxidation at 1150°C for 10h, but the scale could be easily scratched off. Examinations of these scratch-induced spalled areas revealed fine oxide imprints with no interfacial voids, as shown in Figure 2a. After longer isothermal exposures (100 and 250 hrs), extensive scale spallation occurred on the NiAl coating (Fig. 2b,c). These spalls took place almost exclusively along grain-boundary ridges, whether or not there were interfacial voids, which formed preferentially along these ridges.

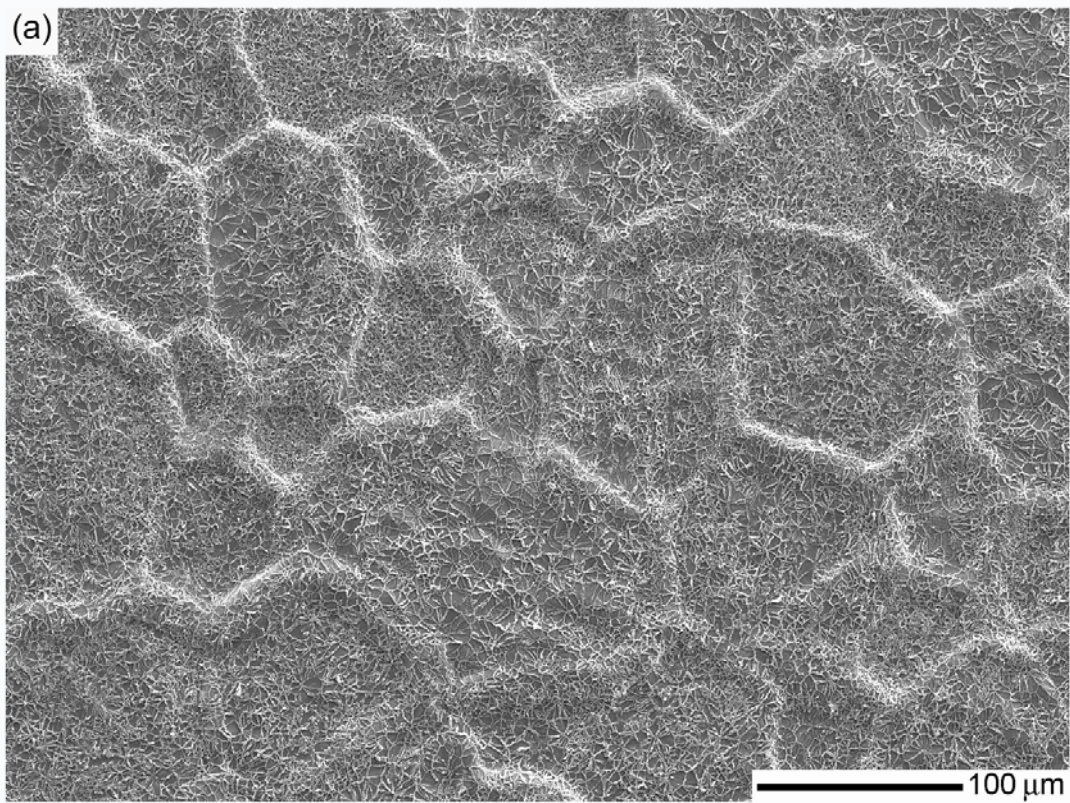
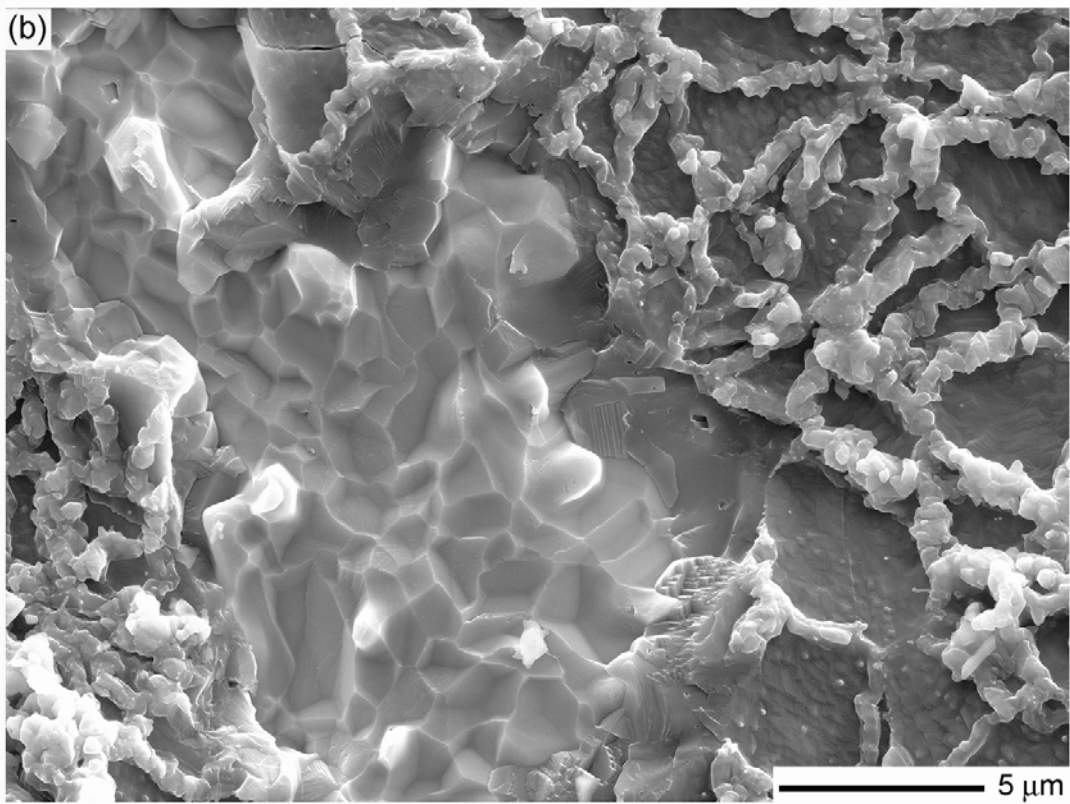
Figure 3: NiPtAl surface showing no spallation after 250h (a) isothermal oxidation and oxide imprints on a scratch-induced spall (b).

Figure 3a shows the NiPtAl surface after 250h isothermal oxidation. Ridges similar to those found on the NiAl coating can be seen, but there was no scale spallation;

furthermore, the oxide scale was difficult to scratch off, indicating strong interface adhesion. Scratching only induced small areas of spalls (Fig. 3b as an example), which showed oxide imprints with no voids.

Spallation of the oxide on NiAl after 200-300 cycles or after 100h and 250h isothermal oxidations occurred preferentially along grain boundary ridges (Fig. 3), where

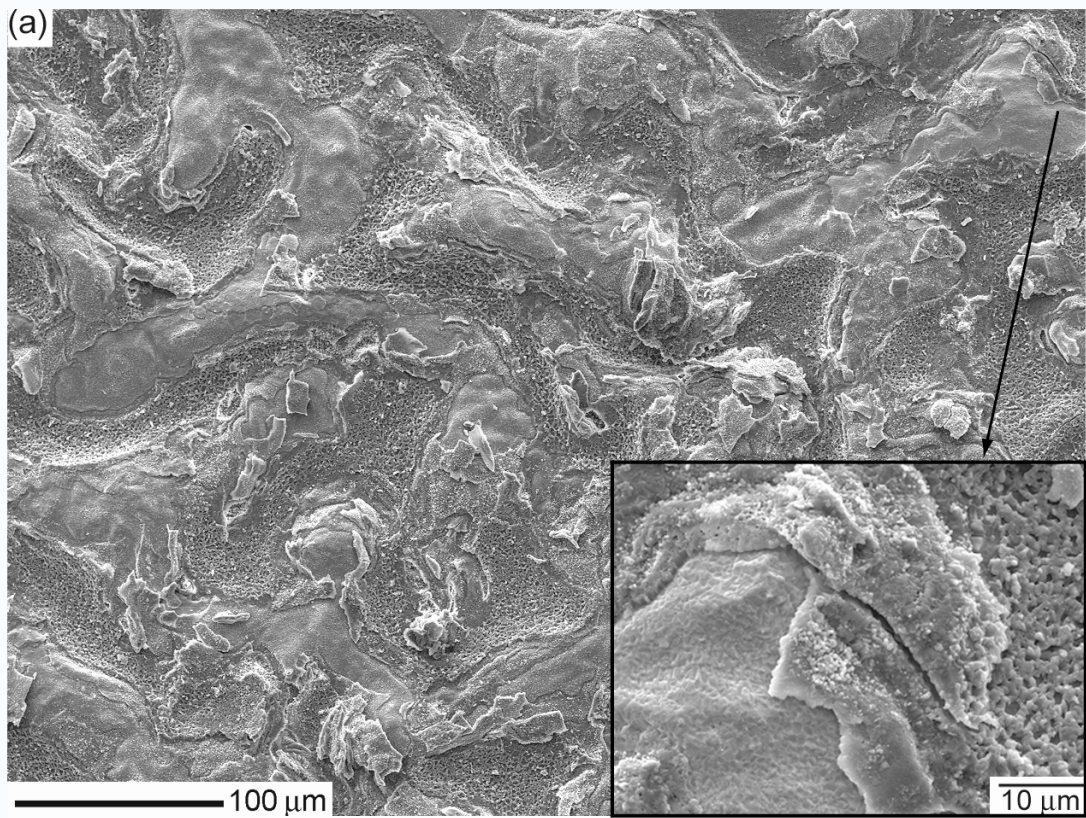
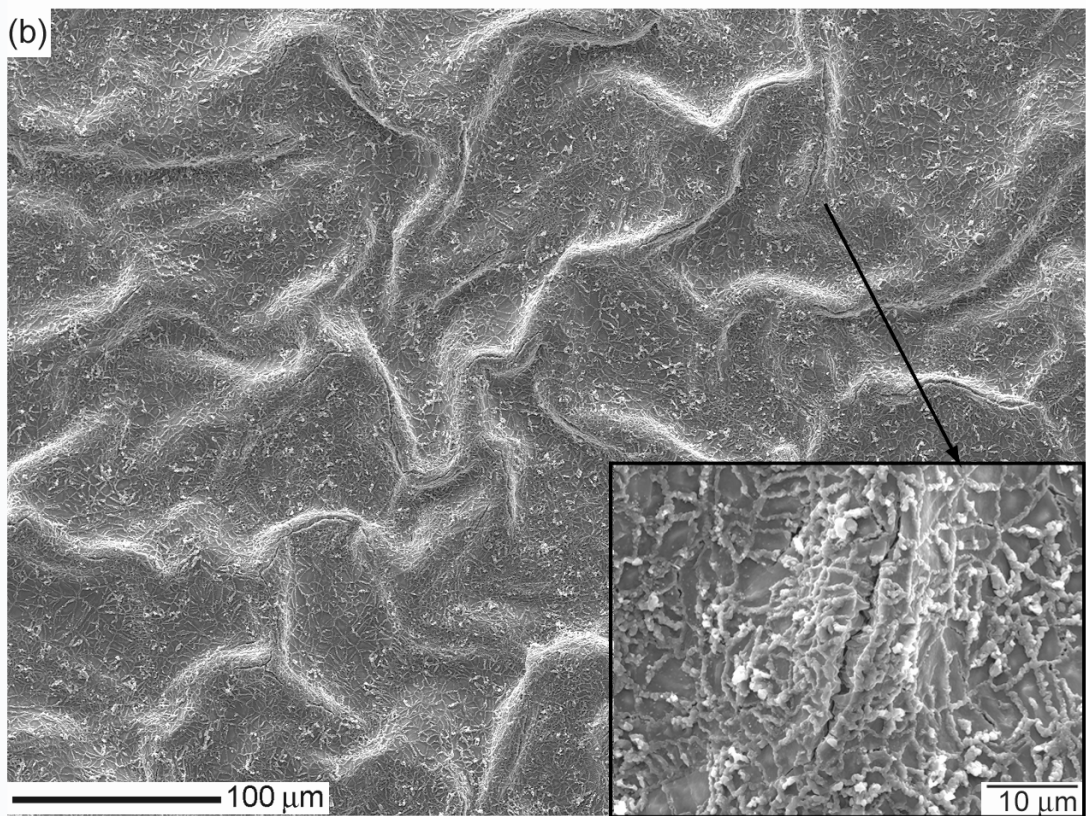
Figure 4: Surface morphology of NiAl (a) and NiPtAl (b) coatings after 2000 10-min cycles at 1150°C. Magnified views are added as inserts showing the lack of interface voids in (a) and oxide cracking along surface ridges in (b).

Significant roughening (rumpling) of both coatings occurred during cyclic oxidation (Figure 4), but it was less pronounced on the NiAl due to repeated scale spallation from ridges and peaks. Unlike under isothermal conditions, these spalled areas were free of interfacial voids. No spallation was observed on the NiPtAl coating after cyclic oxidation, even though cracks were often found in the alumina along the ridges (see inset of Fig. 4b).

On the NiPtAl coating, the interface is significantly stronger; consequently, no spallation was observed even when extensive undulations developed after prolonged cyclic oxidation (Fig. 4b). AES analysis of the interface chemistry showed no segregation of sulfur (Fig. 5b). This absence of sulfur at the oxide-metal interface appears to be the major reason of strong scale adhesion on the NiPtAl coating, although the mechanism by which platinum prevents sulfur segregation is not determined in this study. Taking into account that both coatings were deposited on the same alloy, it can be argued that the amount of sulfur in the NiPtAl should not be any smaller than in the NiAl. Also, given that no Pt enrichment was observed at the oxide-metal interface, it is unlikely that the absence of sulfur is a result of site competition with platinum (unless there is a strong repulsive interaction between S and Pt). It is possible that the presence of Pt by itself strengthens the interface. However, previous study on a similar NiPtAl coating on a different substrate showed poor scale adhesion due to S co-segregation with Cr [7], indicating that any interface strengthening effect due to Pt must be suppressed by the presence of S at the interface.

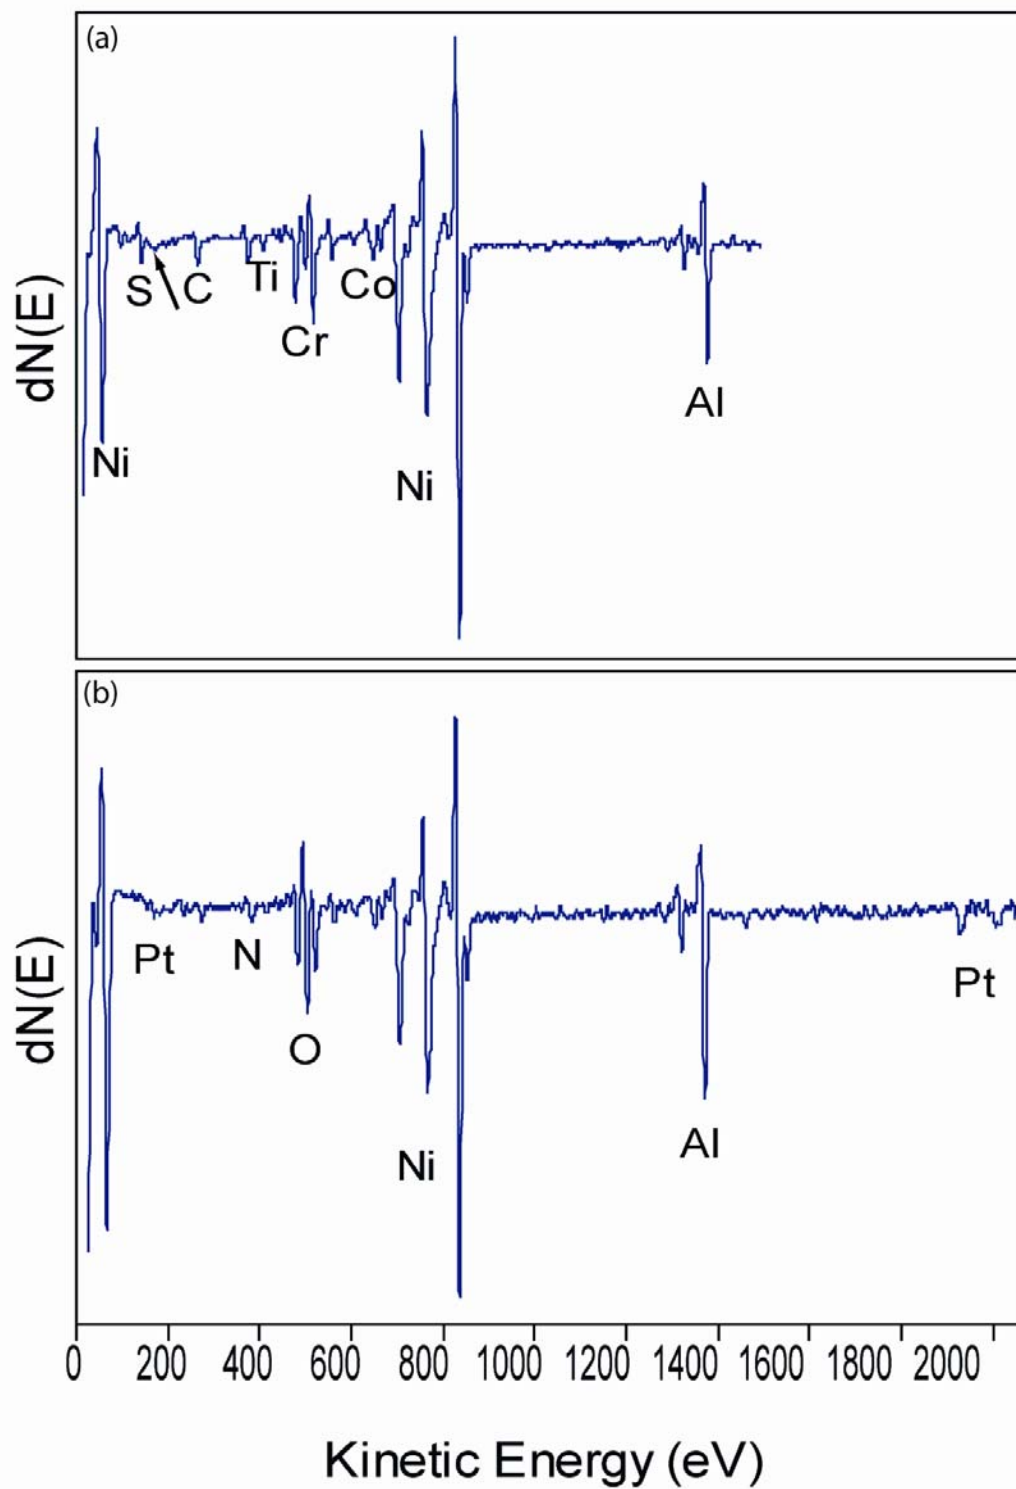
Figure 5: Typical AES spectrum found on NiAl (a) and NiPtAl (b) after Al<sub>2</sub>O<sub>3</sub> scale removal in ultra high vacuum.

Auger analysis clearly showed sulfur segregation everywhere at the  $\text{Al}_2\text{O}_3/\text{NiAl}$  interface regardless of its morphology (Fig. 5a); its surface concentration after 10h, 100h and 250h was  $0.9\pm0.3$ ,  $1.1\pm0.4$  and  $0.9\pm0.3$  (at.%), respectively. These numbers indicate that the amount of interfacial sulfur has already reached a steady state level after 10 hrs. Most of the void surfaces were covered with a thin layer of oxide (due to spallation or cracking of the scale above them during cooling). Some voids that were found to be oxide-free during the AES measurements demonstrated significantly higher, up to 15 at.%, concentration of sulfur. Contrary to the NiAl coating, no sulfur was detected at the  $\text{Al}_2\text{O}_3/\text{NiPtAl}$  interface (Fig. 5b).

In addition to the major elements in the coatings (Ni, Al and Pt), both interfaces also had Cr, Co, Ti, N, O and C, as illustrated in Fig. 5. Whereas oxygen and carbon are usual UHV contaminants (their levels increased with exposure time in the AES chamber), Cr, Ti and Co were enriched at the interface relative to their concentrations in the bulk (determined by analyses made within the scratch track). On the  $\text{Al}_2\text{O}_3/\text{NiAl}$  interface, a

group of peaks (marked by the arrow in Fig. 5a) with energies close to that of Ta, W and Re are present. Closer examinations suggested that they might correspond to rhenium. Nano-sized Re [2] and Cr [2,7] particles at  $\text{Al}_2\text{O}_3/\text{NiPtAl}$  interfaces have been previously detected by TEM, but their effect on scale adhesion is unknown. Overlaps with low-energy Pt Auger signals prevented detection of these peaks on the NiPtAl, but high levels of Cr were found at some locations, which may be due to the presence of Cr-rich precipitates at the interface.
