**FEDERAL FACILITY AGREEMENT AND CONSENT ORDER (FFACO)
RECORD OF TECHNICAL CHANGE (ROTC)**

CAU Description: Roller Coaster Lagoons and Trench (TTR)

ROTC No.	<u>DOE/NV-11718-187 UC-702-ROTC 2</u>	Page	<u>1</u>	of	<u>8</u>
Document Type	<u>Closure Report (CR)</u>	Date	<u>11/19/2019</u>

Closure Report for
Corrective Action Unit 404:
Roller Coaster Sewage Lagoons
and North Disposal Trench,
Tonopah Test Range, Nevada

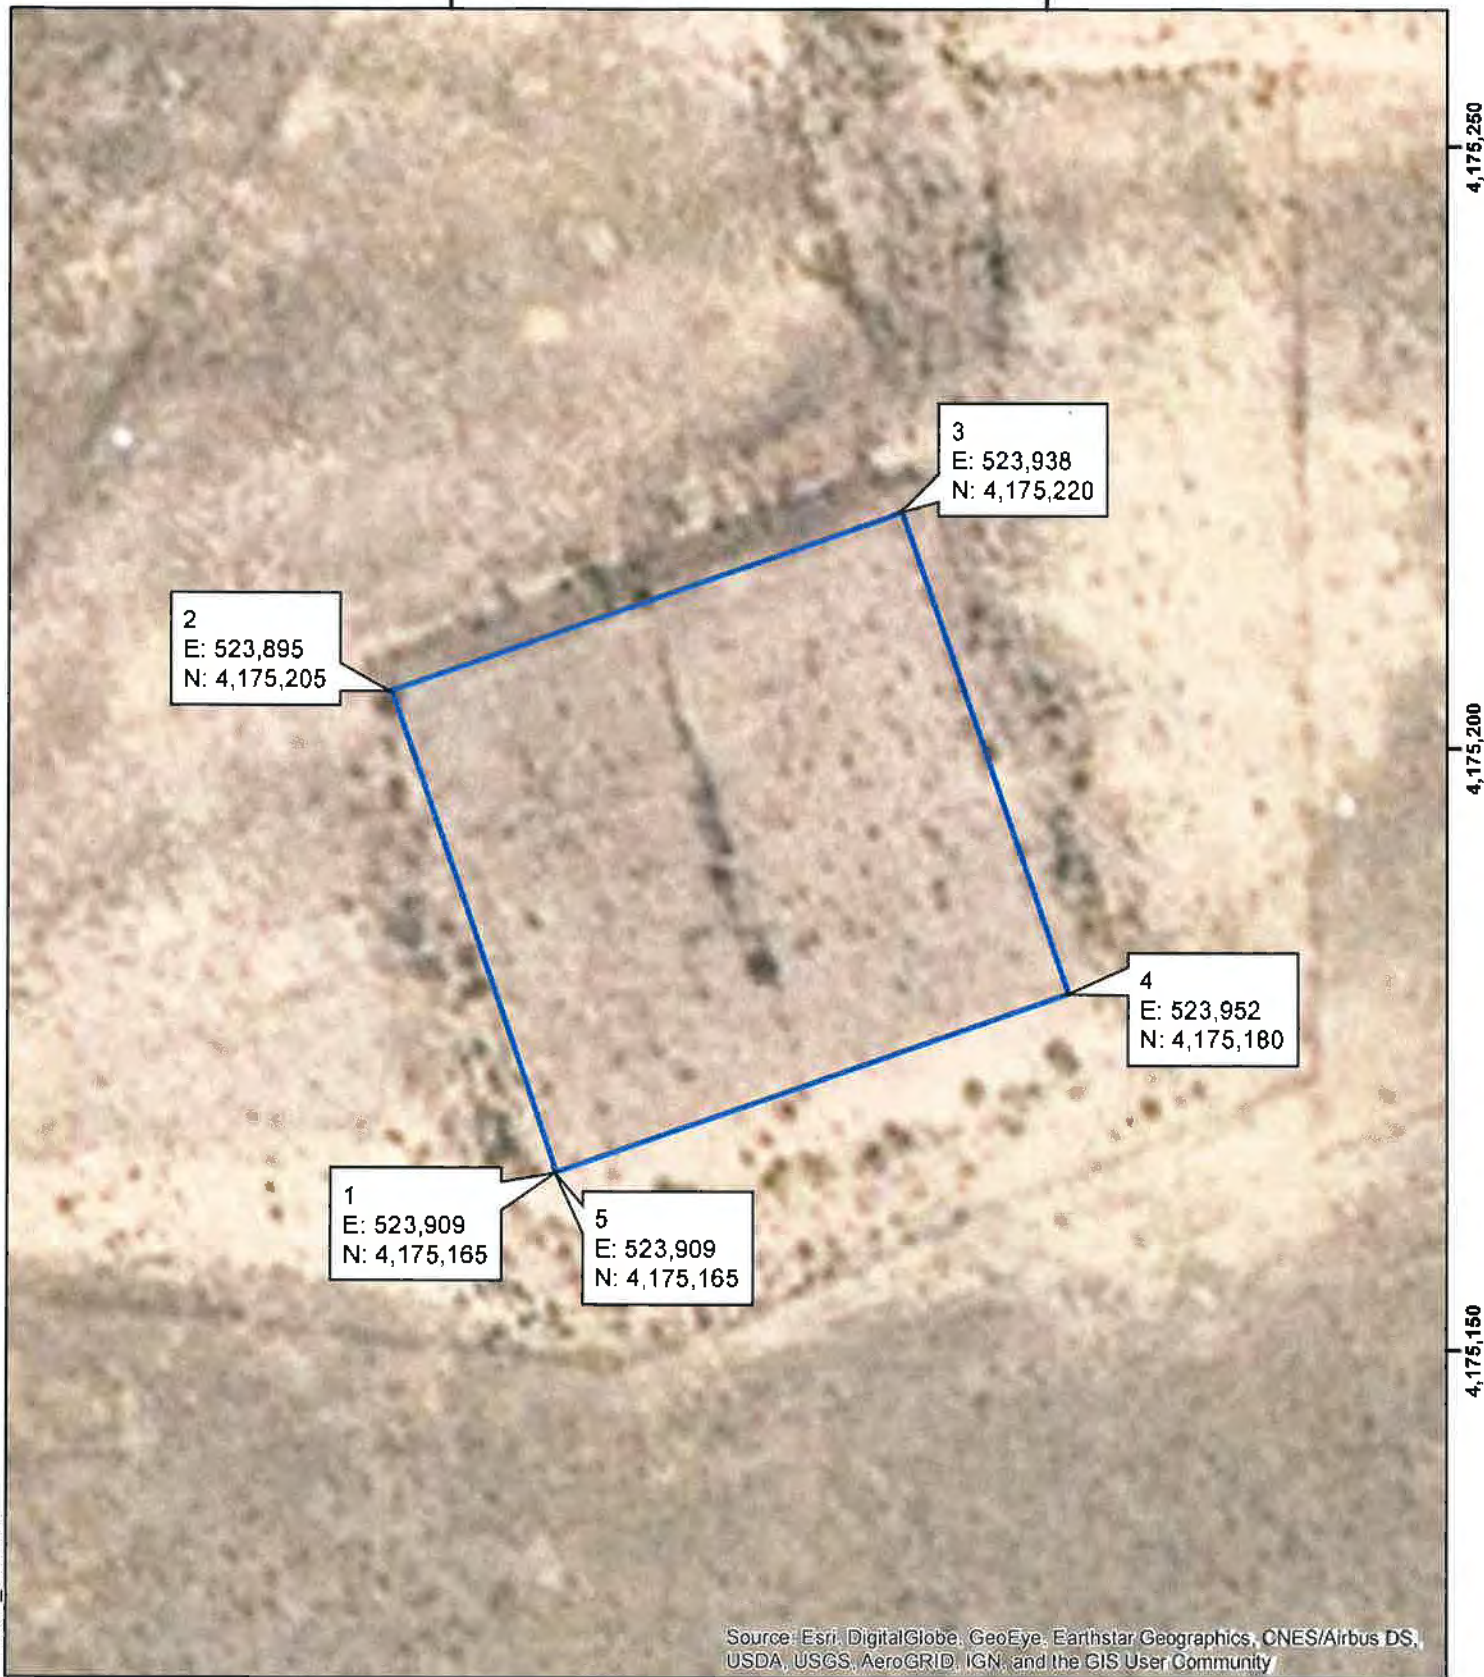
**CAU 404, CAS TA-03-001-TARC
Roller Coaster Lagoons
Administrative UR Boundary**

Surveyed Area (UTM, Zone 11, NAD 83, meters):

UR Boundary	UR Point ¹	Easting ²	Northing ²
Admin Boundary	1	523,909	4,175,165
	2	523,895	4,175,205
	3	523,938	4,175,220
	4	523,952	4,175,180
	5	523,909	4,175,165

Boundary Applies to: Subsurface

Starting Depth: 50 **Ending Depth:** _____
Depth Unit: Centimeters
Survey Source: GPS

This Administrative UR is recorded as described in **Section IV. Recordation Requirements** to restrict activities within the area defined by the coordinates listed above and depicted in the attached figure without prior notification of NDEP unless the activities are conducted under the provisions of 10 CFR, Part 835, Occupational Radiation Protection and 10 CFR, Part 851, Worker Safety and Health Program.
