# **A study of defects on EUV masks using blank inspection, patterned mask inspection, and wafer inspection**

## **ABSTRACT**

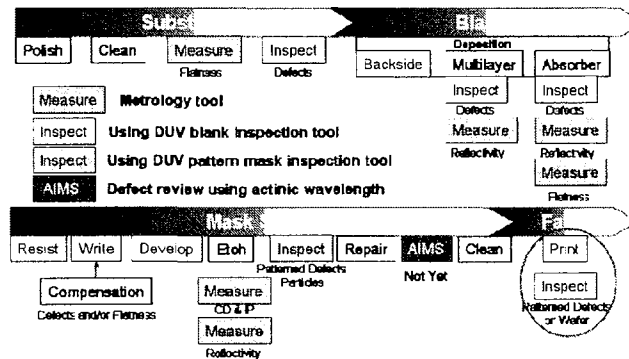
Figure 2. EUV mask fabrication flow for pilot line application or early HVM

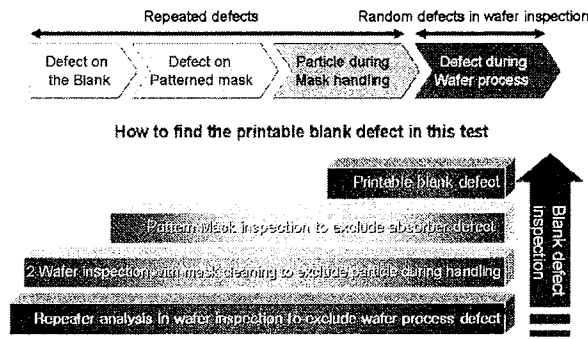
Figure 4. Procedure to identify defects from wafer inspection

inspection. The experimental plan is explained in the Figure 4. After mask fabrication, patterned mask inspection was done to qualify defects on the patterned absorber. After that the mask was shipped from Asia to the USA without using a dual pod. Particles may be added to the mask during mask handling and shipping. These particles cannot be detected by a patterned mask inspection tool. However they will be detected as repeater defects on the wafer inspection tool. At CNSE in Albany, NY, the mask was exposed with the EUV ADT. Then the wafer was inspected with CNSE's KLA 28XX wafer inspection tool to classify printable pattern defects, blank defects, and particles. The mask was then sent back to Asia for cleaning to remove particles from the first ADT exposure. The cleaning removed all the particles, but other particles were added in different locations. One more ADT exposure and wafer inspection was done to exclude the particles on the EUV mask. When the coordinates of the wafer inspection overlap in first and second wafer inspection, they can be considered printable blank or pattern defects. However, when a coordinate does not overlap, it can be classified as a particle, as all particles are removed or added at different locations after mask cleaning. Figure 4 summarizes how to classify defects on the blank and patterned absorber, particles, and process defects. Figure 4 explains the classification procedure, which is outlined in more detail as follows:

- After repeater analysis, any random process defect can be excluded from the results of wafer inspection. Repeated defects include blank defects, pattern defects, and particles.
- Two wafer inspections were conducted. After the first wafer inspection, the mask was shipped back to the mask shop and cleaned to remove the particle from the original site. Overlapping coordinates indicate blank defects and pattern defects. The others are particles added during mask shipping and handling.
- Patterned defects are excluded from the results of the repeater analysis using the information from patterned mask inspection. Finally, a printable blank defect can be obtained without the information from the blank inspection.

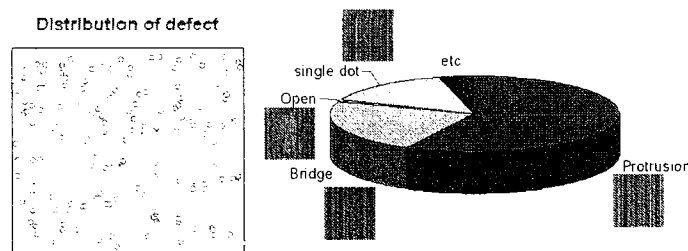
Figure 7. The result of patterned mask inspection

After patterning the absorber, the mask was inspected using a DUV patterned mask inspection tool with a wavelength of 257nm. The tool can inspect part of the inherent blank defects on the substrate and patterned defects generated during patterning of the absorber. Defects were classified as protrusion, bridge, open, single dot, etc. Figure 7 shows the distribution and Pareto chart classifying each defect. Protrusion and bridge types have the highest percentage. The printable/inspectable defects, printable/uninspectable defects, and unprintable defects are classified based on the inspection and defect review.

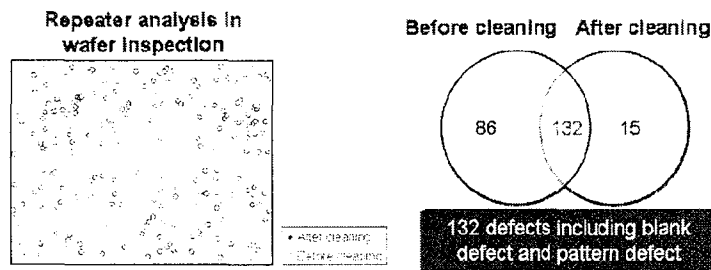
Figure 8. Particles in the repeater analysis to extract defects on the blank and pattern

After repeater analysis, non-repetitive process defects can be excluded from wafer inspection. Two wafer inspections, including mask cleaning, were performed to classify particles added during mask handling and shipping. As a dual pod was not used when the mask was shipped from Asia to the USA, many particles can be added or removed by cleaning. However, when a dual pod is used for this kind of test, fewer particles are added. When the coordinates of the two inspection results are compared, a coordinate that is not overlapped is considered a particle, because all particles can be cleaned or moved to another location. Overlapped coordinates are classified as a printable pattern defect or blank defect. The first and second wafer inspections detected 218 and 147 repeated defects, respectively. Unoverlapped 86 and 15 defects from two repetitive wafer inspections were classified as particles, and 132 defects can be considered blank and patterned defects. This assumption is based on the fact that all particles could be cleaned during mask cleaning. The coordinates of the defects from wafer inspection and patterned mask inspection were compared to determine which patterned defect is detectable by patterned mask inspection. The rest of the defects can be considered printable blank defects, which are detected by wafer inspection tool (see Figure 9). Ninety-five defects were detected by patterned mask inspection, but not by wafer inspection. Fifty-eight defects were detected by both inspection tools. Seventy-four defects were detected by only the wafer inspection tool. Those can be considered printable blank defects. The printable blank defect density was  $0.63/\text{cm}^2$ .

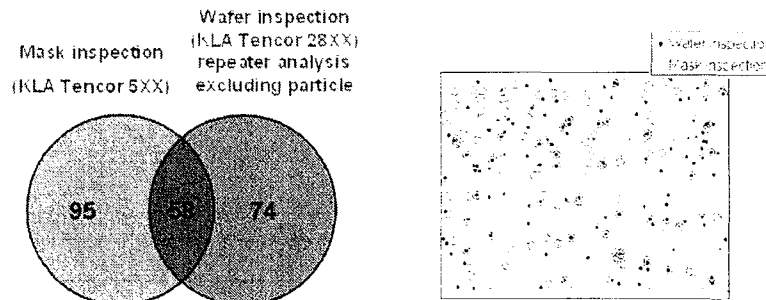
(a) Comparison of mask inspection and wafer inspection (b) Coordinates of defects

Figure 9. Comparison of patterned mask inspection and wafer inspection

Ninety-five defects, which were detected by only the patterned mask inspection tool, were reviewed by wafer review scanning electron microscopy (SEM) to determine whether they are unprintable on the wafer or undetectable by the wafer inspection tool. Twenty-five defects were printable on the wafer, but not detected by the wafer inspection tool. The other 70 defects were unprintable on the wafer, which is why they could not be detected by the wafer inspection tool. Figure 10 shows the kinds of defects that are more detectable by the wafer inspection tool. Small defects such as protrusions are difficult to detect with the wafer inspection tool, but they can be detected with the patterned mask inspection tool. Large defects or bridge defects are easily detected by both inspection tools. From these results, the patterned mask inspection tool is more sensitive than the wafer inspection tool. We therefore need to find ways to improve the sensitivity of wafer inspection. SEMATECH is focusing on improving sensitivity using the two methods described below. Figure 11 shows some SEM images of the defects from this study.

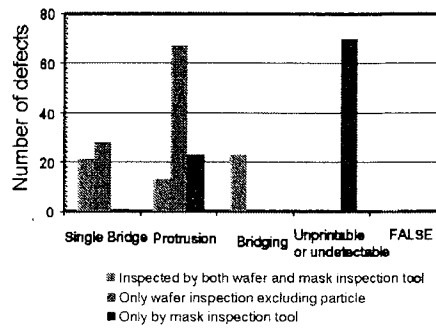
Figure 10. Comparison of sensitivity to defects on an EUV mask

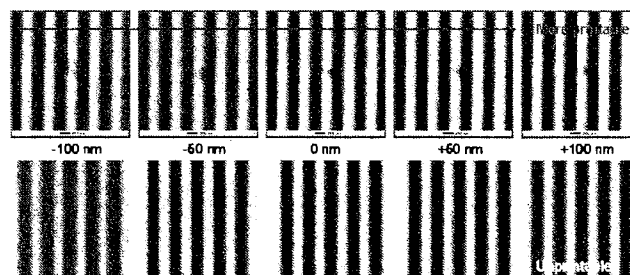
AIT Images In through focus @ pixel 4 in M7360

Figure 11. AIT images in through focus @ pixel 4 in M7360

Phase defects on mask blanks have a strong focus-dependent printability on the wafer. The printability of pits and bumps is opposite from through focus. Figure 11 shows some AIT review images of blank defects on the mask [4]. Each defect has a different printability at through focus [5]. This means that through-focus wafer inspection can improve the detectability of the wafer inspection tool. Wafer inspection of the exposed sample from through focus can improve the sensitivity toward blank defects. Defect printability depends on size, profile, and location. Furthermore, different wafer stack will induce different sensitivity. Wafer inspection is less sensitive toward developed resist images than SiN wafer stacks because of the improved contrast in the pattern of the SiN stack on the wafer in the wavelength of the inspection source. An improved wafer inspection sensitivity of about 20% has been demonstrated using an underlayer stack (SiN) rather than developed resist (see Figure 12).
