Inspection Methods for Characterizing Subsurface Impact Damage in Solid Laminate Aerospace Composites

**Stephen Neidigk, Dennis Roach,
Tom Rice, Randy Duvall**
FAA Airworthiness Assurance Center
Sandia National Labs

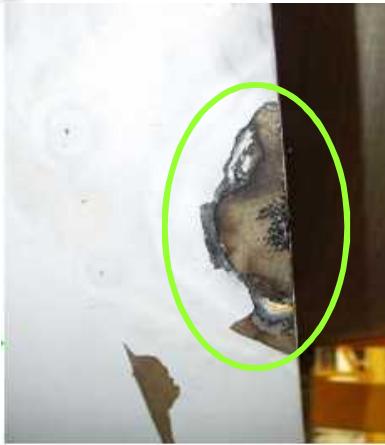
Lightning Strike on Thrust Reverser

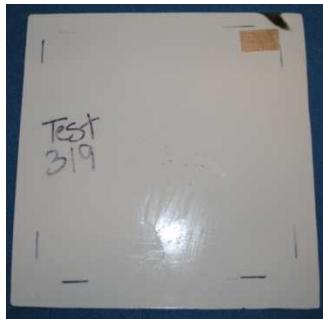
TC-16-25

Impact Energy (J) - 525.1

Flaw Size MAUS PE (mm²) - 37,128
Flaw Size Omniscan PE (mm²) - 28,380
Flaw Size TTU UCSD (mm²) - 26439

Picture
