# Effect of Build Orientation and Post Machining on AM 316L Part Failure

Michael Heiden, David Saiz, Dan Tung, John Miers, David Moore, Bradley Jared

Sandia National Laboratories, Albuquerque, NM

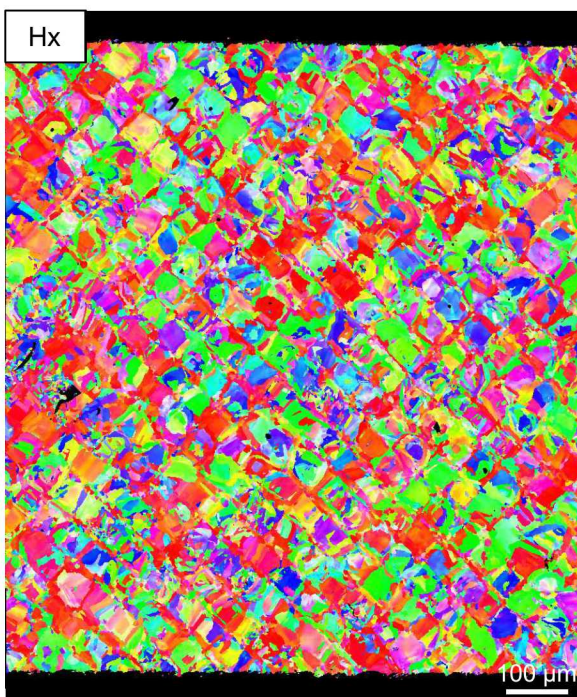
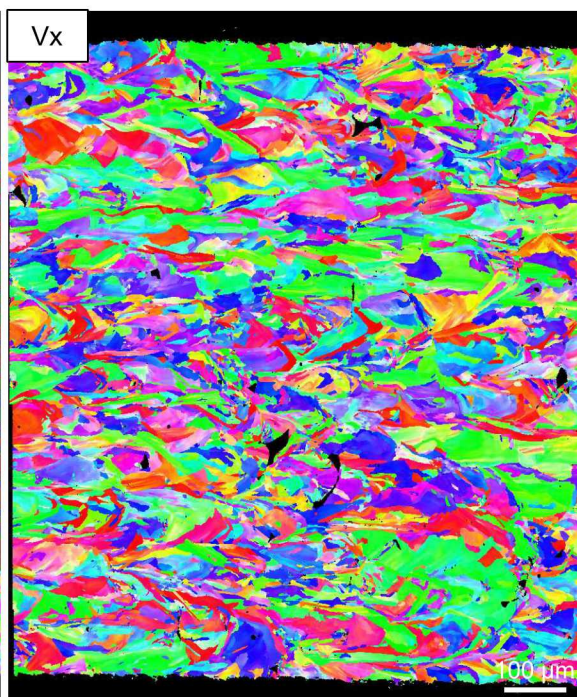
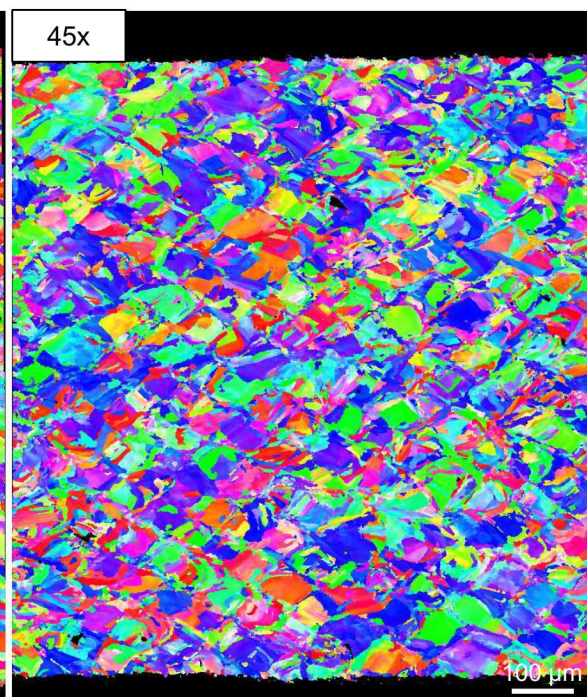
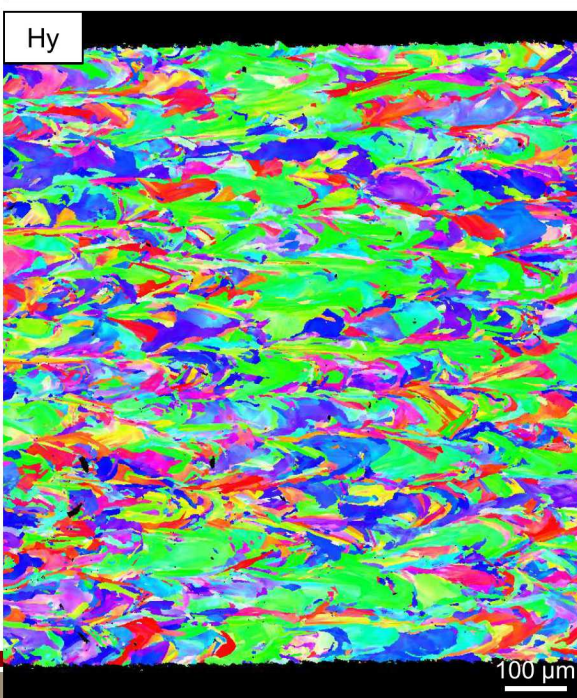
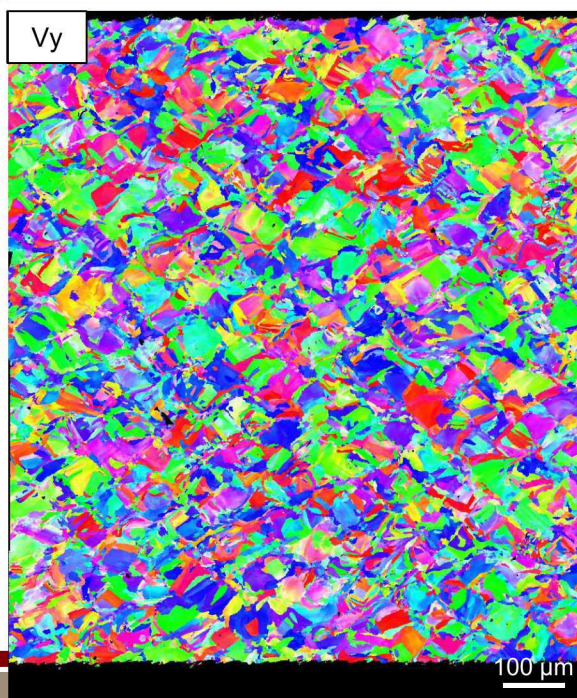
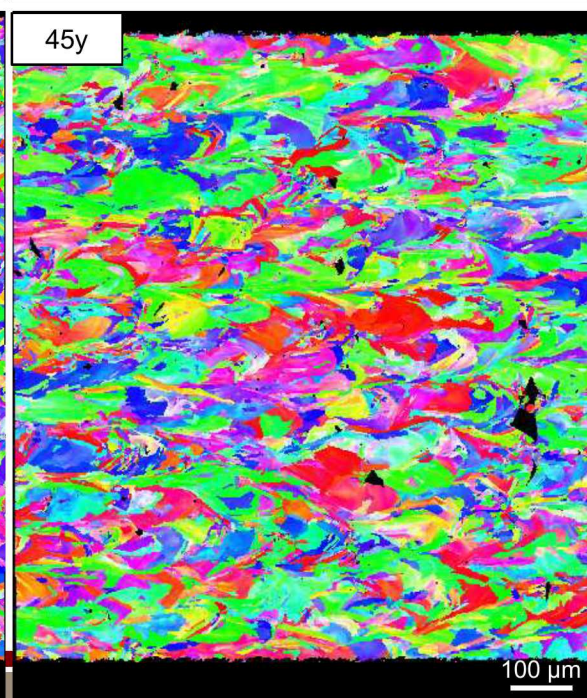
# Fractography

- 45° orientations fracture at that angle
- Out of page build direction  $\otimes$
