Crevice Corrosion in Seawater Using CFRP Composite as Part of a Novel Crevice Former

F. Presuel-Moreno*, B. A. Hernandez-Sanchez**,

Materials Challenges for Marine Renewables

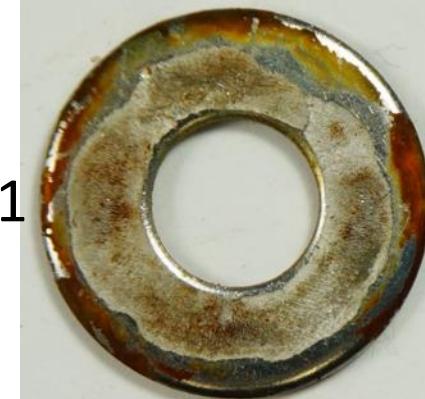
302 days

Stainless Steel Washers in contact with the CFRP composite, top row smooth side, bottom row rough side

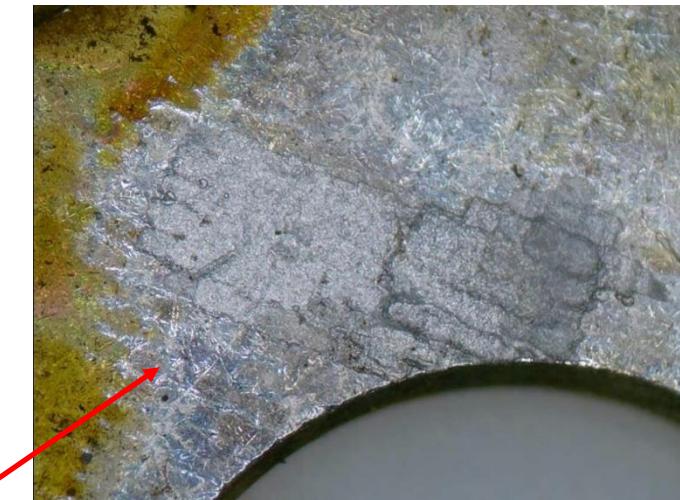
C1 corrosion occurred with large surface coverage on stainless steel, and most corrosion products leached out.

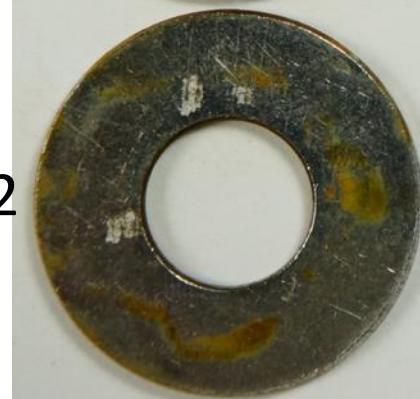
C2 corrosion occurred as different sizes of pits on stainless steel and as brown corrosion products that flaked easily on Monel washers.

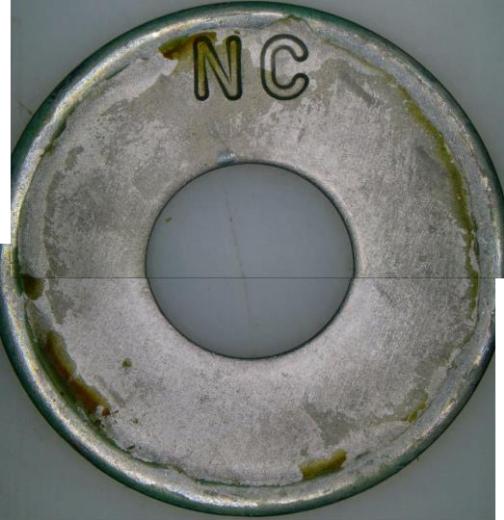
365 days

Monel washer surfaces in contact with the CFRP composite, top row smooth side, bottom row rough side

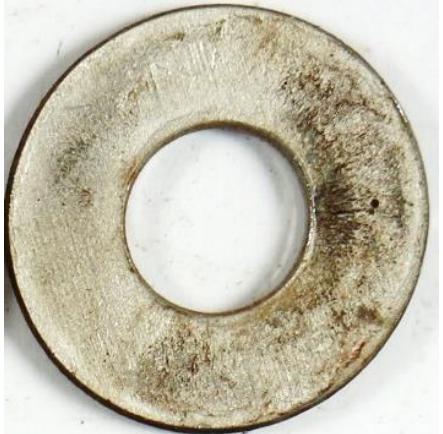
273 days

Stainless Steel Washers in contact with the CFRP composite, top row smooth side, bottom row rough side

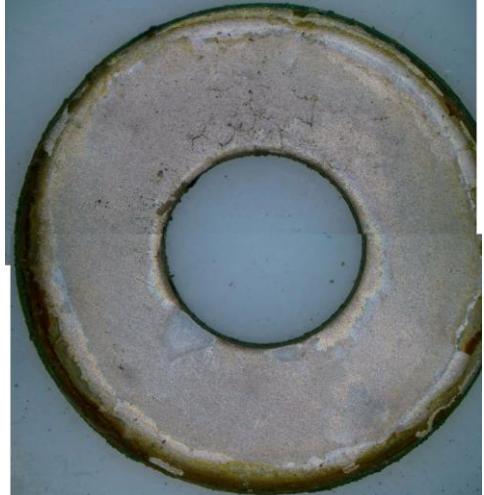
288 days

Monel Washers in contact with the CFRP composite, top row smooth side, bottom row rough side

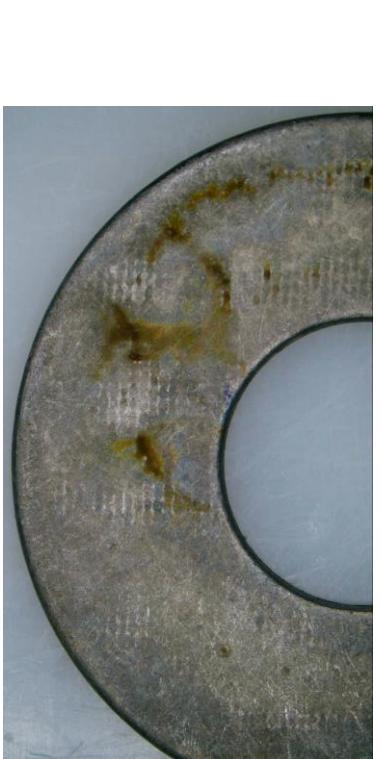
316 days

Titanium washers in contact with the CFRP composite, top row - smooth side, bottom row - rough side

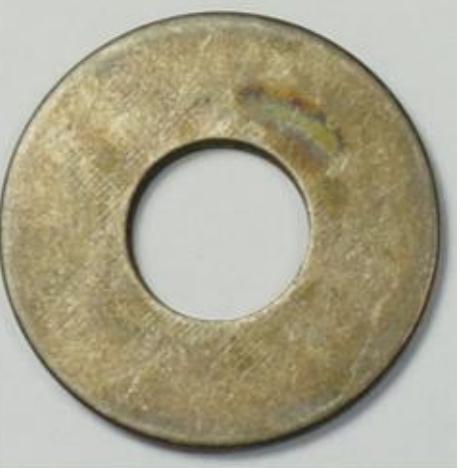
806 days

No corrosion took place on the Titanium washers within the time monitored

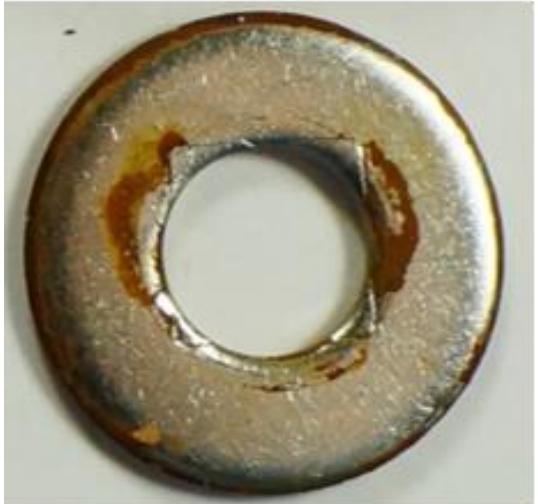
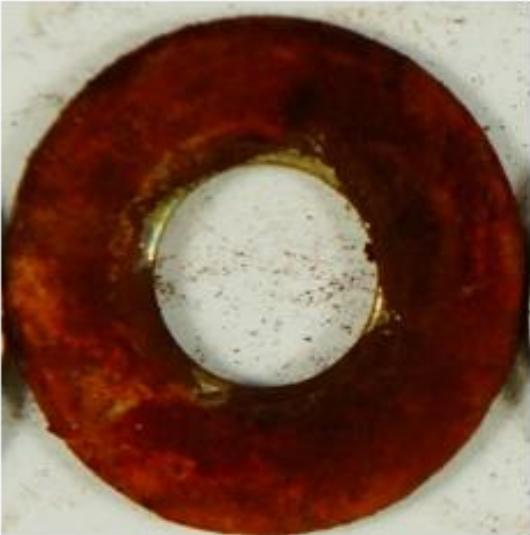
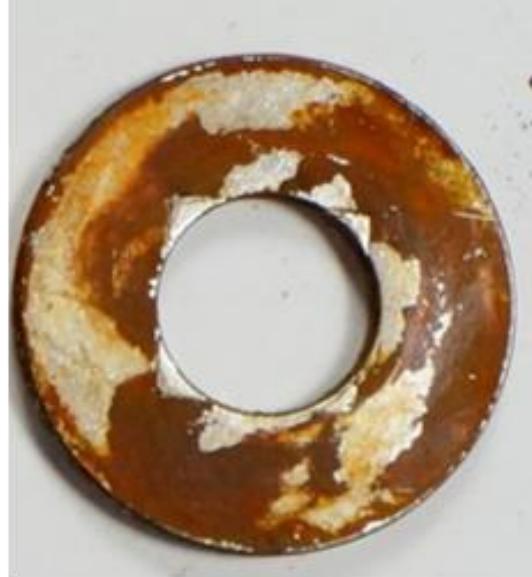
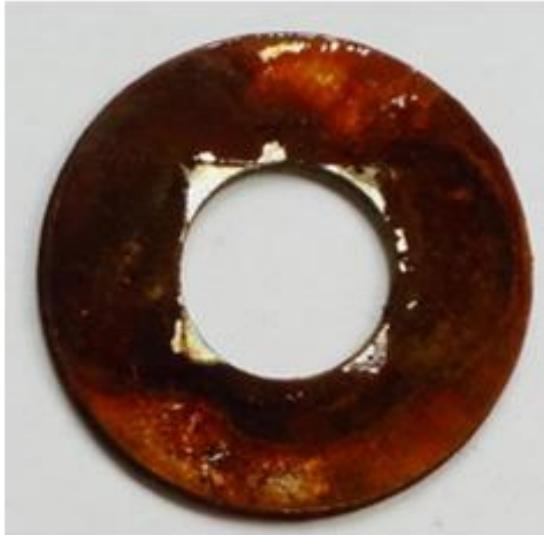
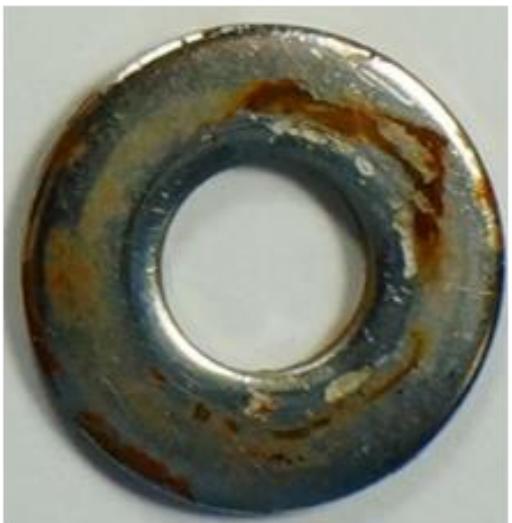
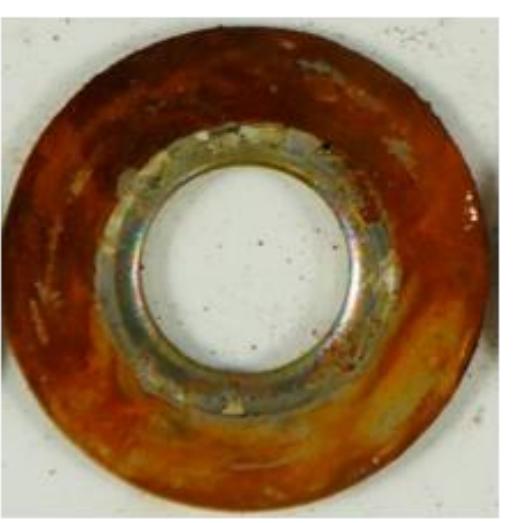
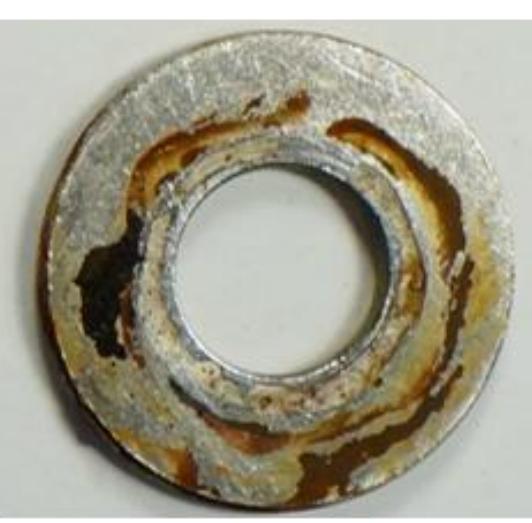
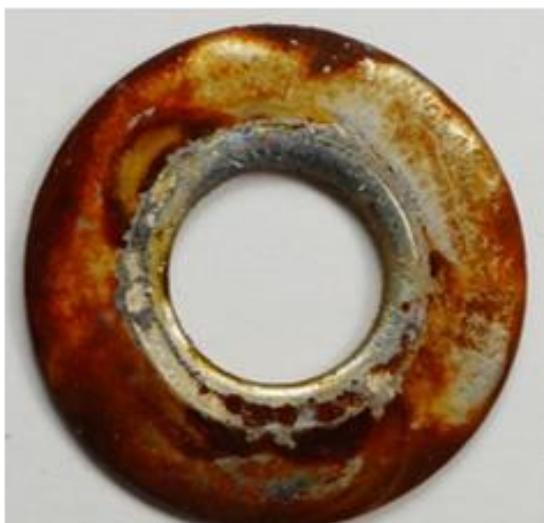
Elevated Temperature – Stainless Steel

Stainless Steel Washers in contact seawater, top row bolt, bottom row nut side

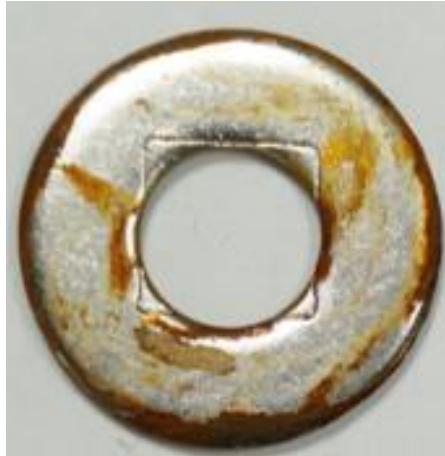
316 days

Washers in contact with the Hybrid composite, top row – bolt side, bottom row –nut side
