**Summary Environmental Site Assessment  
Report for the U.S. Department of Energy  
Oxnard Facility, Oxnard, California**

**February 1996**

Prepared by  
Rust Geotech  
Grand Junction, Colorado

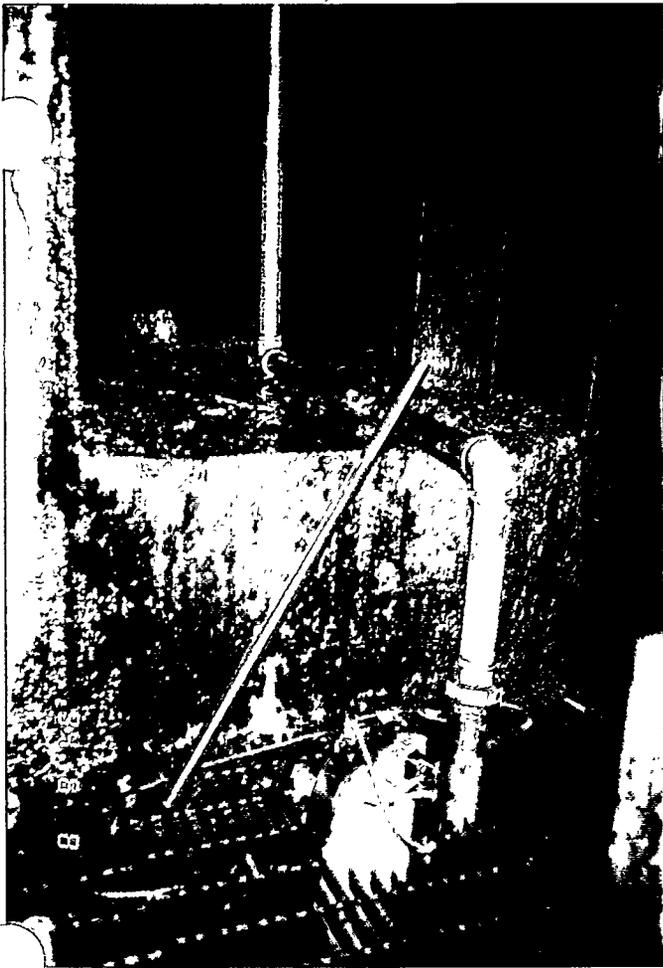
Building #6  
Forging Hammer Trench  
Forging Hammer Pedestal

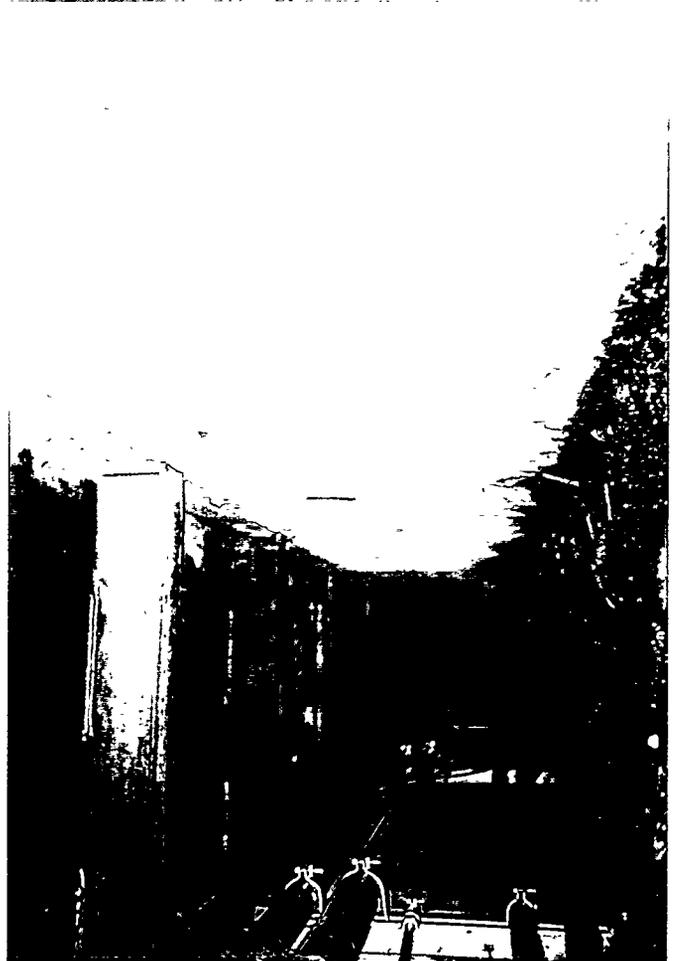
Building #6  
Forging Hammer Trench  
Oily Metal Shavings
