Title: 43-0434 Bridge Inspection Report 2022

Routine & Fracture Critical Member (FCM) Inspection Report (Interim)

Property ID No. 43-0434 – Los Alamos Canyon Bridge

Inspection Date: September 23 - 25, 2022

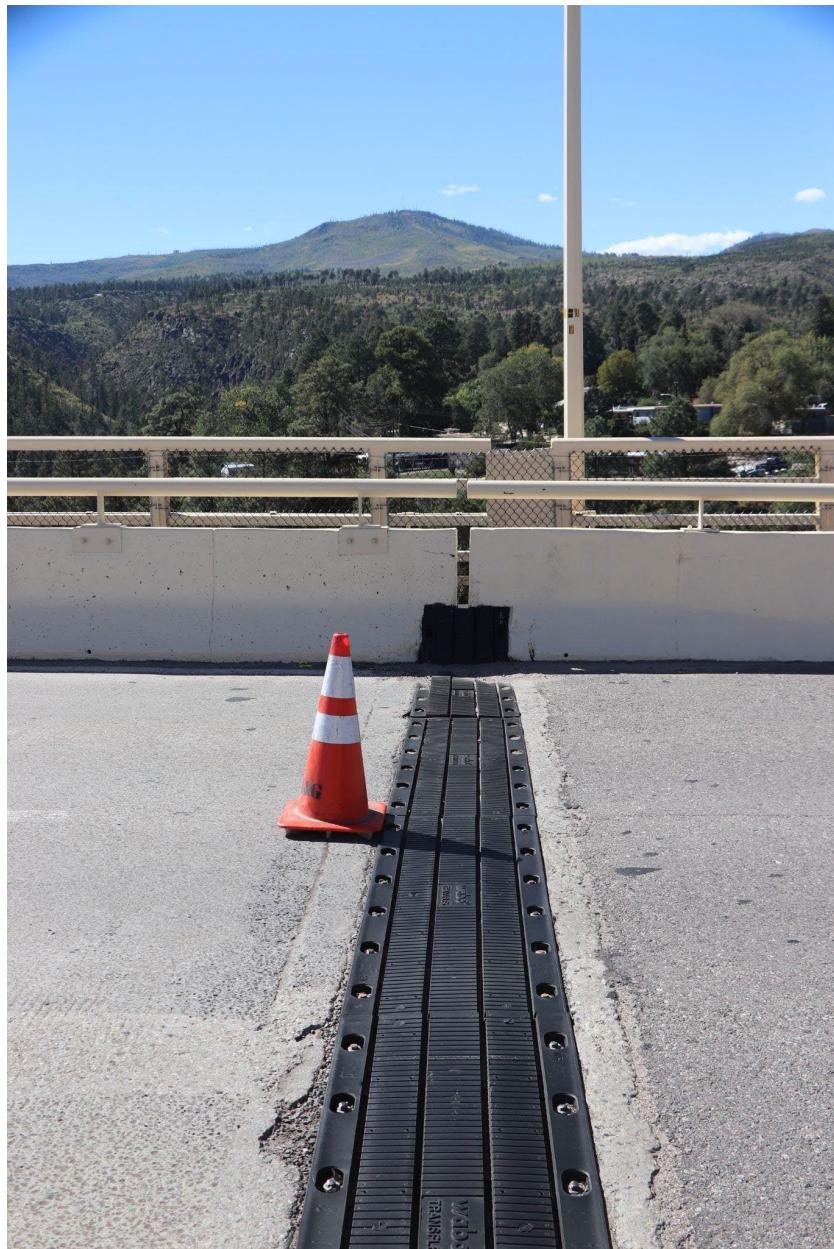
LANL 1 (IMG_6306.jpg)

The **deck edges** adjacent to the east and west bridge barriers have light map cracking, light leaching, and several small spalls. This condition is likely caused by water runoff which drains transversely in the east and west directions and then from the south to north end of the bridge. Installation of new north and south joints was being completed during the time of the 2022 inspection. See pictures LANL 1, LANL 2, and LANL 3 (south joint), and LANL 4 (north joint).

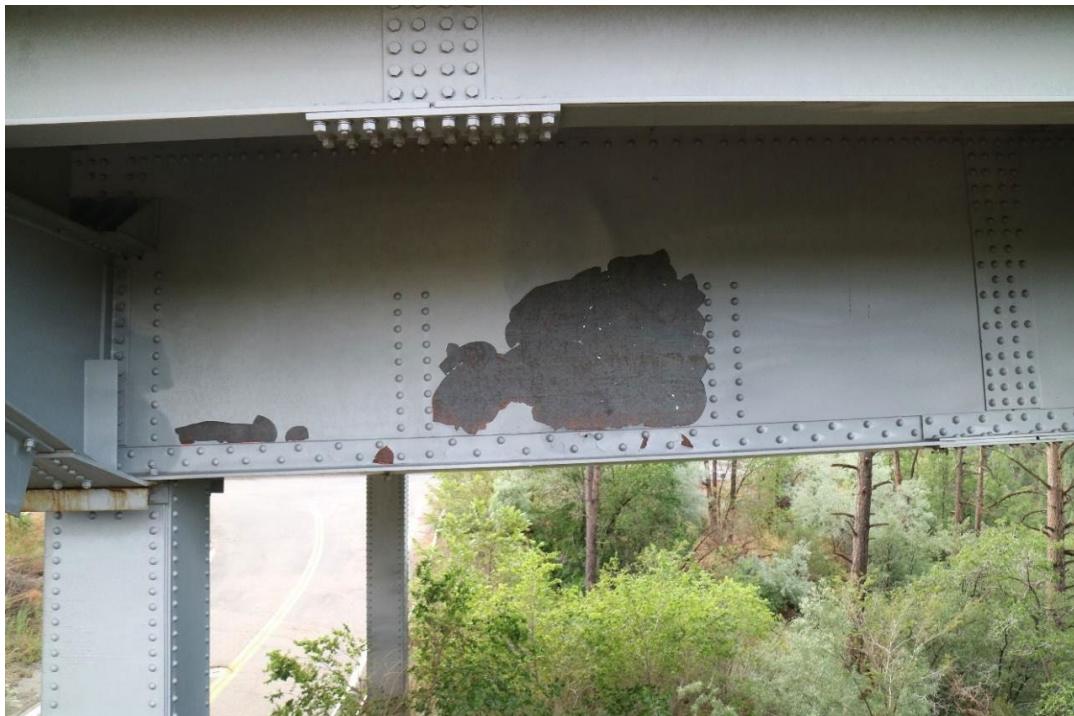
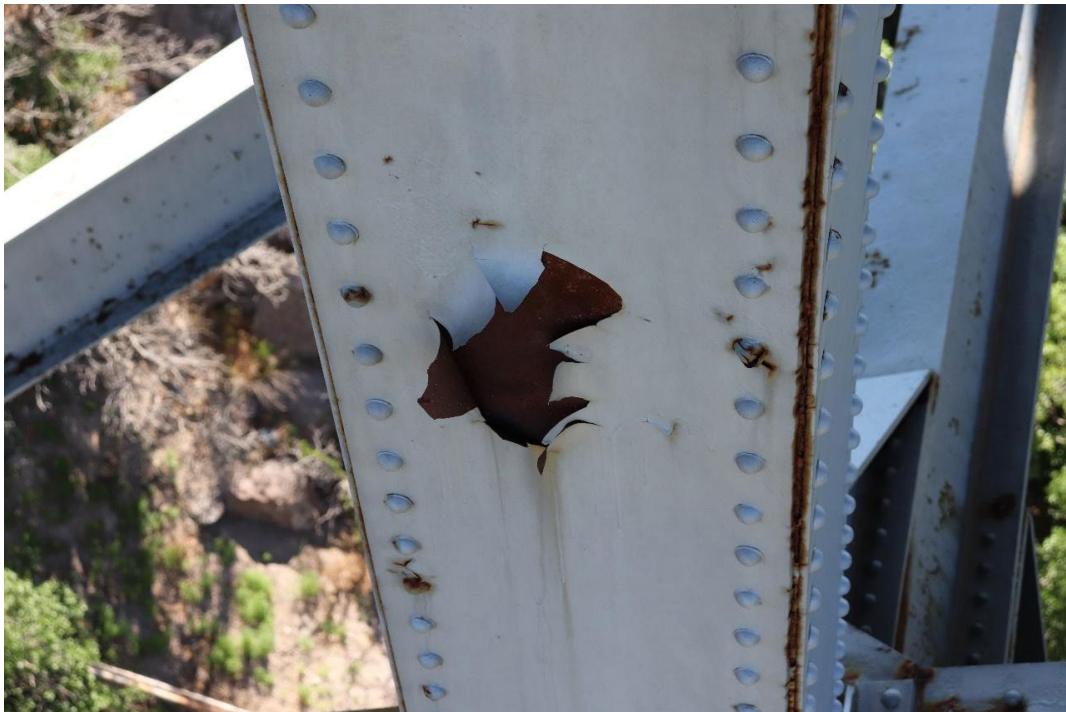
LANL 19: Moderate paint peeling on spandrel girder and column (2018).

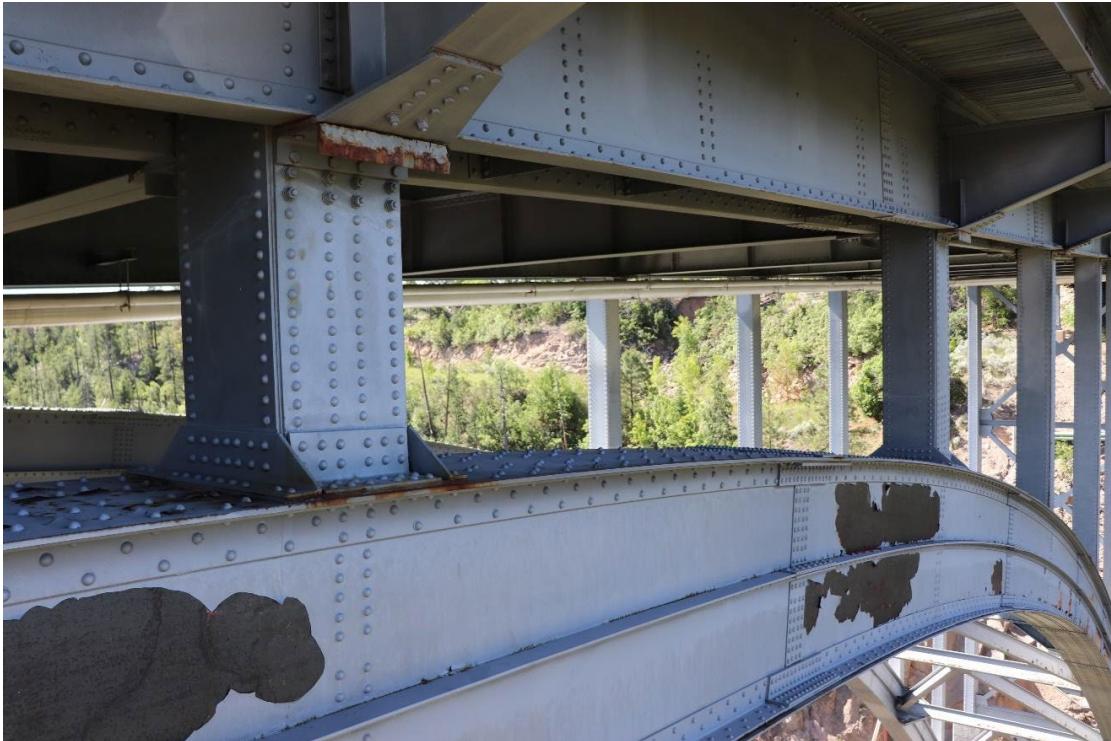
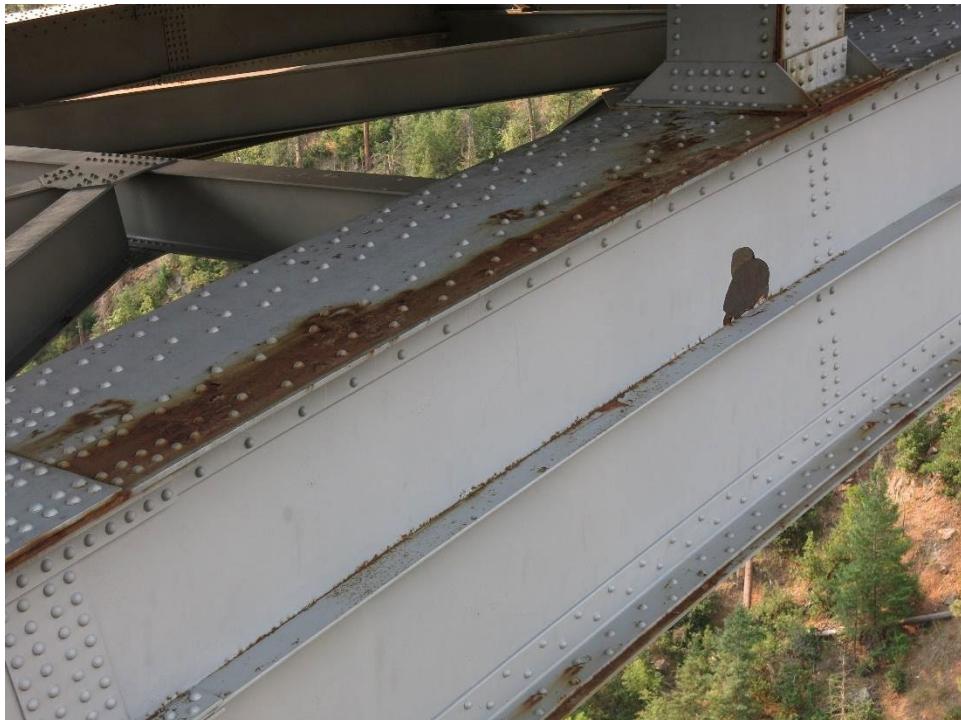
LANL 20: Moderate paint peeling on arch rib (2017).

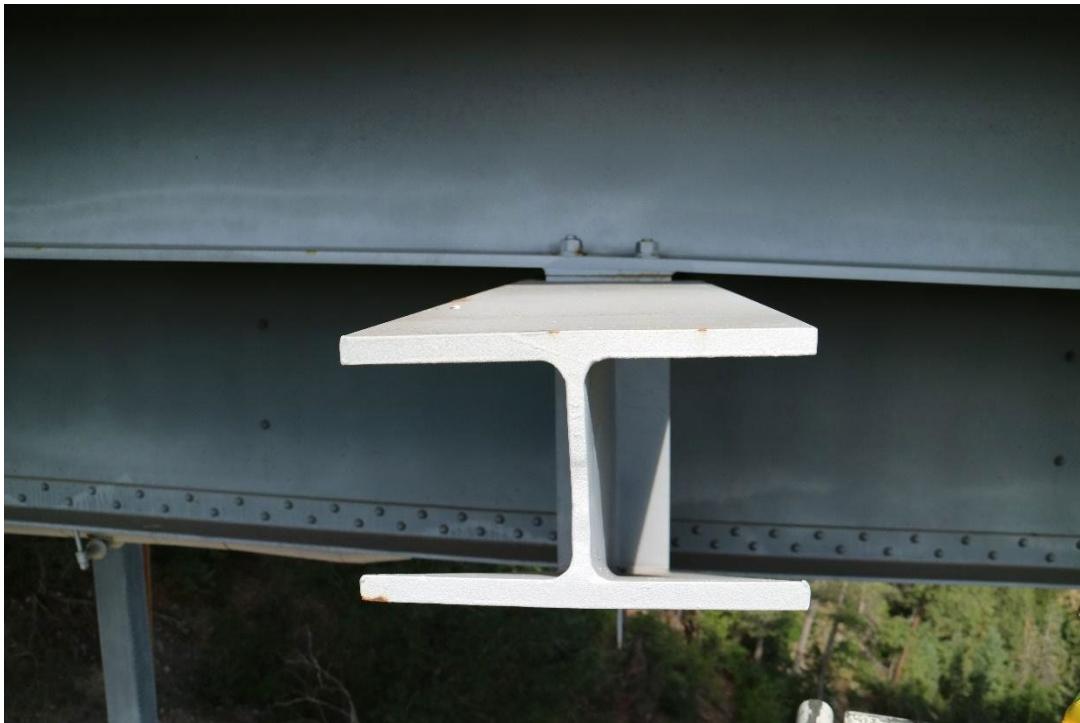
(a) Distortion (typical) of outriggers (2016)

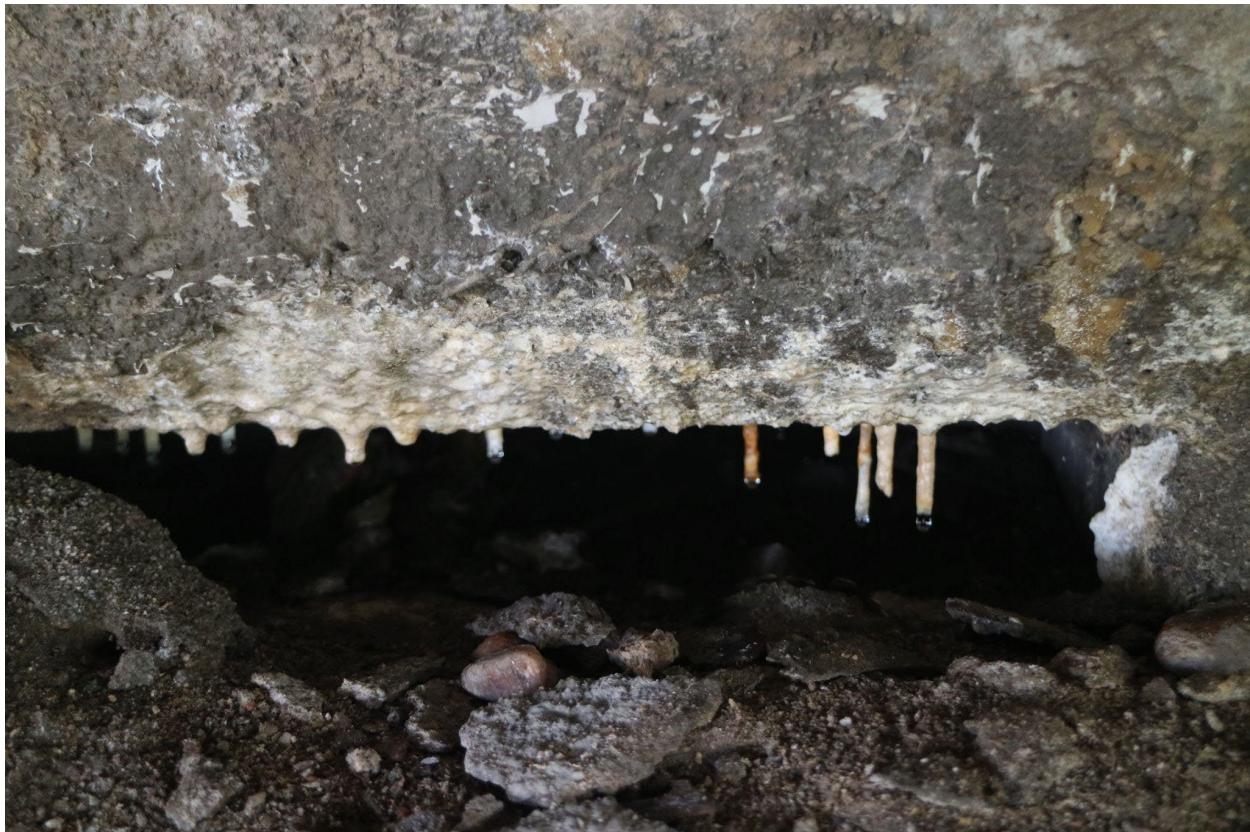
LANL 30 (IMG_0911)

Map cracking exists on the east and west sides of the back wall. Cracks in the west wingwall and the east side of the back wall have been sealed with epoxy. The steel top plate just under the expansion joint has cracked through the full thickness between stringers 3 and 4 (initially observed in 2006) and corrosion is evident at the crack and front edge of the plate. [See picture LANL 38](#). East side of the breast wall has undermined and the asphalt landing at the top of the slope continues to erode. [See pictures LANL 39 and LANL 40](#). Minor settlement of the west end of the bridge seat is evident.

Periodic cleaning and repainting of the bearing elements and ultrasonic testing of the pins is recommended.

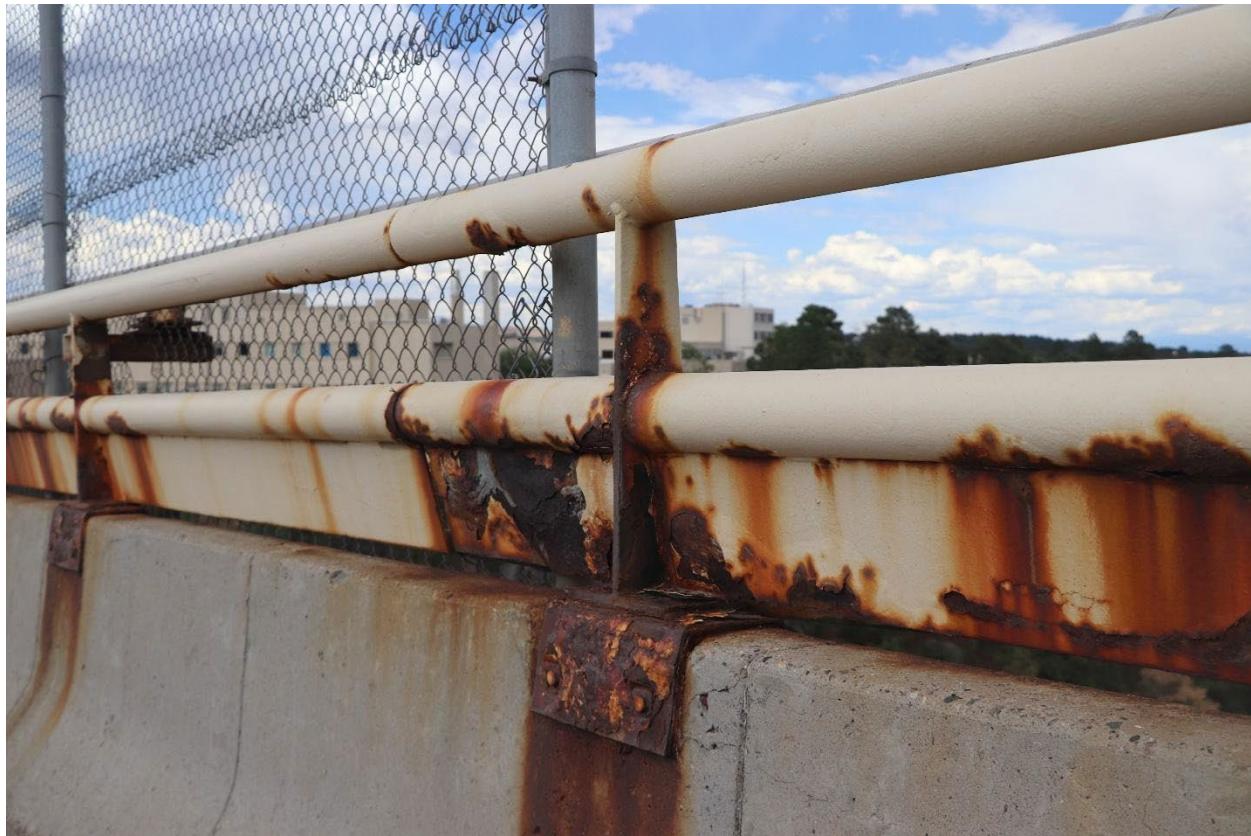
LANL 60 (IMG_0539.jpg) (2021)

concrete had spalled under the connection plates at several locations. At the west bridge rail, collision damage was previously found (consisting of severe cracking, delamination, and spalling) at a location adjacent to the north end of the pedestrian fencing and a longitudinal crack in the rail towards the south end. See pictures LANL 58 and LANL 59. At the east bridge rail, there was a large spall (measuring greater than 1 in. deep and greater than 6 in. diameter), a horizontal crack with delamination, and major scaling at the bottom half of the CBR located along the length of the pedestrian fencing. The bridge rail also had scrape marks with moderate corrosion on the north and sound ends and major corrosion on the south side of the pedestrian fencing. See pictures LANL 60. The steel bridge rail on the east side of the roadway was in worse condition than the west side.
