Title: Routine & Nonredundant Steel Tension Member (NSTM) Inspection Report (Final) Property ID No. 43-0434 - Los Alamos Canyon Bridge

Inspection Dates: June 7-9, 2024

Property ID No. 43-0434 - Los Alamos Canyon Bridge

Los Alamos Canyon Bridge on NM-501 (Diamond Drive) over Omega and Dulce Roads

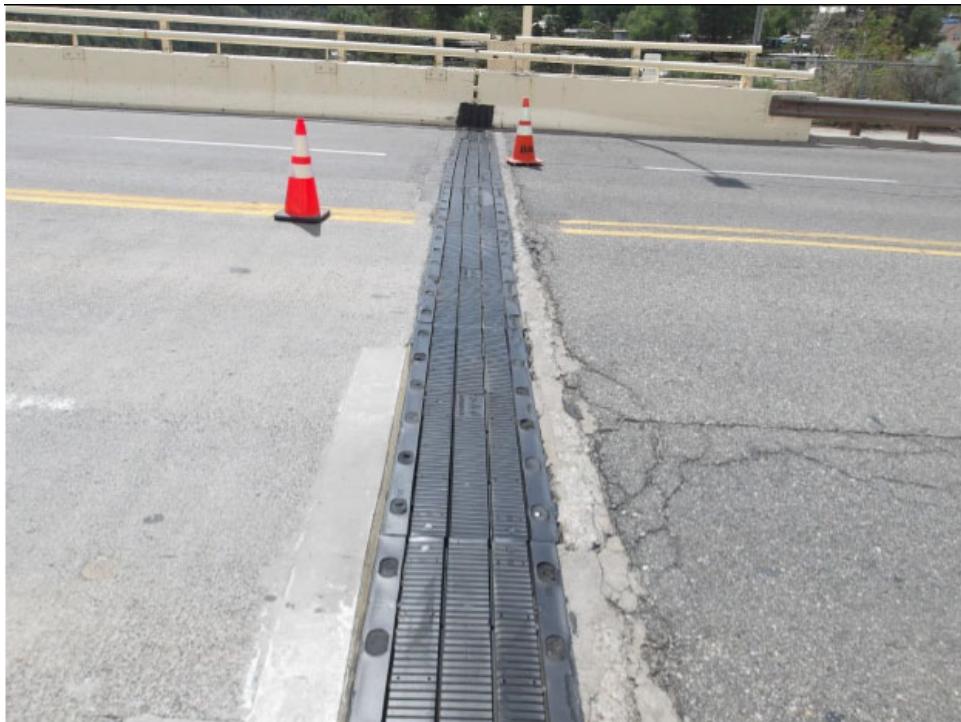
At the south joint, delaminated areas were found on the adjacent header areas of the bridge deck and approach roadway. Patch repairs at both the north and south expansion joints are adhering but there are cracks and delaminations at both joints (**Photos 2 & 3**). Additionally, cracking and spalling continues outside of the patches immediately north of the north expansion joint. There is a $\frac{3}{4}$ " vertical displacement in the southern expansion joint at the pedestrian walkway (**Photo 4**). Installation of new north and south joints was completed in September 2022 (**Photos 3 & 5**).

Photo 2- North expansion joint looking west; small spalls and delaminations (up to 1') along both edges of the deck joint.

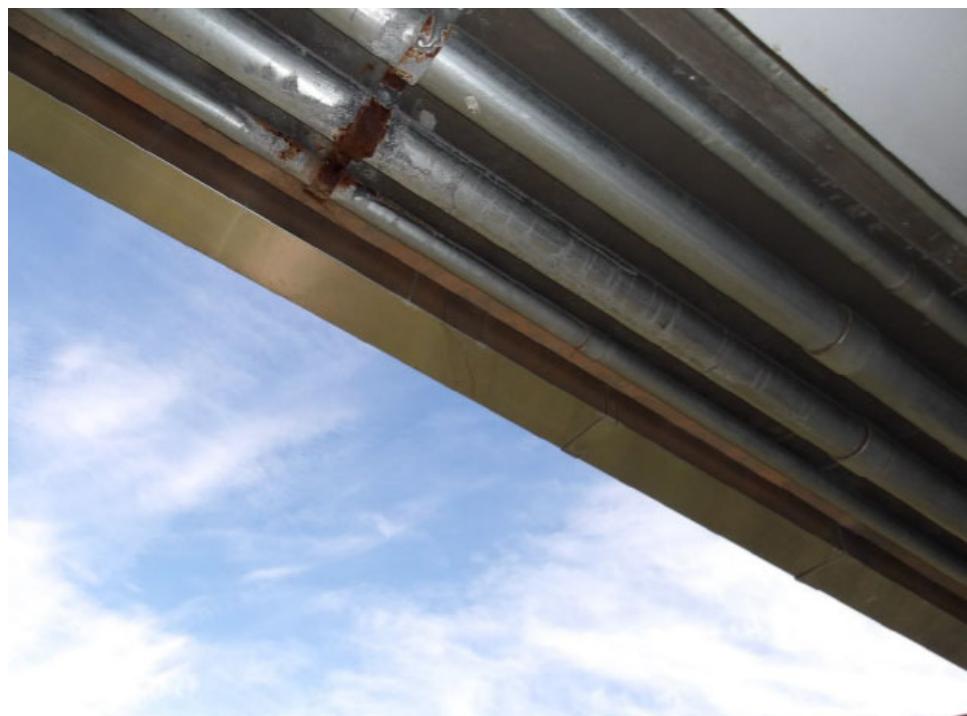
The light poles and supports previously had corrosion but were repainted in 2022 (**Photo 9**). The utility conduit clips under the western deck are heavily corroded due to the drainage at the west side of the bridge (**Photo 10**).

Photo 10- Utility pipes at west overhang. Heavy corrosion at the utility pipe clips. This defect is typical at all utility pipe clips at the west overhang.

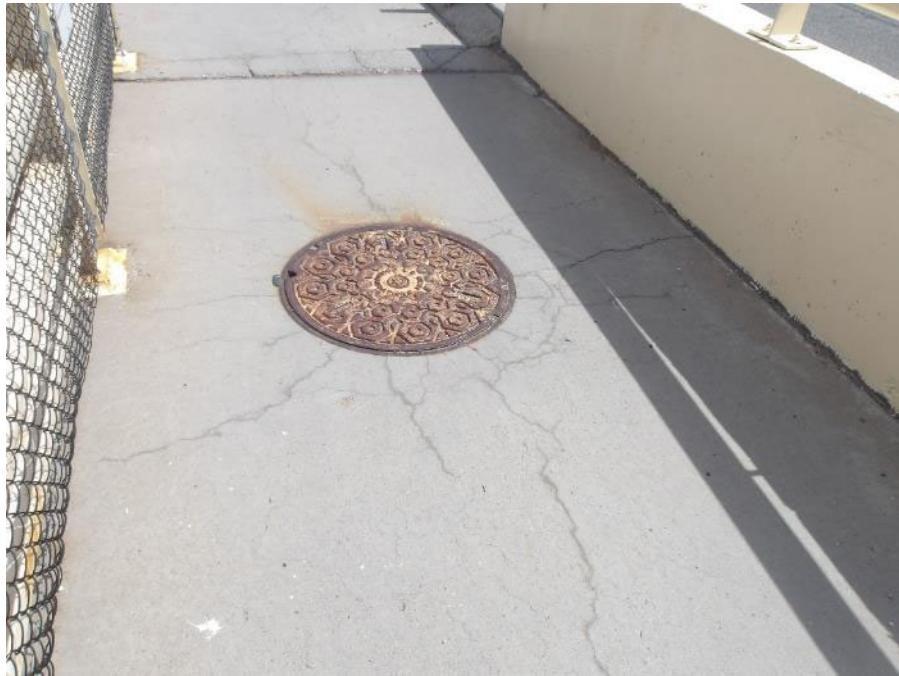
In general, the concrete sidewalk on the west side of the bridge has areas of abrasion/ wear with transverse, longitudinal and map cracks (**Photo 11**). Map cracking exists intermittently throughout the pedestrian walkway, notably at the north end and at the manhole cover at the north approach (**Photos 12 & 13**). There are numerous very small spalls and delaminations located adjacent to the base plates of the pedestrian rail connecting to the concrete sidewalk (**Photo 14**). The concrete at the pedestrian barrier is undermined at the north end towards the raised section of fence (**Photo 15**). Other inspection findings include minor leaching, undermining, and scaling of the concrete sidewalk adjacent to the CBR, minor corrosion of the pedestrian rail, damage to six (6) fence panels, minor debris buildup on the sidewalk, intermittent spalling (**Photo 16**), and missing joint material and debris buildup in the joints (**Photo 17**). The pedestrian rail was repainted in 2021 and chain link fencing was added that spans the areas between the rails. Damaged areas of the fencing identified in previous inspections have been repaired. In 2023, Suicide and Crisis Lifeline (988) signs were added on the walkway near the north and south ends and near midspan of the bridge.

Photo 12 – Map cracking at manhole cover at north approach of pedestrian walkway.
Map cracking is typical throughout the pedestrian walkway.

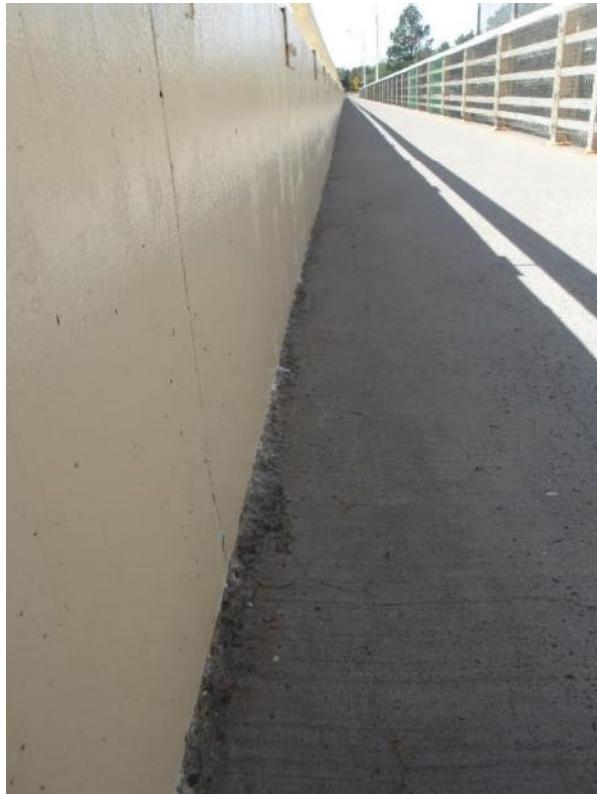
Photo 15- Undermining of the concrete bridge barrier towards the north end of the raised section of the fence.

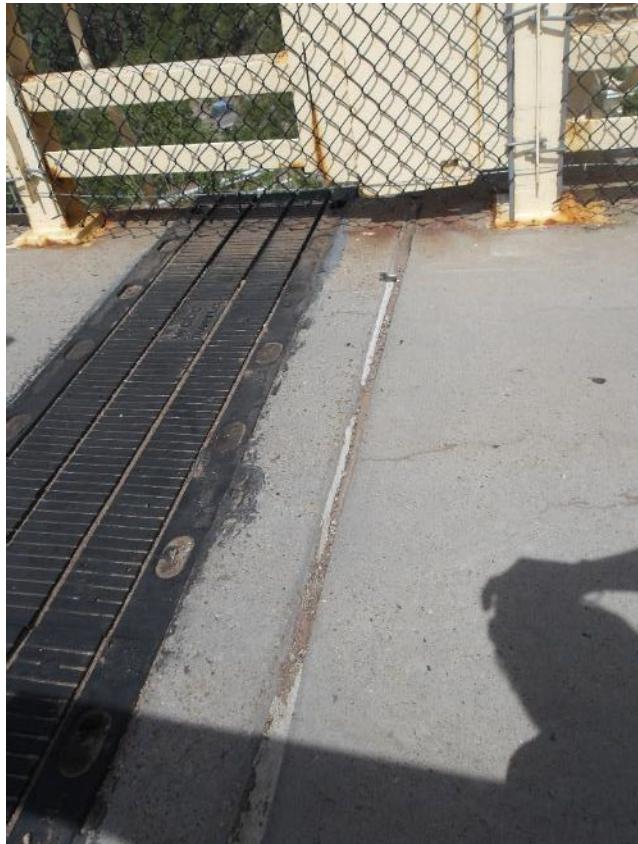
Photo 17- Missing joint material and debris accumulation at north end of pedestrian walkway.

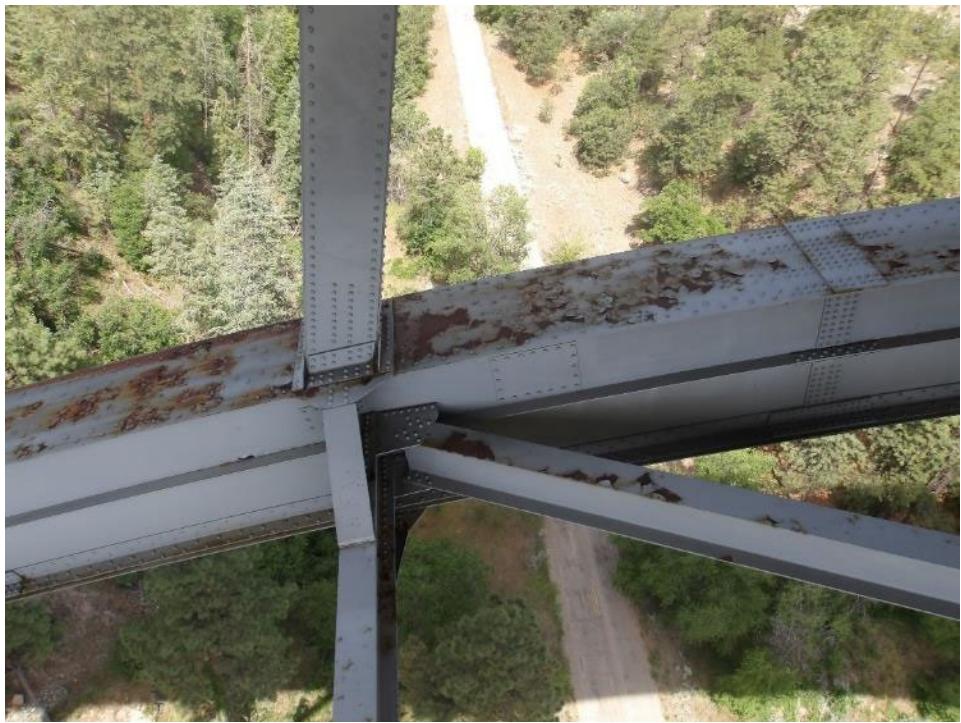
Photo 21- Minor corrosion on top plate of west arch at column 5.

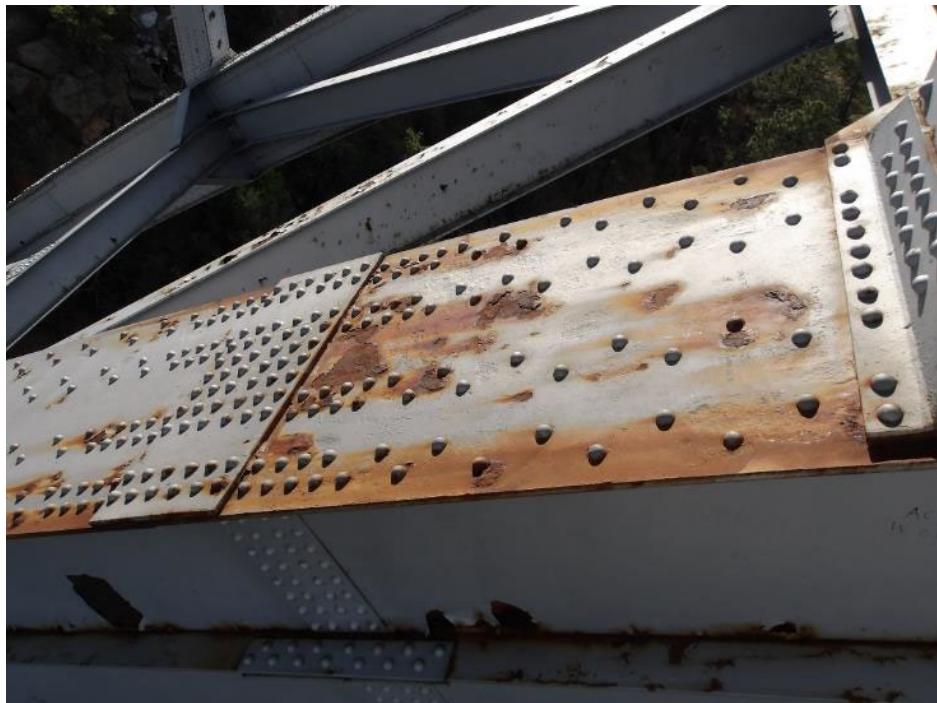
Photo 22- Minor corrosion on top plate of west arch at column 11.

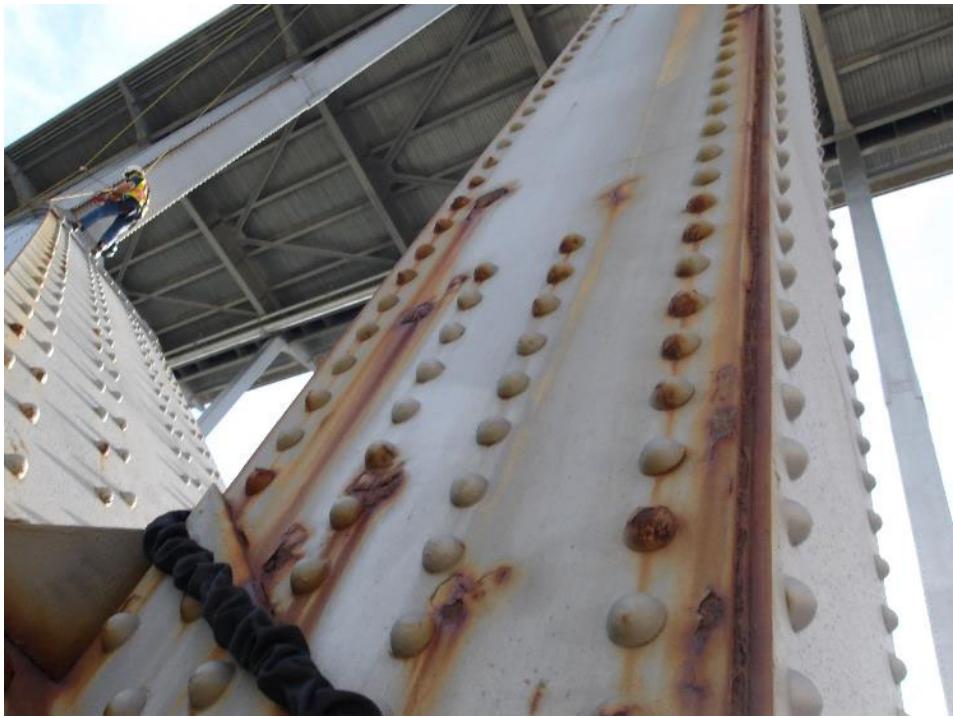
Photo 35- Arch column 1W, minor corrosion and paint failure at base.

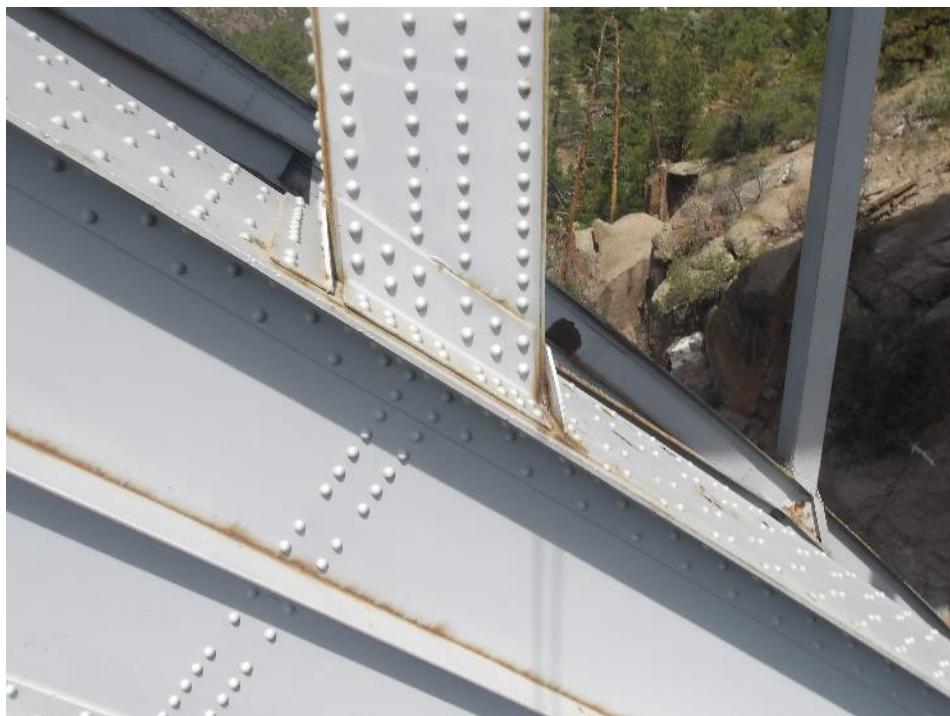
Photo 36- Arch column 13E, minor corrosion at base.

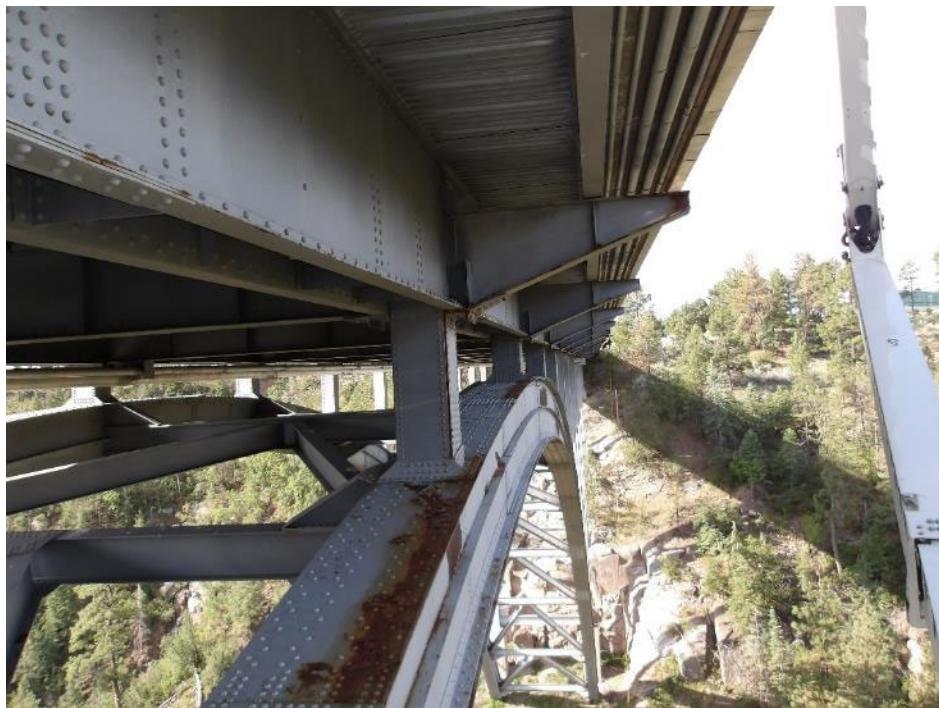
Photo 43- General view of spandrel girder in satisfactory condition, looking at arch column 10W. Note minor corrosion and pack rust at splice location.

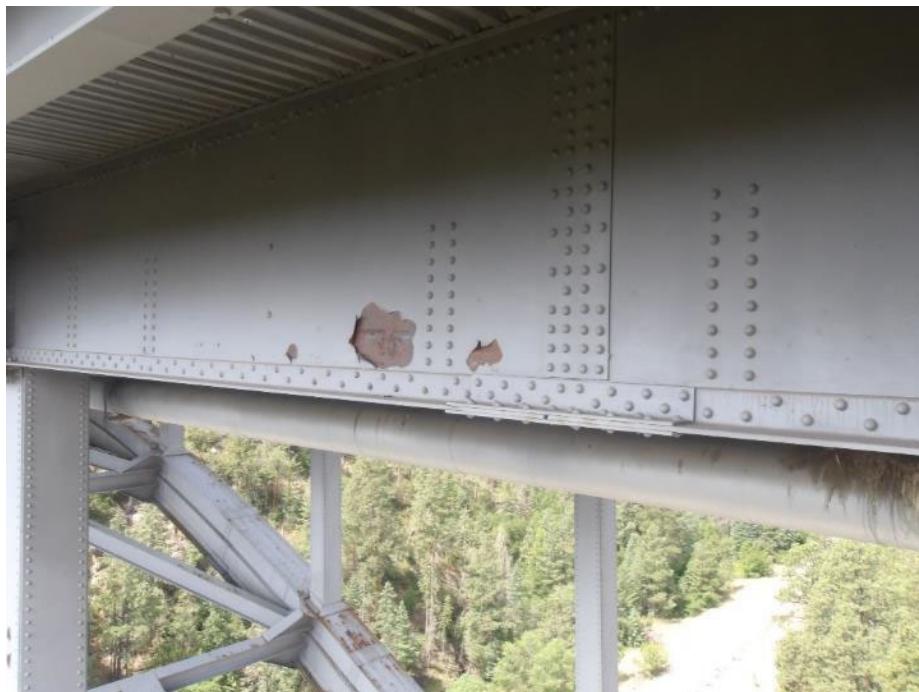
Photo 44- General view of spandrel girder in satisfactory condition, east face near arch column 13E. Paint peeling and minor corrosion.

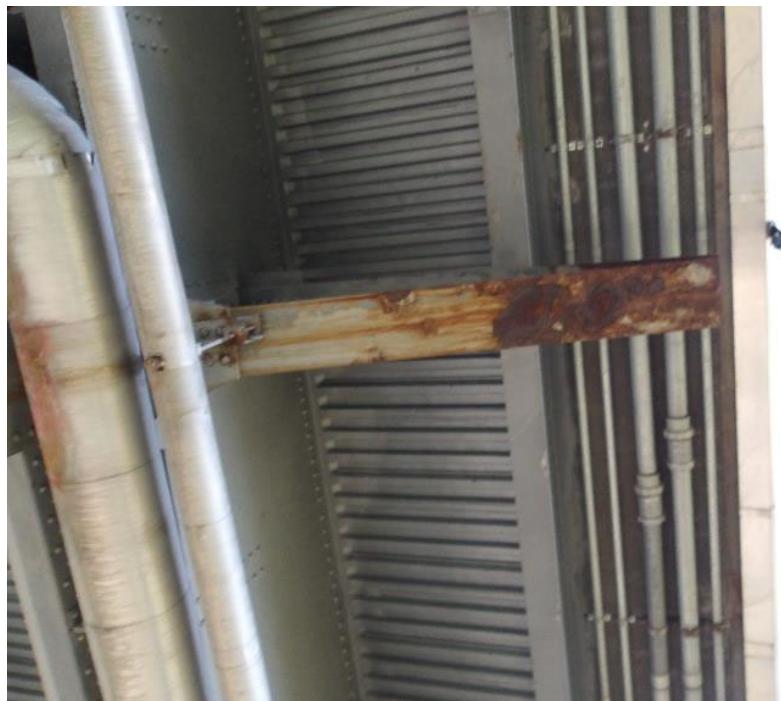
Photo 48- End of outrigger at column 1W west side, moderate corrosion and section loss in zero stress area past the stringer. Minor corrosion with no section loss from stringer to spandrel girder.

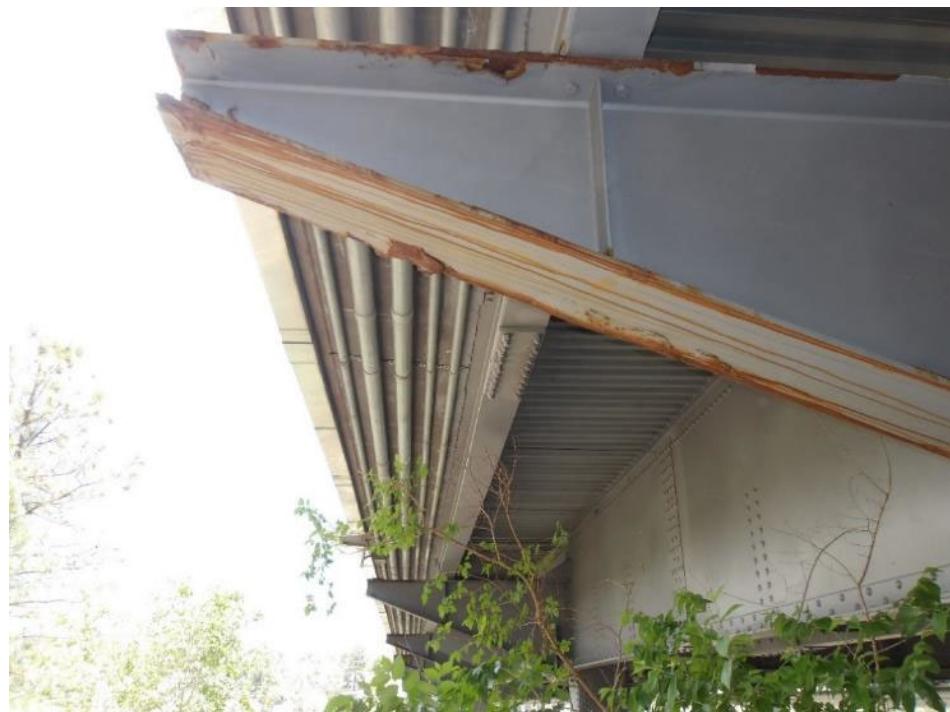
Photo 49- View of outrigger at FB2 on West side, minor surface corrosion.

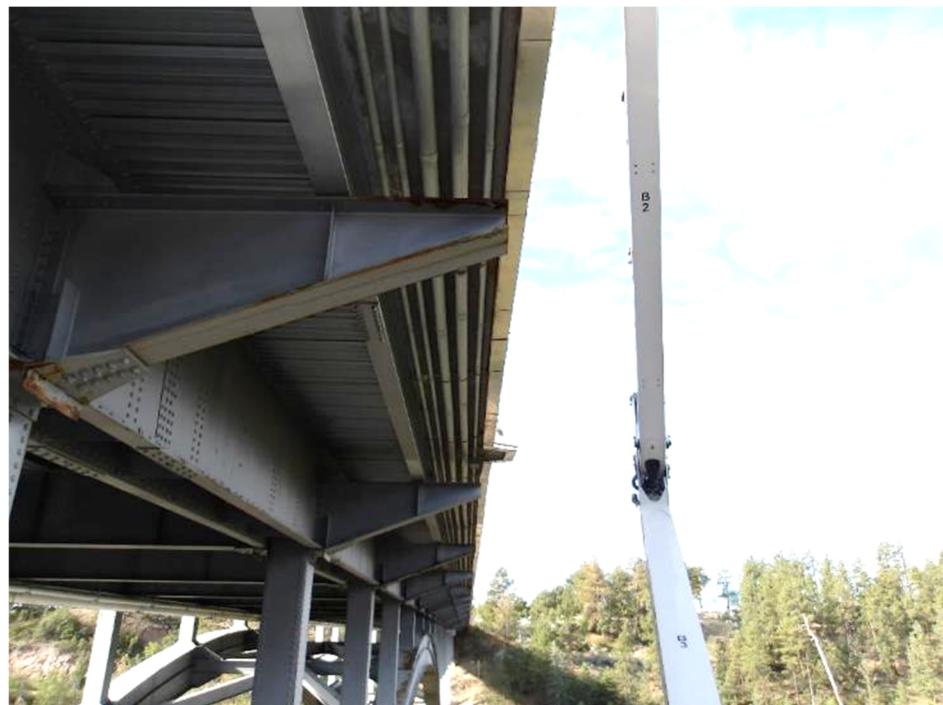
Photo 50- General view of outriggers in satisfactory condition, taken on west side at arch column 11.

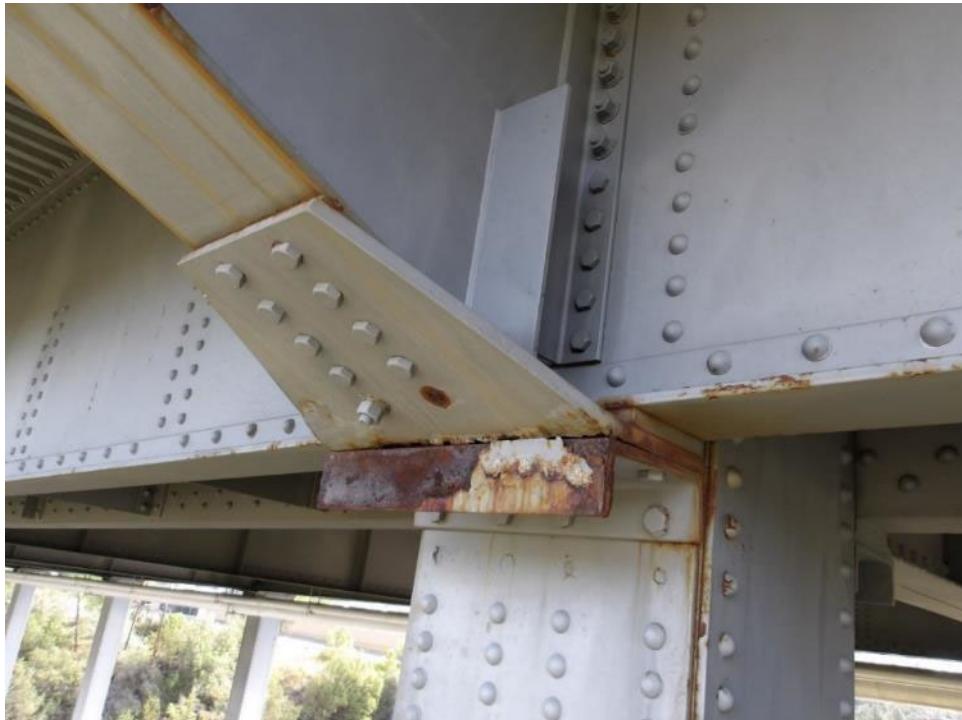
Photo 52- Missing nut and broken bolt at outrigger gusset plate at arch column #8, west. Moderate corrosion and pack rust between channel and bottom of outrigger.

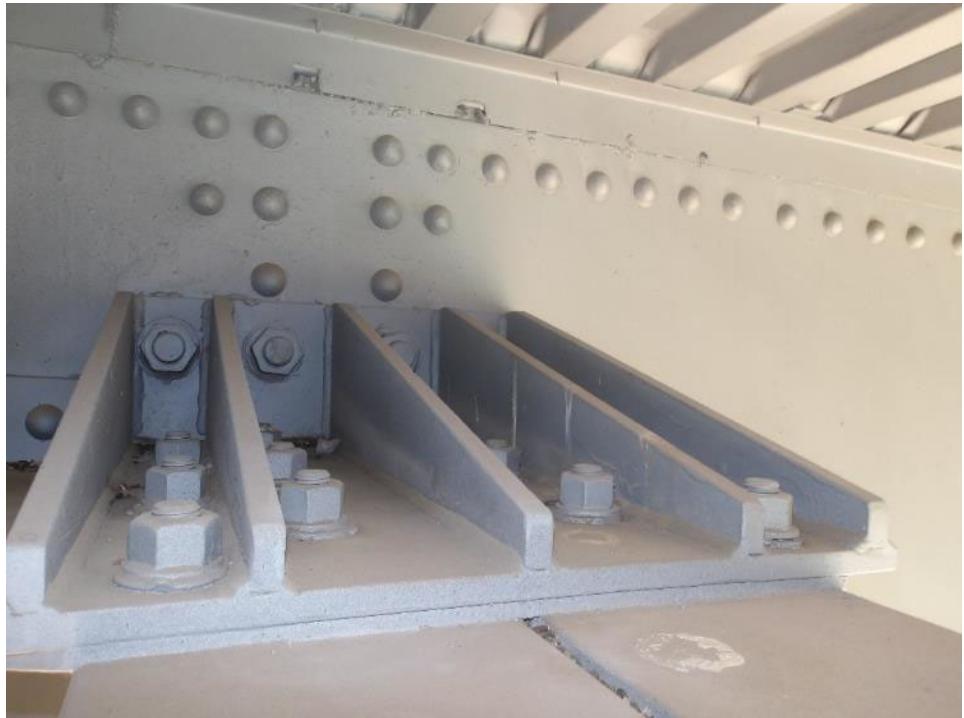
Photo 53- Typical connection of outrigger to floorbeam on interior side in good condition.

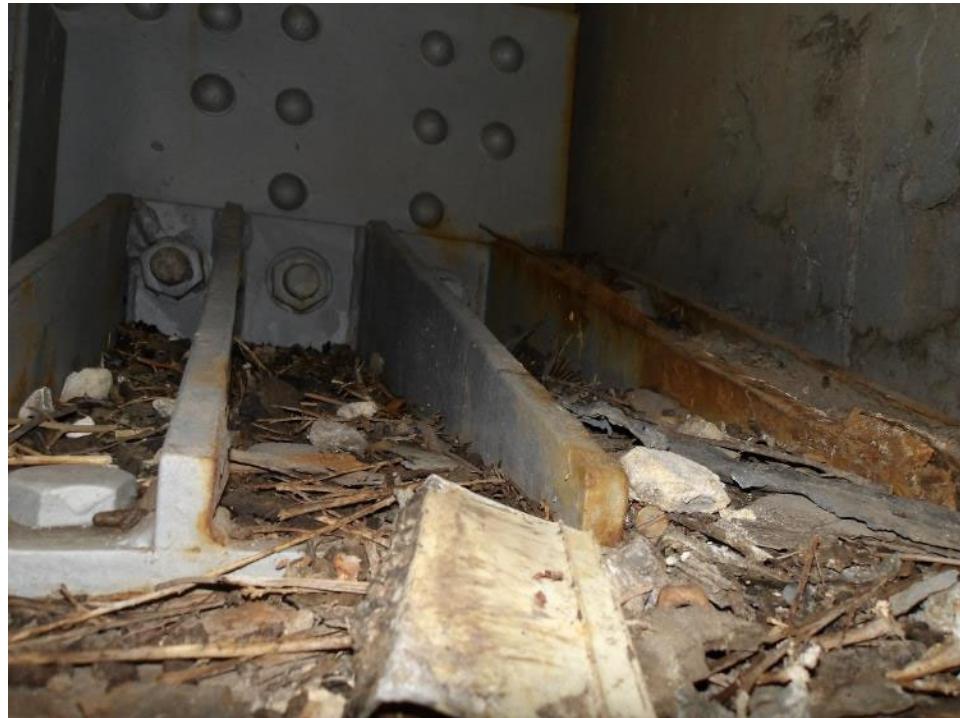
Photo 55- East interior outrigger connection at south abutment, debris buildup and minor corrosion.

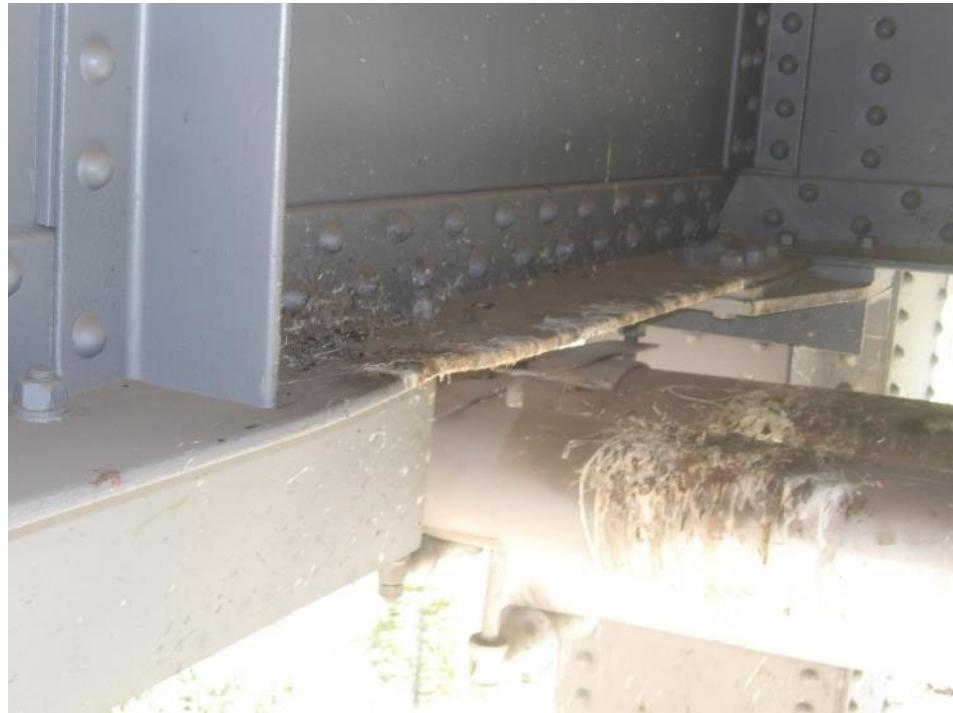
Photo 59- Typical minor deformation in bottom flange angle of floorbeam, east end of FB at column S1 shown.

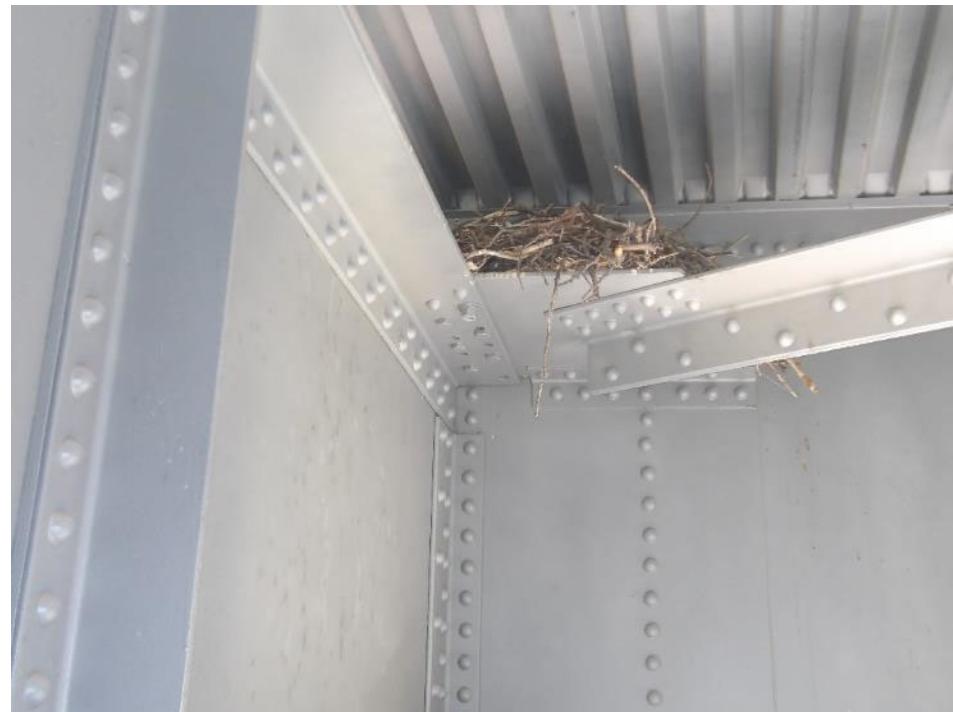
Photo 60- Bird nest on top of connection plate and floorbeam top flange, noted in multiple locations on bridge, east side floorbeam at south skewback column shown.

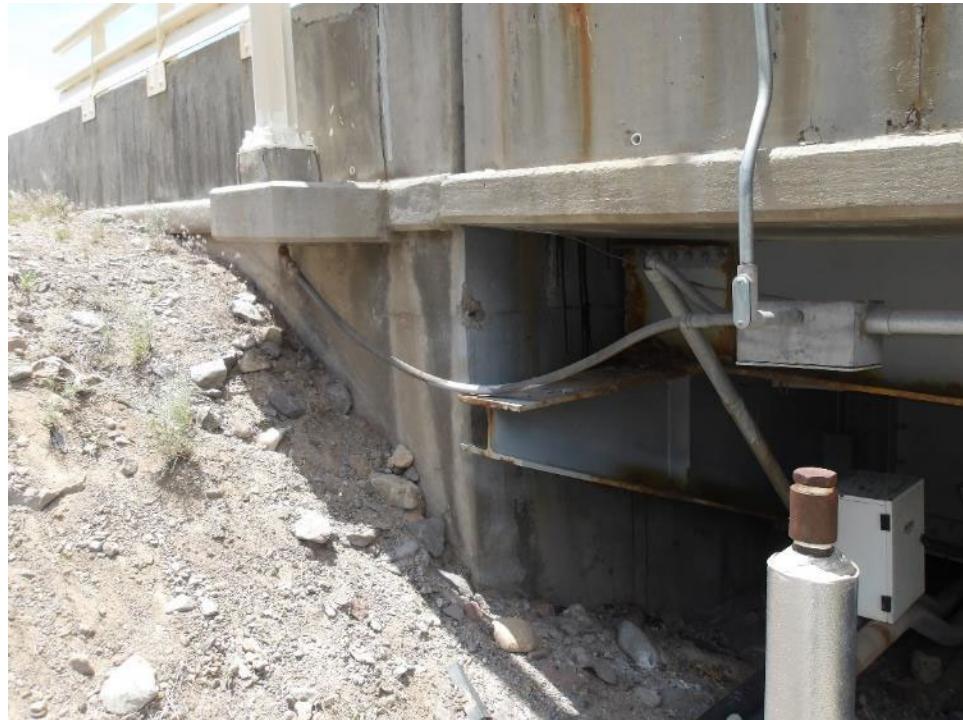
Photo 71- East wingwall at south abutment. Small spall with exposed reinforcement.

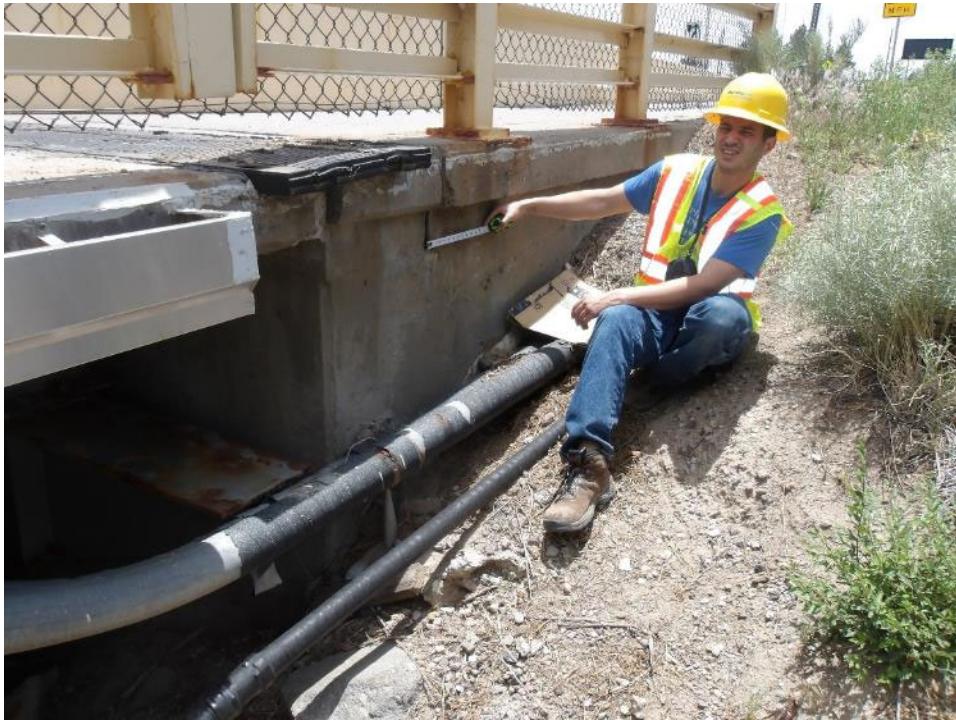
Photo 72- West wingwall at south abutment.

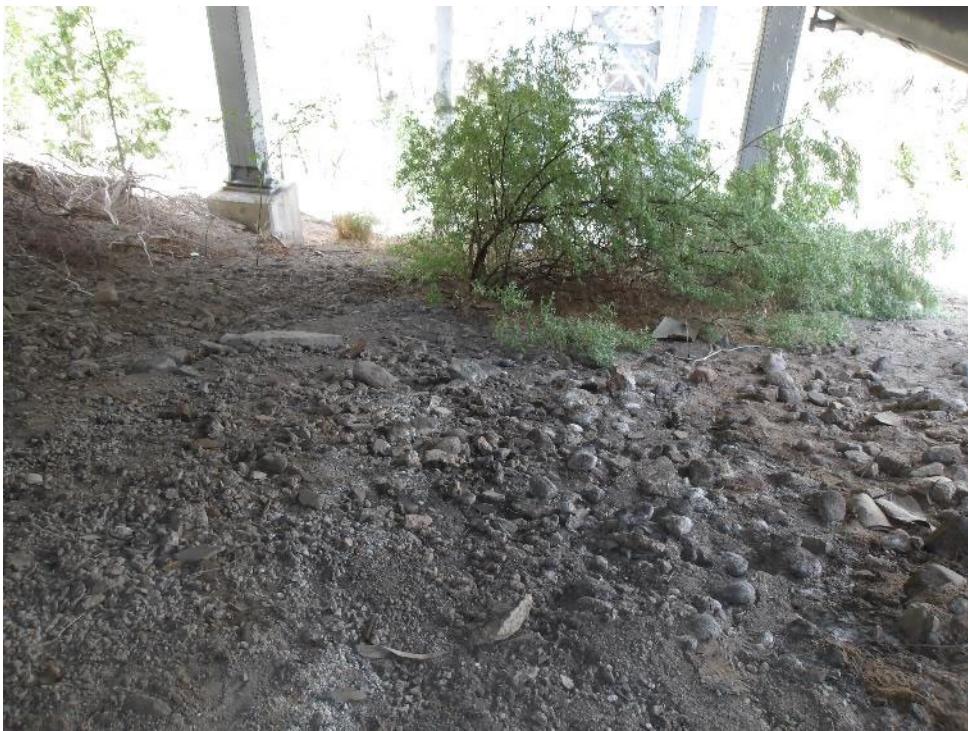
Photo 73- South abutment embankment, looking at pier 1 from south abutment. Minor erosion down slope and around piers.

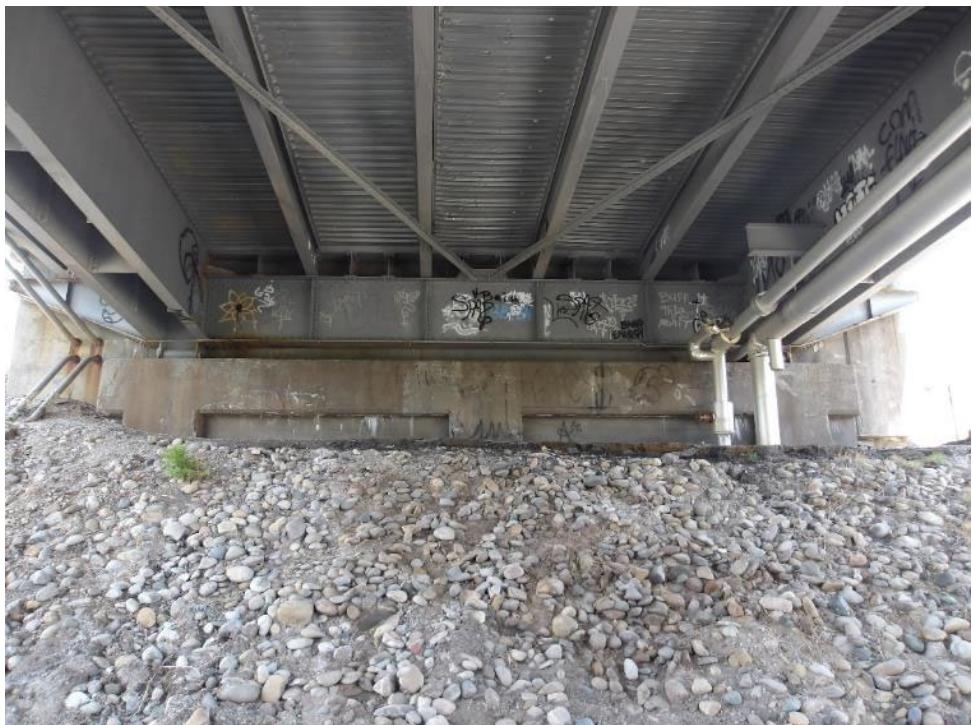
Photo 74—Elevation view of north abutment. Debonding of concrete protective coating is present throughout the abutment.

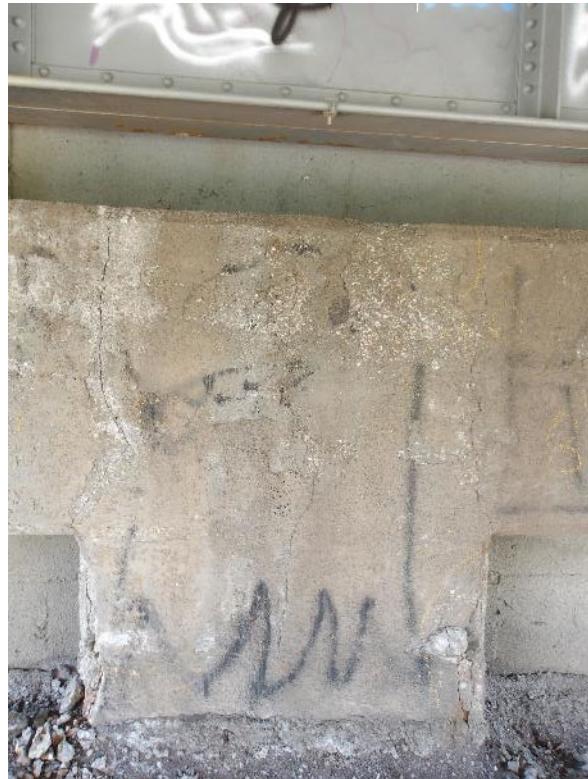
Photo 76- Vertical cracking and small spalls at center of north abutment.

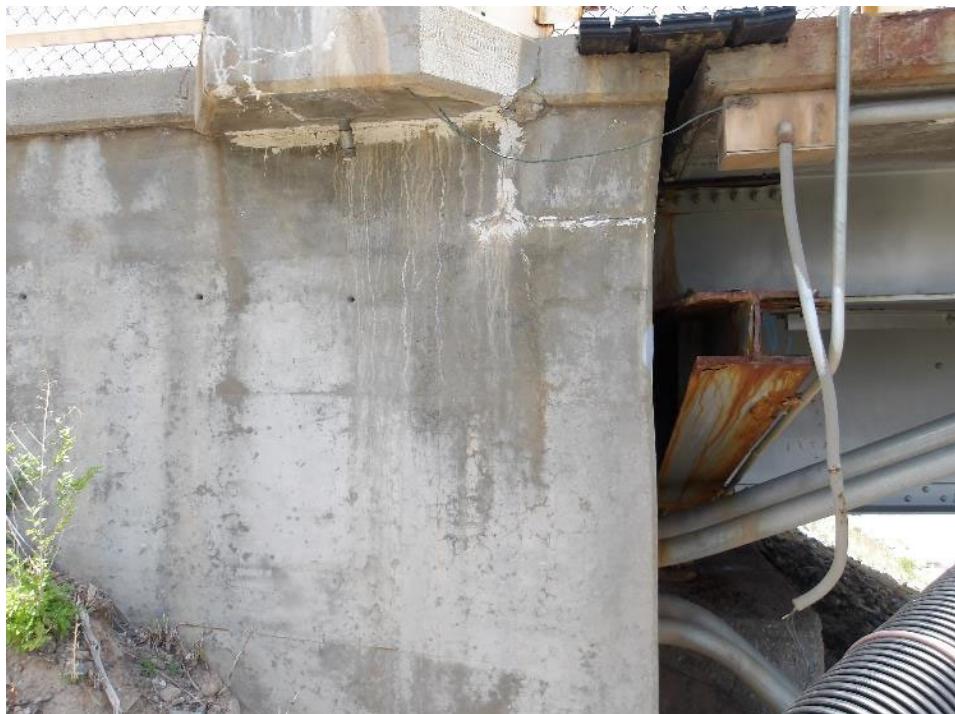
Photo 80- East wingwall at north abutment, hairline cracking. Undermining at south end of wall, wrapping around to the backwall.

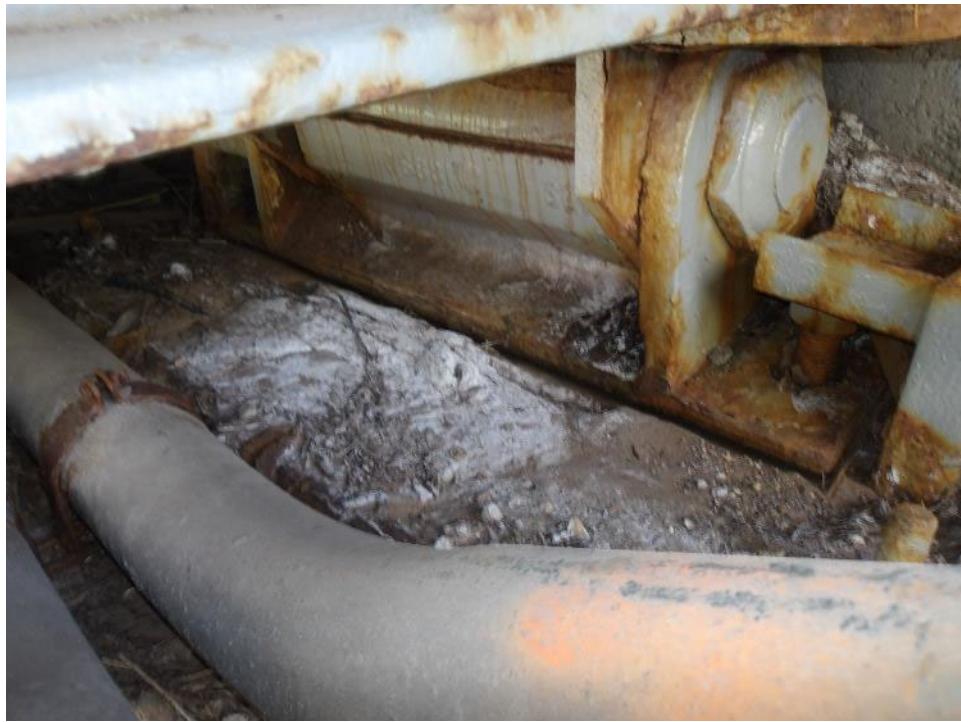
Photo 85– Corrosion and rust staining at southeast bearing with debris accumulation on the abutment seat.

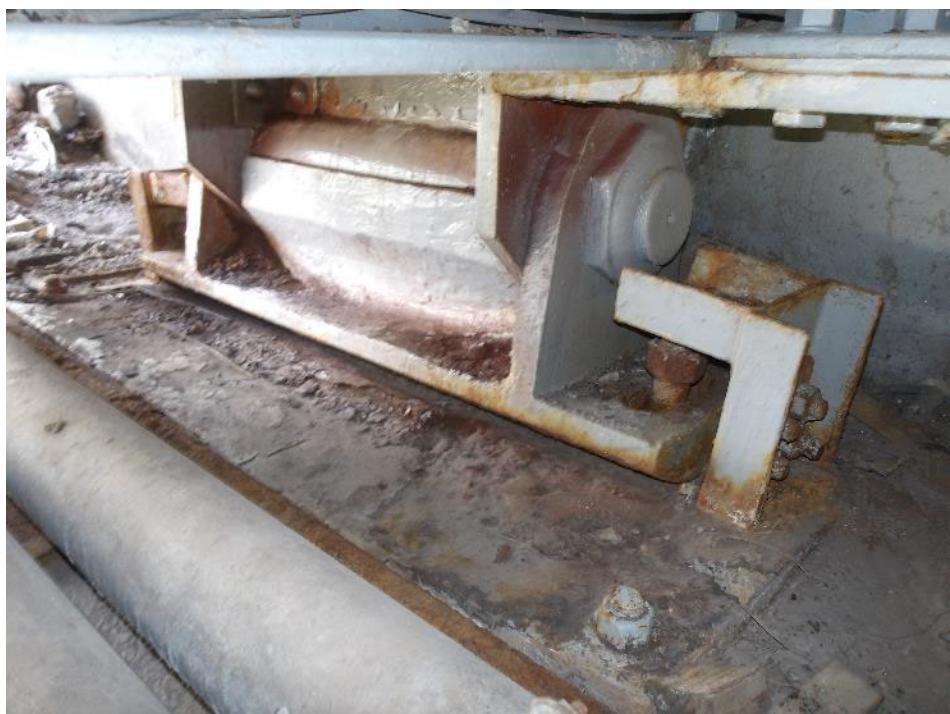
Photo 86- Northwest rocker bearing with paint failure and laterally displaced bolt with partially threaded nut.

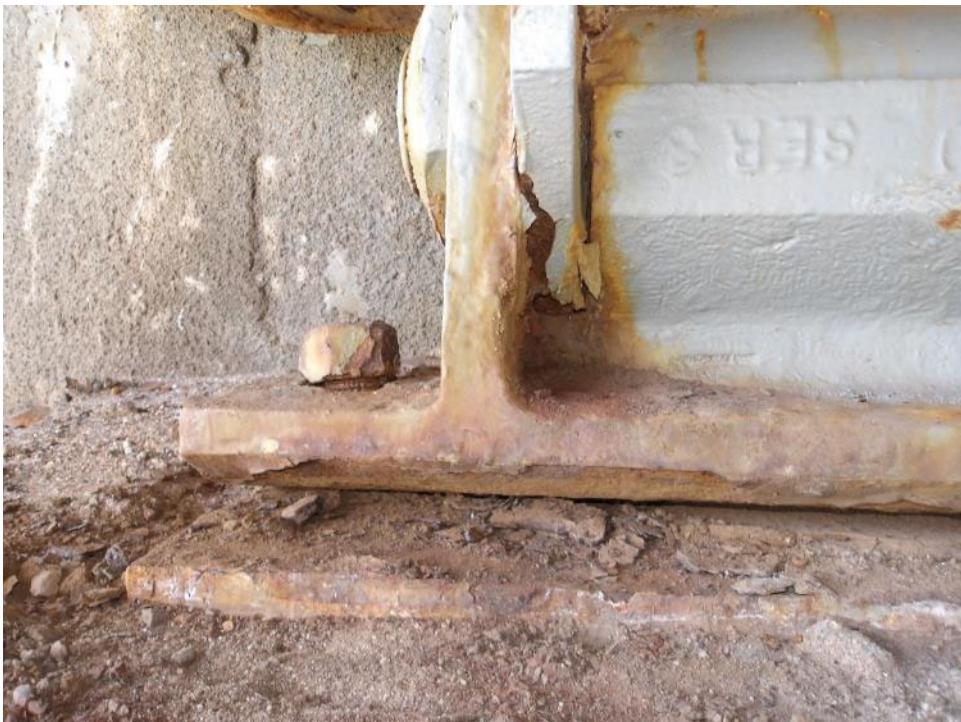
Photo 87- Northeast rocker bearing with paint failure corrosion.

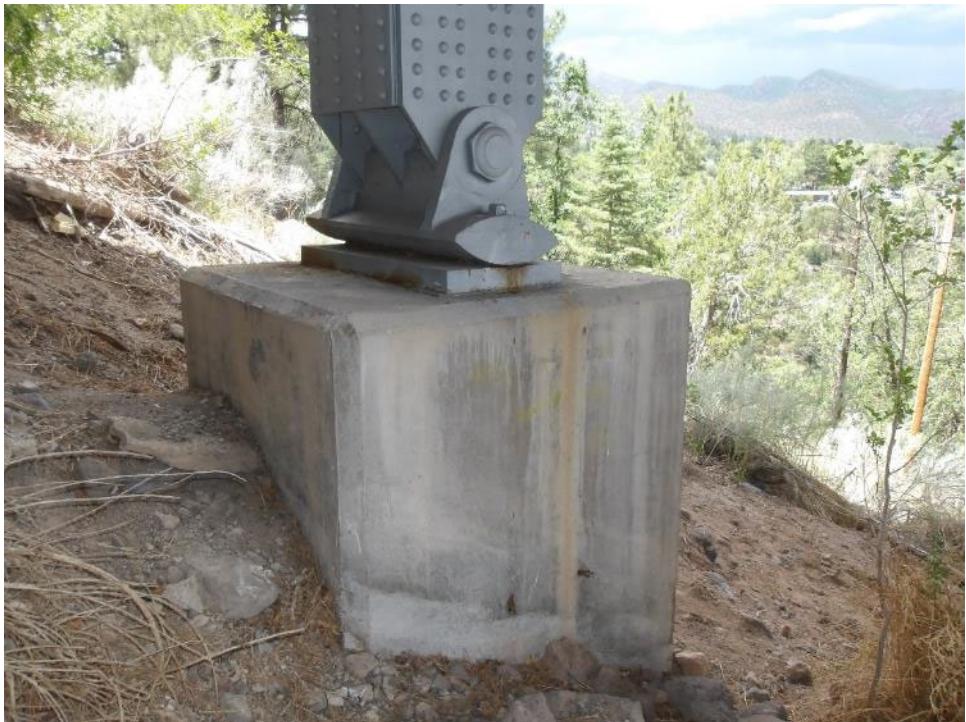
East Face	<ul style="list-style-type: none"> - 43" to 67" of exposed surface - Map cracking up to 0.010" - Honeycombing on NE corner - Vertical crack with leaching and minor rust staining (Photo 89)
West Face	<ul style="list-style-type: none"> - 26" to 45" exposed surface - Minor rust straining from form steel - Minor horizontal and vertical cracking 0.013" wide
Top Face	<ul style="list-style-type: none"> - Cracks on chamfers (extend into vertical faces) - Minor Pack rust under bearing and above masonry plate - Minor corrosion on masonry plate at bearing contact area - Cracks up to 0.02" wide at approximately 12" spacing

Photo 89- East face of concrete pier column 1, west.

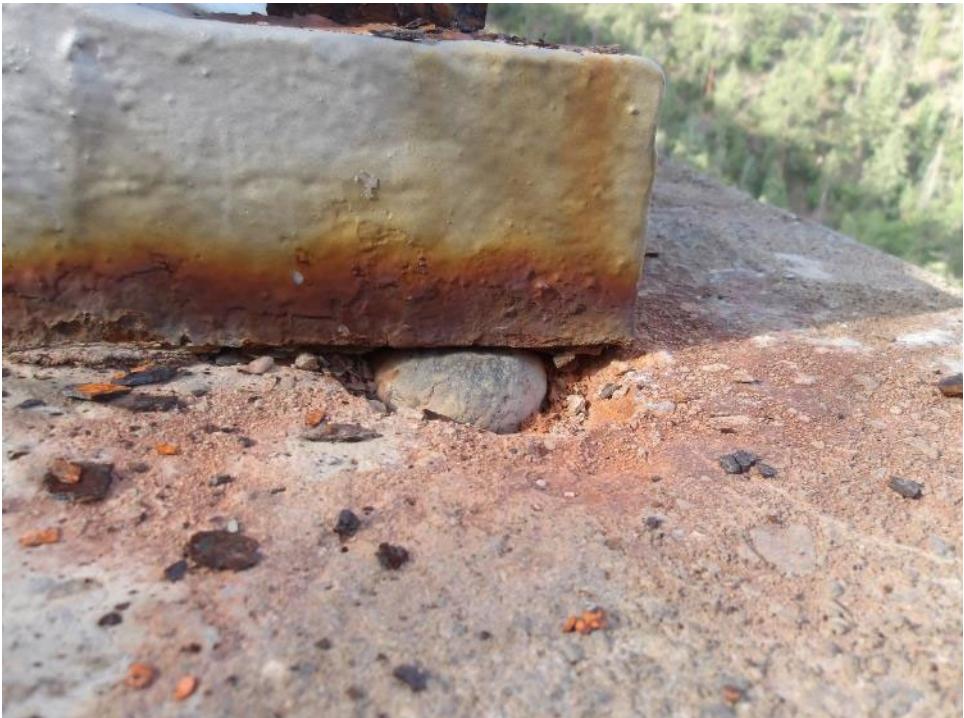
Photo 93- $\frac{1}{2}$ " deep undermining at the northwest portion of the bearing pad at concrete pier column 3, west.

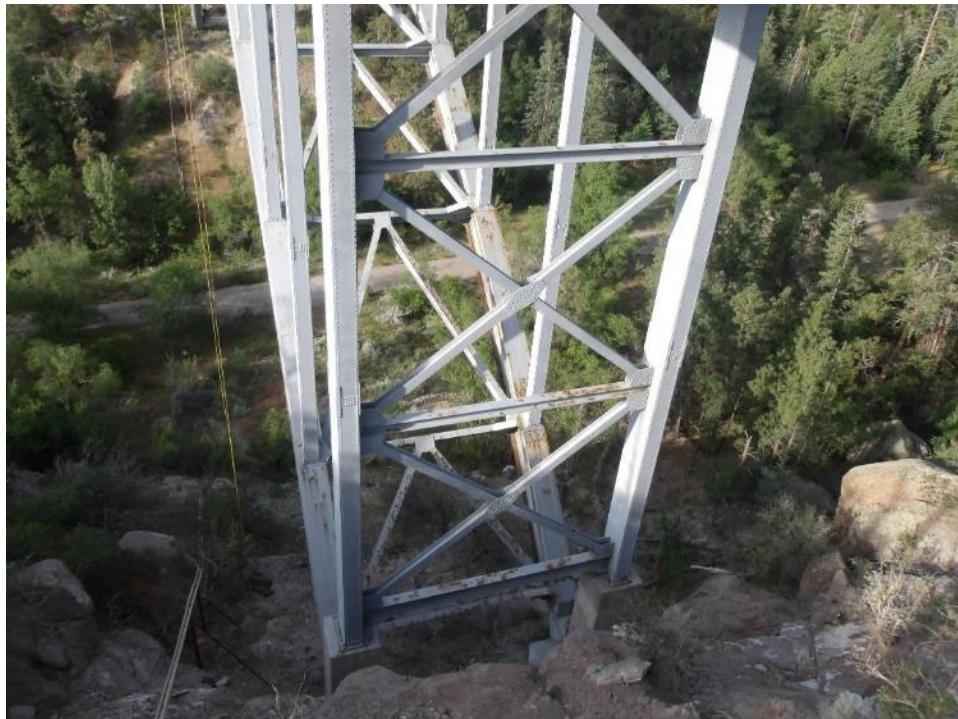
The steel columns at piers 1-4, and at the skewback columns are in SATISFACTORY condition, similar to the other steel on the bridge. The portal bracing towers and lateral bracing members are overall in FAIR condition. The paint has failed in numerous areas throughout the bracing members and there is minor corrosion in these areas with no measurable section loss. See **Photos 100-101** for general photos.

Photo 100- View of North skewback columns. Minor paint peeling and corrosion on bracing members.

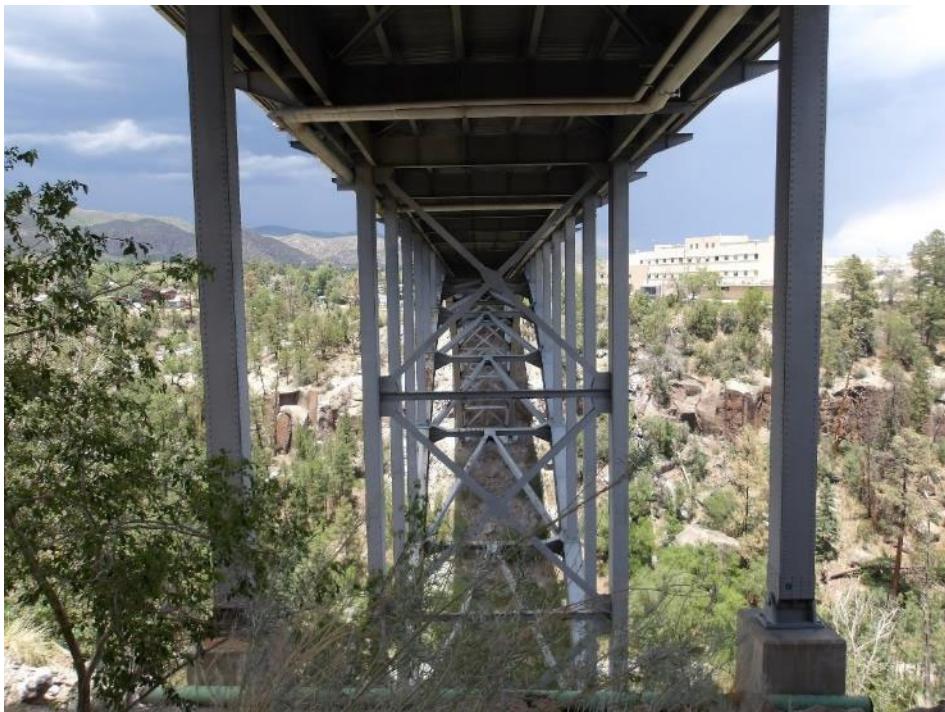
Photo 101- General view of columns at Pier 2.
