Title: Routine & Nonredundant Steel Tension Member (NSTM) Inspection Report (Final) Property ID No. 43-0434 - Los Alamos Canyon Bridge

Inspection Dates: June 7-9, 2024

Property ID No. 43-0434 - Los Alamos Canyon Bridge

Los Alamos Canyon Bridge on NM-501 (Diamond Drive) over Omega and Dulce Roads

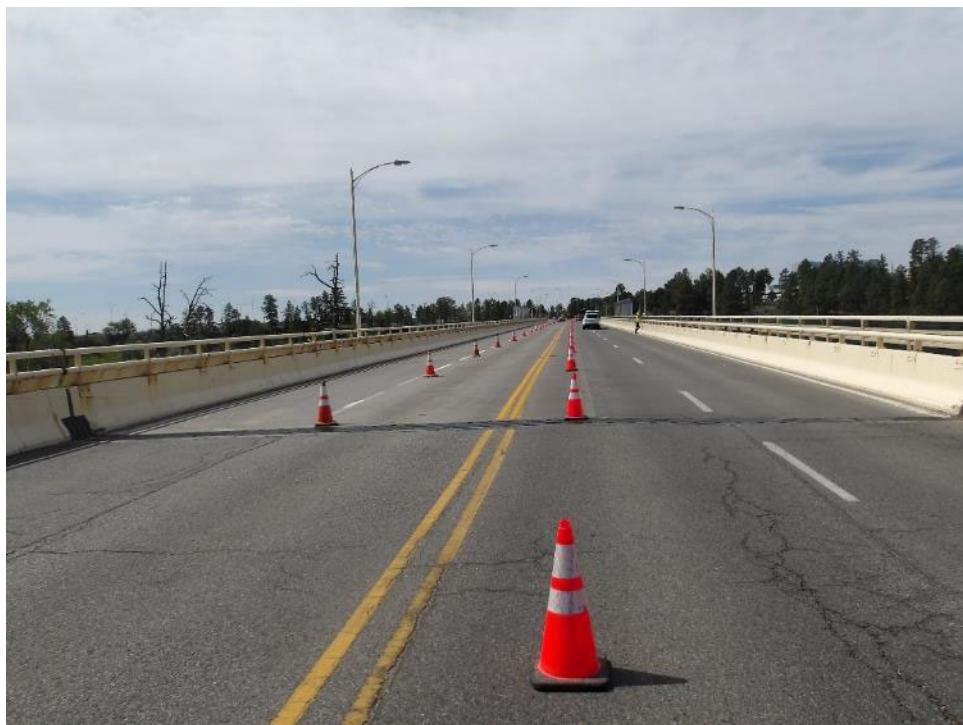
At the north approach roadway, minor defects and deterioration including longitudinal cracks on the southbound / northbound lanes were observed on the roadway (**Photo 102 and 103**). There are spalls and delaminations on the header near the expansion joint (**Photo 104**). The grate openings for drainage on the east and west sides had minimal debris.

Photo 102- North approach, looking south.

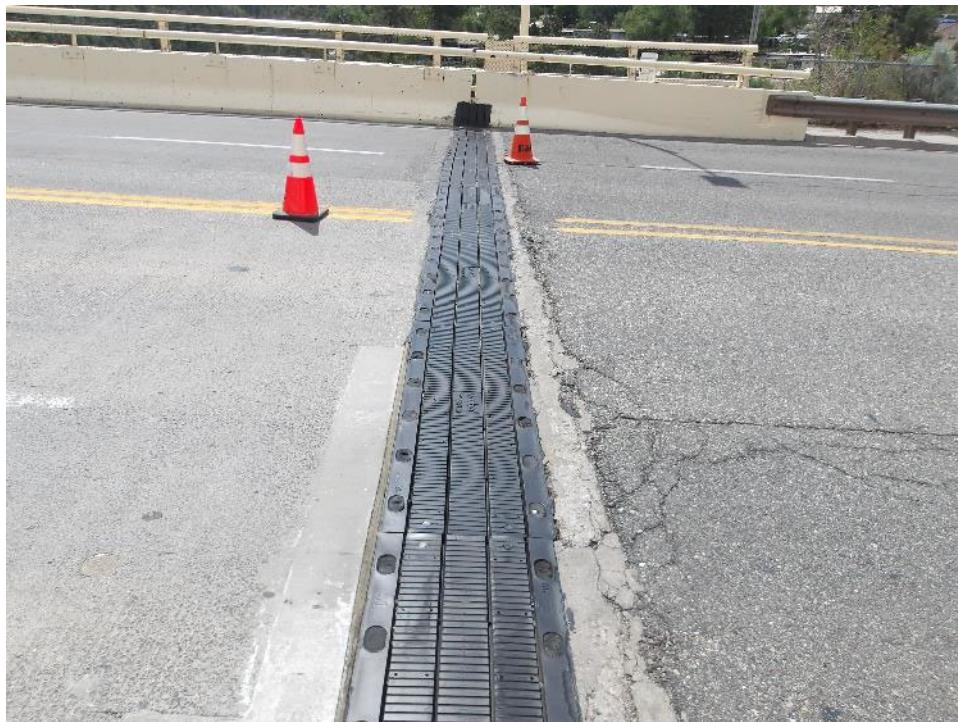
Photo 104- Deterioration of asphalt and concrete on the approach side at the north abutment joint.

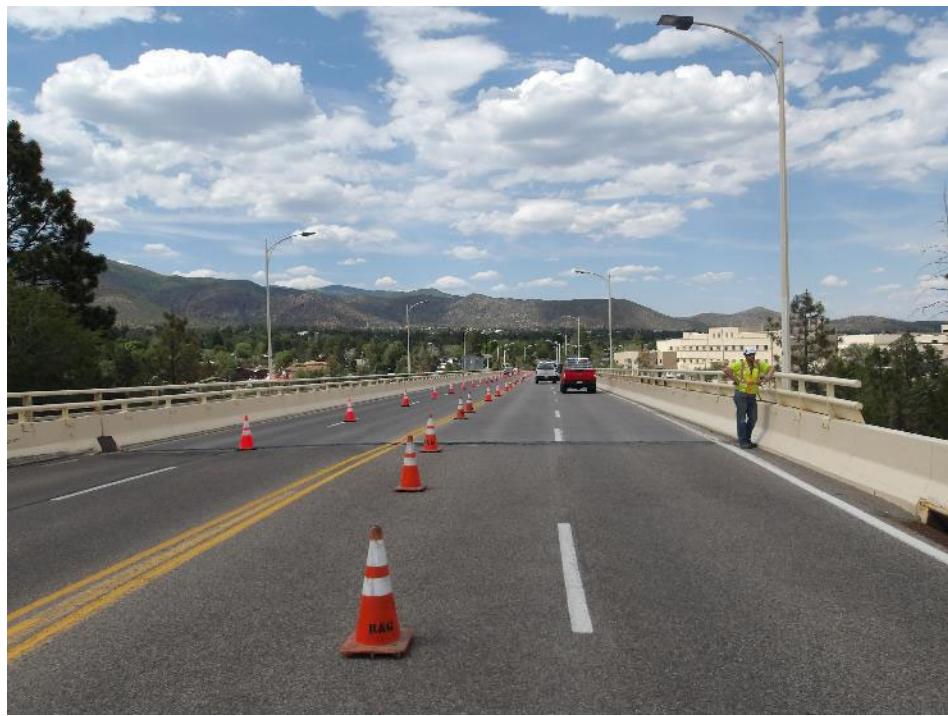
At the south approach roadway, longitudinal cracks are present between lanes (**Photo 105**). Some spalling of the asphalt has occurred and there are several spalls and delaminations near the header and joint (**Photo 106**). The grate openings for drainage have minor debris accumulation on the east and west sides.

Photo 105- General view of south approach looking north.

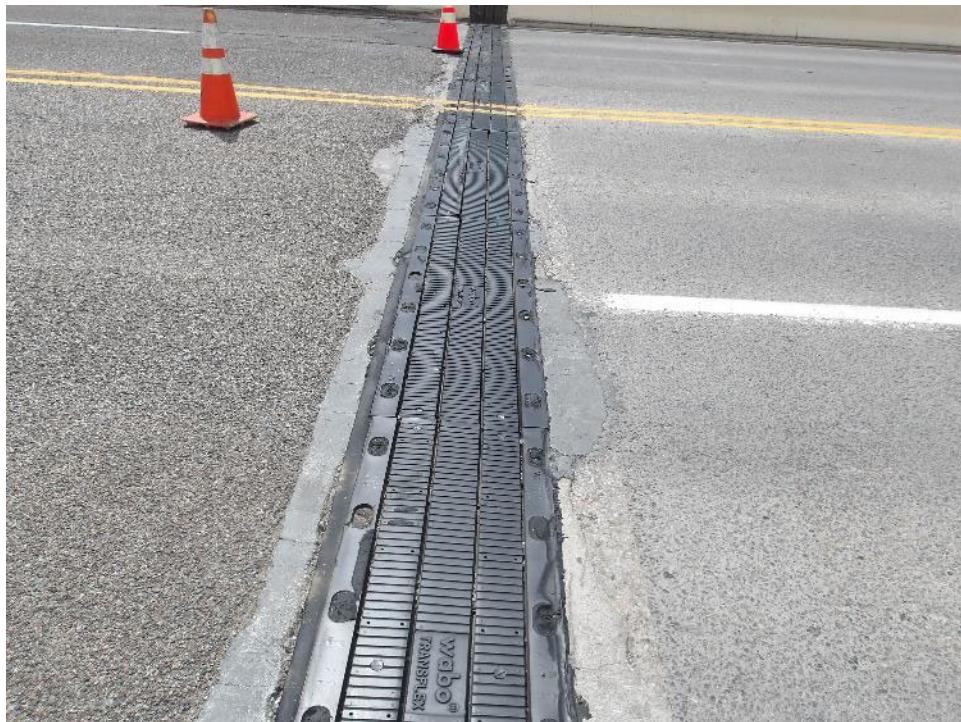
Photo 106- Deterioration of asphalt and concrete on the approach side at the south abutment joint.

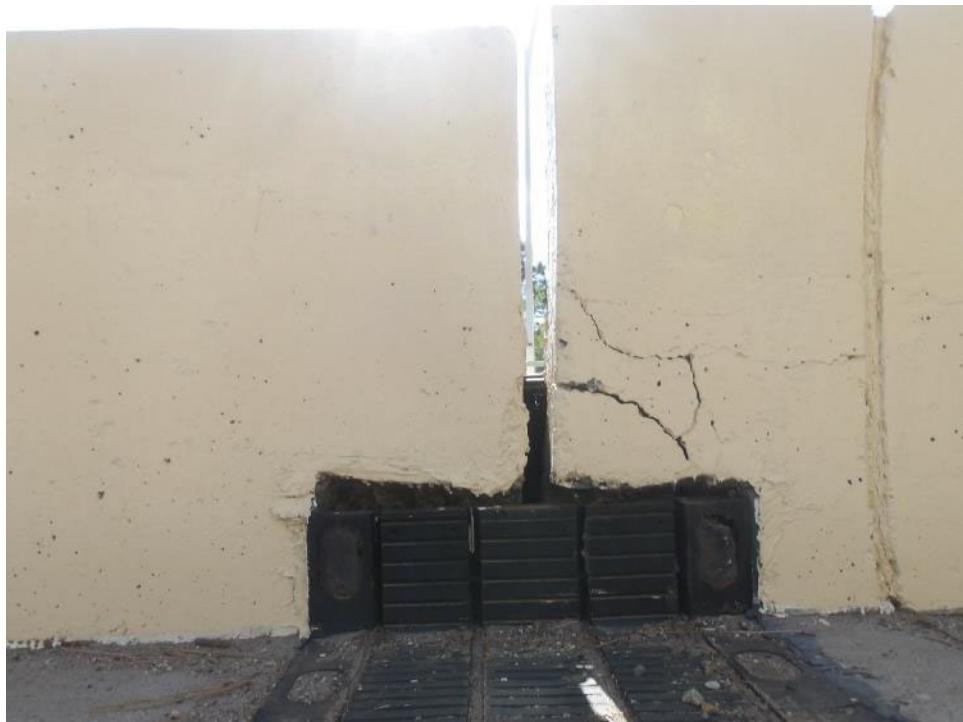
In general, the concrete barrier rails (CBRs) on the east and west sides of the bridge have vertical, horizontal, and map cracks with isolated areas of traffic damage. Additionally, there are several delaminations on the CBR that were repaired as part of the rail maintenance. The vertical cracks are concentrated near the drain holes at the bottom of the CBR and extend the full thickness of the CBR (**Photo 107**). Cracks radiating from the joints is also typical along the concrete barrier rail, particularly at the joints (**Photo 108**). Previously repaired patches have new delaminations and spalling (**Photo 109-110**).

Photo 108- 1/8" crack in the west concrete barrier rail immediately above the southern joint.

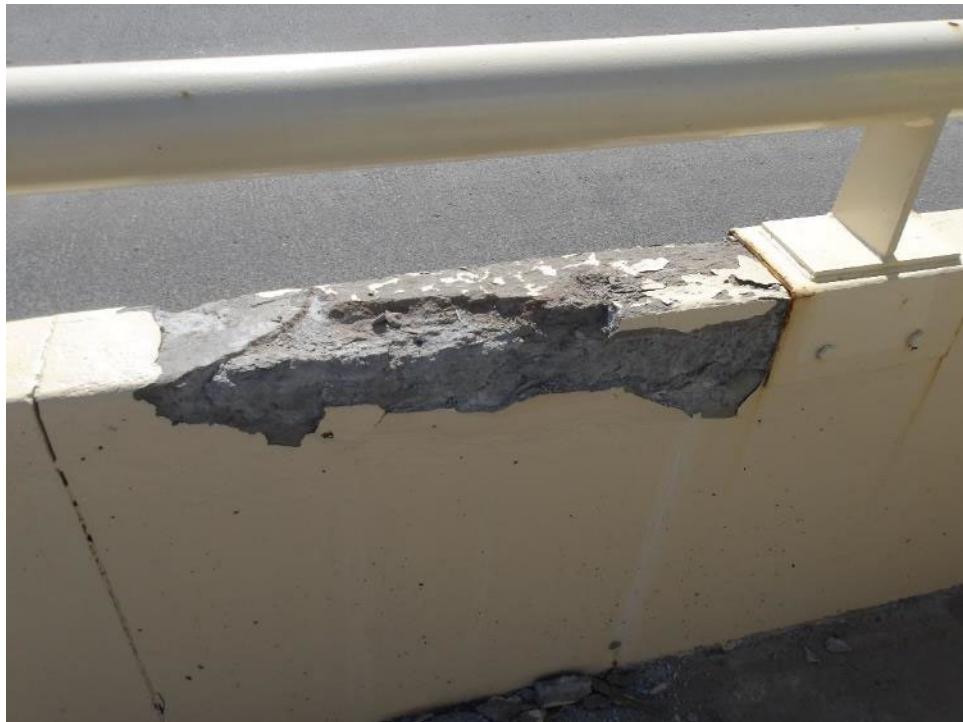
Photo 110- Large (3'xFull Widthx1") spall in the west concrete barrier rail at midspan.

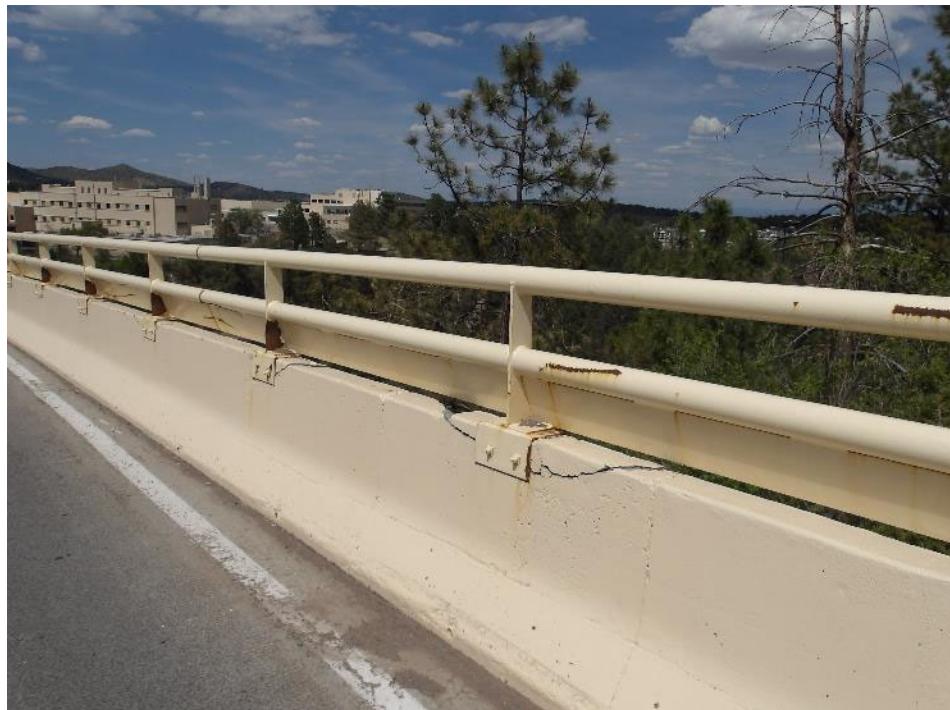
The metal rails were replaced prior to the 2022 inspection. Since replacement, the metal rails have locations of paint peeling, and corrosion has initiated at several locations (**Photos 111-112**). Additionally, there has been some collision damage to many of the vertical rail to concrete barrier connections on both the east and west side of the bridge. This damage has resulted in distortion of these members (**Photo 113-114**). Impact damage has also caused large cracks and complete separation of concrete at one location on the west rail (**Photo 115**) and at multiple locations on the east rail (**Photo 116**).

Photo 116- Impact damage on the east bridge rail near the south abutment has caused cracking and spalling of concrete with complete separation of concrete at 6 connections.

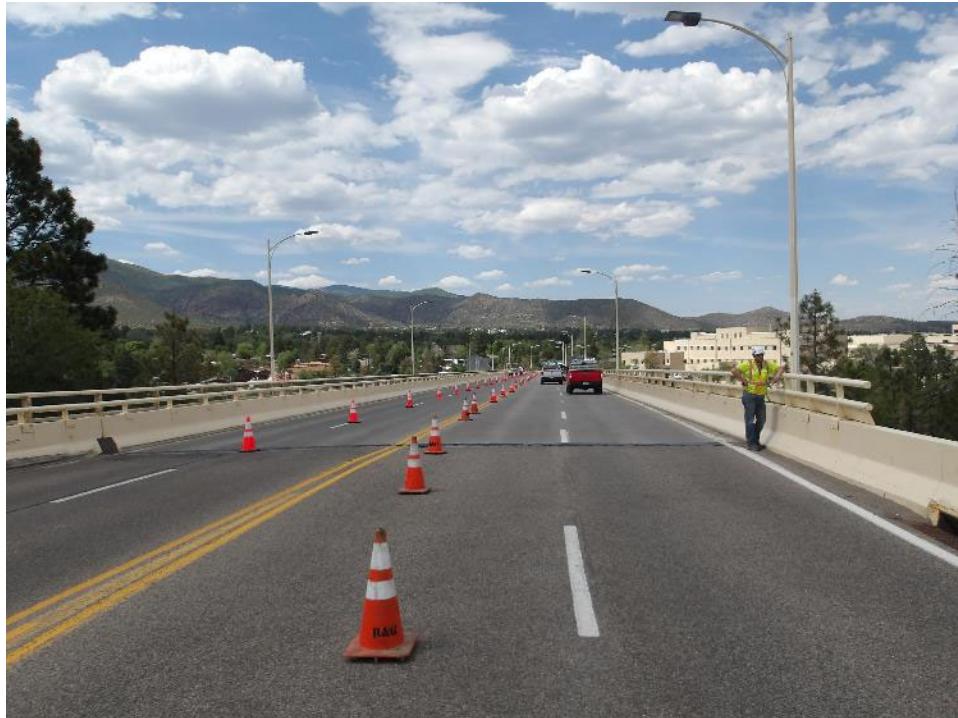
The steel rail terminates in a blunt end at all four corners of the bridge (**Photo 117**). This poses a safety hazard to drivers in the event of a crash. The ends should be extended and turned down on a radius.

Photo 117- Steel railing terminates with a blunt end that poses a safety hazard in the event of a crash.

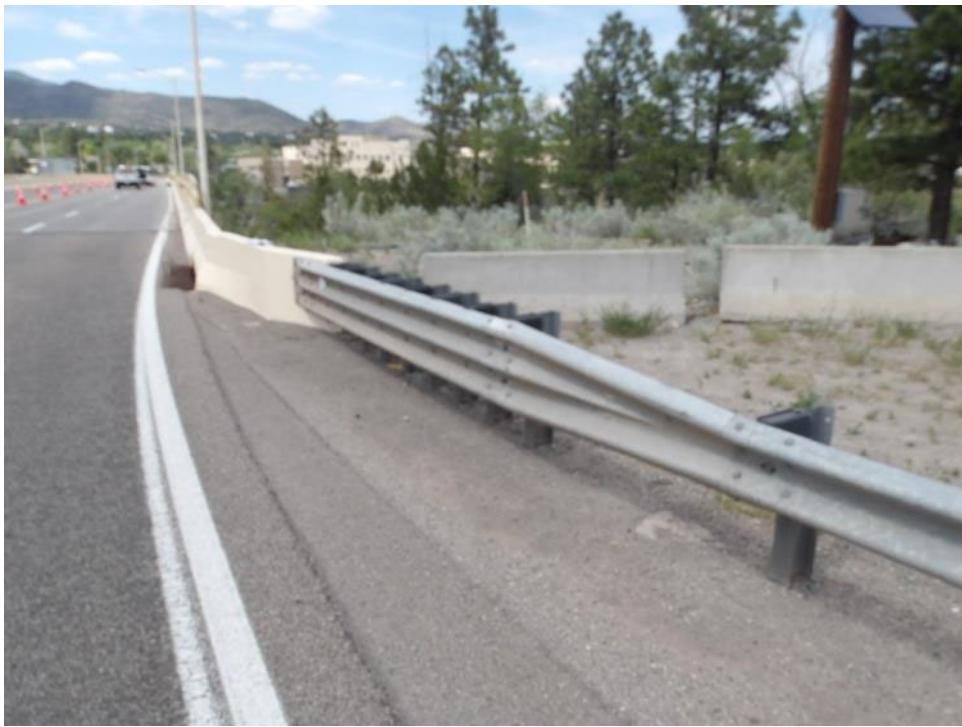
The approach guardrails consist of a steel guardrail with timber blackouts on timber posts at the terminals or rubber blackouts on steel posts along the length. All guardrail connections to the concrete rail are in GOOD condition and properly detailed (**Photo 118**).

Photo 118- Southeast approach guardrail, looking north.

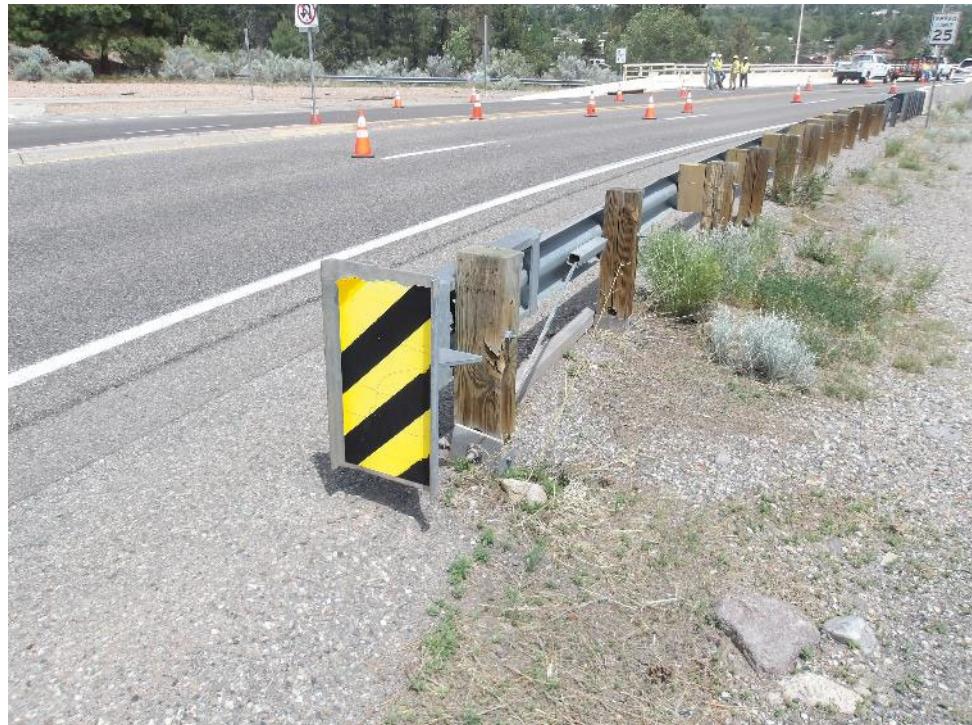
At the south approach guardrail, there is minor collision damage on the east side. The steel guardrail has a minor bend in it. The timber blocking on the east rail has been replaced since the last inspection. Some timber posts are split along their height and/or deformed at the base in the terminal end, but this generally does not affect the terminal as it is designed to have the rails break on collision (**Photo 119**). There is no steel guardrail on the south west side, as the concrete transitions down to meet with the curb (**Photo 120**)

Photo 119- Southeast end terminal. Note new timber blocking place at posts.

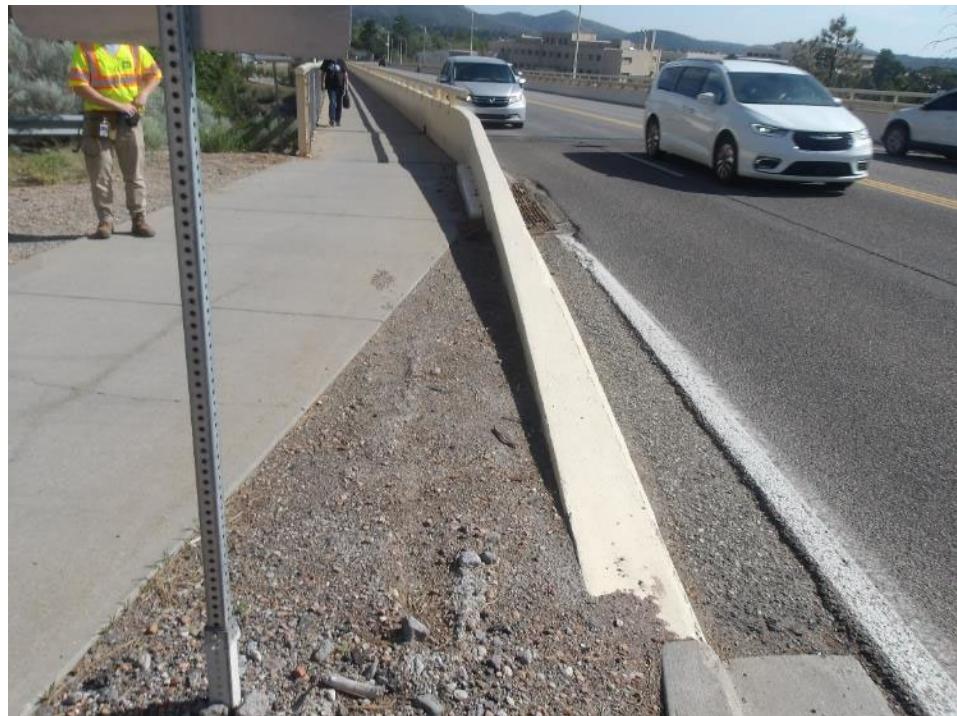
Photo 120- Southwest approach concrete barrier rail transition, looking south.
