2024 Annual Site Inspection and Monitoring Report

Uranium Mill Tailings Radiation Control Act Title I Disposal Sites

MARCH 2025

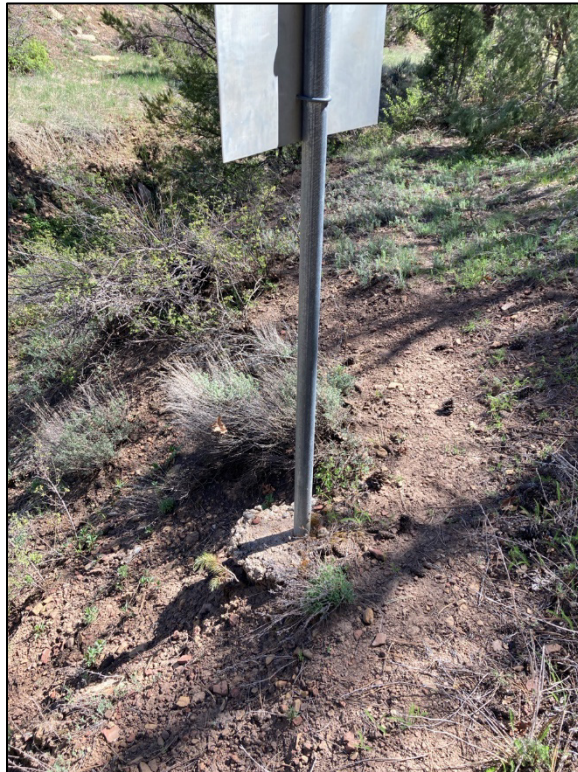
PL-5. Perimeter Sign P56 with Undercut Base and Unstable

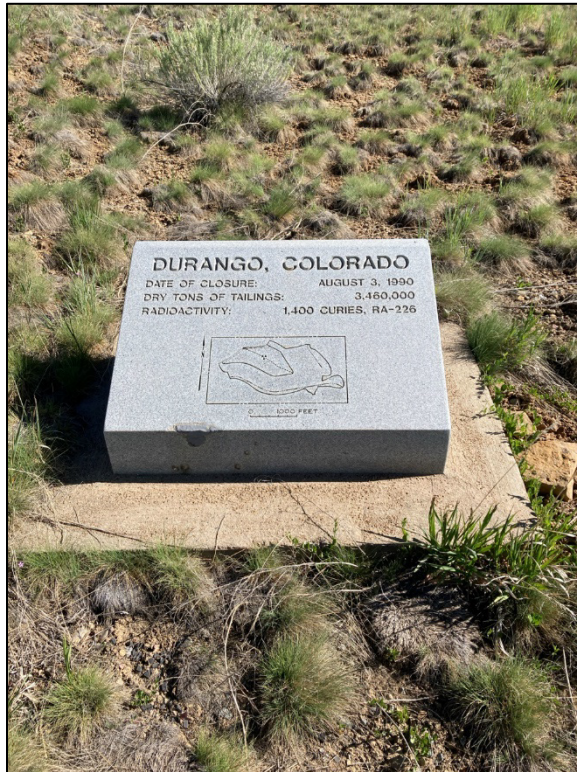
The site has two site markers. Site marker SMK-1 is just inside the original entrance gate and was in good condition (PL-8). Site marker SMK-2 is on the top slope of the disposal cell and was also in good condition. No maintenance needs were identified.

PL-8. Site Marker SMK-1 at Entrance Gate

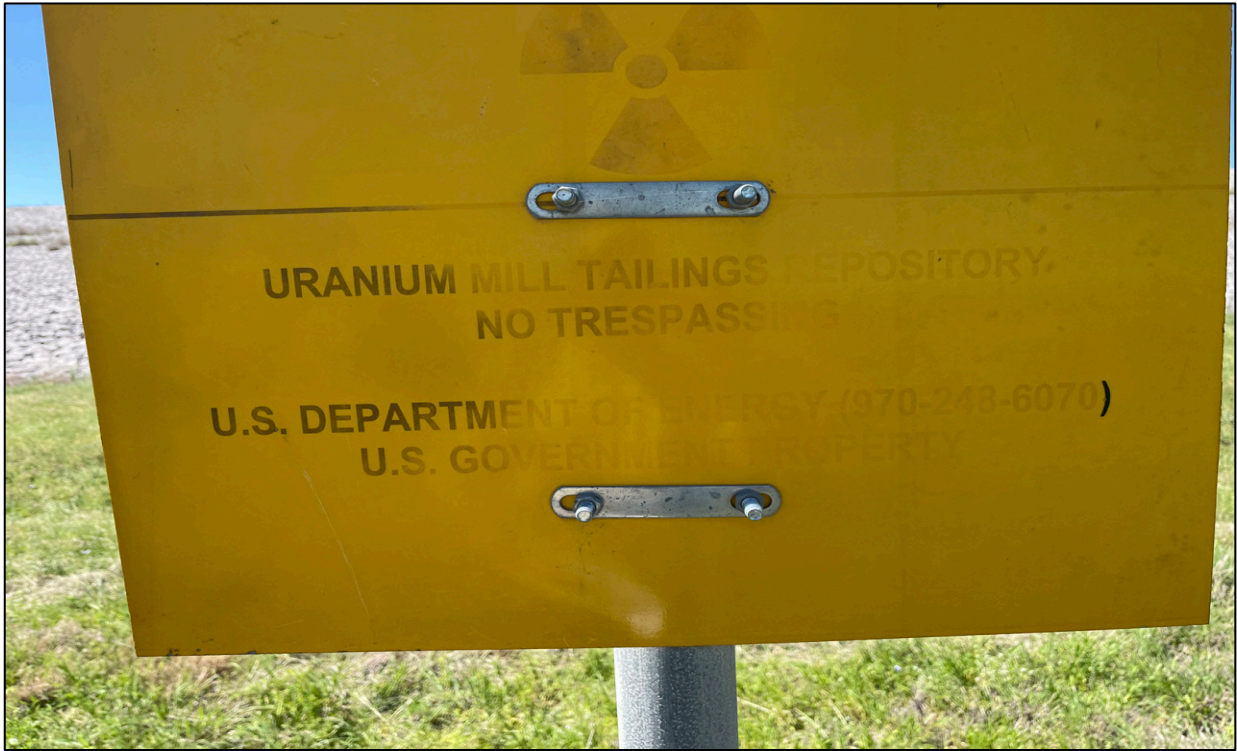
PL-3. Faded Perimeter Sign P15

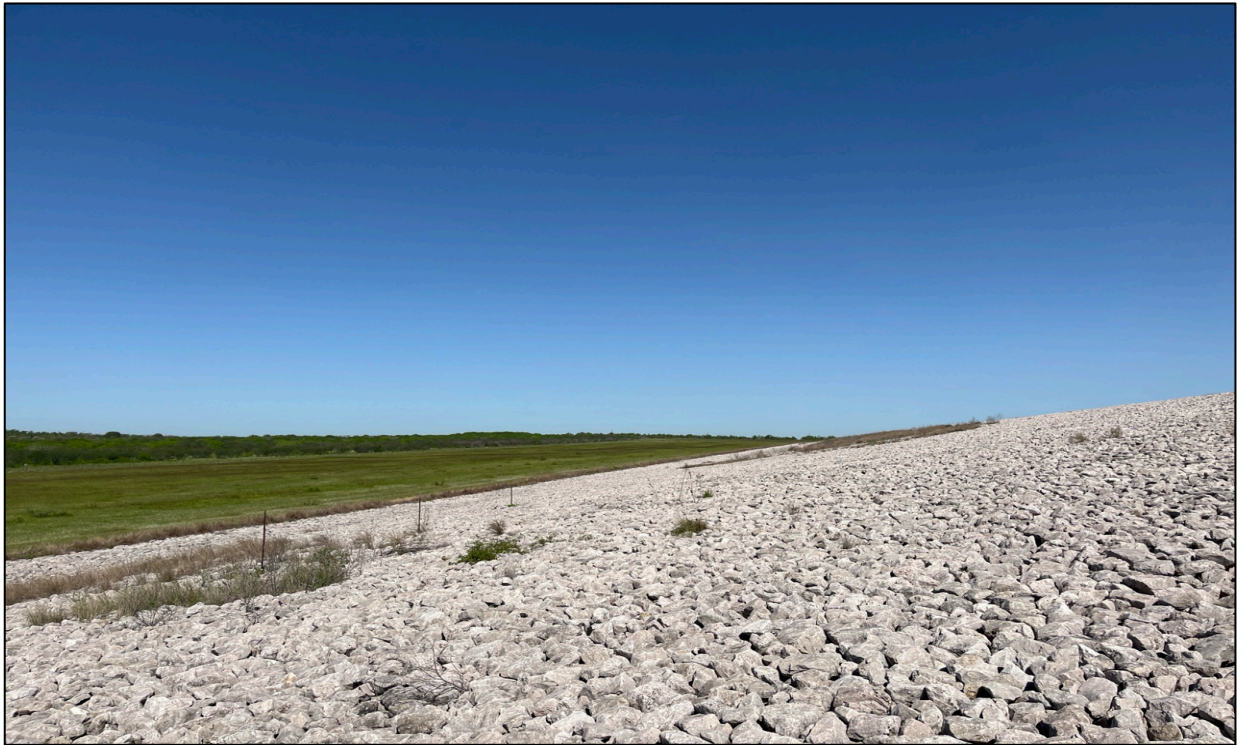
PL-5. Vegetation Growth on Southwest Slope of Disposal Cell

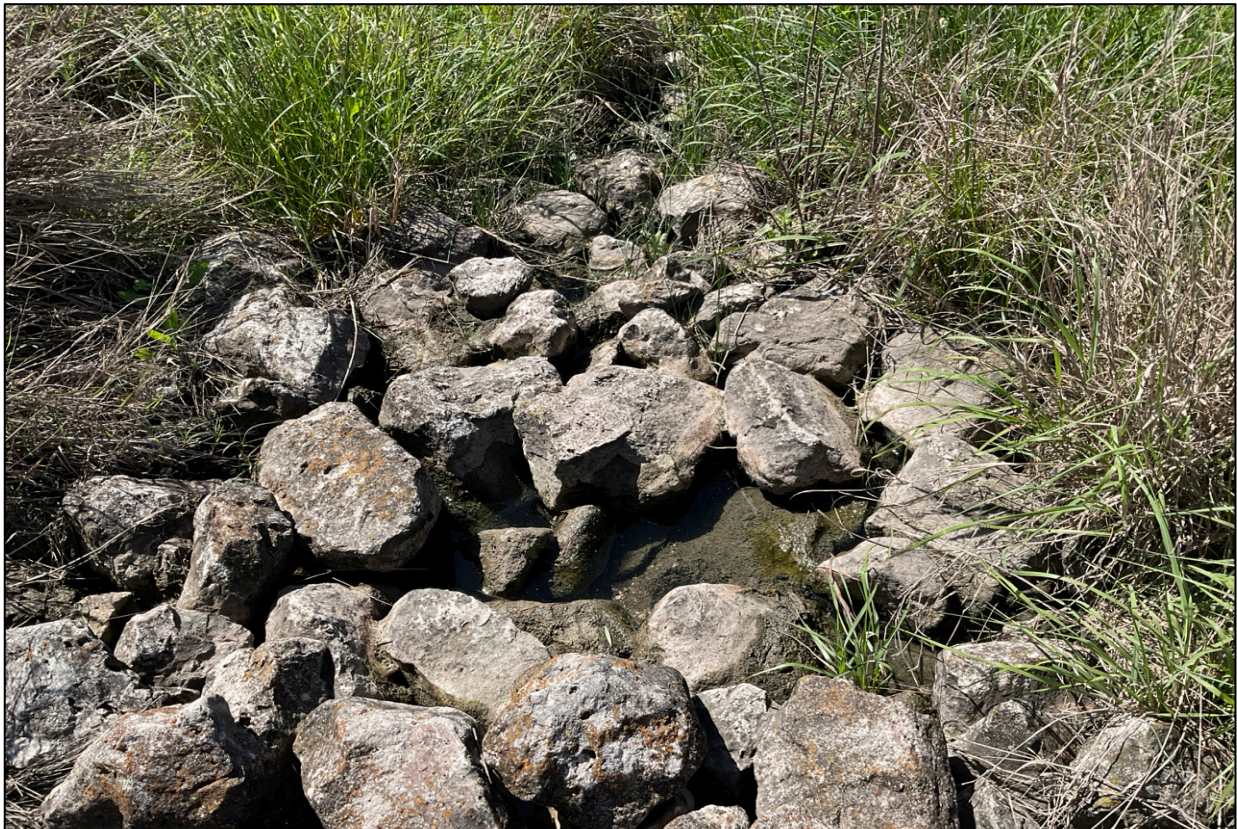
PL-8. Surface Water Present at South Rock Drain

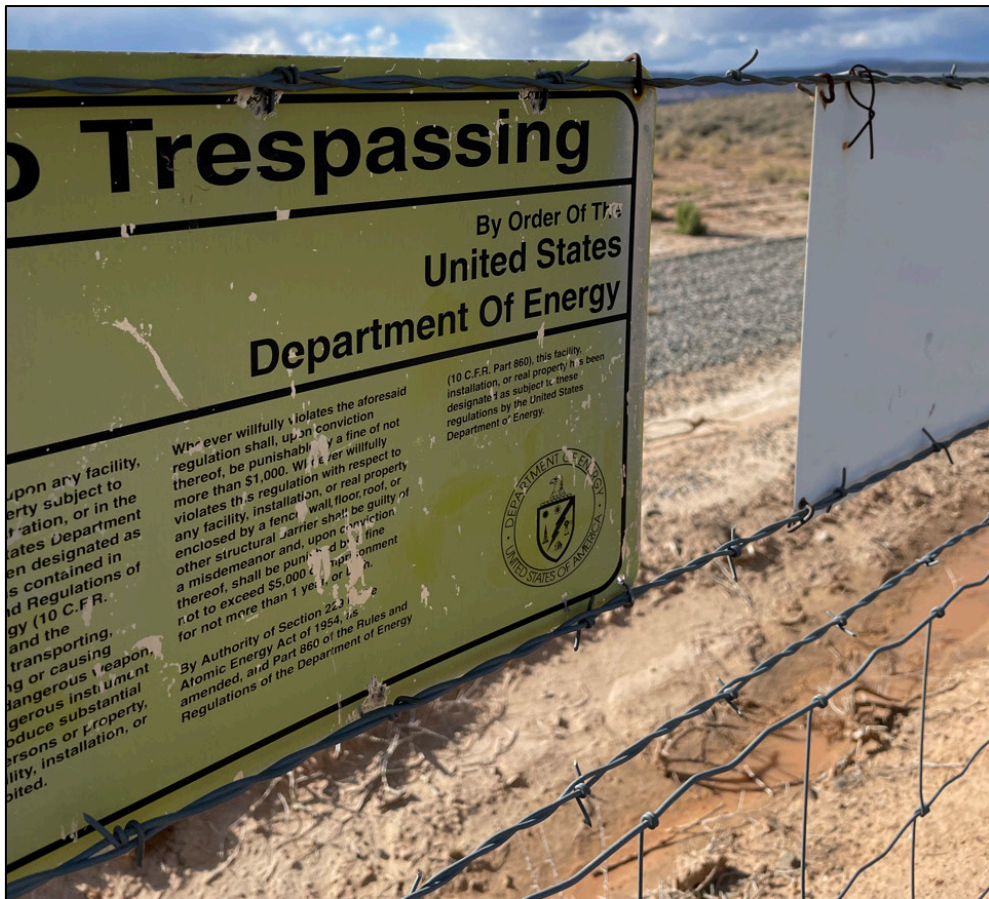
PL-2. No-Trespassing Sign (Faded but Legible)

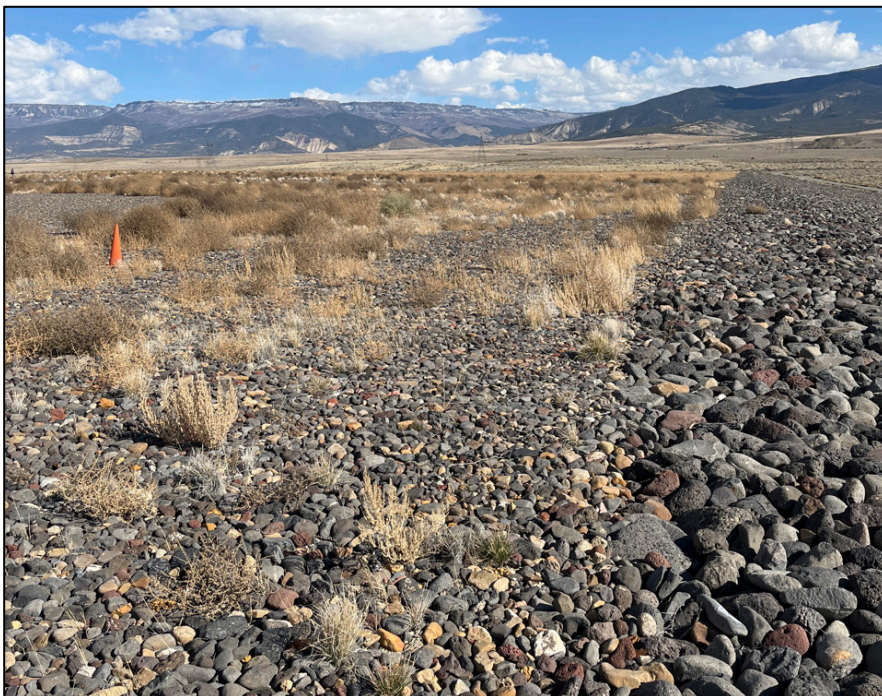
PL-6. Grasses Growing on Disposal Cell Cover

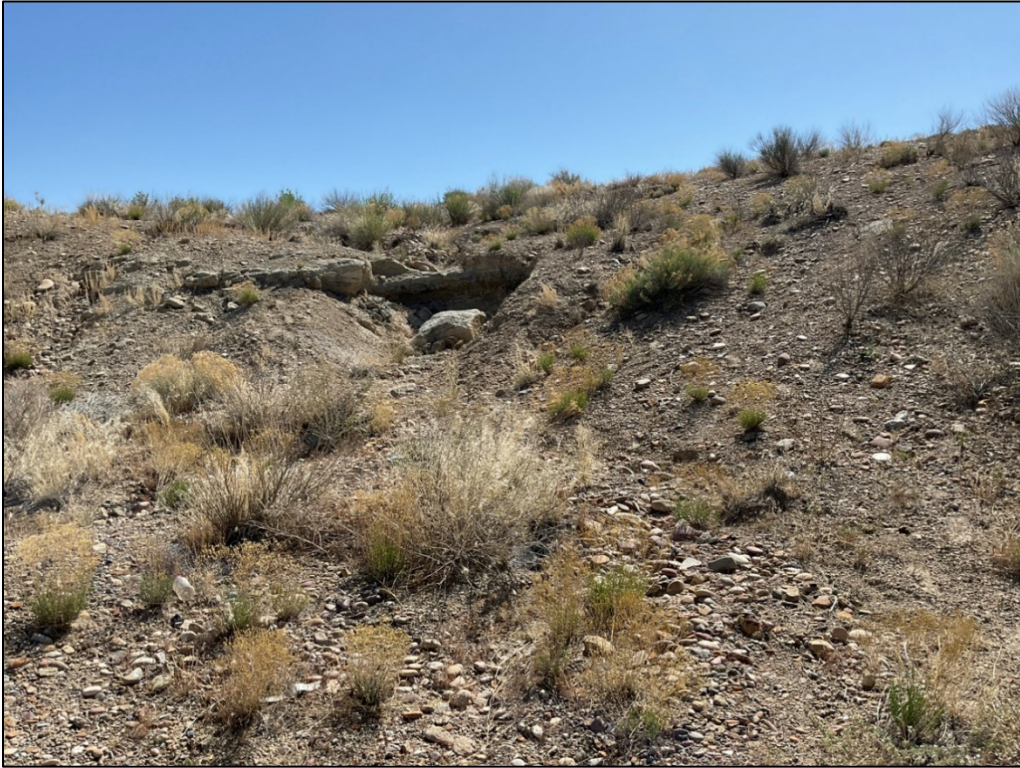
Signs of erosion noted during previous inspections appear in multiple areas in the site perimeter. Erosional rills are present on the west side of the site near perimeter sign P7 and the water tower (PL-7) but are currently not affecting site surveillance features. Rills and gullies are also present along the escarpment northeast of the disposal cell between boundary monument BM-7 and survey monument SM-3 (approximately 400 feet [ft] from the base of the disposal cell). The maximum gully depth in this area is approximately 3 ft, but the erosion appears to be stabilizing as larger rocks drop to the bottom of the gullies and provide armoring. A portion of the

PL-7. Erosion near Perimeter Sign P7 and the Water Tower

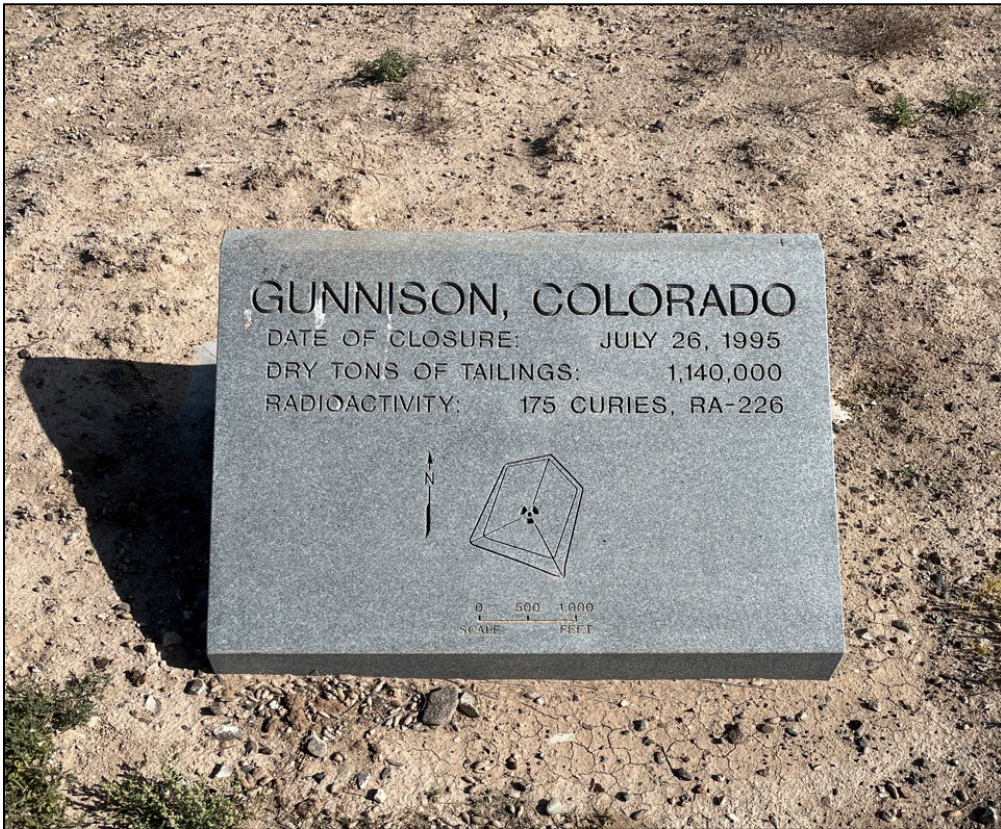
PL-2. Site Marker SMK-1

The site has two granite site markers. Site marker SMK-1 (PL-2) is just inside the entrance gate, and site marker SMK-2 is on the top slope of the disposal cell. The concrete base of site marker SMK-2 has cracks lining up with each of the four monument corners but remains stable. No maintenance needs were identified.

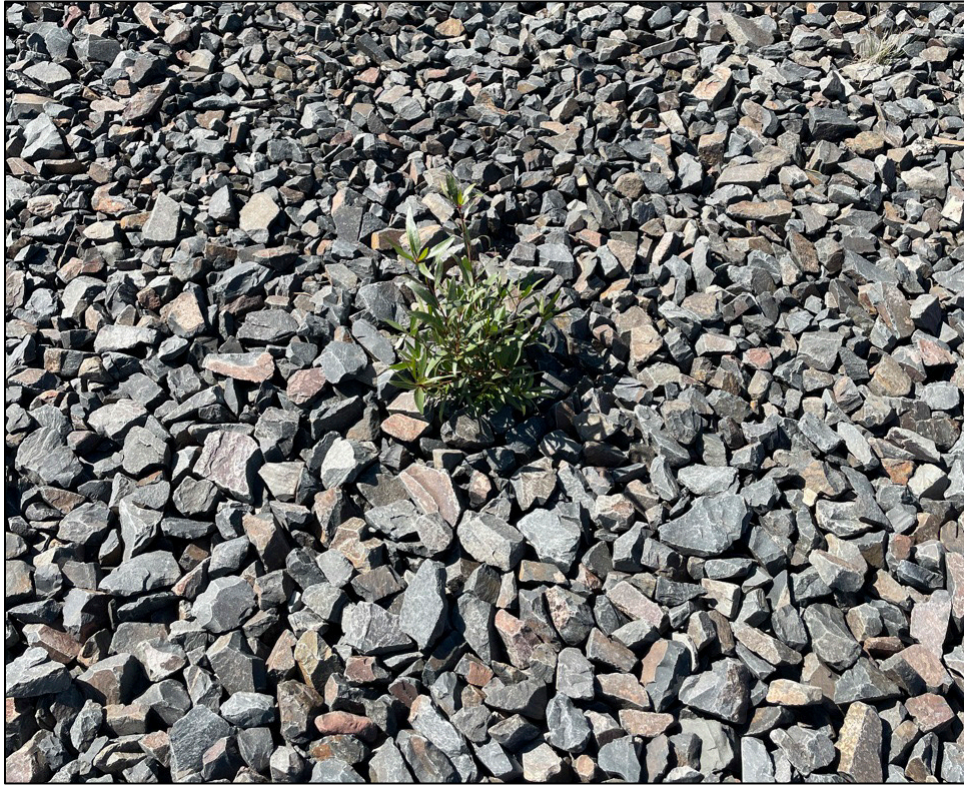
PL-5. Woody Vegetation on Disposal Cell

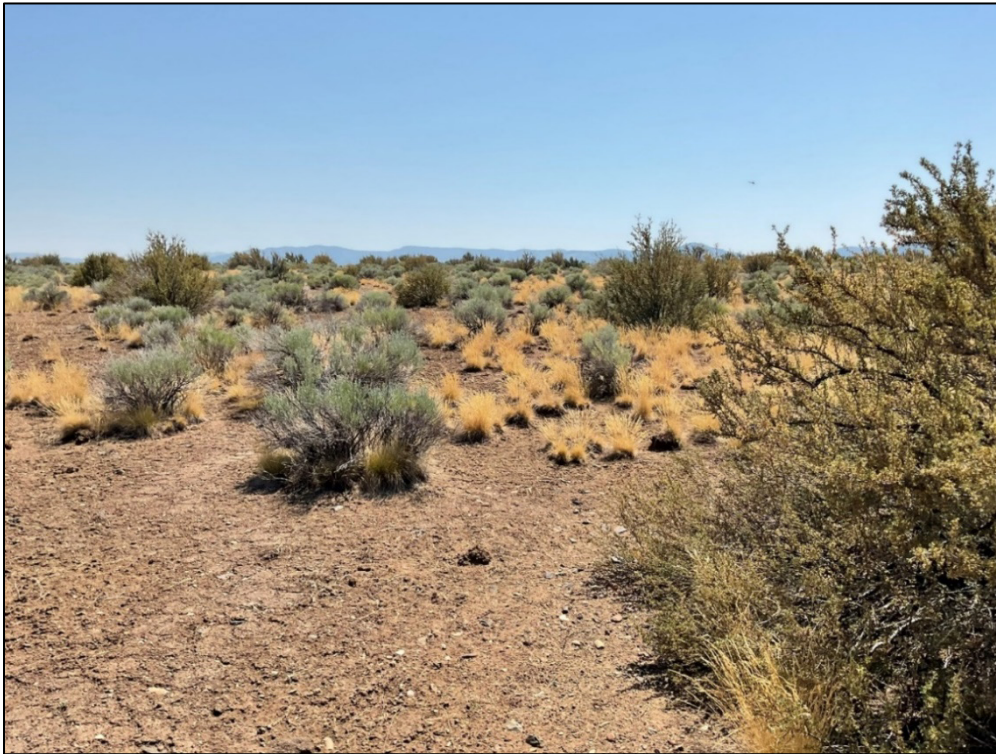
PL-6. Grasses and Forbs on Top of the Disposal Cell

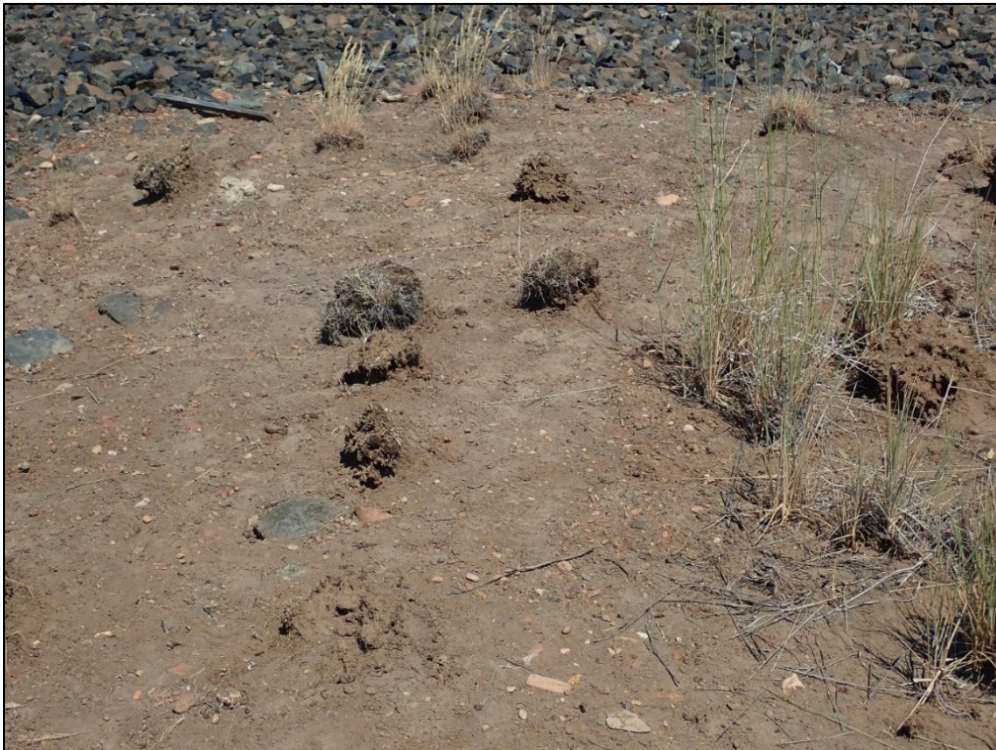
PL-7. Windblown Erosion on Northwest Corner of the Disposal Cell

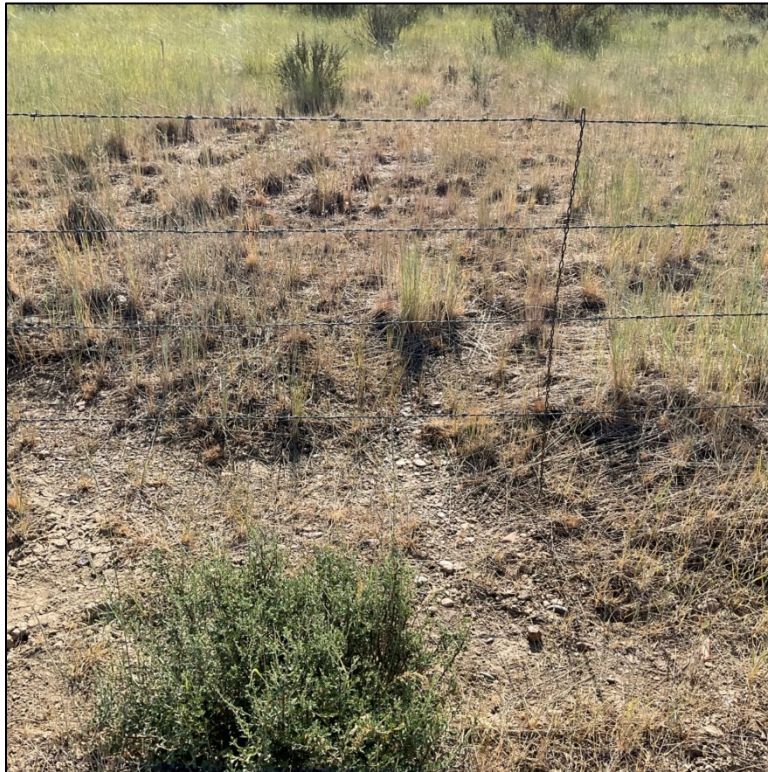
PL-8. Livestock Trail Outside Site Boundary

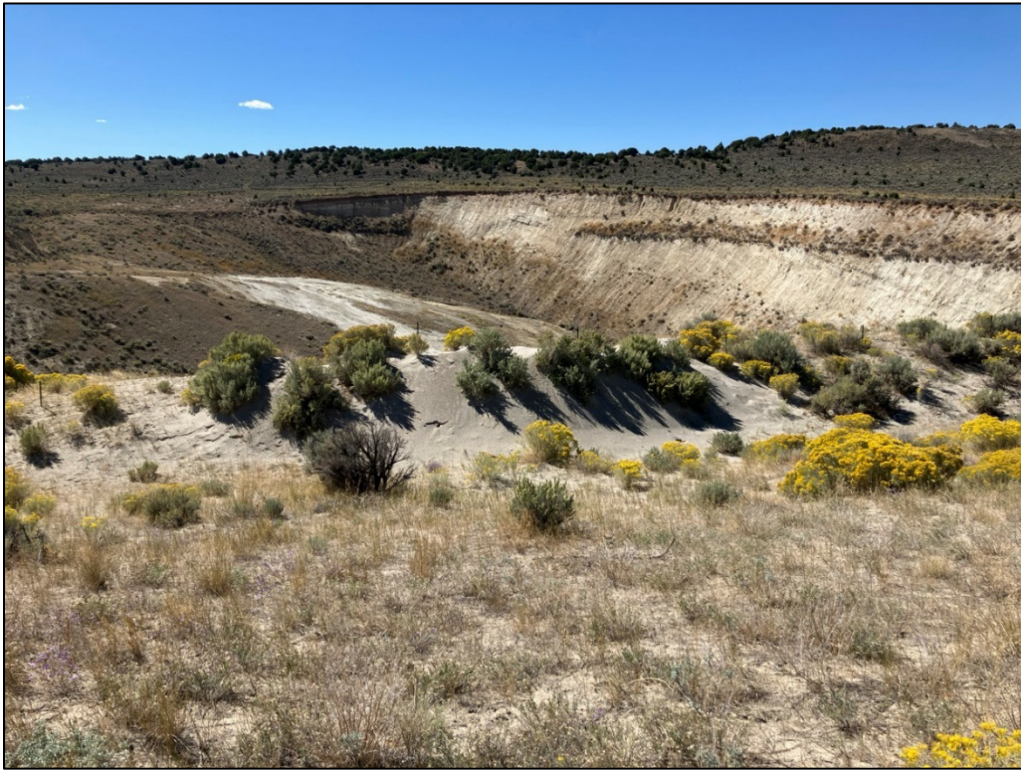
PL-9. Sand Buildup Along Fence near Johnson Pit

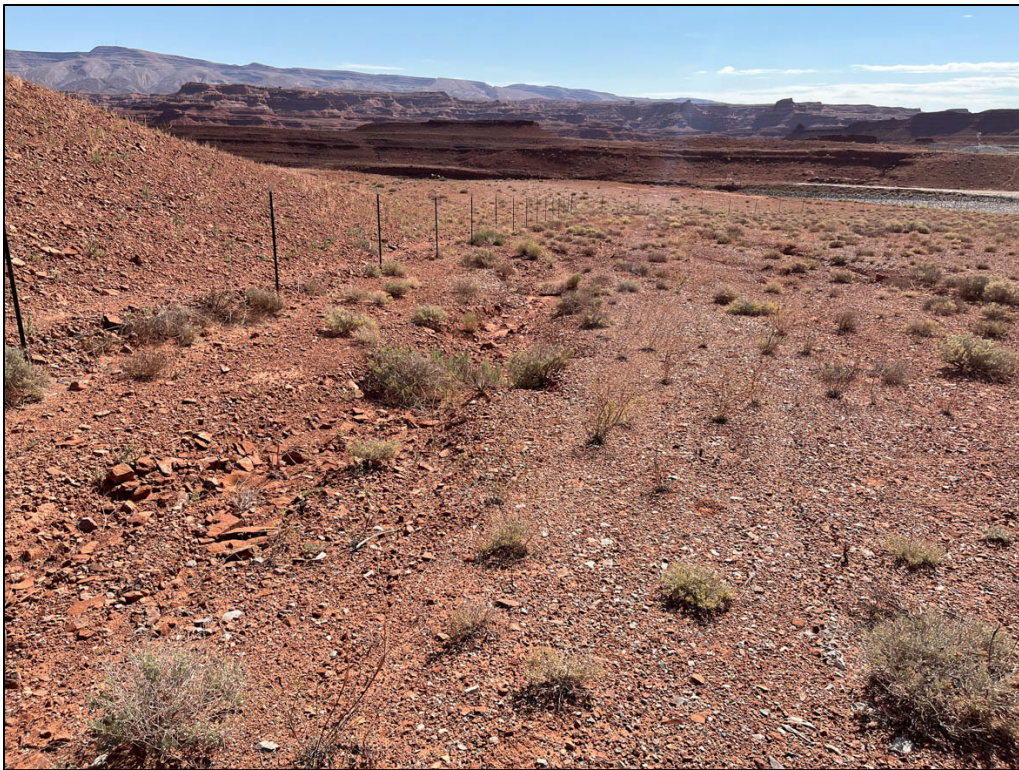
PL-4. Group of Rills

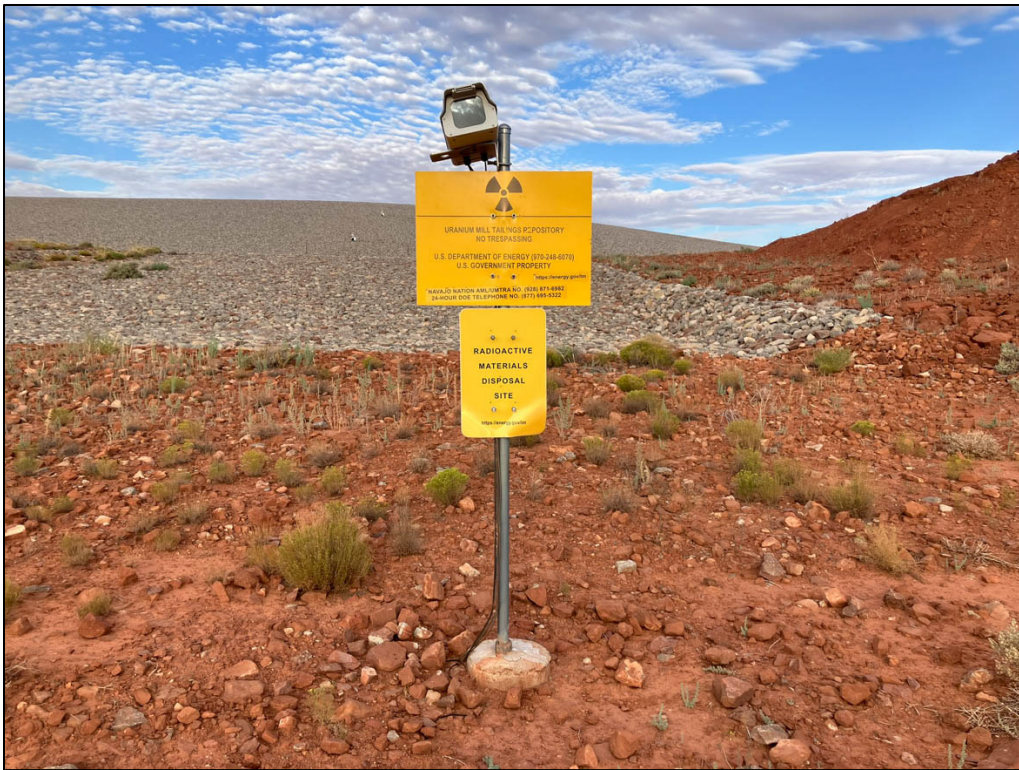
PL-6. Perimeter Sign P16 with Bent Corners

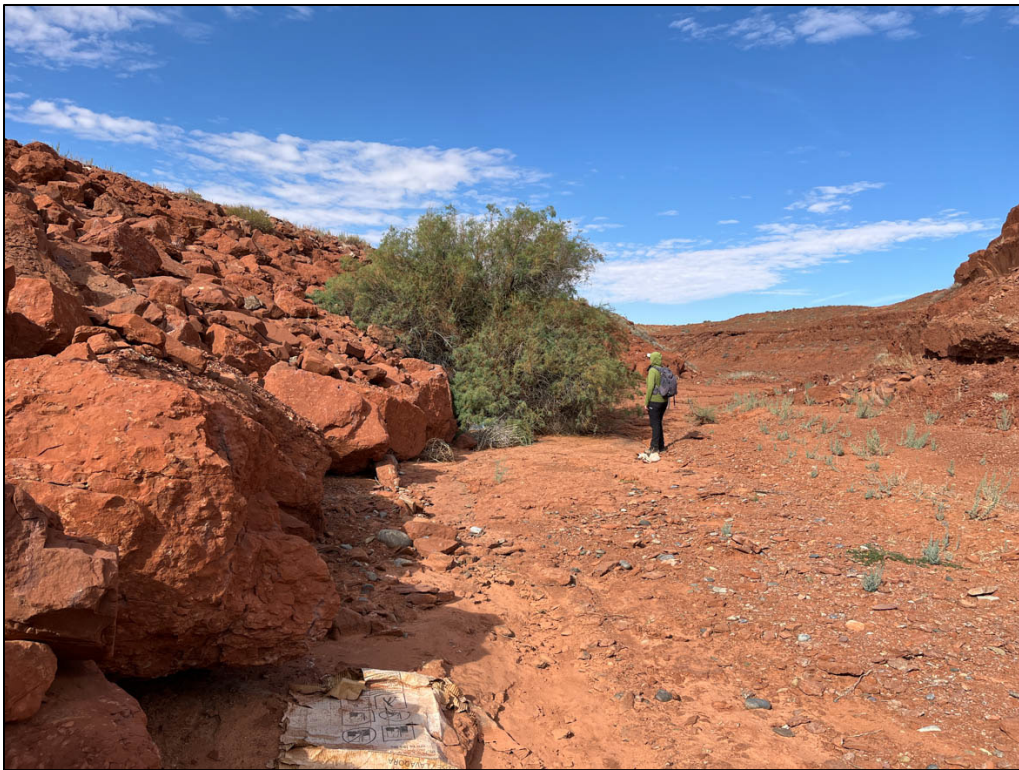
PL-12. Large Tamarisk Tree

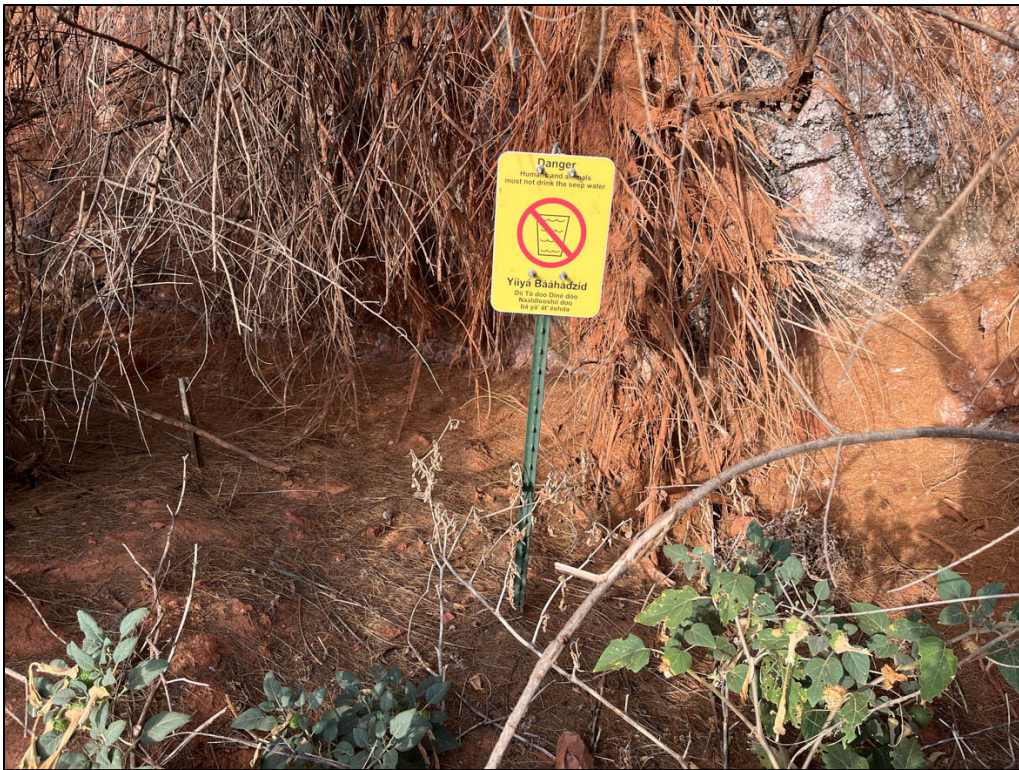
PL-14. Seep 0248, Dry

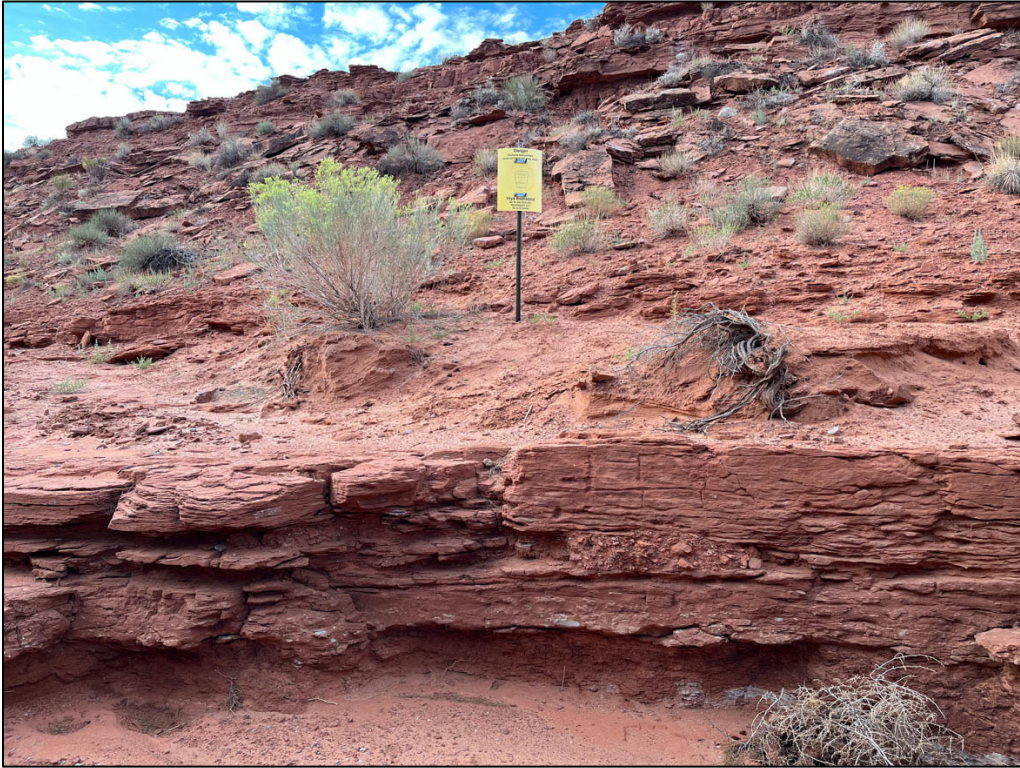
PL-15. Seep 0922, Dry

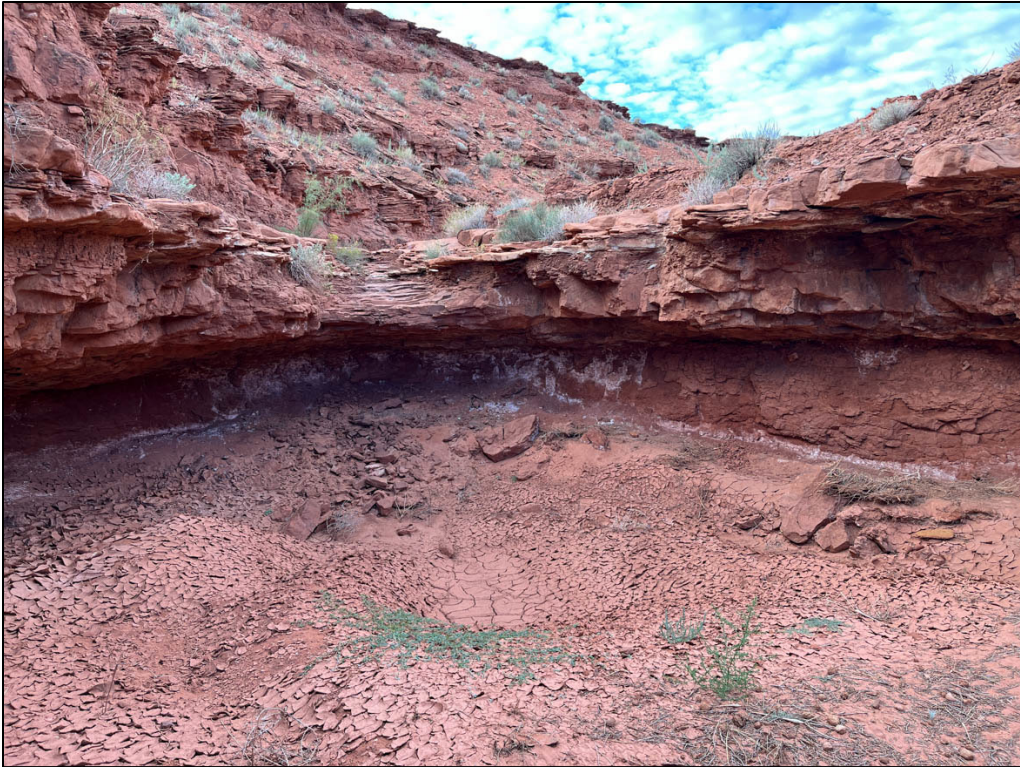
PL-16. Seep 0254, Dry

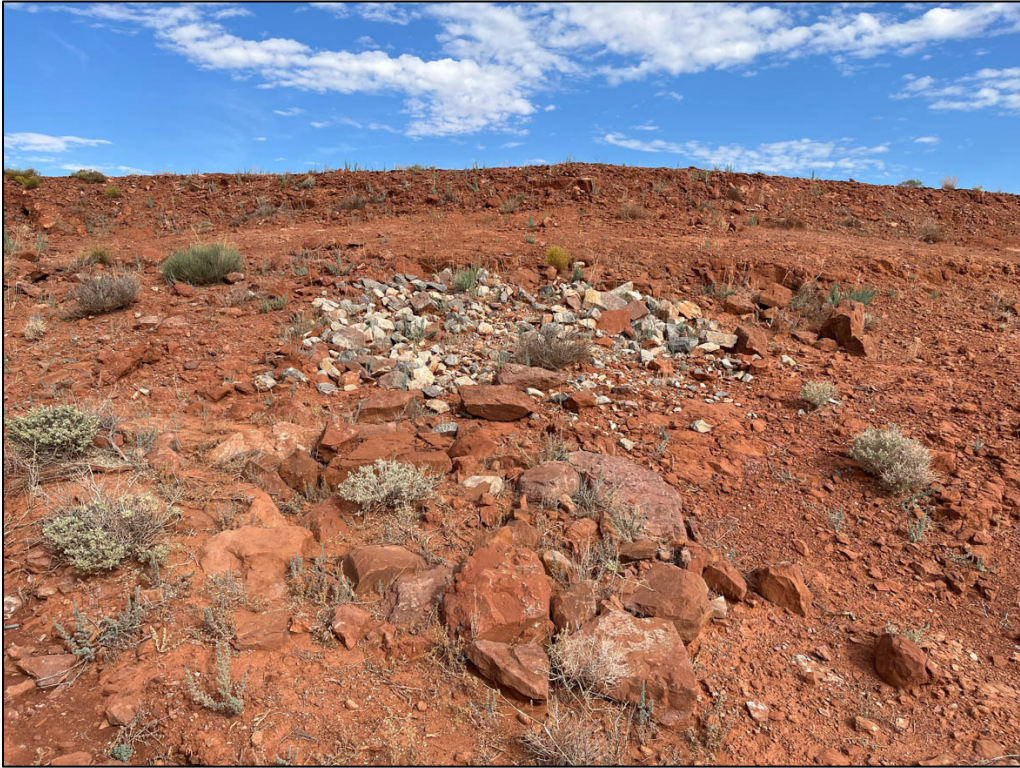
PL-17. Seep 0249, Dry

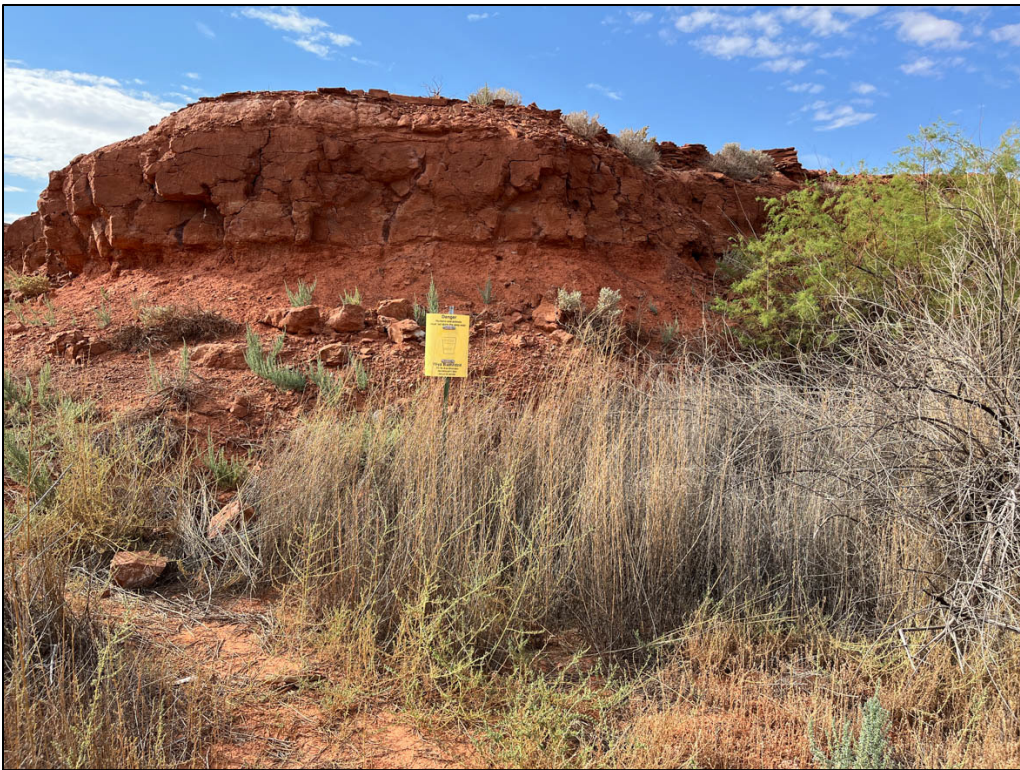
PL-18. Seep 0264, Dry

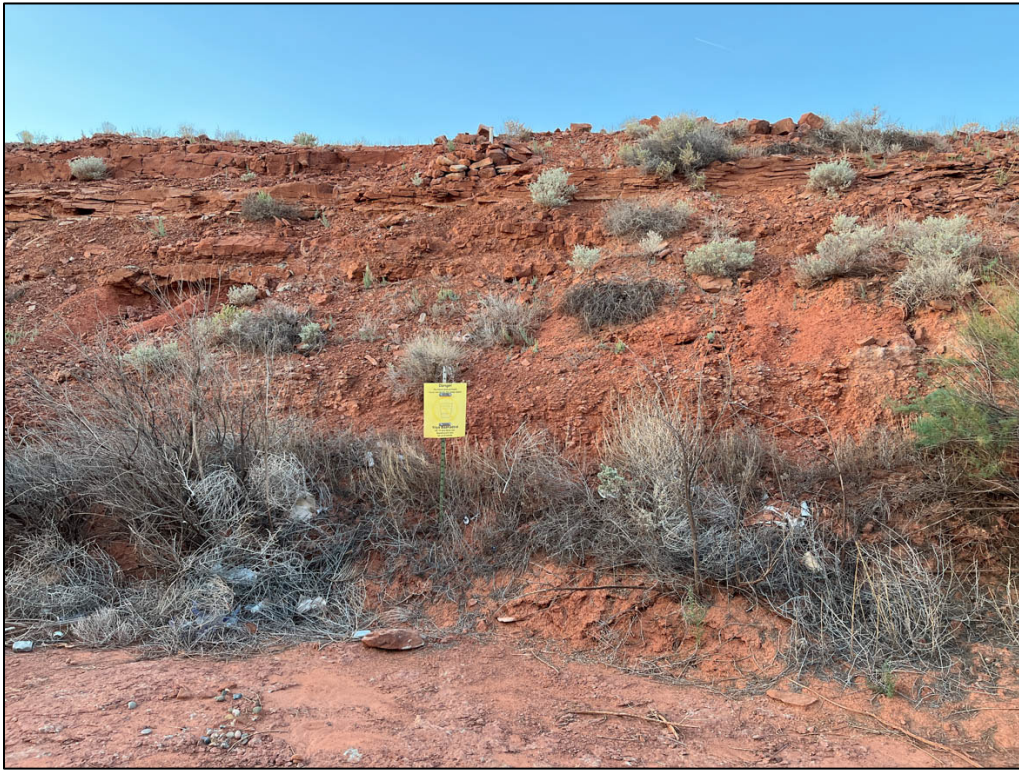
PL-19. Seep 0251, Dry

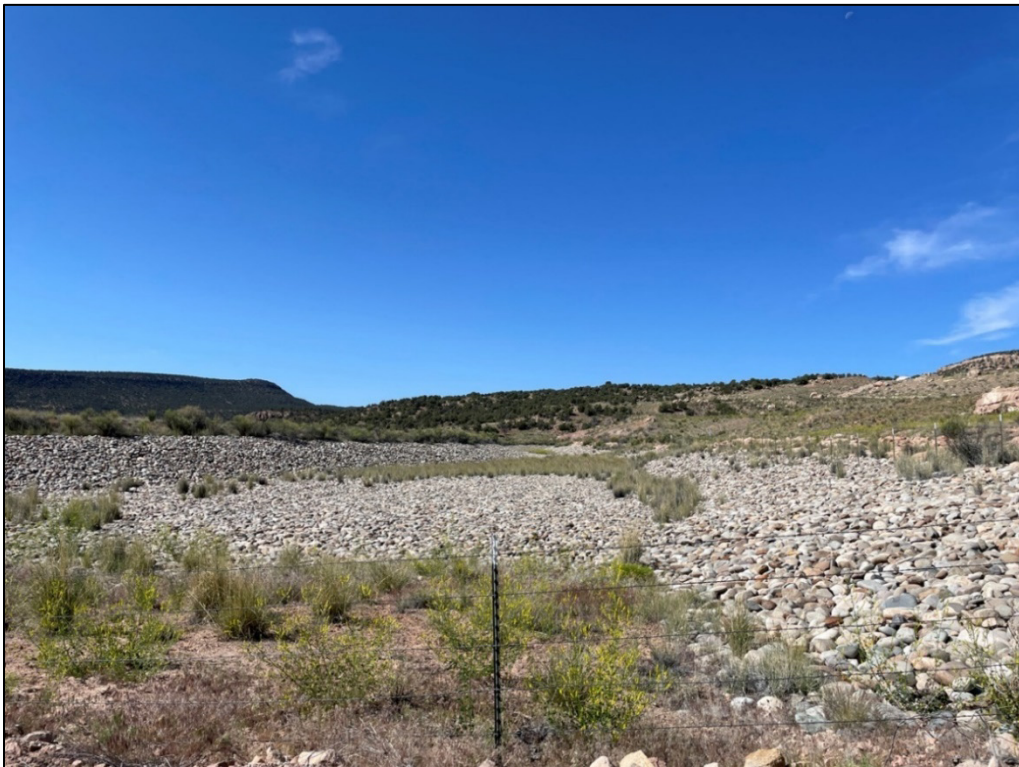
PL-6. Interceptor Trench on North Side of Site

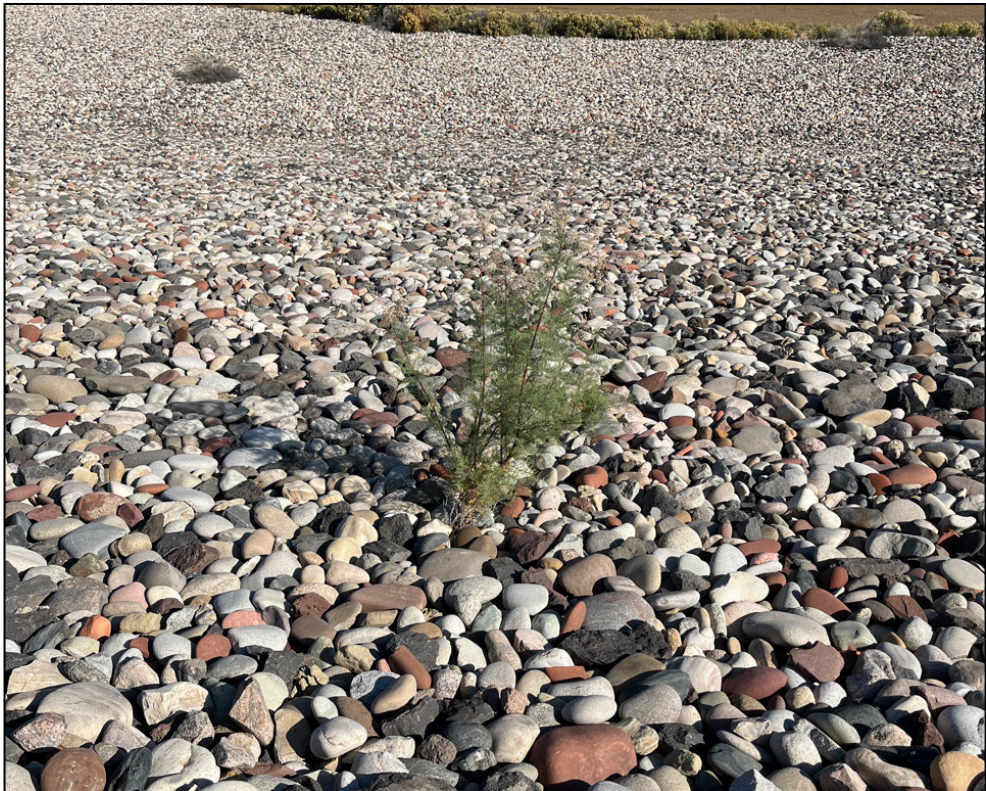
PL-8. Tamarisk Growing in Toe Ditch

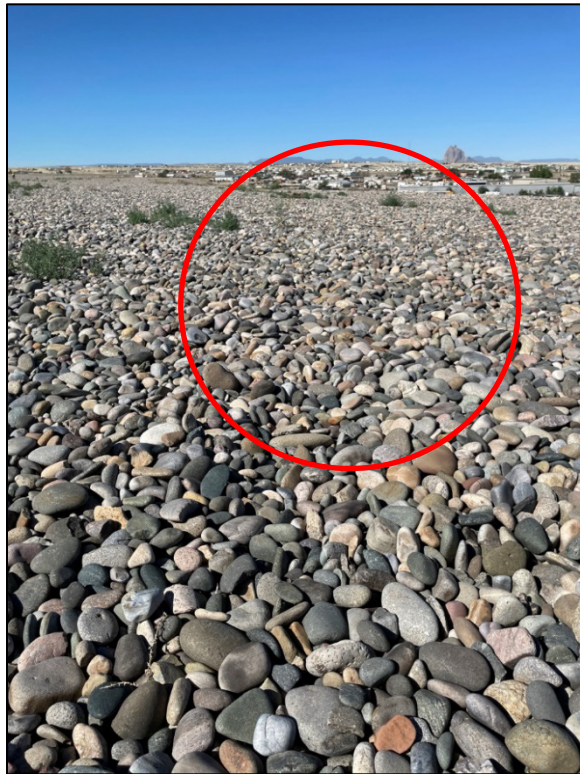
PL-11. Vehicle Ruts

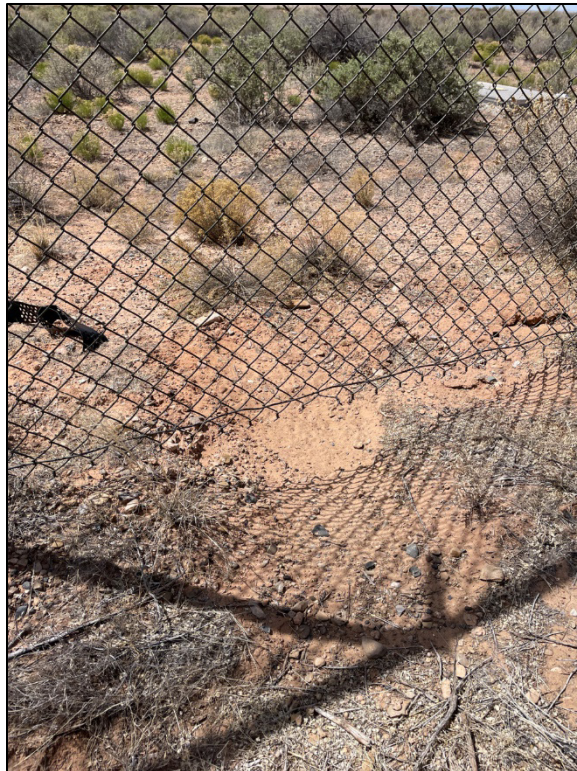
PL-2. Gap Created by Animals Under Fence Between Perimeter Signs P12 and P13

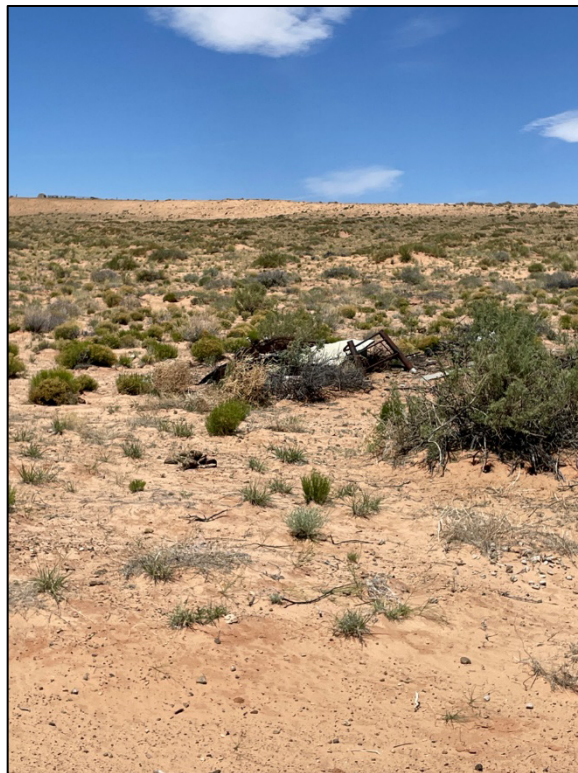
PL-4. Debris near Perimeter Sign P9

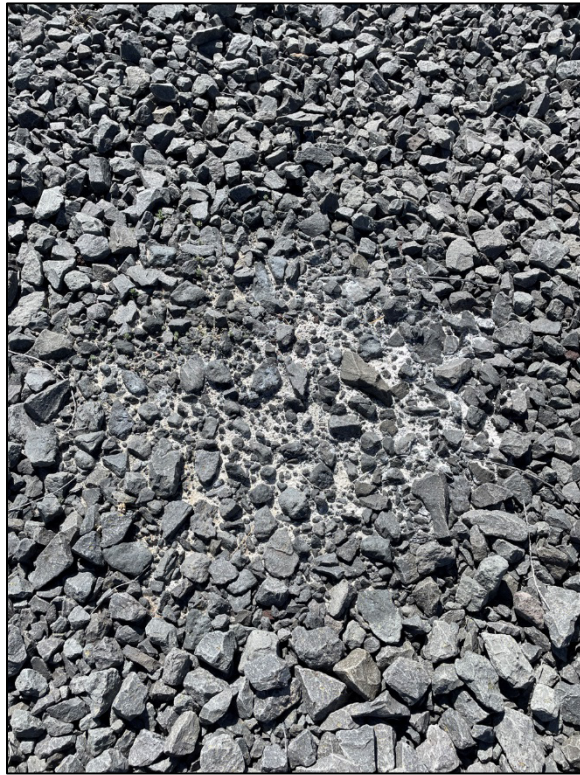
PL-7. Evaporative Materials on Top Slope of Disposal Cell

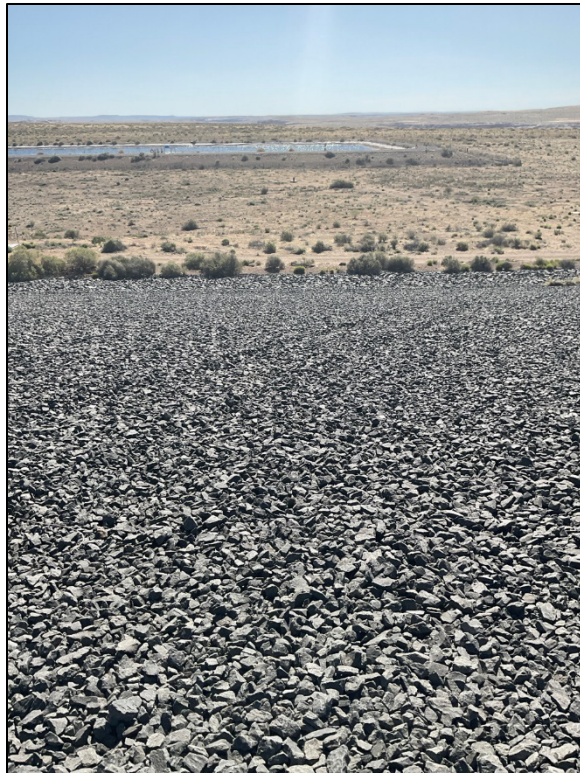
PL-8. Potential Tire Tracks on the Southeast Corner of the Disposal Cell

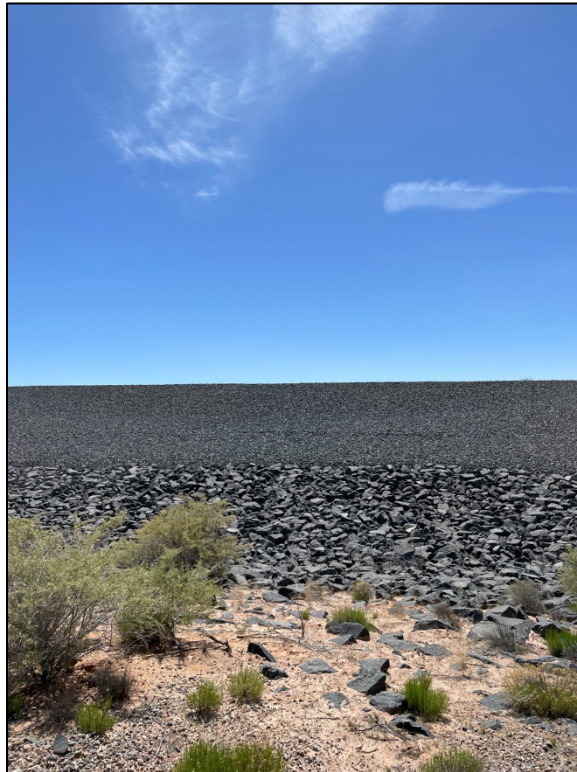
PL-9. Horizontal Lines on West Slope of Disposal Cell

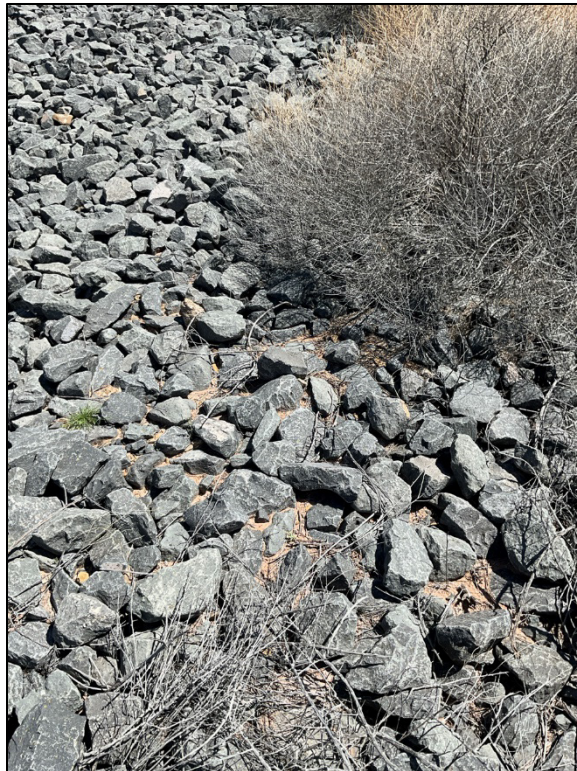
PL-10. Sediment Deposition on the South Slope of the Disposal Cell
