2024 Annual Site Inspection and Monitoring Report

Uranium Mill Tailings Radiation Control Act Title I Disposal Sites

MARCH 2025

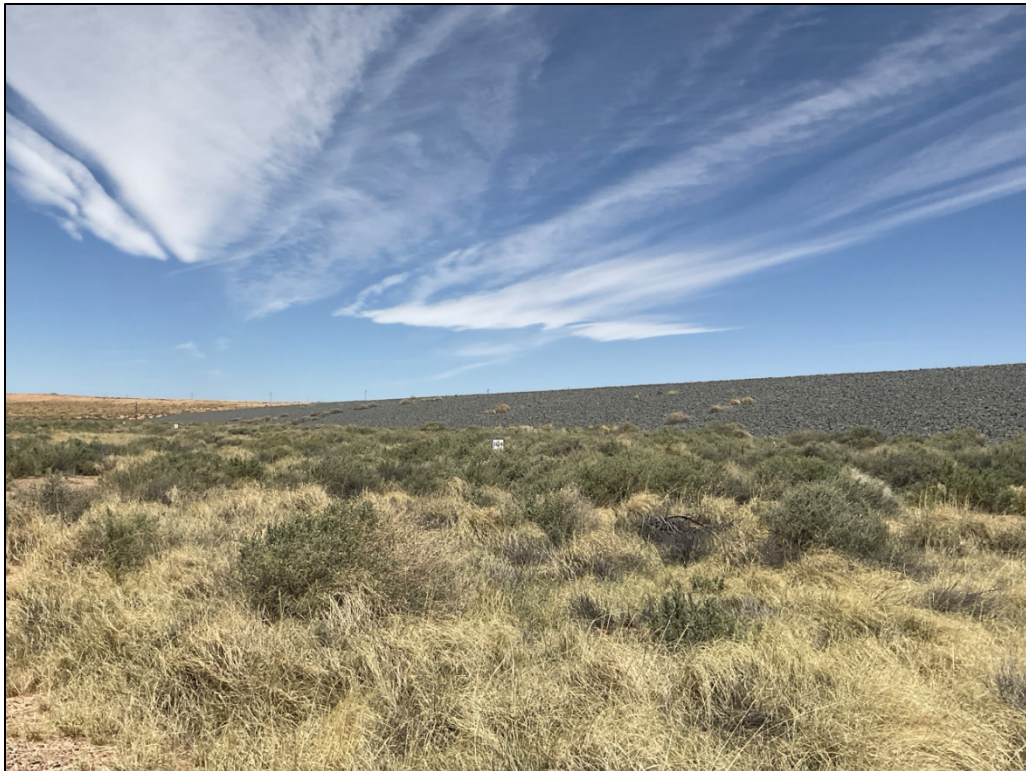
PL-12. Vegetation on South Slope of the Disposal Cell

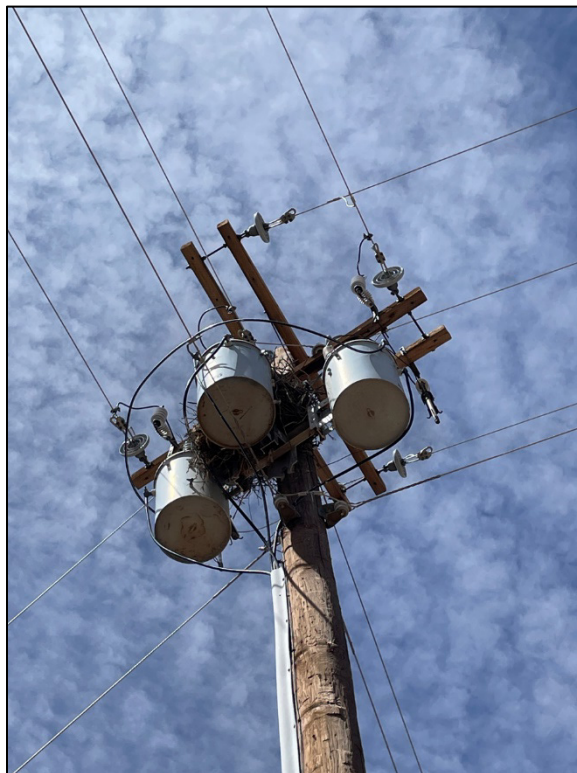
PL-14. Active Bird Nest on Power Pole Southwest of Disposal Cell
