OPERATION  
**PLUMB BOB**

NEVADA TEST SITE  
MAY-OCTOBER 1957

Project 30.7

TEST OF GERMAN UNDERGROUND  
PERSONNEL SHELTERS

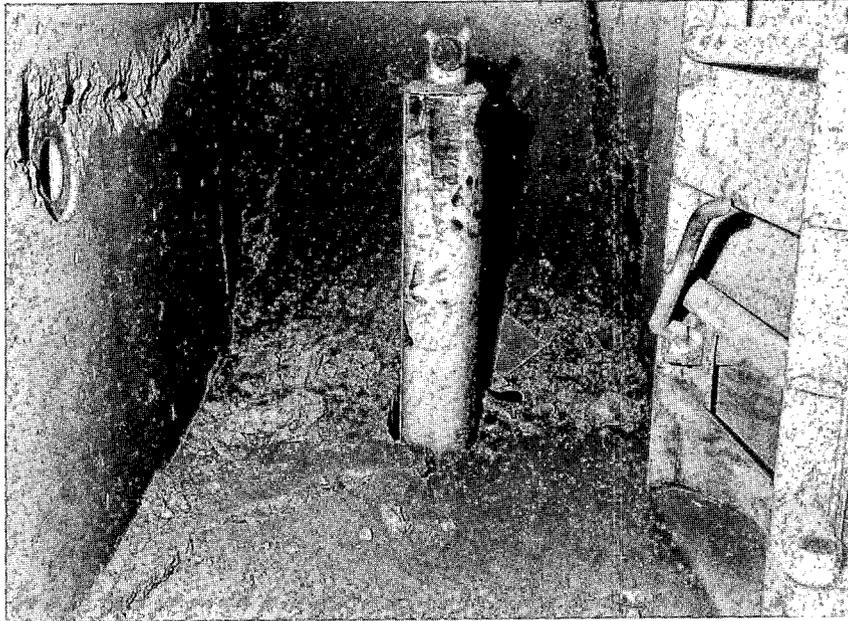
A 3-in. crack in the landing floor slab ran from the contraction joint at the bottom of the ramp along the center line of the slab to the Q-gauge mount. There it became a 2-in. crack, running diagonally to the exterior wall. A  $1\frac{1}{2}$ - to 2-in. crack was located along the intersection of the floor slab and the exterior wall. The crack was continuous the full length of the landing. The roof slab had a continuous longitudinal 1-in. crack along its center line. Two diagonal cracks  $\frac{1}{16}$  in. in width branched off the main crack, one terminating at the interior wall and the other at the exterior wall. A  $\frac{3}{8}$ -in. crack was produced along the intersection of the roof slab and the exterior wall. The exterior wall was badly damaged, having a longitudinal crack located at the mid-height of the wall. Spalling of 2 to 3 in. on each side was observed along its entire length.

Fig. 3.8—Landing floor slab looking toward GZ (structure RAa). Note debris at bottom of ramp before cleaning.

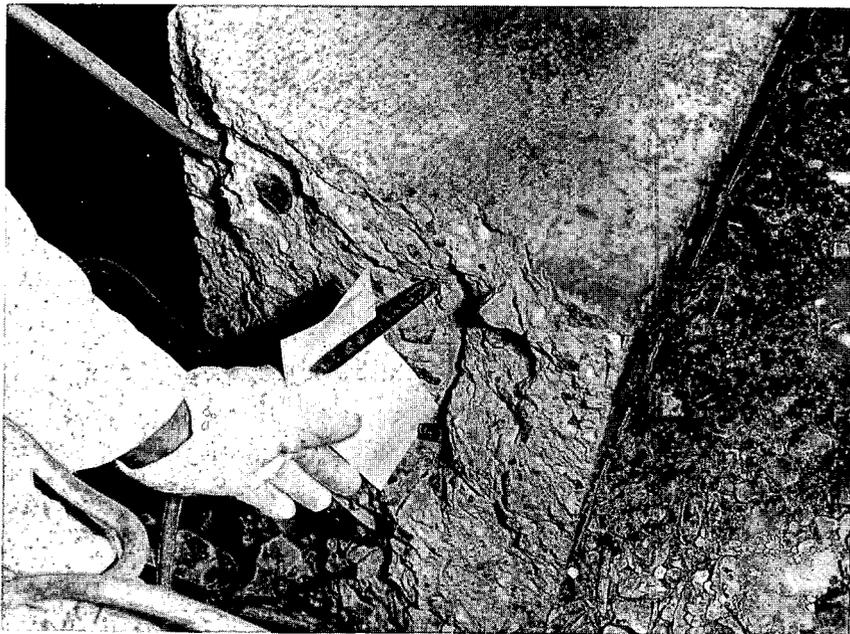
Fig. 3.21—Detail of necked-down reinforcement torn from interior wall at parapet (structure RAa).

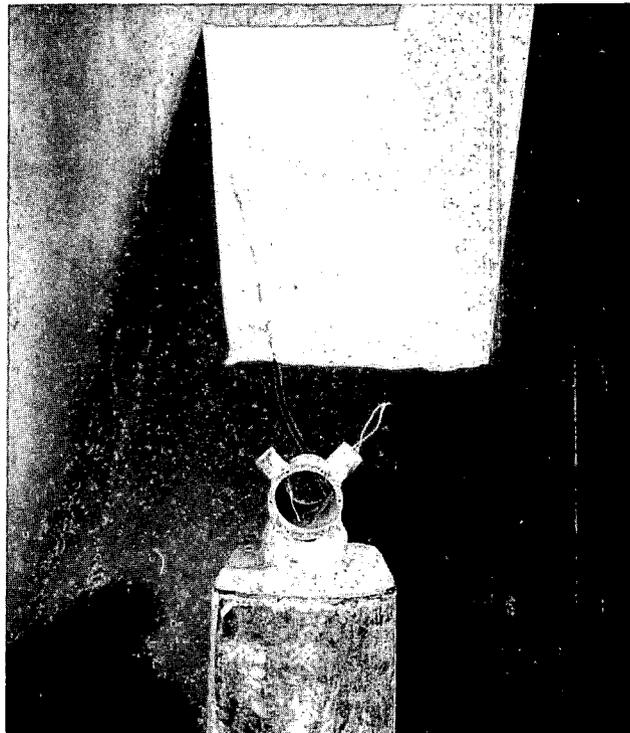
Fig. 3.49—Looking up entrance toward GZ, after cleaning (structure RAc).

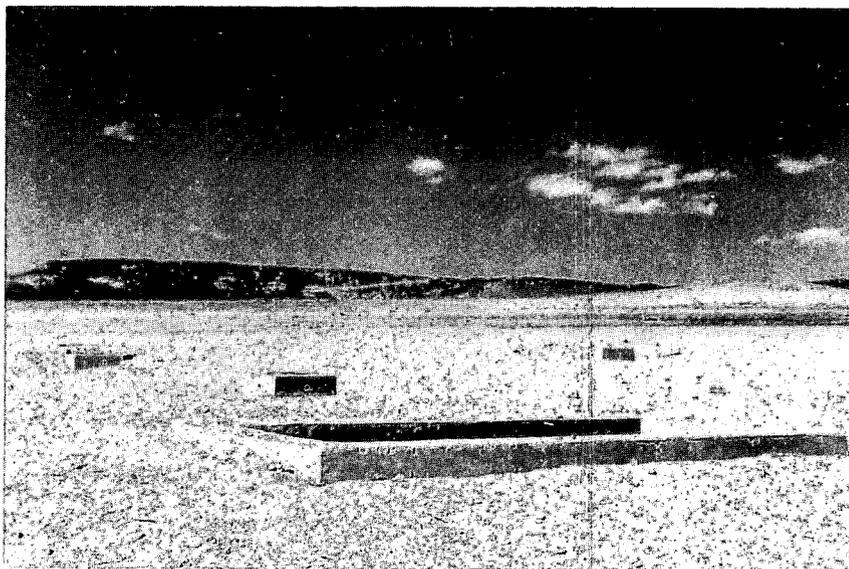
Fig. 3.72—Above-ground portion of main entrance and emergency-exit shaft (structure CAa).

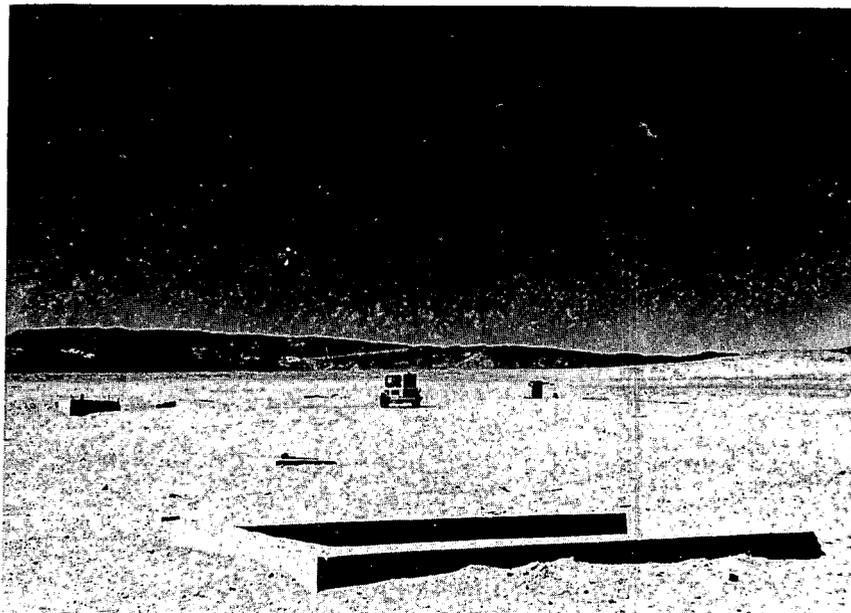
Fig. 3.81—Above-ground portion of main entrance and emergency-exit shaft (structure CAb).

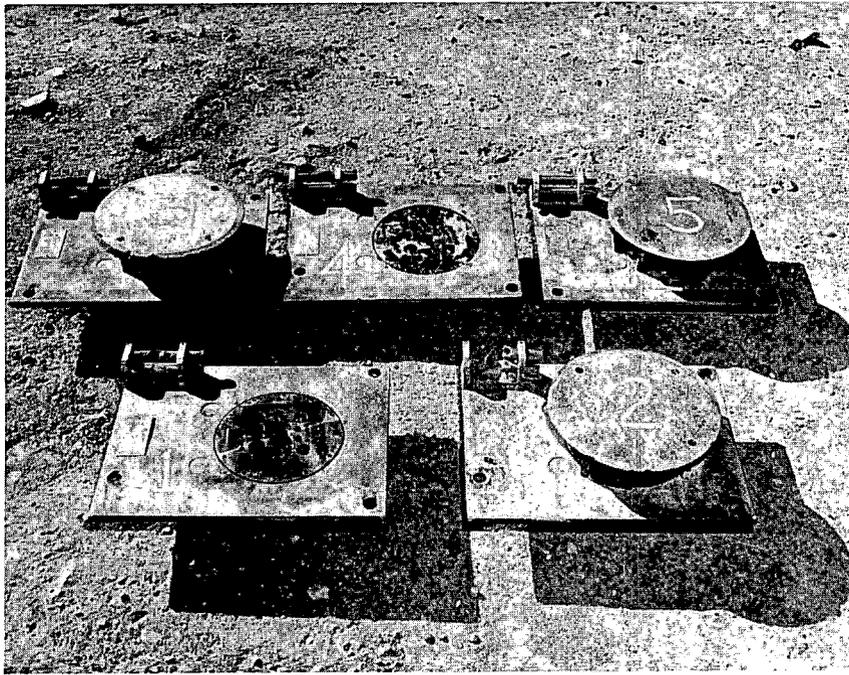
struments is given by Project 30.5c in report WT-1536. Figures 3.110 to 3.116 show the condition of these gauges after recovery from their field locations.

Fig. 3.110—German pressure gauges 1 to 5, following test.
