Steam Turbine Rotor Reliability— Task Details

EPRI NP-923
Project 502
Interim Reports
November 1978

Steam Turbine Rotor Reliability — Task Details

NP-923
Research Project 502

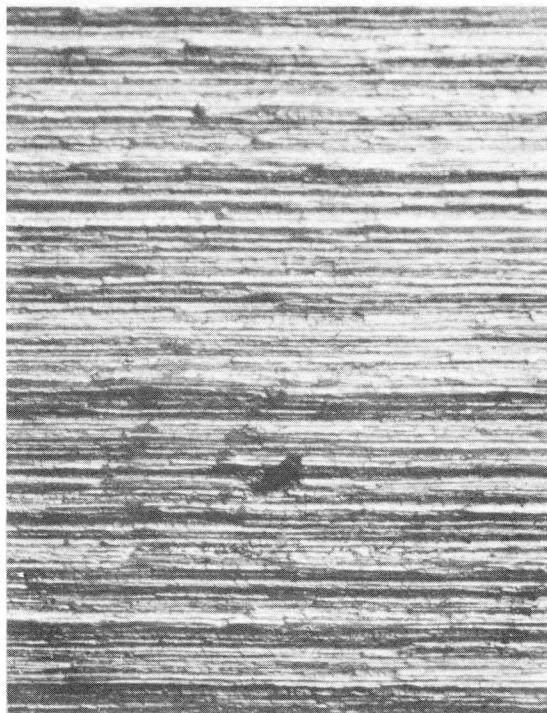
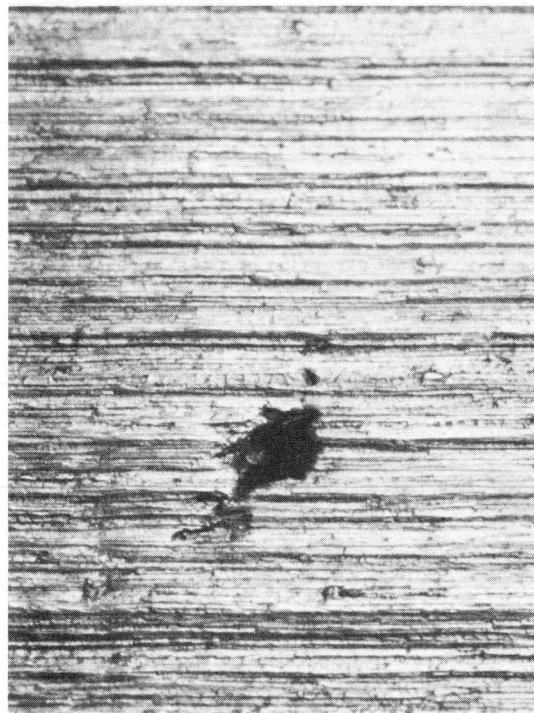
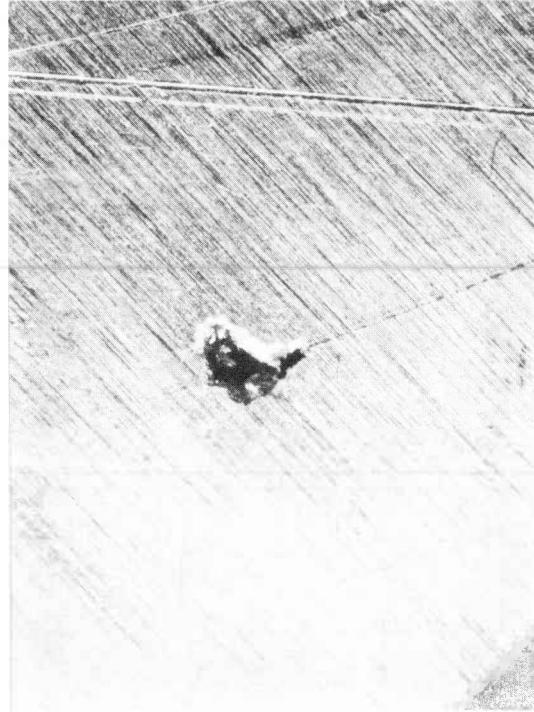
FIG. 2 - Holes in Joppa 3 Revealed by Saw Cuts.
Mag. 10X

The first saw cuts were made transverse to the rotor axis, removing discs four to ten inches thick containing the flawed areas of interest. The discs were then cut into pie shaped segments by radial cuts and chordal cuts made to discard material beyond a radius of 5 to 6 inches (boresonic UT indications were only reported to about 4 in. from the rotor center line). Further cuts were then made perpendicular to the Z axis in order to achieve relatively thin pieces for radiography or UT inspection in the Z direction. Figure 1 shows a typical disc cross section with the cuts discussed above. In this case the pieces marked J7A1 and J7A3 are the pieces of interest for further sectioning. Similar sketches were made of most cuts in order to secure a permanent record of piece location. Typical flaws sometimes revealed on saw cut surfaces at this stage are shown in Fig. 2.

$Z = 100.4''$, $R = 0.81''$, $\theta = 360^\circ$

$Z = 98.7$, $R = 0.81''$, $\theta = 360^\circ$

$Z = 102.3''$, $R = 2.31''$, $\theta = 3.57^\circ$

$Z = 102.3''$, $R = 2.06''$, $\theta = 357^\circ$

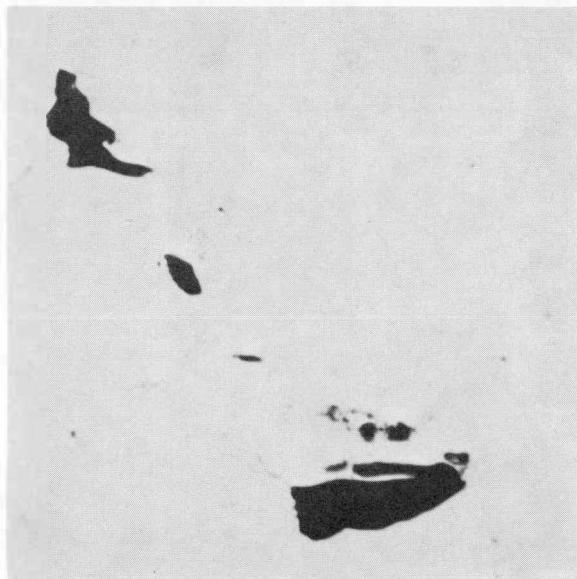
FIG. 10 - Microstructure of Joppa 3.
STBS Etch.

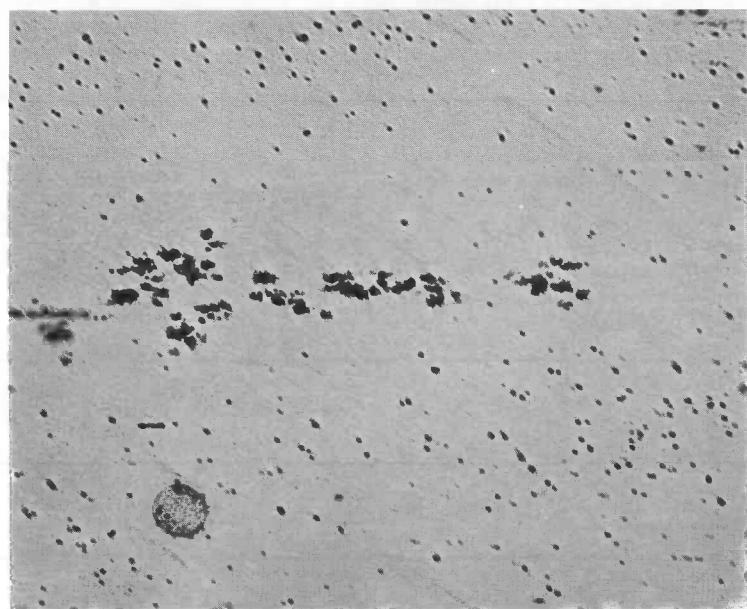
Three specific types of flaws were found in Joppa 3. Figures 11, 12 and 13 are typical examples. For purposes of this program the three types have been labeled as follows:

FIG. 11 - Examples of Type I Flaws
in Joppa 3.

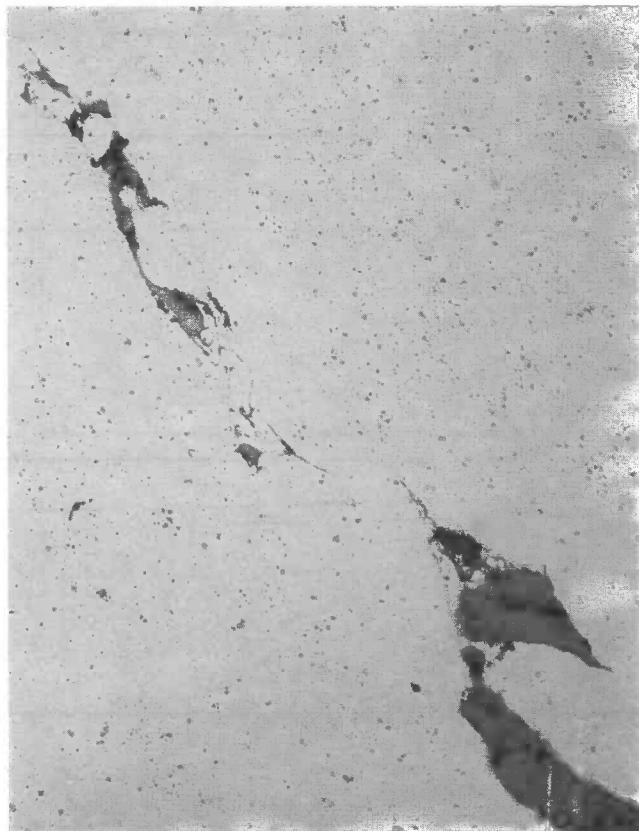
FIG. 13 - Examples of Type III Flaws in Joppa 3.
In 'a' the Sulfides are Associated With
a Type I Void.

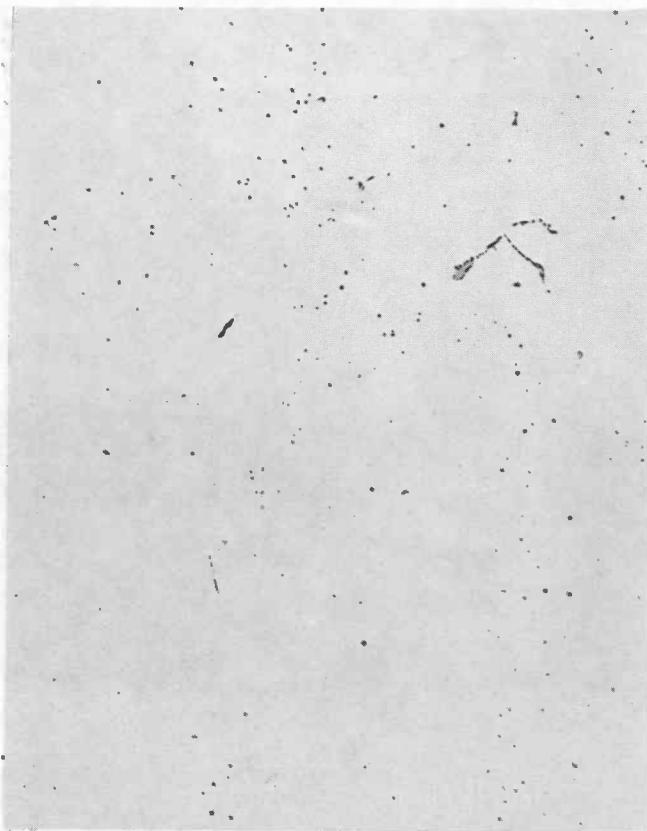
Type III. Manganese sulfide inclusions. These are generally of two forms; the first relatively large and slightly elongated, frequently lying in the laps associated with Type I defects (Fig. 14); the others are small spherical manganese sulfide inclusions, Figs 15 and 16, distributed rather densely on some planes of polish. These small manganese sulfides are occasionally densely clustered around Type I holes as seen in Fig. 17.

FIG. 14 - Magnified View of Inclusion Stringer Coming from Lower Right Corner of Fig. 13a. Note Forging Laps.

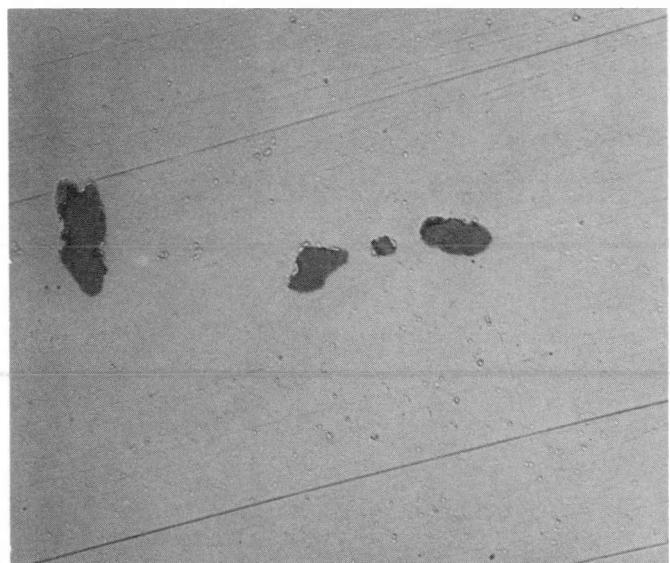
FIG. 15 - Typical Small Spherical Manganese Sulfide Inclusions in Joppa 3. RZ Plane of Polish.
Mag. 100X

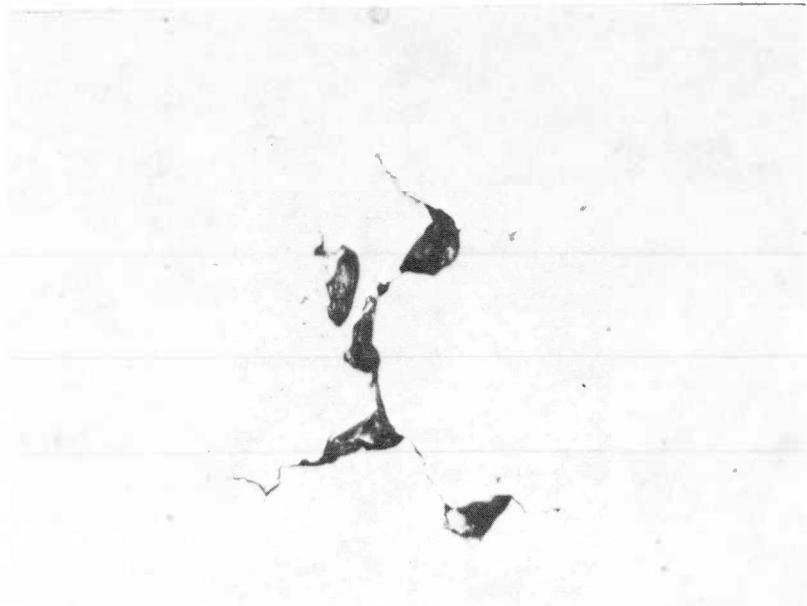
FIG. 17 - Examples of Small MnS Inclusions Densely Grouped Near Type I Holes in Joppa 3. Mag. 100X

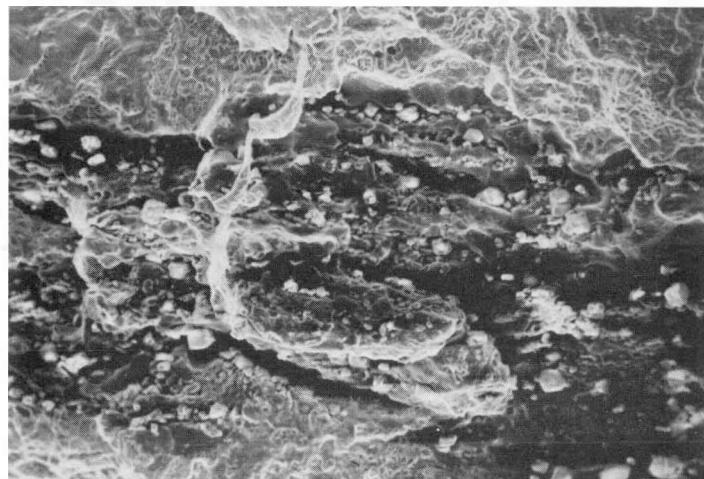
The fracture surface of interest is from a Low Cycle Fatigue (LCF) specimen which contained an actual bore surface. Figure 23 is a low magnification view of the RZ plane of fracture. The dull gray semi-circular portion of the fracture toward the top of the photo is the fatigue portion of the crack, while the shiny faceted remainder of the surface is the overload portion which failed by cleavage. Several smaller fatigue portions also appeared on the fracture. The fatigue portion was extremely rough, contrary to the usually flat smooth nature of fatigue cracks. Peak to base depths in this crack are on the order of 1/4 in. It is believed that this extensive departure of the crack from the RZ plane of maximum stress is due to the crack's attempt to follow flaws in the structure. Figure 24 is a Scanning Electron Microscope (SEM) photomicrograph of a flaw detected on the fatigue fracture. Figure 25 is a higher magnification shot in the same area as Fig. 24 and shows that many of the inclusions laying in the fracture surface are angular in nature. This corresponds to the shape of the inclusions in Fig. 12, and leads to the belief that this is a Type II flaw. An EDAX analysis (an X-ray analysis performed on the small inclusions in the SEM which identifies chemical elements but not the quantity present) on several of the particles identified the presence of aluminum and silicon as primary constituents with some calcium also present. These inclusions were probably washed into the ingot from refractories.

FIG. 23 - Light Photomicrograph of Low Cycle Fatigue Specimen Fracture
on RZ Plane of Joppa 3. Mag. 3.5X

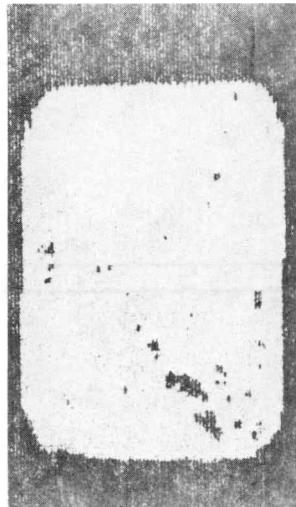
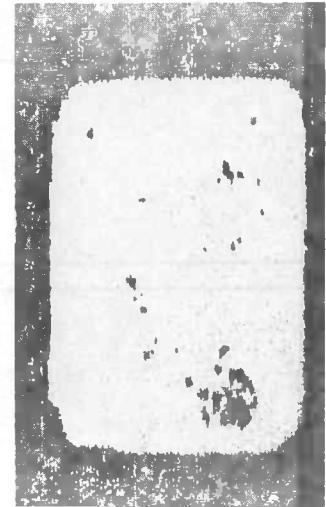
Figure 27 shows results of an ultrasonic C-scan at 10 MHz through the RZ plane of the specimen before progressive sectioning was begun. Figure 28 shows a calibration chart for the 10 MHz C-scan which permits a comparison between the size of reflectors in the specimen and flat-bottomed round holes of various diameters drilled into a steel test block. Note that the

FIG. 27 - 10 MHz C-Scan from $\theta = 332^\circ$ Face of Piece
J7A1-6. Gated at Depths Indicated. Top
Edge at $Z = 99.8$ in., bottom at $Z = 101.5$ in.,
Front Left Edge at $R = 0.11$ in. and Front
Right Edge at $R = 1.3$ in.

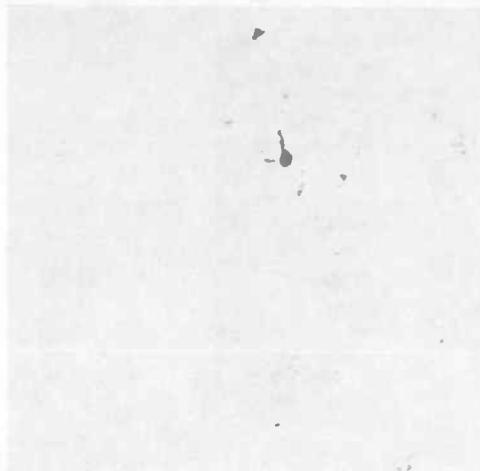
Radiography of the same specimen is shown in Fig. 29. The large flaw corresponds to the large UT indication in the lower right corner of the Fig. 27 C-scan.

FIG. 29 - Radiographs of Piece J7A1-6 from Joppa 3. Calculation of flaw position in cylindrical coordinates must either be done graphically in conjunction with Fig. 4 or mathematically.

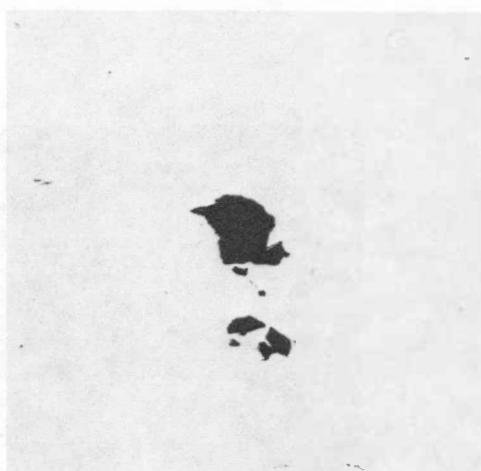
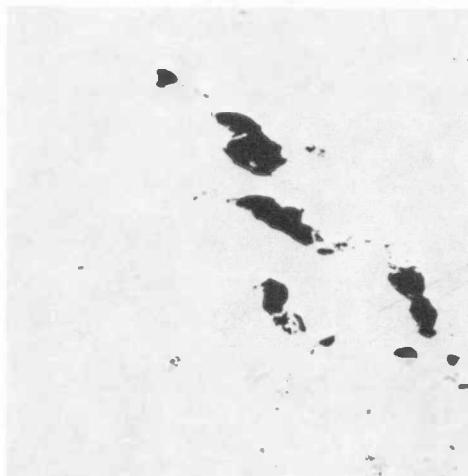
Dissection revealed that this indication was indeed a large hole with many lobes and side arms, extending about 0.25 in. in the Z direction, 0.15 in. in the R direction and more than 0.4 in. in the θ direction as shown in Fig. 30. The following table compares the center position of this hole in rotor (cylindrical) coordinates, as found during dissection, to the results of the commercial boresonic inspections of Westinghouse (W) and Commercial Machine Works (CMW).

FIG. 30 - Large Flaw from Joppa 3 Piece J7Al-6. Material Removed from 332° Plane of Polish is Indicated. Mag. 6X

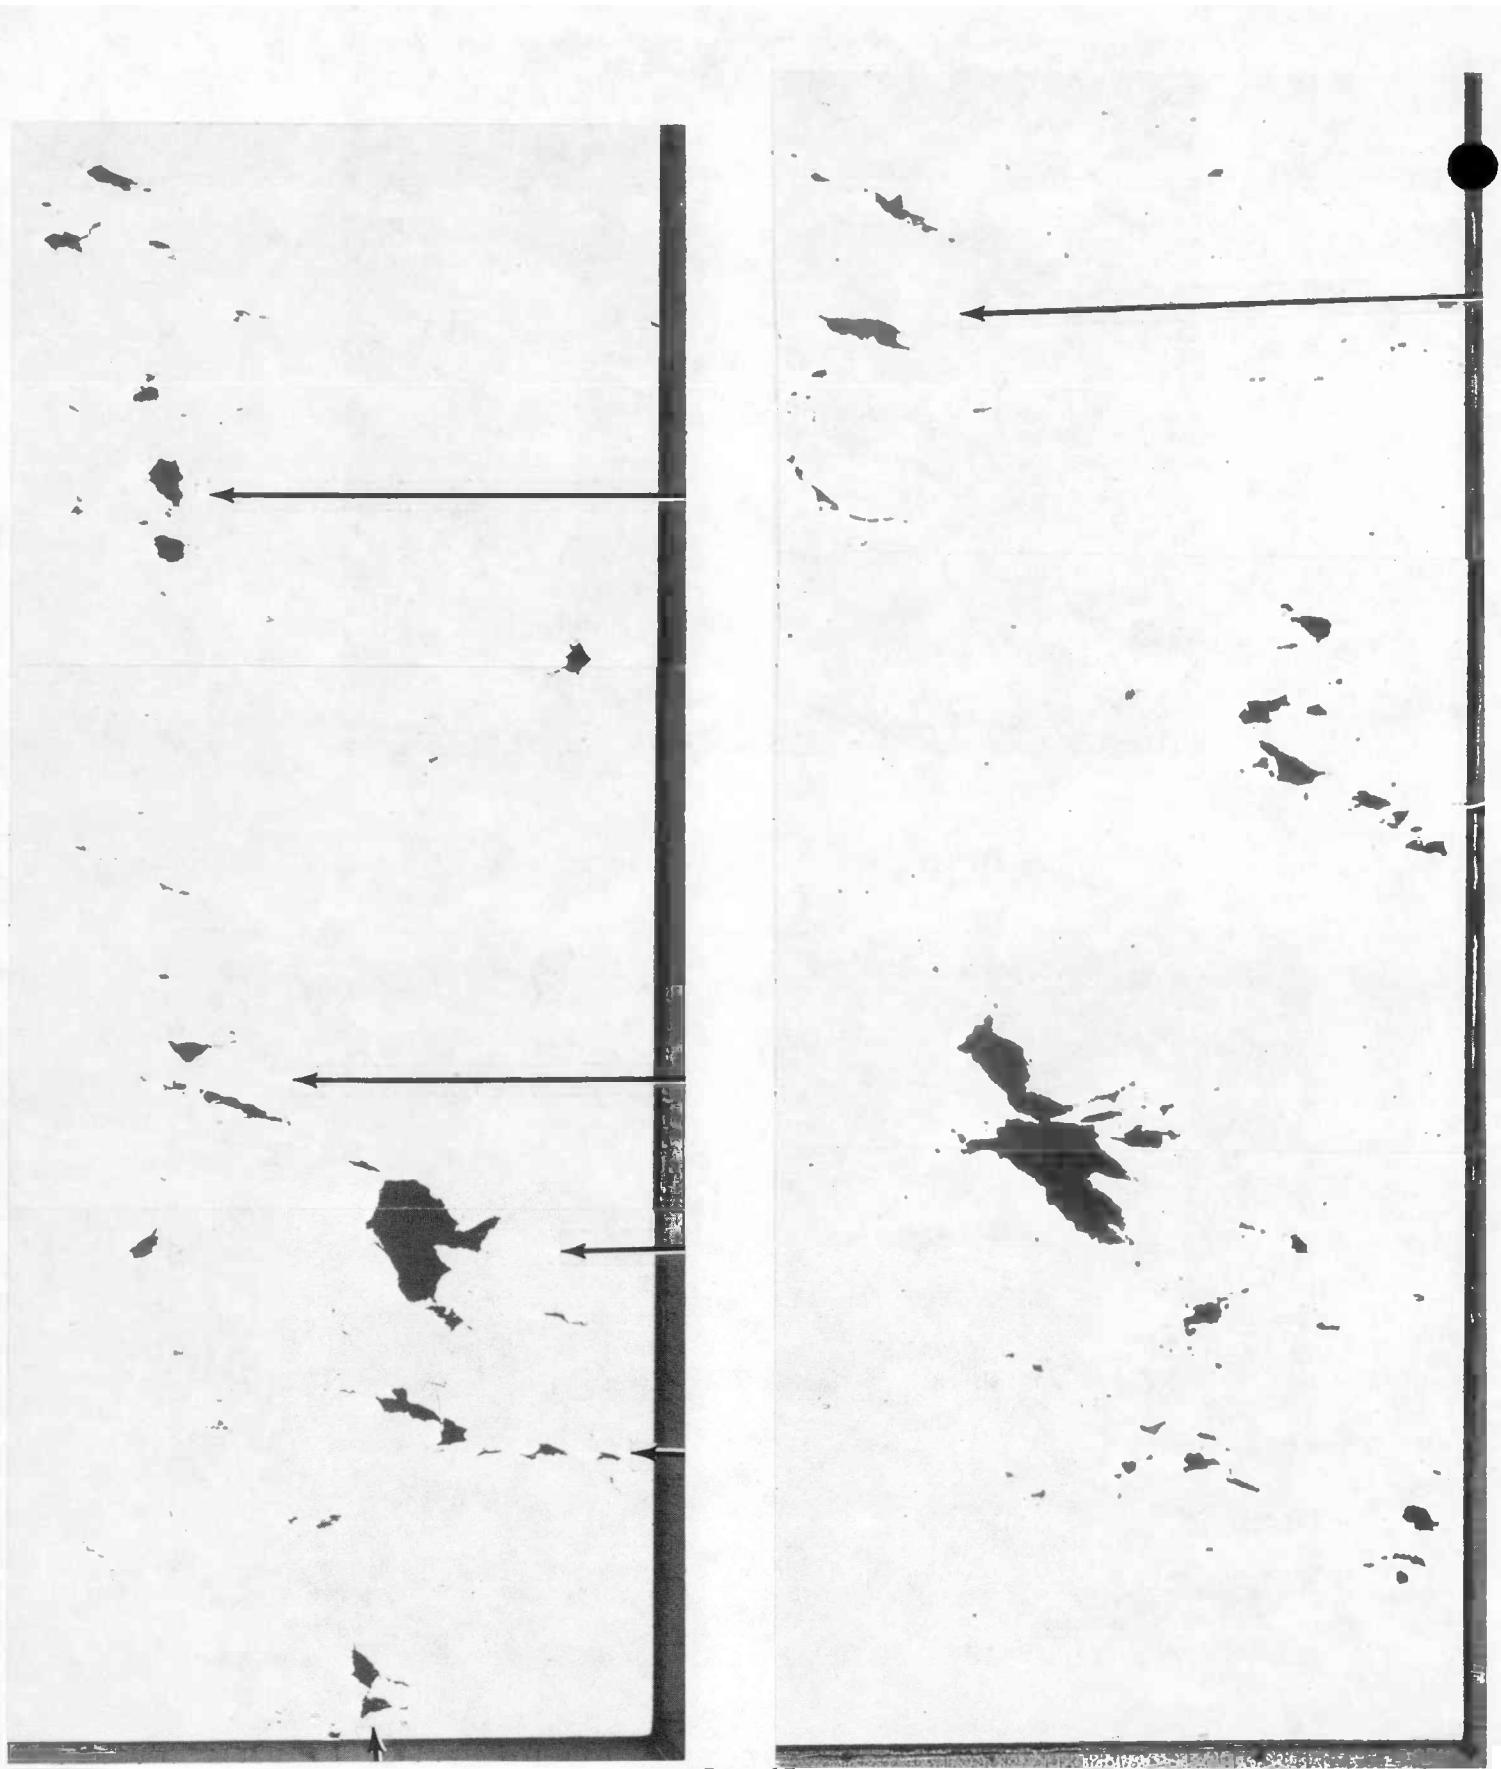
FIG. 67

Radially Oriented Flaw in Piece J7A5-22 from Joppa 3.
Bottom is Actual Bore Surface, Z Increasing Right to
Left. Mag. 8.5X.

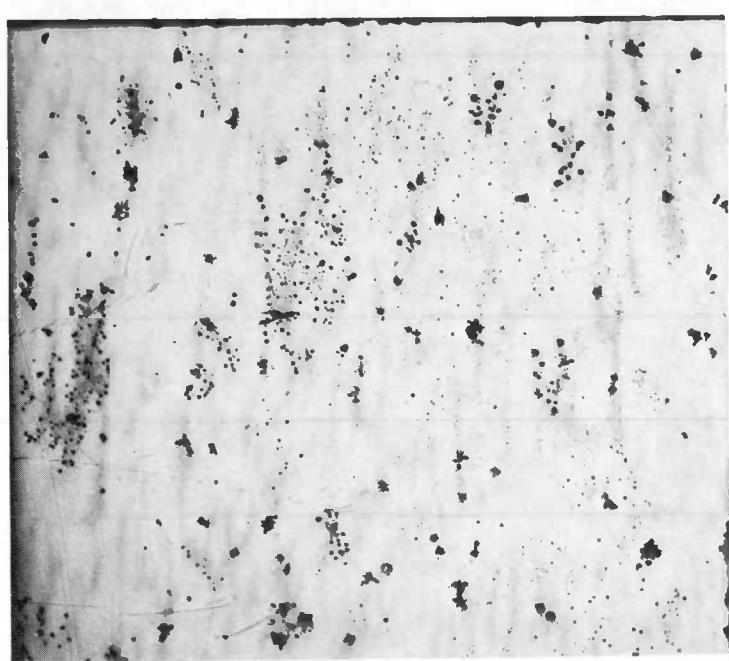
Figure 76 presents a low magnification view of a polished and etched RZ plane of Buck 6. This figure is badly pitted due to a poor etch but it does show the same coring due to chemical segregation during ingot solidification as was found in Joppa 3.

FIG. 76 - Cored Structure in Buck 6.
STBS Etch. Mag. 6X

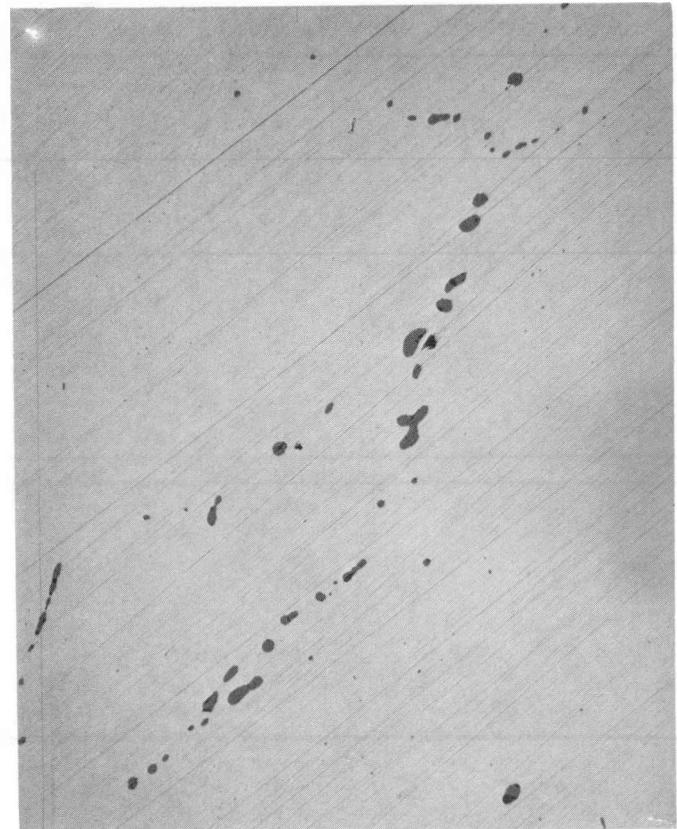
The flaws found in Buck 6 were similar to those found in Joppa 3 with only minor variations. Type I was present in both and was not significantly different. Type II was identical to Joppa but less numerous, at least in the areas examined. The Type III manganese sulfides were noticeably different from Joppa 3. They were often present in branching alignments as shown in Fig. 80 whereas this was an infrequent arrangement in Joppa 3. This figure also shows that individual inclusions contained a second phase and were of odd shapes. Figure 81 is a view of this at higher magnifications. This variation in Type III inclusion form probably does not affect UT results. The presence of a different phase in the inclusion does indicate a chemical change, possibly an addition such as a rare earth element.

FIG. 80 - Type III Inclusions in Buck 6.
Unetched. Mag. 100X

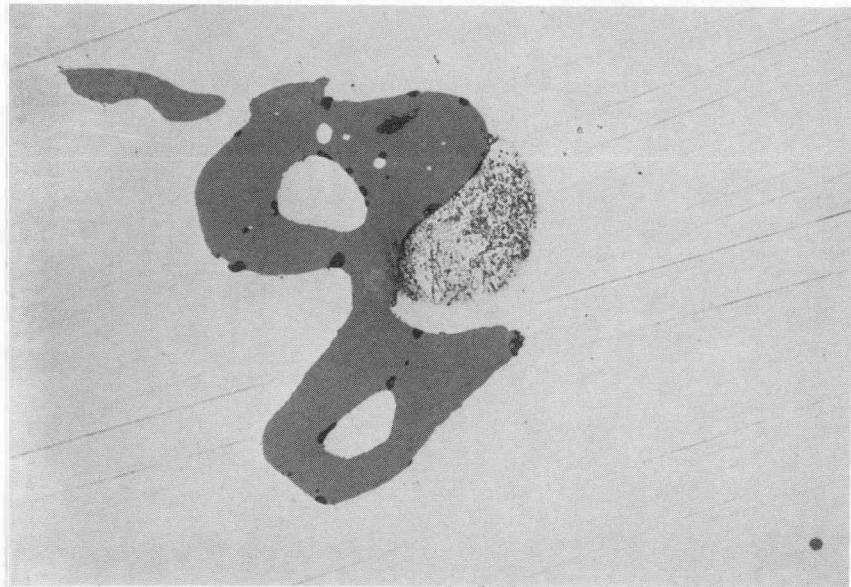
FIG. 81 - Type III Inclusions in Buck 6. Unetched.
Mag. 500X

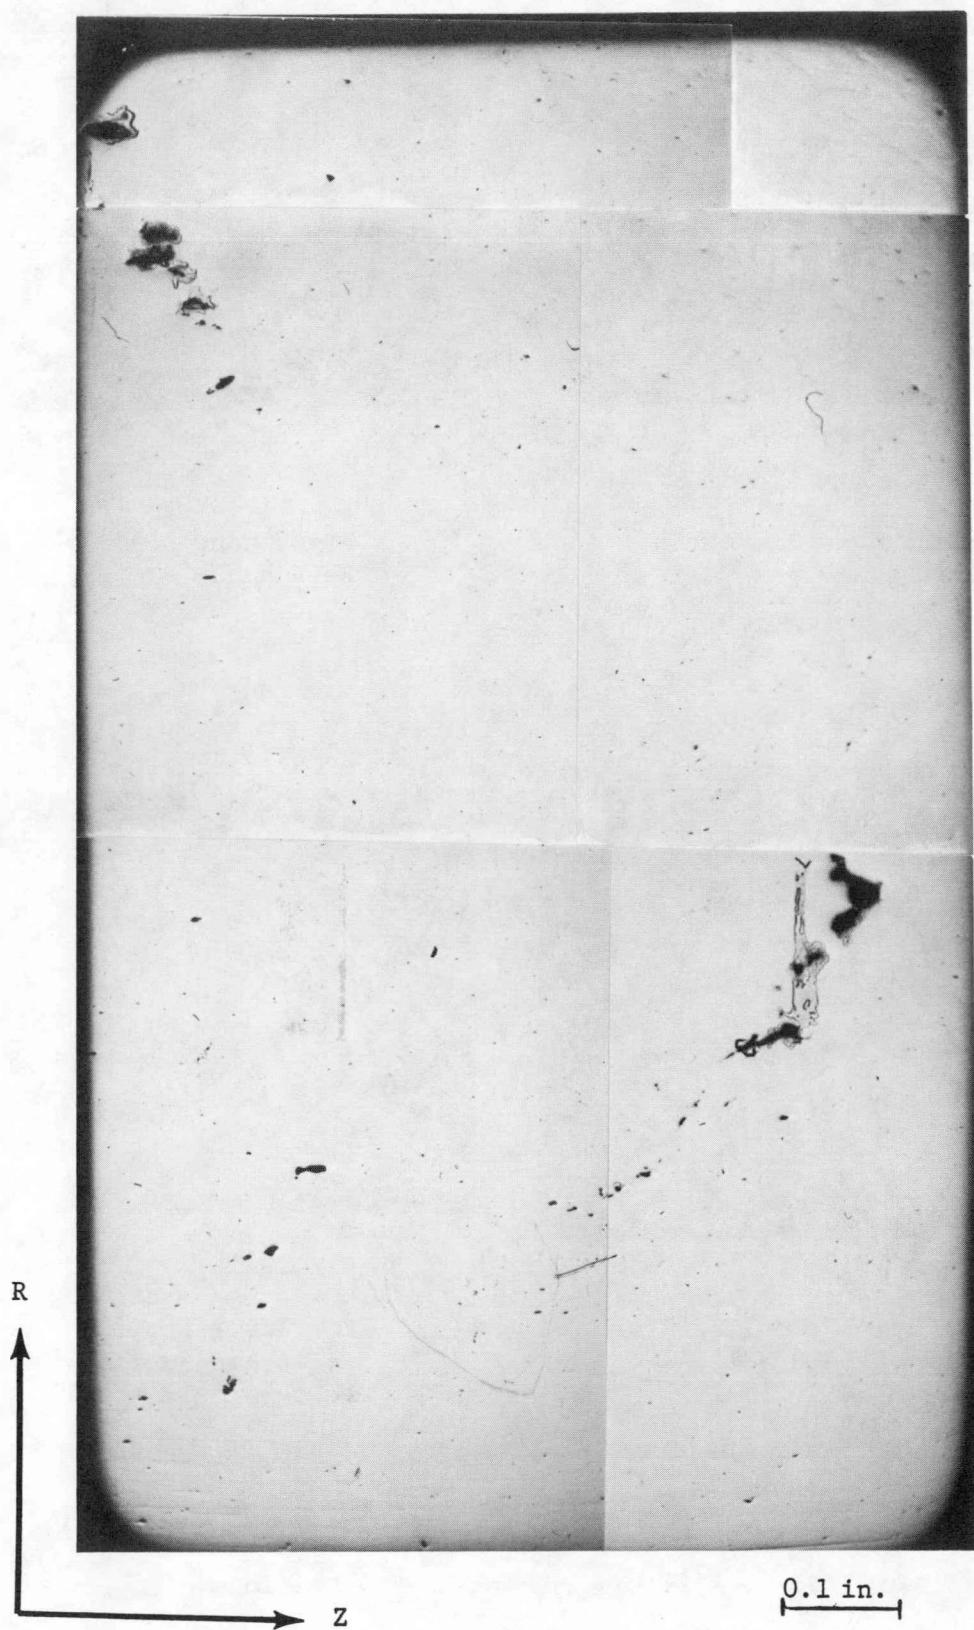
FIG. 85

Montages of B114 (BCL Flaws B&C) are presented in Figs. 85 through 99, B1121 (BCL Flaw A) is shown in Figs. 100 through 112, and B313 (BCL Flaw P) in Figs. 113 through 116. The only flawed area in B312 (BCL Flaw I) may be seen in Fig. 117.

Piece B114 from Buck 6 - 0.002 in. Removed.
0.0117 Area Fraction Flaw.

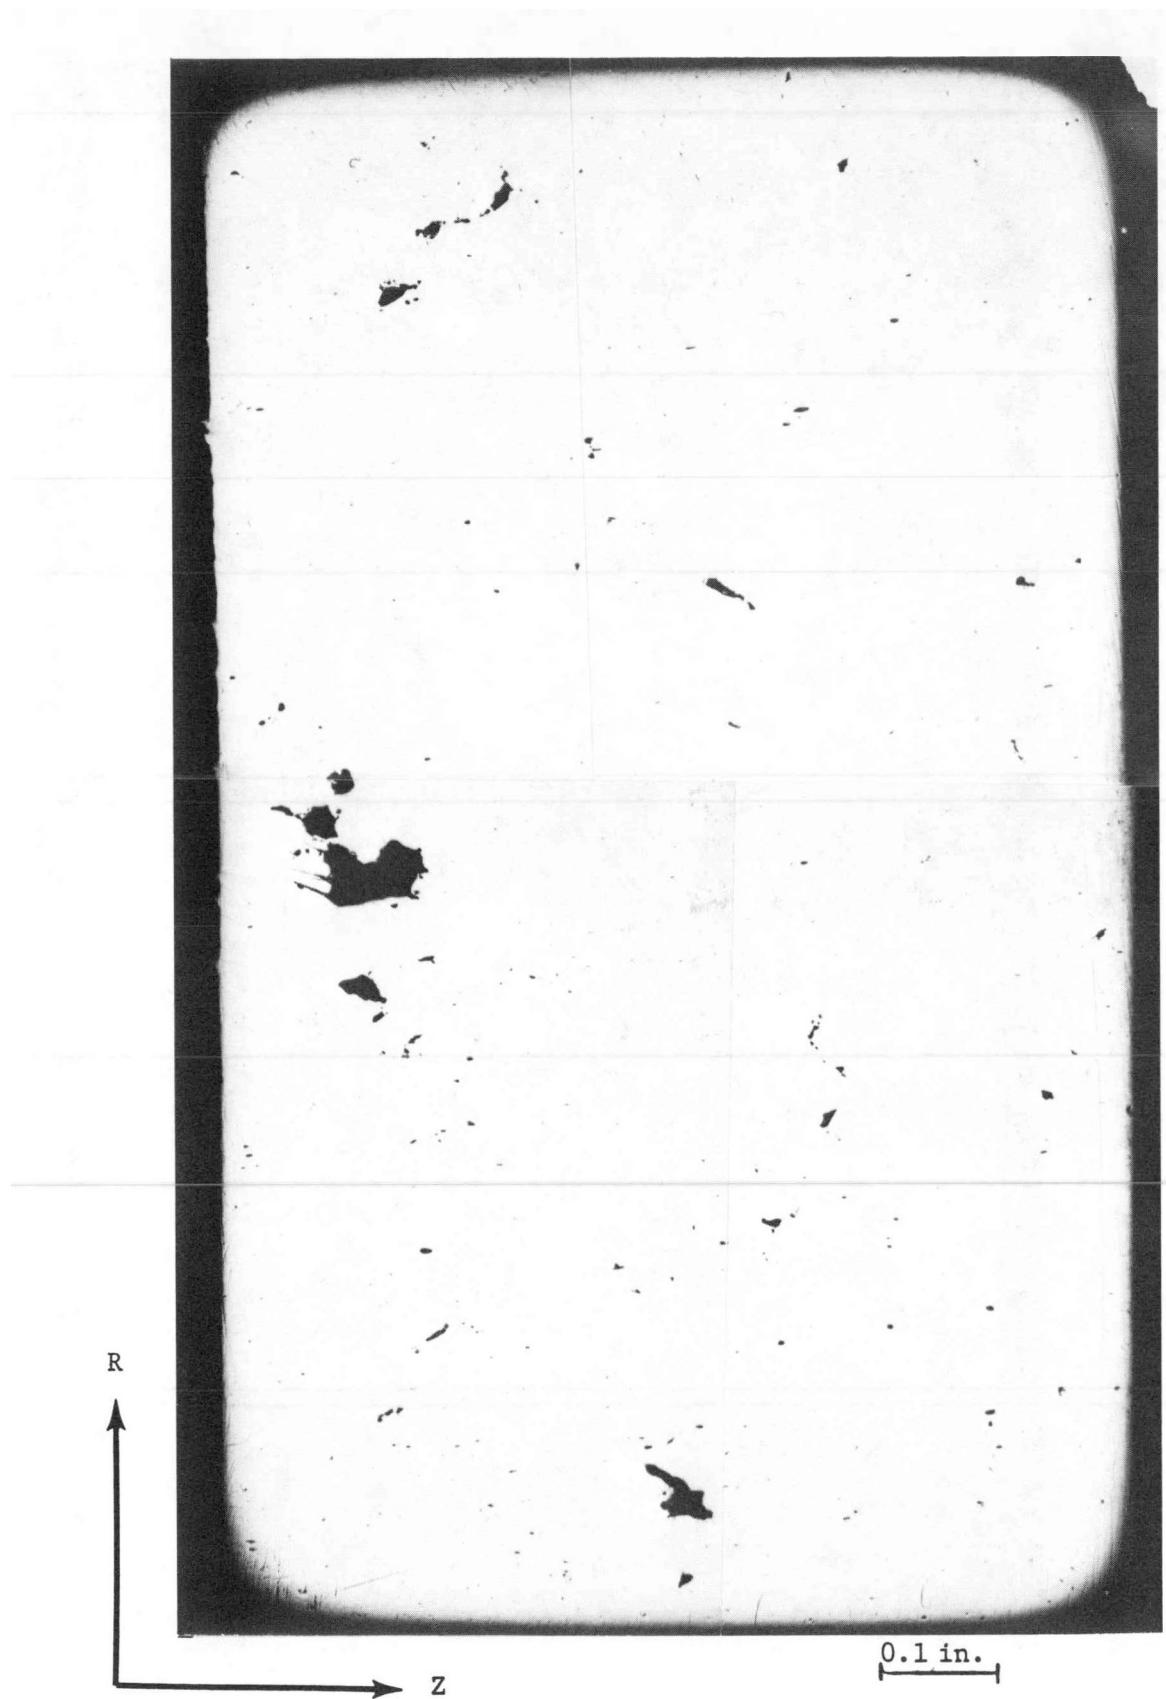
FIG. 92

Piece B114 from Buck 6 - 0.443 in. Removed.
0.0110 Area Fraction Flaw.

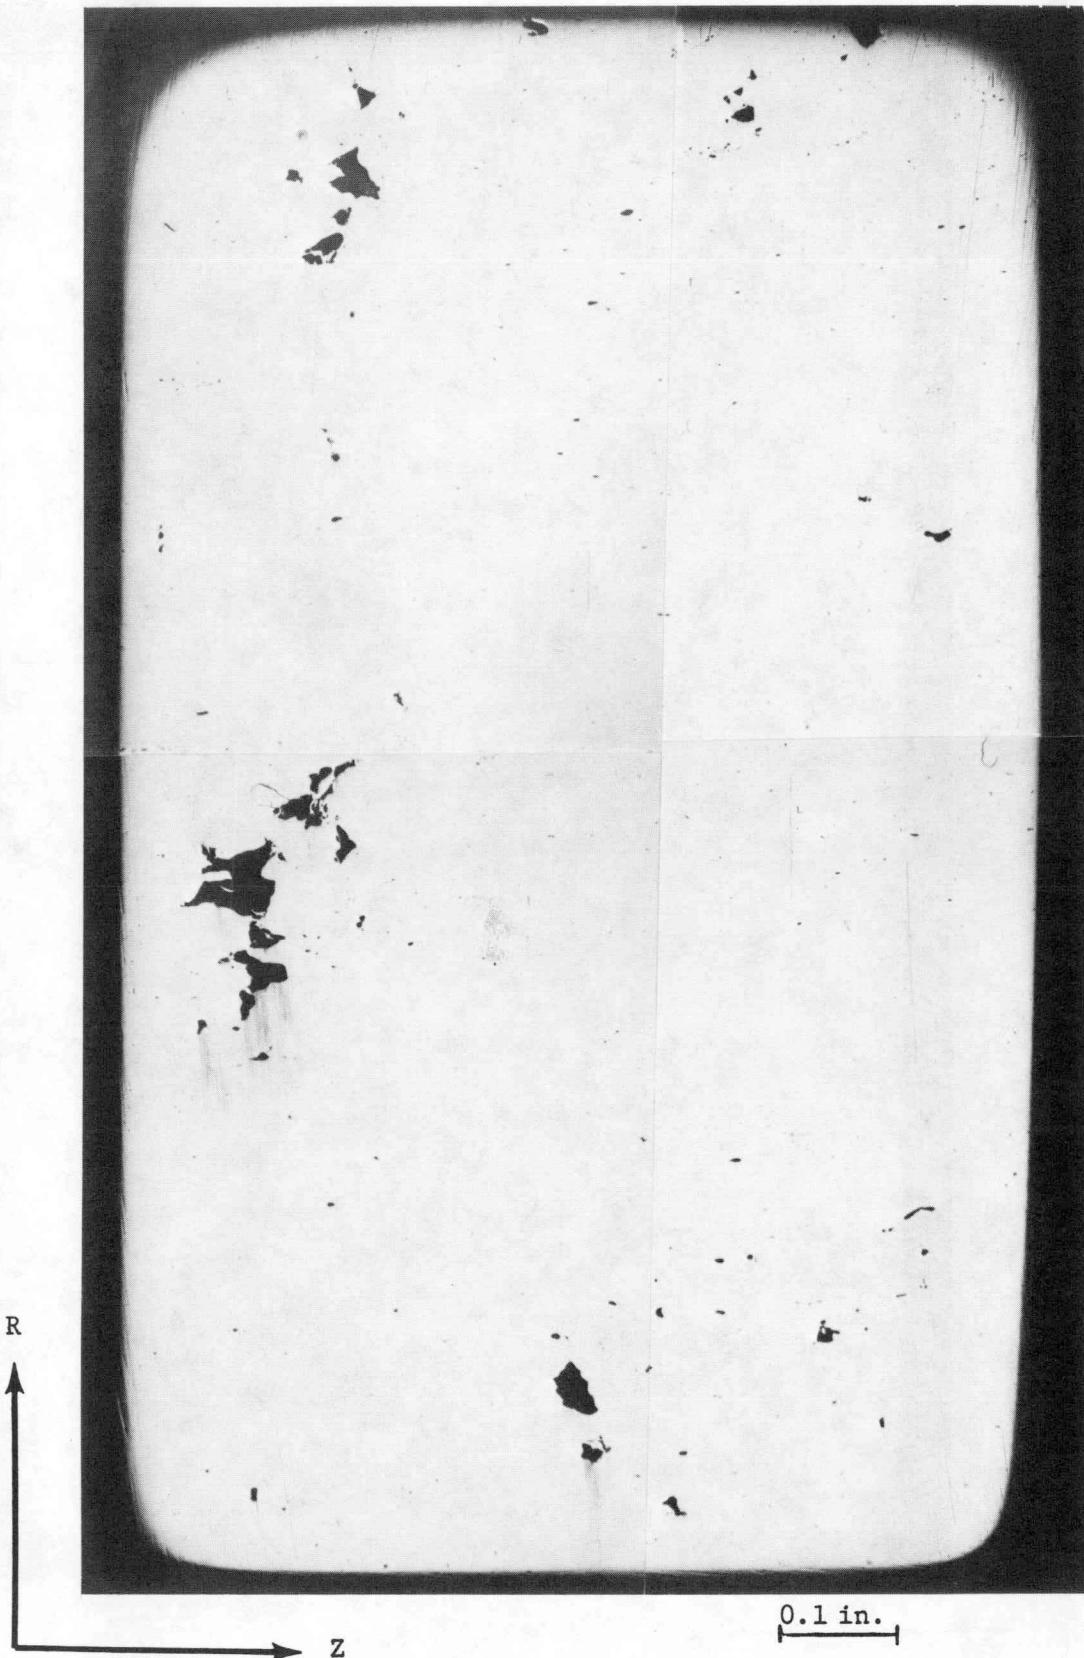
FIG. 93

Piece B114 from Buck 6 - 0.505 in. Removed.
0.0114 Area Fraction Flaw.

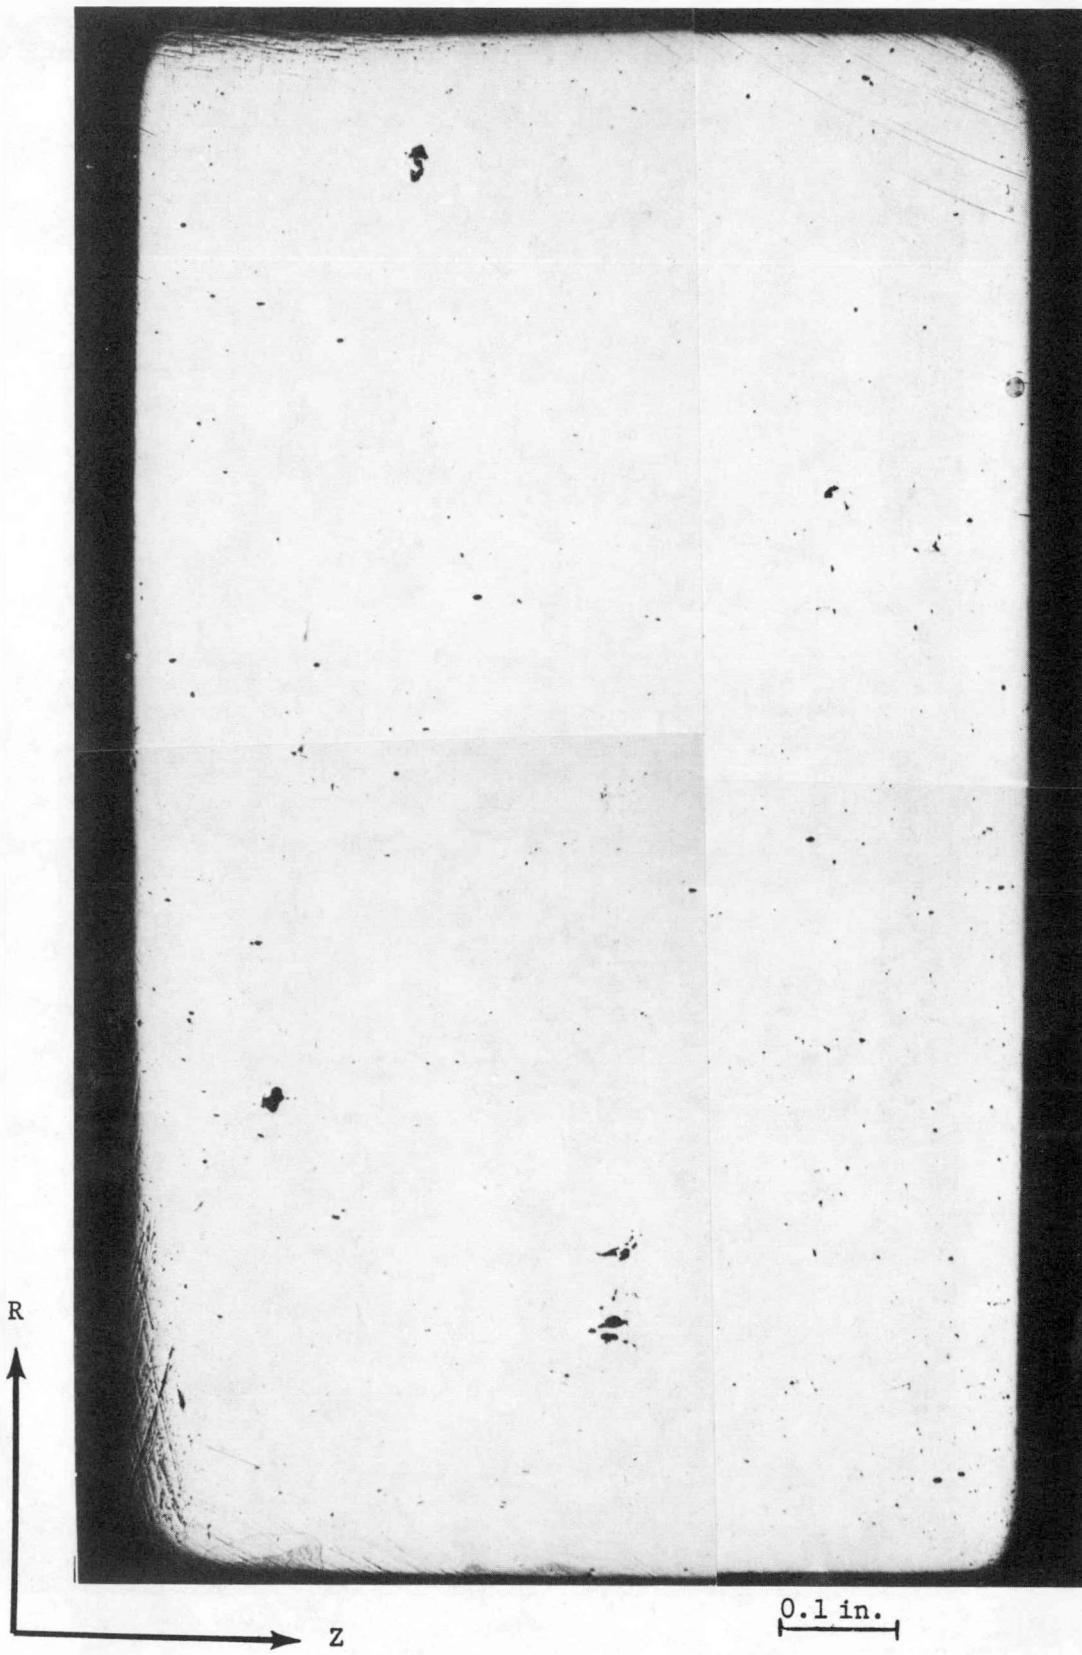
FIG. 95

Piece B114 from Buck 6 - 0.630 in. Removed.
0.0027 Area Fraction Flaw.

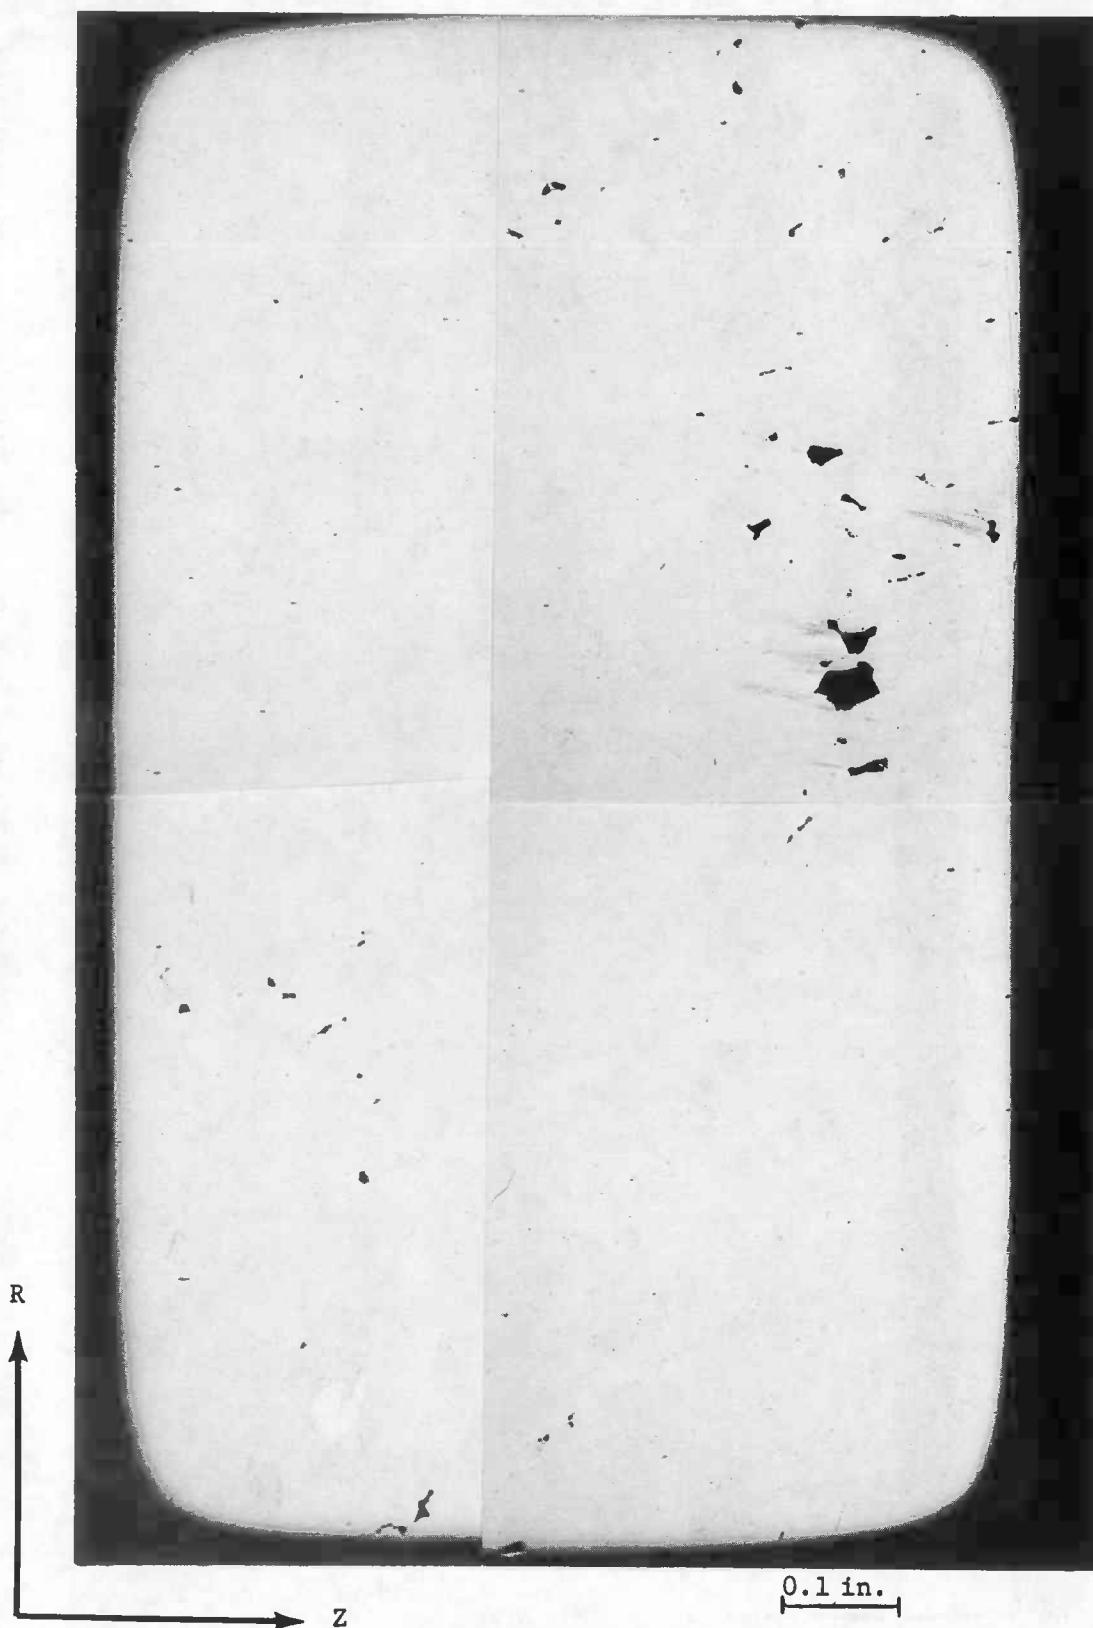
FIG. 97

Piece B114 from Buck 6 - 0.755 in. Removed,
0.0045 Area Fraction Flaw.

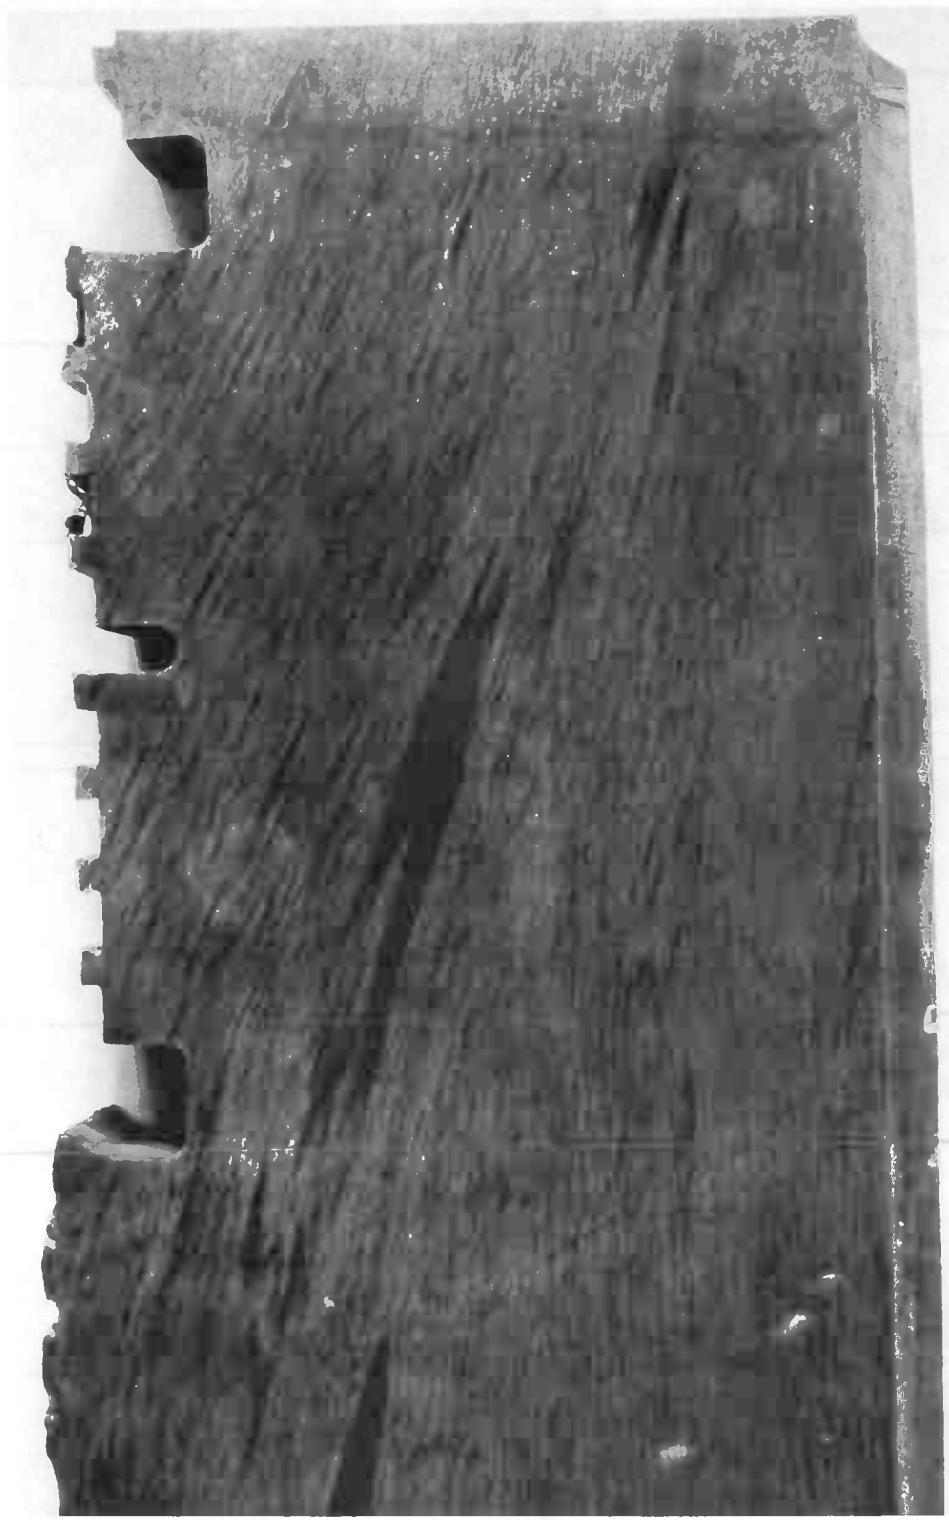
Fig. 2.2 – 2.5X Ammonium persulfate macroetch showing segregation pattern in the Gallatin forging
