Steam Turbine Rotor Reliability— Task Details

EPRI NP-923
Project 502
Interim Reports
November 1978

Steam Turbine Rotor Reliability — Task Details

NP-923
Research Project 502

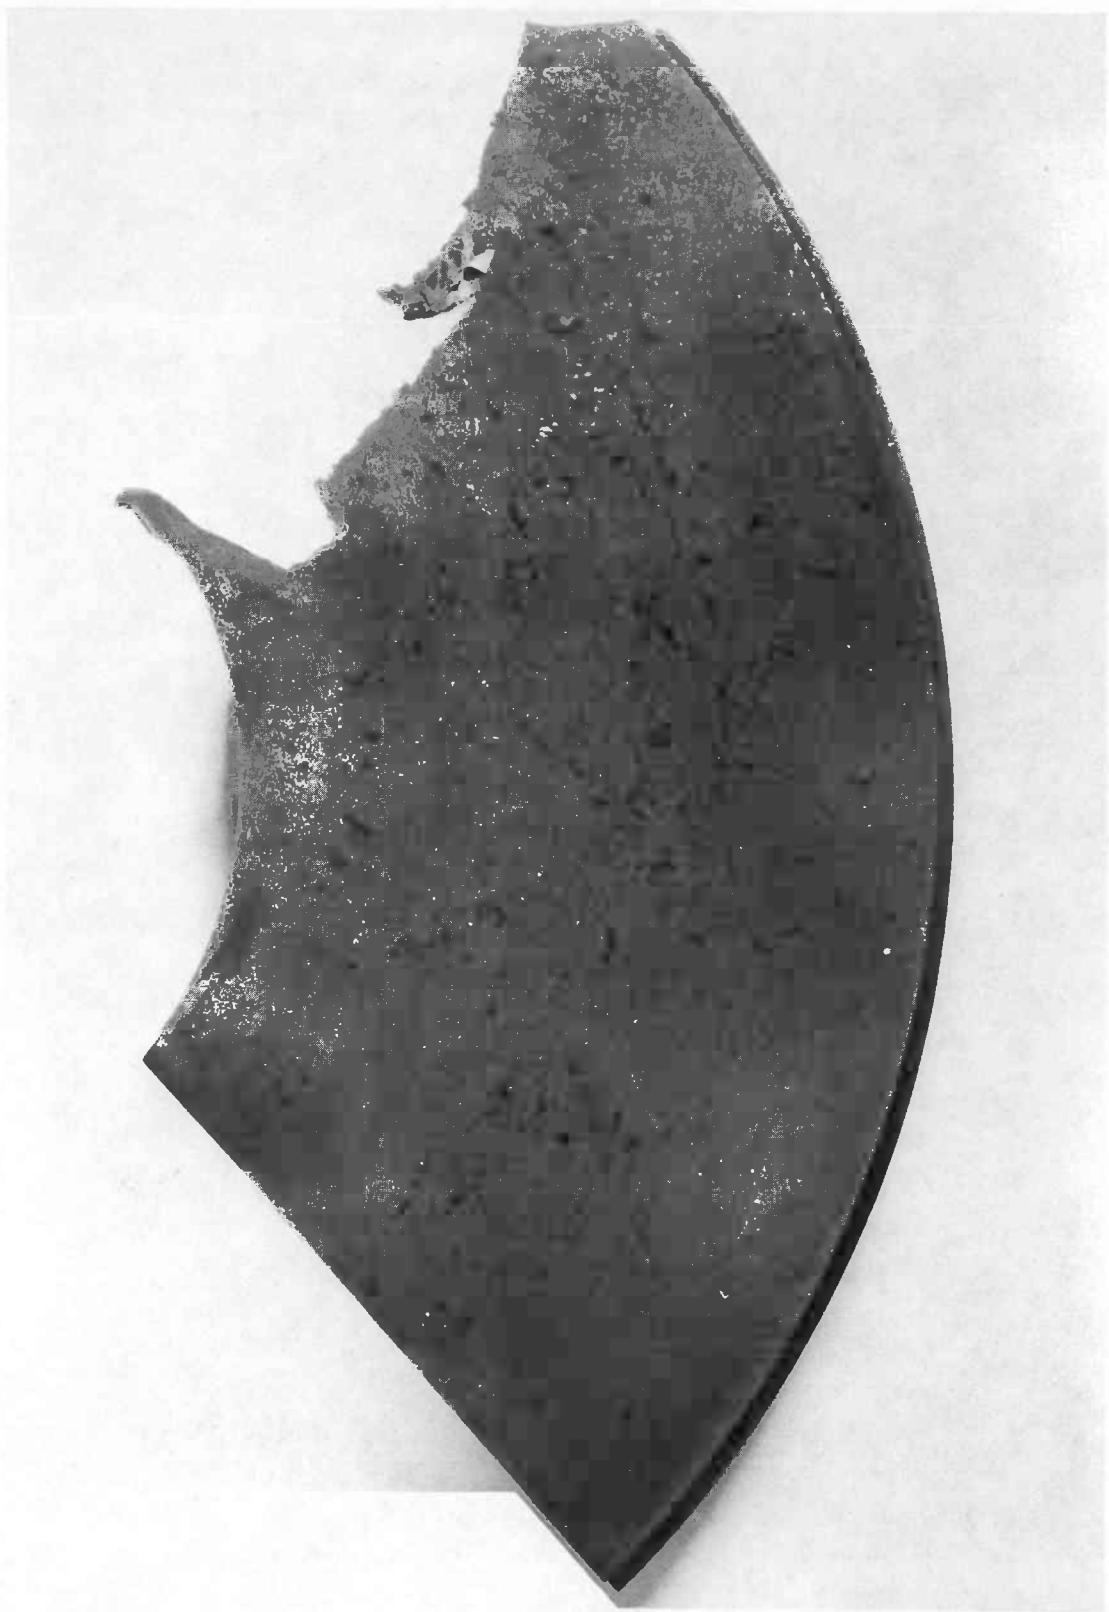
Fig. 2.3 – 2.5X Ammonium persulfate transverse macroetch of section shown in Fig. 1.2

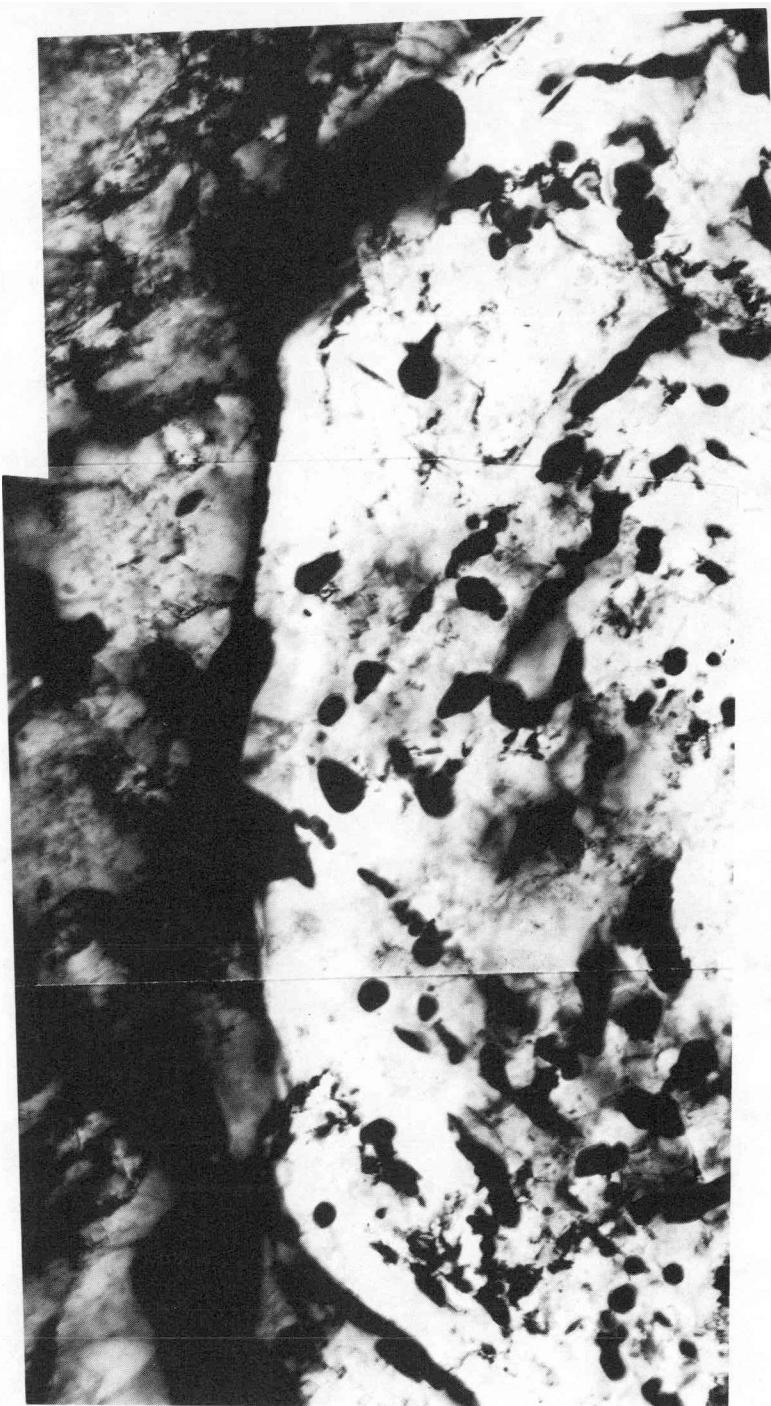
Fig. 2.7 – 25000X. Denudation along a bainitic grain in M5. Note the Fe₃C spheroidization compared to Figure 12

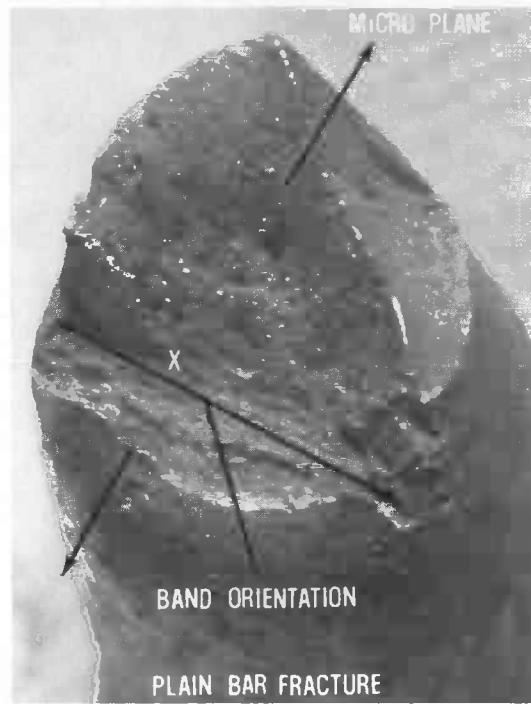
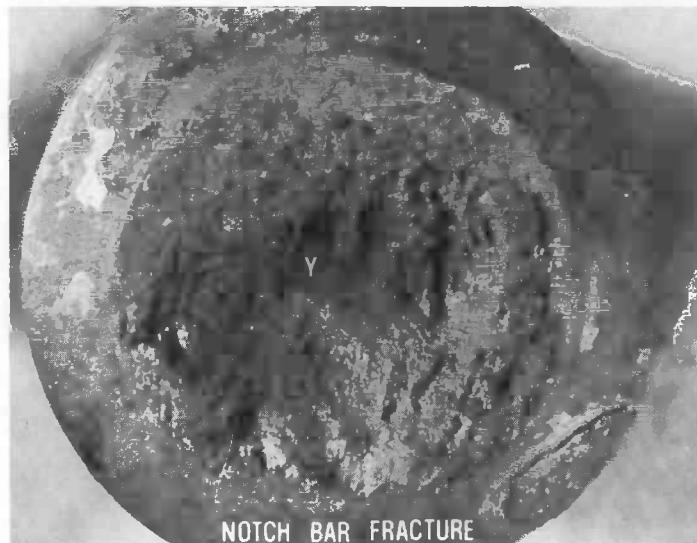
Fig. 3.6 – Fractographic features of both the plane bar and the notch bar fracture surface of the stress rupture specimen CT3A

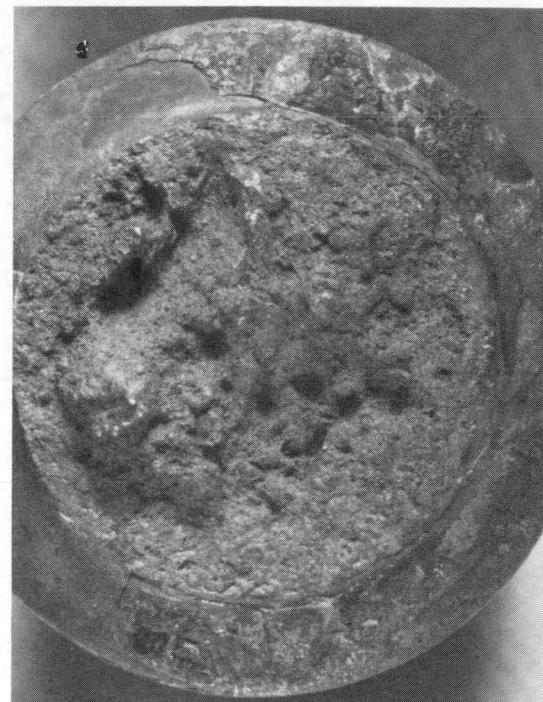
Fig. 3.11 – Fractographic features of both the plane bar and notch bar fracture surfaces of the stress rupture specimen CT12A

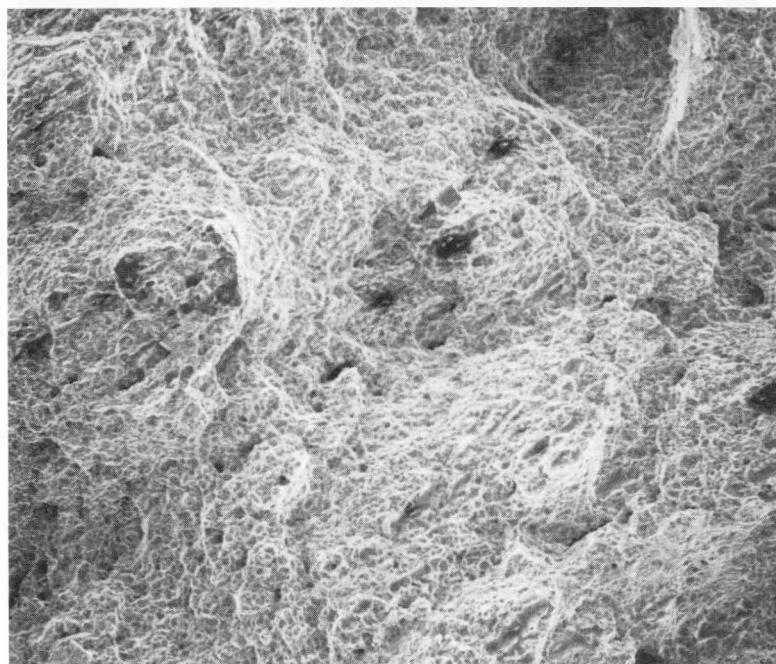
Fig. 3.13 – Fractographic features of the notch bar fracture surface of specimen CT12A

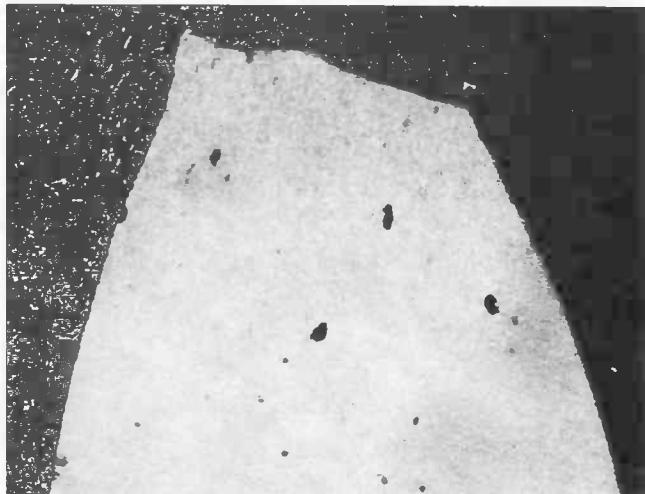
Fig. 3.14 – Micrographs of an axial section taken through the plane bar fracture surface of specimen CT12A

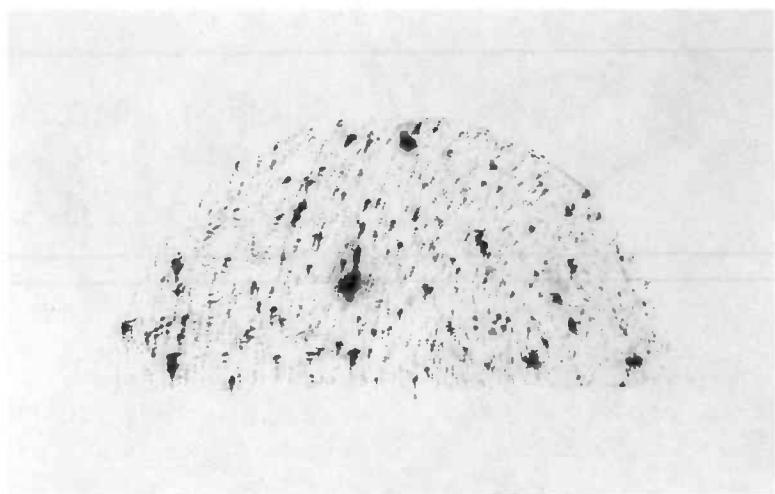
Fig. 3.35—Sulfur print of the cross-section of a large low cycle fatigue specimen taken from the periphery of the Gallatin rotor

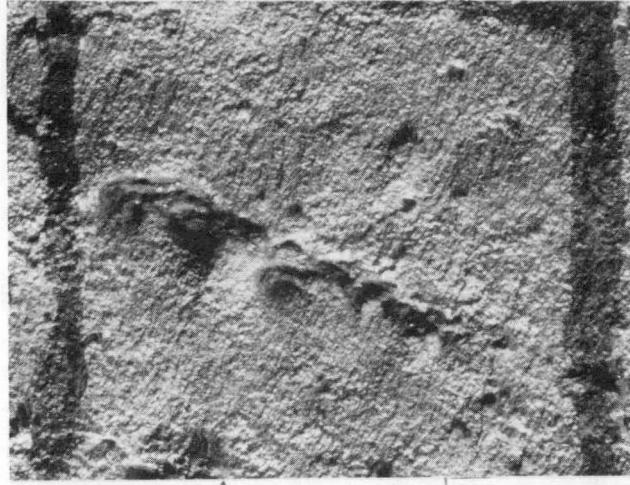
Fig. 3.38-12X. Optical macrographs of the 0.42, 1.04 and 1.55 inch locations on specimen 1A

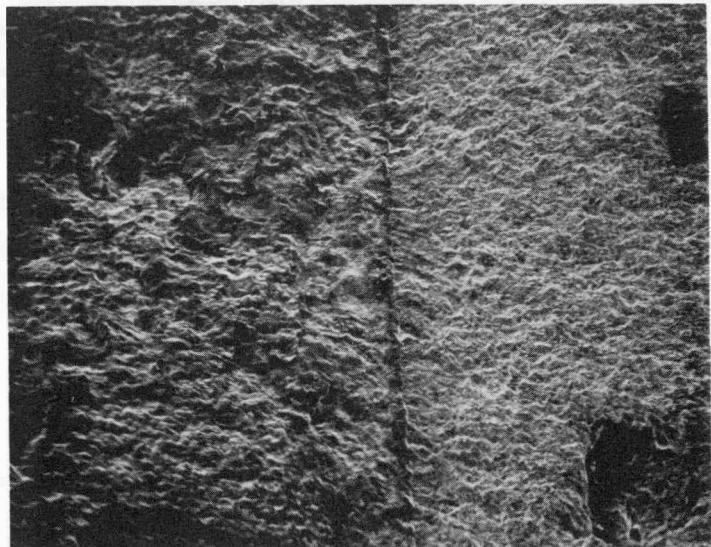
Fig. 3.44 — Fatigue band widths for 160 cycles at $\Delta K = 18 \text{ ksi} \sqrt{\text{in.}}$ magnified to (A) 50X and (B) 200X for specimen number FRIA2 tested at 800°F (427°C) at a frequency of 1 cycle per 24 hrs

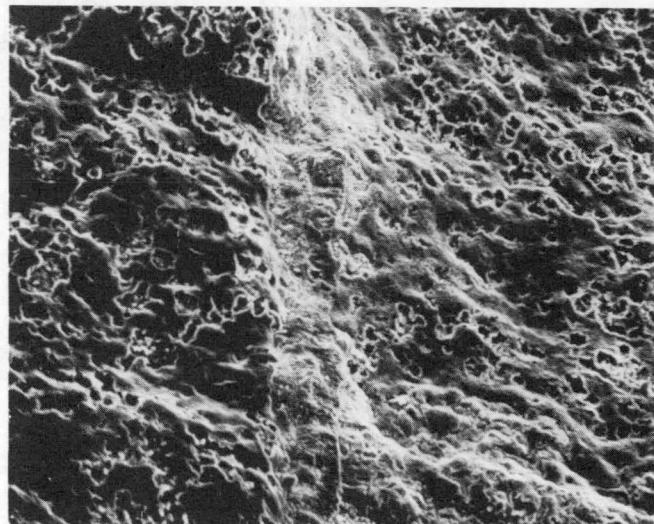
Fig. 3.46 — Fatigue band widths in specimen FRIA1 at 200X for two separate fatigue periods. (A) at a $\Delta K = 25.6 \text{ ksi} \sqrt{\text{in.}}$ for 160 cycles and (B) at $\Delta K = 55.28$ for 50 cycles tested at 800°F (427°C) with a frequency of 1 cycle per 24 hrs

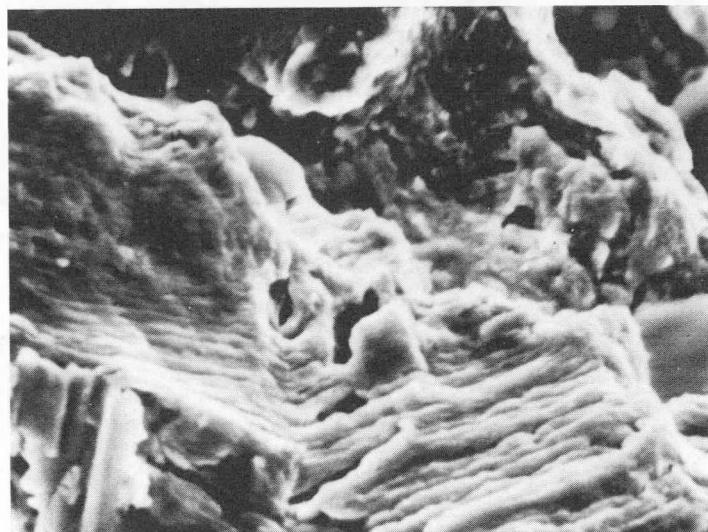
1000X

2000X

Fig. 4.32 – Fatigue striations found in the region of blue color (see Fig. 4.30)
