Nevada  
Environmental  
Restoration  
Project

Post-Closure Inspection Report for  
the Tonopah Test Range, Nevada

For Calendar Year 2004

April 2005

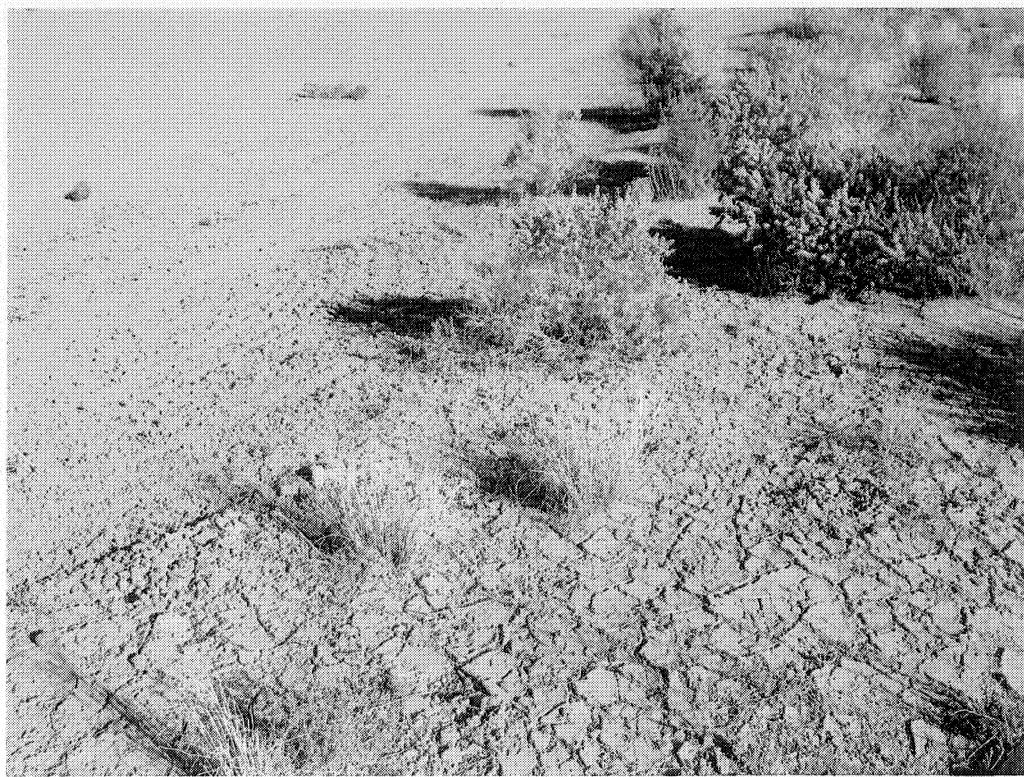
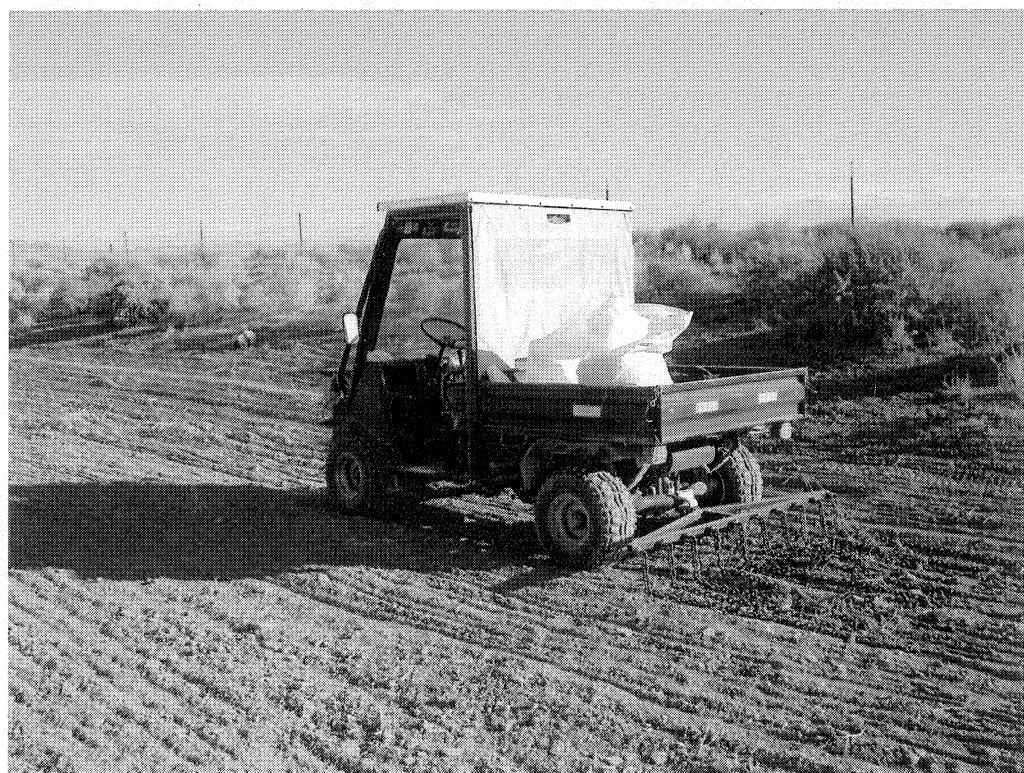
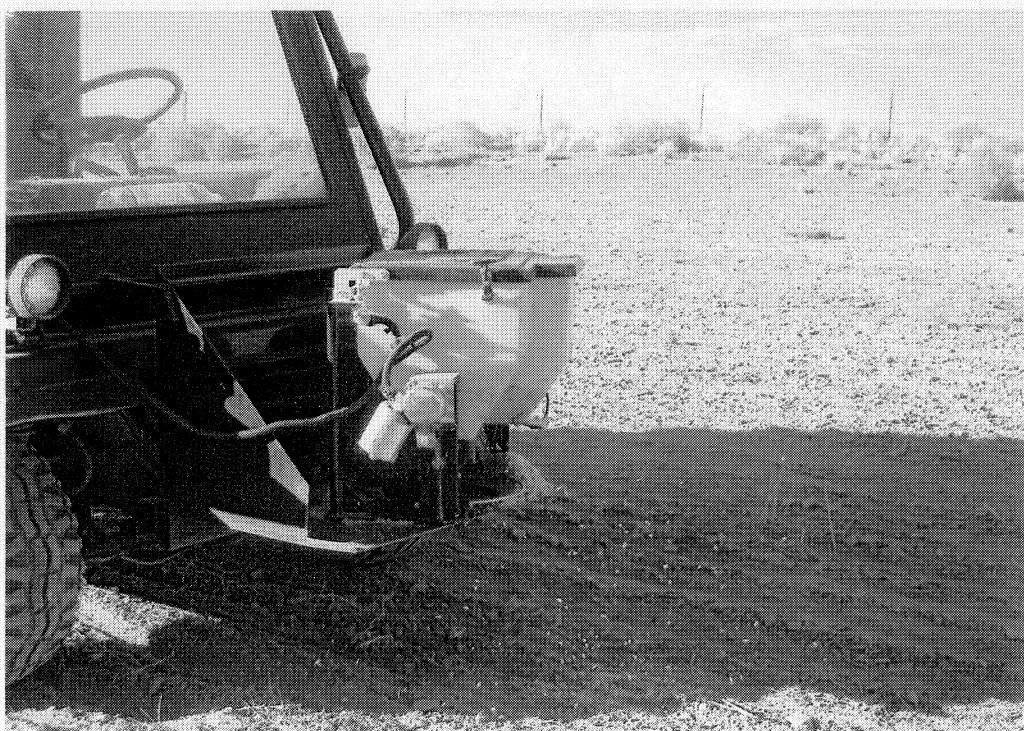
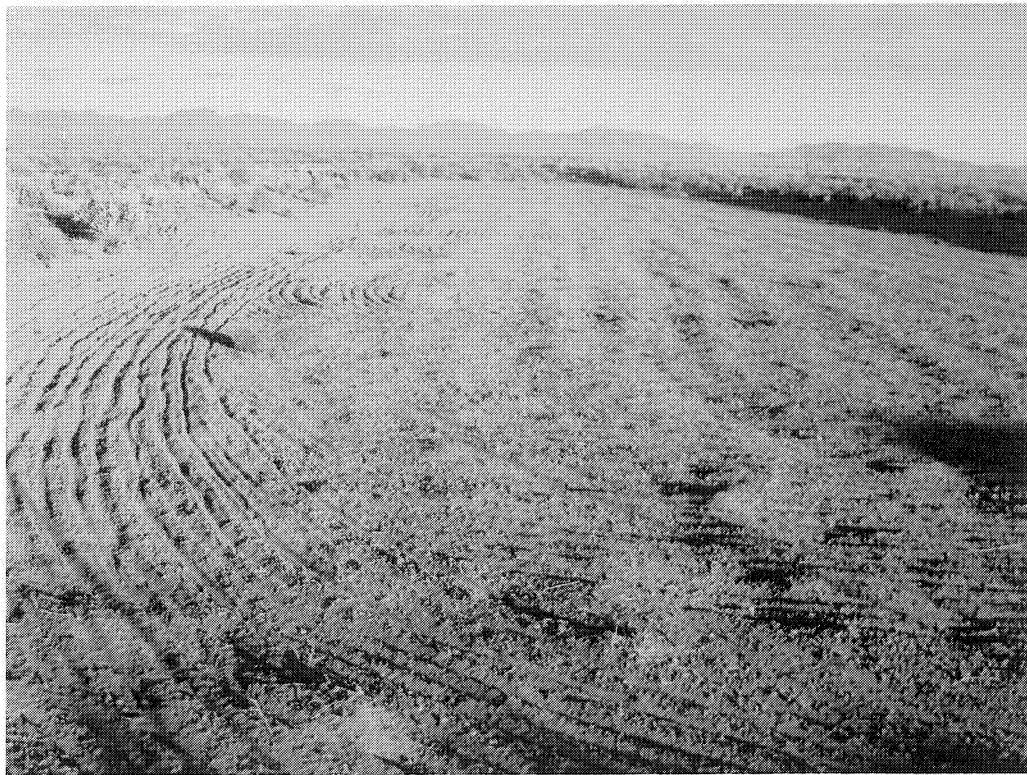
Photograph 9: CAU 400 Five Points Landfill, Reseeding, 11/16/2004

Photograph 10: CAU 400 Five Points Landfill, Reseeding, 11/16/2004

Photograph 11: CAU 400 Five Points Landfill, Reseeding, 11/16/2004

Photograph 12: CAU 400 Five Points Landfill, Reseeding, 11/16/2004

12:55 ARRIVE CAU 400. WALK SITE TO VERIFY LOCATION OF BALES,  
PRESENCE OF T-POSTS. PROCEED TO ANCHOR STRAW BALES  
AS CHECK DAMS IN THE WASH ENTERING FENCED SITE FROM THE  
EAST. HAND T-POST POUNDER USED, + SLEDGE HAMMER.  
CARE TAKEN TO LIMIT PENETRATION TO  $\leq 12''$  (VERTICAL).  
T-POSTS POUNDED AT STEEP ANGLE THROUGH BALES.

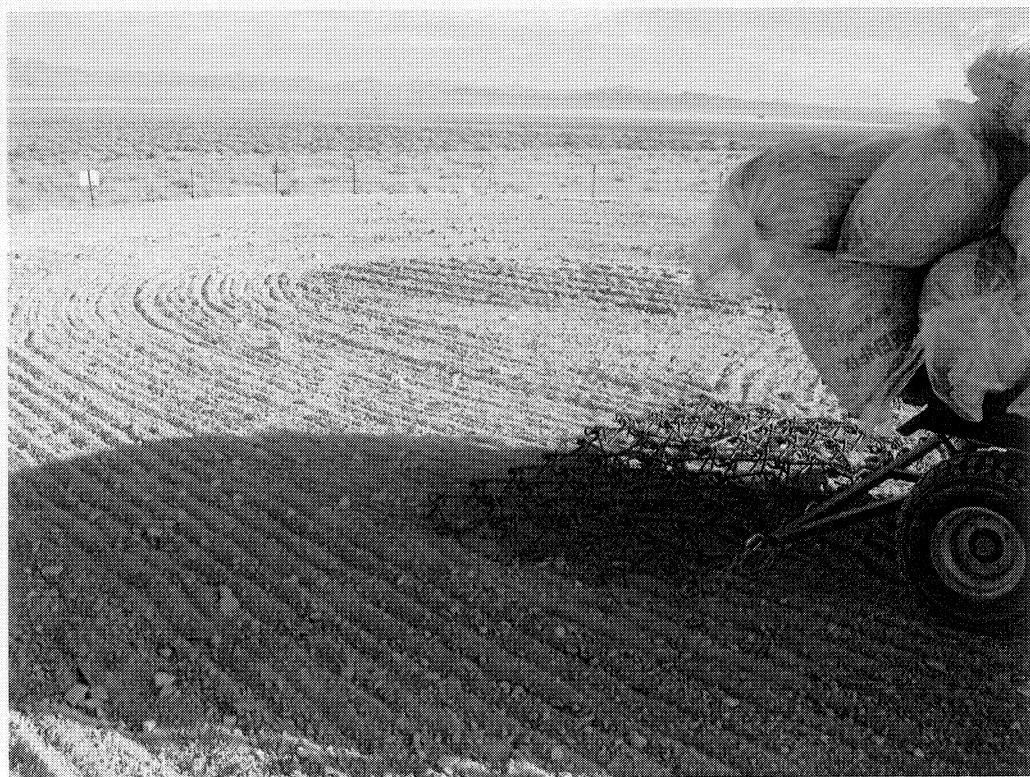
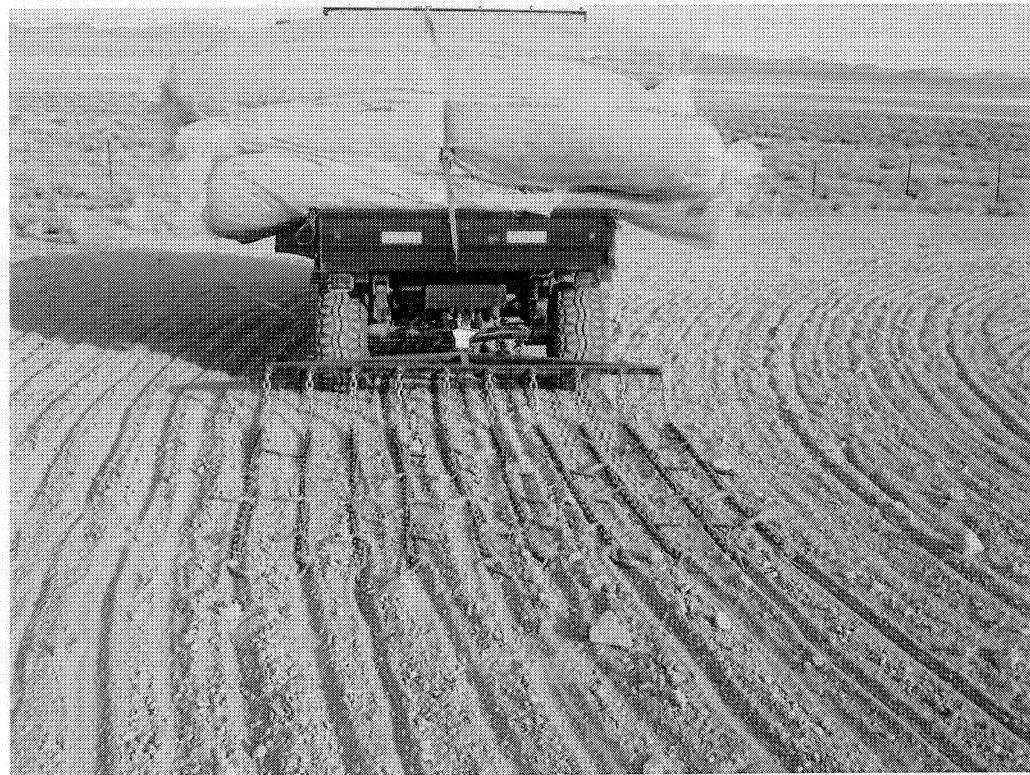
Photograph 21: CAU 407, Reseeding, 12/01/2004

Photograph 22: CAU 407, Reseeding, 12/01/2004

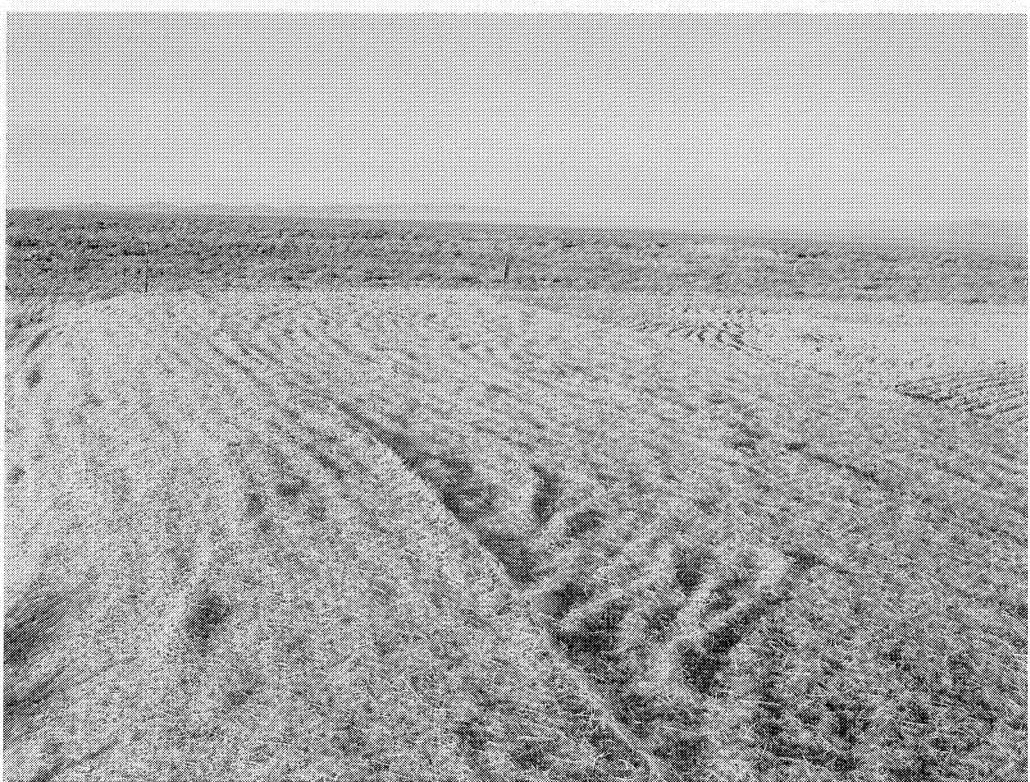
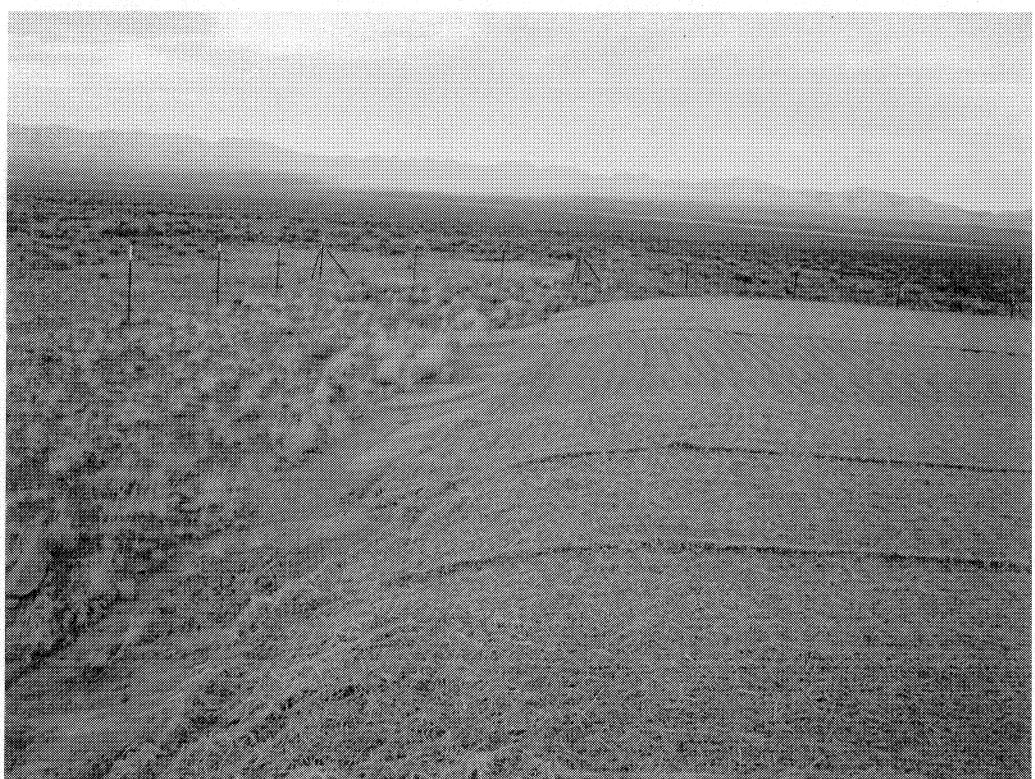
Photograph 23: CAU 407, Erosion Blanket, 12/01/2004

Photograph 24: CAU 407, Erosion Blanket, 12/01/2004

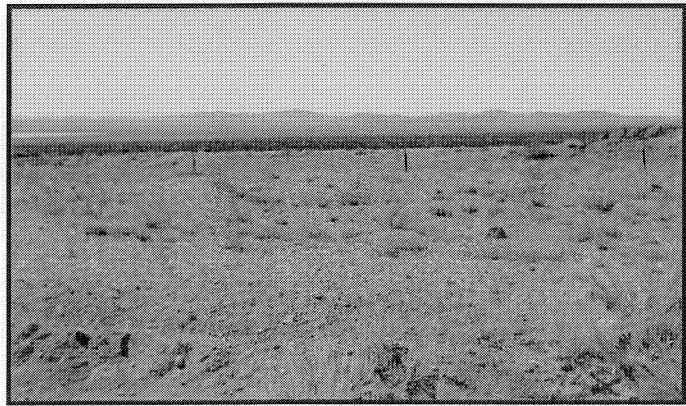
Inside fence, looking southeast, June 2002

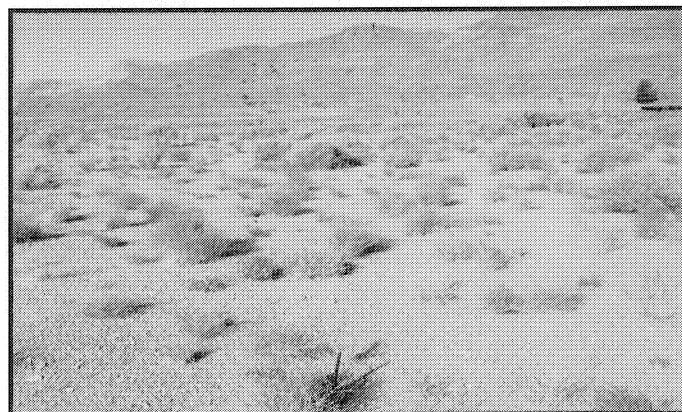
Inside fence, looking west, June 2004

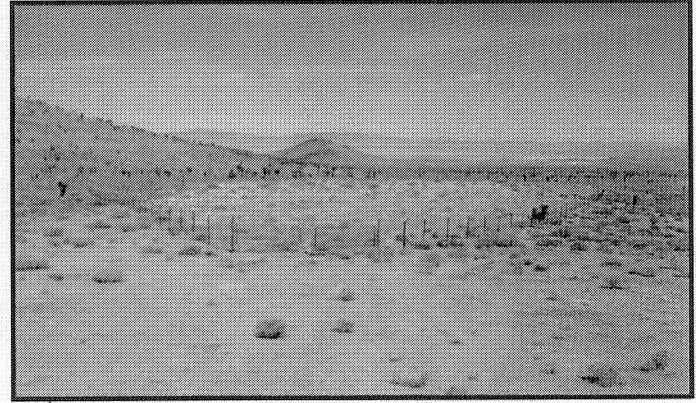
Inside fence, looking east, June 2000
