DOE/NV--1207

Post-Closure Inspection Report for the Tonopah Test Range, Nevada

For Calendar Year 2006

U.S. Department of Energy
National Nuclear Security Administration
Nevada Site Office

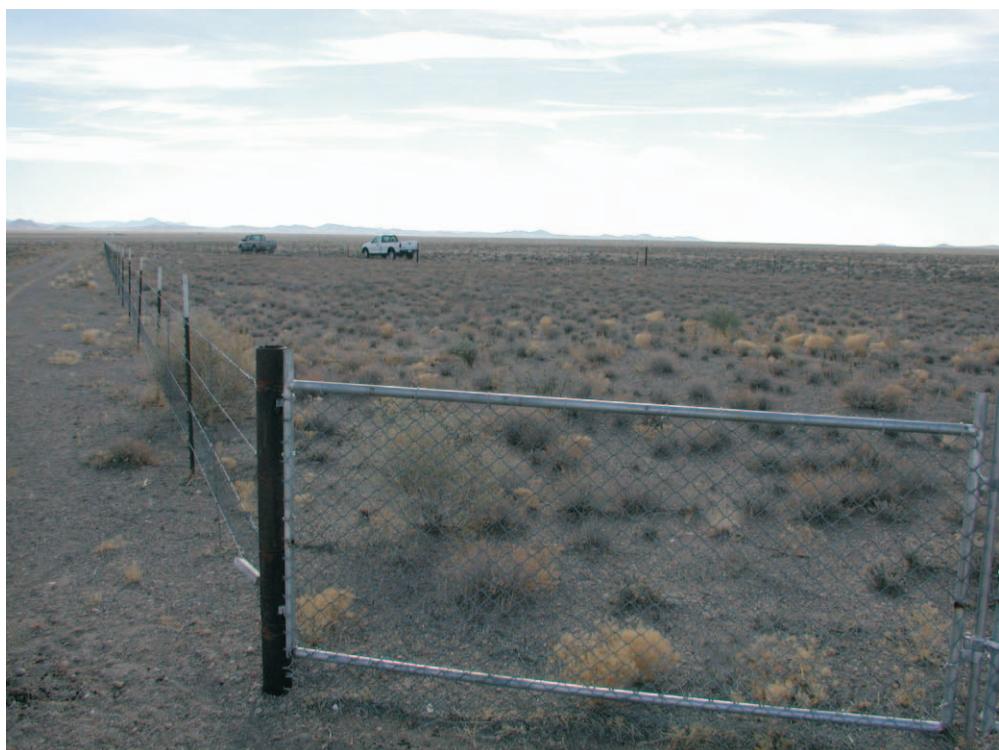
Photograph 2: CAU 400 Bomblet Pit, looking south, 11/15/2006

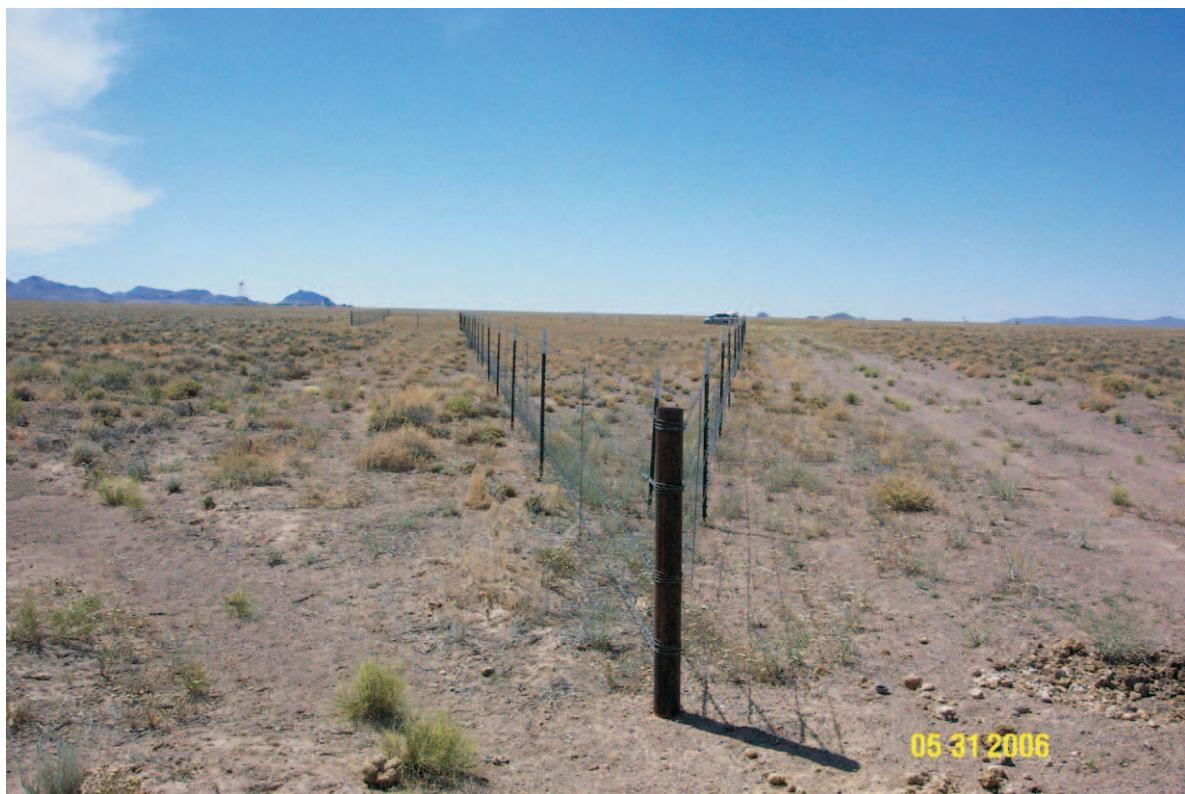
Photograph 3: CAU 400 Bomblet Pit, looking north, 05/31/2006

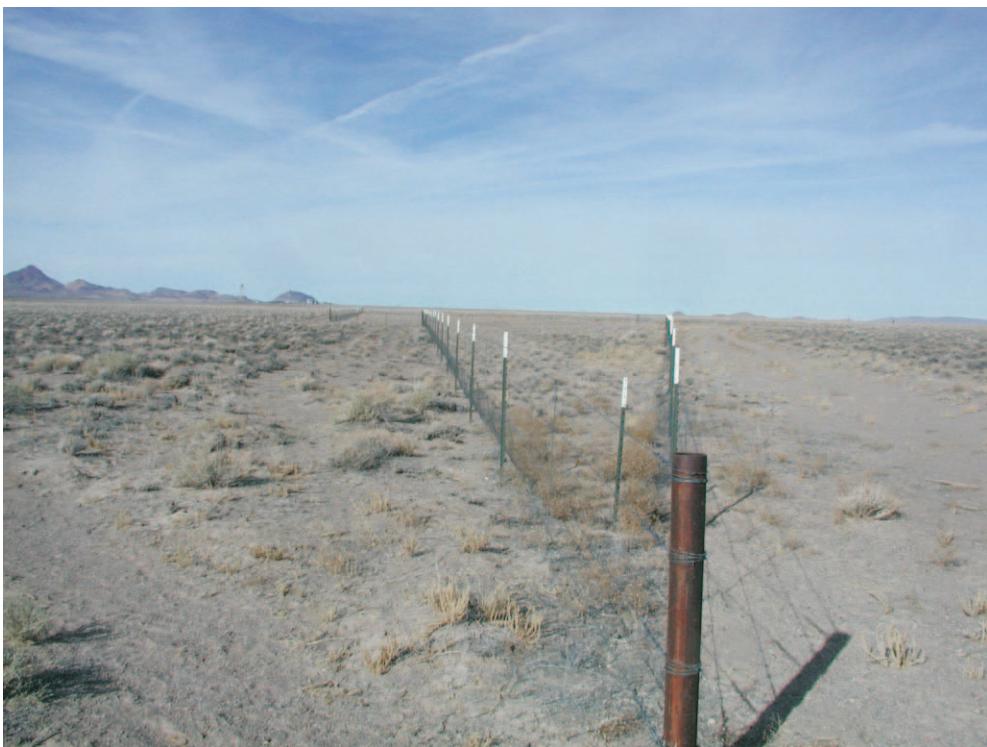
Photograph 4: CAU 400 Bomblet Pit, looking north, 11/15/2006

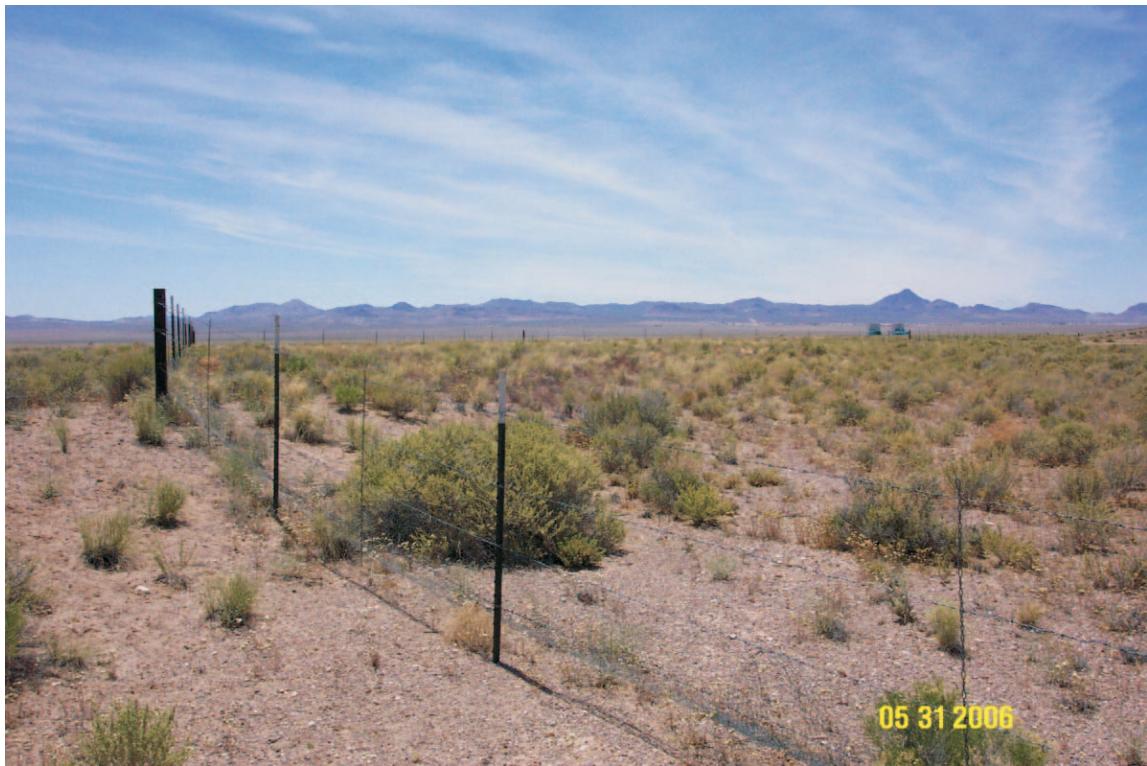
Photograph 7: CAU 400 Five Points Landfill, looking west, 05/31/2006

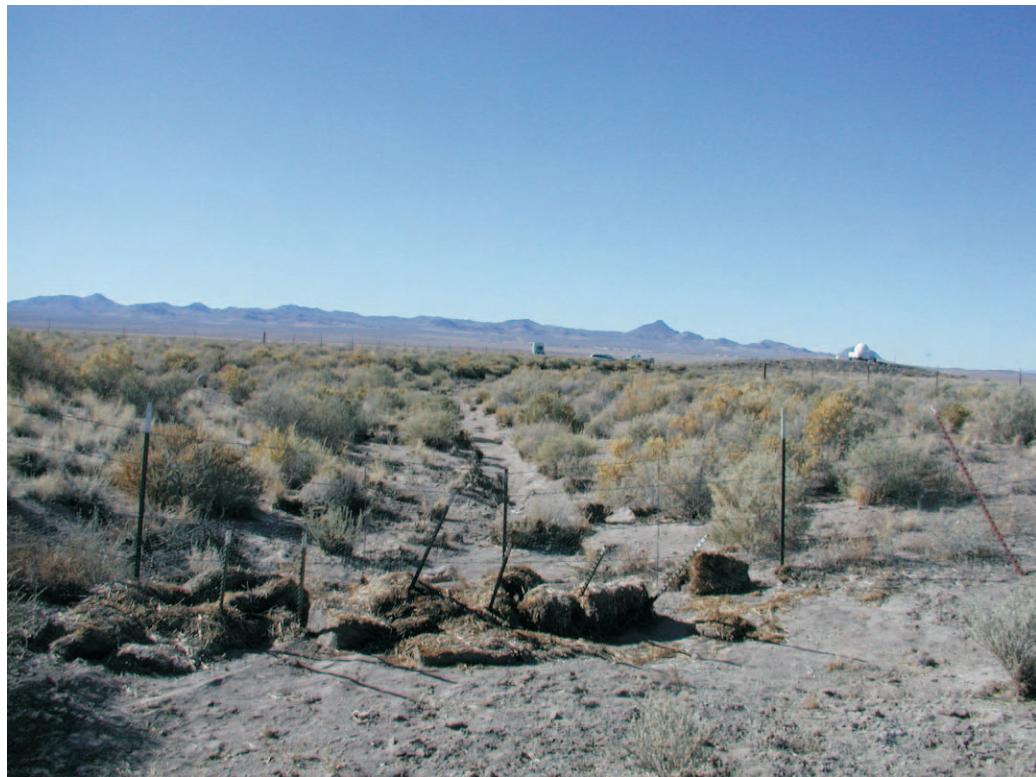
Photograph 8: CAU 400 Five Points Landfill, looking west, 11/15/2006

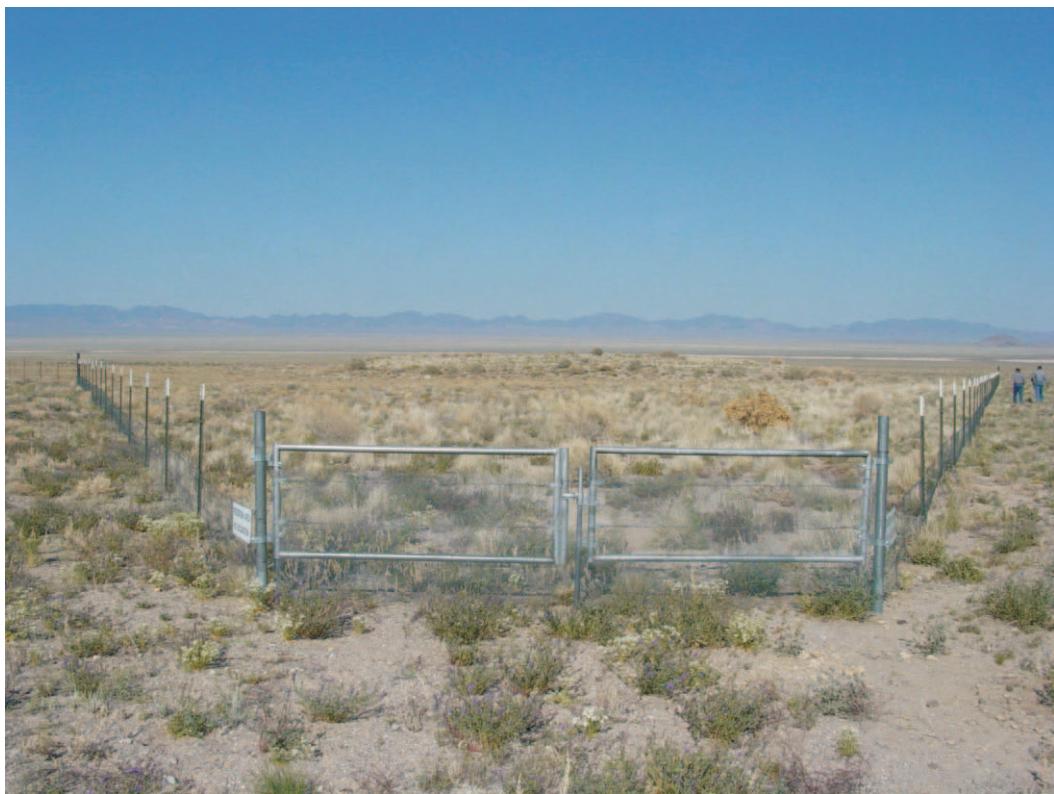
Photograph 9: CAU 404, looking east, 05/09/2006

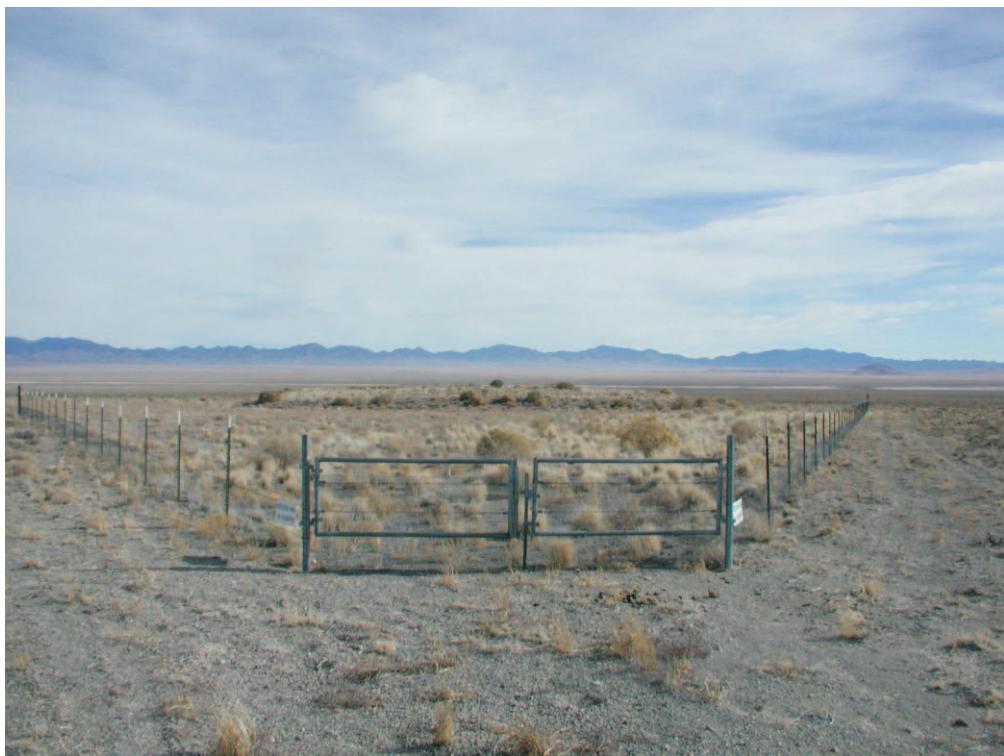
Photograph 10: CAU 404, looking east, 11/15/2006

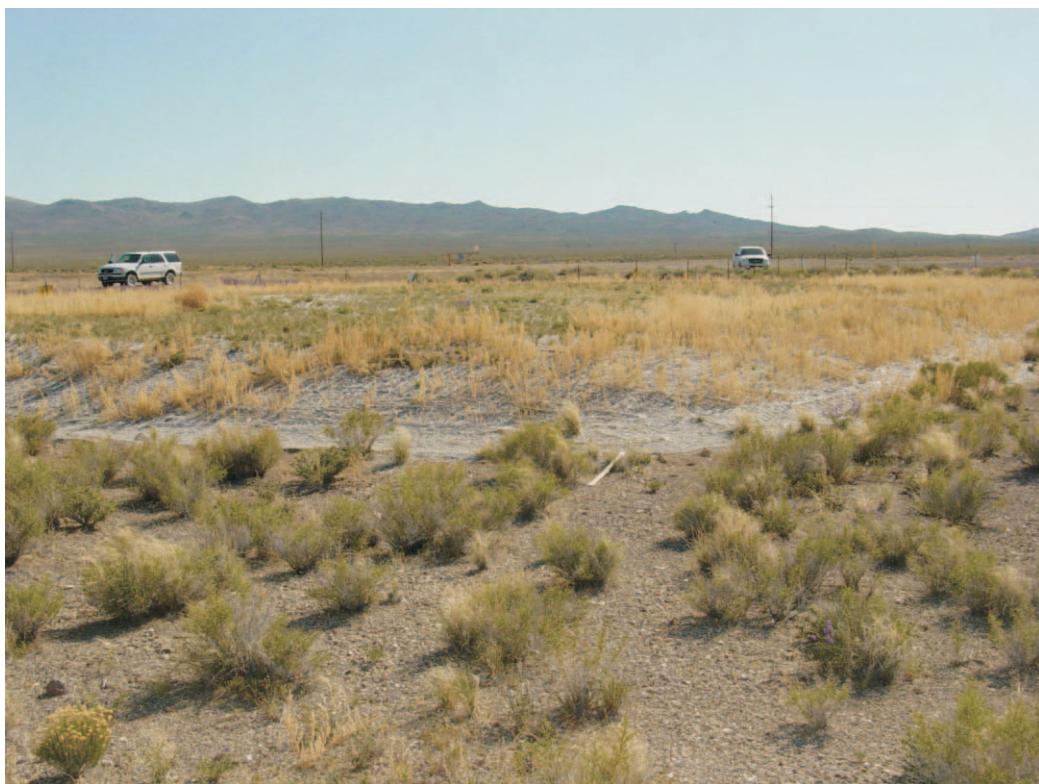
Photograph 13: CAU 407, looking southwest, 05/09/2006

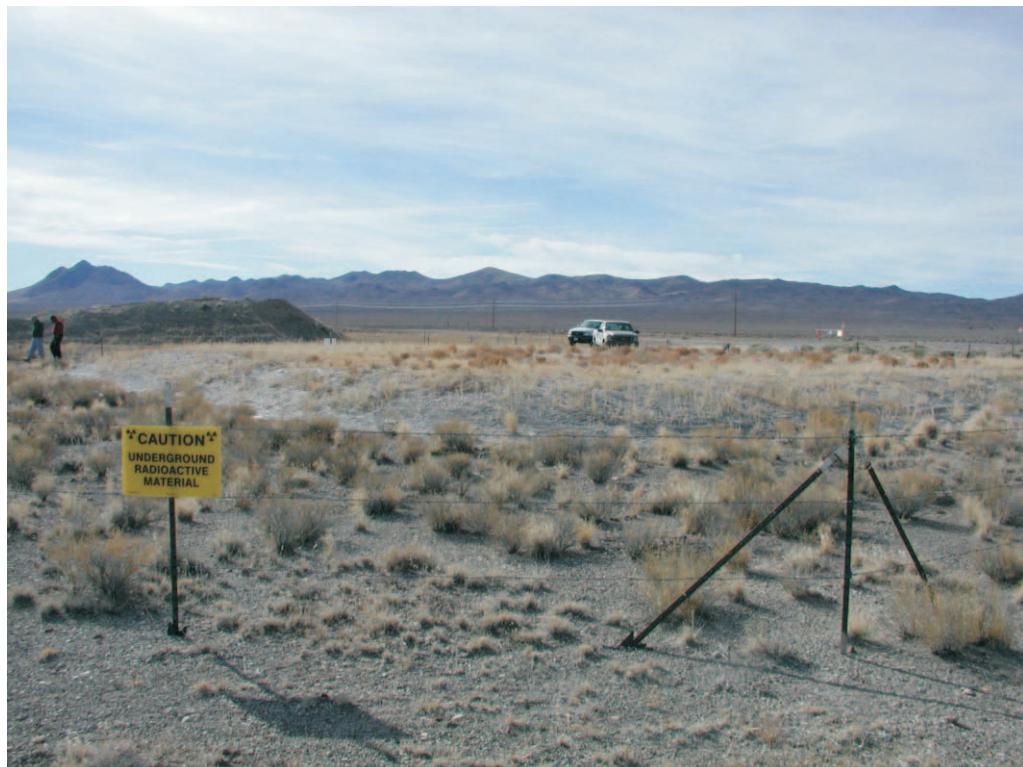
Photograph 14: CAU 407, looking northeast, 11/15/2006

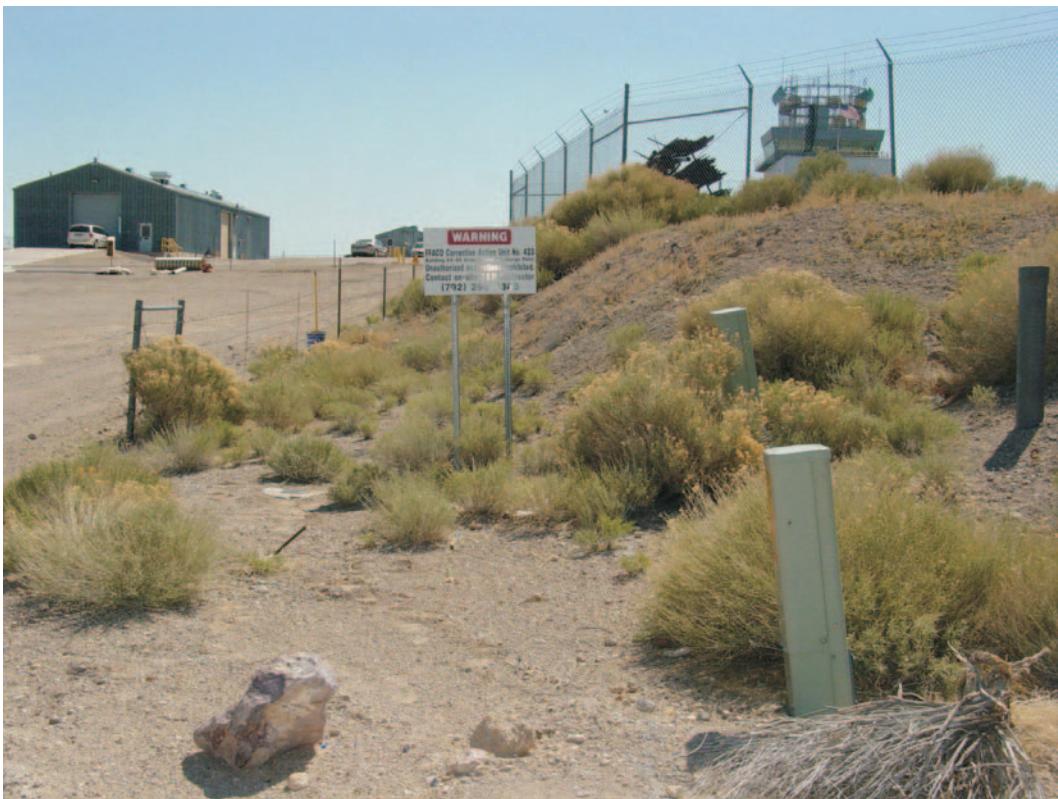
Photograph 15: CAU 423, looking east, 05/09/2006

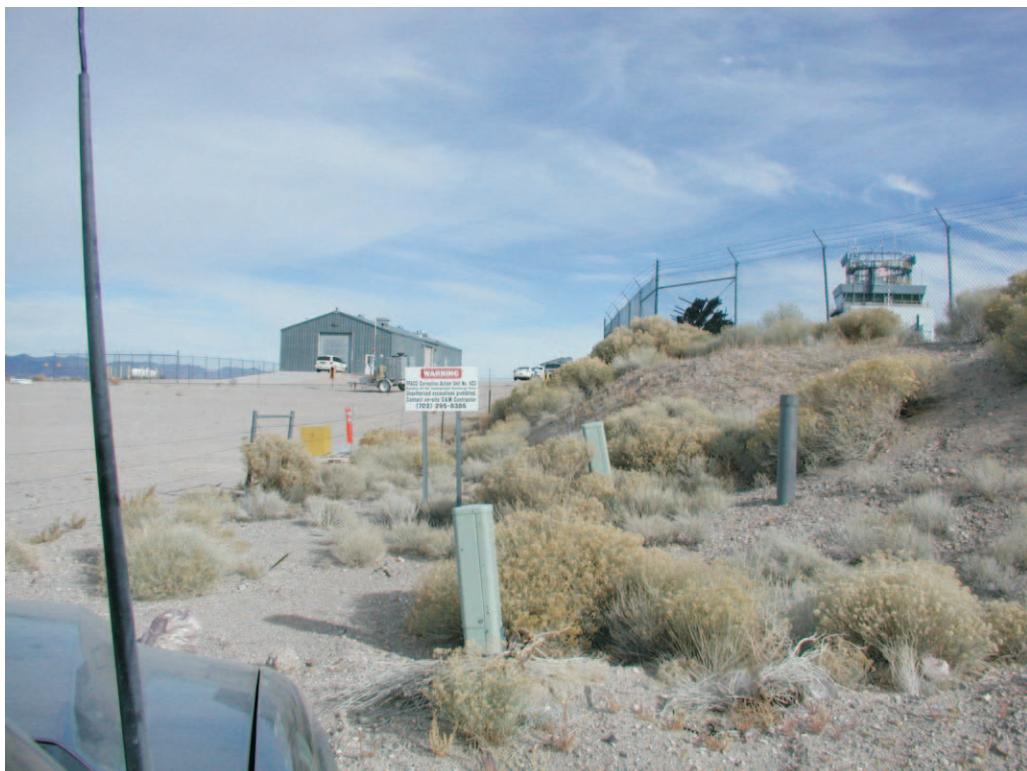
Photograph 16: CAU 423, looking east, 11/15/2006

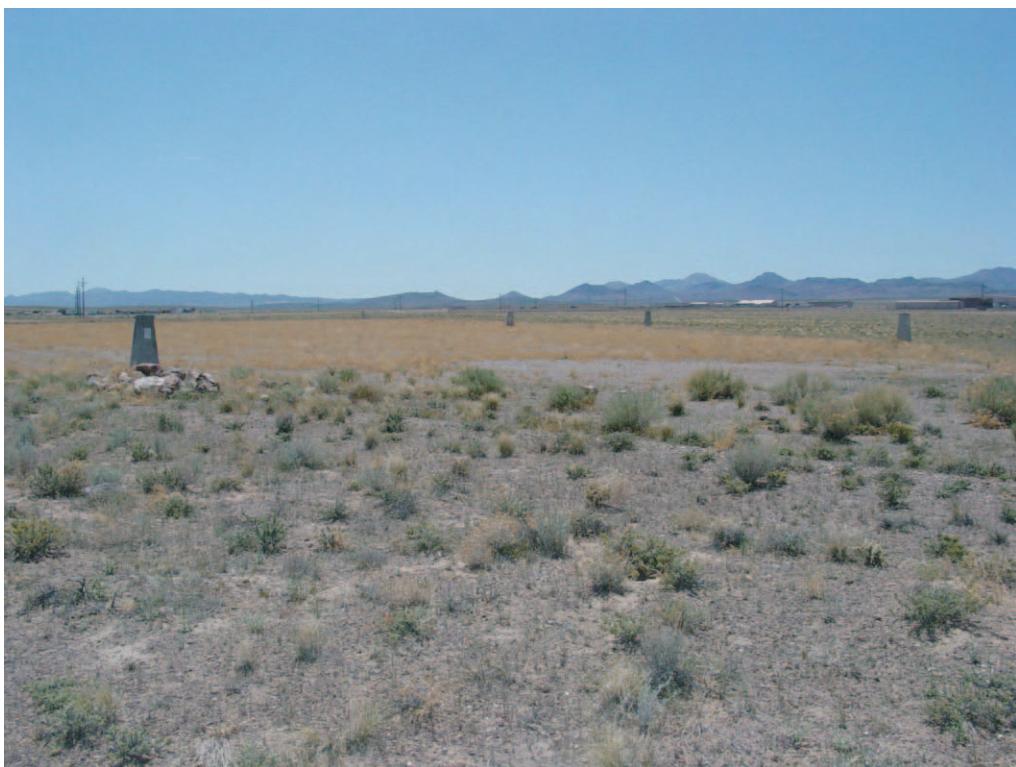
Photograph 17: CAU 424, Landfill Cell A3-1, looking south, 05/09/2006

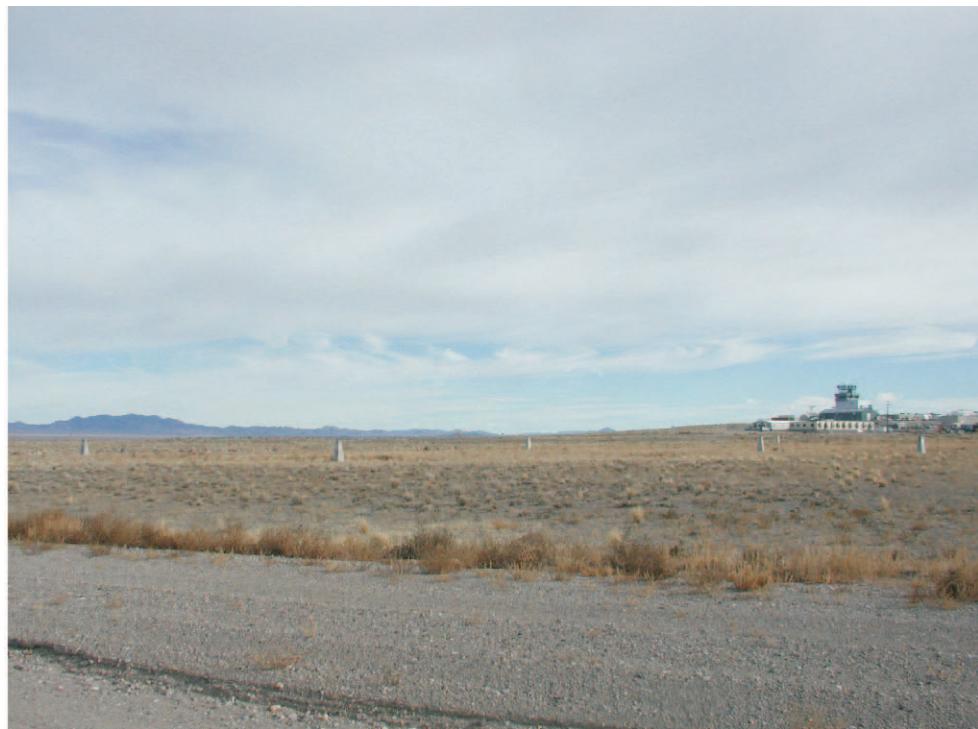
Photograph 18: CAU 424, Landfill Cell A3-1, looking north, 11/15/2006

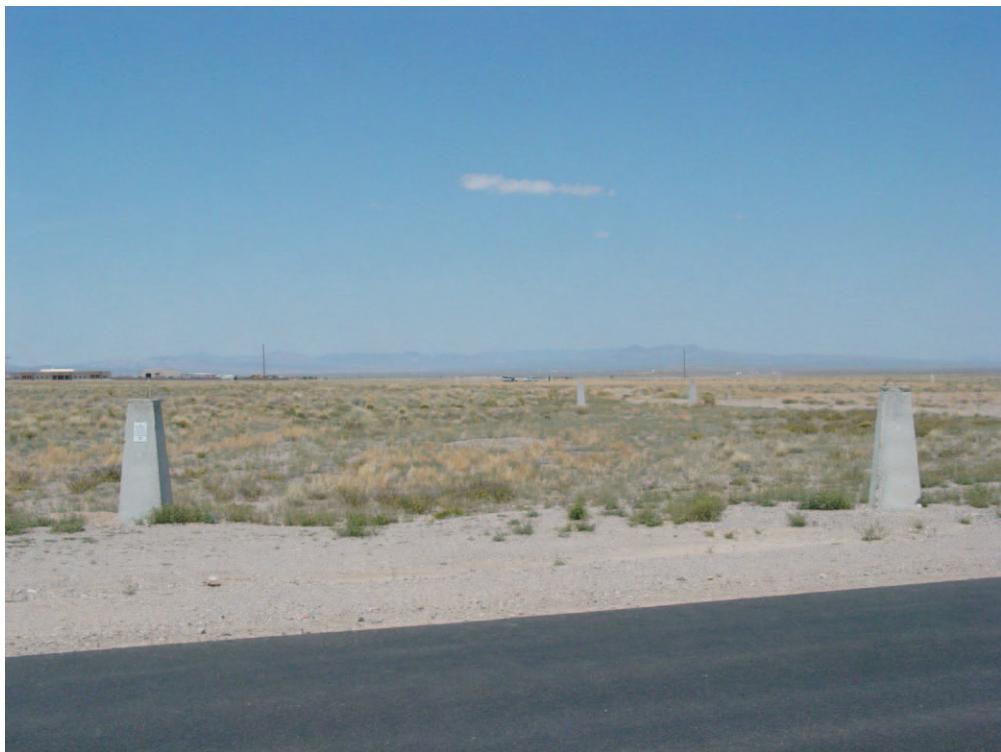
Photograph 19: CAU 424, Landfill Cell A3-2, looking north, 05/09/2006

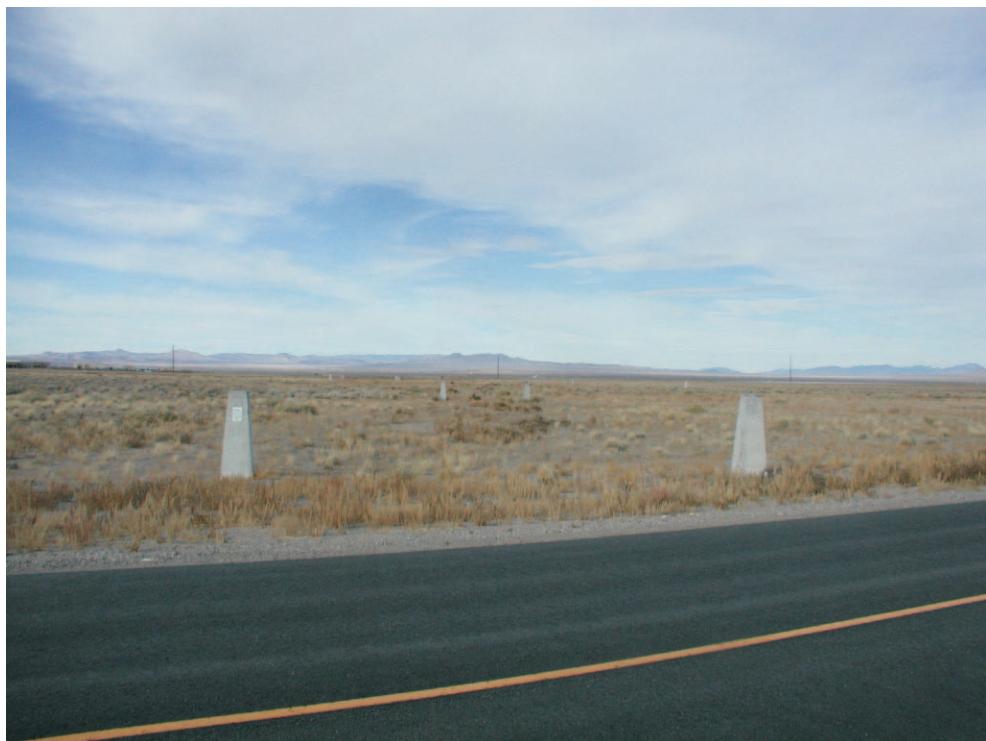
Photograph 20: CAU 424, Landfill Cell A3-2, looking north, 11/15/2006

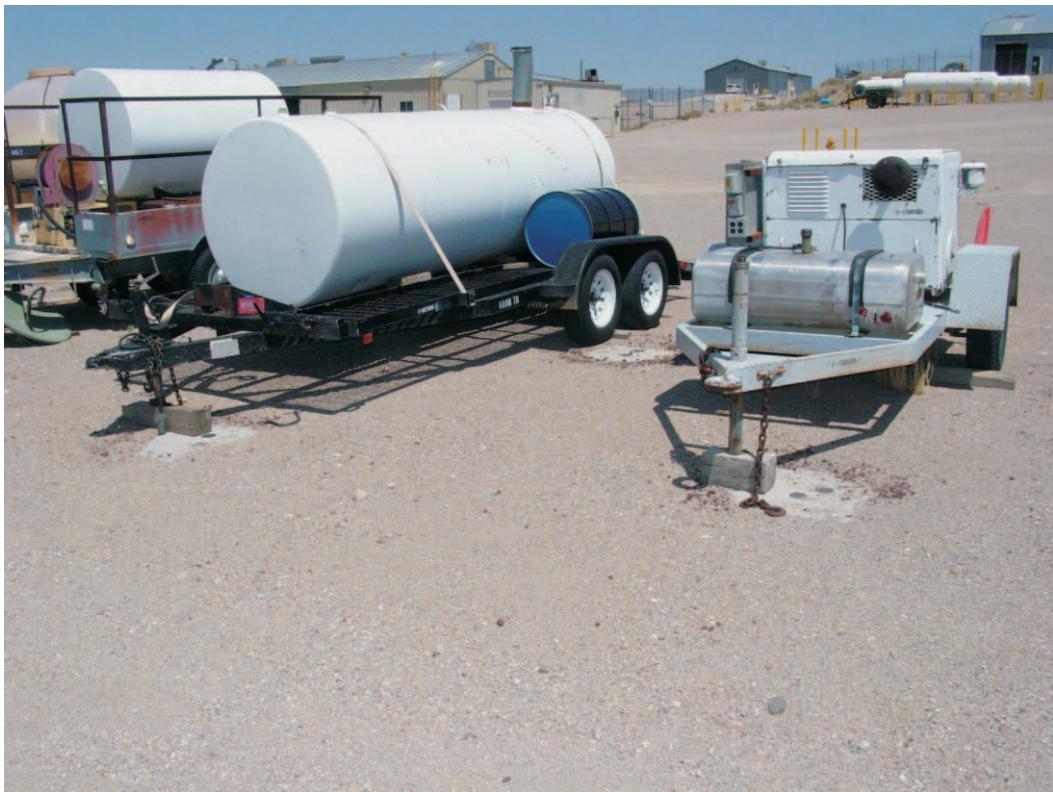
Photograph 21: CAU 424, Landfill Cell A3-3, looking east, 05/09/2006

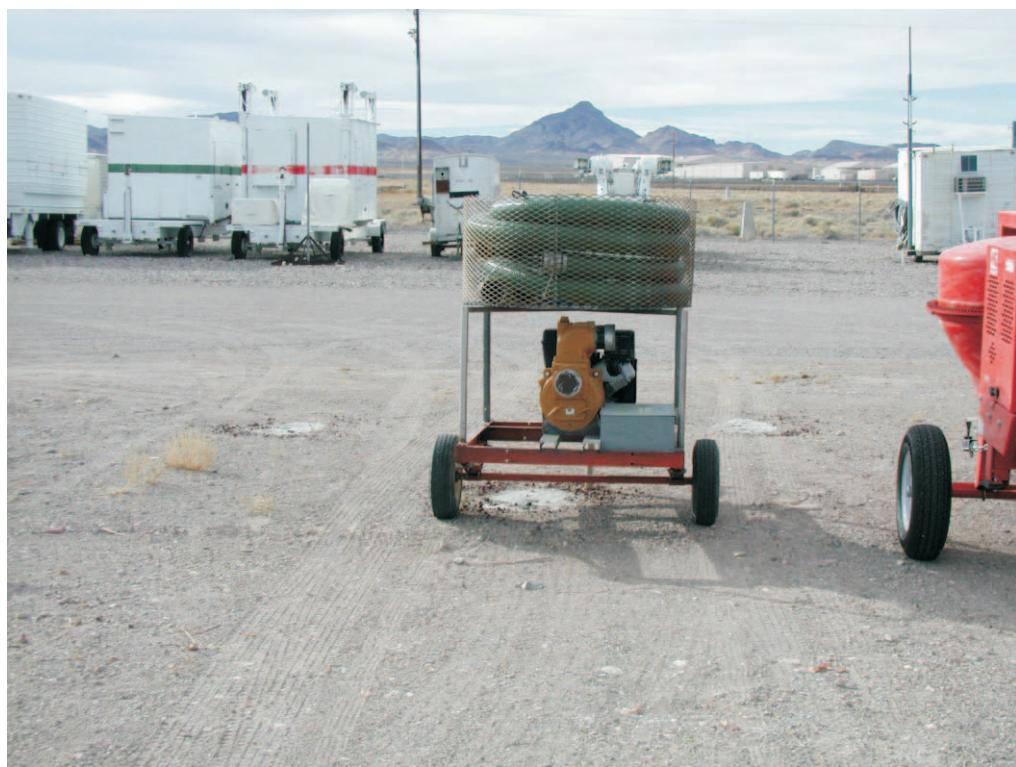
Photograph 22: CAU 424, Landfill Cell A3-3, looking west, 11/15/2006

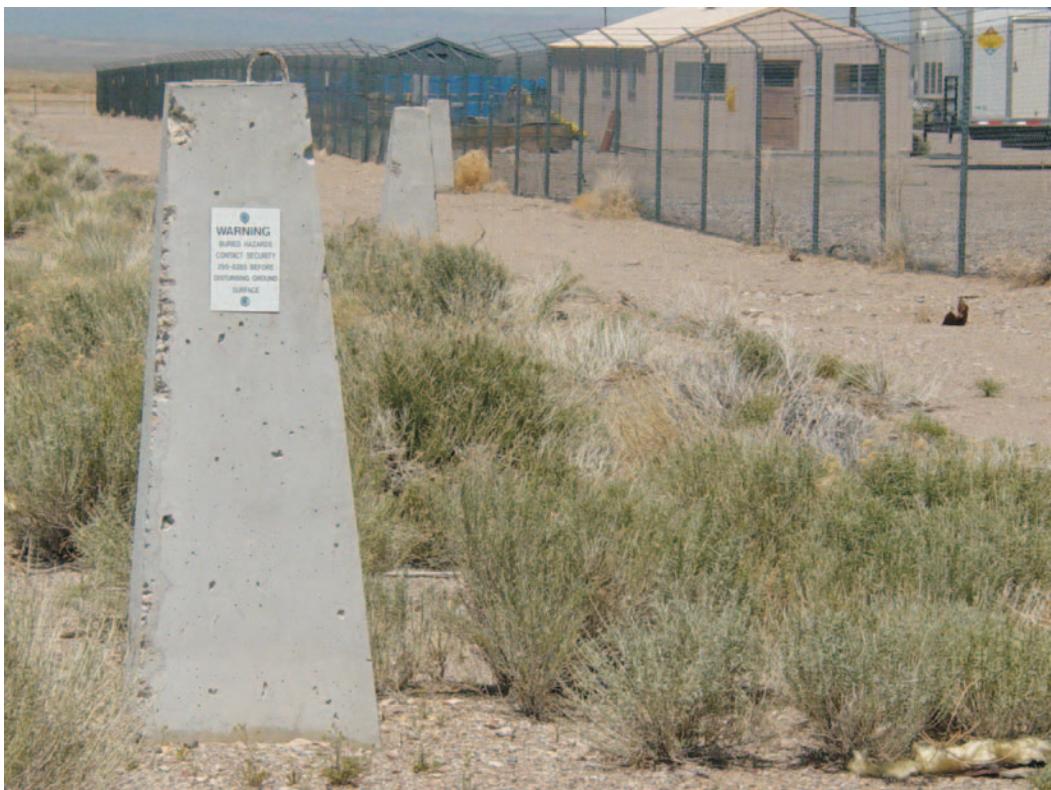
Photograph 23: CAU 424, Landfill Cell A3-3, looking north, 05/09/2006

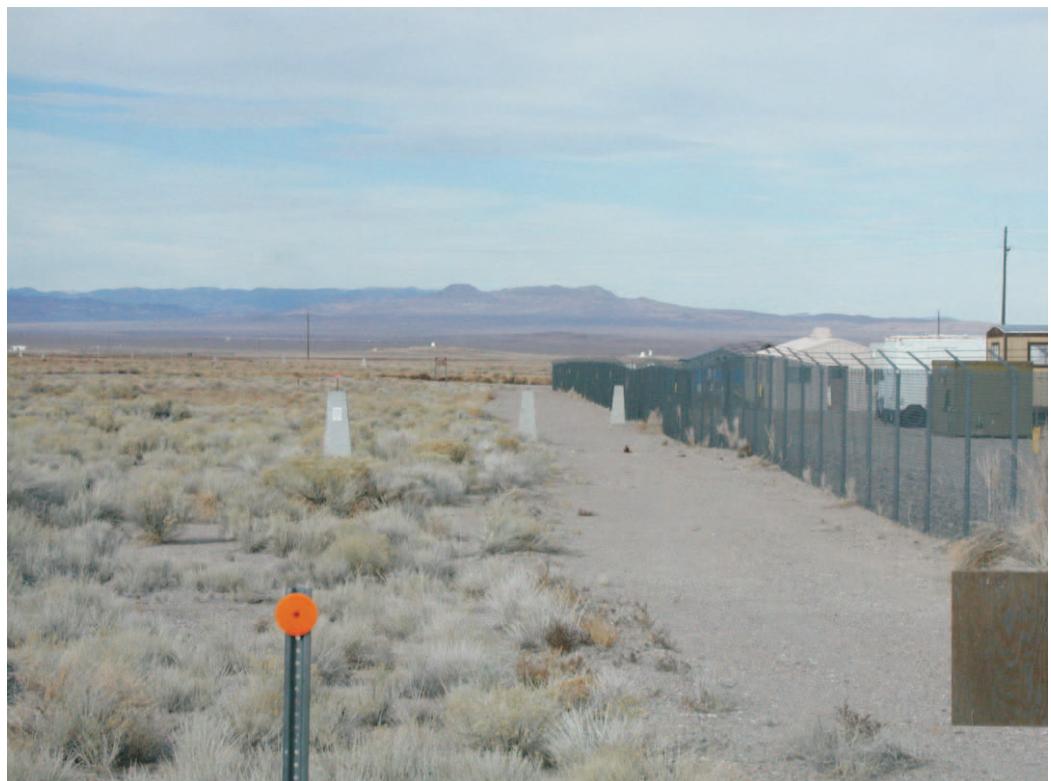
Photograph 24: CAU 424, Landfill Cell A3-3, looking north, 11/15/2006

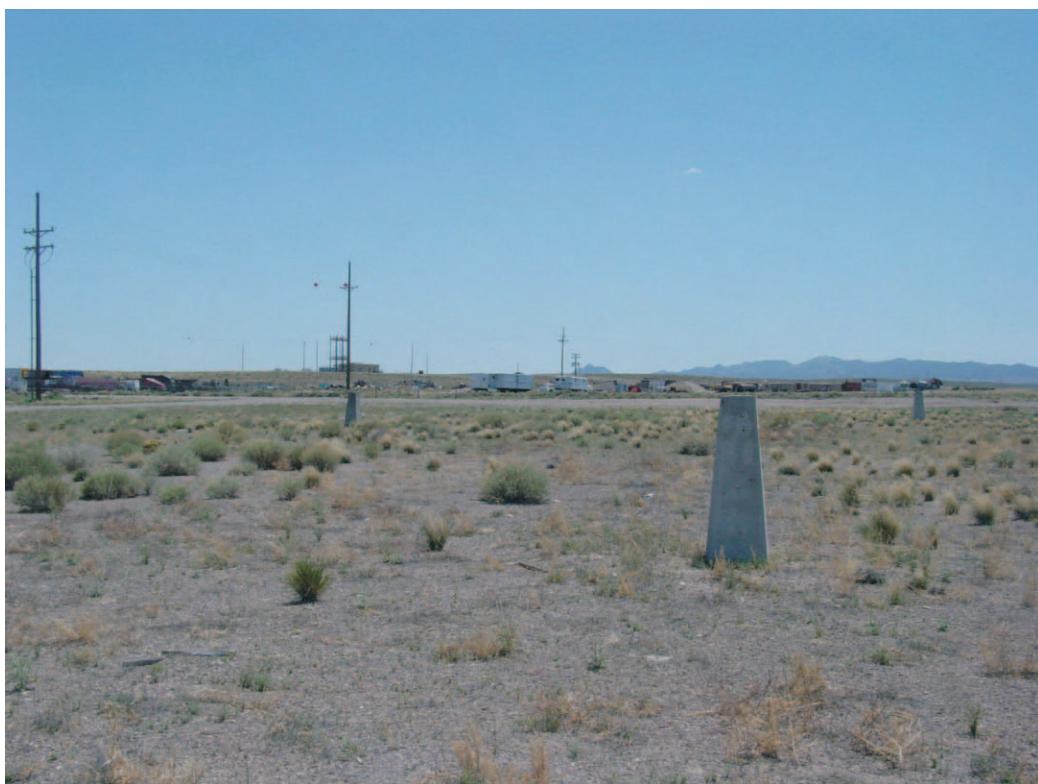
Photograph 25: CAU 424, Landfill Cell A3-4, looking northeast, 05/09/2006

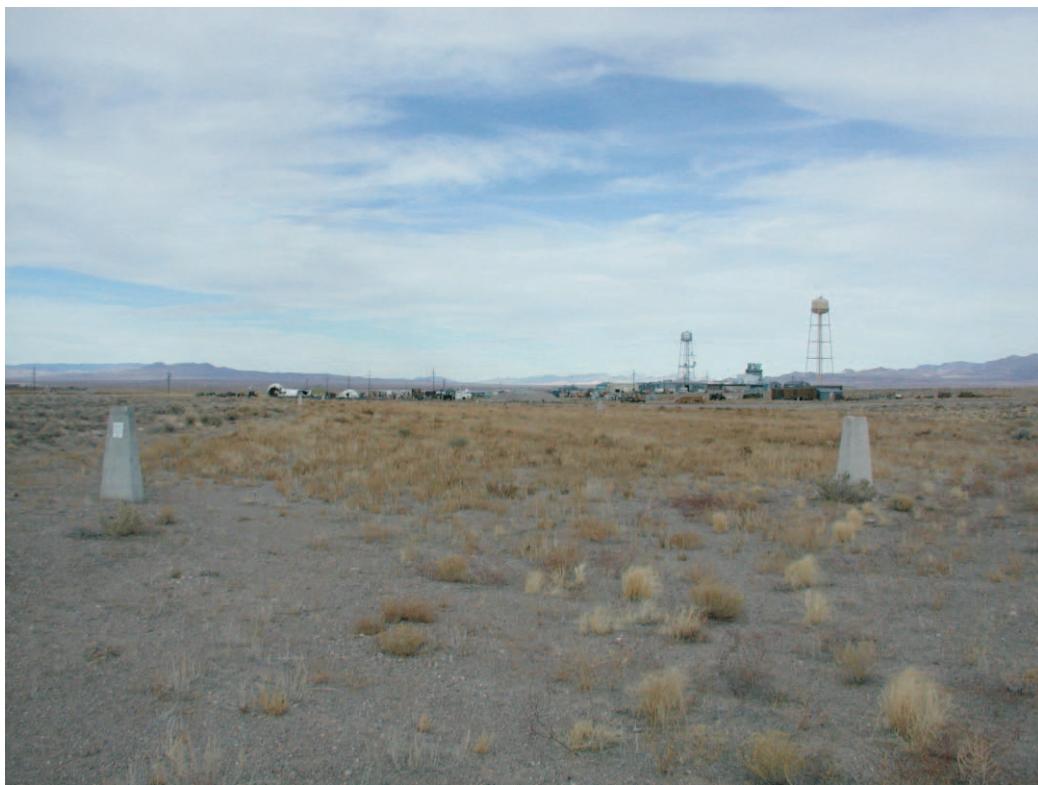
Photograph 26: CAU 424, Landfill Cell A3-4, looking north, 11/15/2006

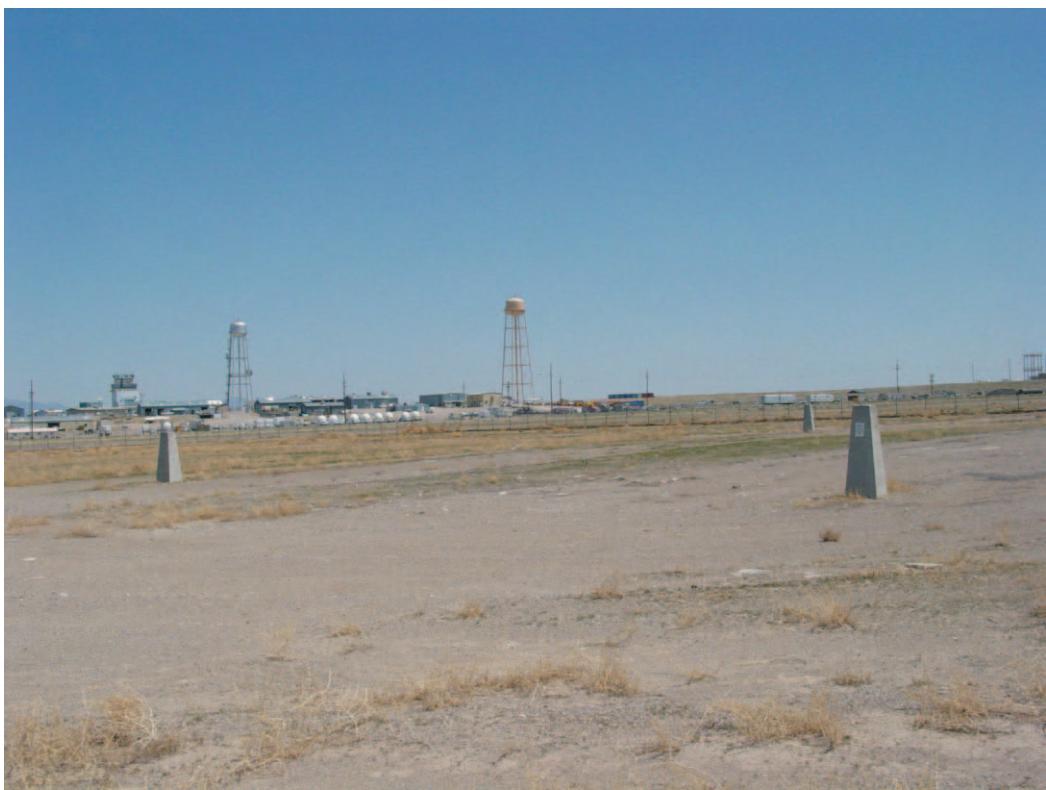
Photograph 27: CAU 424, Landfill Cell A3-5, looking southeast, 05/09/2006

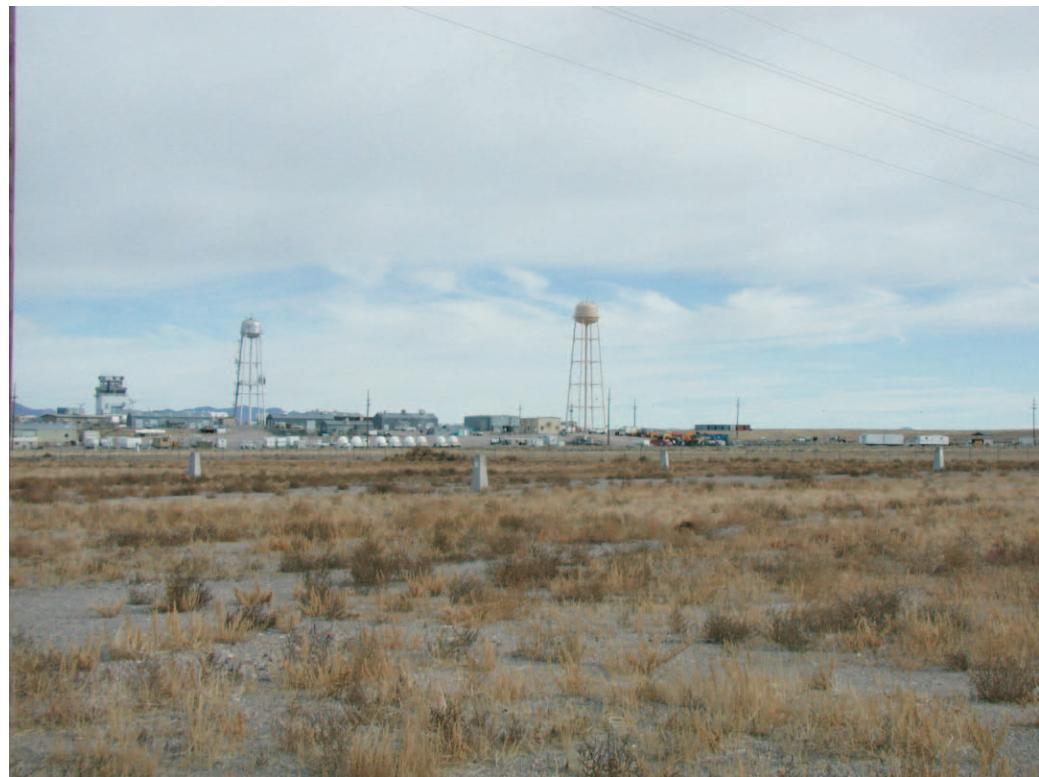
Photograph 28: CAU 424, Landfill Cell A3-5, looking southeast, 11/15/2006

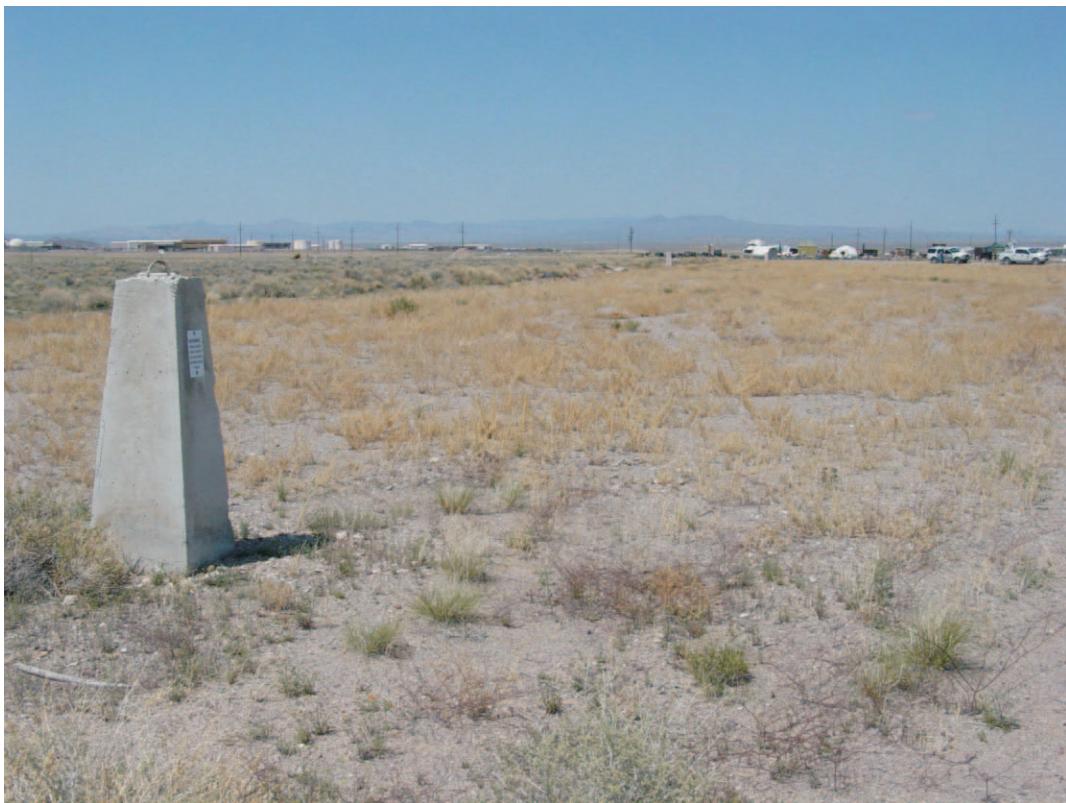
Photograph 29: CAU 424, Landfill Cell A3-6, looking northwest, 05/09/2006

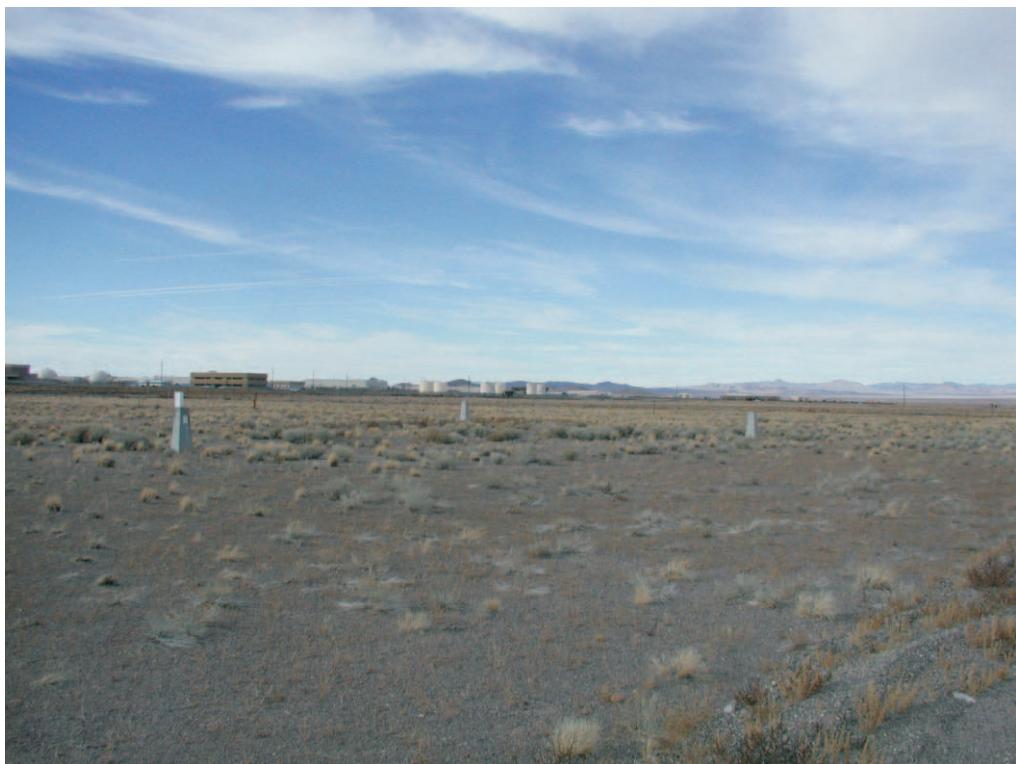
Photograph 30: CAU 424, Landfill Cell A3-6, looking northwest, 11/15/2006

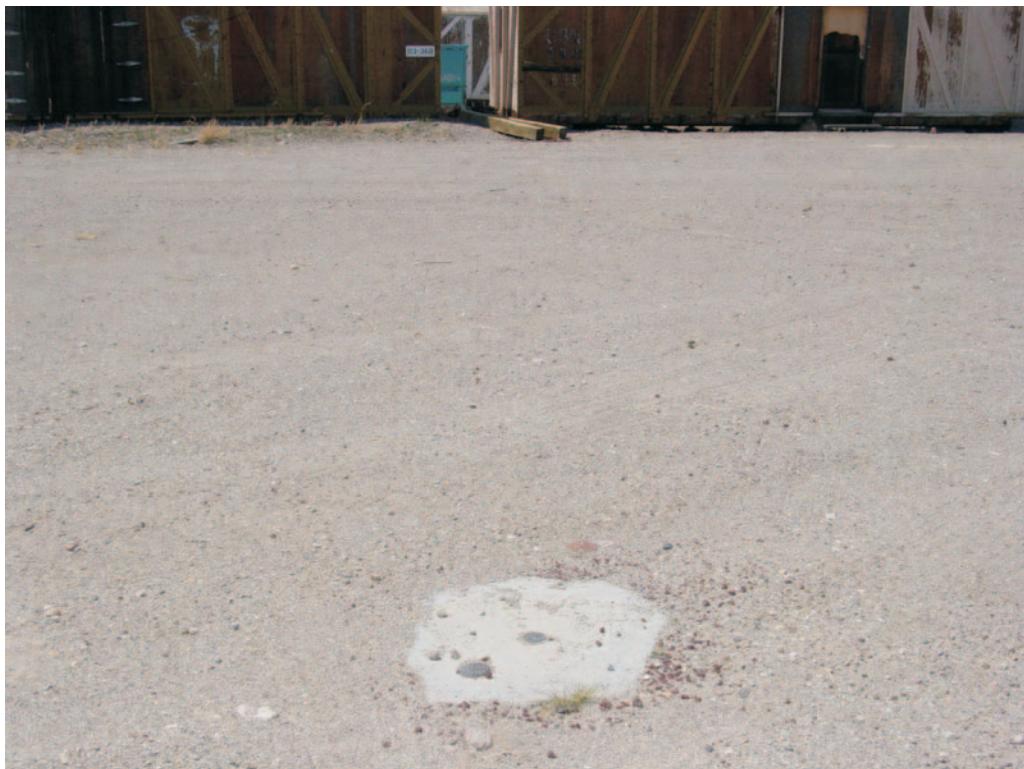
Photograph 31: CAU 424, Landfill Cell A3-8, looking west, 05/09/2006

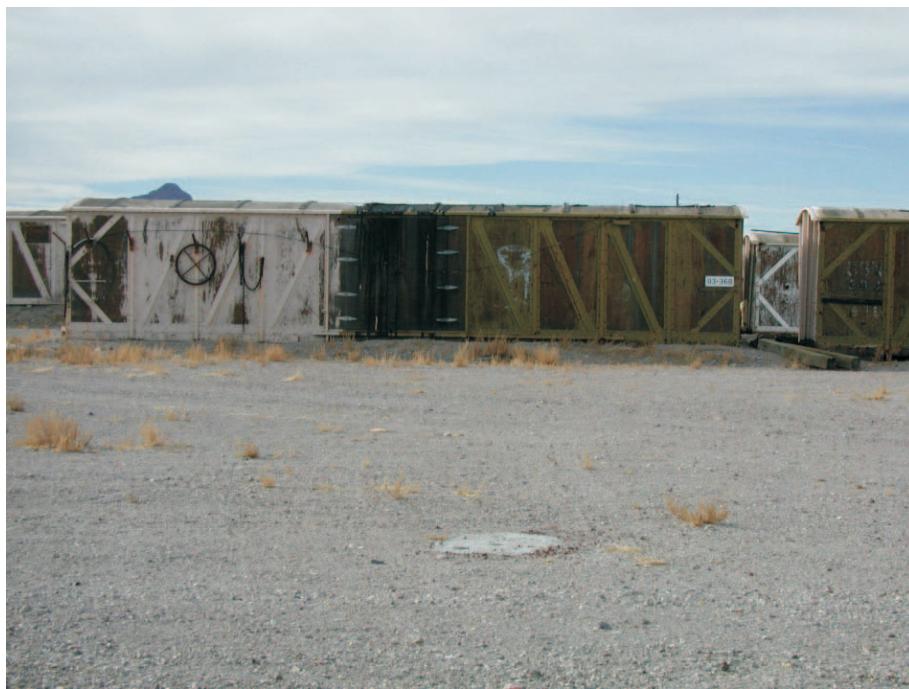
Photograph 32: CAU 424, Landfill Cell A3-8, looking west, 11/15/2006

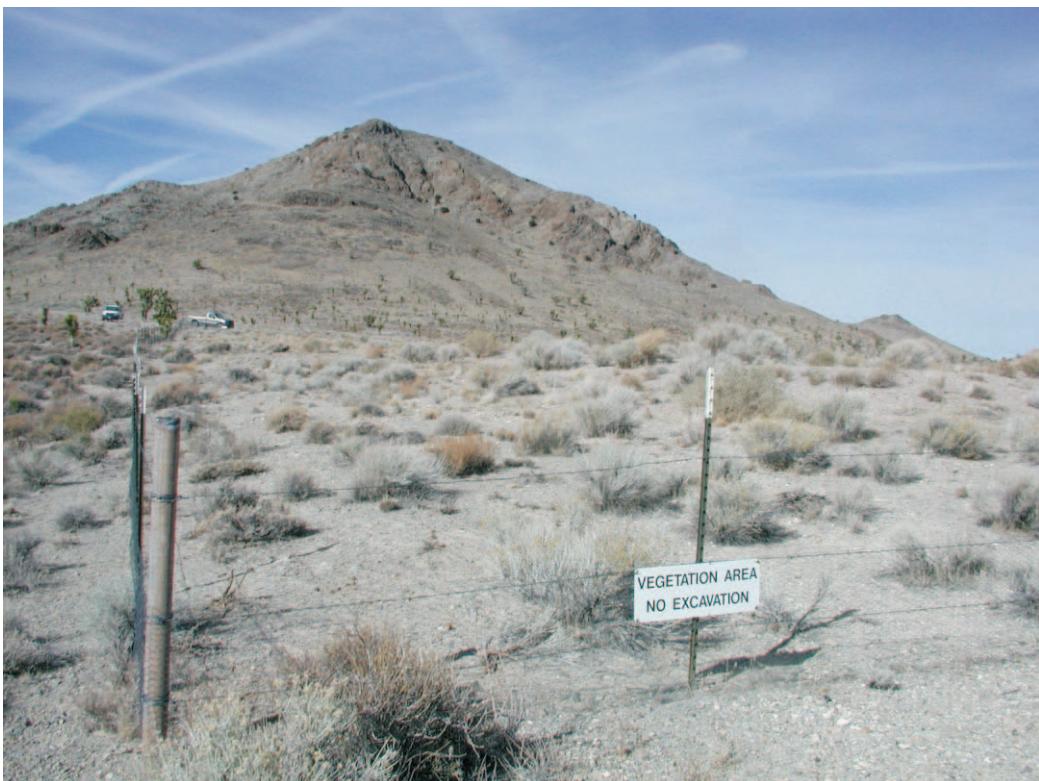
Photograph 34: CAU 426, looking north, 11/15/2006
