DOE/NV--1207

Post-Closure Inspection Report for the Tonopah Test Range, Nevada

For Calendar Year 2006

U.S. Department of Energy
National Nuclear Security Administration
Nevada Site Office

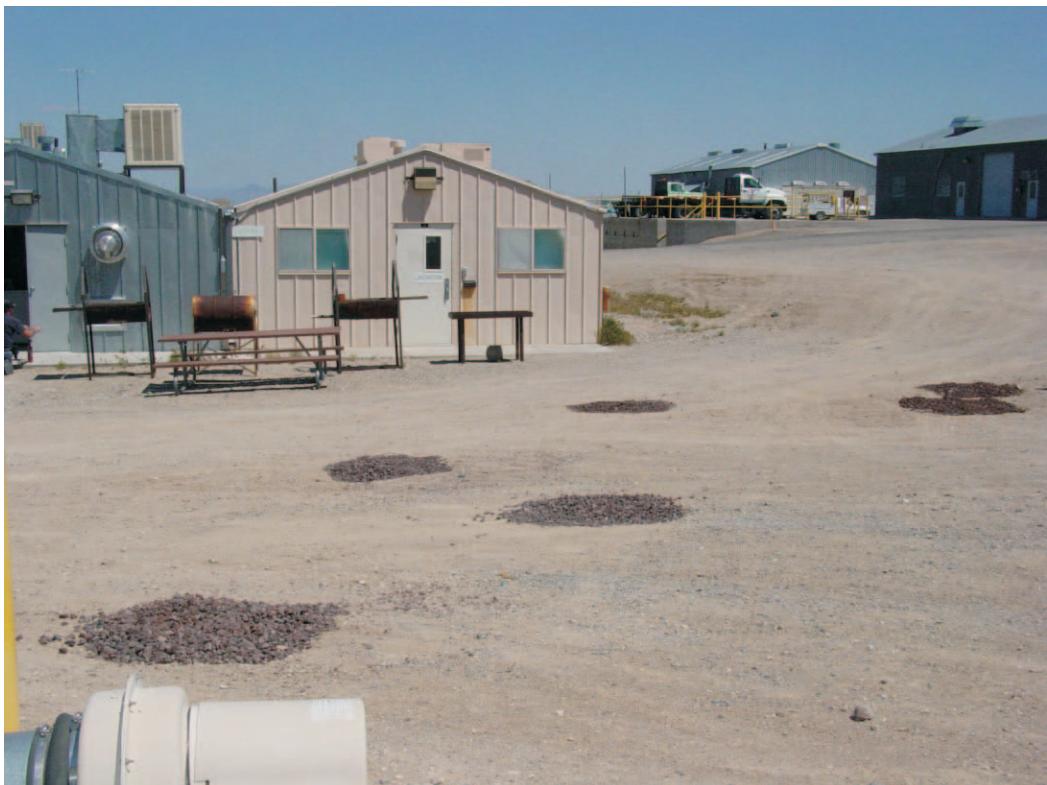
Photograph 35: CAU 427, looking north, 05/09/2006

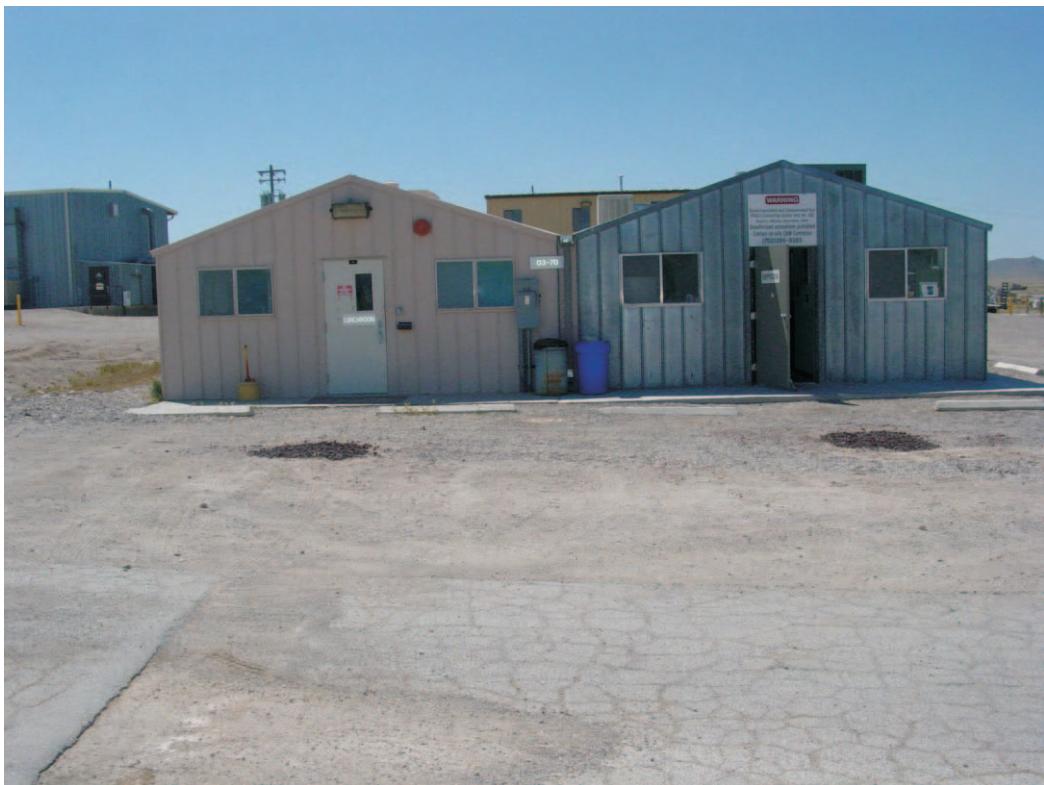
Photograph 36: CAU 427, looking northwest, 11/15/2006

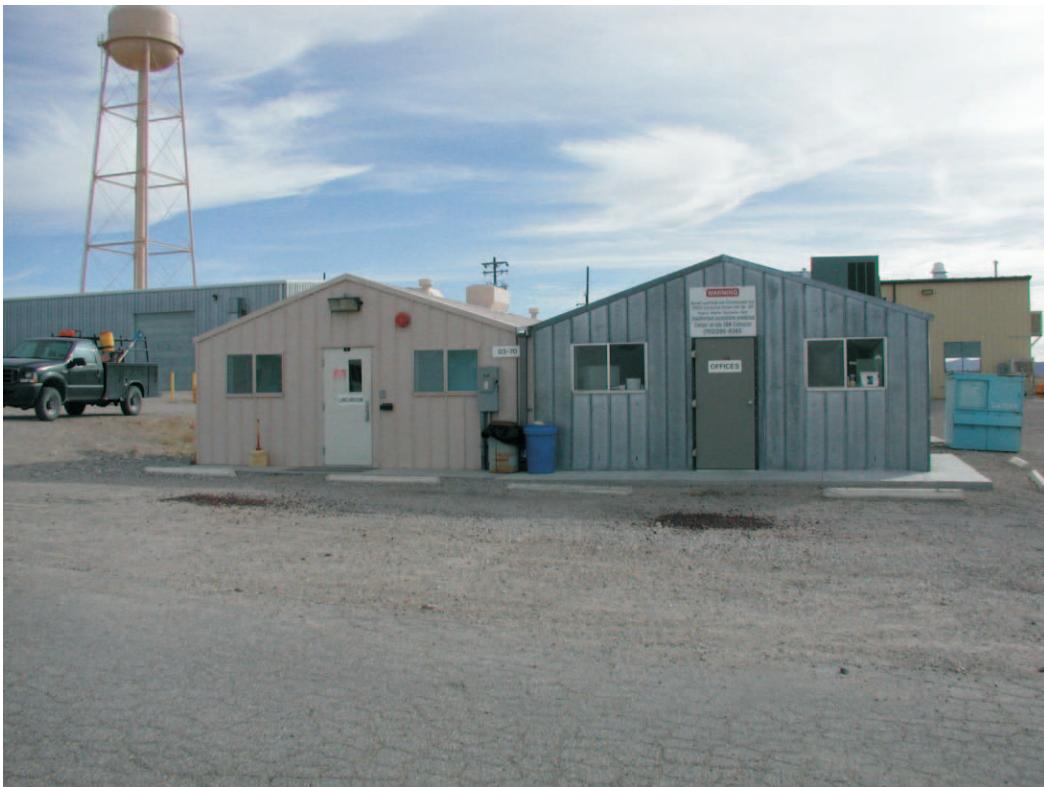
Photograph 37: CAU 427, looking south, 05/09/2006

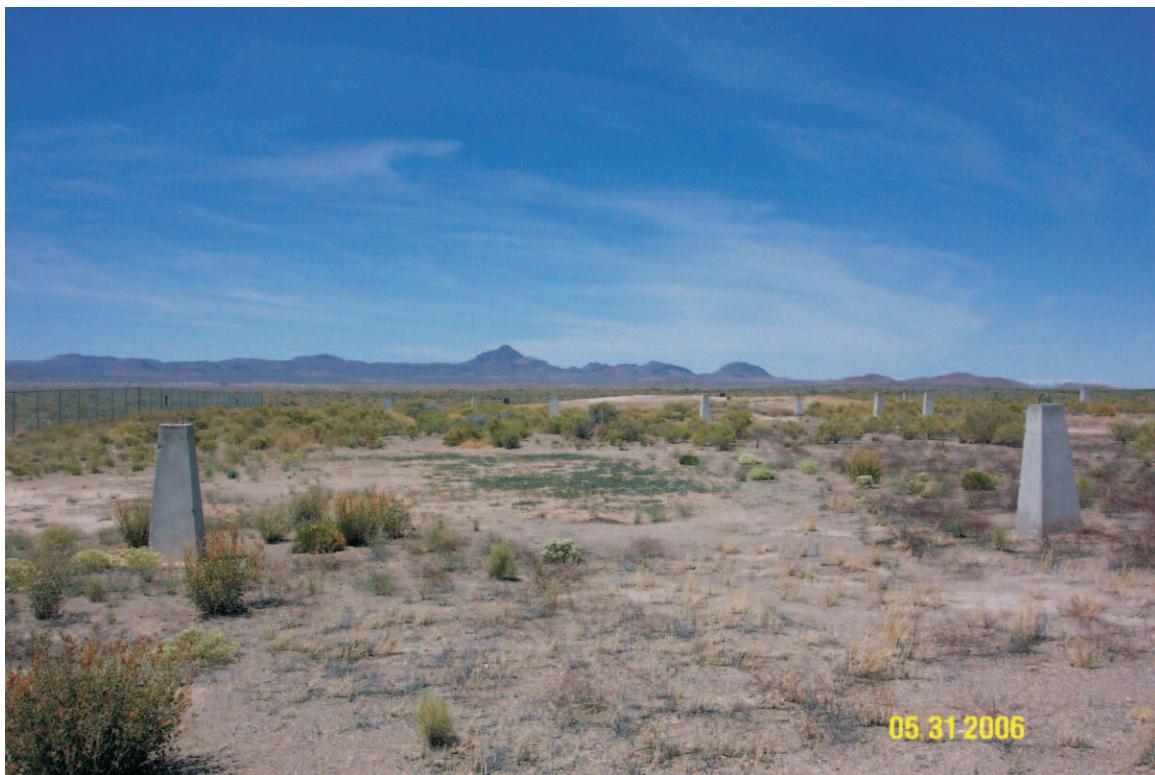
Photograph 38: CAU 427, looking south, 11/15/2006

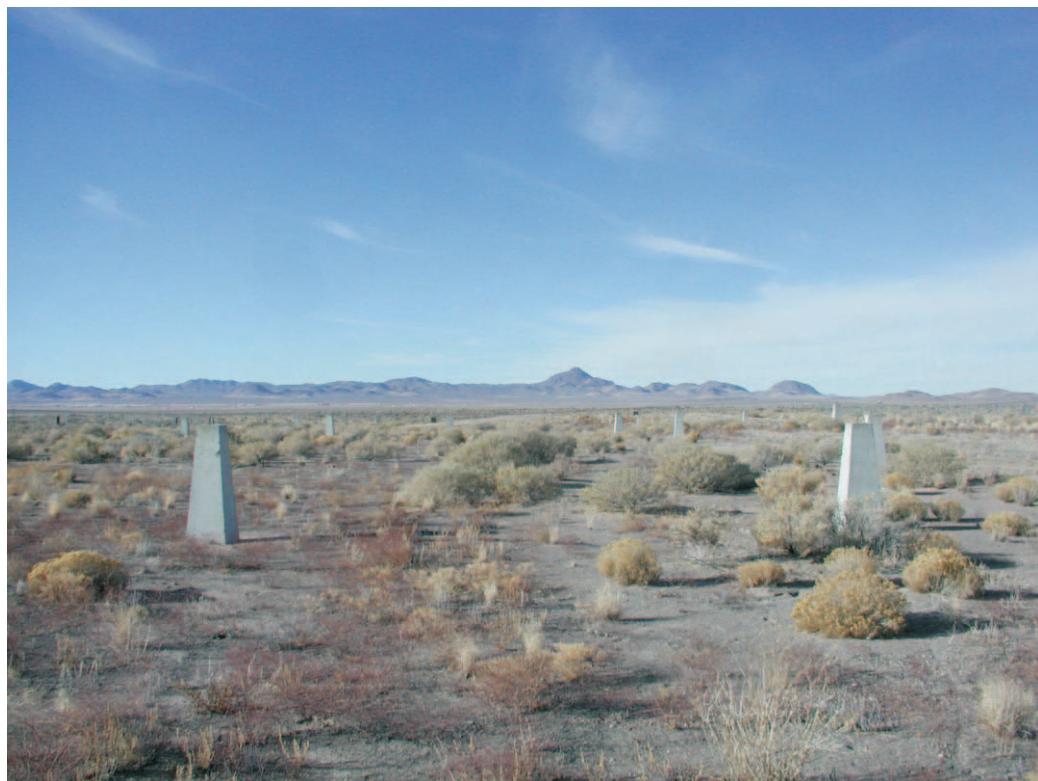
Photograph 39: CAU 453, looking west, 05/31/2006

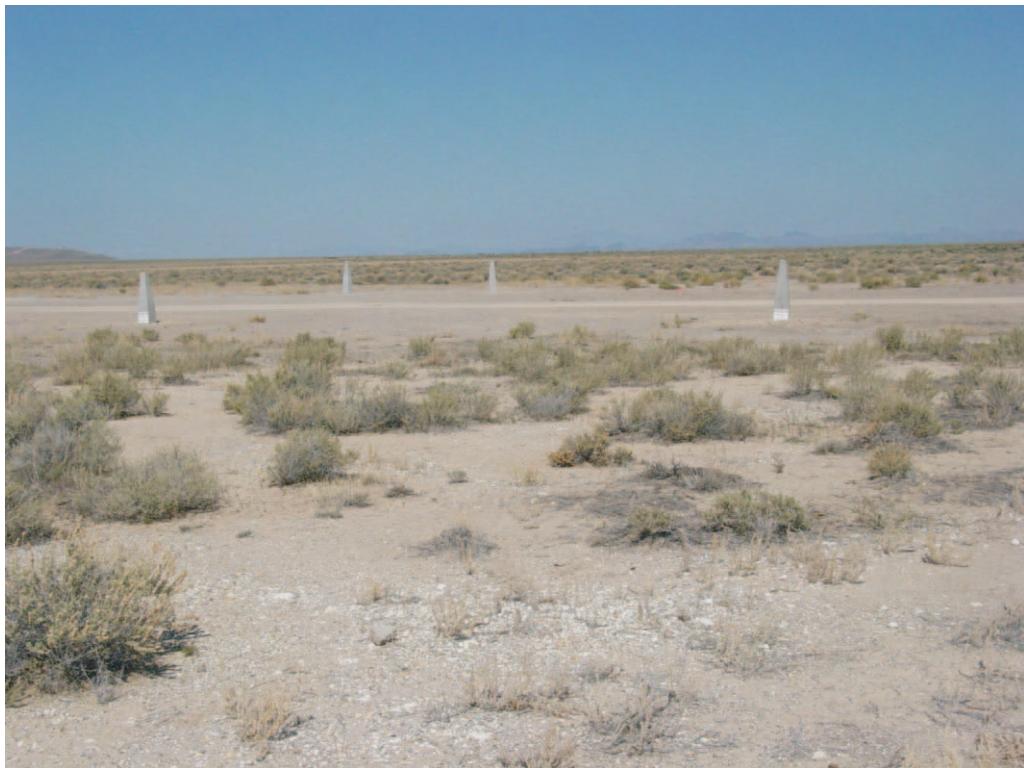
Photograph 40: CAU 453, looking west, 11/15/2006

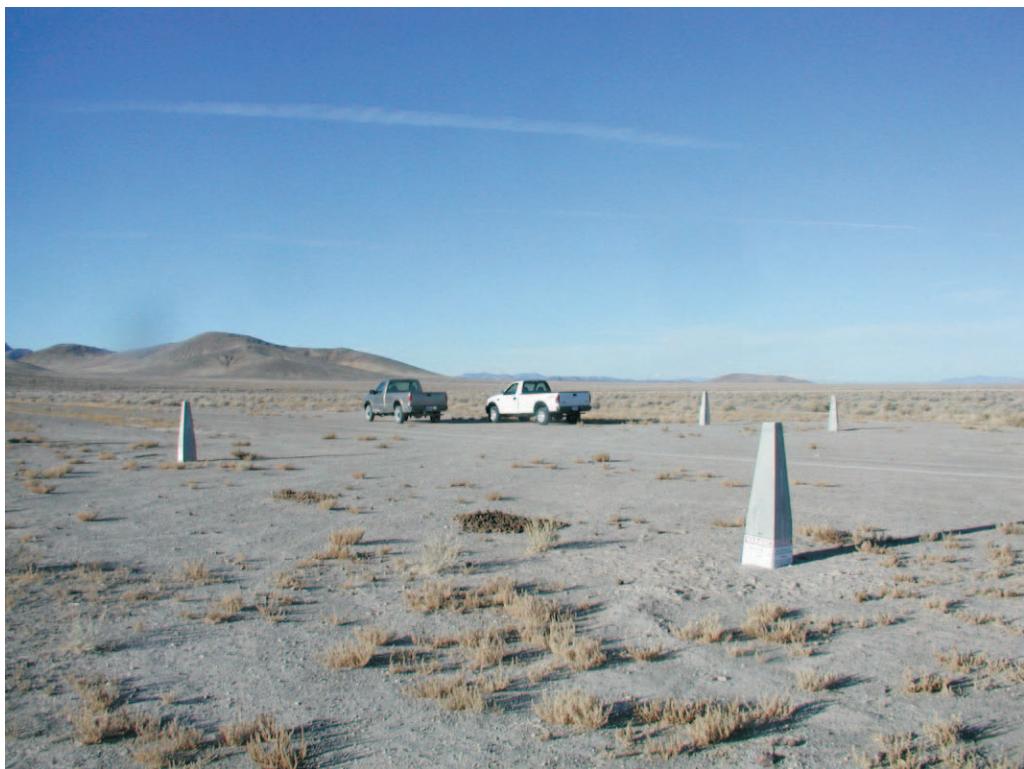
Photograph 41: CAU 487, A-8 anomaly, looking west 05/09/2006

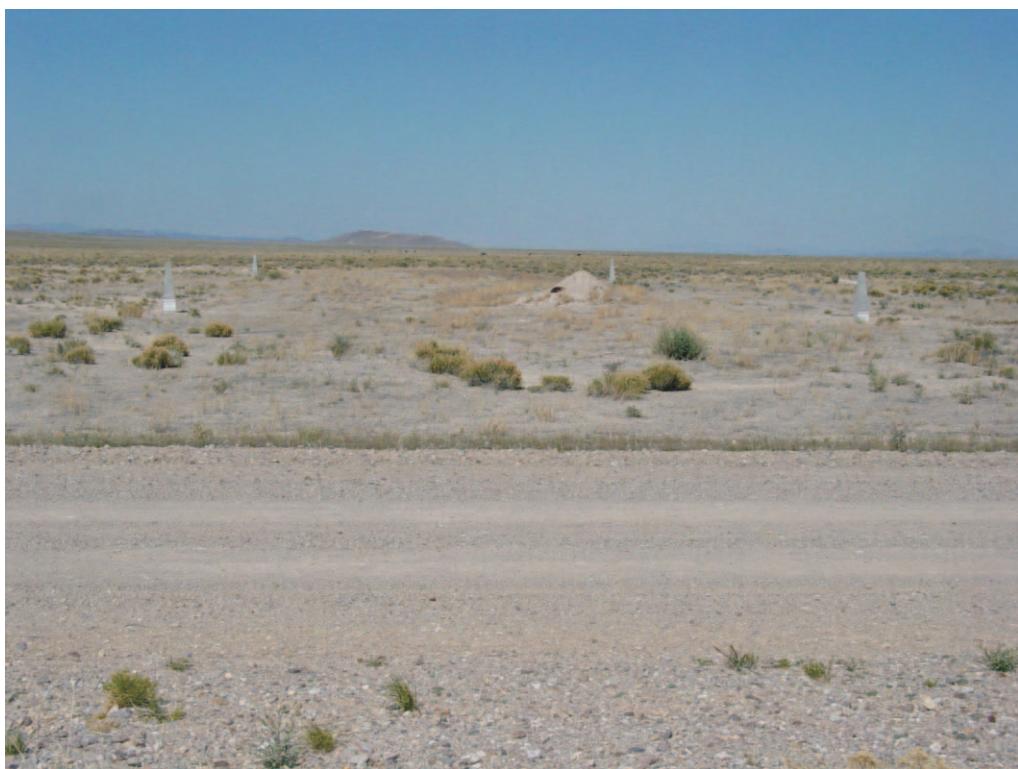
Photograph 42: CAU 487, A-8 anomaly, looking southwest 11/15/2006

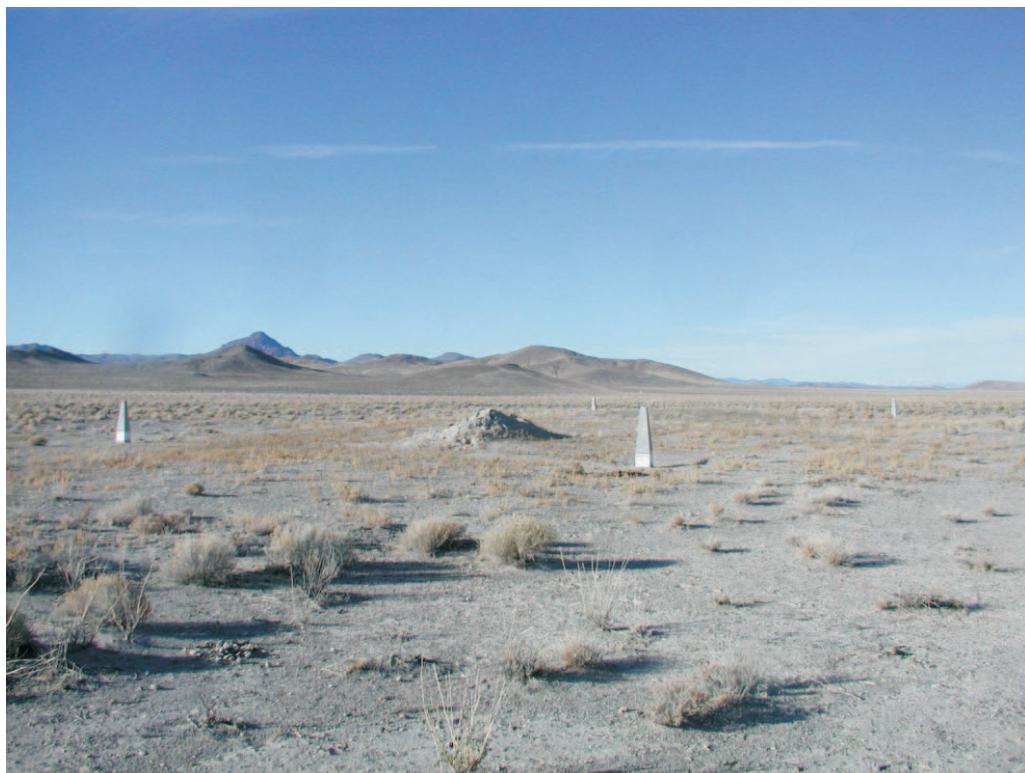
Photograph 43: CAU 487, A-17 anomaly, looking west 05/09/2006

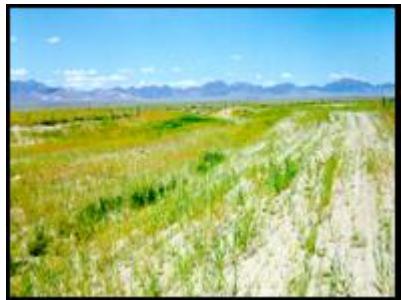
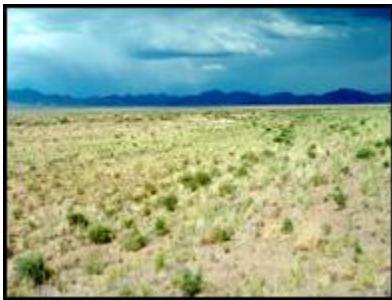
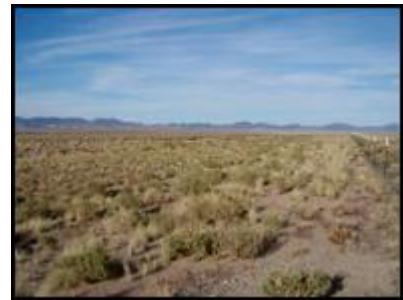
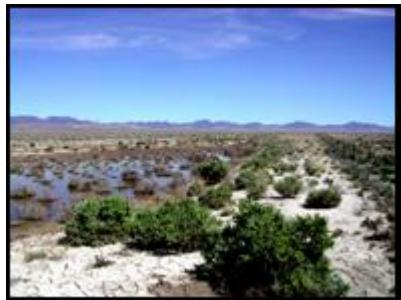
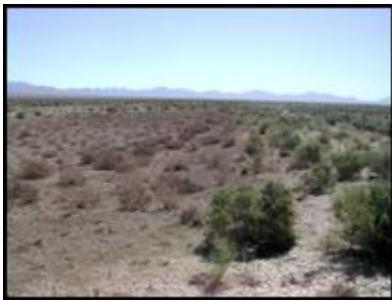
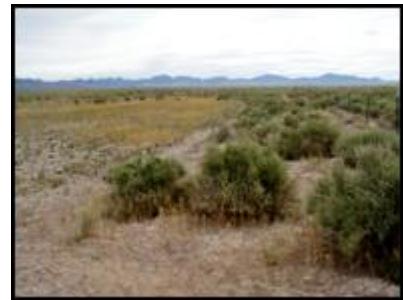
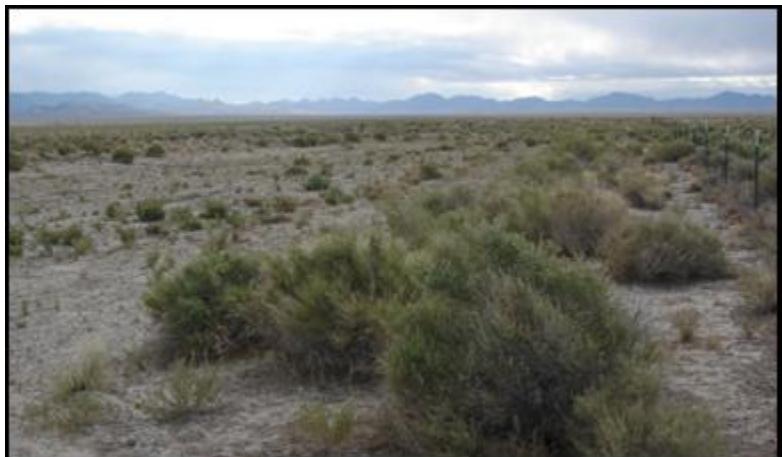
CAU 400, FIVE POINTS LANDFILL, PHOTOGRAPHIC REFERENCE

There was no evidence of erosion until the low-lying areas were flooded in 2003. Standing water was present for several months, resulting in the loss of all vegetation. After the flooded area was reseeded in 2004, there has again been some standing water in the low-lying areas, but the check dams upstream are in place and there were no signs of flooding. There is a small layer of silts/sands in the bottom areas, suggesting some overland erosion, but no erosion gullies were observed, and there does not appear to be any damage to the vegetation.

Perennial plants found in the low-lying areas that were flooded and reseeded in 2004 have only experienced two growing seasons and are not as well established as the shrubs and grasses in the non-flooded areas. It would benefit these newly established plants to keep the perimeter fence, at least until revegetation success standards are met for 2 to 3 consecutive years.

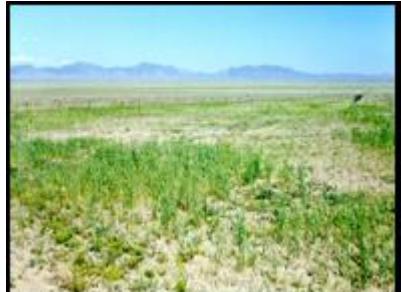
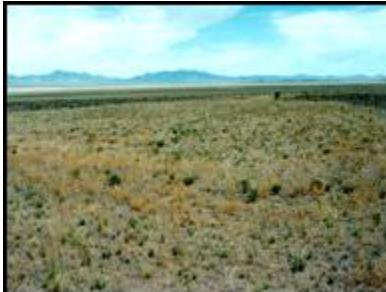
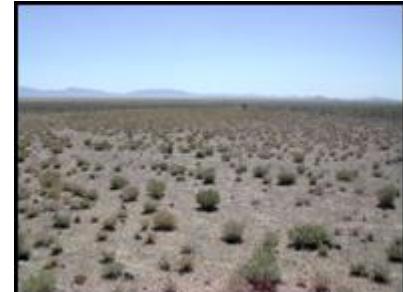
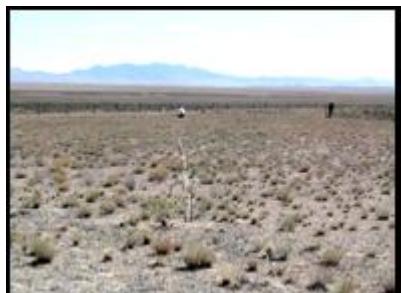
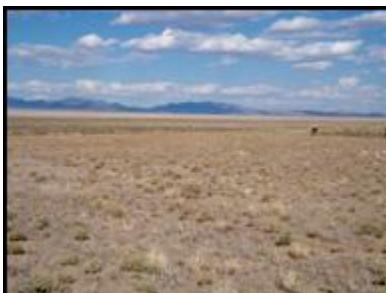
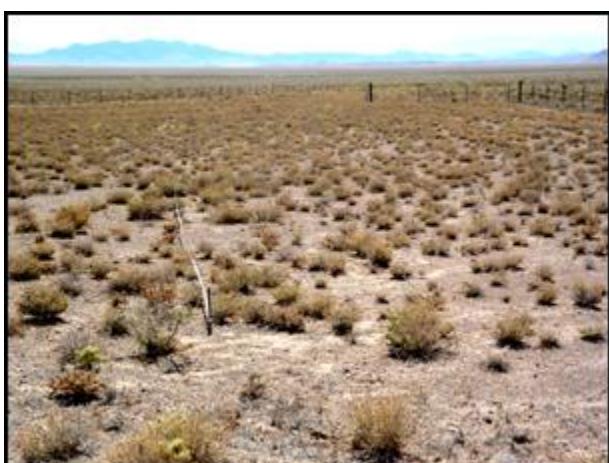
CAU 400, BOMBLET PIT, PHOTOGRAPHIC REFERENCE

The density of perennial shrubs and grasses has not changed significantly since 2004. In 2006, there was an increase in the number of shrubs, and for the first time since 2003, Indian ricegrass was found on the site. Shadscale is still the most abundant shrub on the site, but there was an increase in the number of bud sagebrush in 2006. Winterfat, once present at the site, has been absent since 2003. Bud sagebrush, shadscale, and winterfat are the primary shrub species on the reference area. There were no annual forbs encountered in 2006.

The only concern at this site is the lack of grasses. After revegetation there was an abundance of grasses. Since then grasses have gradually declined. The reappearance of Indian ricegrass this year is encouraging. With favorable growing conditions in the future, native grasses like Indian ricegrass may become established and contribute more to overall plant cover and density. Shrubs have become well established as indicated by higher cover values and densities than shrubs on the reference area. The fence has protected the shrubs and grasses from the impacts of grazing animals. Removal of the fence may decrease the potential for the grasses to establish on the site. In the event the fence is removed, it would be beneficial to evaluate the site periodically to document the effect, if any, of removing the fence.

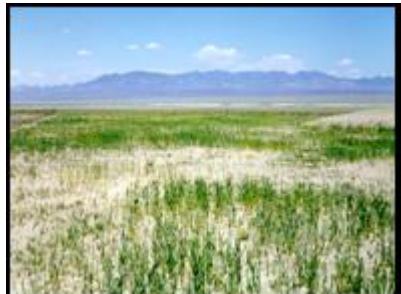
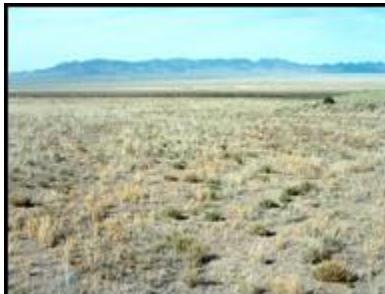
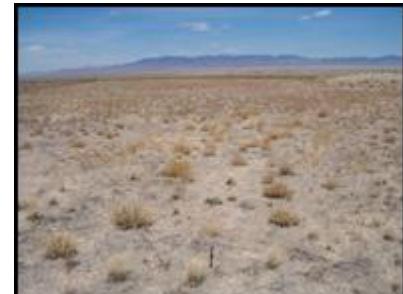
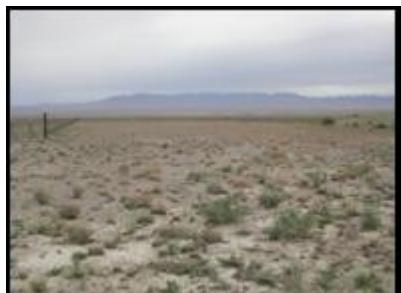
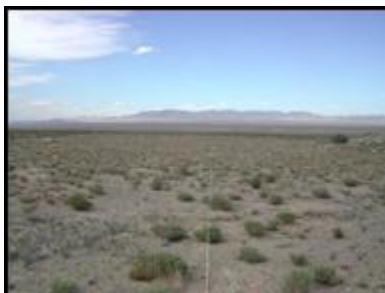
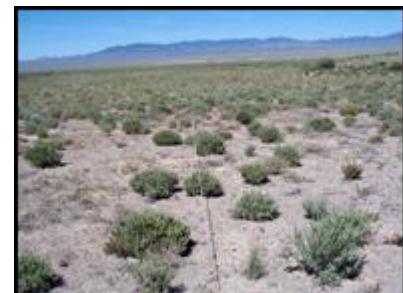
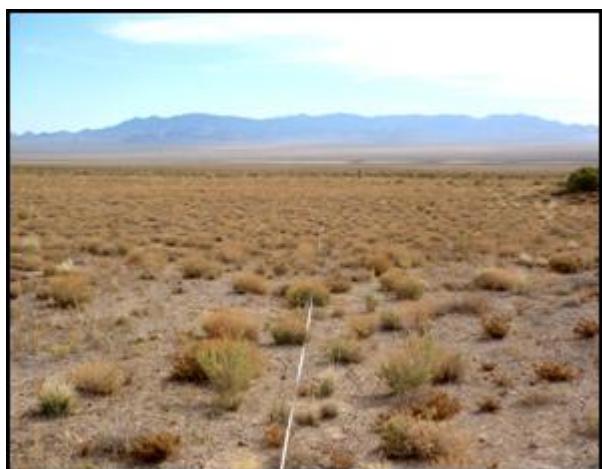
CAU 404, ROLLER COASTER LAGOONS AND TRENCH, STAGING AREA, PHOTOGRAPHIC REFERENCE

Halogeton, a noxious weed, has been found on the staging area as well as in the native plant community. The density of halogeton was 3.0 plants per m^2 the first year after revegetation, decreased to 0.5 plants per m^2 the following year, showed a slight increase over the next 3 years to a high of 1.6 plants per m^2 in 2004, decreased to 0.1 plants per m^2 in 2005, and was not encountered in 2006. The establishment of both perennial and annual native plants has been the best control measure for this noxious weed.

Plant cover and density are higher on the revegetated area than on the adjacent undisturbed reference area. However, grasses have not met revegetation standards for either cover or density. Removal of the fence at this time may put stress on the grasses because they would be exposed to grazing animals, and the vigor and abundance of grasses may decline to a point where they may not meet standards set to determine revegetation success.

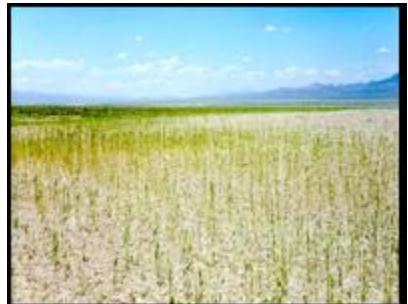
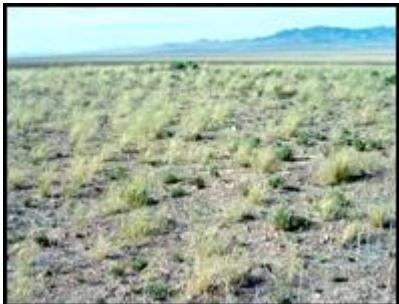
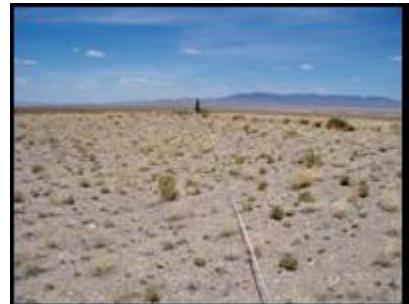
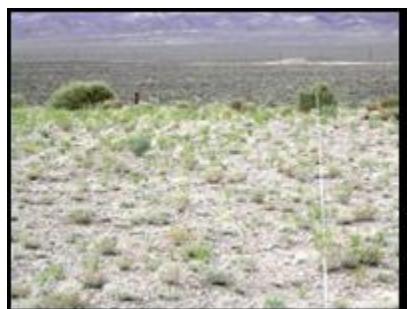
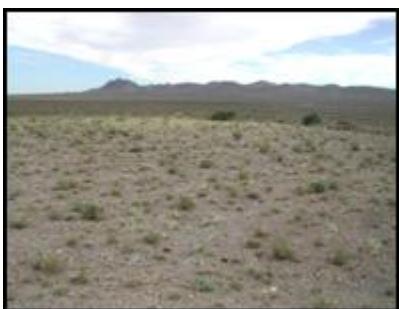
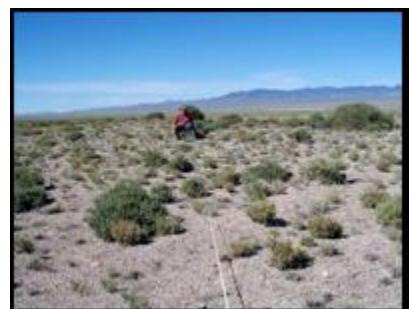
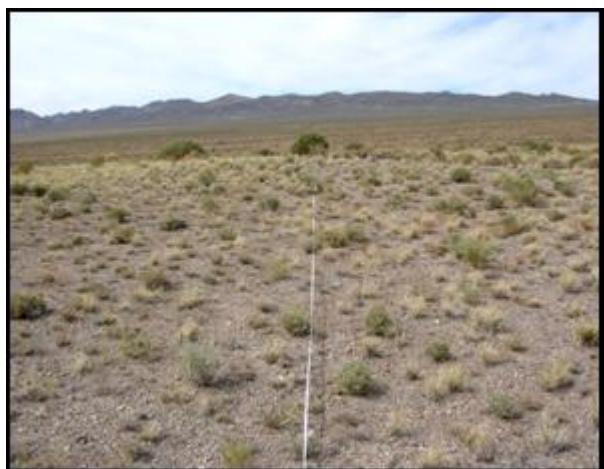
CAU 404, ROLLER COASTER LAGOONS AND TRENCH, COVER, PHOTOGRAPHIC REFERENCE

As noted in previous years, there continues to be a number of small mammal burrows around the periphery of the cover berm. The presence of the burrows indicates use of the site by native wildlife species. Increased erosion due to the burrowing activity was not seen in 2006, nor has it been an issue in previous years. There was some overland flooding along the southern edge of the berm, but no channeling or furrowing has been observed.

Removal of the fence at this site may not have as detrimental effect on the cover as on the staging area because of the excellent mix of native shrubs and grasses that have established on the cover. Plant density and vigor may decline with unrestricted access for both horses and antelope.

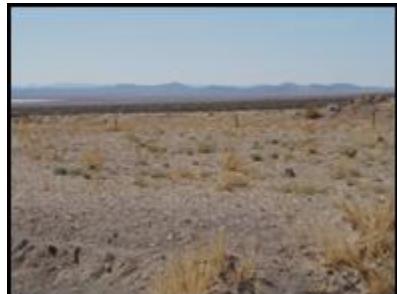
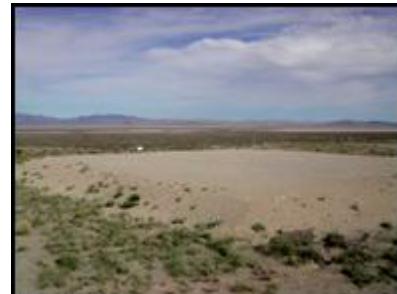
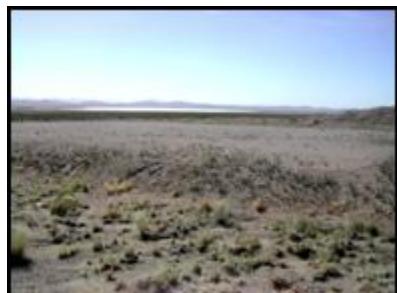
CAU 407, ROLLER COASTER RADSAFE AREA, PHOTOGRAPHIC REFERENCE

There is an abundance of old, dead stalks of halogeton (Figure 2) from the abundant rainfall in 2005. Halogeton is very common along roadsides and almost any place that has been disturbed, and is characterized by succulent, fleshy leaves and a central reddish stem. The number of plants has decreased by approximately 50 percent from 2005 to 2006. A similar trend has been observed at other revegetated sites, where halogeton becomes less abundant as native plants become established.

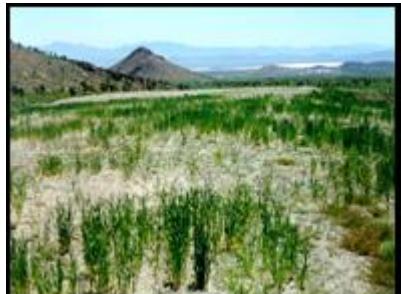
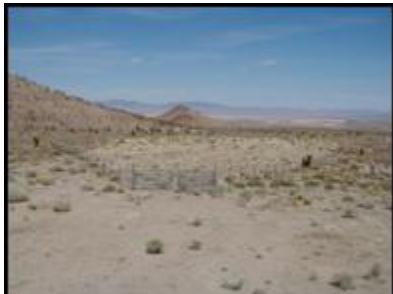
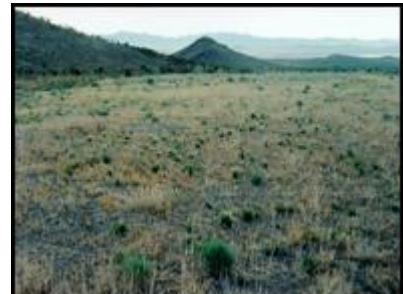
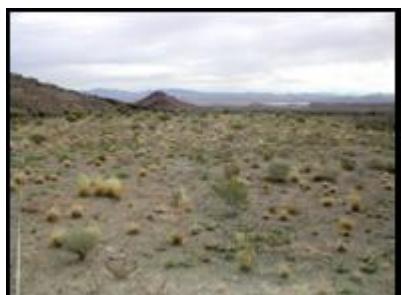
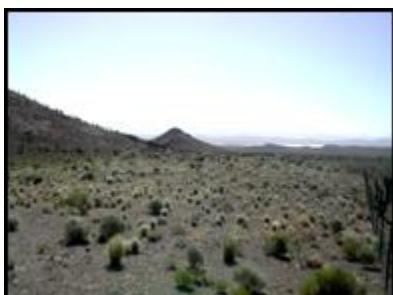
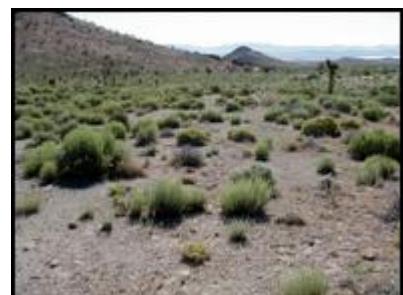
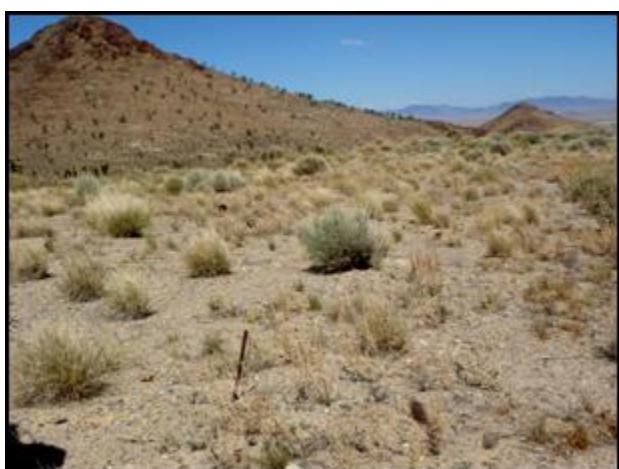
CAU 426, CACTUS SPRING WASTE TRENCHES, STAGING AREA, PHOTOGRAPHIC REFERENCE

This site was disturbed prior to closure activities, and halogeton, a noxious weed, occupied much of the area. Since revegetation, the density of halogeton has decreased from 15 plants per m^2 in 2000 to 1.4 plants per m^2 in 2006. The abundance of this species is usually kept in check by the presence of native plant species and the absence of new soil disturbances.

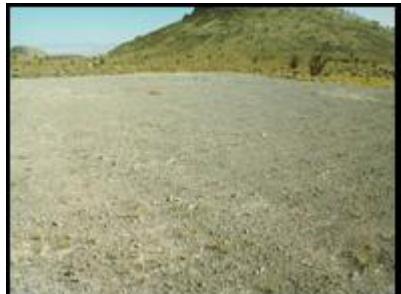
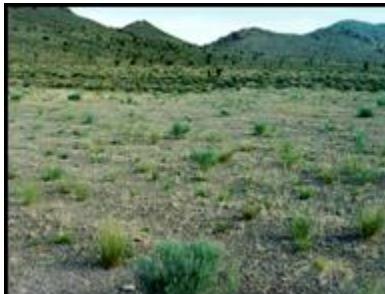
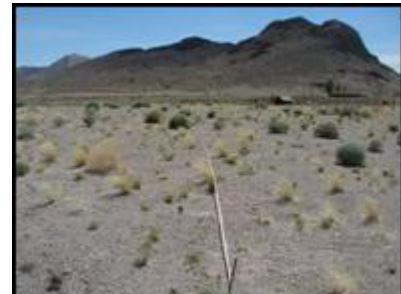
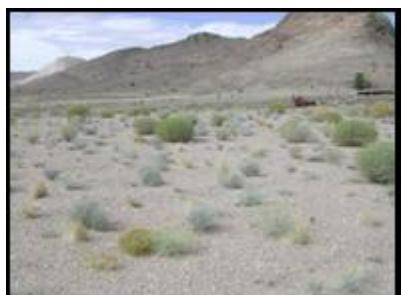
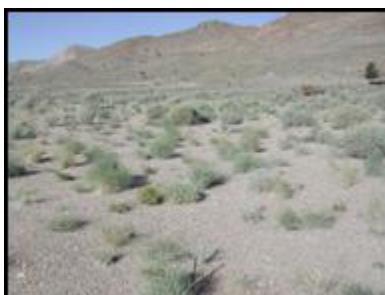
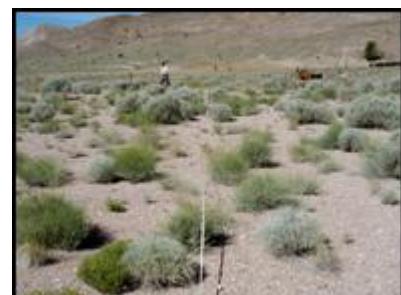
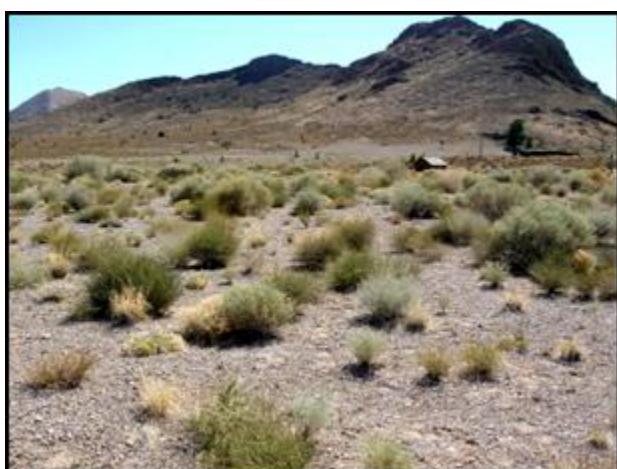
CAU 426, CACTUS SPRING WASTE TRENCHES, COVER, PHOTOGRAPHIC REFERENCE

In the event the fence around this site is removed, there are several issues to consider. The proximity of this site to grazing animals such as horses and antelope is evident due to the area around the site having very few grasses. The grasses on the cover may attract the horses visiting the nearby water source, and the abundance and vigor of the grasses may be impacted. Another issue is halogeton, a noxious weed. If the site becomes a gathering point or trail for grazing animals, the soil may be disturbed and favor the growth and dominance of halogeton, possibly to levels attained before the site was revegetated. In the event the fence is removed, periodic monitoring of the site is recommended to determine the effect of grazing animals. Such information would be valuable for future revegetation efforts in the region.
