Nevada
Environmental
Restoration
Project

DOE/NV--1315

Post-Closure Inspection Report for the Tonopah Test Range, Nevada

For Calendar Year 2008

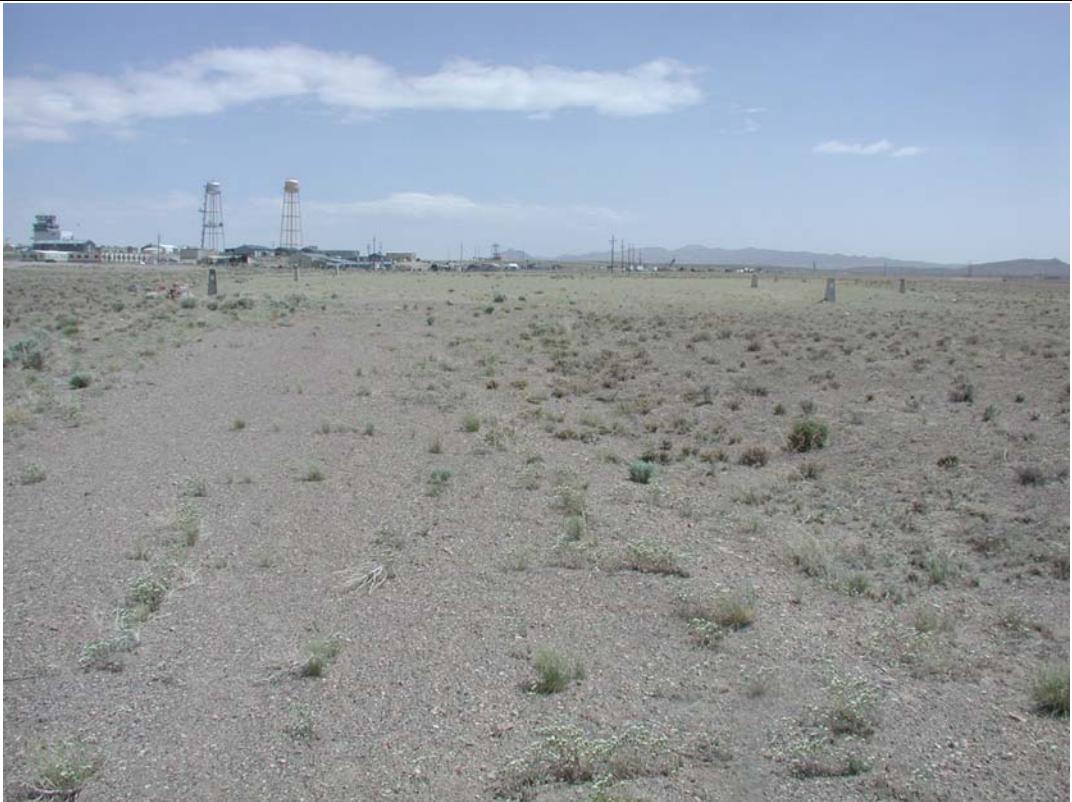
Photograph 9: CAU 424, Landfill Cell A3-1, looking southeast, 05/21/2008

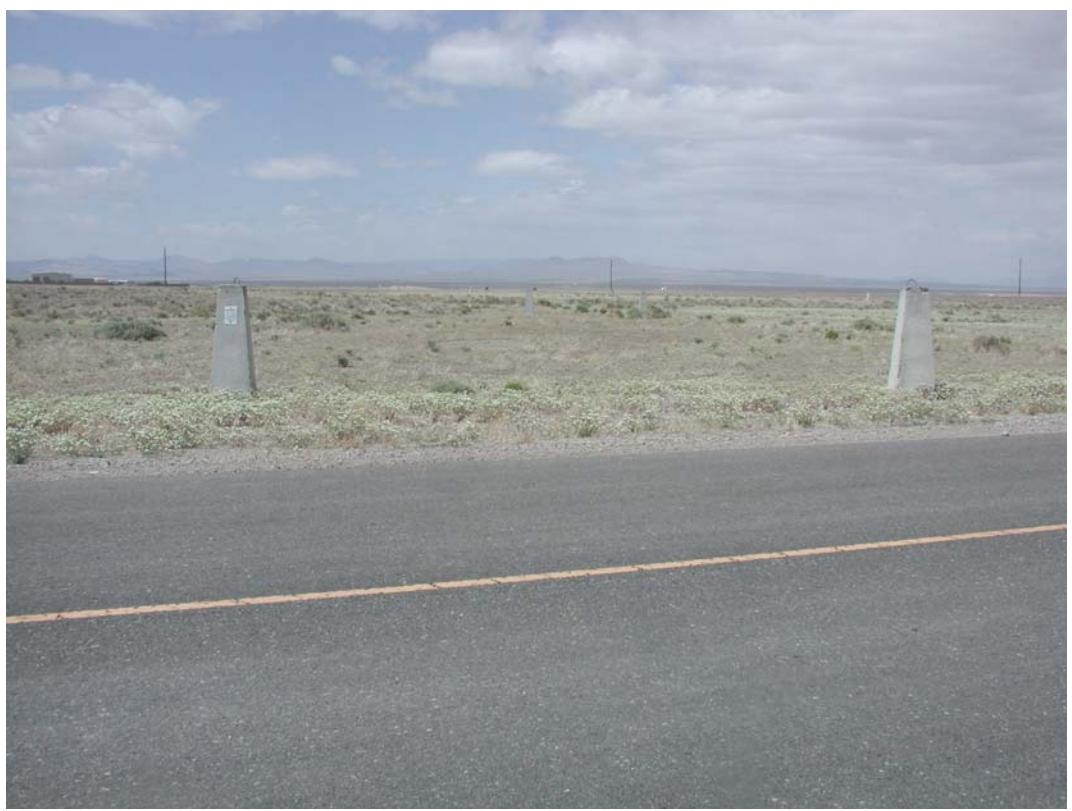
Photograph 10: CAU 424, Landfill Cell A3-2, looking north, 05/21/2008

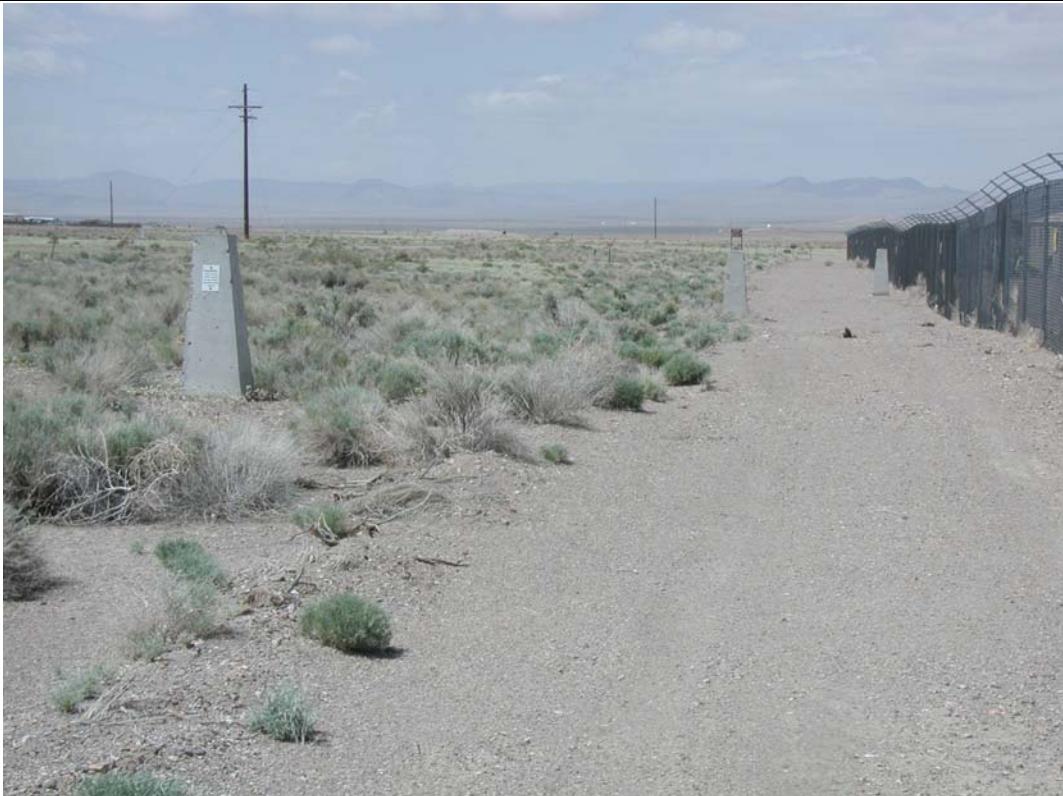
Photograph 11: CAU 424, Landfill Cell A3-3, looking northwest, 05/21/2008

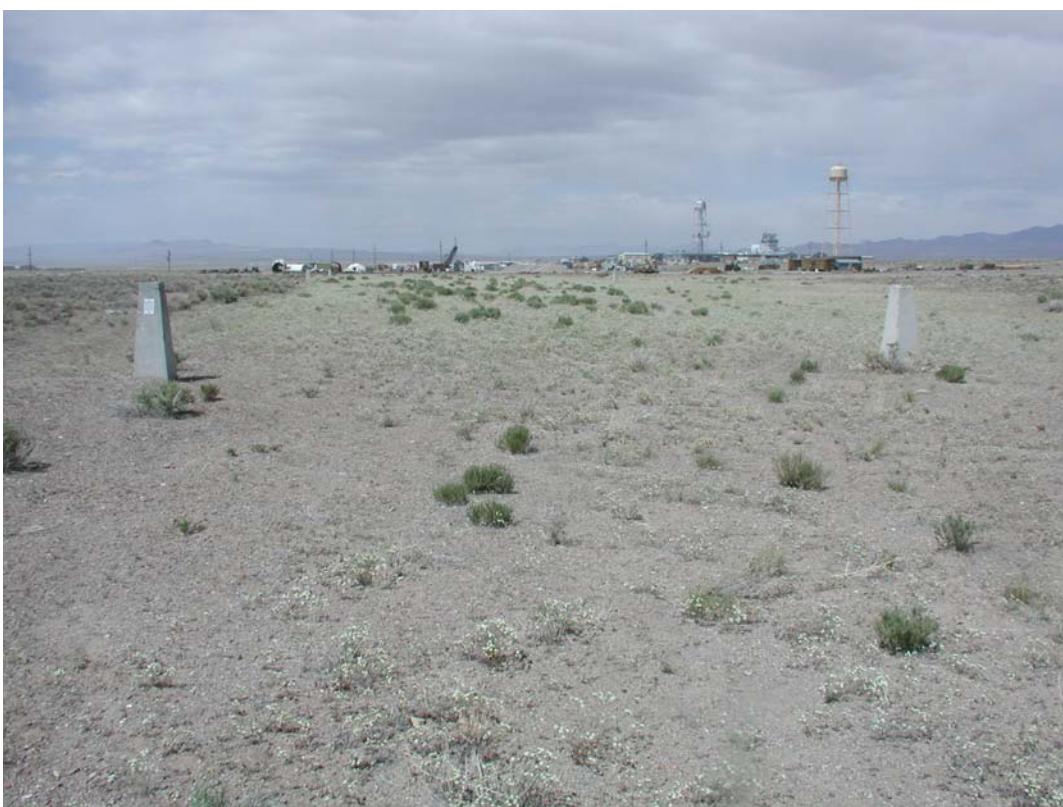
Photograph 12: CAU 424, Landfill Cell A3-4, looking north, 05/21/2008

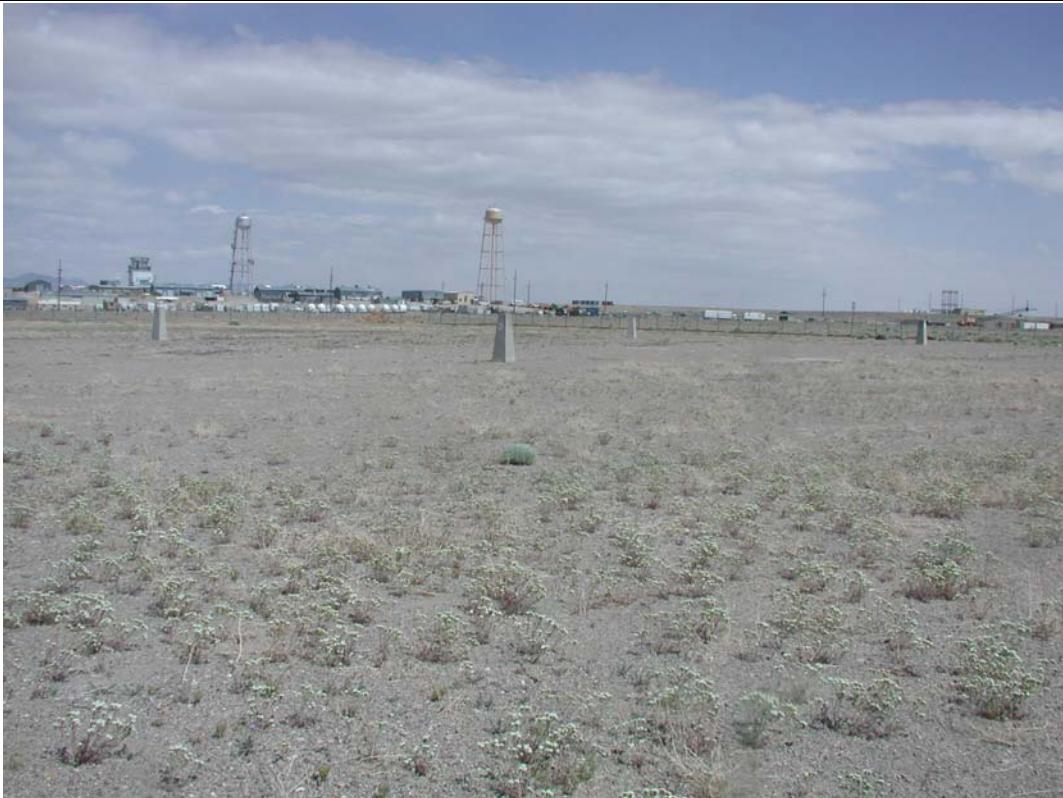
Photograph 13: CAU 424, Landfill Cell A3-5, looking southeast, 05/21/2008

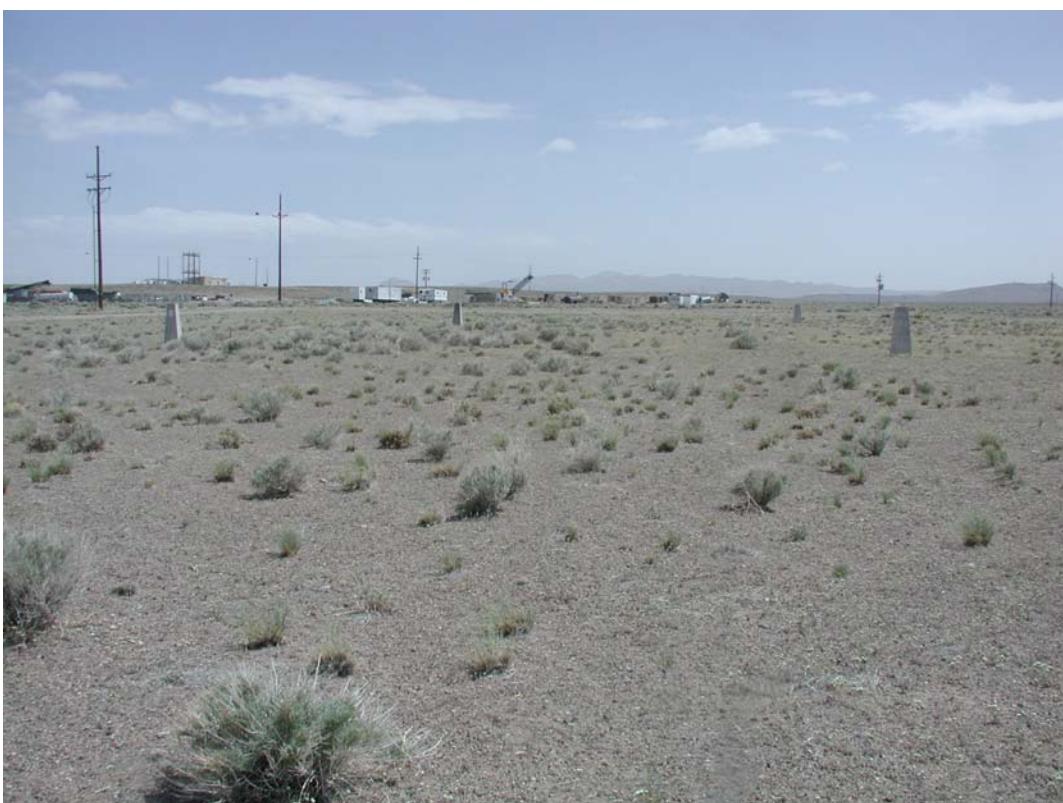
Photograph 14: CAU 424, Landfill Cell A3-6, looking south, 05/21/2008

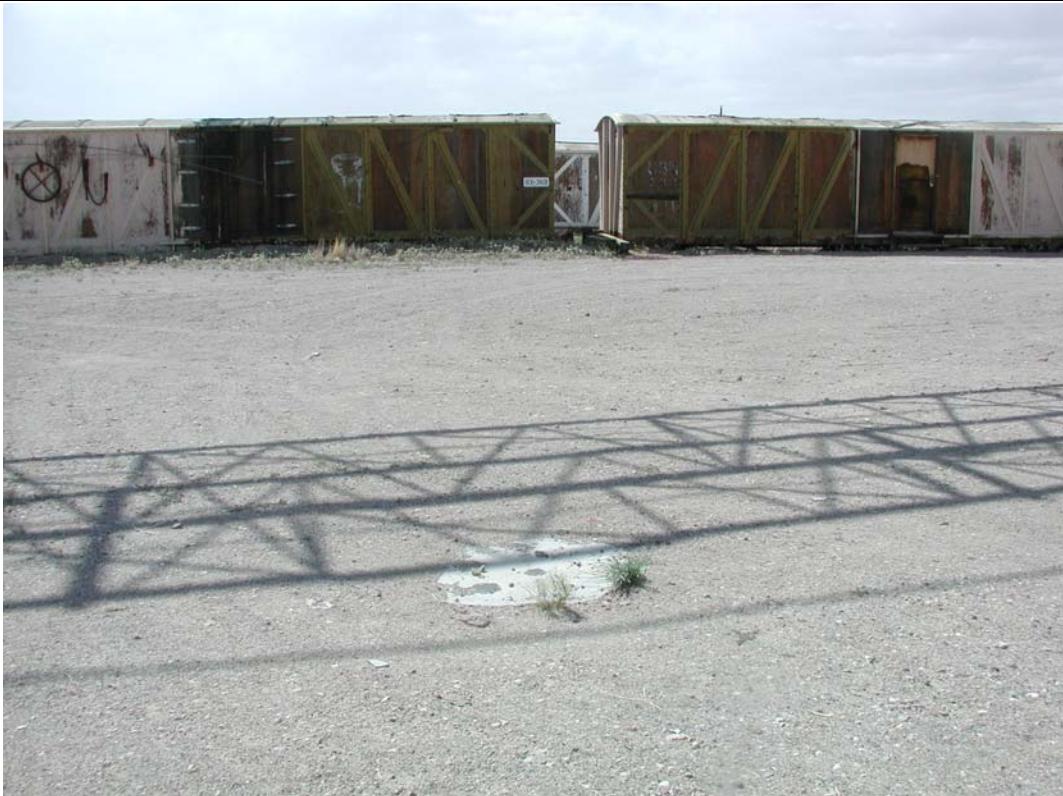
Photograph 15: CAU 424, Landfill Cell A3-8, looking west, 05/21/2008

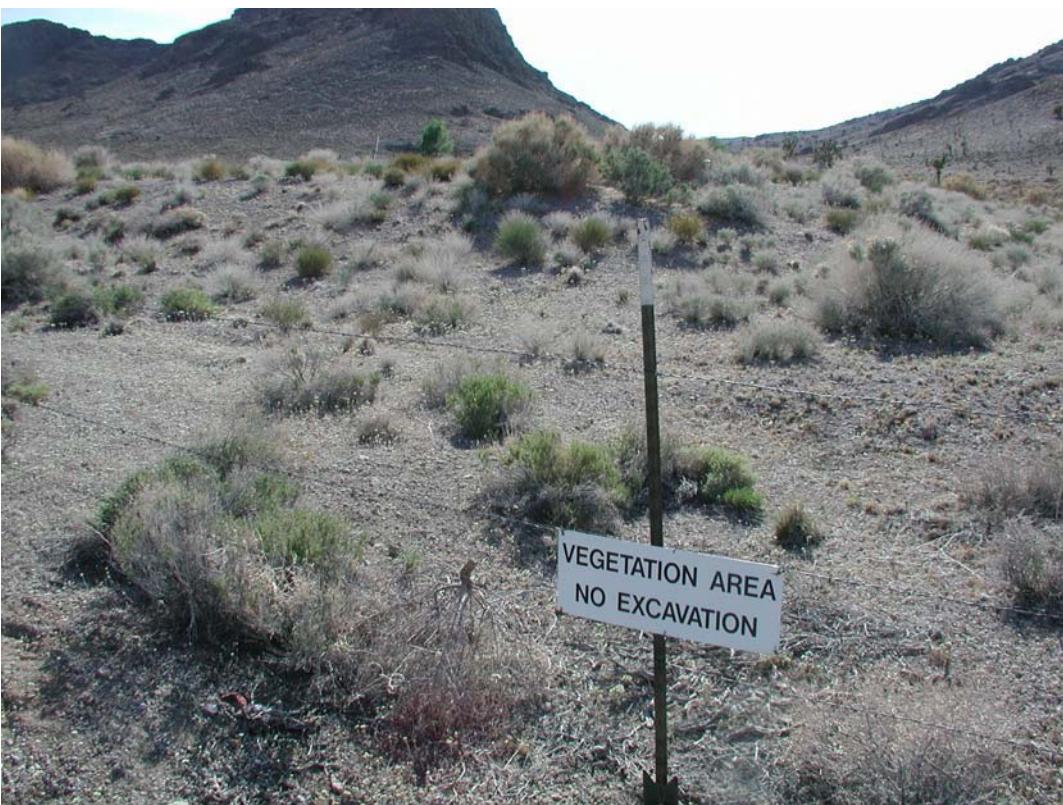
Photograph 16: CAU 426, looking southwest, 05/20/2008

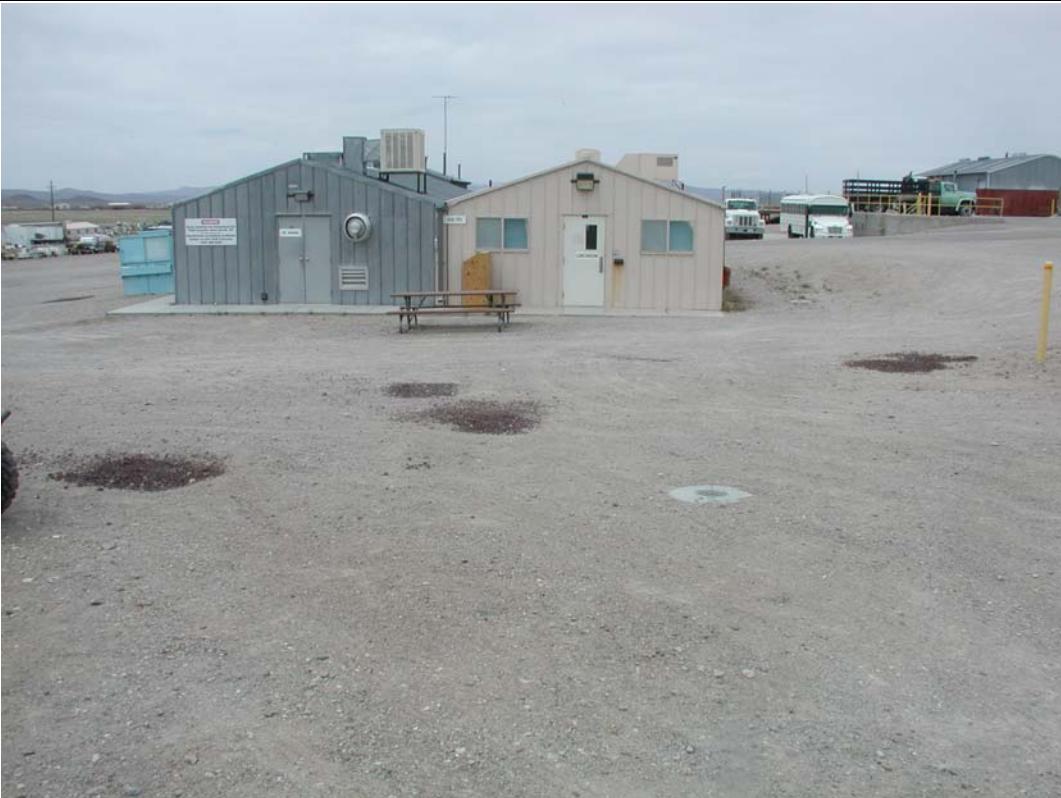
Photograph 17: CAU 427, looking north, 05/20/2008

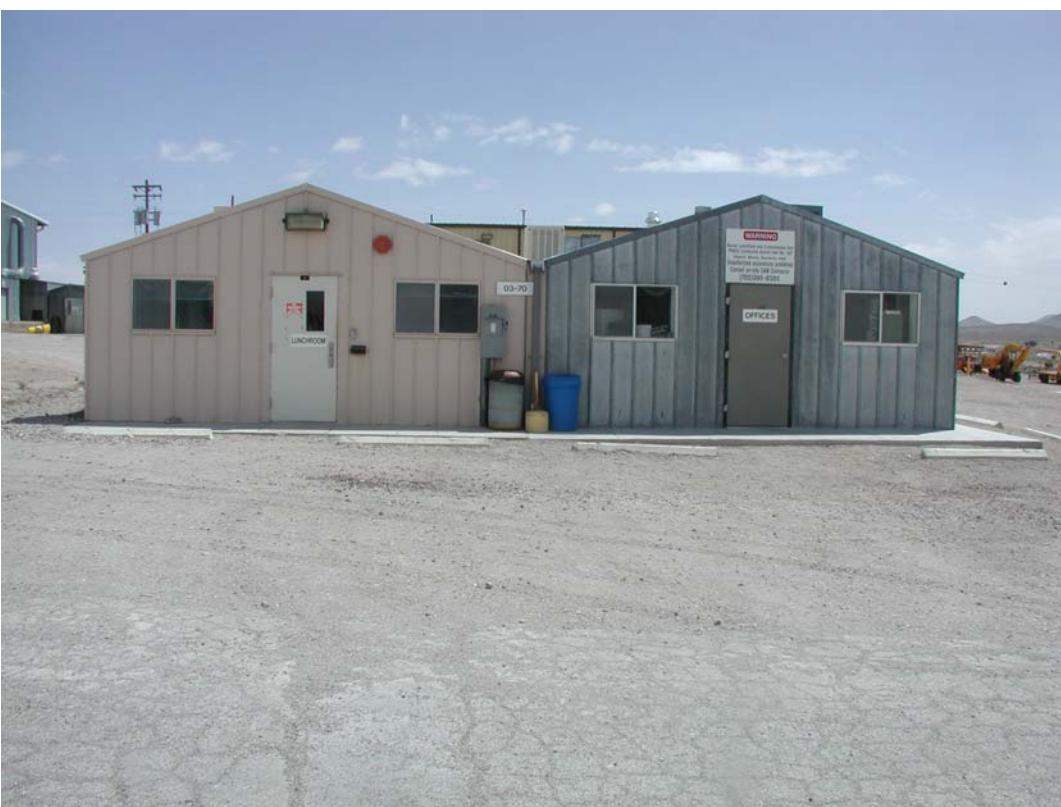
Photograph 18: CAU 427, looking south, 05/20/2008

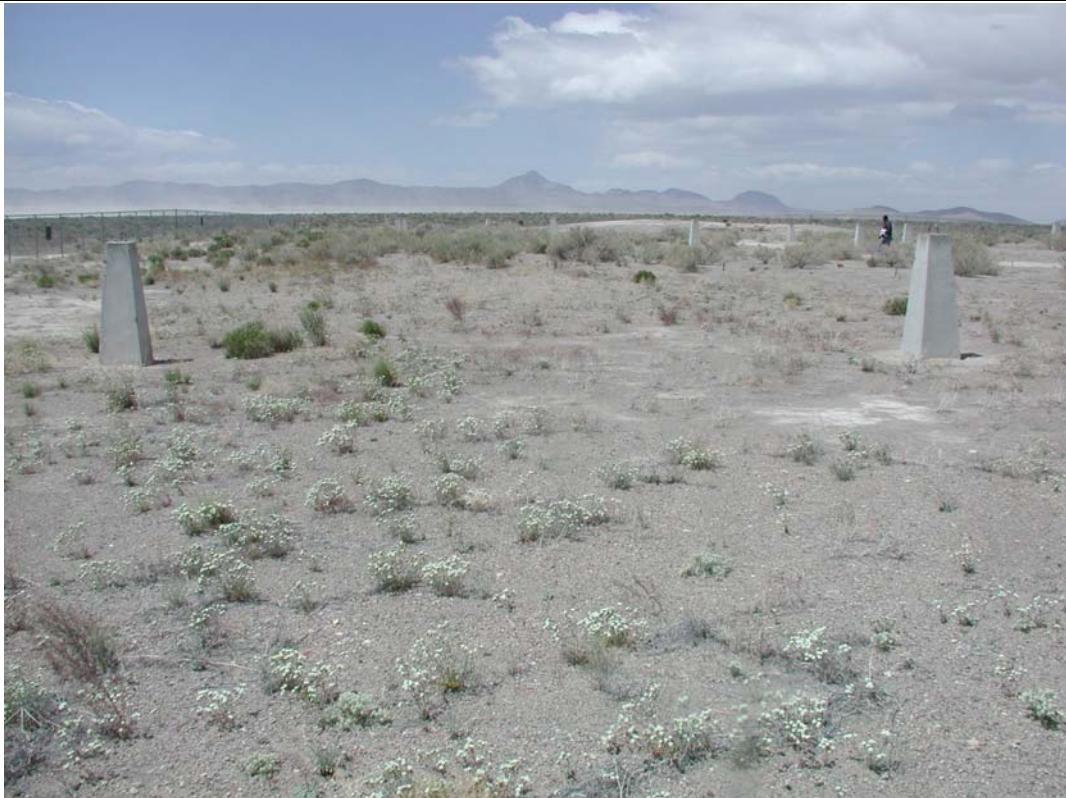
Photograph 19: CAU 453, looking northwest, 05/21/2008

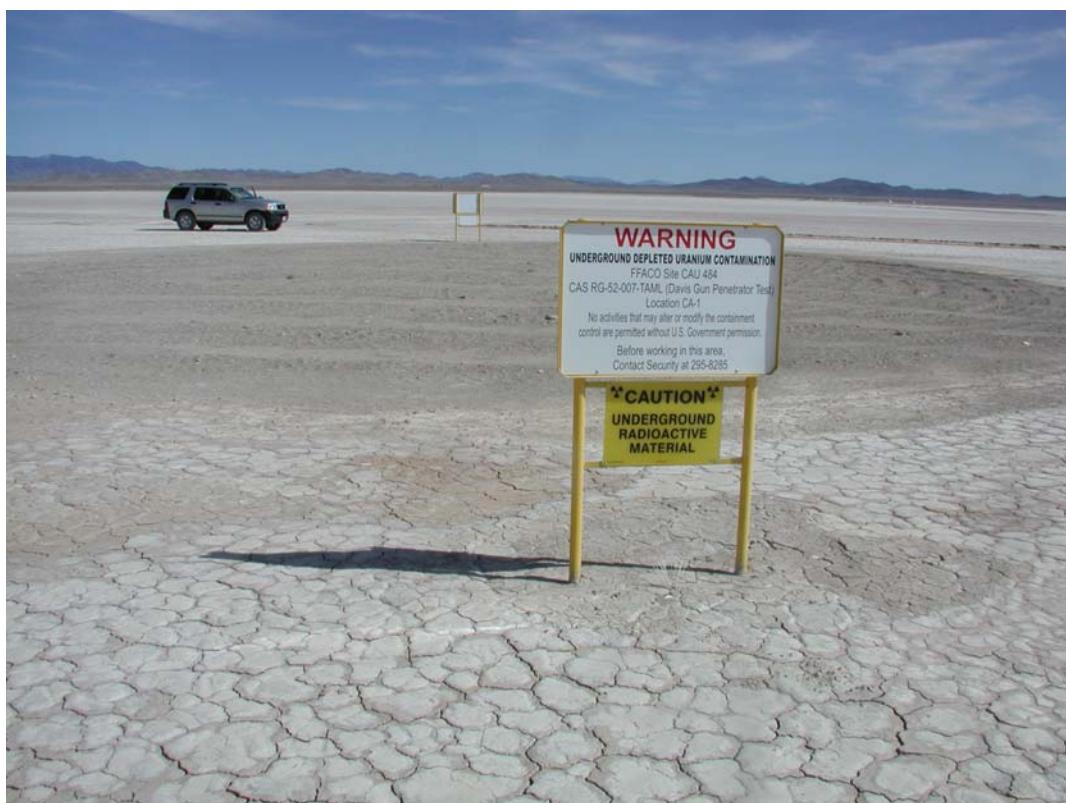
Photograph 20: CAU 484, CA1 anomaly, looking east, 03/06/2008

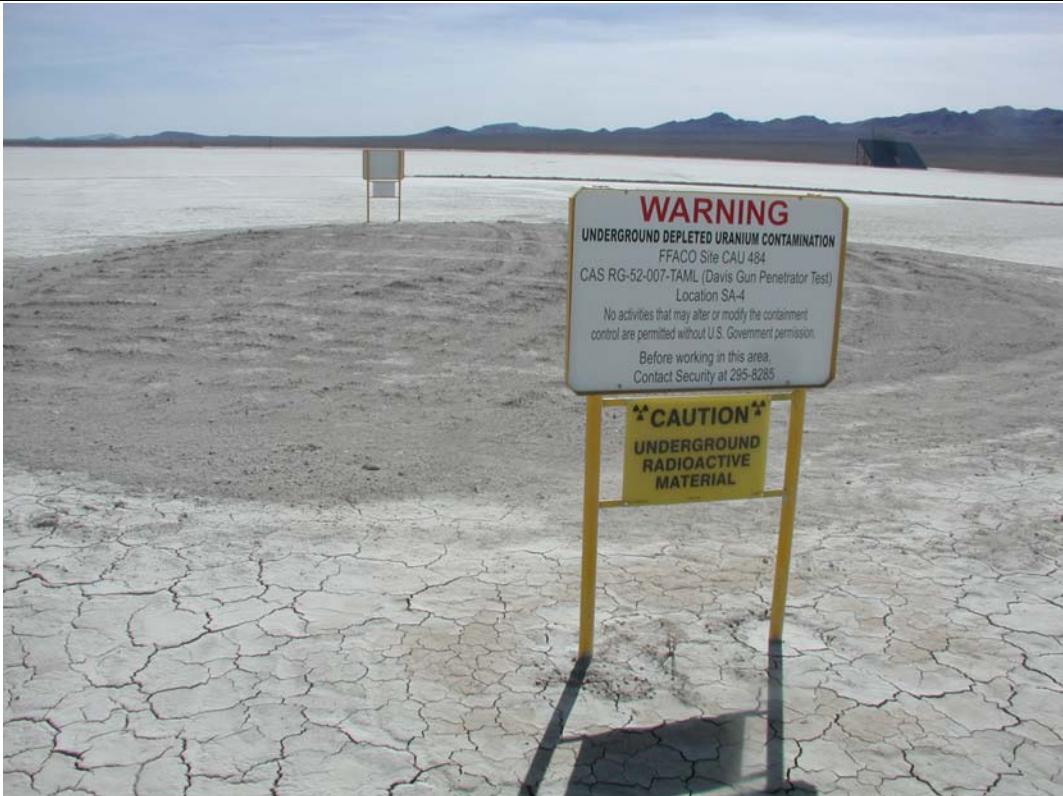
Photograph 21: CAU 484, SA4 anomaly, looking south, 03/06/2008

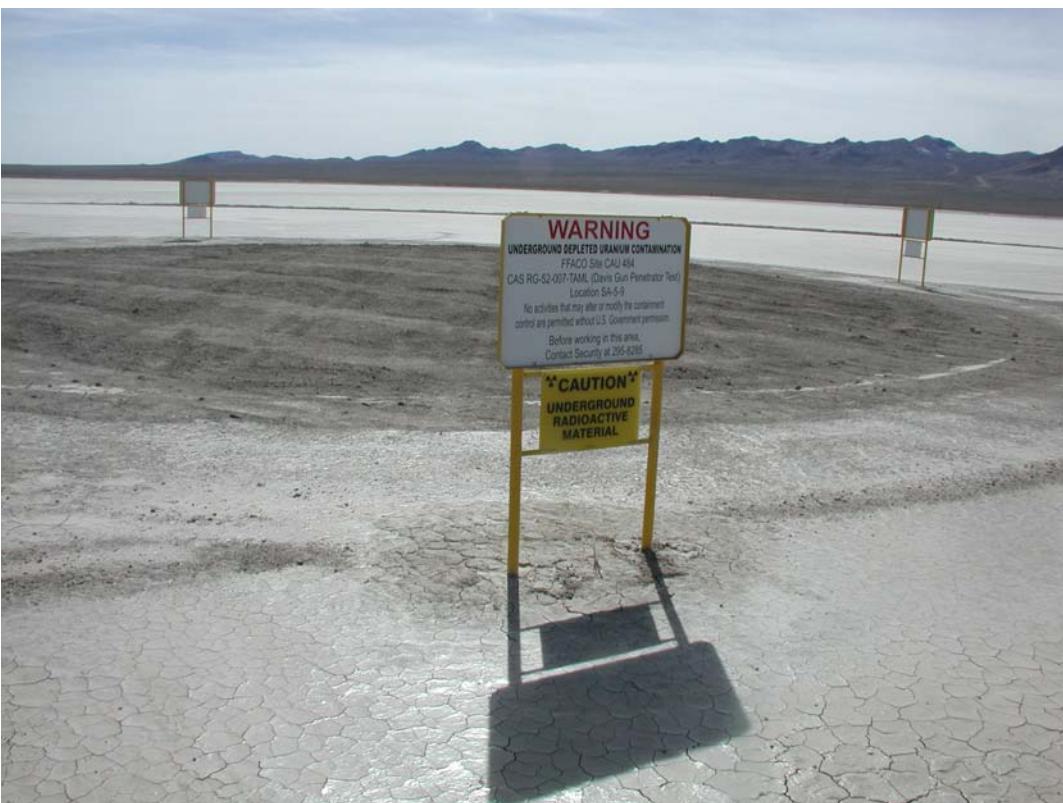
Photograph 22: CAU 484, SA5-9 anomaly, looking southwest, 03/06/2008

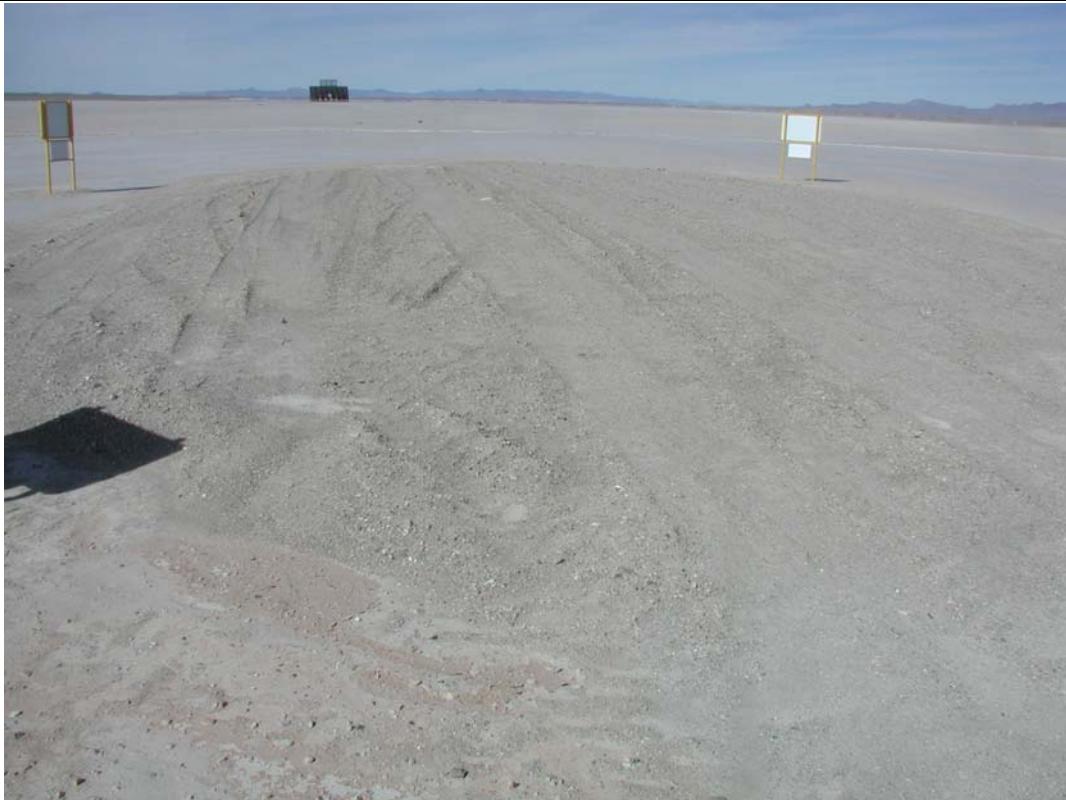
Photograph 23: CAU 484, SA12-15 anomaly, looking northwest, 03/06/2008

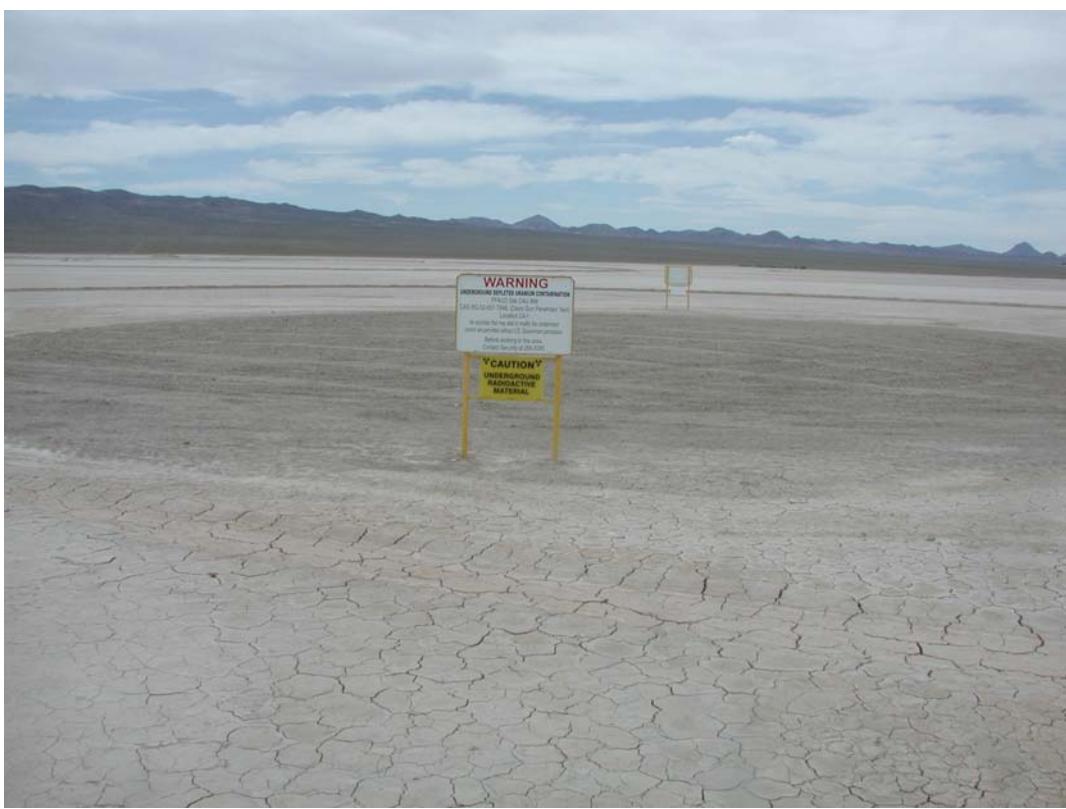
Photograph 24: CAU 484, CA1 anomaly, looking west, 05/20/2008

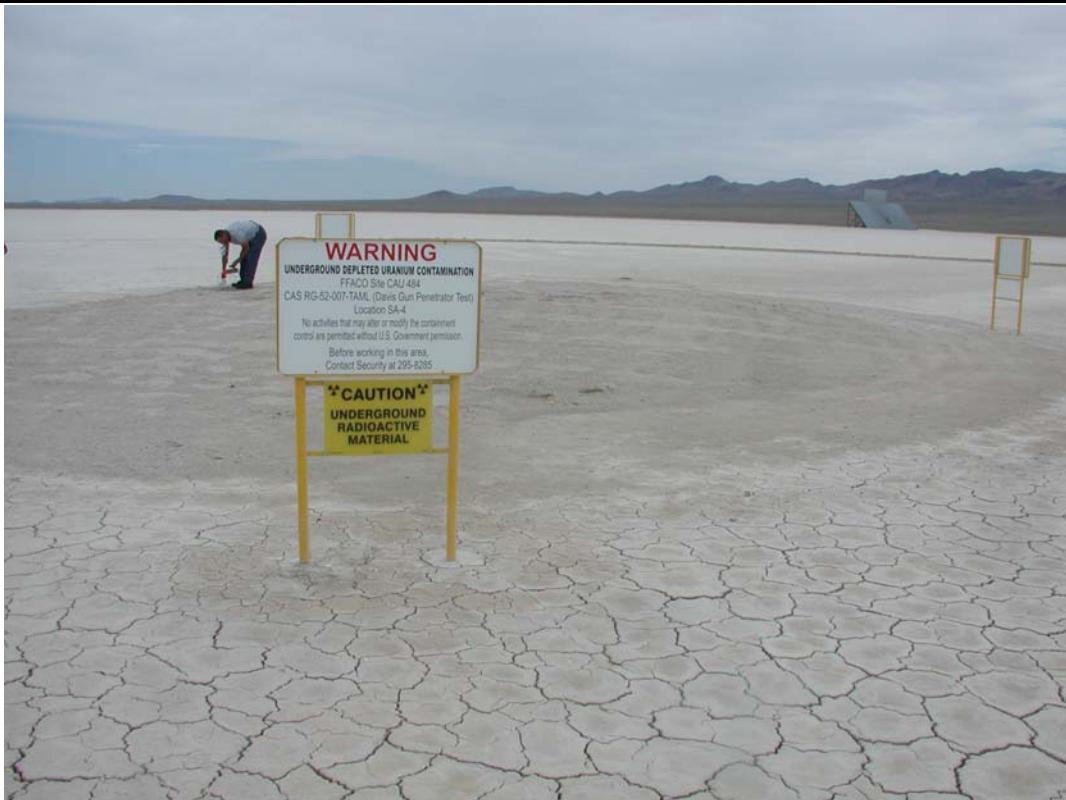
Photograph 25: CAU 484, SA4 anomaly, looking south, 05/20/2008

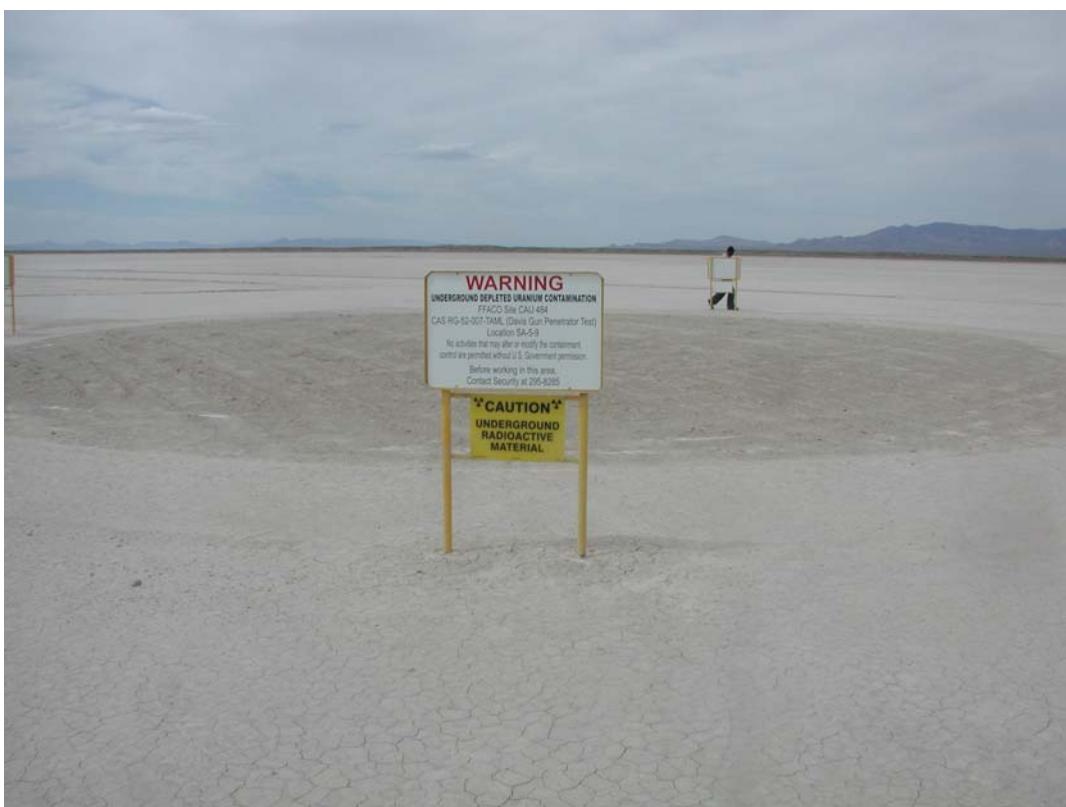
Photograph 26: CAU 484, SA5-9 anomaly, looking north, 05/20/2008

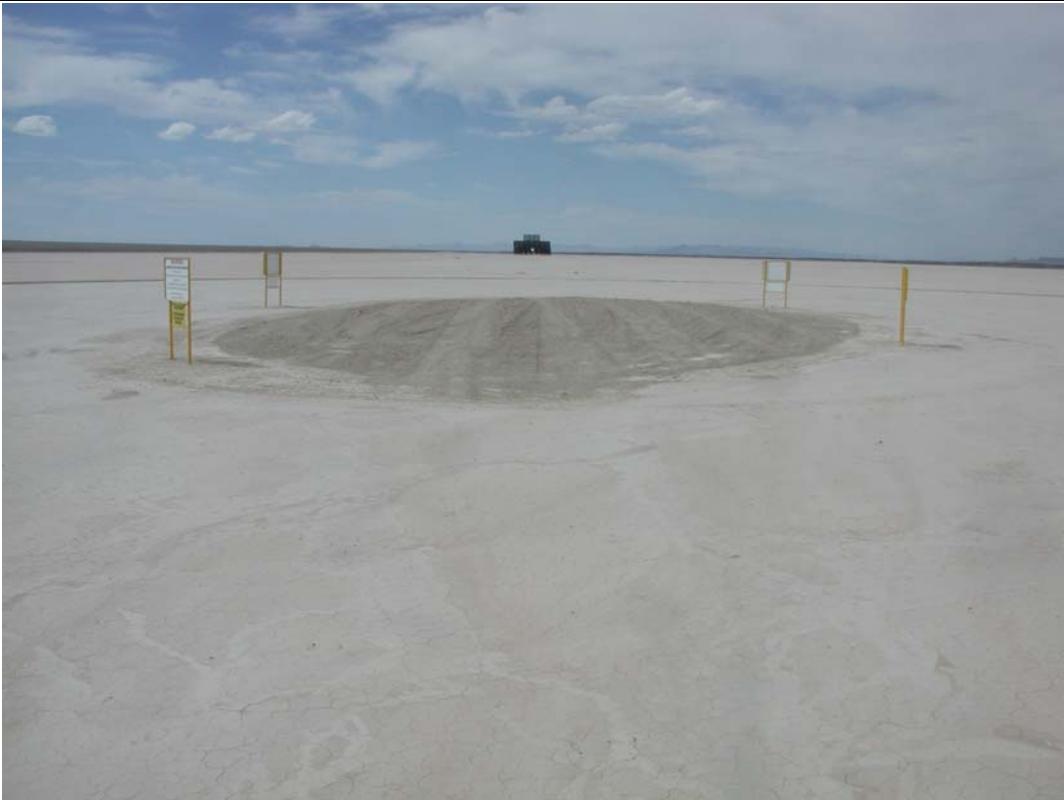
Photograph 27: CAU 484, SA12-15 anomaly, looking northwest, 05/20/2008

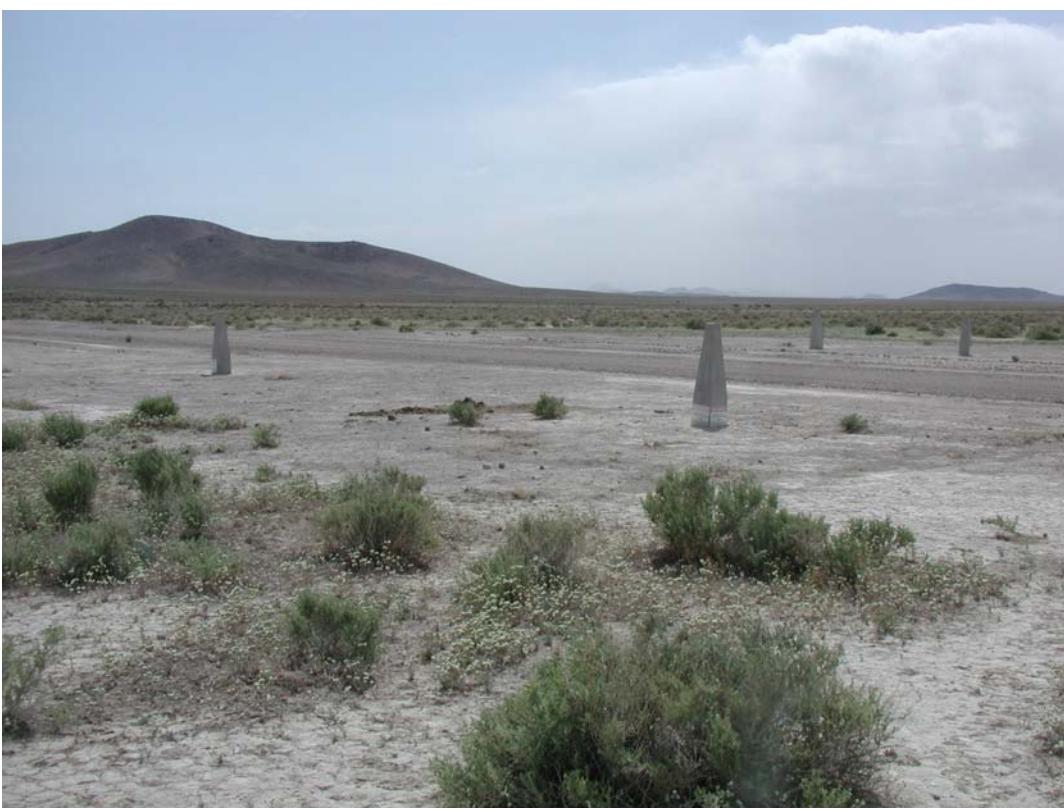
Photograph 28: CAU 487, A-8 anomaly, looking southwest, 05/21/2008

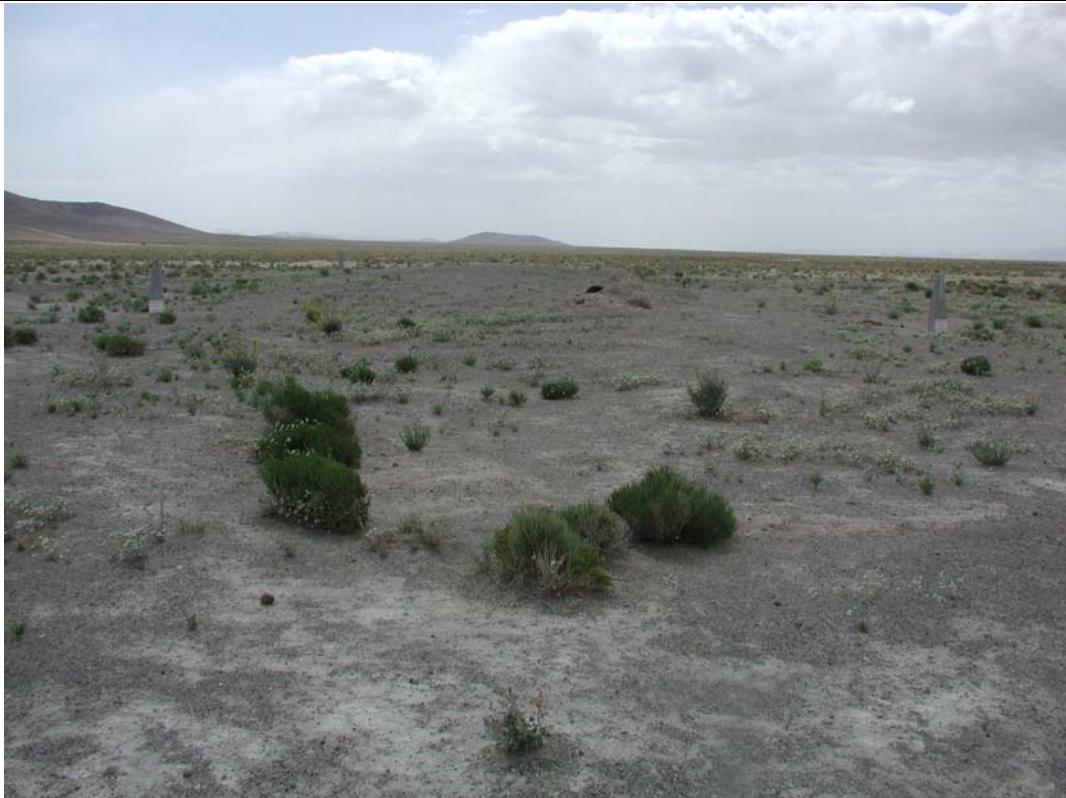
Photograph 29: CAU 487, A-17 anomaly, looking west, 05/21/2008

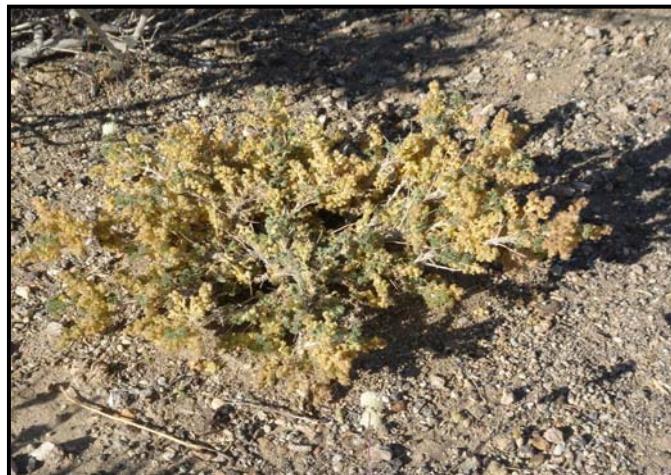
Shrub cover increased to 20 percent in 2008, up from 17 percent in 2007. The 20 percent shrub cover was slightly higher than previous highs in 2005 and 2006. Shadscale accounted for approximately 80 percent of the shrub cover, bud sagebrush contributed another 19 percent, and the remaining was from winterfat. This was the first time that winterfat has contributed to total plant cover since 2004. The amount of cover contributed by shadscale was a good indication that this plant has successfully established on the site. Bud sagebrush increased from about 1 percent cover the last couple years to more than 3 percent in 2008. Bud

Figure 5. Bud sagebrush in full flower and early seed on the staging area of the CAU 404 staging area

sagebrush was flowering and setting seed during the 2008 monitoring (Figure 5).

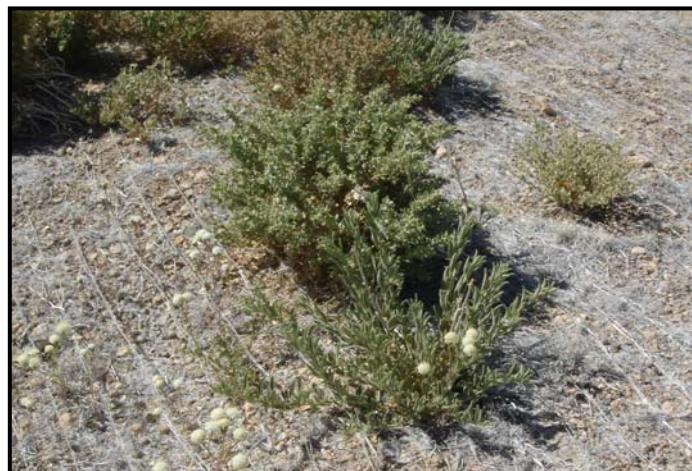
The density of shrubs increased slightly from 2007 to 2008 (Table 14). The increase can be attributed to an increase in the density of shadscale. All other shrubs experienced a decrease in density. Of the species of shrubs present on the site, shadscale was most likely the species best adapted to the dry conditions experienced the last few years. Its density and overall vigor have remained high even during less than favorable growing conditions (Figure 8). Bud sagebrush, fourwing saltbush, winterfat, and especially rubber rabbitbrush were not as well adapted to the drier conditions, and the density of these species has declined the last couple of years (Table 14).

Figure 8. Fourwing saltbush, foreground, and shadscale, background, were the most common shrubs at CAU 407

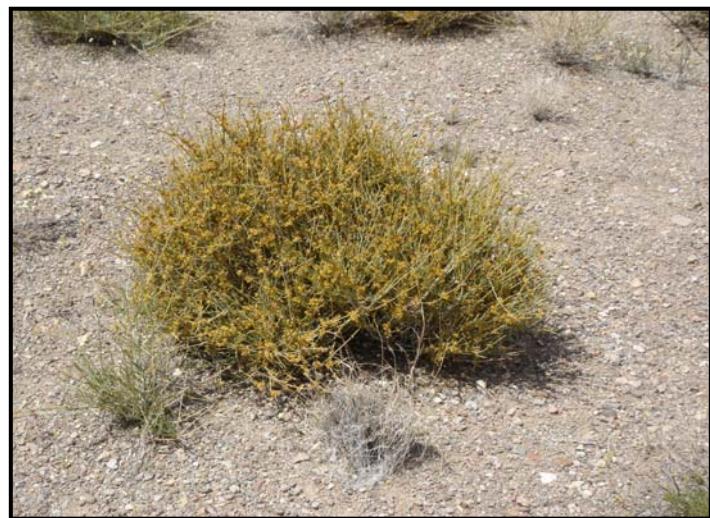
Figure 10. Nevada jointfir in full flower on the cover at CAU 426
